## **ARBORICULTURAL DEVELOPMENT IMPACT ASSESSMENT REPORT**

**ESQ Stages 4 and 5, Panthers North Precinct  
Mulgoa Road, Penrith NSW**

**REVISION A**

**20<sup>th</sup> of September 2023**

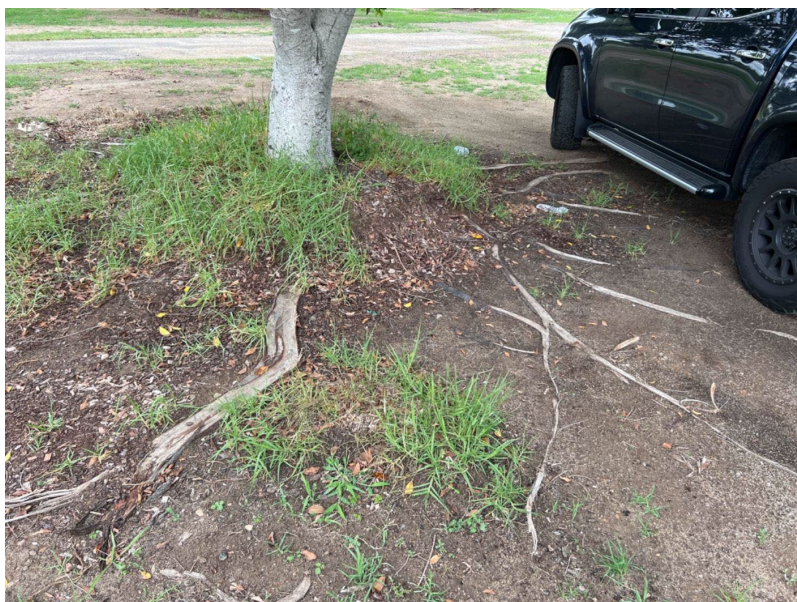
The subject trees are in good health and condition with the exception of Trees 224, and 225 which are in fair condition with chlorotic foliage as a result of significant mechanical damage to the root crown and surface roots.

- 3.16. Tree 224 *Ficus benjamina***  
This mature tree is approximately 9m tall with a canopy spread of 8m. It has multiple co-dominant trunks from the base with an aggregate DBH of 45mm. This tree is in fair health and condition with chlorotic foliage. There is evidence of damage to the root crown and significant damage to surface structural roots.

**Figure 1 - Tree 224 damage to root crown and surface roots**

| Tree no. | Species | Common Name | Height | Spread(m ) | Trunk (single, twin, multiple @) | DBH (mm) | TPZ Radius (m) | Diameter at Root Flare (DRF) (mm) | SRZ radius (m) | Trunk lean | Tree Age | Overall Health & Vigour | Crown Distribution | Structure | Pruning History | Defects | Pest Infestation | Canopy Density | Deadwood | Epicormic Growth | Life expectancy | Env. & Landcape significance | Retention Value | Notes/Comments |
|---|---|---|---|---|---|---|---|---|---|---|---|---|---|---|---|---|---|---|---|---|---|---|---|---|
| 224 | Ficus benjamina | Weeping Fig | 9 | | Multiple Stems | 453 | 5.44 | 350 | 2.13 | Nil | Mature | Fair (60-69) | Symmetrical | Fair | No evidence | No evidence | No evidence | Normal | <5% | <5% | 40+ years | Medium | Medium | Damage to root crown. Significant damage to surface structural roots. Chlorotic foliage |

| 224 | <i>Ficus benjamina</i> | Remove | Not viable to be retained due to the proposed development. |

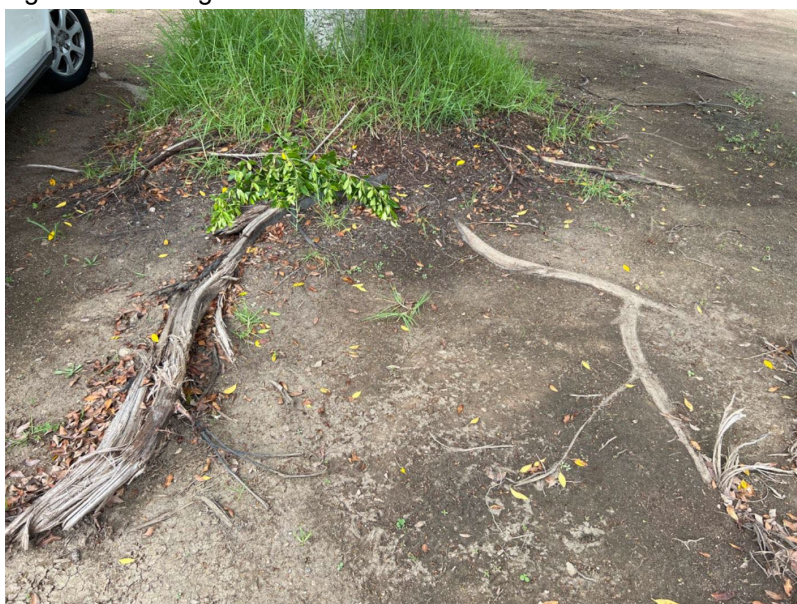
This mature tree is approximately 10m tall with a canopy spread of 8m. It has multiple co-dominant trunks from the base with an aggregate DBH of 45mm. This tree is in fair health and condition with chlorotic foliage. There is evidence of damage to the root crown and significant damage to surface structural roots.

**Figure 2 - Damage to root crown and surface roots Tree 225**

| Tree no. | Species | Common Name | Height | Spread(m ) | Trunk (single, twin, multiple @) | DBH (mm) | TPZ Radius (m) | Diameter at Root Flare (DRF) (mm) | SRZ radius (m) | Trunk lean | Tree Age | Overall Health & Vigour | Crown Distribution | Structure | Pruning History | Defects | Pest Infestation | Canopy Density | Deadwood | Epicormic Growth | Life expectancy | Env. & Landcape significance | Retention Value | Notes/Comments |
|---|---|---|---|---|---|---|---|---|---|---|---|---|---|---|---|---|---|---|---|---|---|---|---|---|
| 225 | Ficus benjamina | Weeping Fig | 10 | | Multiple Stems | 446 | 5.35 | 360 | 2.15 | Nil | Mature | Fair (60-69) | Symmetrical | Fair | No evidence | No evidence | No evidence | Normal | <5% | <5% | 40+ years | Medium | Medium | Chlorotic foliage. Significant damage to root crown and surface structural roots |

| 225 | <i>Ficus benjamina</i> | Remove | Not viable to be retained due to the proposed development. |
