14 February 2024

Our ref: SYDEN346305-L01

Addendum to Report on Detailed Site Investigation (Contamination), Proposed Seniors Housing Development, Uniting Edinglassie Development, Emu Plains

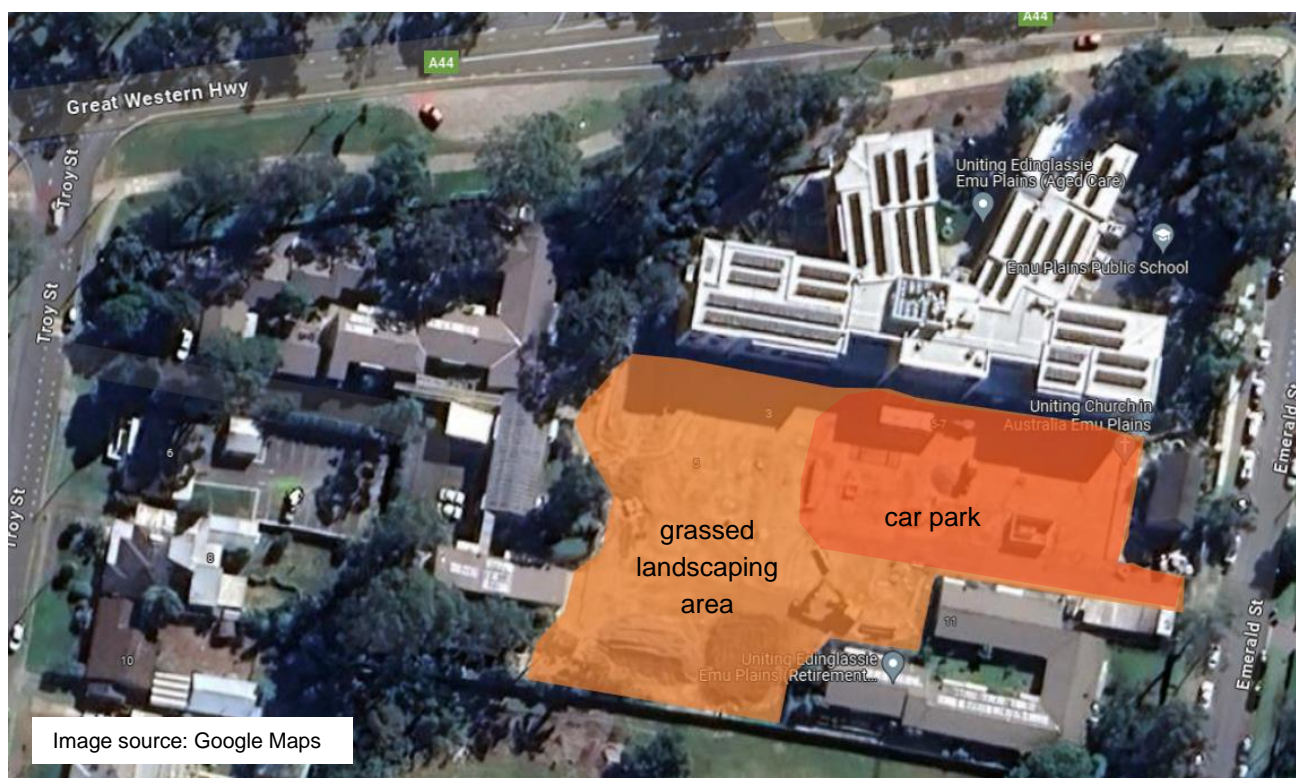
Figure 1: Approximate Extent of Imported Fill (information provided by Midson Group)

Based on EI Australia (2021), Douglas Partners (2022) understood that the source site of the imported fill for the car park subgrade was located at 219-223 Maroubra Road, Maroubra. A dry cleaner operated at that premise until 1988. Douglas Partners (2022) reported that EI Australia collected eight (8) samples and the samples were analysed for heavy metals, PAH, BTEX, TRH, OCP, OPP and PCB. In addition, twelve (12) samples were analysed for asbestos. Based on the results, EI Australia (2021) concluded that the assessed material could be classified as virgin excavated natural material (VENM) for reuse offsite. However, Douglas Partners considered VOC was a chemical of potential concern due to potential dry cleaning solvent use. However, Douglas Partners (2022) reported that VOC was not selected for analysis by EI Australia. Douglas Partners (2022) considered that the absence of VOC analysis represents a data gap and further assessment of the material fill should be undertaken.

Coffey was subsequently provided with a copy of the Waste Classification Certificate prepared by EI Australia (2021). Based on Coffey's review of the certificate, Coffey understands that fill had been removed with natural sands and sandstone bedrock exposed for sampling by EI Australia. Whilst VOC was not analysed, nine primary samples were analysed for TRH and they were reported below laboratory's limits of detection (LOR). This indicates significant concentrations of VOC would not likely to be present and the samples were not likely to have been impacted by dry clearing solvents.

On behalf of Uniting, Midson Group made a request to Randwick City Council to access additional contamination reports associated with the source site in Maroubra. A number of additional reports were subsequently obtained and provided to Coffey for review. These included the Detailed Site Investigation report prepared by EI Australia (2019) for 219-223 Maroubra Road, Maroubra. The EI Australia (2019) investigation comprised groundwater sampling from three (3) shallow groundwater monitoring wells (generally screening between 5m and 9m below ground level). The groundwater samples were analysed for VOC along with TRH. Both VOC and TRH were detected below laboratory's limits of reporting (LOR).

On the basis of the above, Coffey considers that the subject material was not likely to have been impacted by dry clearing solvents. Therefore, no additional investigation or remediation would be warranted with respect to the subject imported fill.

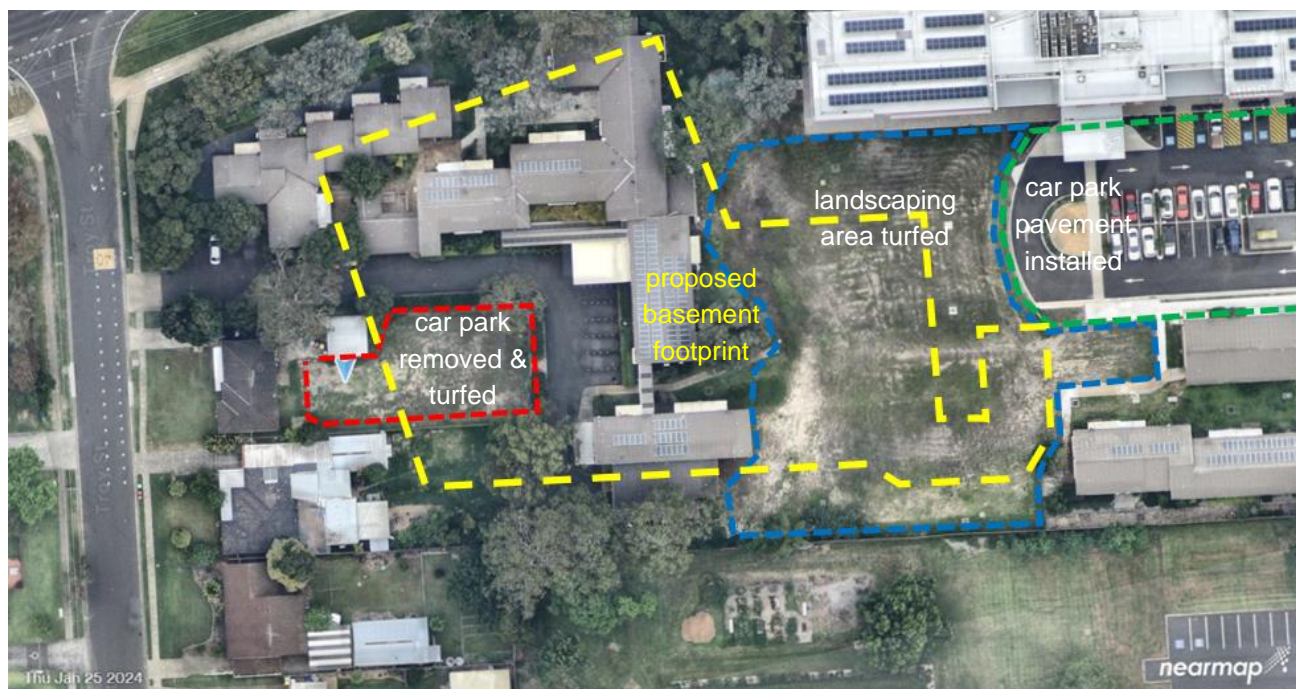
Figure 2: Activities completed Since the Preparation of the DSI (information provided by Midson Group)

- Coffey understands that the carpark on the eastern side (green outline) generally comprised pavement installation and the landscaping area (blue outline) generally comprised turf installation. Earthwork activities² following completion of the DSI were relatively minor and superficial, generally to facilitate the installations of pavement and turf.
- Coffey understands that the rear of 6 Troy Street (red outline) was used as a temporary car park (as reported in the DSI report) during the development of the residential aged care facility, approved under a separate development consent. Midson Group advised that the temporary car park has since been removed and turfed, as a condition of the development consent.

Coffey considers the above pavement and turf installation activities, completed as part of a separate development consent, are of low material risk with respect to contamination. The pavement area is located outside the proposed seniors housing (independent living units) development. Therefore, further investigation of the pavement area is not warranted for the proposed seniors housing development.

The proposed seniors housing development will include a basement car park. The proposed basement excavation (yellow outline) will cover a large portion of the landscaping area (blue outline) and most of the rear of 6 Troy Street (red outline). Therefore, most of the subject areas will need to be excavated regardless of contamination status, as part of the basement construction.

Coffey considers that there will be sufficient safeguard with respect to managing potential contamination risks associated with minor works that have been completed after the DSI at the landscaping area (blue outline) and rear of 6 Troy Street (red outline), for the following reasons:

- The completed pavement and turf installation works, completed as part of a separate development consent, are of low material risk with respect to contamination.
- Most of the subject areas will need to be waste classified and excavated regardless, as part of the basement construction.
- Potential contamination, if present in an unlikely case, could be managed under an unexpected finds protocol (UFP), which has already been recommended in the DSI report by Douglas Partners (2022).
