## HAZARDOUS MATERIALS MANAGEMENT REGISTER

Shine Motor Corp Pty.Ltd

8 Noonan Road Ingleburn

REPORT NO: J22019203052022HMMR

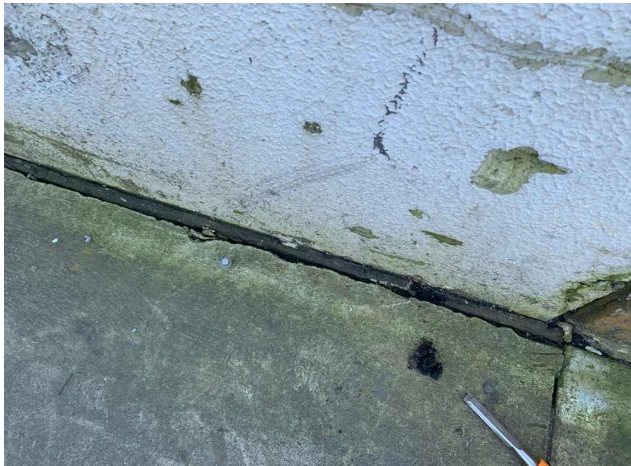
1 - External / GF / Perimeter / Damp proof course to walls and expansion joints / Bitumen (J220192255A3) - NAD,ORG

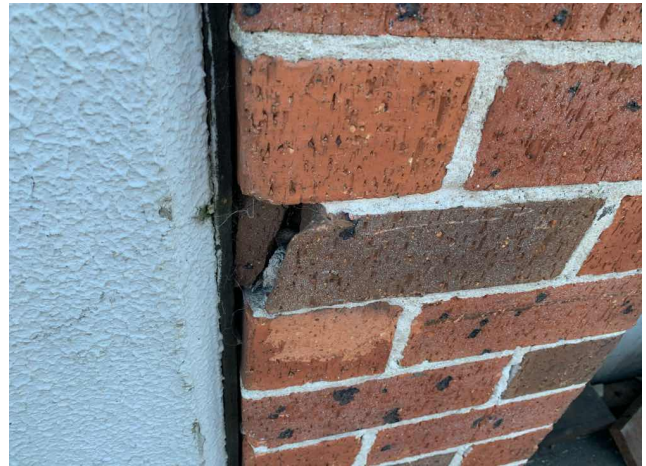
1.1 - External / GF / Perimeter / Damp proof course to walls and expansion joints / Bitumen (J220192255A3) - NAD,ORG

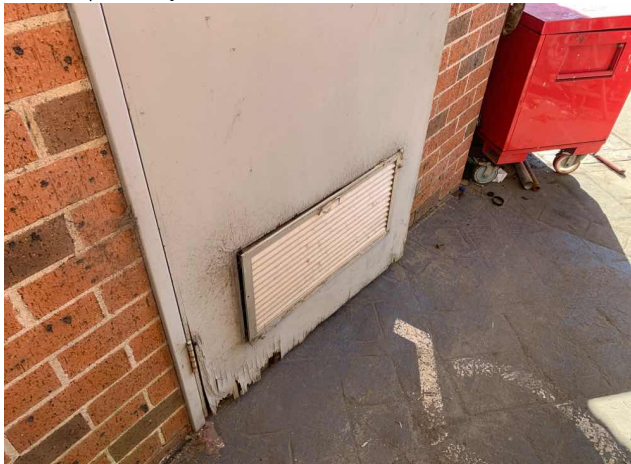
2 - External / GF / Perimeter / Doors and door frames / Topcoat -Blue (J220192255LP1.7) - <0.1%w/w

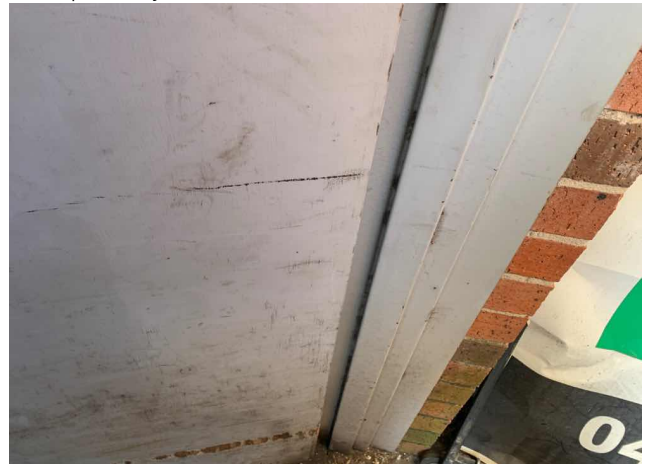
2.1 - External / GF / Perimeter / Doors and door frames / Topcoat -Blue (J220192255LP1.7) - <0.1%w/w

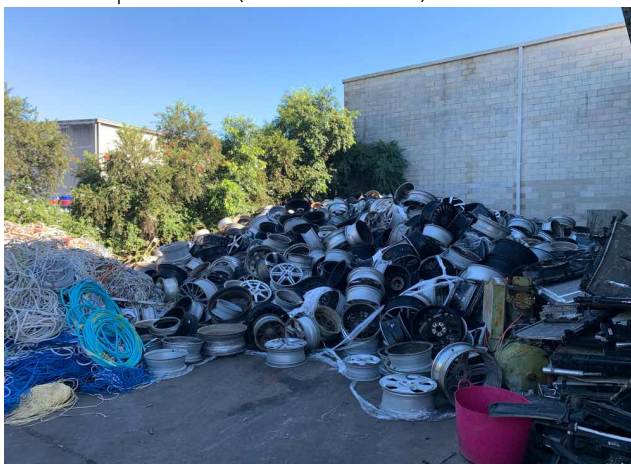
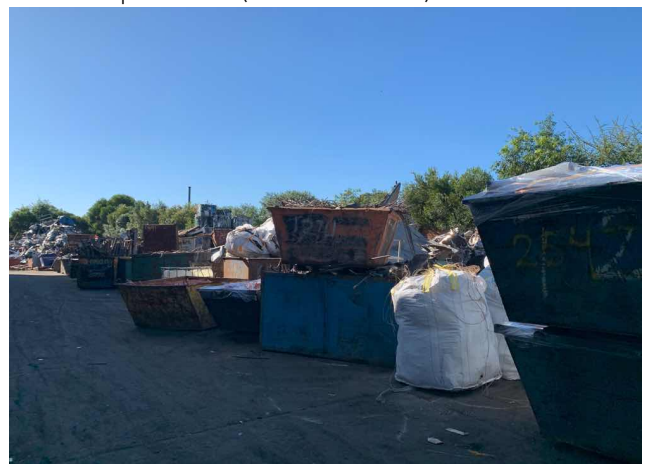
3 - External / GF / Perimeter / External areas /  
(J220192255La3) - Presumed to contain asbestos or  
hazardous materials

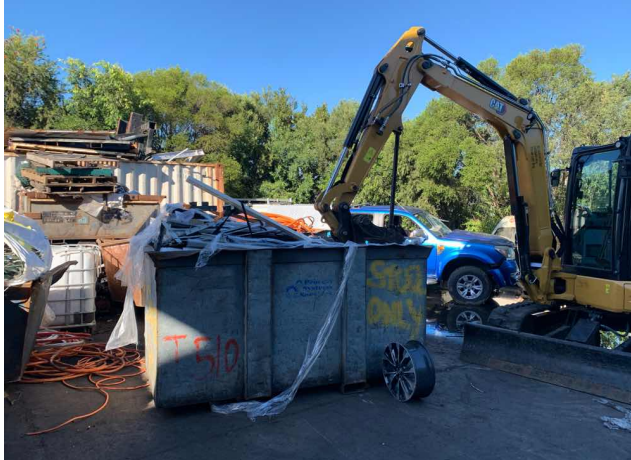
3.2 - External / GF / Perimeter / External areas /  
(J220192255La3) - Presumed to contain asbestos or  
hazardous materials

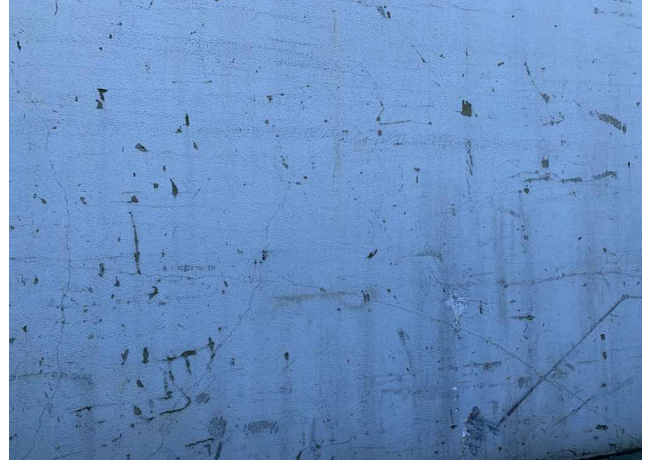
4 - External / GF / Perimeter / Walls / Textured Coating  
(J220192255A4) - NAD,ORG

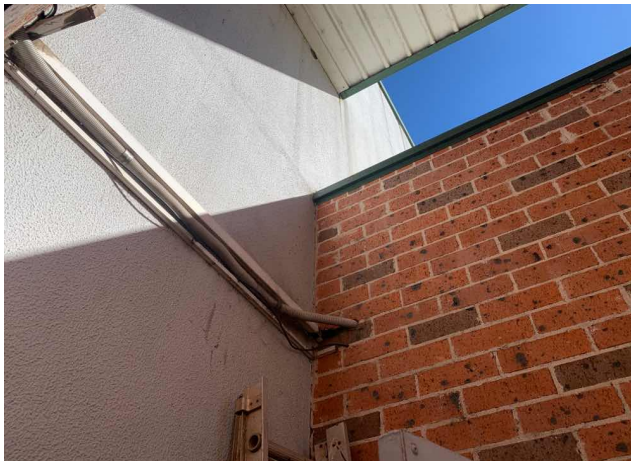
4.1 - External / GF / Perimeter / Walls / Textured Coating  
(J220192255A4) - NAD,ORG

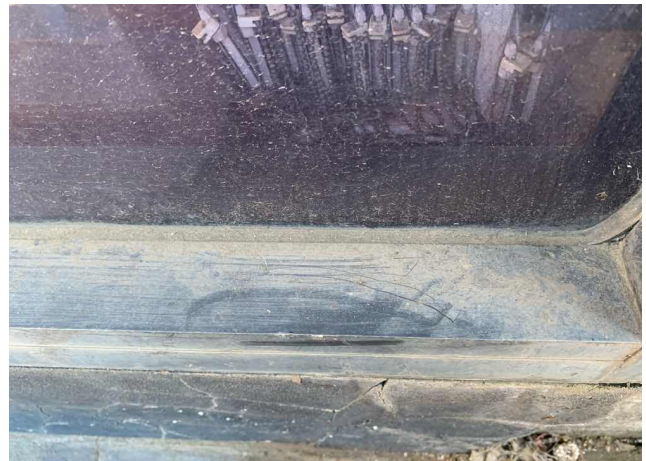
Location	Material Description	Risk Rating
External / GF / Perimeter / Reception step and low level stonework	Topcoat - Black	Low
Internal / GF / Warehouse / Staircase and storage containers	Topcoat - Navy blue	Low

5.1 - External / GF / Perimeter / Reception step and stonework /  
Topcoat - Black (J220192255LP5) - 0.14%w/w

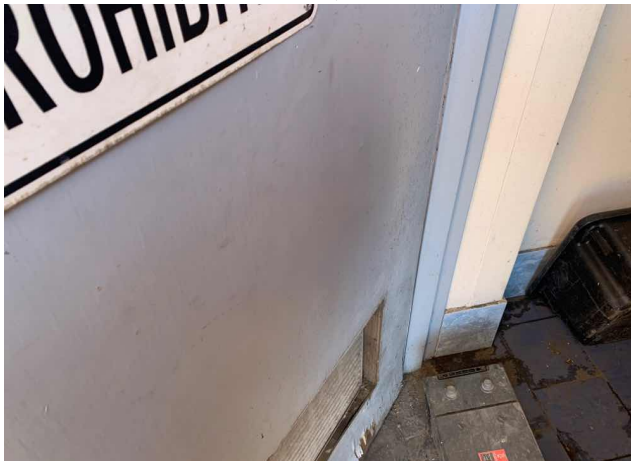
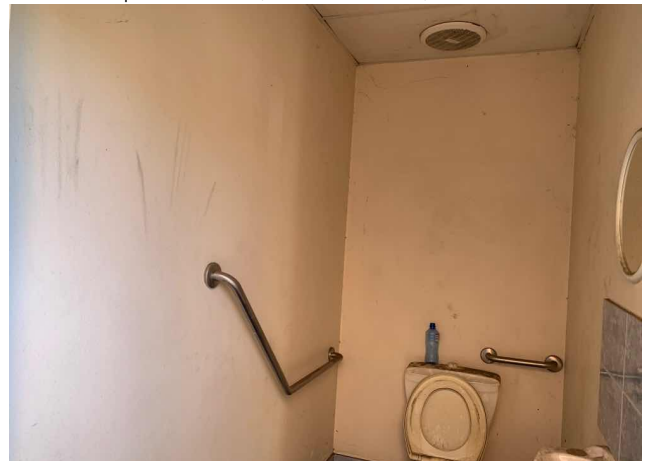
6 - Internal / GF / Handicapped toilet / Door and door frame / Topcoat -Blue (J220192255LP1.8) - <0.1%w/w

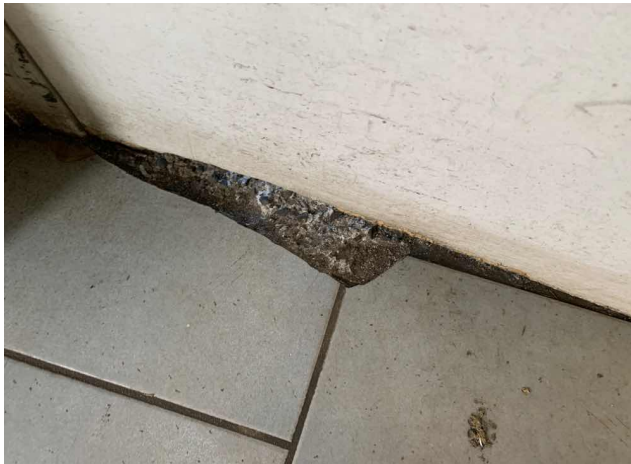
9 - Internal / GF / Kitchen / Beneath ceramic tiles / (J220192255La1.1) - Presumed to contain asbestos or hazardous materials

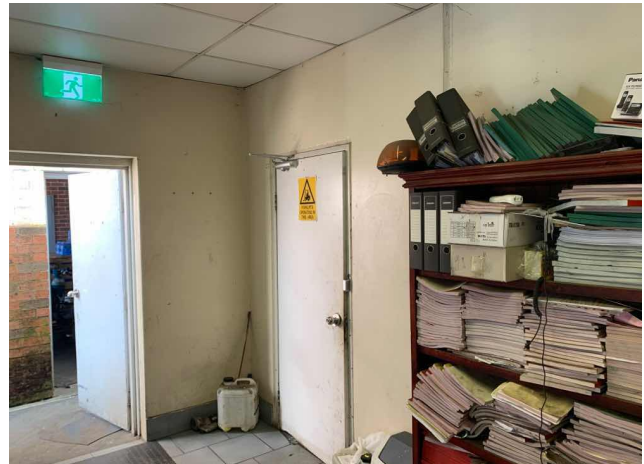
9.1 - Internal / GF / Kitchen / Beneath ceramic tiles / (J220192255La1.1) - Presumed to contain asbestos or hazardous materials

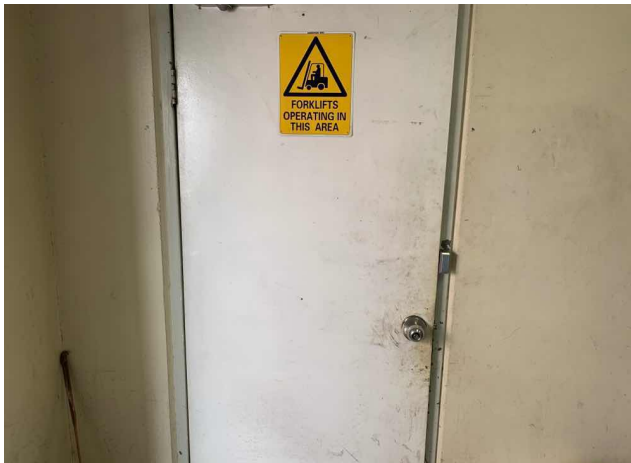
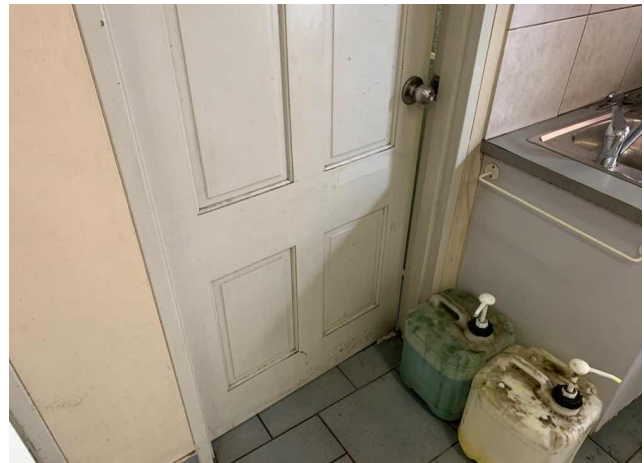
11 - Internal / GF / Kitchen / Doors leading to the warehouse & outside / Topcoat -White (J220192255LP3) - <0.1%w/w

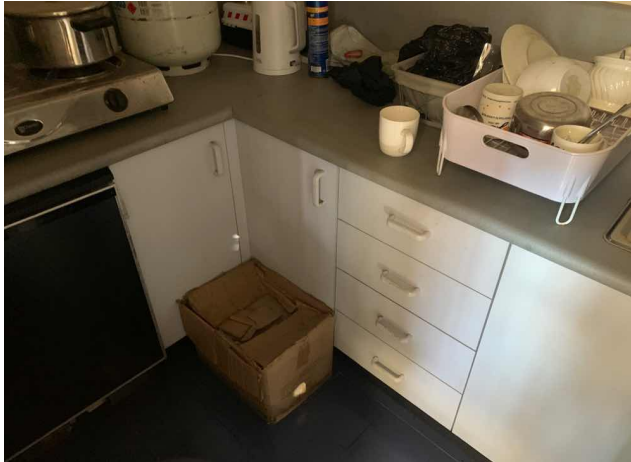
12 - Internal / GF / Kitchen / Doors, Door frames & Skirting boards / Topcoat -Blue (J220192255LP1.3) - <0.1%w/w

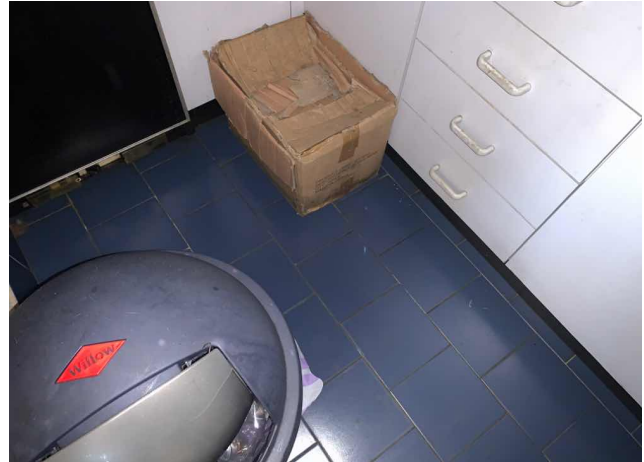
13 - Internal / GF / Kitchen & shower room / Behind kitchen unit / (J220192255NA2) - Presumed to contain asbestos or hazardous materials

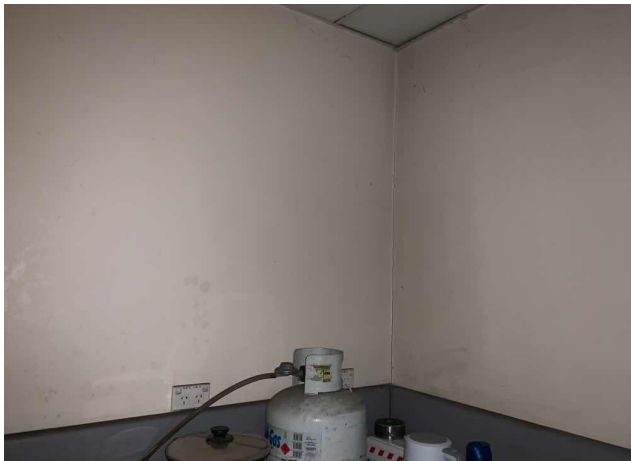
14 - Internal / GF / Kitchen & shower room / Beneath the ceramic tiles / (J220192255NA1.1) - Presumed to contain asbestos or hazardous materials

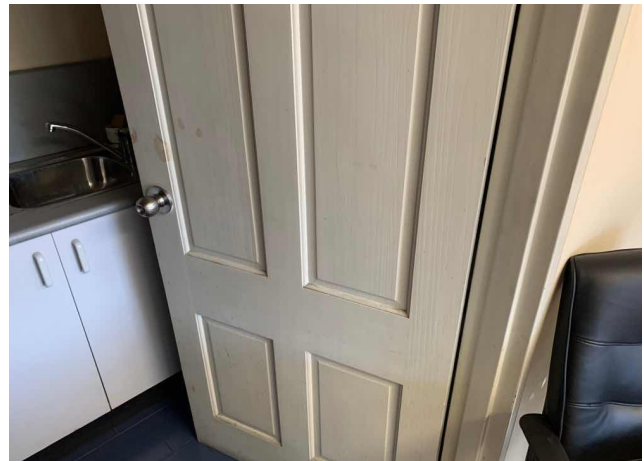
15 - Internal / GF / Kitchen & shower room / Concrete walls / Topcoat -Cream (J220192255LP2.2) - <0.1%w/w

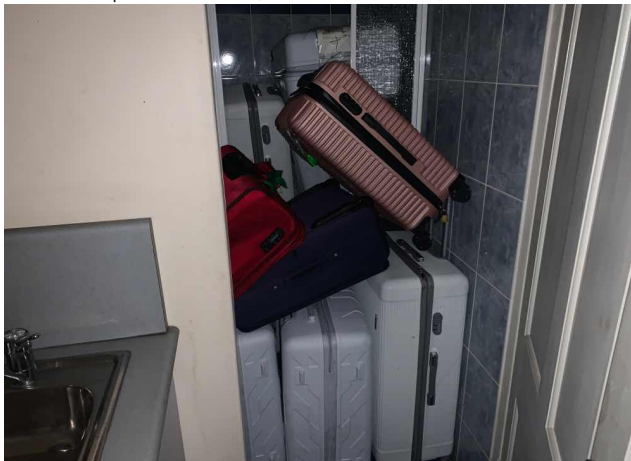
16 - Internal / GF / Kitchen & shower room / Door & door frame / Topcoat -Blue (J220192255LP1.1) - <0.1%w/w

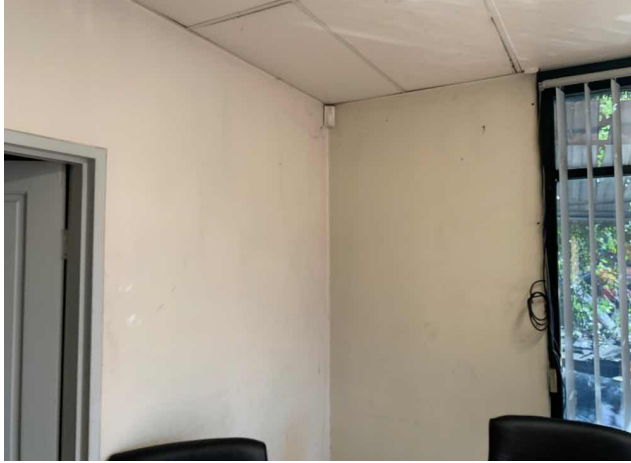
18 - Internal / GF / North western office / Beneath the ceramic tiles / (J220192255NA1) - Presumed to contain asbestos or hazardous materials

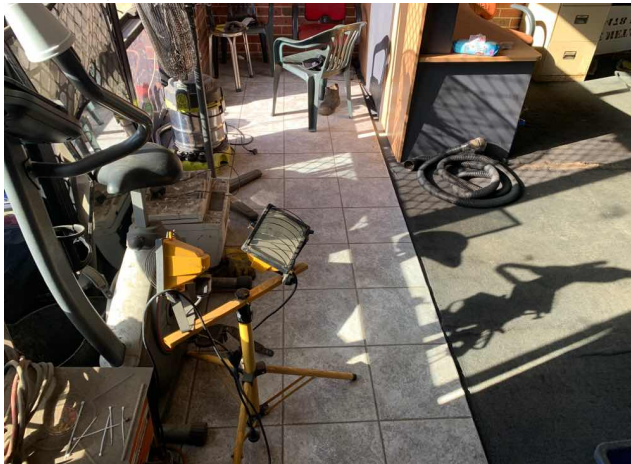
20 - Internal / GF / Office/Store room / Beneath the carpet / Vinyl Tiles - Beige (J220192255A2) - NAD,ORG

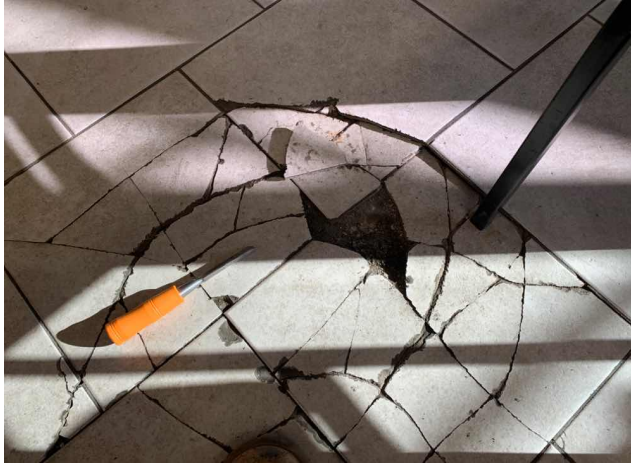
25 - Internal / GF / Reception / Beneath ceramic tiles /  
(J220192255La1) - Presumed to contain asbestos or  
hazardous materials

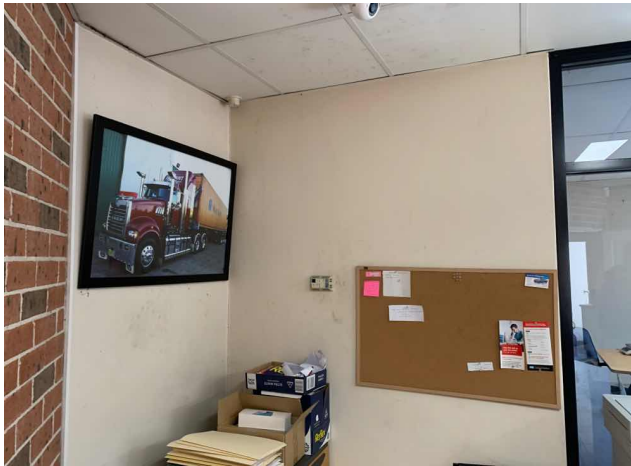
26 - Internal / GF / Reception / Concrete walls / Topcoat -  
Cream (J220192255LP2) - <0.1%w/w

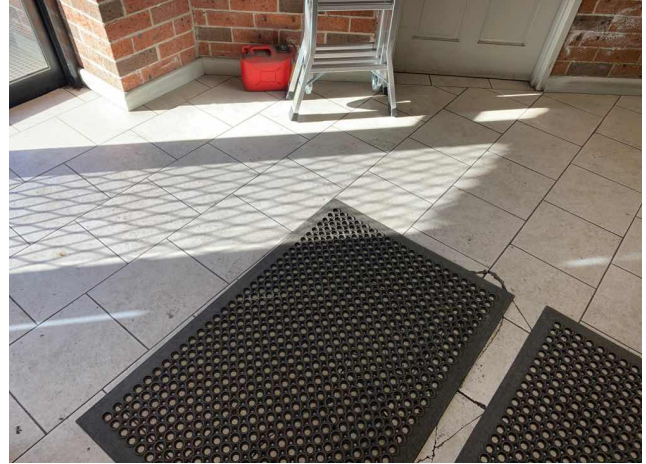
25.1 - Internal / GF / Reception / Beneath ceramic tiles /  
(J220192255La1) - Presumed to contain asbestos or hazardous  
materials

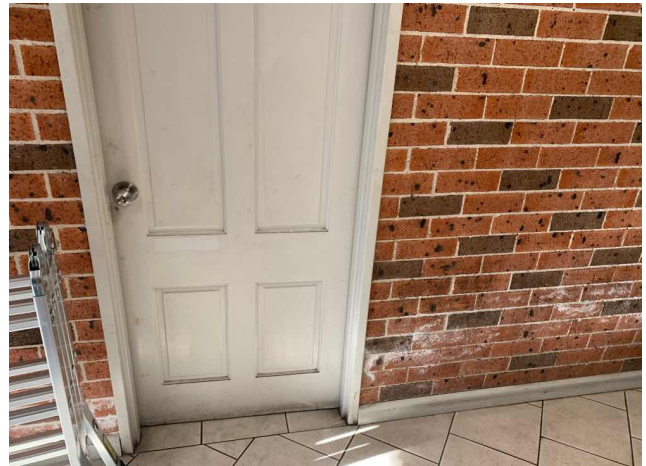
27 - Internal / GF / Reception / Doors, Door frames & Skirting  
boards / Topcoat -Blue (J220192255LP1) - <0.1%w/w

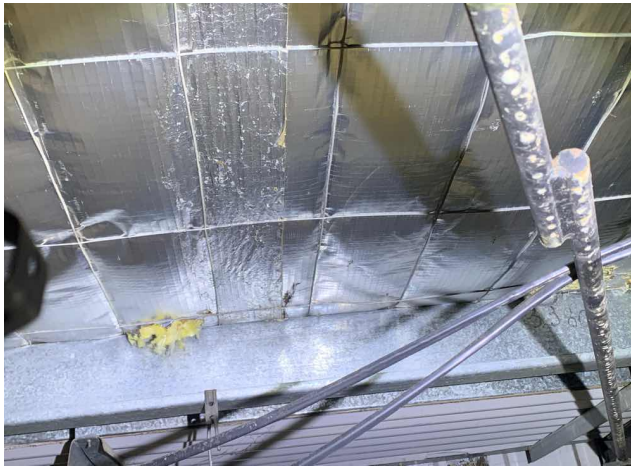
Location	Material Description	Risk Rating
Internal / GF / Roof void / Ceiling	Sarking Insulation	Very Low
Internal / GF / Roof void / Ductwork insulation	Insulation Material	Very Low

28 - Internal / GF / Roof void / Ceiling / Sarking Insulation (J220192255S1) -

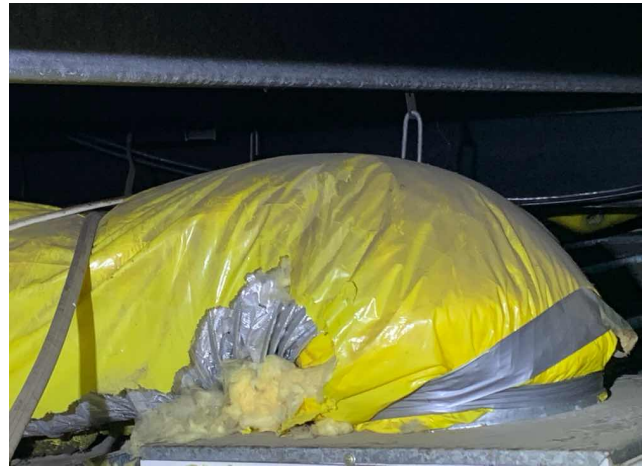
29 - Internal / GF / Roof void / Ductwork insulation / Insulation Material (J220192255S2) -

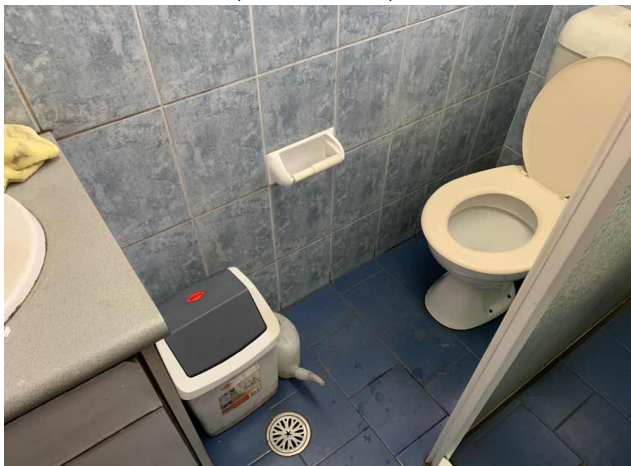
31 - Internal / GF / Showerroom / Behind the ceramic tiles to the walls and floor / (J220192255NA1.4) - Presumed to contain asbestos or hazardous materials

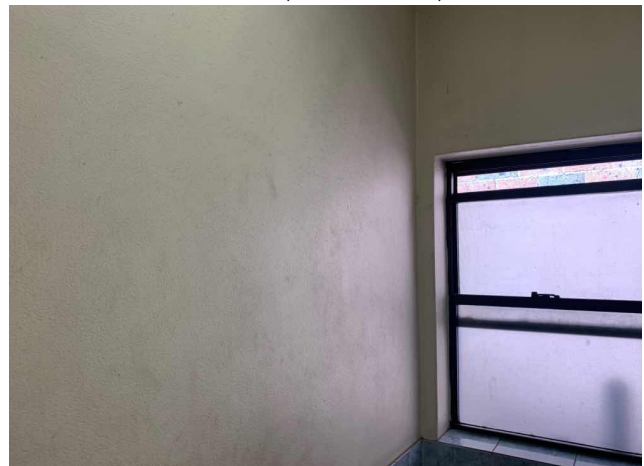
32 - Internal / GF / Showerroom / Concrete walls / Topcoat - Cream (J220192255LP2.6) - <0.1%w/w

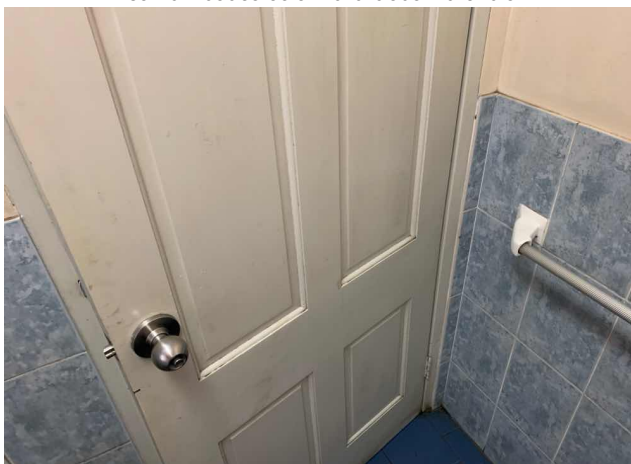
33 - Internal / GF / Showerroom / Door and door frame / Topcoat -Blue (J220192255LP1.5) - <0.1%w/w

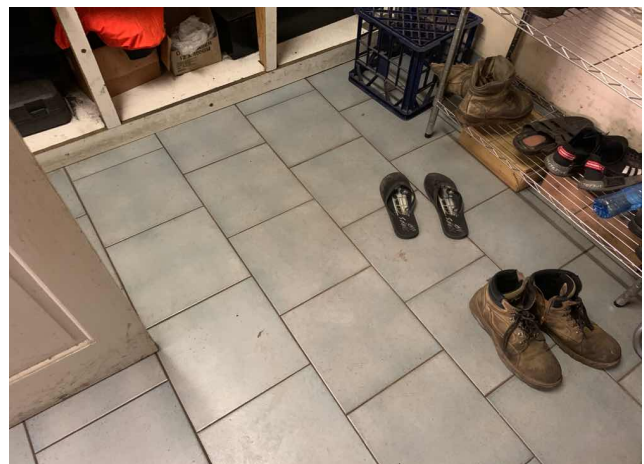
34 - Internal / GF / Staff changing room / Beneath the ceramic tiles / (J220192255NA1.3) - Presumed to contain asbestos or hazardous materials

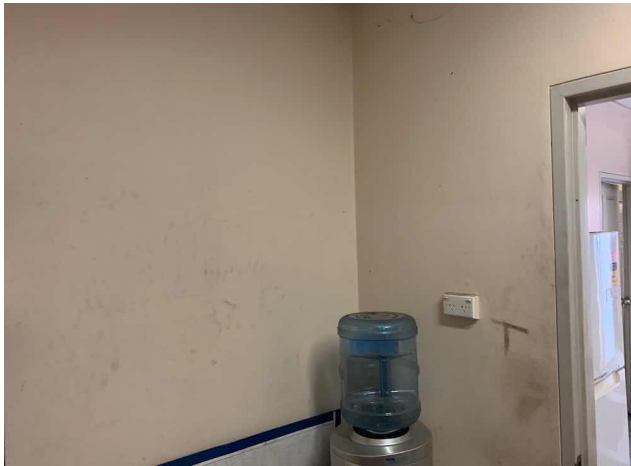
35 - Internal / GF / Staff changing room / Concrete walls / Topcoat -Cream (J220192255LP2.5) - <0.1%w/w

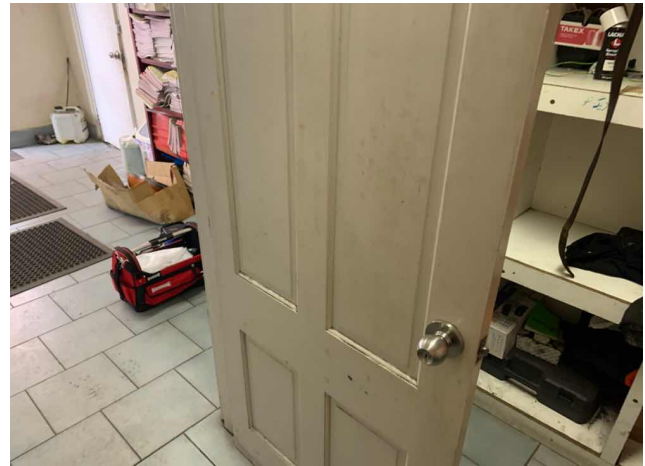
36 - Internal / GF / Staff changing room / Door and door frame / Topcoat -Blue (J220192255LP1.4) - <0.1%w/w

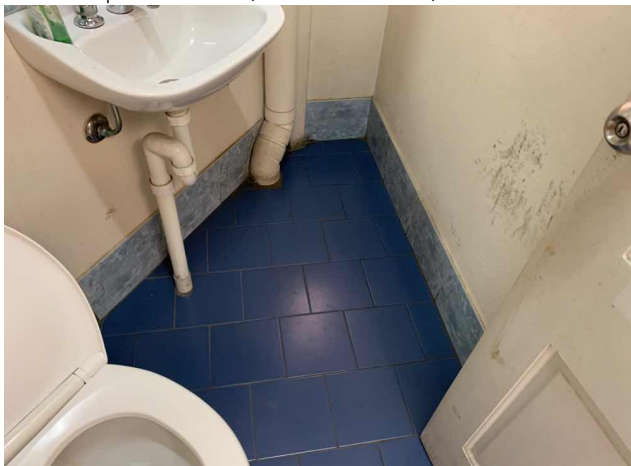
37 - Internal / GF / Toilet / Beneath the ceramic tiles / (J220192255NA1.2) - Presumed to contain asbestos or hazardous materials

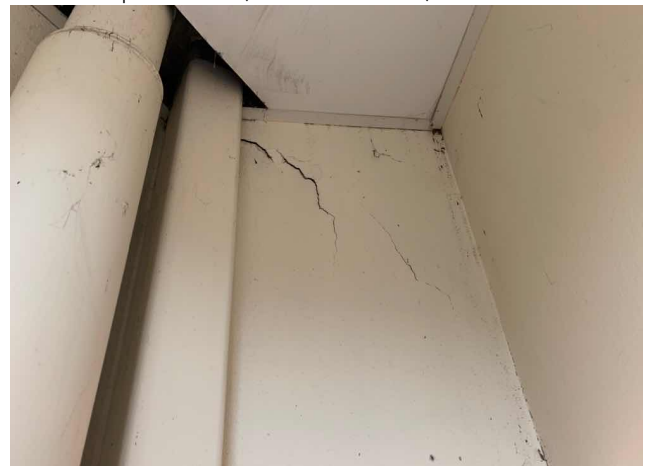
38 - Internal / GF / Toilet / Concrete walls / Topcoat -Cream (J220192255LP2.3) - <0.1%w/w

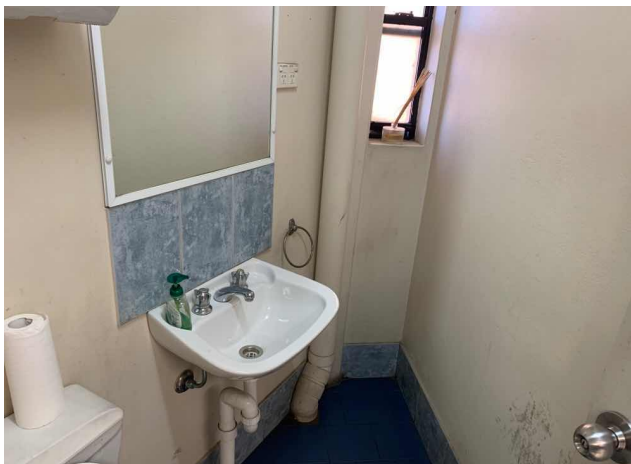
38.1 - Internal / GF / Toilet / Concrete walls / Topcoat - Cream (J220192255LP2.3) - <0.1%w/w

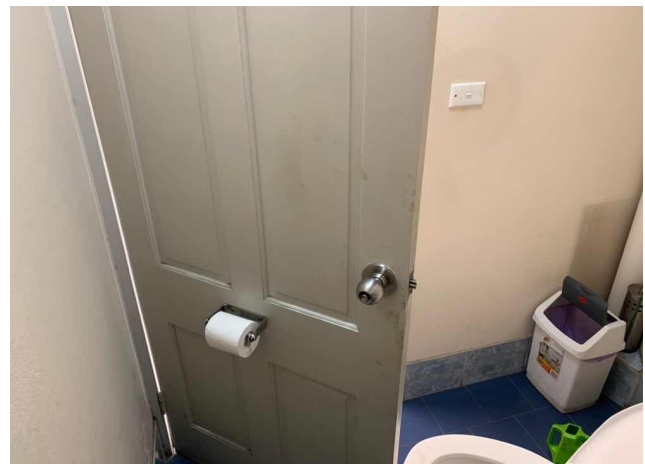
39 - Internal / GF / Toilet / Door and door frame / Topcoat -Blue (J220192255LP1.2) - <0.1%w/w

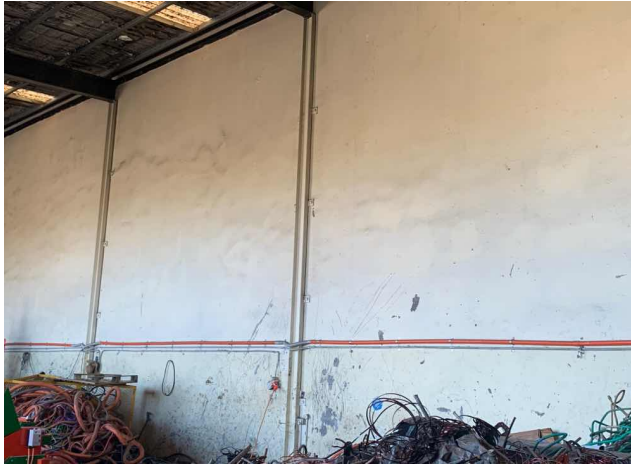
40 - Internal / GF / Warehouse / Concrete walls / Topcoat - Cream (J220192255LP2.8) - <0.1%w/w

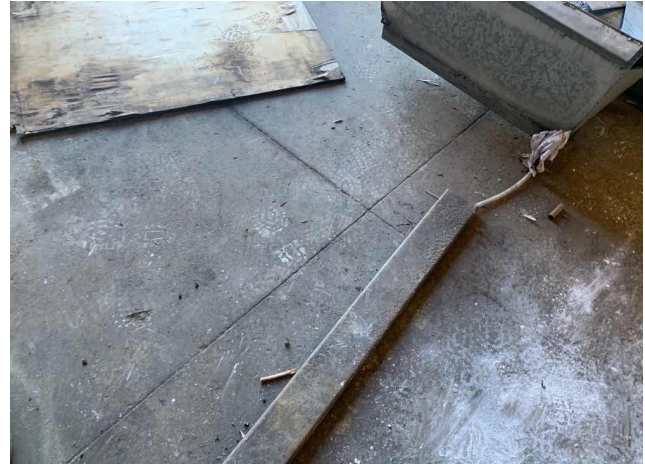
41 - Internal / GF / Warehouse / Expansion joints within concrete / Bitumen (J220192255A3.1) - NAD,ORG

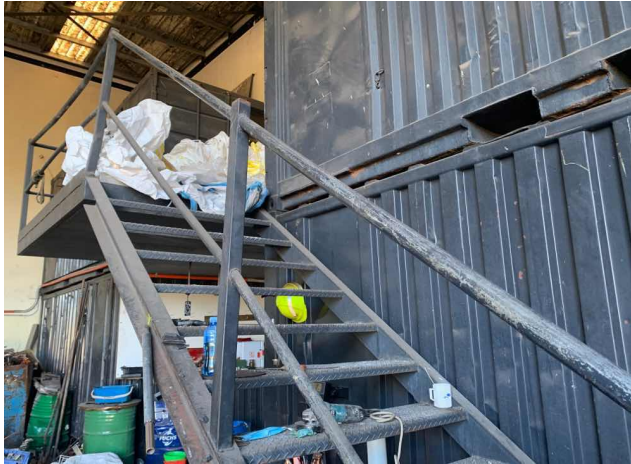
42 - Internal / GF / Warehouse / Staircase and storage containers / Topcoat - Navy blue (J220192255LP4) - 0.3%w/w

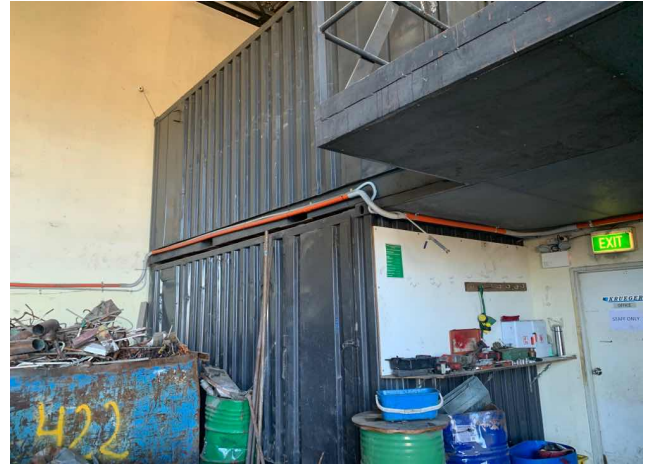
43 - Internal / GF / Warehouse / Within storage containers / (J220192255NA4) - Presumed to contain asbestos or hazardous materials

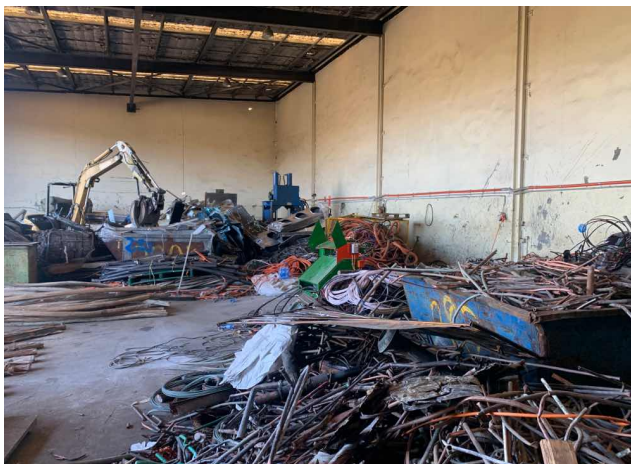
44 - Internal / GF / Warehouse / Within warehouse due to stored items & scrap metal / (J220192255La4) - Presumed to contain asbestos or hazardous materials

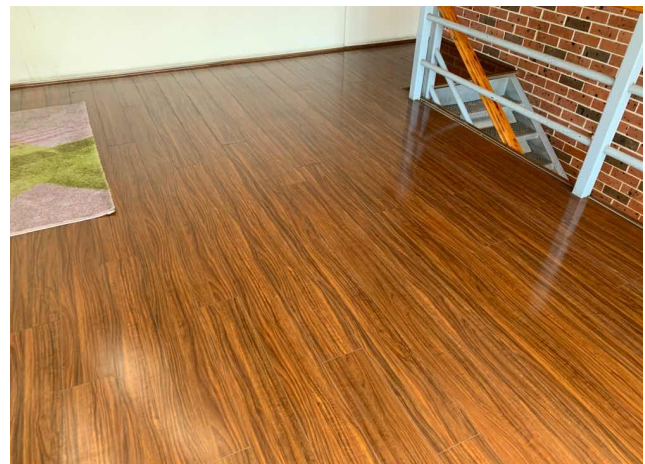
45 - Internal / L1 / Office / Beneath the laminated timber flooring / (J220192255NA3) - Presumed to contain asbestos or hazardous materials

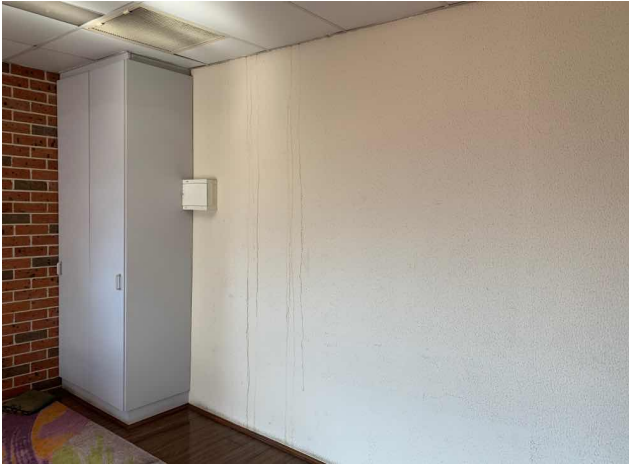
46 - Internal / L1 / Office / Concrete wall / Textured Coating (J220192255A1.1) - NAD,ORG
