Allambie Cottages, 1256-1258 Old Bell's Line of Road, Kurrajong Heights
SWCPP Site Inspection 27th September 2023

Allambie Cottages, 1256-1258 Old Bell's Line of Road, Kurrajong Heights SWCPP Site Inspection 27th September 2023

2.0 Site Inspection Brief Report

4.0 Initial Site Inspection Summary

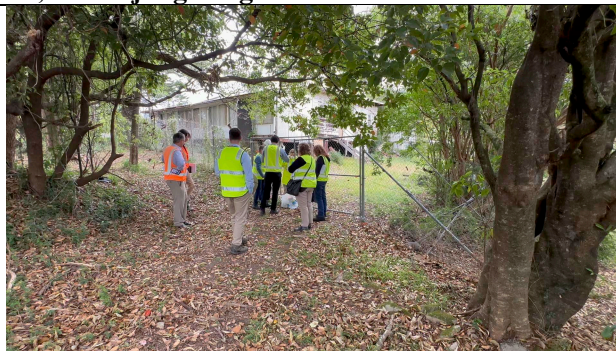
Douglas Street view of the SWCPP on-site meeting and the Cyclone mesh security fence. The security fence does not appear to have been erected on the property boundary and if so does not provide protection to a number of possibly significant early garden plantings on Douglas Street frontage (ref HR 2012 CI 13 1)

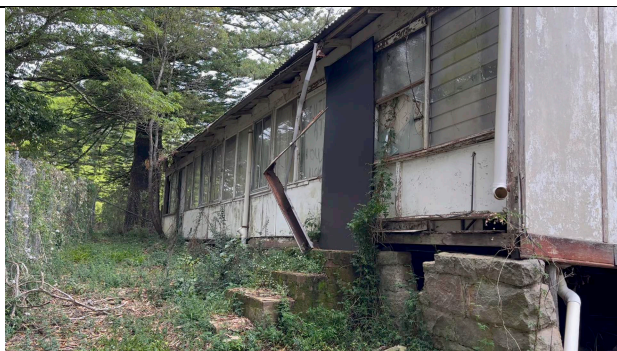
View of the east elevation illustrating the lack of weather protection with collapsed gutters, uncontrolled discharge of stormwater from the roof, gutters and downpipes, broken windows and damaged cladding (ref HR 2012 Part3 Div 1 Requirement 10 Weather Protection (CI 1a-h)). The unprotected eaves and wall openings are likely to invite entry of birds and other pests (ref ref HR 2012 Part3 Div 1 Requirement 15 Essential Maintenance and Repair (CI 2a)).

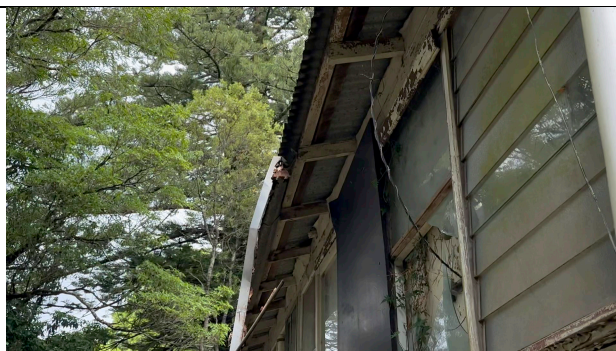
As per image on left. The neglected condition of the building has impacted the security of the building with unprotected doors and windows. (ref HR 2012 Part3 Div 1 Requirement 10 Weather Protection (2))

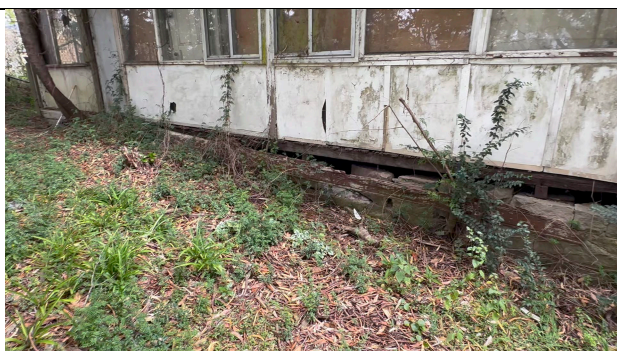
View of the east elevation illustrating the lack of weather protection with water damage to the wall cladding and foundation walls impacted by uncontrolled rainwater movement leading to settlement (ref HR 2012 Part3 Div 1 Requirement 15 Essential Maintenance and Repair (CI 3 and b))

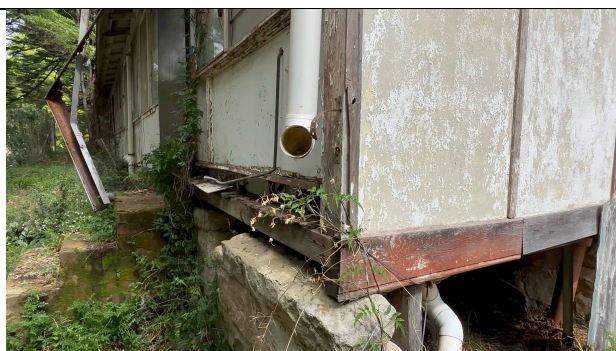
View of the north-east corner showing uncontrolled discharge of rainwater and impact on ground conditions in the vicinity leading to settlement of foundations. (ref HR 2012 Part3 Div 1 Requirement 15 Essential Maintenance and Repair (CI 3 and b))

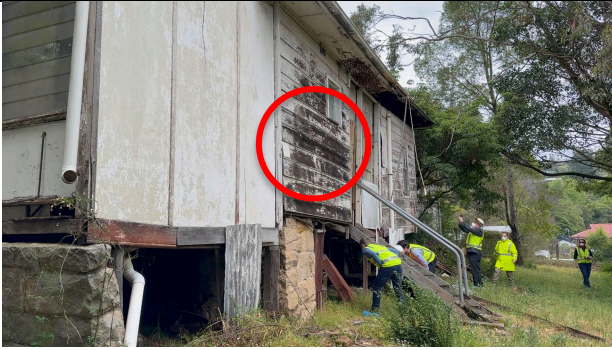
View of the northern facades illustrating the lack of protection of the wall cladding materials.

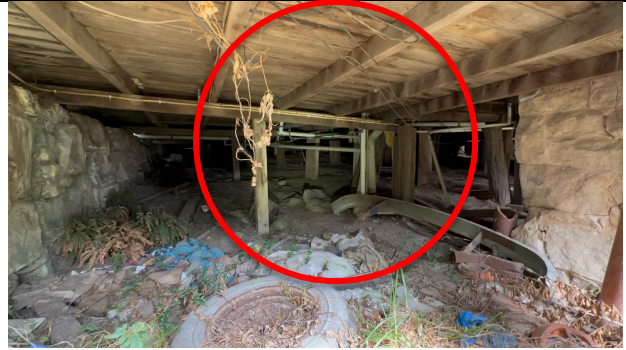
View of subfloor area from the north-eastern corner illustrating that the apparent damage is focused on the perimeter of the cottages resulting from uncontrolled discharge of stormwater around the perimeter of the building.

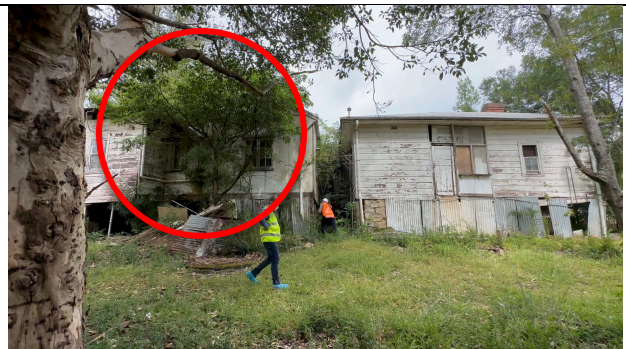
View looking south towards the NW end of the cottages illustrating the proximity of some trees and vegetation posing a physical risk and likely to raise moisture levels in and around the building with damaging consequences to the fabric.

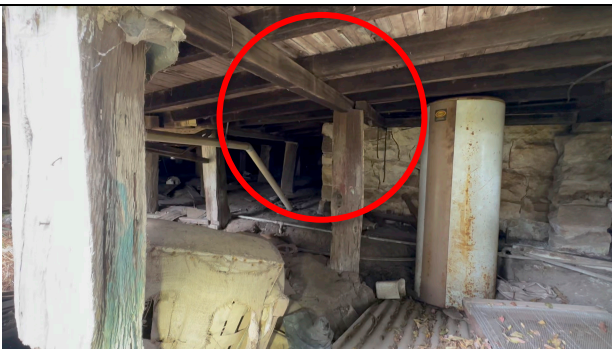
View of the subfloor area from the north-western corner illustrating the condition of the stone footings for fireplaces and the hardwood piers located away from the perimeter of the building appear to be in fair condition.

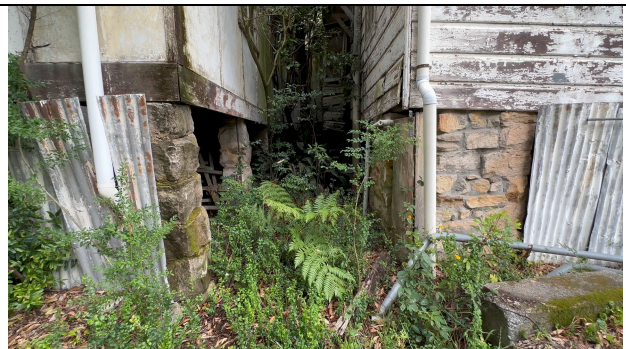
View of the western recess between the western cottage and the link illustrating the damage to the perimeter of the cottages resulting from uncontrolled discharge of rainwater from the roof and gutters. The high moisture levels around the perimeter of the cottages has resulted in some settlement of perimeter walls and piers.

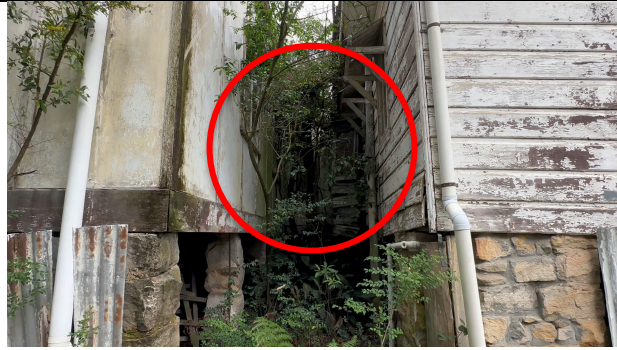
View of the western recess between the western cottage and the link illustrating the damage to the original weatherboarded bay window resulting from ongoing discharge of rainwater onto this section of the façade from the roof. Invasive plant growth due to high moisture conditions limited access.

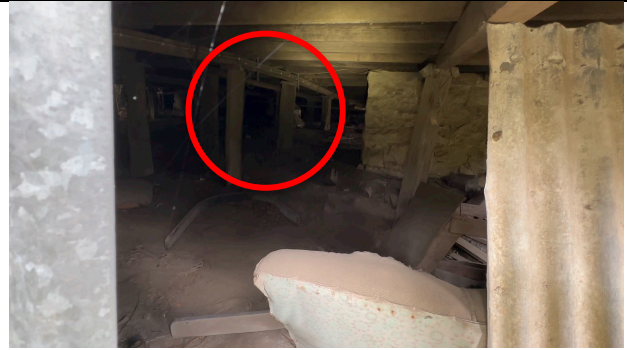
View of the subfloor area from the north-western corner illustrating the condition of the timber piers, bearers and joists.

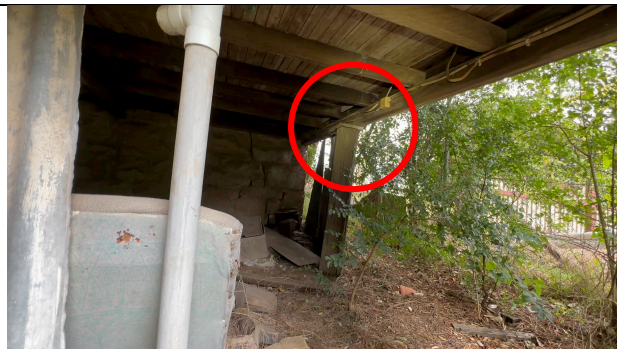
View of the subfloor area from the north-western corner illustrating the hardwood timber piers with galvanised iron ant caps that will have provided some protection from termite attack.

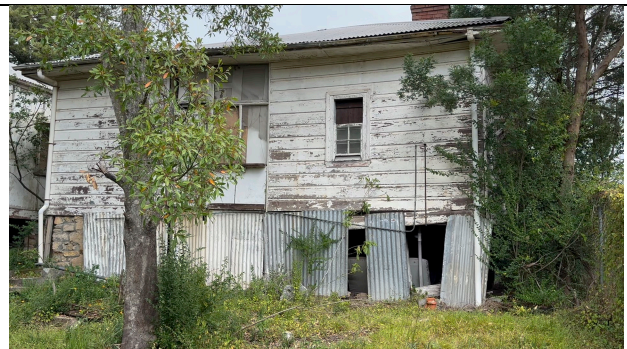
View of the western end of the northern façade illustrating the lack of weather protecting and security with open windows and poorly secured later sheeting.

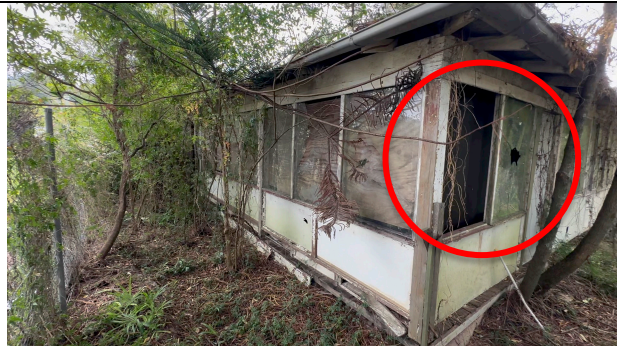
View of the southern façade of the eastern cottage illustrating the overgrown shrubs plantings and trees limiting access and compromising the integrity of footings due to tree root growth. Damaged glazing and missing screens pose a security risk for this unoccupied building

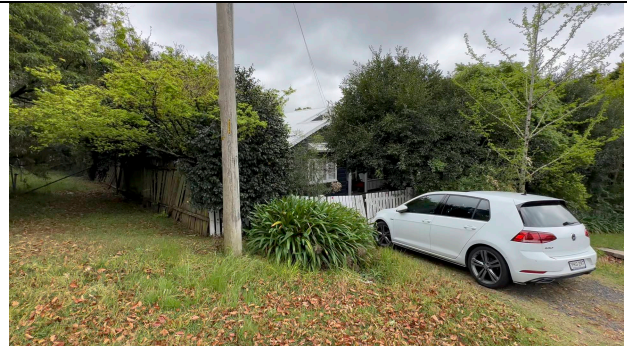
View from Douglas Street of the third cottage of the original 1920s group illustrating the difference that care and regular maintenance make to the condition of a building..
