Our Ref: 2303702RE Allambie Cottages, 1256 Bell's Line of Road, Kurrajong - Structural Report  
09 October 2023

## ALLAMBIE COTTAGES, 1256 BELL'S LINE OF ROAD, KURRAJONG STRUCTURAL REPORT

Site Inspection of 'Allambie Cottages', 1256 Bell's Line of Road, Kurrajong was undertaken on 27 September 2023 by Hari Gohil, shreeji consultant p/l. The inspection was to assess the structural integrity of the buildings.

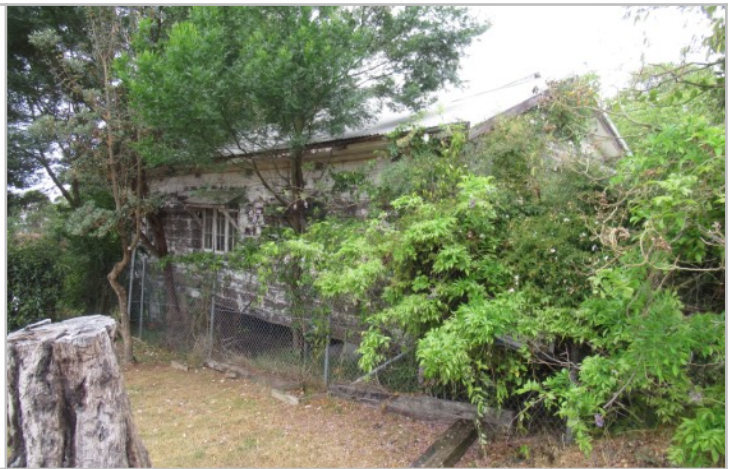
### 2.1.

South Cottage - view from the west.

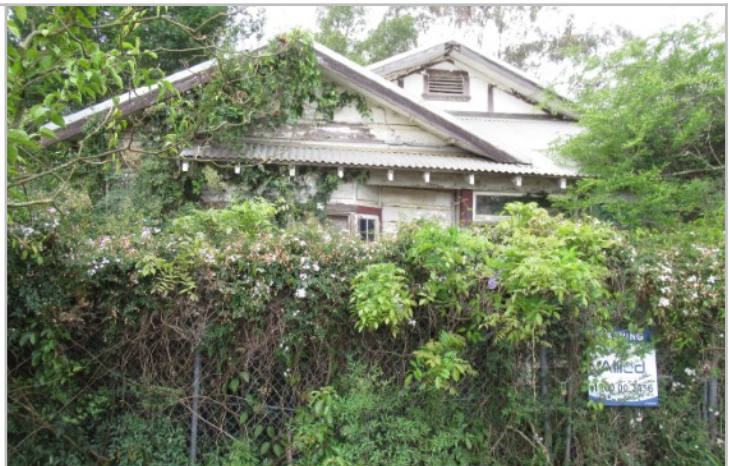
### 2.2.

North Cottage - view from the west

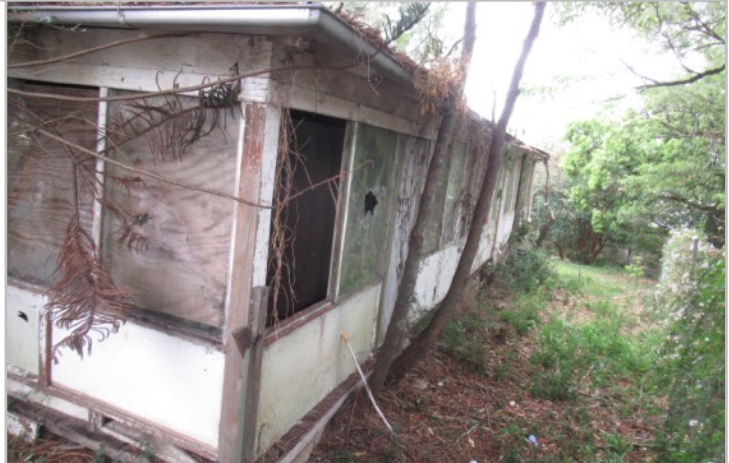
2.3.

South Cottage - view to the east from the southwest corner.

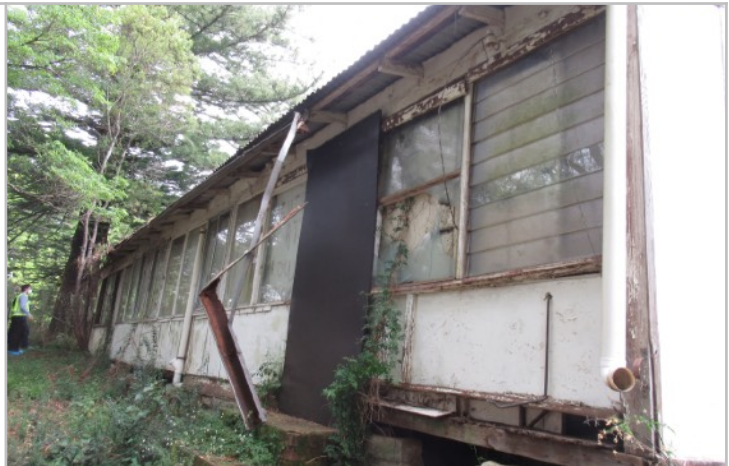
2.4.

South Cottage - view to the west from the southeast corner.

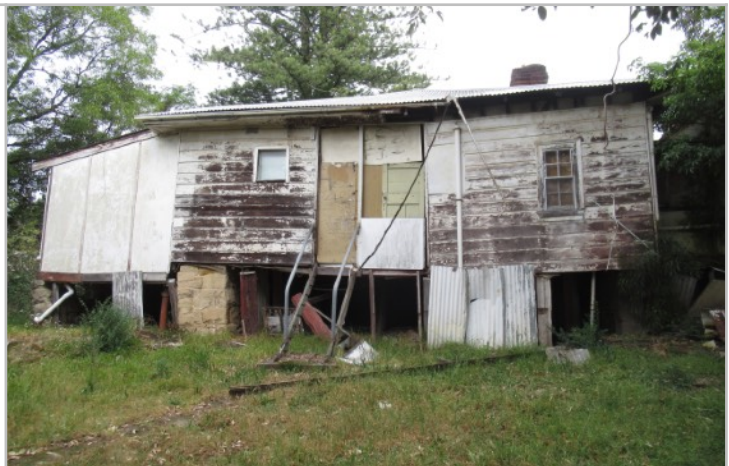
2.5.

South Cottage - view from the east

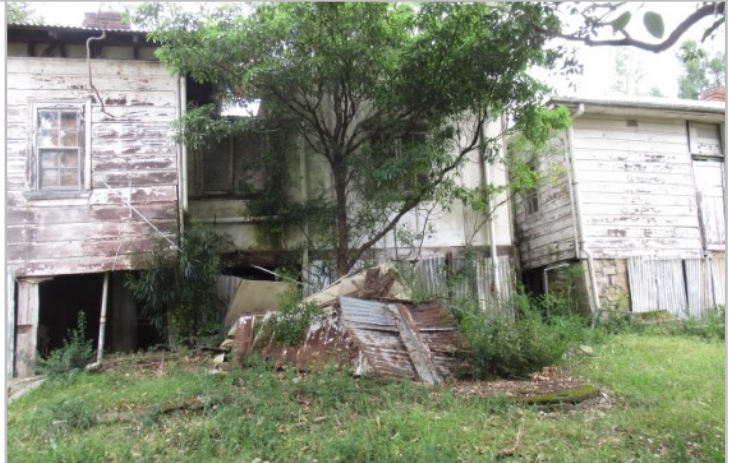
2.6.

Infill between the North and the South Cottage - view from the east

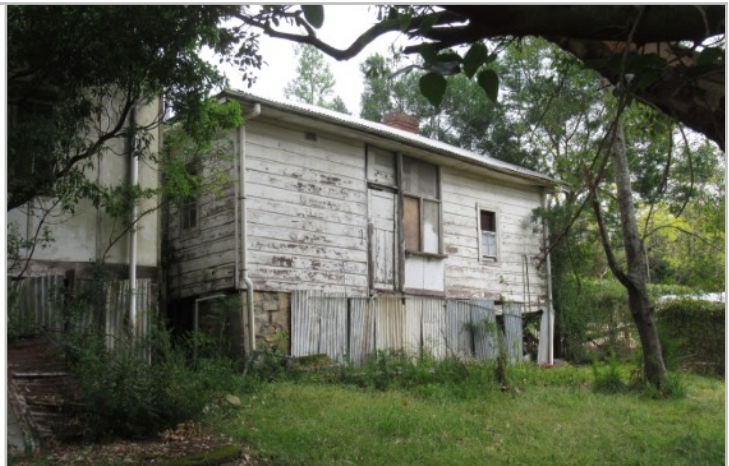
2.7.

North Cottage - view from the east

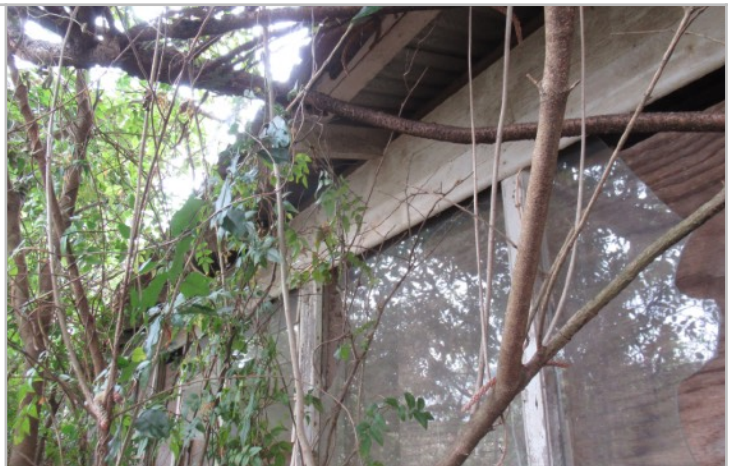
2.8.

The gutters have corroded through and are non existence.

- 4.6. The roof water is fed to the base of the foundation soils by the failed gutters over a prolonged period.
- 4.7. The building has lacked regular maintenance which would have picked up the leaking gutters and roof and the set in of the termite activity.

- 4.10. The gutters and down pipes of adequate size are to be installed and the collected roof water is to be taken away from the building foundations.

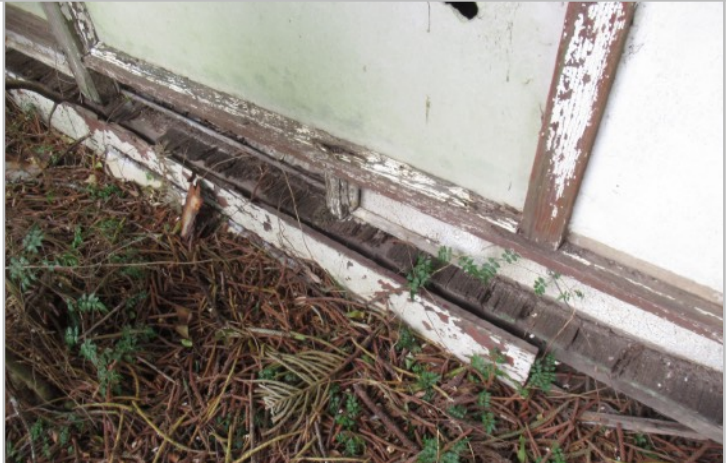
2.9.

The ends of the floor boards affected by constant moisture from the leaking gutter.

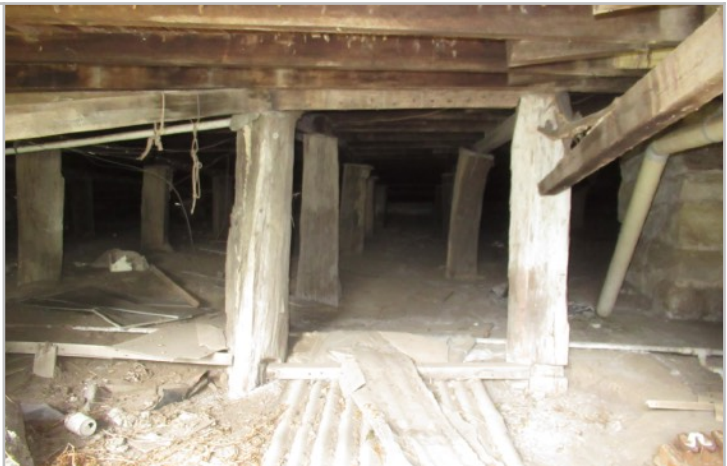
2.10.

South Cottage - underfloor support.

Hardwood timber stumps, some have termite trails in the sap rings.

- 4.4. Some of the underfloor stumps in timber have the embedded base in soil affected by wet rot due to presence of moisture over a prolonged period and caused them to collapse.

- 4.13. The building structural elements are to be inspected at close hand to assess their integrity.
- 4.14. The timber stumps to have dry feet by introducing concrete bases or concrete encasement.

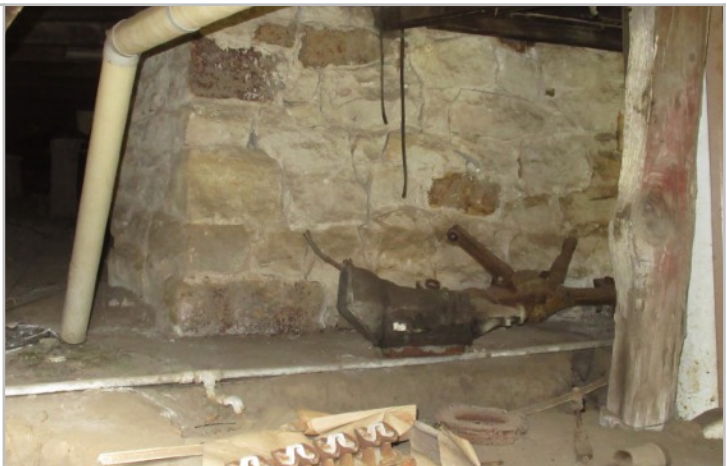
2.11.

South Cottage - sandstone base to the chimney

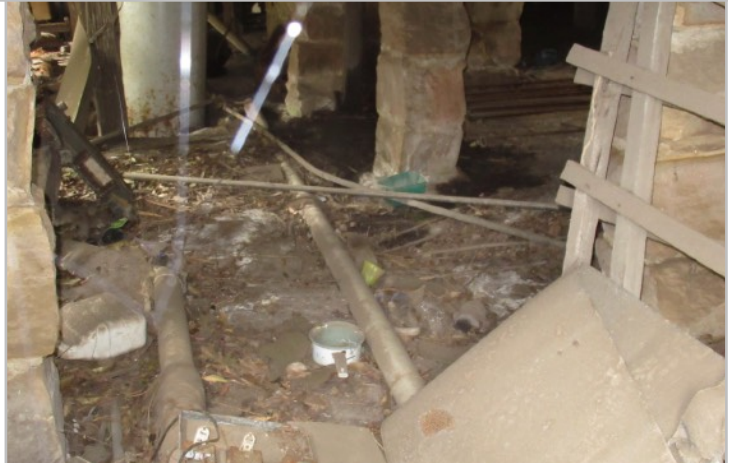
2.12.

The Infill Connection between the North and the South Cottages have sandstone piers underfloor support

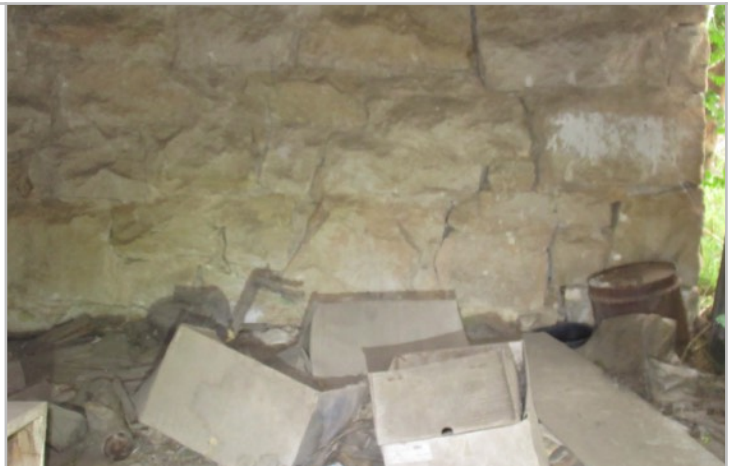
2.13.

North Cottage - sandstone base under the chimney

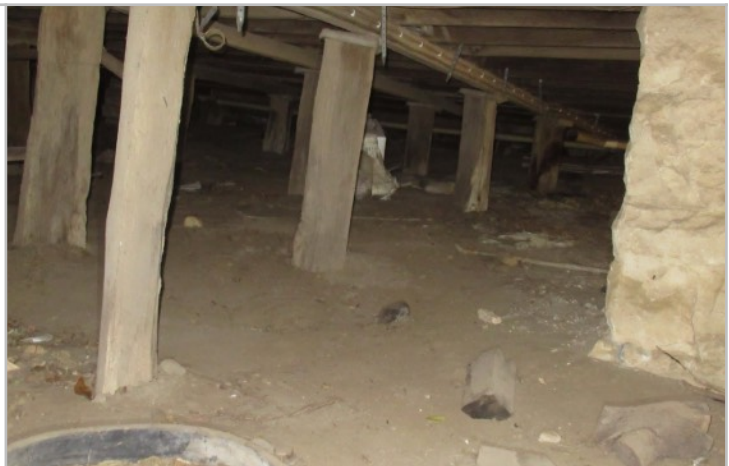
2.14.

North Cottage - hardwood stumps under the floor

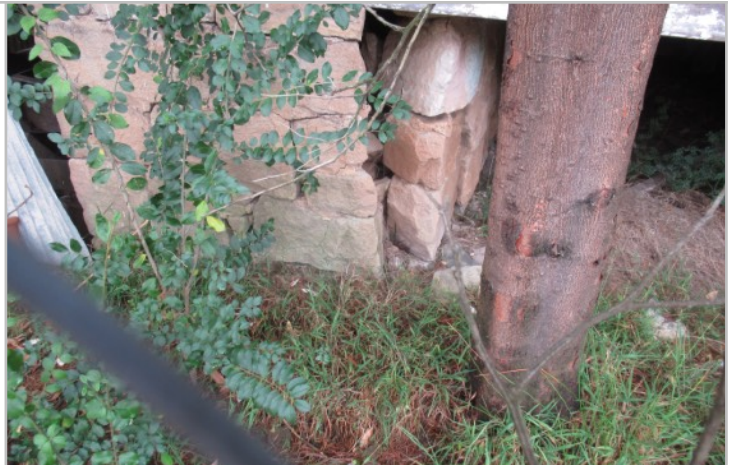
2.15.

North Cottage - the sandstone base to the chimney has cracked.

- 3.8. The stumps, some of them, have wet rot at the base and have collapsed.
- 3.9. The sandstone bases to the chimneys and some piers have cracked due to wash out of the foundation soil.

- 4.15. The cracked and displaced bases to the chimneys, if required partly rebuilt and remediated by stainless steel 316 reinforcement stitching.
