SWCPP DEFERRAL RECOMMENDED ACTION - DATED 1st DECEMBER 2024
RESPONSE TO TfNSW CONSULTANTS 2024 REPORTS – HERITAGE 21

PART A – CONSERVATION ARCHITECT RESPONSE TO HERITAGE 21 REPORT DATED 29TH FEBRUARY 2024

PART B1 – CONSERVATION ARCHITECT ILLUSTRATION OF A METHODOLOGY FOR A ‘FULSOME ANALYSIS OF FABRIC’

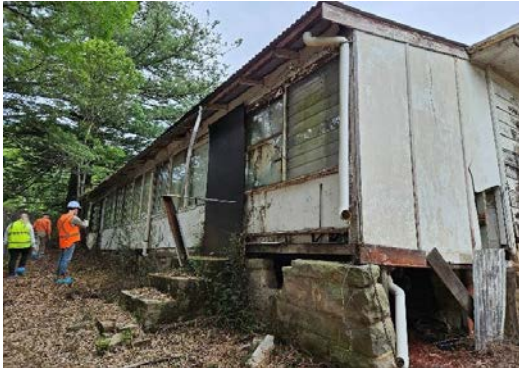
Extracts from <i>Heritage 21</i> Heritage Review Site Visit dated 25 th January 2024 Site Report dated 24 th February 2024	<i>CA&Associates</i> Response Findings Site Inspection dated 18 th April 2024 Site Analysis dated 20 th April 2024	<i>CA&Associates</i> Conclusions and Comment
	<p>Extract from Heritage 21 Report Figure 17 Caption : <i>Southeast elevation pictured showing later addition asbestos clad verandah.</i></p>

<p>Note : the Heritage 21 caption correctly refers the later addition of an asbestos clad verandah...but does not draw attention to the reasons for the localised ground settlement resulting from the collapsed gutter, disconnected and missing downpipe or discharge of rainwater over the wall and footing. This illustrates the selective approach in the Heritage 21 site ‘<i>observations</i>’.</p> <p>Note : Figure 18 on p15 of the Heritage 21 report incorrectly notes photograph as being “<i>the rear NW corner of the building</i>” but is actually still the south-eastern corner of the building. This error may suggest to readers of the Heritage 21 report that the stonework deterioration is more extensive than is the case. A stonewall approximately 3m to the right of the Heritage 21 photograph does not suffer the same issues but was not included in the Heritage 21 photograph. Therefore the issue at the south-eastern corner is more localised and related directly to stormwater mismanagement.</p> <p>CA&Assoc images (ref below) show more representative examples elsewhere in the building where the impact of stormwater management is not as great.</p>

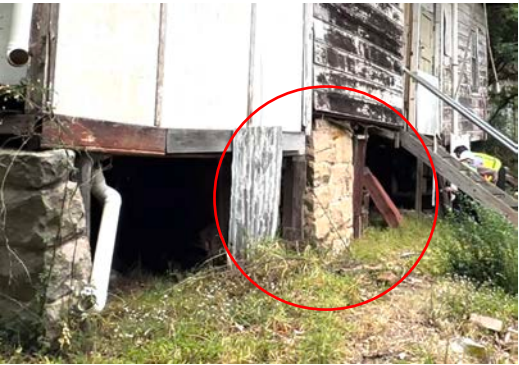
<p>CA&Assoc photo of foundation stonework to the right of the south-eastern corner <u>not</u> suffering from the same impact.</p>	<p>The physical evidence documented in paragraph 3 of the Heritage 21 report is not methodical or detailed but based on an ‘observation’ of the perimeter of the building only. Therefore, the conclusions arrived at in the Heritage 21 report may not be correct or accurate without a fulsome inspection and analysis of the fabric.</p> <p>The resultant damage to the building fabric in the south-eastern corner would involve the following scope of work to restore the verandah to its original use:</p> <ul style="list-style-type: none">• Removal of the damaged fibro sheeting to repair the associated timberwork. The damaged fibro sheeting and c1960s glass louvres would not be replaced as they are later additions not associated with the period of high heritage significance.• The restoration work would focus on the like-for-like replacement of damaged timber sections resulting from exposure to weather and water. Note : Repair work would retain sound timbers and either splice in new short sections or double up matching timbers where necessary, both of which are heritage sympathetic solutions.• Repair of the gutter and downpipe to the SE corner to discharge roof water safely to the ground level away from the building. Historic photographs would be used to reinstate appropriate gutter and downpipe profiles.• Partial dismantling and underpinning if necessary. Note: by halting the rainwater flow over the building fabric in SE corner the in-ground settlement on the SE corner resulting from stormwater mismanagement will similarly halt.• Reconstruction of the low stone wall using original stones and lime-based mortar to match the original.• Repair of timber fascia, timber edge beam, wall plate and lower edge fascia where exposed to long-term water using like-for-like timber sizing and profiles.• Repair of original verandah boards and restoration of original timber handrail and steps. <p>The above restoration work approach and methodology provides ‘<i>a more fulsome analysis of fabric showing clearly with little to no significant fabric lost through restoration</i>’.</p>

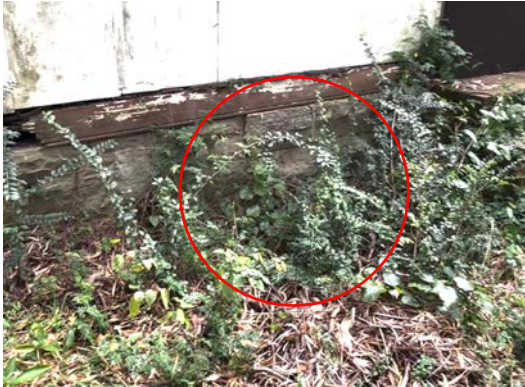
</div> <p>CA&Assoc photo of foundation stonework to the left of the south-eastern corner <u>not</u> suffering from the same damage.</p> <div>

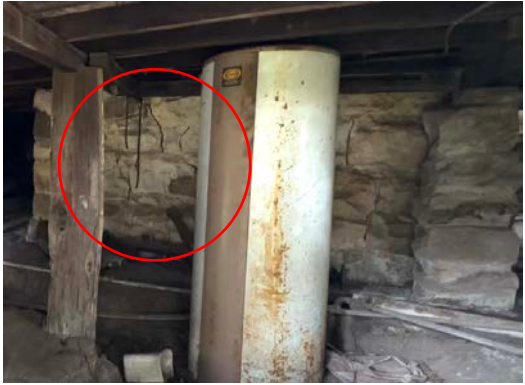
</div> <p>CA&Assoc photo of foundation stonework <u>not</u> exposed to water damage and similarly <u>not</u> suffering from the same damage as the unnecessarily exposed SE corner of the building.</p> <p>To provide context - The marked-up floor plan below illustrates the relatively isolated area affected referred to by the Heritage 21 report.</p> <div>

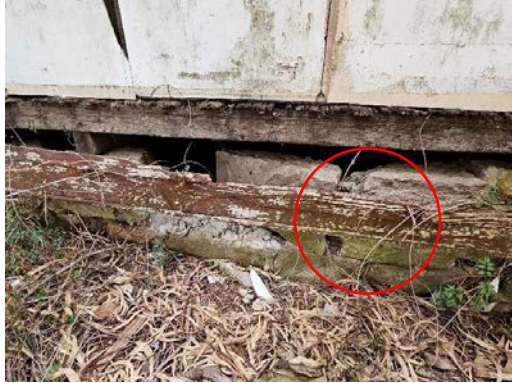
<p>Extract from Heritage 21 Report Figure 21 <i>Figure 21. Deteriorated and termite eaten foundations to the front verandah.</i></p>

<p>Note : The Heritage 21 report states that ‘many of the timber stumps are termite affected’ but the only image of termite damaged timber is Figure 21 above. The caption states that the image is of “termite eaten</p>	<p>Timber stump construction is common across Australia since first settlement in the early 1800s and it is equally common in Australia for houses to be “restumped”. <i>Canstar</i>, the well-respected organisation that markets itself on its ‘fact-checking process’ has researched restumping of residences https://www.canstar.com.au/home-loans/restumping-cost/</p> <p>Canstar’s analysis concluded that “According to tradie listings website <i>HIREtrades</i>, fully restumping a small to average-sized home with one to three bedrooms could set homeowners back around \$10,000 to \$25,000, or potentially more depending on the specifics of the job. Trade website <i>HiPages</i> estimates that restumping a house could cost anywhere between \$5,000 and \$20,000”.</p> <p>There are many building firms regularly undertaking restumping of residences and although the costs may vary depending on site specific factors the costs are not substantial.</p> <p>Allambie could be restumped to make good the deteriorated posts in a straightforward manner. It is not a complex building task. The Heritage 21 provides no indication of the extent of the deterioration of the stumps without a detailed inspection. Therefore the conclusions arrived at in the Heritage 21 report may not be correct or accurate without a fulsome inspection and analysis of the fabric.</p>

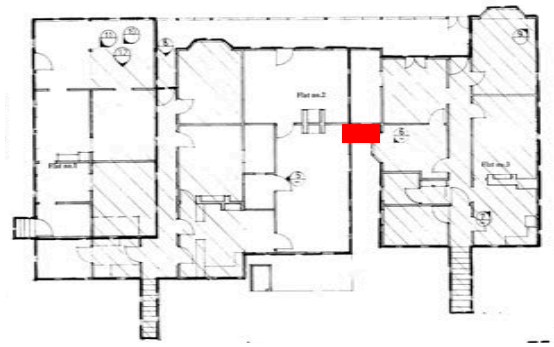
Extracts from <i>Heritage 21</i> Heritage Review Site Visit dated 25 th January 2024 Site Report dated 24 th February 2024	<i>CA&Associates</i> Response Findings Site Inspection dated 18 th April 2024 Site Analysis dated 20 th April 2024	<i>CA&Associates</i> Conclusions and Comment
	<p><i>foundations</i>” but the image appears to be a termite damaged fascia board on the side verandah (east). A fascia board is a decorative timber trim and is not a ‘foundation’ member and plays no structural role. There are no detailed images of any termite trails only distant views of timber elements without termite activity evident.</p> <p>As raised by CA&Assoc at the December 2023 site inspection, the mismanagement of the stormwater system around the perimeter of the building is likely to have attracted termites because of ongoing damp and moist conditions. CA&Assoc also asked whether TfNSW had a termite inspection program, policy, recent report or set in place typical mitigation measures for a significant historic timber buildings. No termite inspection report was available and no termite mitigation measures were in place by TfNSW.</p> <p>Subsequent to the December 2023 SWCPP site inspection a termite inspection was carried out by <i>Timber Inspection NSW</i> for TfNSW. However, the report is brief and general in nature with only a visual inspection of the <u>perimeter</u> of the building. No methodical inspection appears to have been carried out. No drawings of the building were included. The conclusions of the report are included below.</p> <p>Similarly, no images are included in the Heritage 21 report illustrating (i) <i>the extensive termite damage</i> or (ii) <i>the partially collapsed flooring due to termite damage</i>. Figure 32 in the Heritage 21 report refers to “<i>the lightwell area between the cottages...</i>” and the “<i>collapse of a bay window and fabric below</i>”. However, no images were included as unmaintained vegetation restricts access and visibility to this confined space it was apparently not possible to observe the extent of deterioration or perhaps to conclude the reasons for the collapse.</p> <p>No plans or drawings were included as part of the Heritage 21 report but to illustrate the localised nature of the issue a marked up floor plan has been included by CA&Associates for ease of reference. To provide context - the marked-up floor plan below illustrates the relatively isolated area affected referred to by the Heritage 21 report.</p>

<p>The extent of deterioration and the causes of partial collapse of a possibly localised section of the building does not appear to have been clearly documented. The conclusions arrived at in the Heritage 21 report may not be correct or accurate without a fulsome inspection and analysis of the fabric.</p>

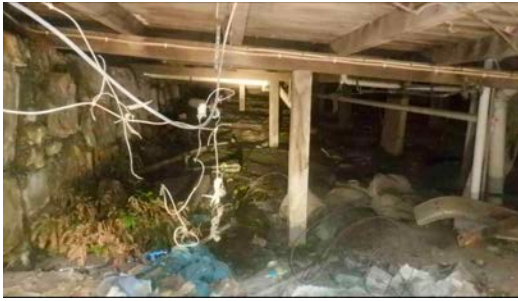
Extracts from <i>Heritage 21</i> Heritage Review Site Visit dated 25 th January 2024 Site Report dated 24 th February 2024	<i>CA&Associates</i> Response Findings Site Inspection dated 18 th April 2024 Site Analysis dated 20 th April 2024	<i>CA&Associates</i> Conclusions and Comment
<p>Para 5 p4 pt1</p> <p><i>“The timber flooring (bearers, joists and floorboards) appear to have experienced extensive termite damage with partial collapse of the flooring due to termite activity to the central connection between the cottages”.</i></p> <p>This issue is limited to the “<i>connection between the cottages</i>”...which is separately referred to in the Heritage 21 report as the “<i>lightwell</i>”. As noted above related to the south-eastern corner image may suggest to readers of the Heritage 21 report that the deterioration is more extensive than is the case. It is the same location.</p> <p>Para 5 p4 pt2</p> <p><i>“Extensive water rot was observed at the rear elevation of the buidling (sic), particularly in the lightwell between the central flat and flat number 3”</i></p> <p>2024 Termite Inspection by <i>Timber Inspection NSW</i> for TfNSW</p>	<p>It is likely that this restricted junction between 2 cottages has suffered from poor stormwater management and discharge similar to the SE corner. The site inspection in December 2023 showed evidence of long-term water flow from the roof down the perimeter walls in this location with water staining and algae on the external walls of the link.</p> <p>Access to the façade of the link was not possible because of vegetation and therefore it is unclear how the Heritage 21 report was able to inspect the deterioration. This should be clarified because if Heritage 21 were unable to inspect the deterioration first-hand in order to arrive at their own conclusions this should have been stated in the report.</p> <p>As noted above the rainwater management in the lightwell area has been severe with corroded gutters and uncontrolled discharge of rainwater from the roof. The constricted layout of the lightwell further slows down water evaporation.</p> <p>The termite inspection concluded that there was <u>no</u> evidence of active termites. (ref <i>Timber Inspection NSW</i> report dated 30th January 2023 para 4.4 p 3). Therefore it must be assumed that the past termite activity was relatively “<i>moderate</i>” and particularly evident in areas suffering from poor storm water management and resulting from long-term neglect of maintenance obligations by the Owner.</p> <p>The recent termite inspection report makes no mention of the partial collapse of the floor and specifically notes that “<i>the inspection was limited what (sic) could be seen from the outside</i>”. A representative view of the existing flooring was included in the termite report. Ref below <i>Photo 6016 p8 Timber Inspection NSW</i> dated 30th January 2024. The image also illustrates the un-managed debris on the ground which could also pose further risk of attracting termite activity.</p>

<p>Furthermore, the above <i>Timber Inspection NSW</i> report image shows apparently true lines for the subfloor structure and elements timber stumps, bearers, joists and intact floor boards in this location. No evidence of partially collapsed floors were included in their report suggesting that the location was inaccessible to view.</p>	<p>The physical evidence documented in paragraph 4 of the Heritage 21 report may have selectively presented an localised condition and then applied the problem throughout the building. The particular causes and effects of neglected maintenance in localised areas of the building could be misrepresented in extent without a more detailed investigation which did not occur as part of the report.</p>

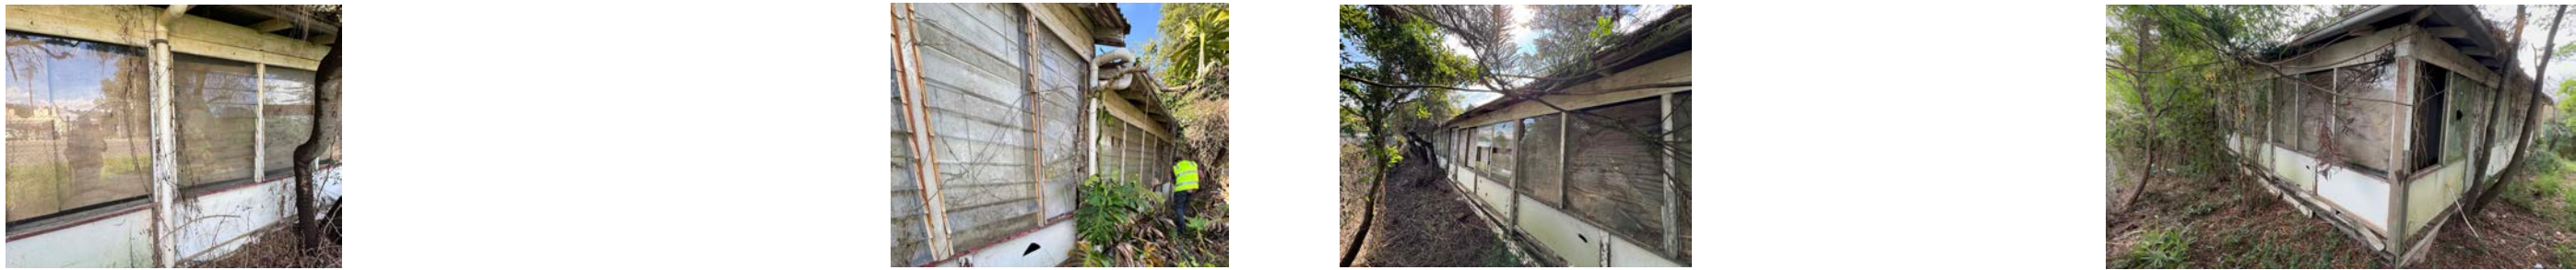
Mid 20th Century later fabric protecting the more significant early 20th Century interiors – the photographs approximately align the external fabric with and internal fabric

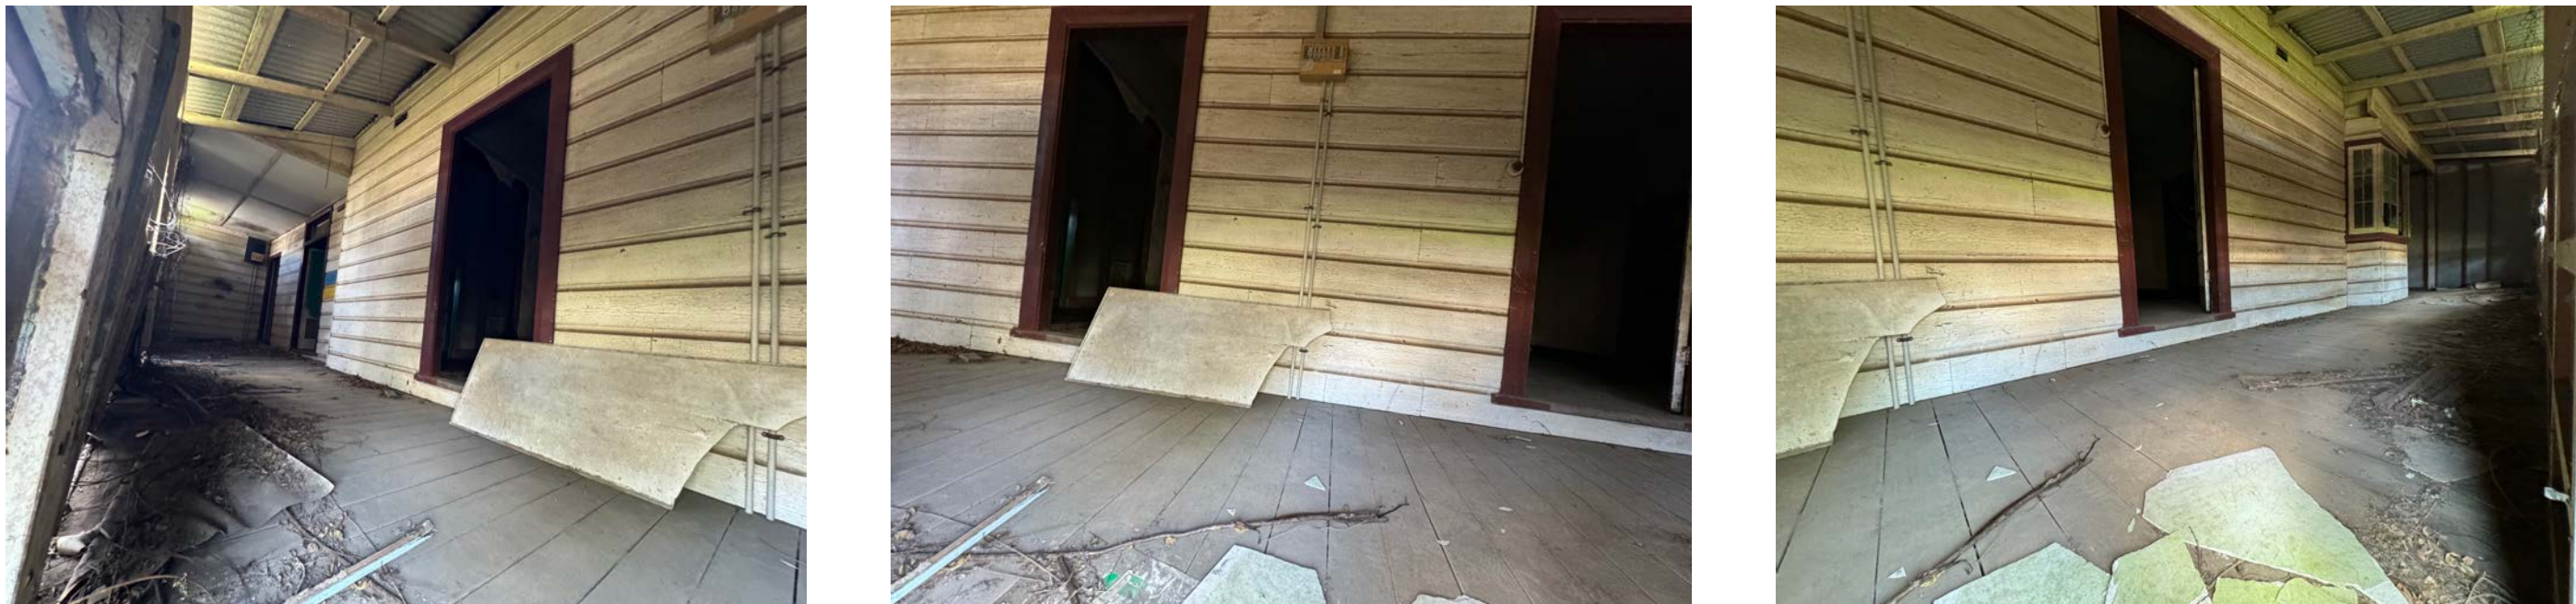
The more significant early 20th Century interiors preserved and protected by the later asbestos sheeting - viewed through cracked fibrous asbestos sheeting (TfNSW restricted access to inspect these areas)

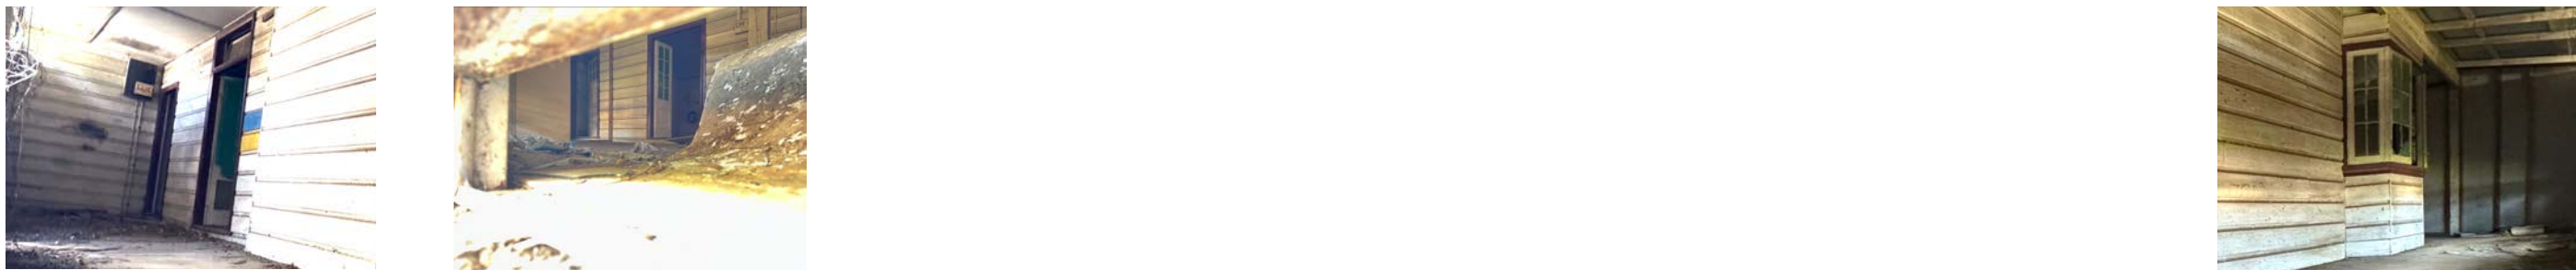
Details of the more significant early 20th Century interiors illustrating timber joinery intact and in good condition
