shreeji consultant

Our Ref: 2303705RE Allambie Cottages - 1256 Bell's Line of Road, Kurrajong - Structural Review
26 March 2024

'ALLAMBIE COTTAGES' - 1256 BELL'S LINE OF ROAD, KURRAJONG STRUCTURAL REVIEW

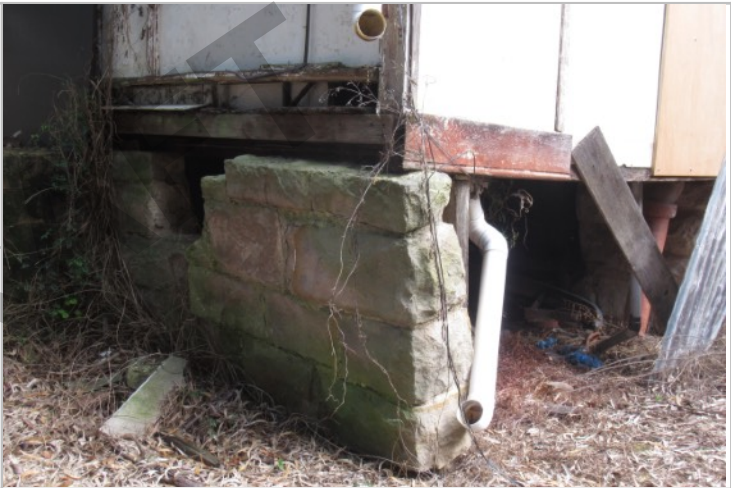
2.1.

South Cottage - southeast corner - sandstone pier is leaning out and unstable.

NOTE:
A disconnected rainwater down pipe in the corner.

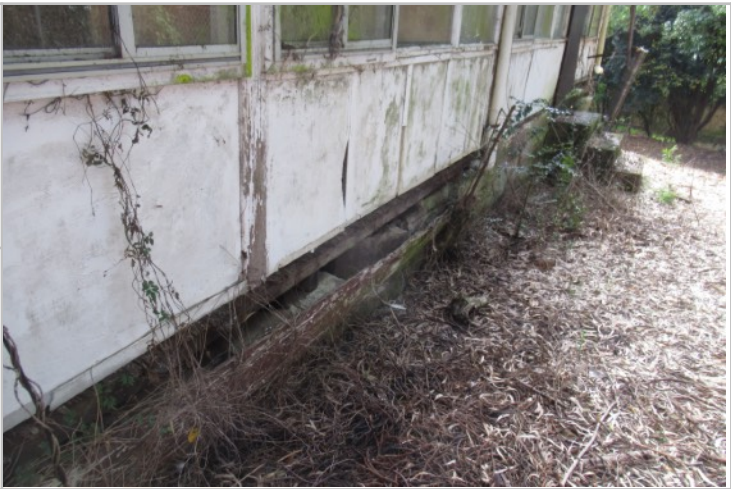
2.2.

South Cottage - South Elevation - the wall at the base is tilting.

Gutter above the area is missing.
Ground is sloping from the west to the east, front to the back.

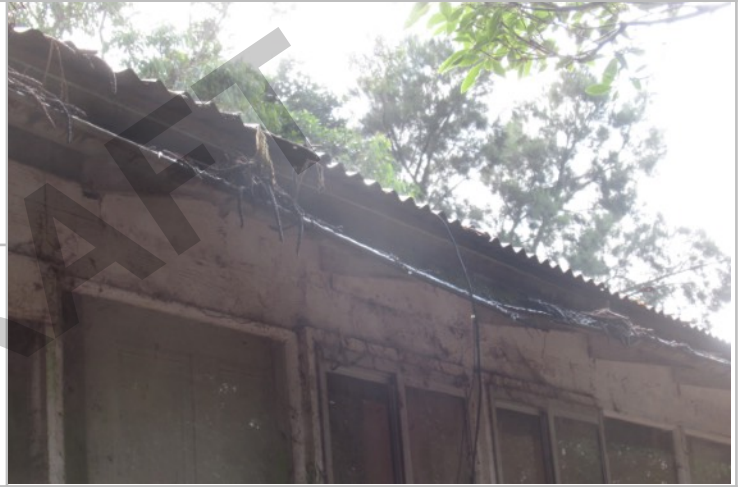
2.3.

South Cottage - South Elevation - gutter above has corroded through and has collapsed.

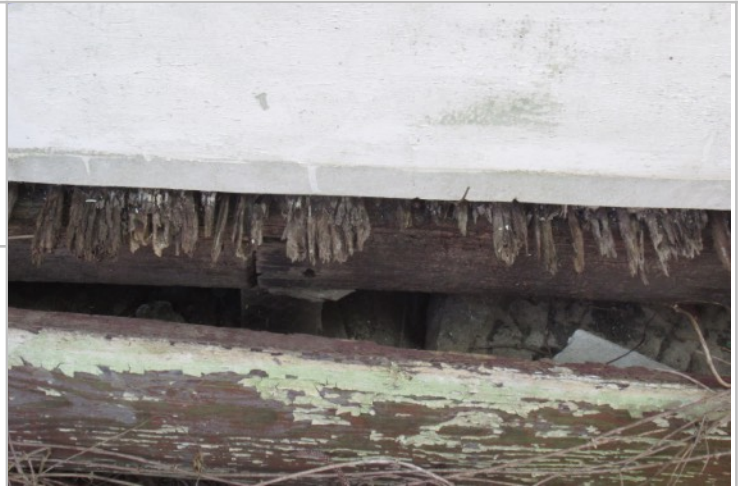
2.4.

South Cottage - South Elevation The edge of the floor boards under the missing gutter.

NOTE:
Advanced weathering from excess moisture over the period.

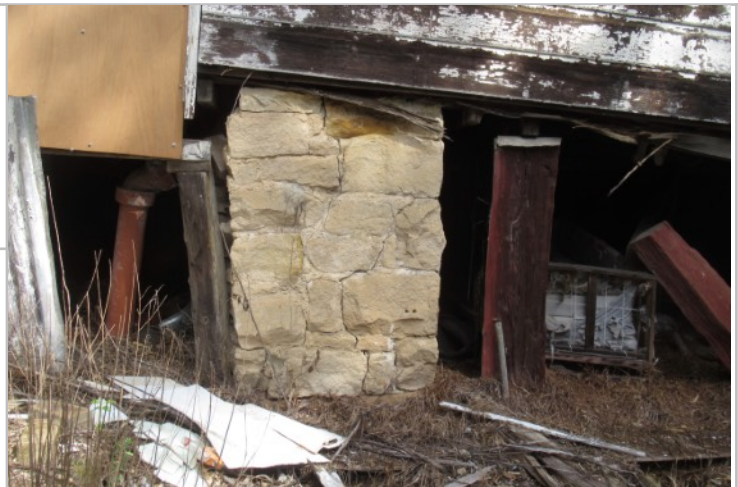
2.5.

South Cottage - East Elevation - Sandstone pier has developed a crack through the mortar joints.

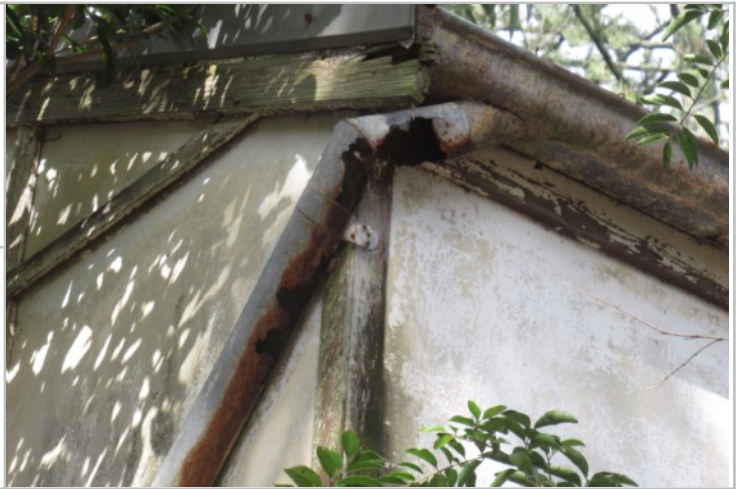
2.6.

Middle Addition - North East corner.

Corroded through down pipe.

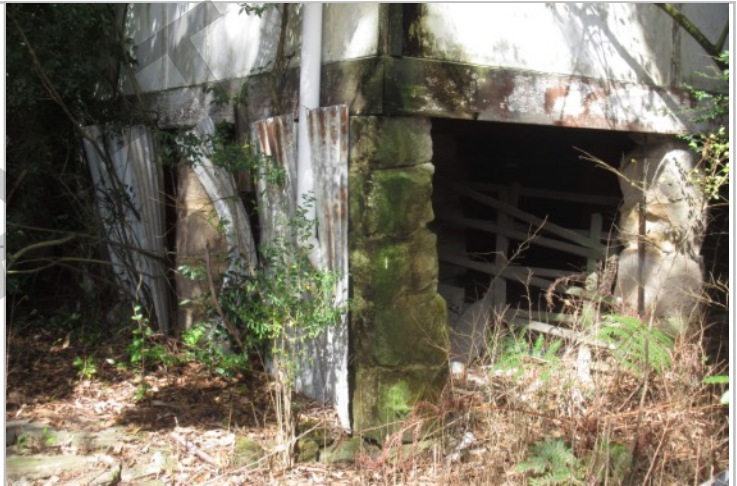
2.7.

Middle Addition - North East corner.

Corroded through down pipe discharging water to the sandstone pier and its base.

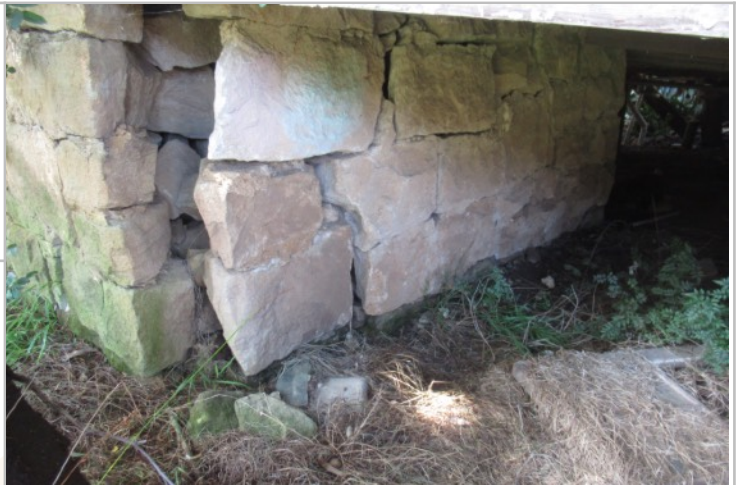
2.8.

North Cottage - North Elevation.

Sandstone base to the chimney has cracked exposing the internal rubble fill.

NOTE:

Water logged ground at the bottom of the base.

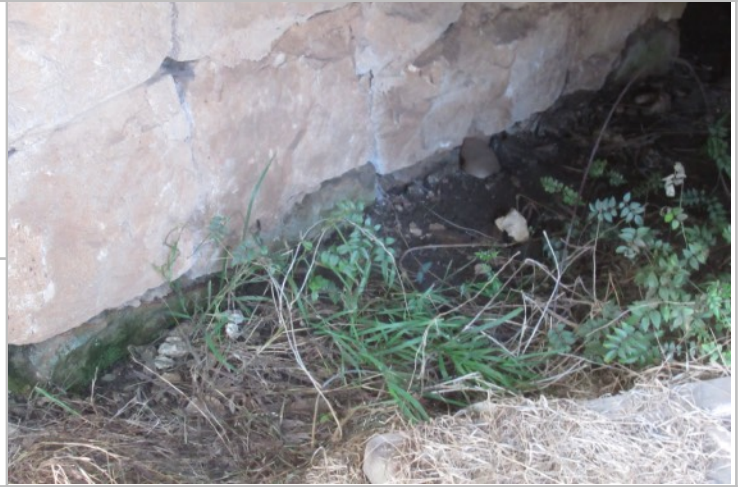
2.9.

North Cottage - North Elevation.

Sandstone base to the chimney has cracked exposing the internal rubble fill.

NOTE:

Water logged ground at the bottom of the base.

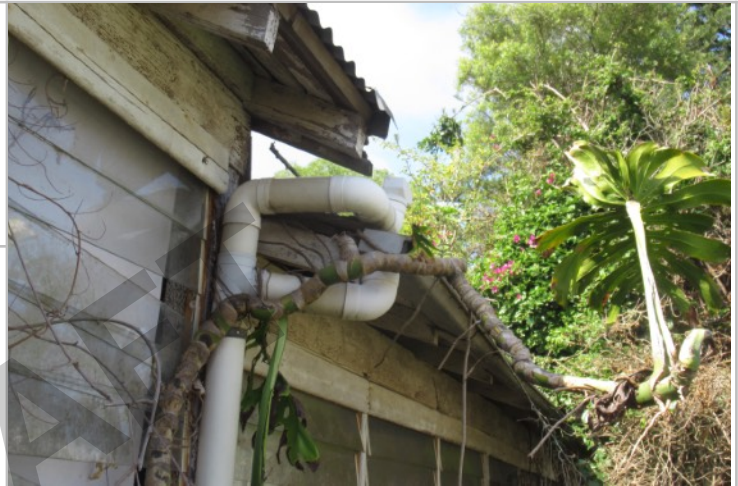
2.10.

Shared Verandah - West Side.

Missing gutters and over grown vegetation to the gutter level.

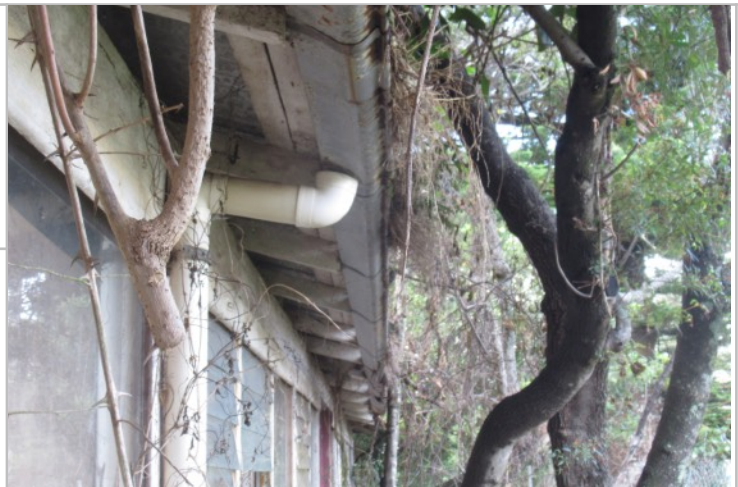
2.11.

Shared Verandah - West Side.

Collapsing gutters full of vegetation and debris.

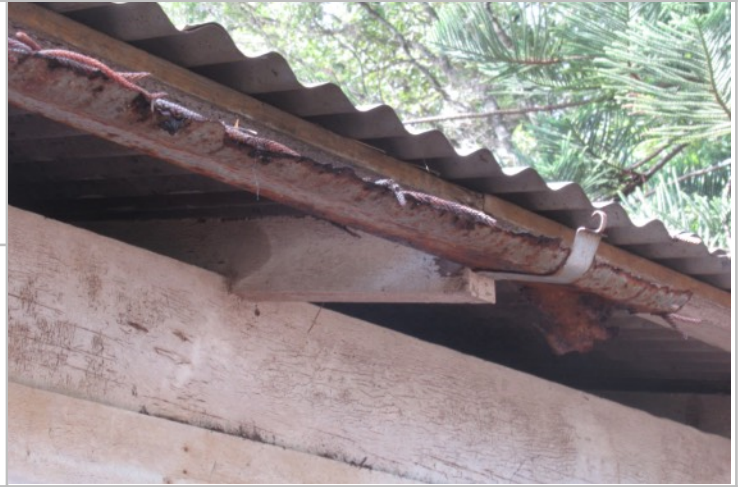
2.12.

Shared Verandah - West Side.

Corrode through gutter.

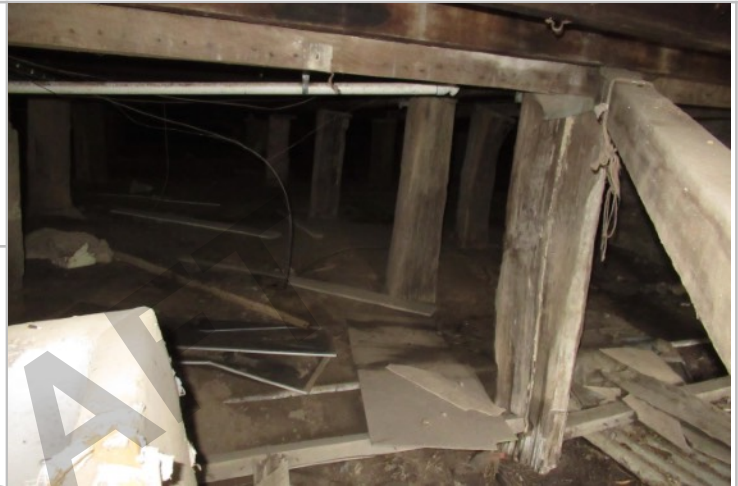
2.13.

South Cottage - view from the east side.

Timber stumps some with termite trail through the splits

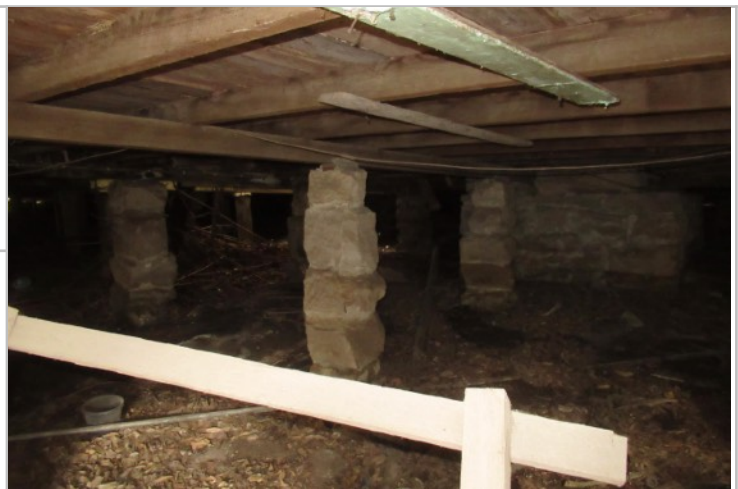
2.14.

Middle Addition - sandstone piers - view from the east side.

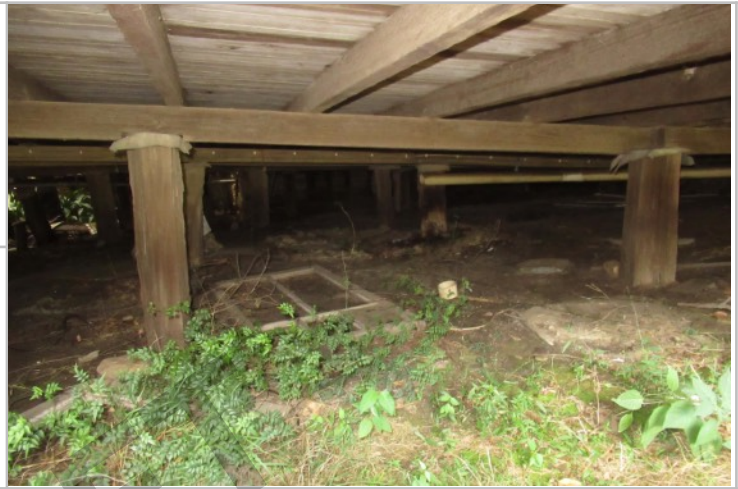
2.15.

North Cottage - Timber stumps - view from the north side.

Piers have metal ant caps.
The bases appear to be affected by wet soil.

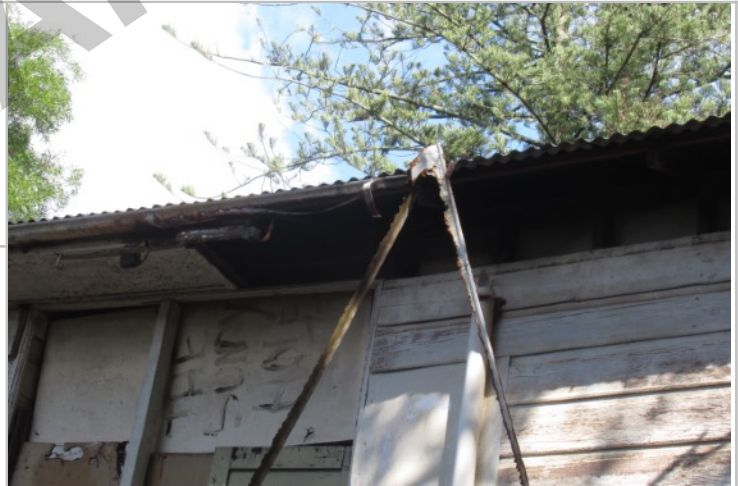
2.16.

North Cottage - south side east end.

Gutter corroded through.

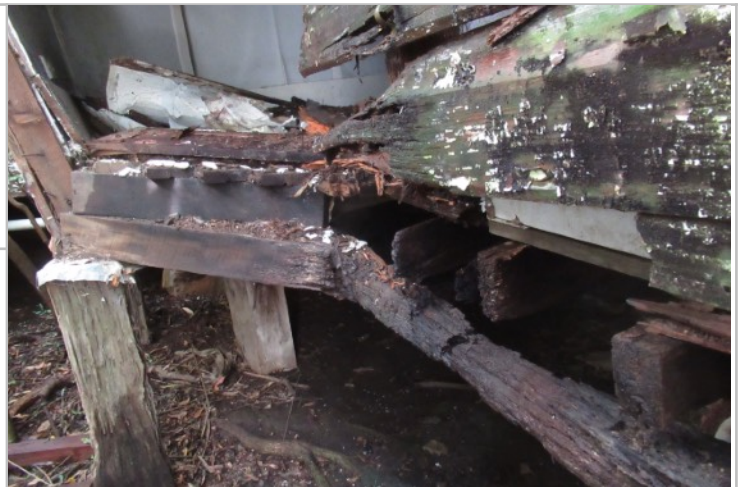
2.17.

North Cottage - south side east end.

Gutter corroded through.
Area under the gutter affected by wet rot and possible fire.

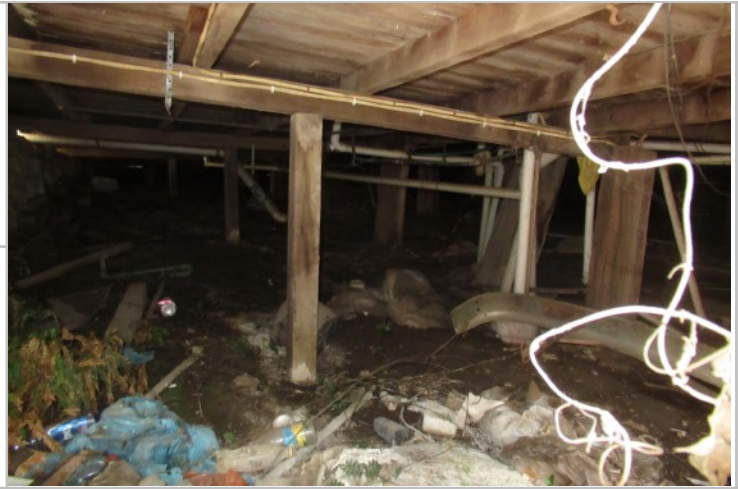
2.18.

South Cottage - view from the east.

Later timber support in sawn timber.

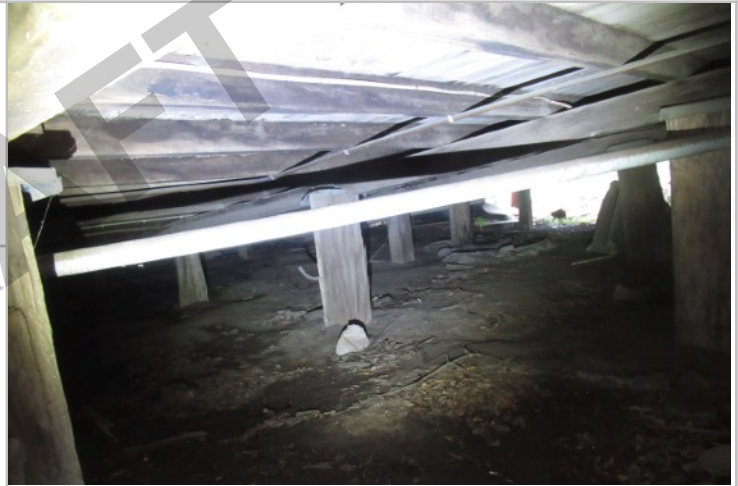
2.19.

North Cottage - view from the north side.

Timber stumps.

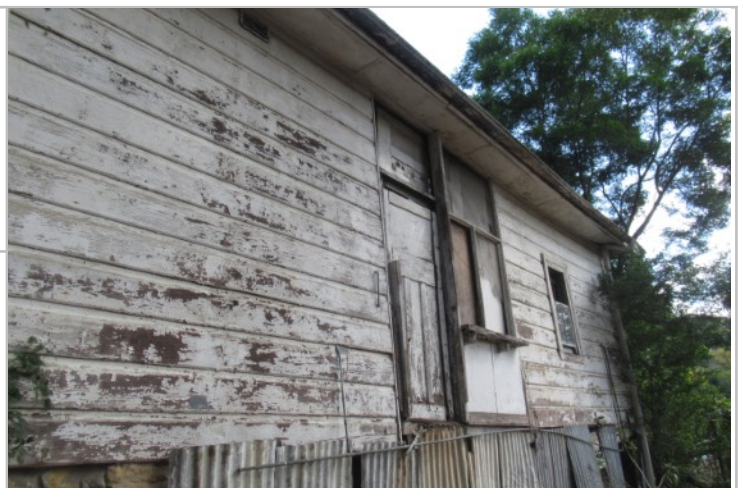
2.20.

North Cottage - East side.

Timber boards affected by moisture - pilling paint.

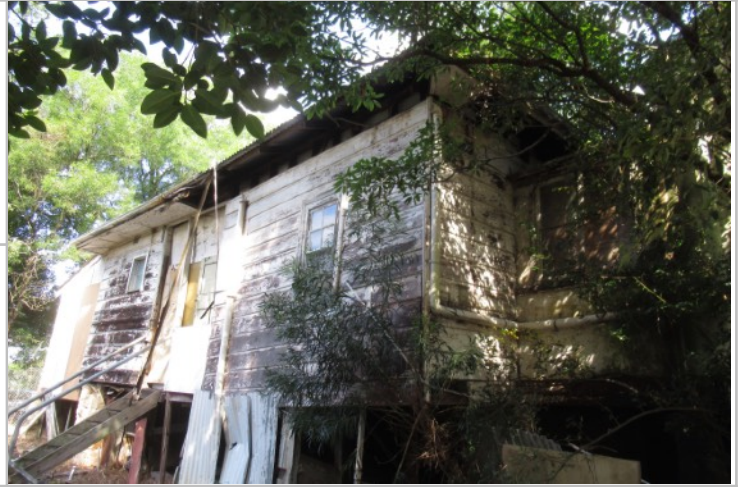
2.21.

South Cottage - East side.

Timber boards affected by moisture - pilling paint and some wet rot.

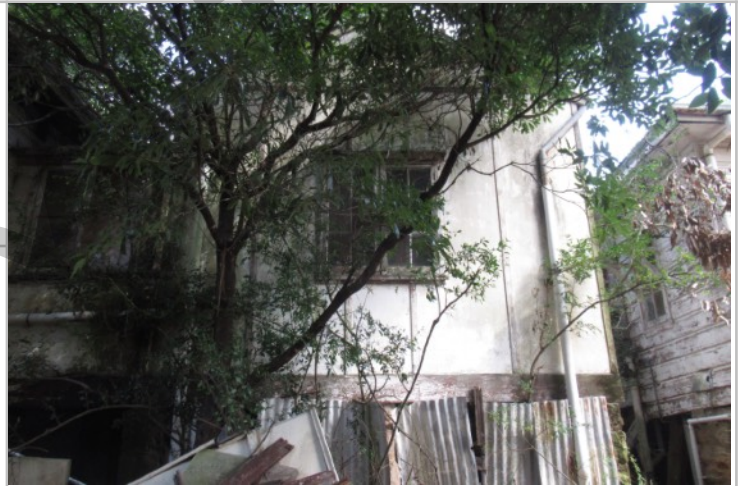
2.22.

Middle Addition - East side.

Fibre cement board lining.

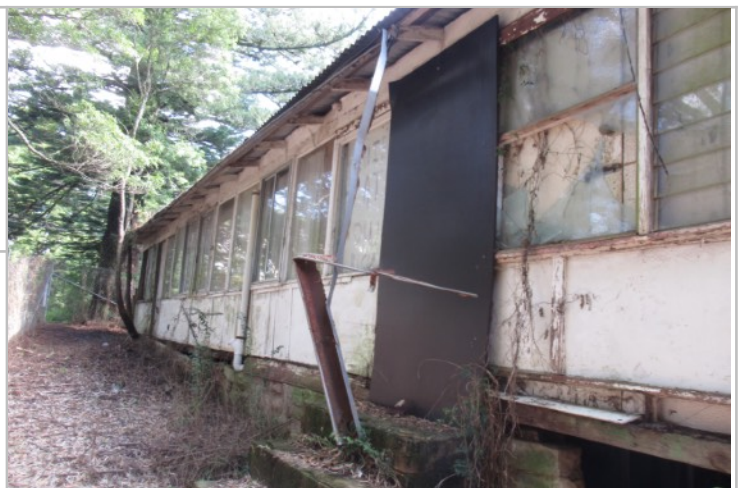
2.23.

South Cottage - south side.

Fibre cement board and windows.

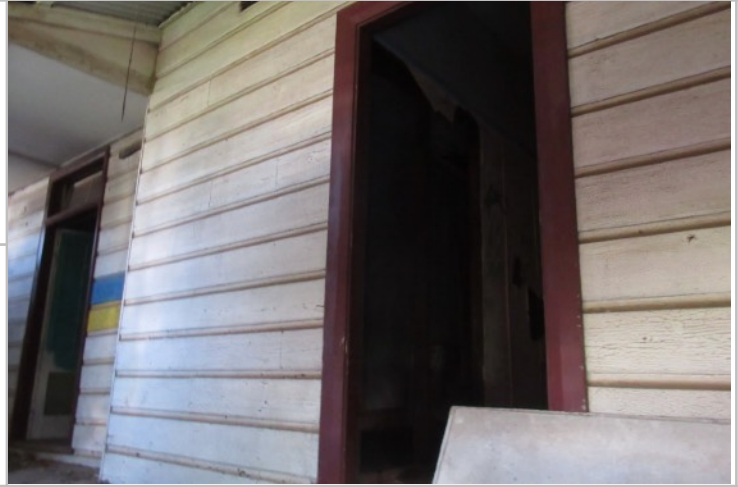
2.24.

North Cottage - West Wall.

View from an opening in the verandah - boards are in very good condition.

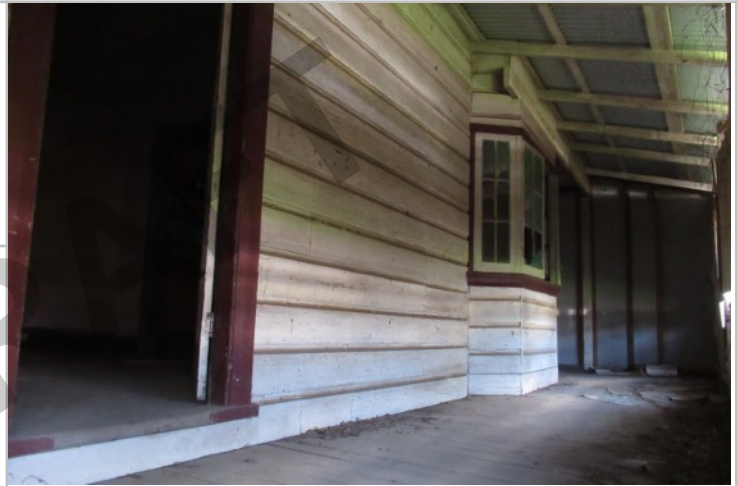
2.25.

South Cottage - West Wall.

View from an opening in the verandah - boards are in very good condition.
