Structural Condition Report

**Allambie Cottages, 1256 Bells Line
of Road, Kurrajong NSW**

Transport for NSW / 28 February 2024

232063

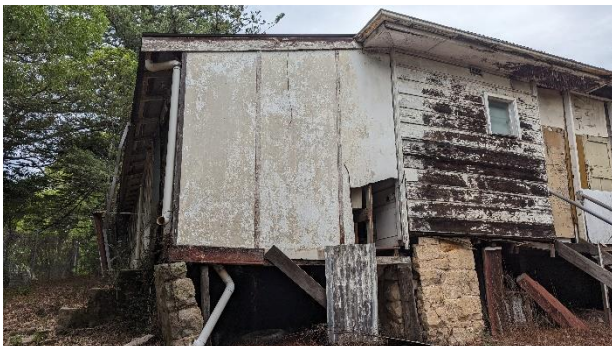
Figure 3 – Leaning and deteriorated sandstone walls and piers and deflection to eastern wall

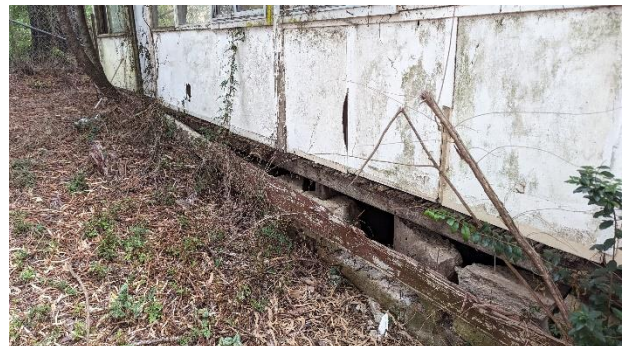
Figure 4 – Leaning sandstone wall with missing units, and water-rot to exposed flooring timbers along southern side

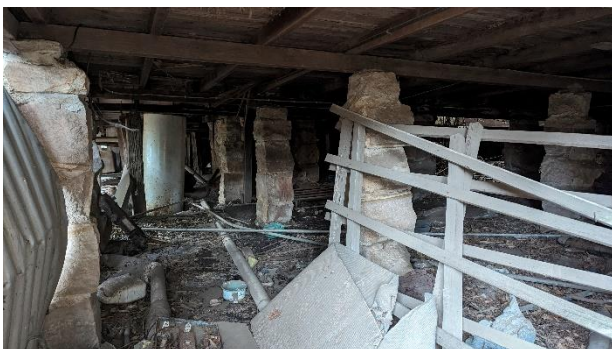
Figure 5 – Leaning and eccentrically loaded sandstone piers to middle cottage

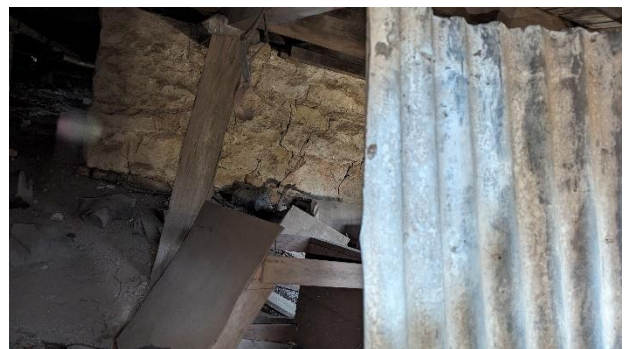
Figure 6 – Cracking to sandstone pier at northern cottage

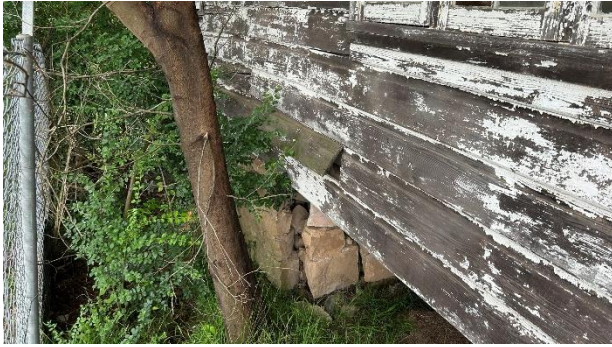
Figure 7 – Splitting at corner of pier (northern cottage), note loose rubble fill

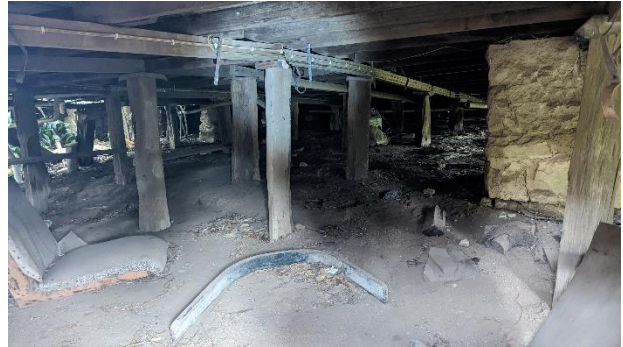
Figure 8 – Deteriorated and deformed stumps below northern cottage

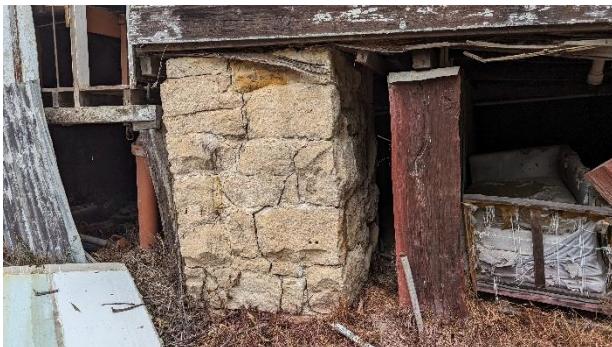
Figure 9 – Close up of cracking to sandstone pier below southern cottage; frass and termite tracks visible in stump

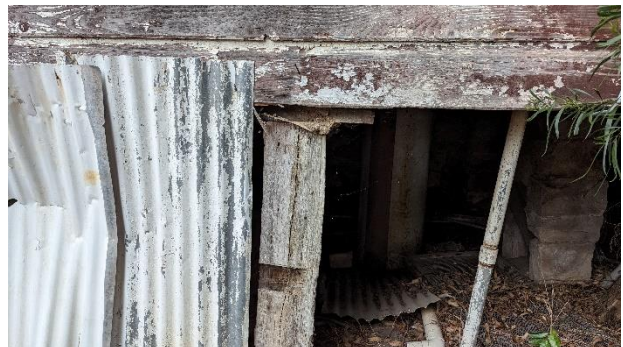
Figure 10 – Termite damage above leaning stump to northern cottage

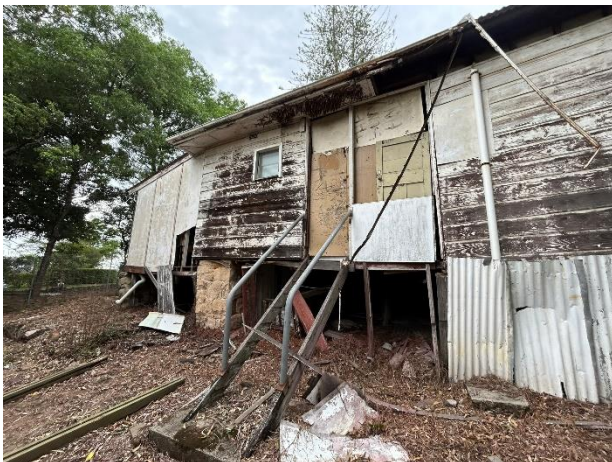
Figure 11 – Failed stumps below southern doorway means that supported is provided by a 75 x 50 mm stud

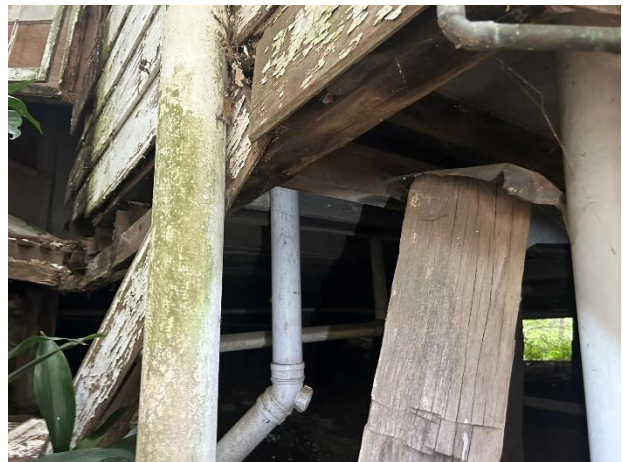
Figure 12 – Failed stump at southern wall of northern cottage

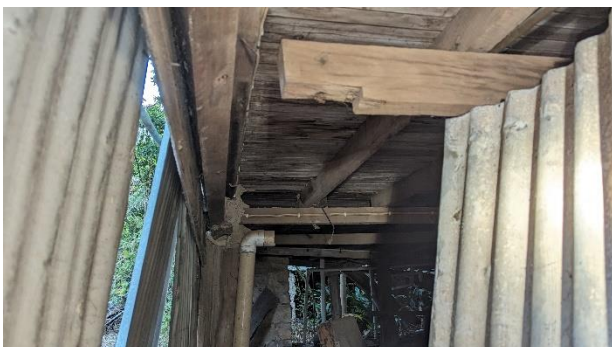
Figure 13 – Disconnected bearer below middle addition

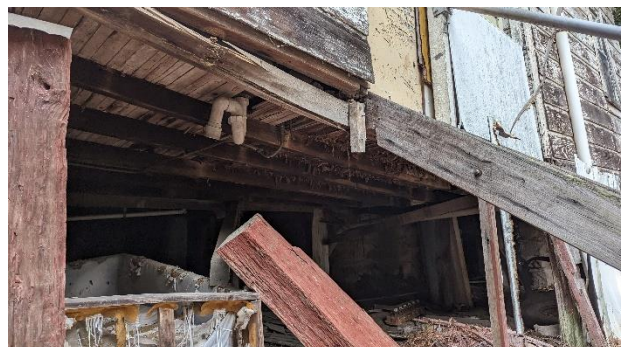
Figure 14 – Failed stump at southern cottage. Note failed joist in foreground and floor framing in background, due to termite damage

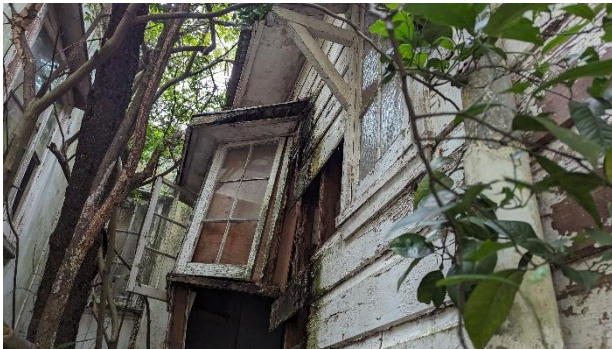
Figure 15 – There is extensive water rot damage to the southern wall of the northern cottage

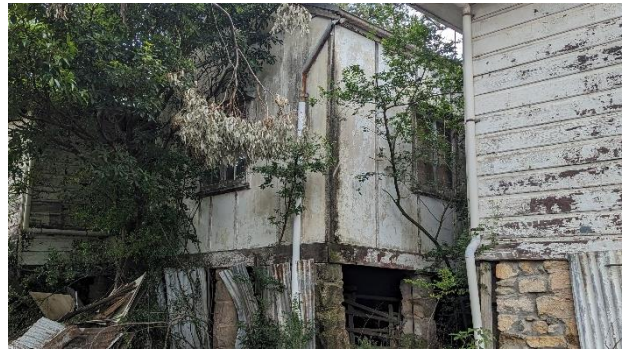
Figure 16 – Water rot to the corner post in the middle addition

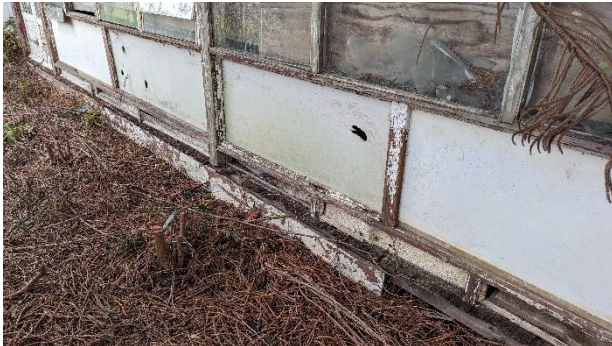
Figure 17 – Typical weathering to exposed flooring, wall framing and wall sheeting (southern side of building)

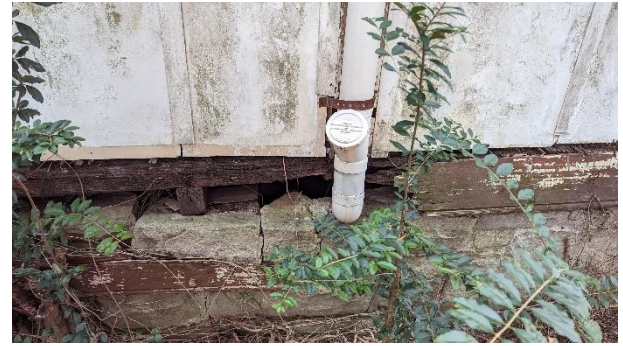
Figure 18 – Deteriorated floor joist due to exposure and water rot

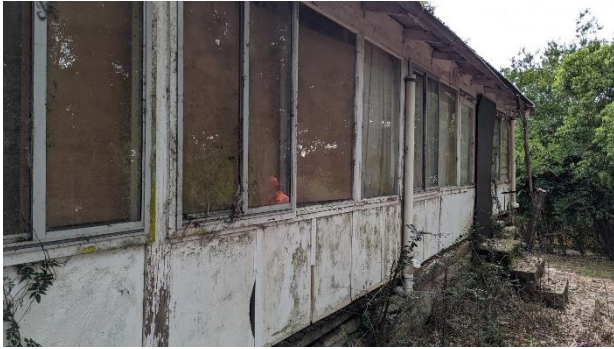
Figure 19 – Typical weathering and deterioration to southern side of building

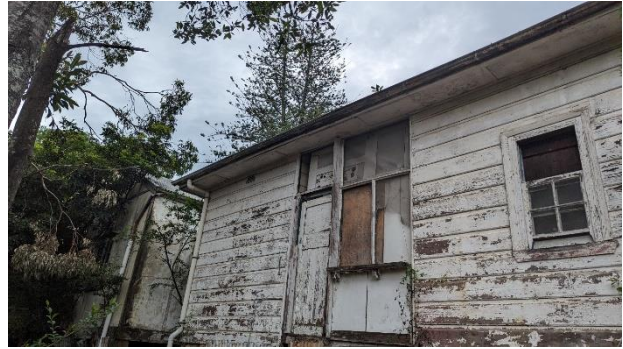
Figure 20 – Typical weathering to weatherboards to eastern side of building

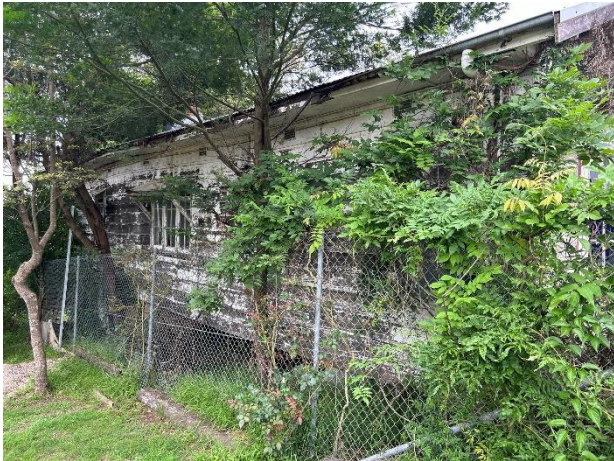
- The entire northern perimeter wall which has deflected and deformed as a result of foundational failures.
 - The shape of the wall suggests that it is cantilevering at the western end, and that the weatherboards are effectively acting as bracing (similar to plyboard bracing in contemporary timber construction).

Figure 21 – Deflection and deformation to northern wall

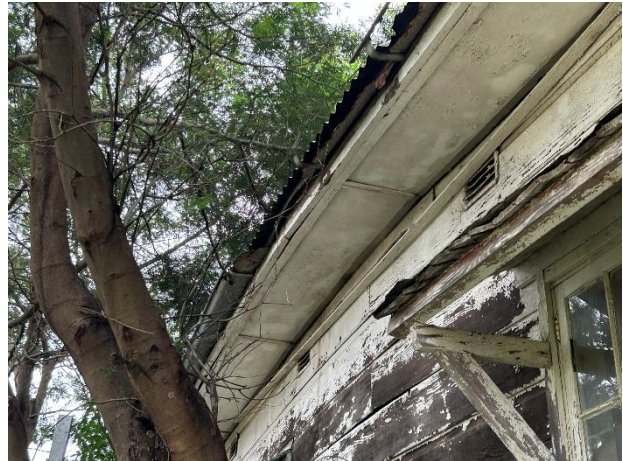
Figure 22 – Swelling and waterrot to eaves at northern side, directly below failed gutters

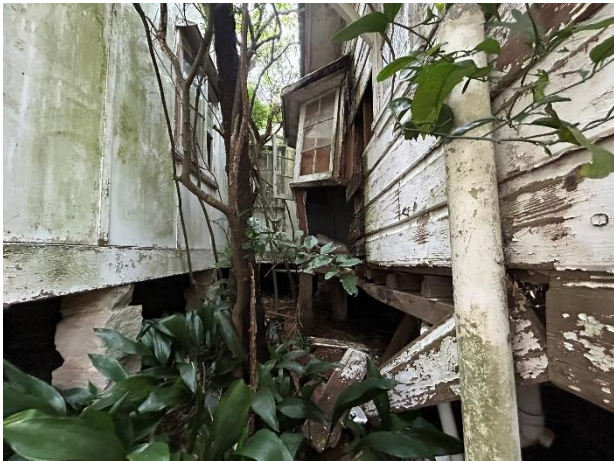
Figure 23 – Partial collapse of wall and window bay to southern side of northern cottage

1. Collapse of the window bay to the southern side of the northern cottage was progressive and occurred since September 2021.
 - The founding stump immediately below this area had already detached by 2016, causing deflection to the wall above. The stump continued to lean away and eventually fall in the years since.

- The extent of biological growth (and thusly water ingress) in the area increased over time, indicating that the failure was ultimately as a result of loss of structural integrity caused by water rot.

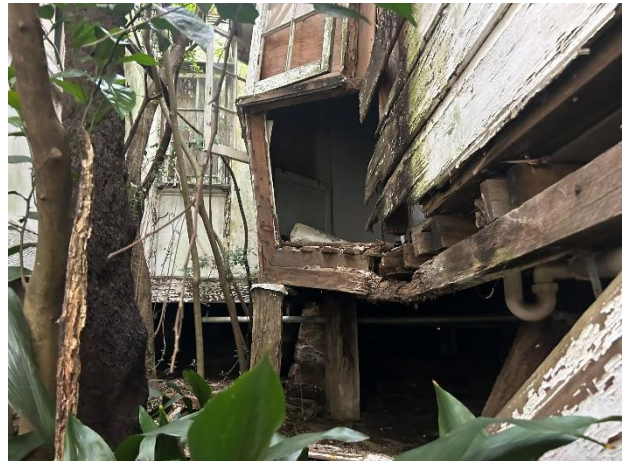
Figure 24 – Close up of framing below failed window bay, noting lack of lateral restraint; note also failed stump to right of image

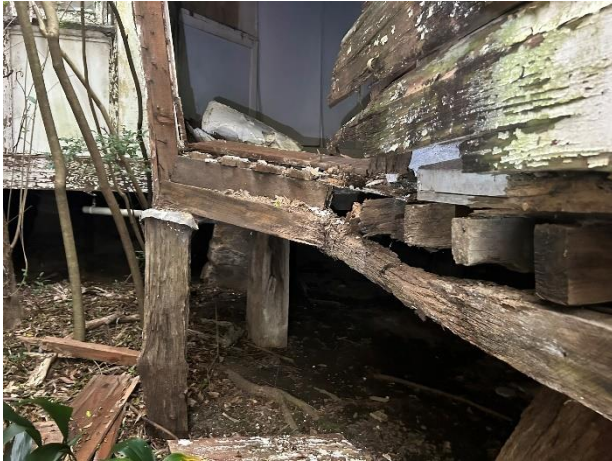
Figure 25 – Close up of water rot damage to remaining stump and failed timber bearer

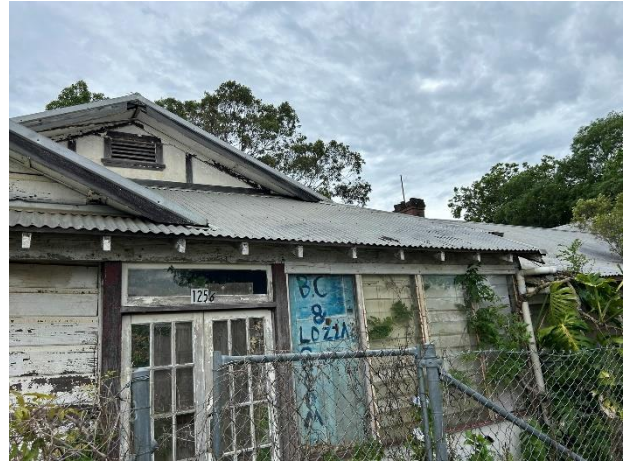
Figure 26 – Deteriorated fascia and gutters to western side of building

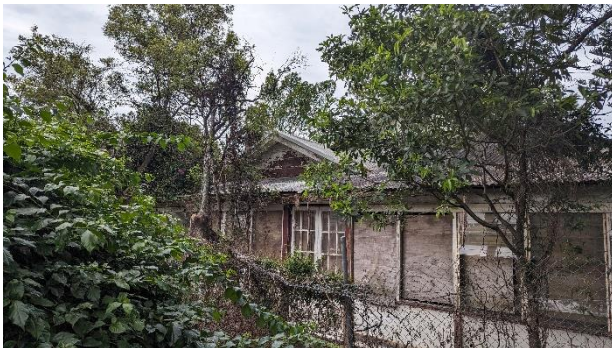
Figure 27 – Deteriorated fascia, cladding and gutters to western side of building

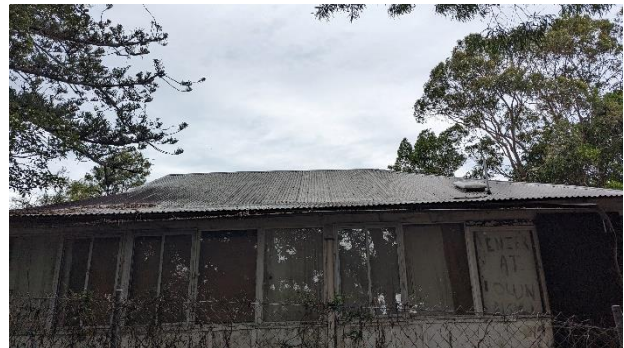
Figure 28 – Deteriorated cladding and gutters to southern side of building

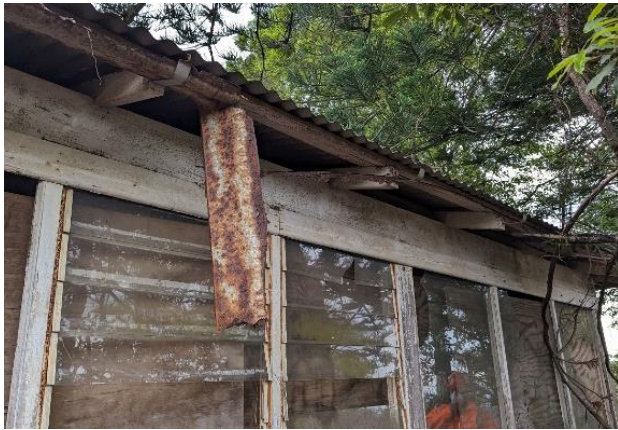
1. Gutters are either completely missing, corroded through, or filled with debris across the entire perimeter of the building.
 - The resultant lack of stormwater management means that rainfall is free to flow across the external walls of the building (leading to water rot and accelerated weathering), ingress into the building interior, or directly reach the timber foundations and soil below.

Figure 29 – Failed gutters to southern side of building

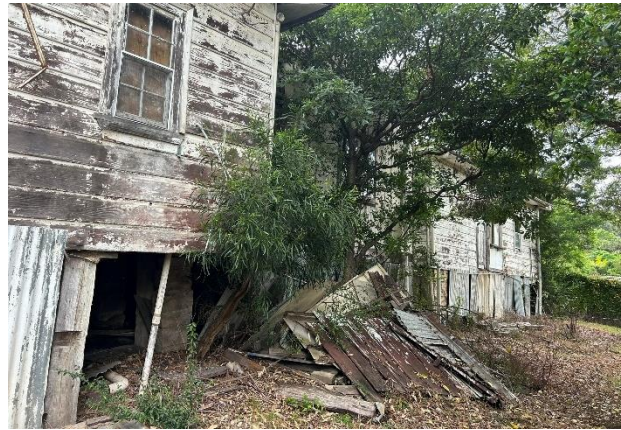
2. The outhouse to the east side of the building has collapsed or been dismantled.
3. Treads to the entrance stairs at the east side of the building are missing.

Figure 30 – Collapsed/dismantled outhouse

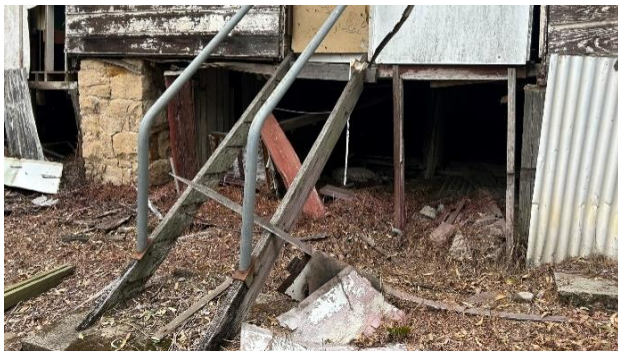
Figure 31 – Missing stair treads at eastern entrance

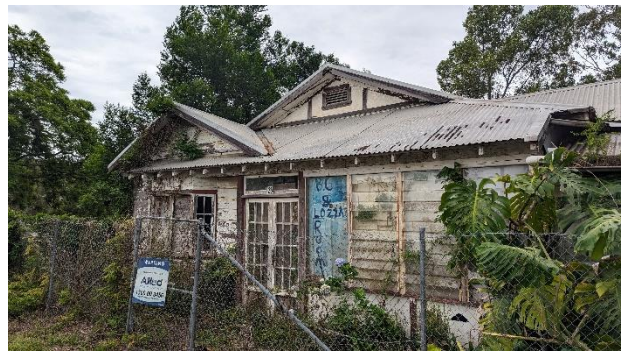
4. Fascia boards (namely to the original portions of building at the northern and western sides) are missing or are noticeably deteriorated from weathering (including swelling and splitting).

Figure 32 – Deteriorated fascia, cladding and gutters to western side of building

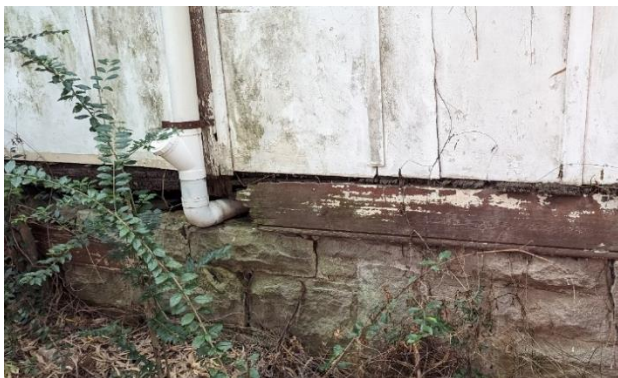
5. On the southern perimeter, a post supporting roofing above is resting directly onto a PVC pipe.
6. Active hornets/wasp nests were found in four locations.

Figure 33 – Roof-support post resting directly over a PVC pipe

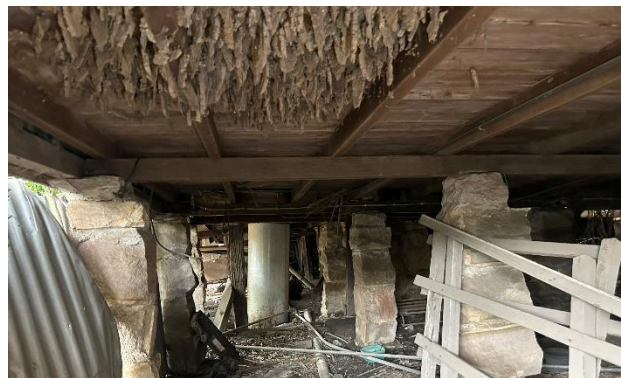
Figure 34 – Hornets/wasp nests under middle addition

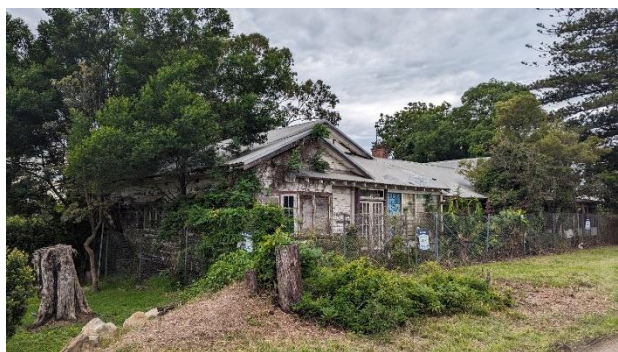
Figure 35 – Plants growing between cladding boards at western side of building

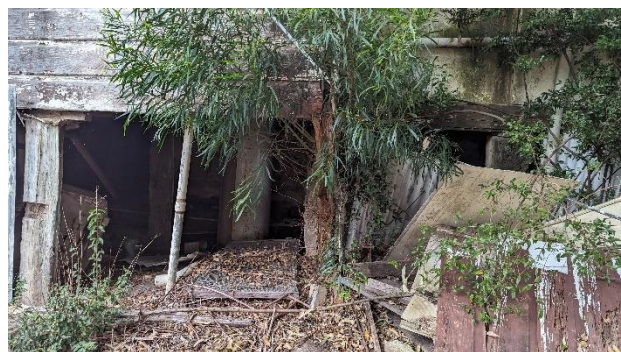
- It is likely that some movement of the footings can be attributed to invasive roots of these nearby trees, although this could not be confirmed on site.

Figure 36 – Tree growing immediately adjacent a stump to the northern cottage; note staining/biological growth to cladding

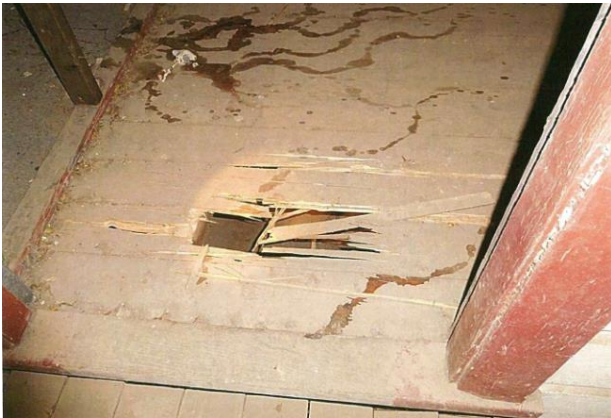
Figure 37 – Termite damage to flooring in Northern cottage (Taylor and Hubert Structural, 2016)

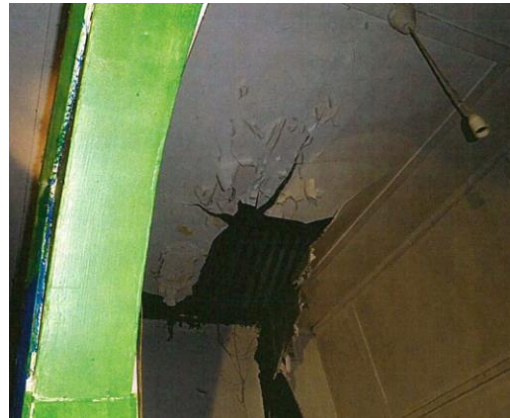
Figure 38 – Ceiling collapse due to water damage (Taylor and Hubert Structural, 2016)

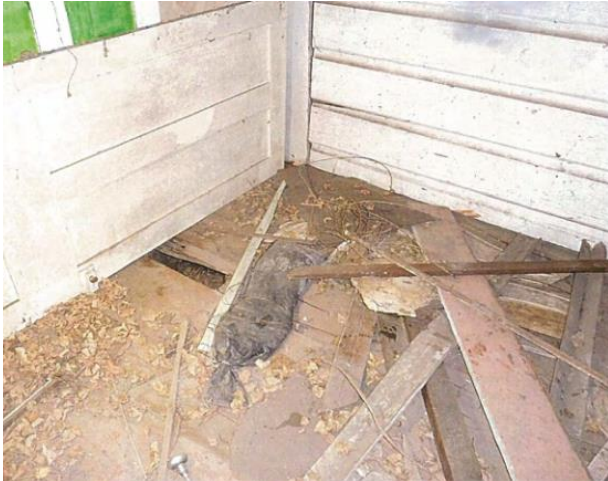
Figure 39 – Termite damage to flooring in verandah (Taylor and Hubert Structural, 2016)

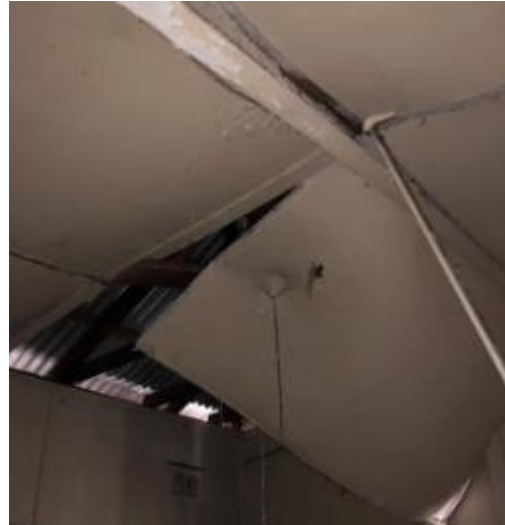
Figure 40 – Collapsed ceiling panels (Dunnings Consulting Engineers, 2021)

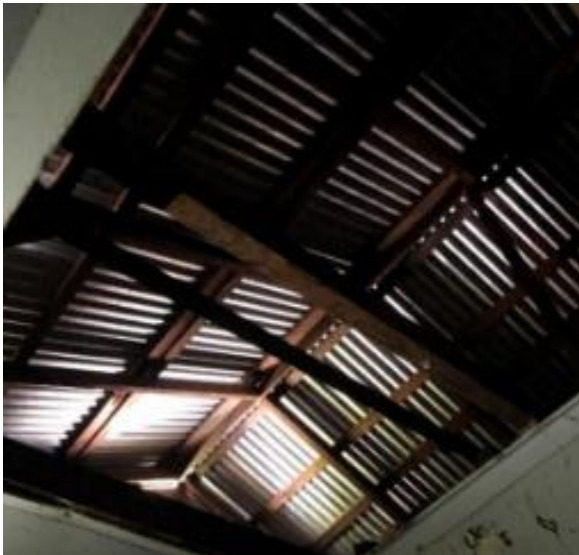
Figure 41 – Exposed roof framing, note lack of insulation/sarking (Dunnings Consulting Engineers, 2021)

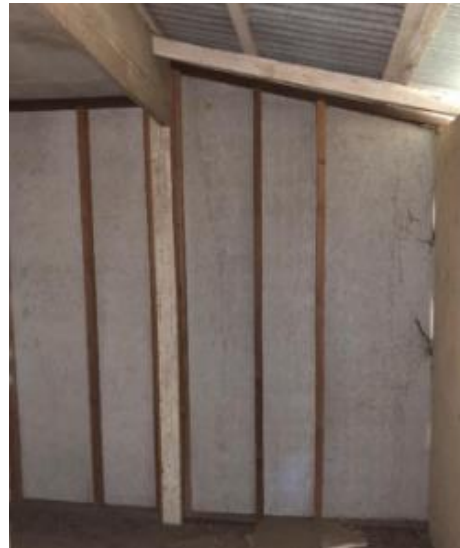
Figure 42 – Internal wall with sheeting removed, noting no noggings to framing (Dunnings Consulting Engineers, 2021)

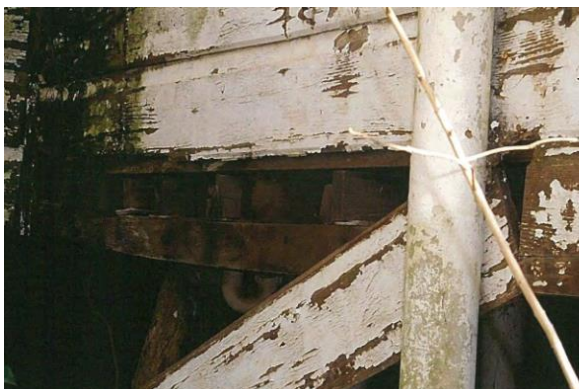
Figure 43 – Southern wall of northern cottage, 2016 (Taylor and Hubert Structural, 2016)

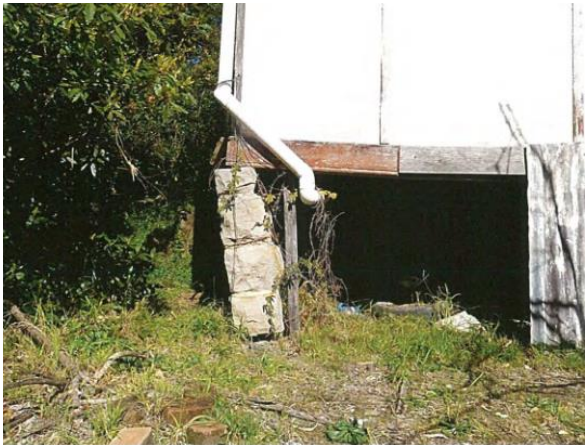
3. The lean of the sandstone wall at the south-eastern corner of the building appears to have worsened over the period 2016-2021.
4. Deterioration of the sandstone piers does not appear to be ongoing.

Figure 45 – Sandstone wall at south-east corner, 2016
(Taylor and Hubert Structural, 2016)

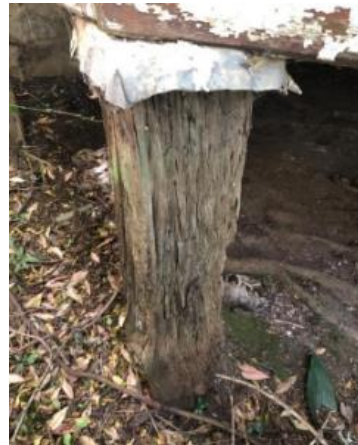
Figure 46 – Termite damaged sump, 'necking' from water rot (Dunnings Consulting Engineers, 2021)

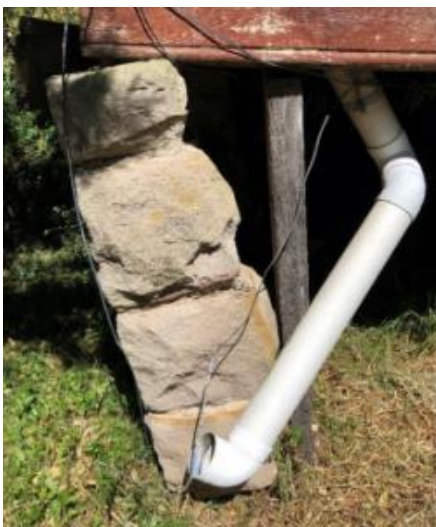
Figure 47 – Sandstone wall, south-east corner, 2021
(Dunnings Consulting Engineers, 2021)

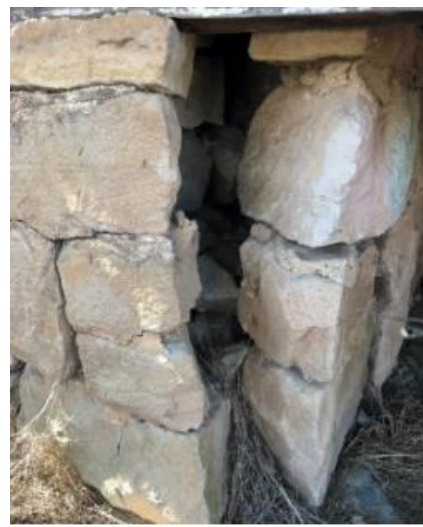
Figure 48 – Splitting sandstone pier, northern cottage
is unchanged since 2021 (Dunnings Consulting
Engineers, 2021)

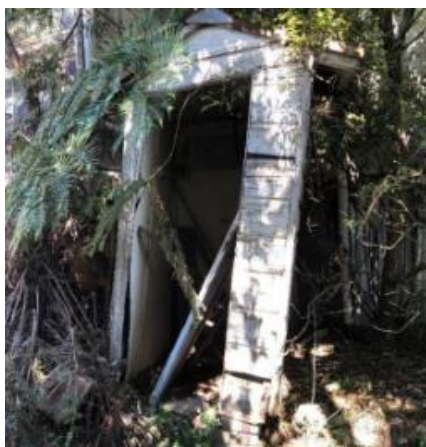
5. Collapse/dismantling of the outhouse structure occurred after September 2021.
6. Treads to the eastern entrance stairs collapsed/were dismantled between August 2016 and September 2021.

Figure 49 – Outhouse building, as pictured 2021
(Dunnings Consulting Engineers, 2021)

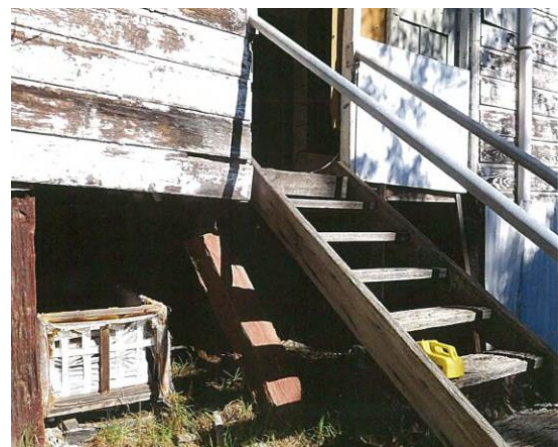
Figure 50 – Eastern entrance stairs, as pictured 2016
(Taylor and Hubert Structural, 2016)

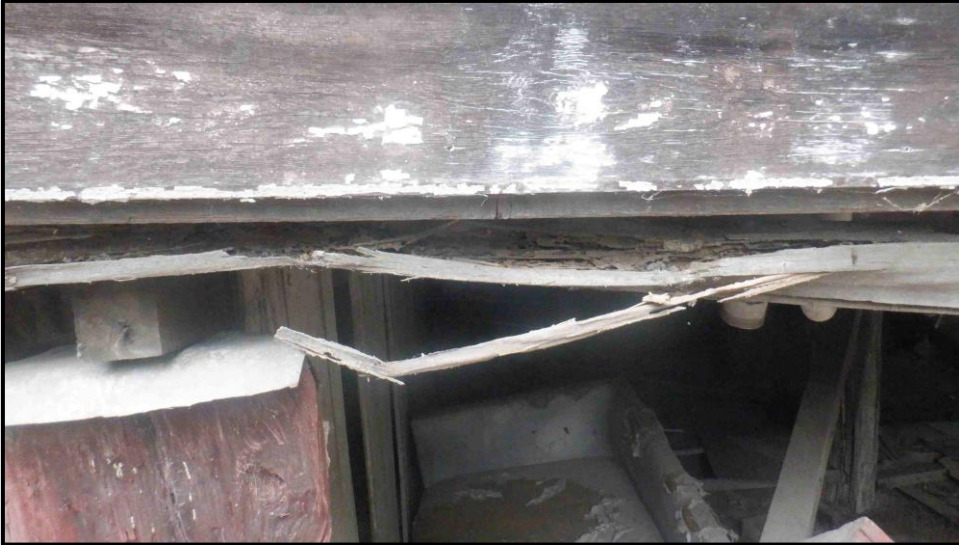
Photo 5998 There was extensive termite damage in flooring timbers.

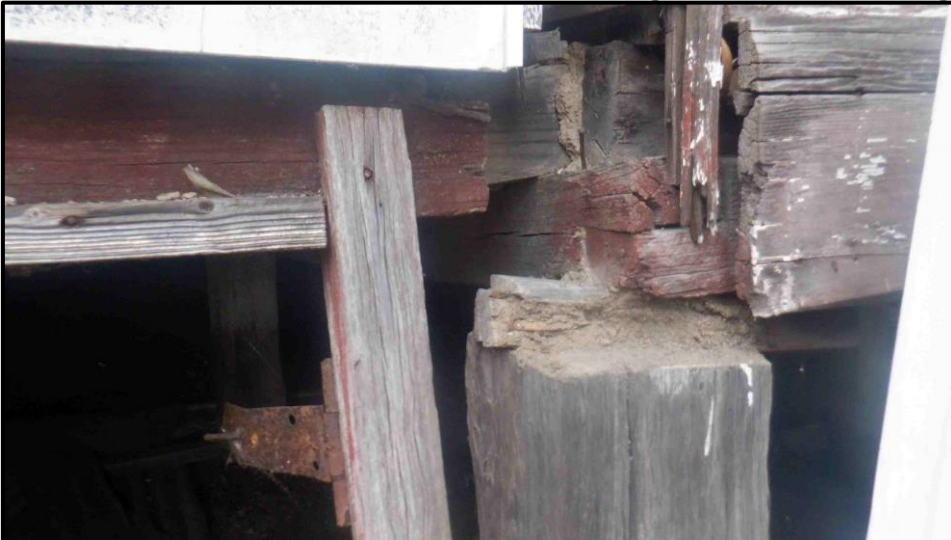
Photo 5902 There was extensive termite damage in wall and flooring timbers.

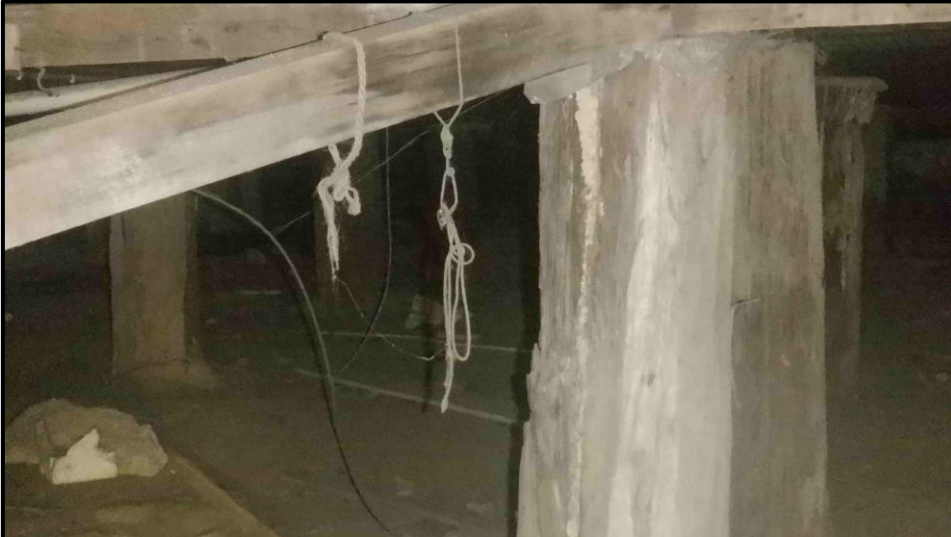
Photo 6003 There was termite damage in stump but close inspection was not possible.

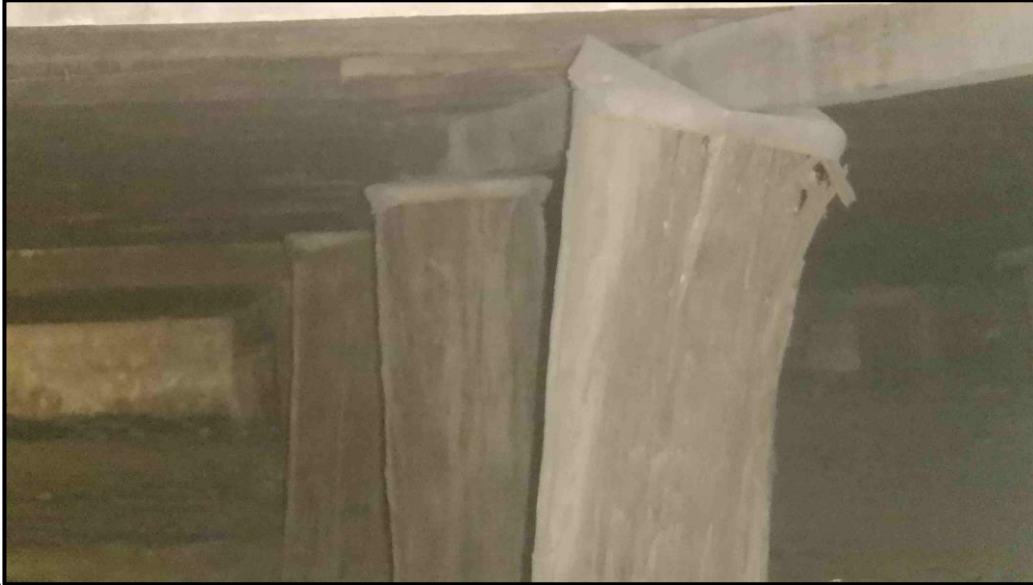
Photo 6005 There was termite damage in stump but close inspection was not possible.

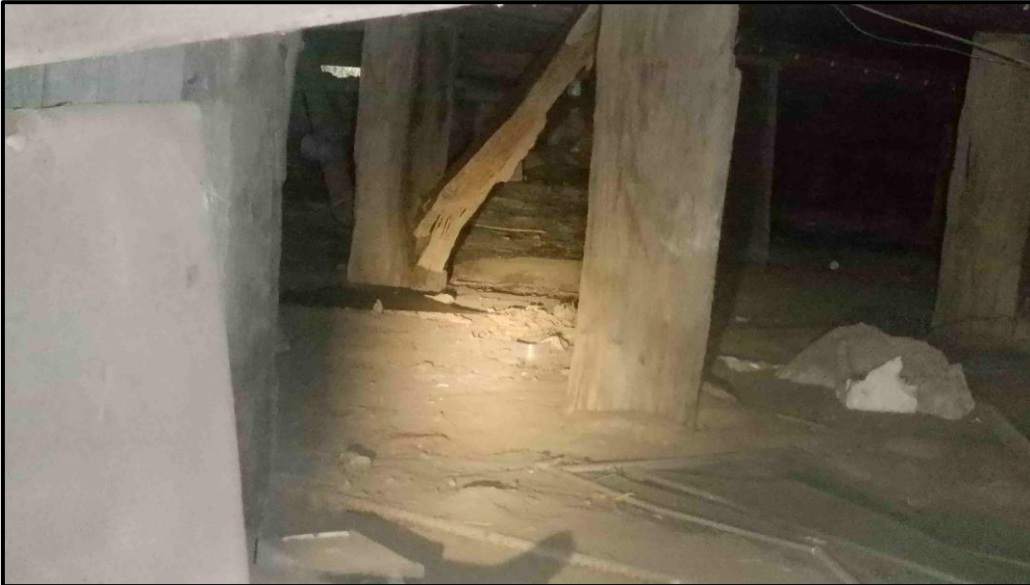
Photo 6004 There was extensive termite damage in flooring timbers.

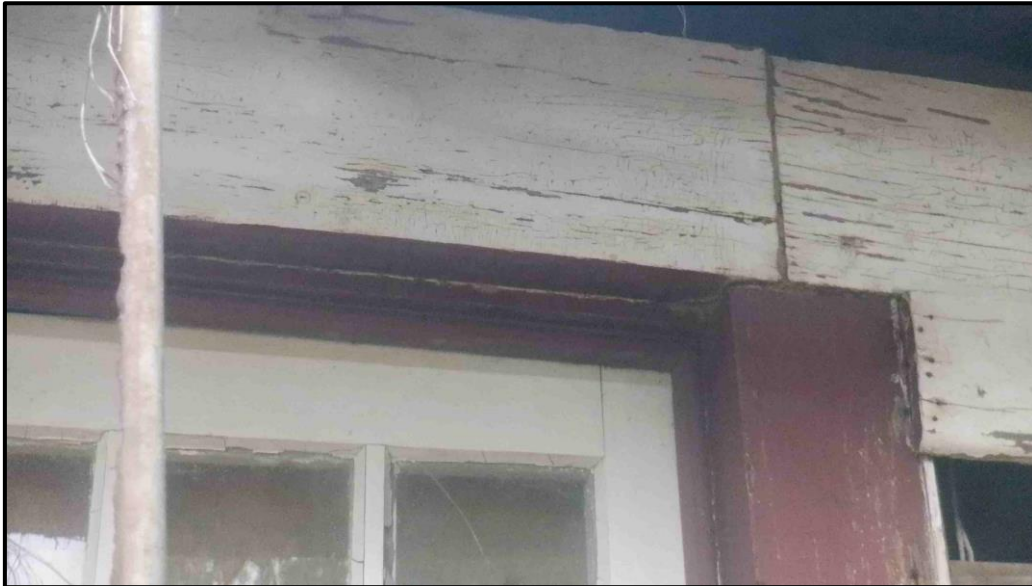
Photo 6024 There was extensive termite damage in exterior timbers.

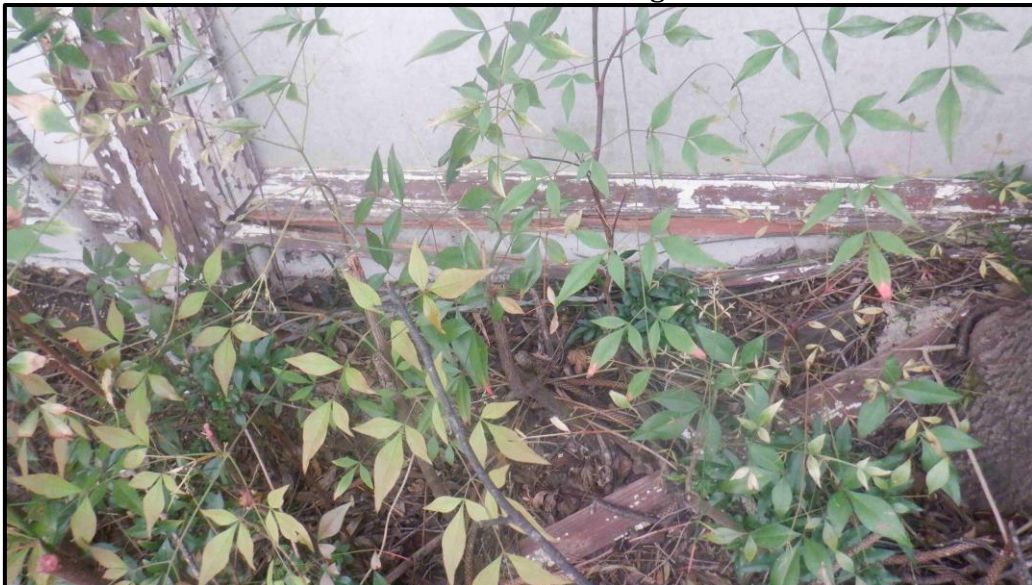
Photo 6020 There was extensive termite damage in exterior timbers.

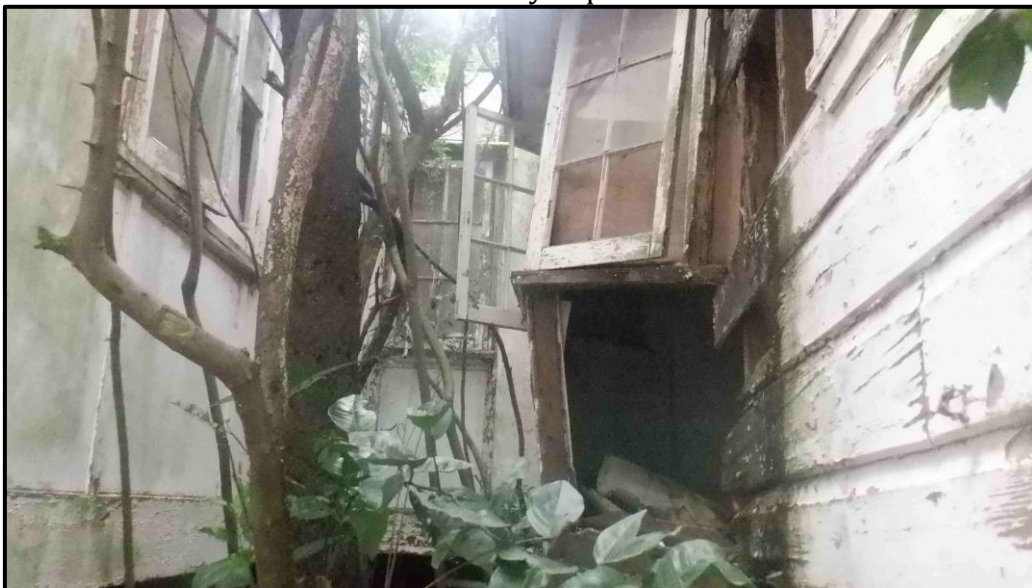
Photo 6009 There was extensive decay in parts of the exterior walls.

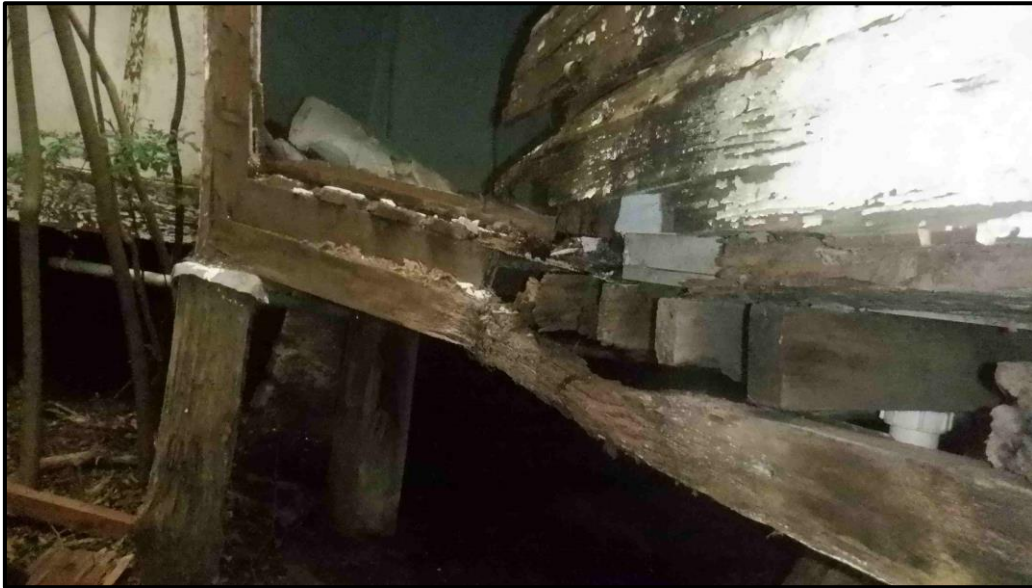
Photo 6010 There was extensive decay in wall and flooring timbers.

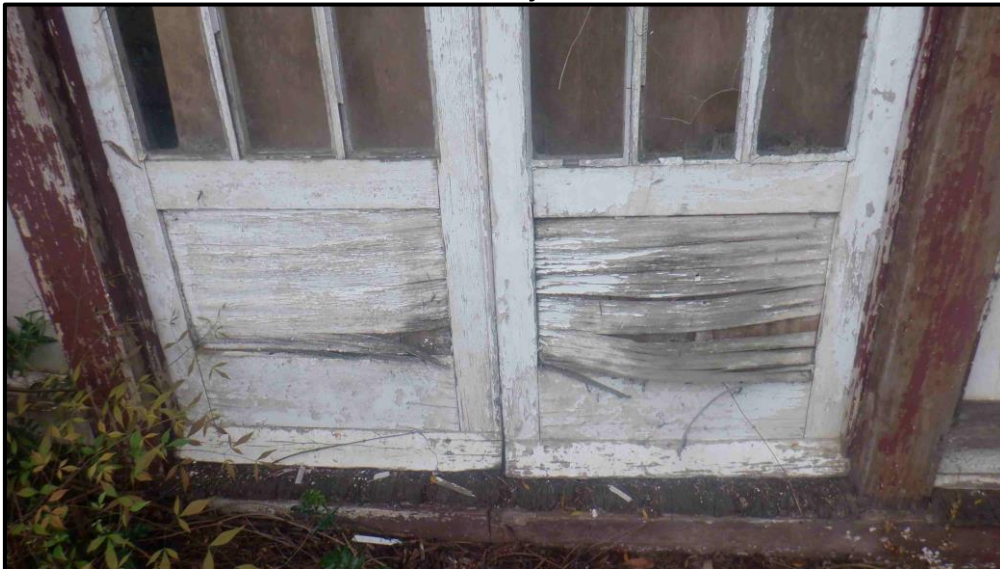
Photo 6027 There was extensive decay in exterior timbers.

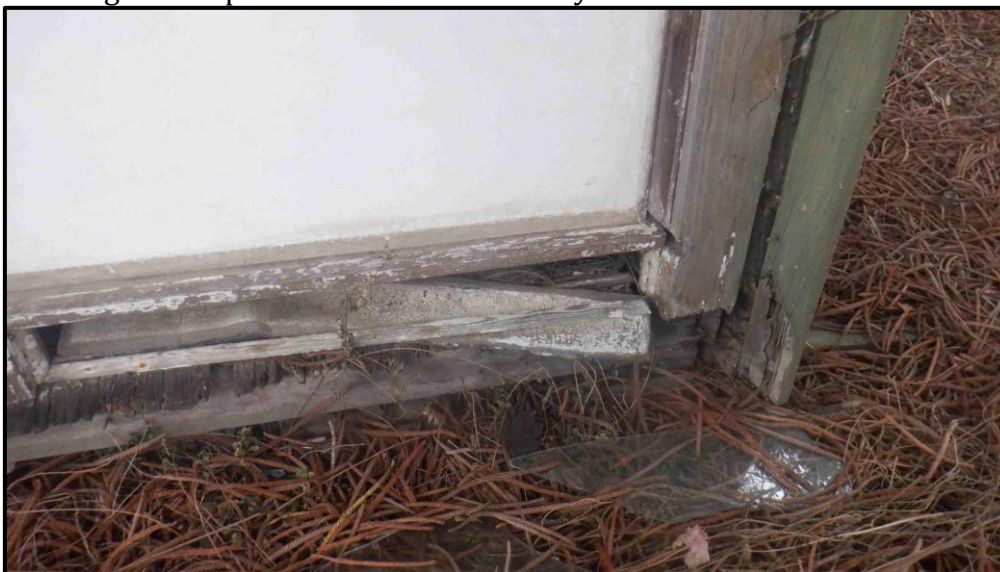
Photo 6019 There was soil build-up along parts of the south western sides of the building allowing for the potential undetected entry of termites.

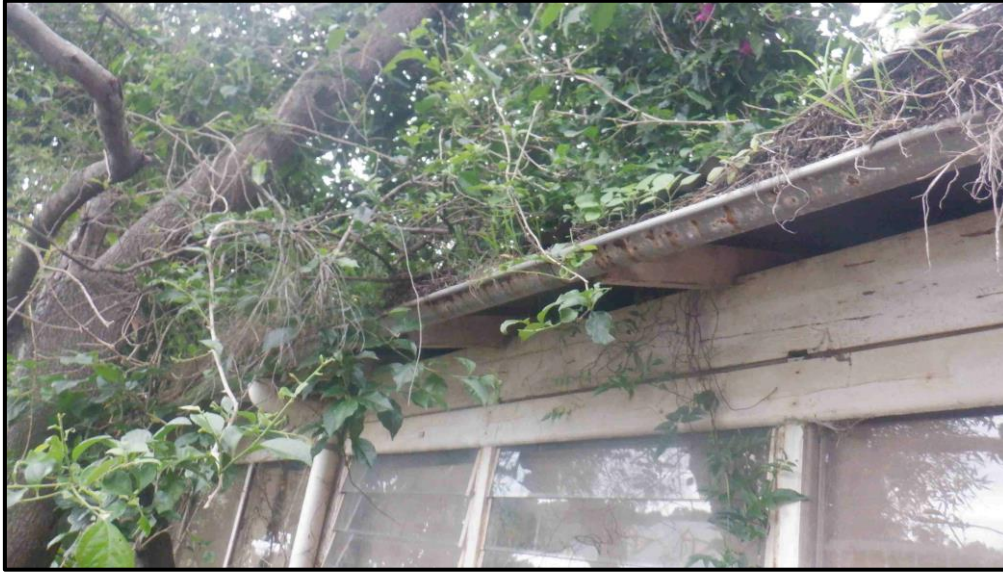
Photo 6026 There was severe corrosion of the guttering.

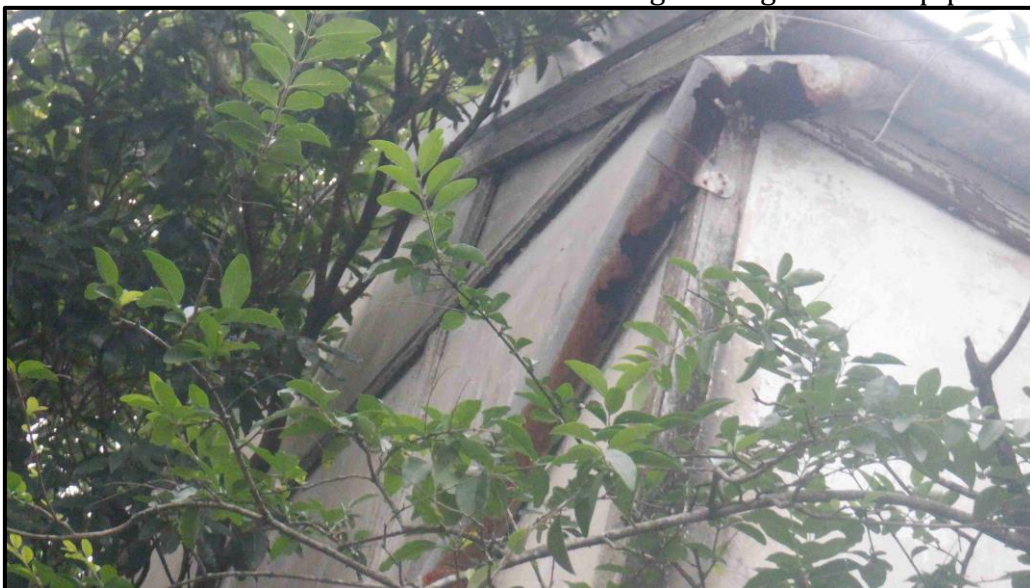
Photo 6042 There was severe corrosion of the guttering and downpipes.

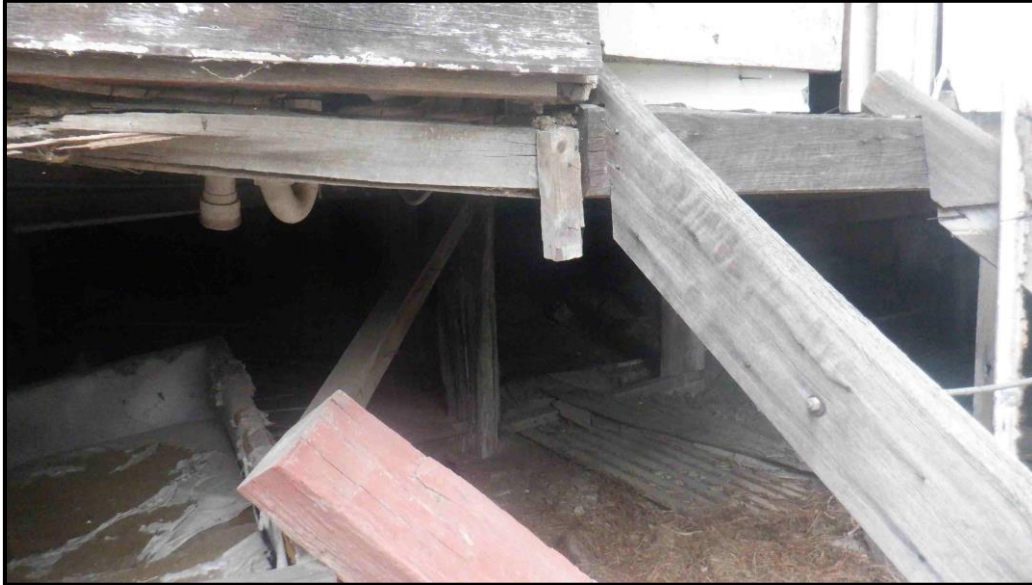
Photo 5999 Piers had collapsed, and the rear stairs were unsupported.

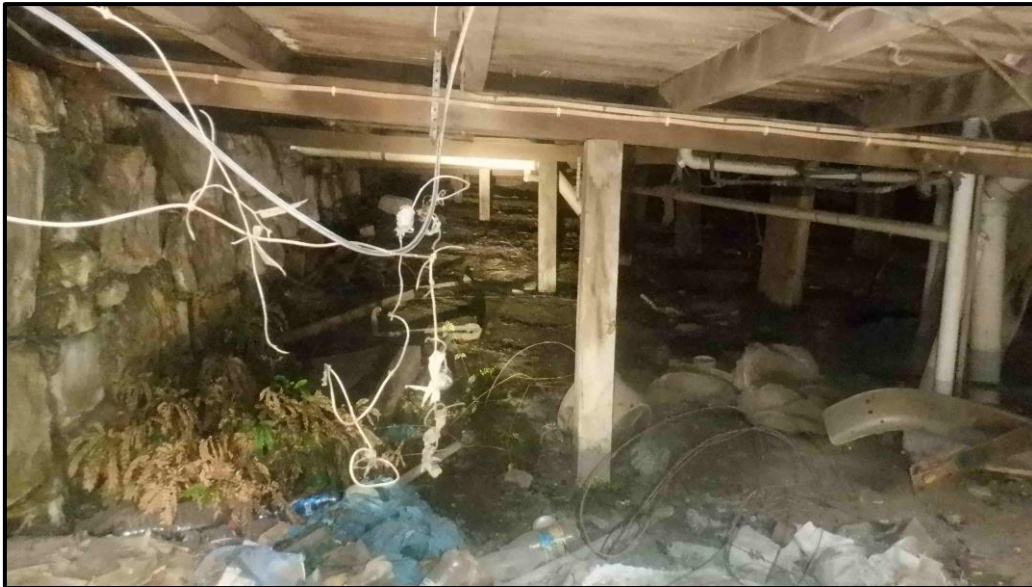
Photo 6033 There were untreated timbers in ground contact used for supports under the south western side of the subfloor.

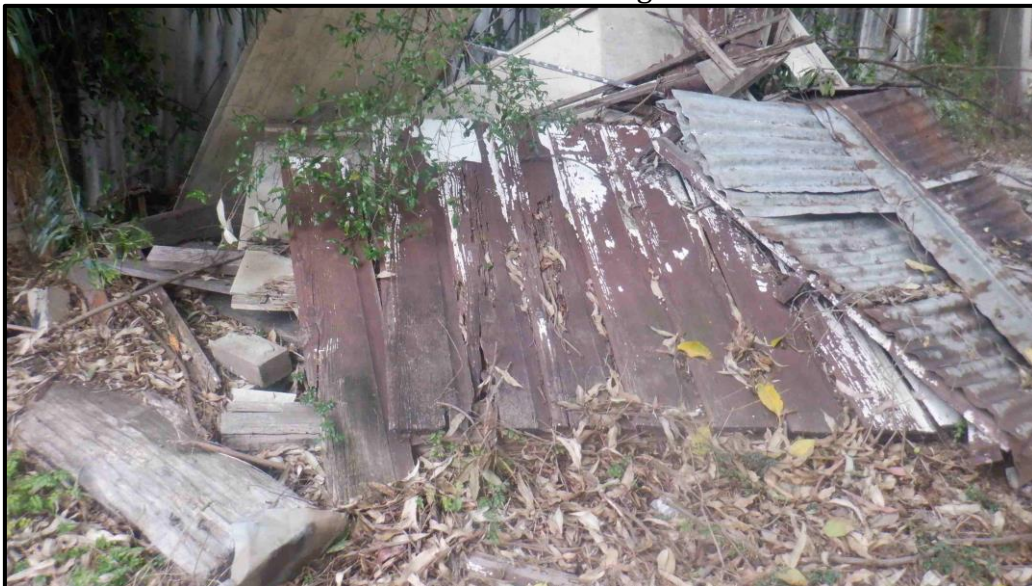
Photo 6016 there were debris timbers on the ground with extensive termite damage.
