Structural Condition Report

**Allambie Cottages, 1256 Bells Line
of Road, Kurrajong NSW**

Transport for NSW / 28 February 2024

232063

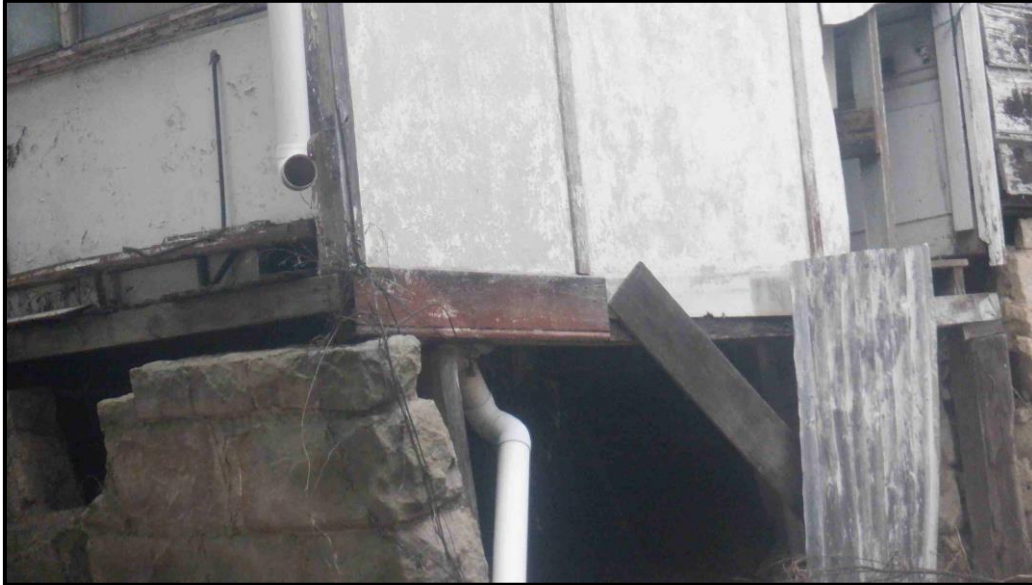
Photo 5989 Foundation walls and piers collapsing.

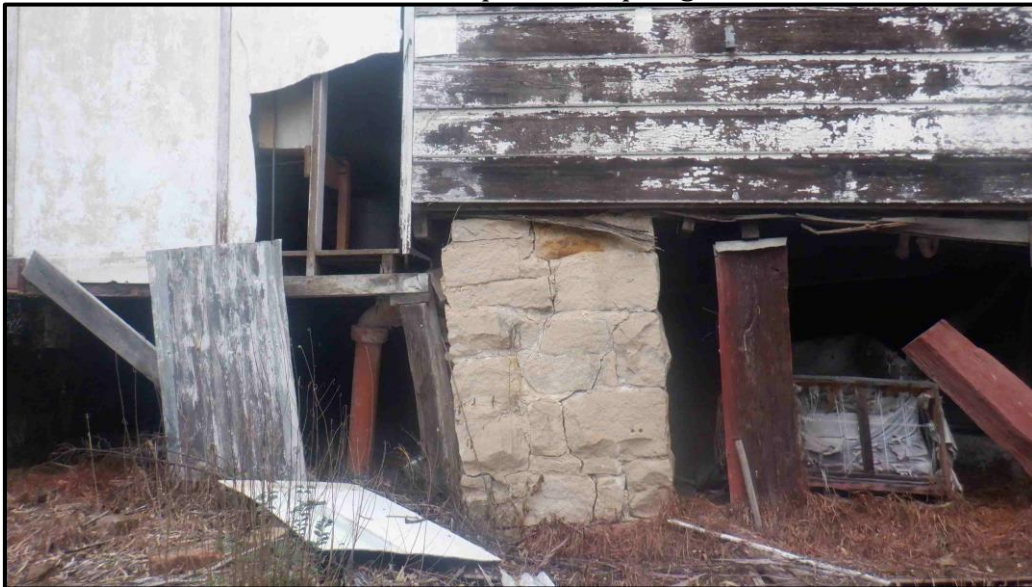
Photo 6046 Foundation walls and piers collapsing.

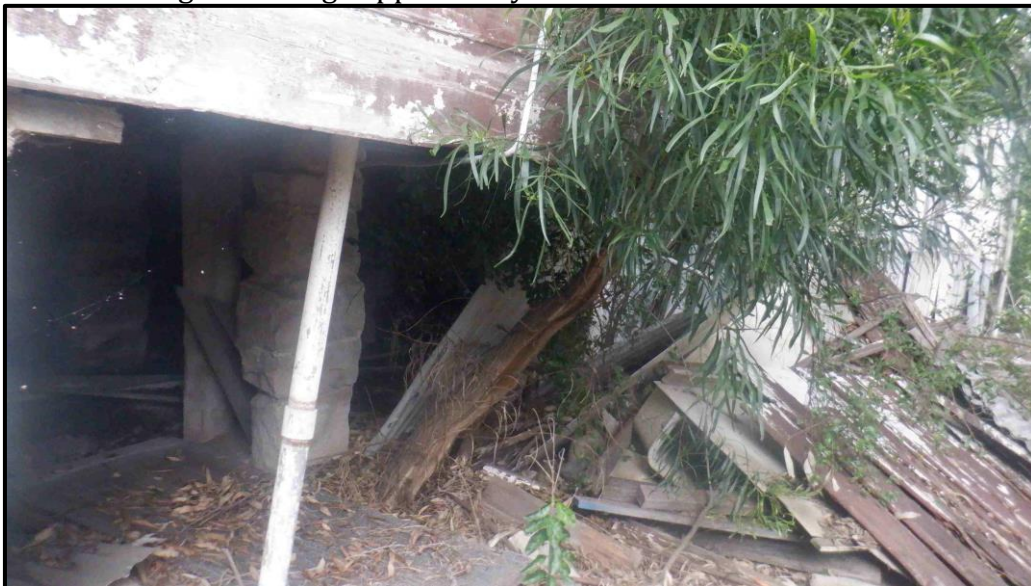
Photo 6015 A pier on the south eastern side of the building had collapsed and that part of the building was being supported by a small shrub.
