Arborist Impact
Assessment

Opal Specialist Aged Care
C/o Matthew O'Sullivan

5-7 Floribunda Avenue
Glenmore Park

24th June 2019

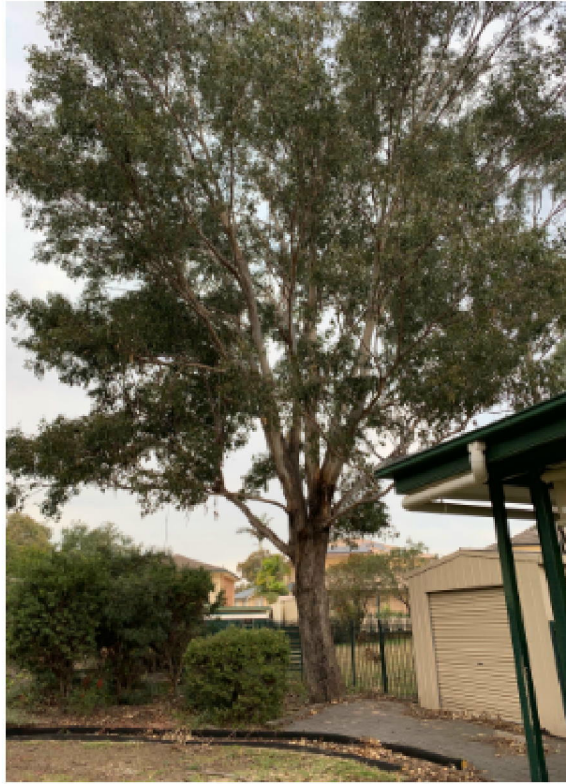
Plate 1. Tree 14b. *Eucalyptus moluccana* Grey Box

14.		<i>Brachychiton acerifolius</i> Flame tree	10	7	20 24	2.4 1.82	Immature, good condition but poor development.	2d	Low Mod	RETAIN & PROTECT
14a.		<i>Brachychiton acerifolius</i> Flame Tree	8	12	28 33	3.36 2.07 7	Mature, good condition but poor development.	2a	Low Mod	RETAIN & PROTECT
14b.		<i>Eucalyptus moluccana</i> Grey Box	14	20	60 70	7.2 2.85	Mature, cavity at 3m, parasitic vine present, mallet sounding test is showing some defect, response wood around inclusion.	2d	Moderate-High	REMOVE & REPLENISH

Moderate to high value

11.9 Trees numbered 3, 4a, 5, 6, 13a, 14b, 15, 20, 21a, 22, 23, 24, 24a, 25, 26, 27a, 27b, 29, 29a, 29b, 29c, 30, 31, 32, 33, 34, 35 have a major impact of 50-100% which is more than the Australian Standards allow. These trees are to be removed and replenished. Tree 8 has an impact on the SRZ by the drainage and is to be removed as it is not viable for retention. Tree 36 has an impact on the SRZ by the extension of the driveway, which can be seen in the landscape plan. As Tree 36 is in poor condition and in decline it is to be removed. Tree 25 is also in decline and is of moderate value.

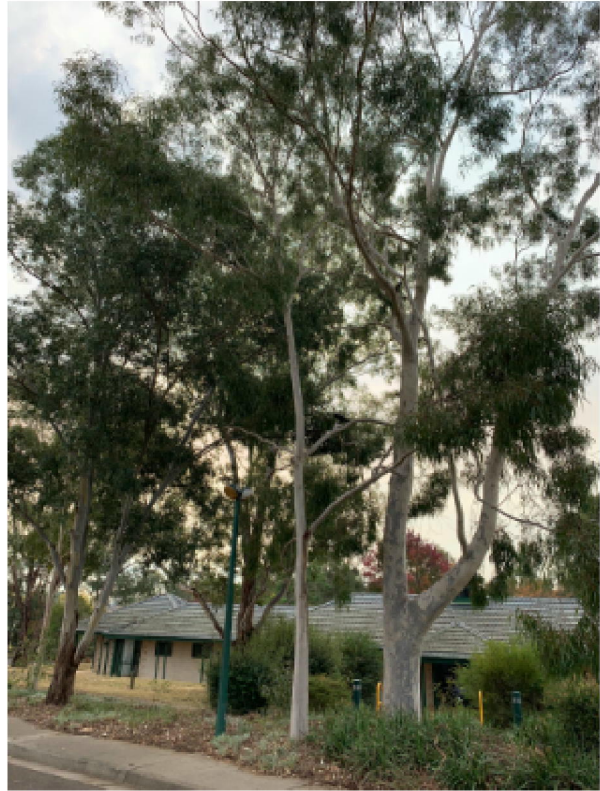
Plate 2. Trees 22-25.

22.		<i>Corymbia maculata</i> Spotted Gum	15	18	65 55	7.8 2.57	Mature, dehydrating branch at 5m, physical damage at 8m, sparse foliage crown on laterals, attachment at 1m.	2d	Mod-High	REMOVE & REPLENISH

23.		<i>Corymbia maculata</i> Spotted Gum	6	12	21 26	2.52 1.88	Immature, physical damage at 3m, sparse canopy.	2d	Low-Mod	REMOVE & REPLENISH
24.		<i>Eucalyptus moluccana</i> Grey Box	12	13	32/21 20	4.59 1.68	Immature, good condition but poor development, broken branch at 7m, previous fail at 4m, epicormics.	2d	Mod	REMOVE & REPLENISH

25.	(front) south of school	<u>Eucalyptus moluccana</u> Grey Box	15	19	71 74	8.52 2.92	Mature, slight lean towards East, inclusion at 5m, termite damage present, borers on response wood at 7m North, epicormics, sparse foliage crown. Dehydrating crown.	3a	Moderate	REMOVE & REPLENISH

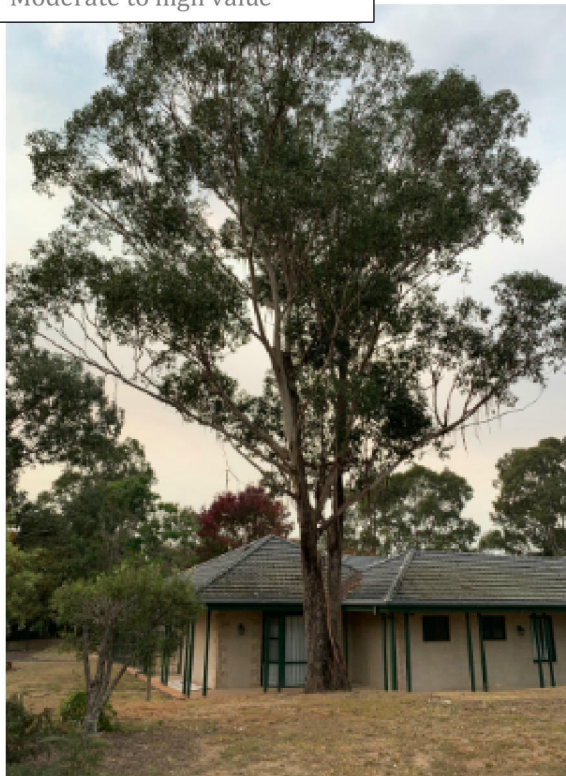
Plate 3. Tree 26 *Eucalyptus moluccana* Grey Box.

26.	Within three metres of the current building.	<u>Eucalyptus moluccana</u> Grey Box	10	17	44/53 92	8.27 3.19 5	Mature, twin stem, inclusion at base, with decay previously pruned at 8m, epicormics.	2d-4c	Moderate-High	REMOVE & REPLENISH
27		<u>Leptospermum species</u> Tea Tree	3	7	22 25	2.64 1.85	Immature, good condition but poor development.	2a	Low	RETAIN & PROTECT
27a.		<u>Leptospermum species</u> Tea Tree	5	7	10/12 /8/8/1 0 34	2.61 2.1	immature, poor development, unbalanced canopy east, in decline.	2d-3d	Low	REMOVE & REPLENISH
27b.		<u>Leptospermum species</u> Tea Tree	5	7	18/15 /8/10 28	3.2 1.94	immature, poor development, unbalanced canopy east, in decline.	2d-3d	Low	REMOVE & REPLENISH

Moderate to high value

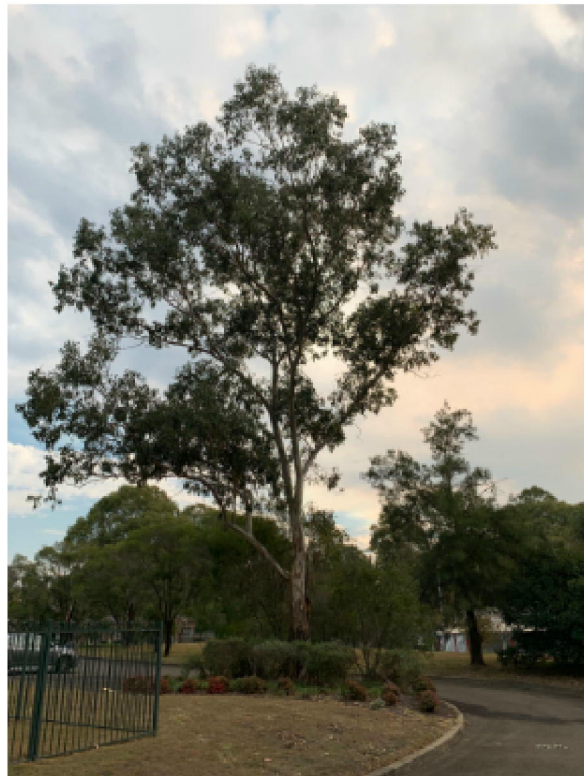
Plate 4. Tree 30 *Eucalyptus tereticornis* Forest Red

30.		<u>Eucalyptus tereticornis</u> Forest Redgum	10	13	50 61	6 2.68	Immature, failed stem, minor borers epicormics, borers and termite damage present.	2d	Moderate-High	REMOVE & REPLENISH

Moderate to high value

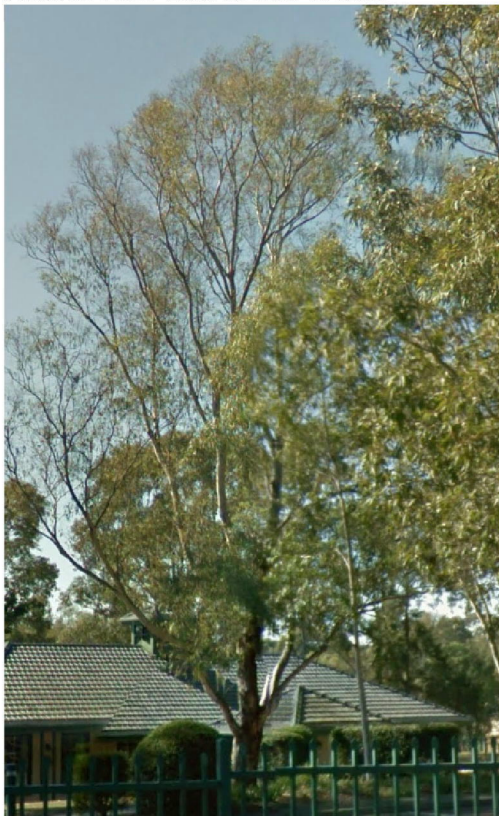
Plate 6. Tree 25 Moderate value in decline
