# ARBORICULTURAL IMPACT ASSESSMENT REPORT

# Prepared for ABA Pty Ltd

## Site address 896-898 Woodville Road Villawood

Date 16 December 2024

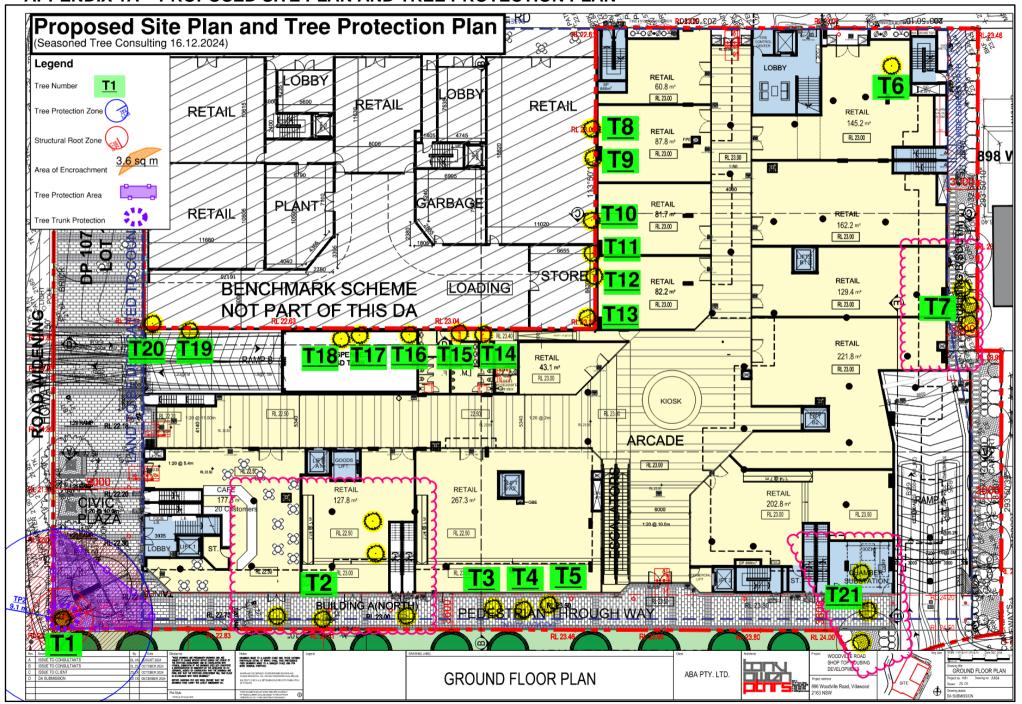
## APPENDIX 1A - PROPOSED SITE PLAN AND TREE PROTECTION PLAN

Trees T8, T9, T10, T11, T12, T13 and T20 (total of 7 trees) are not within the subject development site.
- 8.3 It is recommended that tree T1 (total of 1 tree) is retained. Tree sensitive demolition, design and construction will be required for the proposed hard surfacing within the TPZ of this tree.
  T1 will require tree protection measures to be installed, in the form of trunk protection, plus thick mulch within the TPZ area, plus tree protection fencing. If any below ground features (drainage, power, gas etc) is required to be installed within the TPZ of T1, tree sensitive methods must be used (hydrovacuum or hand dug trenches whilst retaining and protecting any root over 40mm in diameter)
