ARBORICULTURAL IMPACT ASSESSMENT AND TREE MANAGEMENT PLAN

PROPOSED RESOURCE
RECOVERY FACILITY
DEVELOPMENT APPLICATION

25 MARTIN ROAD BADGERYS CREEK, NSW

16th March 2020

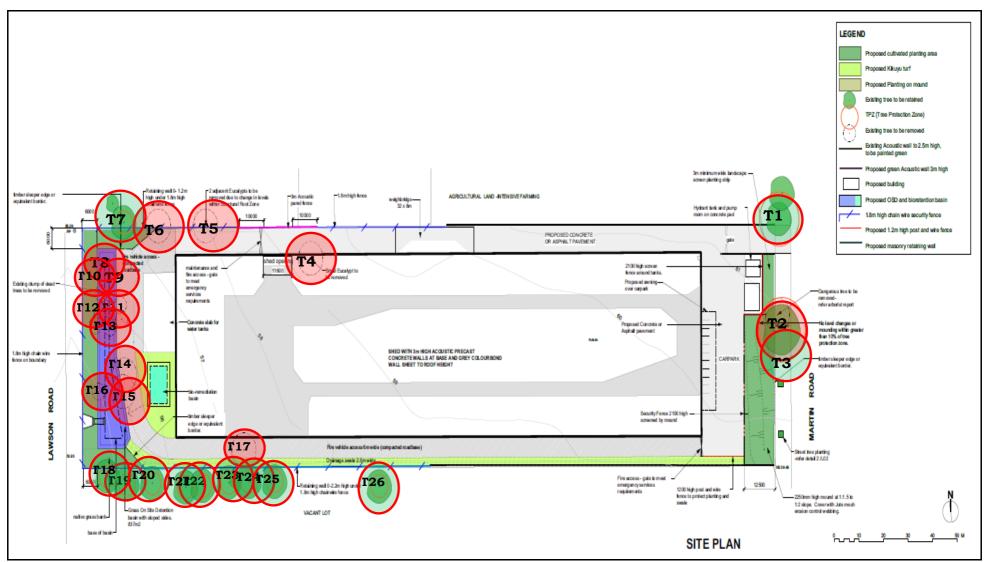
Figure 6 Shows the trees in RED required to be removed based on the plans provided

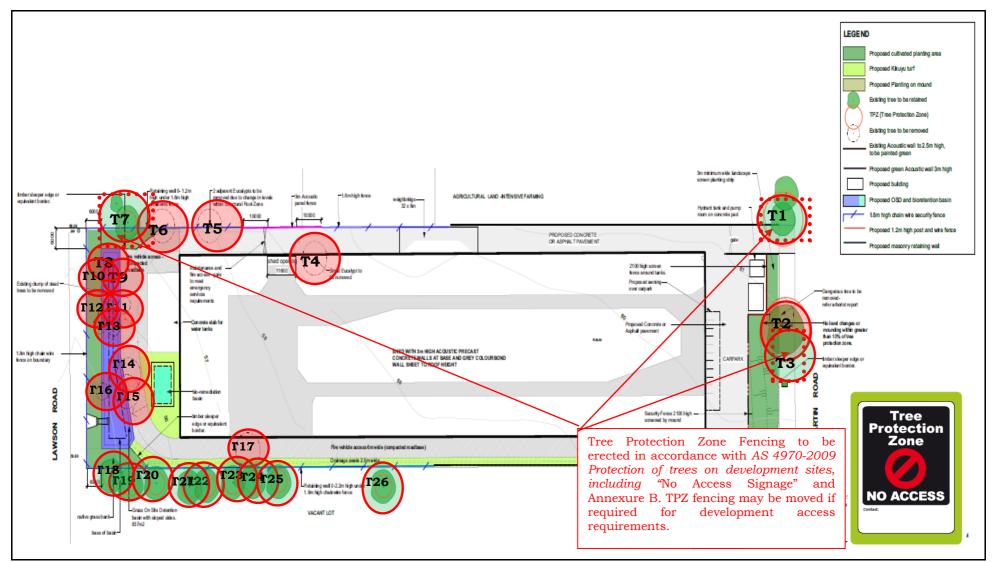
Figure 7 Shows the trees to be retained and tree management fencing proposed

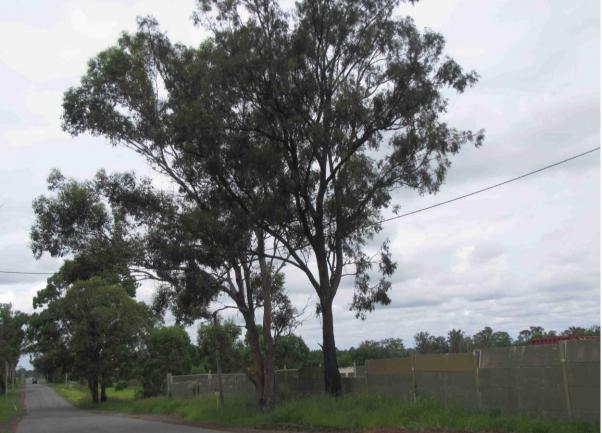
Figure 9 Shows Trees 2 and 3, which are sufficiently distanced to be retained and protected.

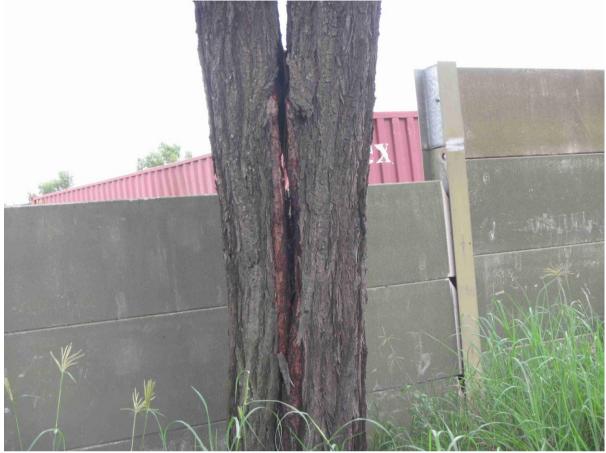
Figure 10 Shows Tree 2 with a split trunk that is dangerous, hence full removal is warranted as a matter of urgency.

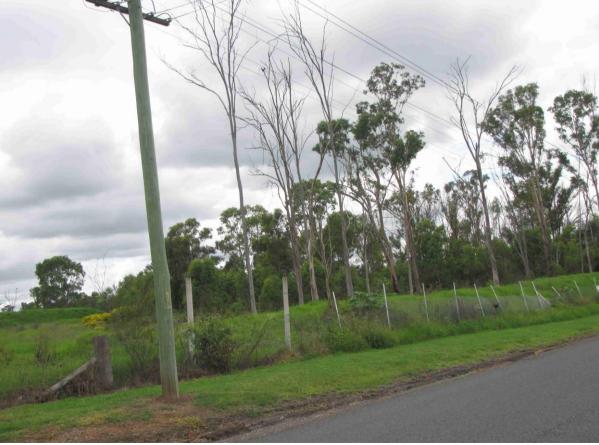
Figure 11 Shows Trees 8 to 16, which are dead and required to be removed.

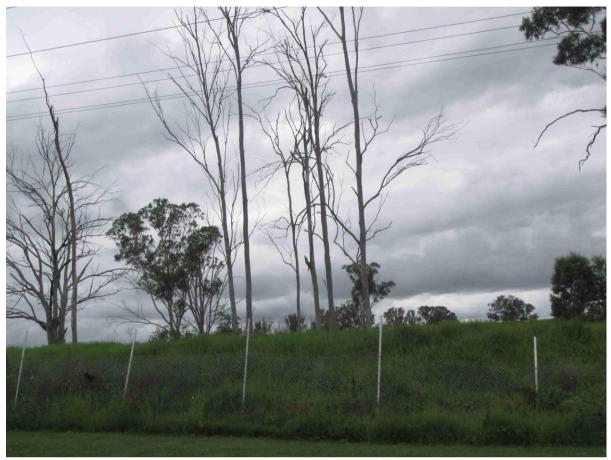
Figure 12 Shows dead trees within the OSD Basin location.

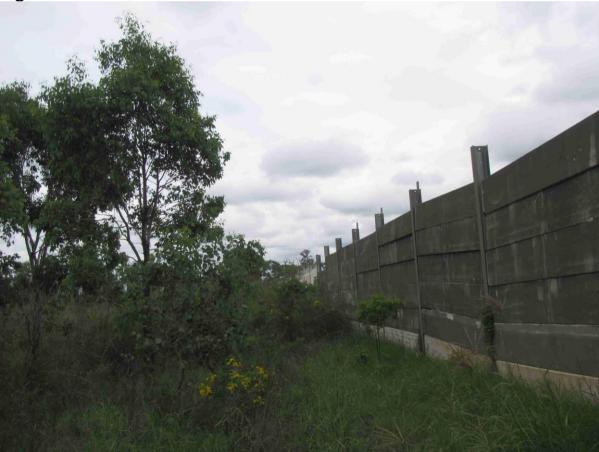
Figure 13 Shows the existing boundary wall with minor adjoining trees to be retained and protected.

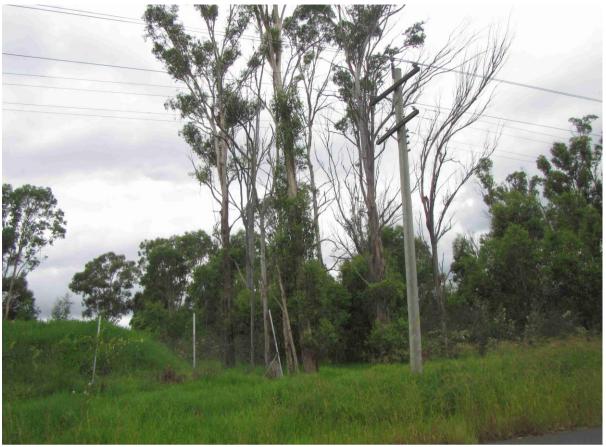
Figure 14 Shows adjoining trees along Lawson Road boundary in poor condition.

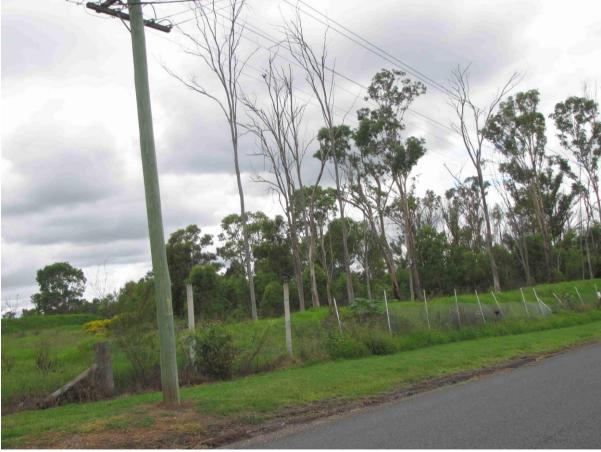
Figure 15 Shows the trees to be removed as they are dead and within the roadway and OSD basin.
