# **Destructive Hazardous Building Materials Assessment V2**

**Liverpool Civic Place**

**52 Scott Street, Liverpool, NSW 2170**

**November 2019**

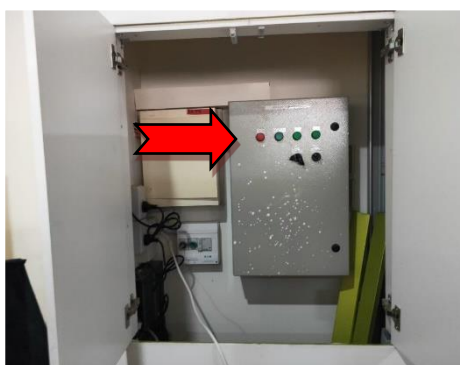
1. The Rising Collective, south corner, switchboard – assumed asbestos-containing bituminous backing board.

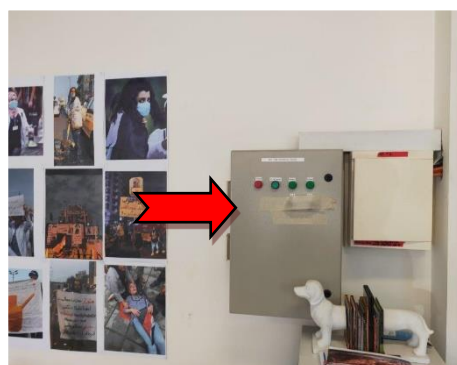
2. Studio 52, interior, south wall, air handling control panel, switchboard – assumed asbestos-containing bituminous backing board.

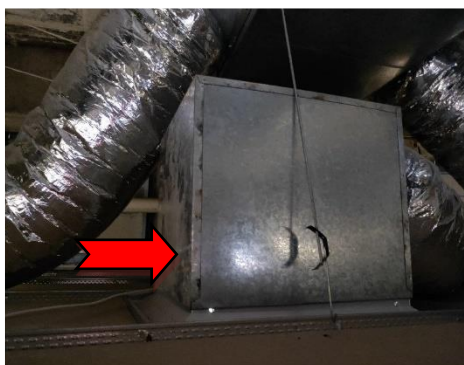
3. Studio 52, interior, ceiling space, centre of room, heater bank – assumed asbestos containing insulation.

- Heater banks were noted within three tenancies throughout the Site, however, as tenancies were occupied and no access was gained within ceiling spaces of areas listed in **Appendix E: Areas not Accessed**. Any heater banks encountered which have not been observed by Prensa should have their status confirmed or be removed by a minimum Class A (friable) asbestos removal contractor prior to demolition or refurbishment.

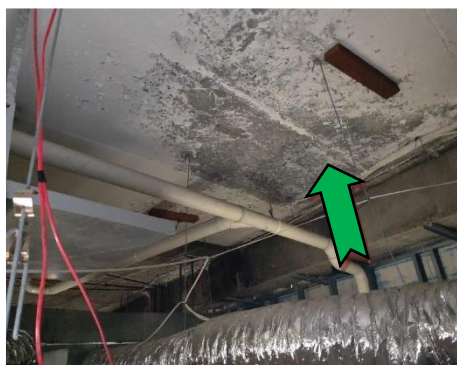
4. Studio 52, interior, ceiling space, throughout – non-lead paint containing grey upper coloured paint system debris.

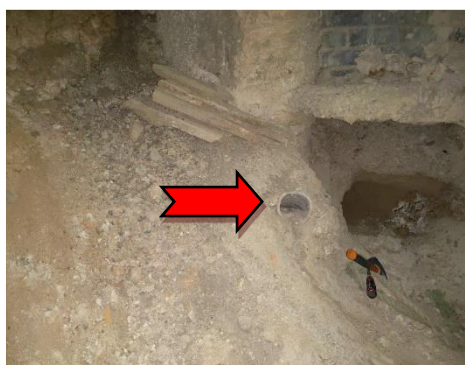
5. Crunch Fitness, interior, subfloor adjacent loading dock, pipe work, throughout – asbestos containing moulded fibre cement.

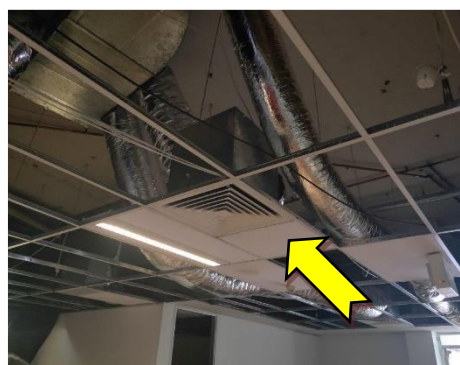
6. Council Offices, interior, ceiling space, throughout – synthetic mineral fibre containing compressed ceiling tiles.

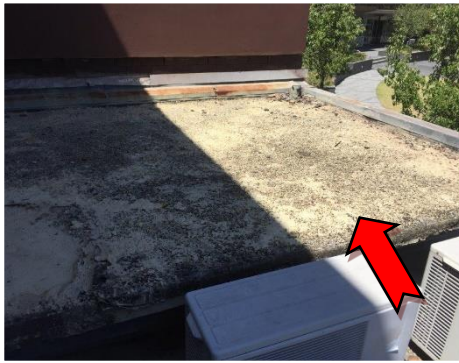
7. Surgery, exterior, rooftop, lower elevated area, throughout - asbestos-containing bituminous material.

- The non-friable bituminous membrane identified to the external lower roof of the surgery should be removed by a minimum Class B (non-friable) asbestos removal contractor. As the material is in poor condition, airborne asbestos monitoring should be undertaken during the removal process to evaluate if asbestos removal control measures are effective.

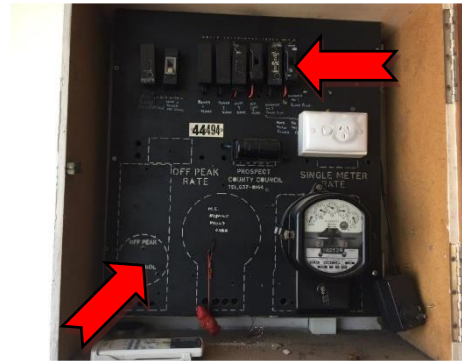
8. Surgery, interior, north-east corner, switchboard – asbestos-containing bituminous backing board and assumed asbestos-containing ceramic fuses.

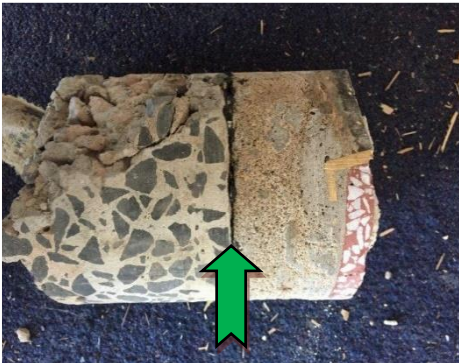
9. Surgery, interior, throughout, floor core sample – non-asbestos containing bituminous material.

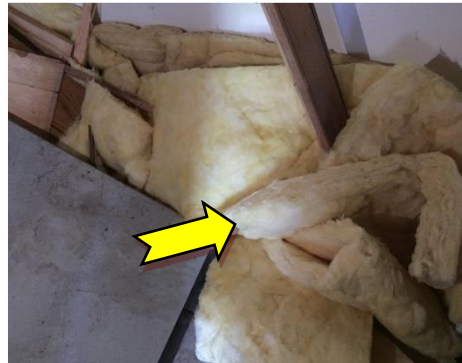
10. Surgery, interior, back room adjacent kitchenette, insulation batts- suspected synthetic mineral fibre insulation.

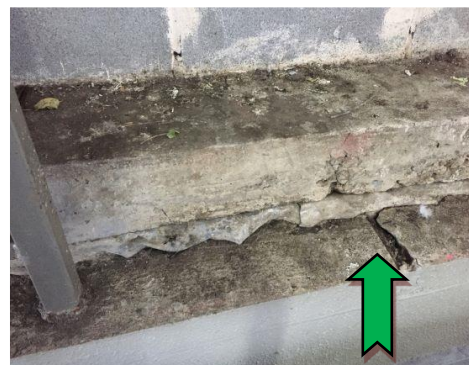
11. Crunch Fitness Car Park, interior, level B, northern elevation adjacent AC cage stairs, dust – non-lead containing dust.

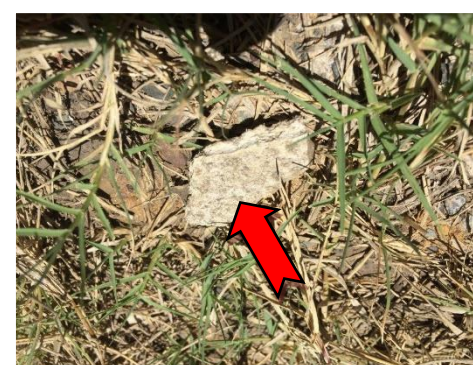
12. Grassed area between Crunch Fitness Car Park and Just Sports tenancy, centre, on ground – asbestos-containing fibre cement sheet debris.

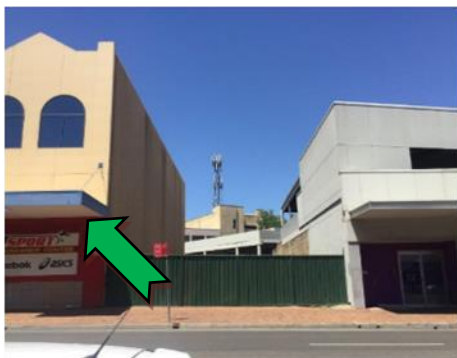
13. Just Sports, exterior, ground floor, shop front, soffit – non-asbestos containing fibre cement sheet.

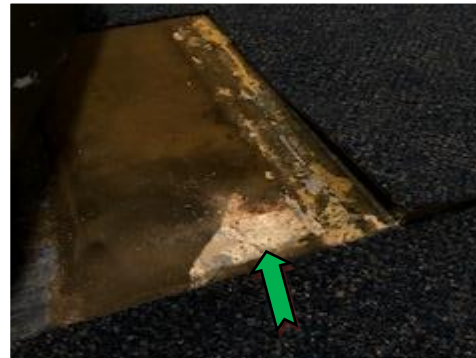
14. Just Sports, interior, under carpet, floor – non-asbestos containing screed.

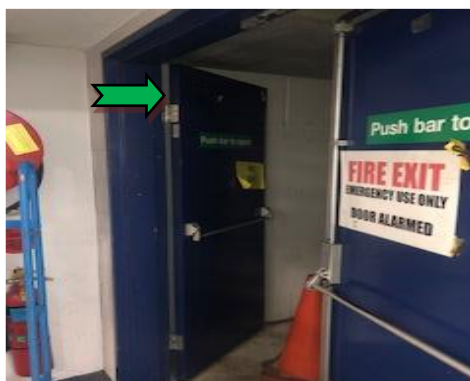
15. Just Sports, interior, throughout, fire exits – assumed non-asbestos containing fire door core.

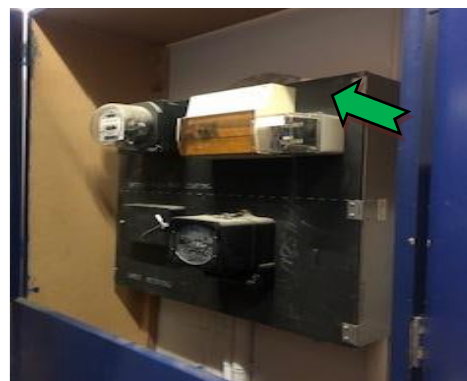
16. Just Sports, interior, ground floor, eastern elevation, switchboard – non-asbestos containing bituminous backing board.

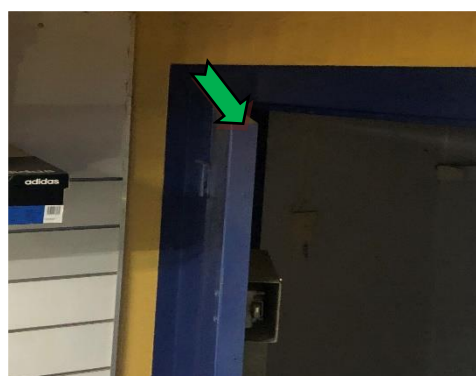
17. Just Sports, interior, ground floor, north-eastern elevation, safe door – assumed non-asbestos containing internal insulation.
