# FIRE SAFETY UPGRADE STRATEGY REPORT

220 Bentinck Street, BATHURST NSW 2795

| <b>Client:</b> | St Stanislaus College |
| <b>Reference:</b> | 23175 |

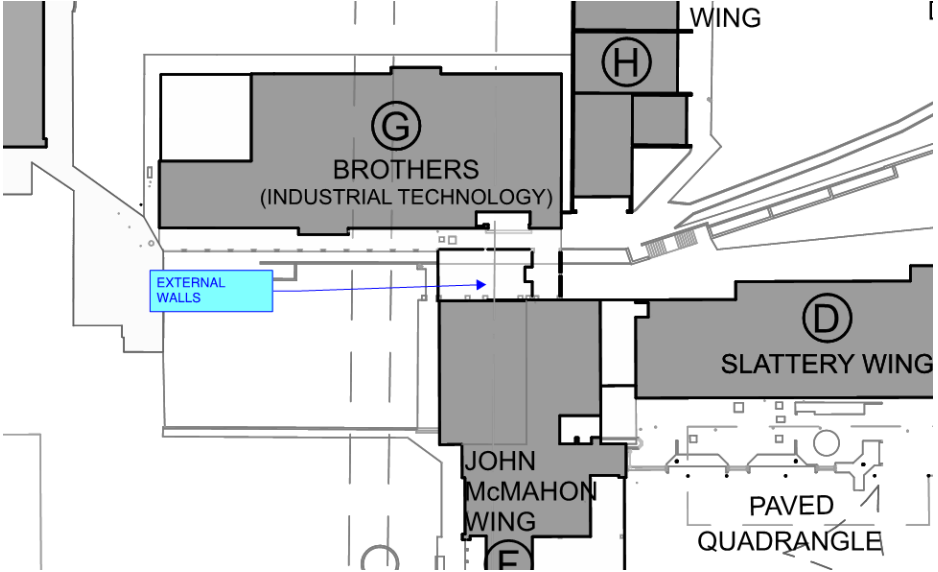
External wall of First Storey Drama Room.

| CLAUSE | PROVISION | COMMENTS | STATUS |
|---|---|---|---|
| C4D3<br>[C3.2] | Protection of openings in external walls | <p>During the site inspection, it was observed the fire-resisting external walls between Block F and the adjoining Drama Room/Block G are not well defined. The area of discussion is identified on the site plan below.</p> <p>The following marked-up photographs highlight the walls that appear to be the external walls providing fire separation between the buildings.</p> | <b>Performance Solution</b> |

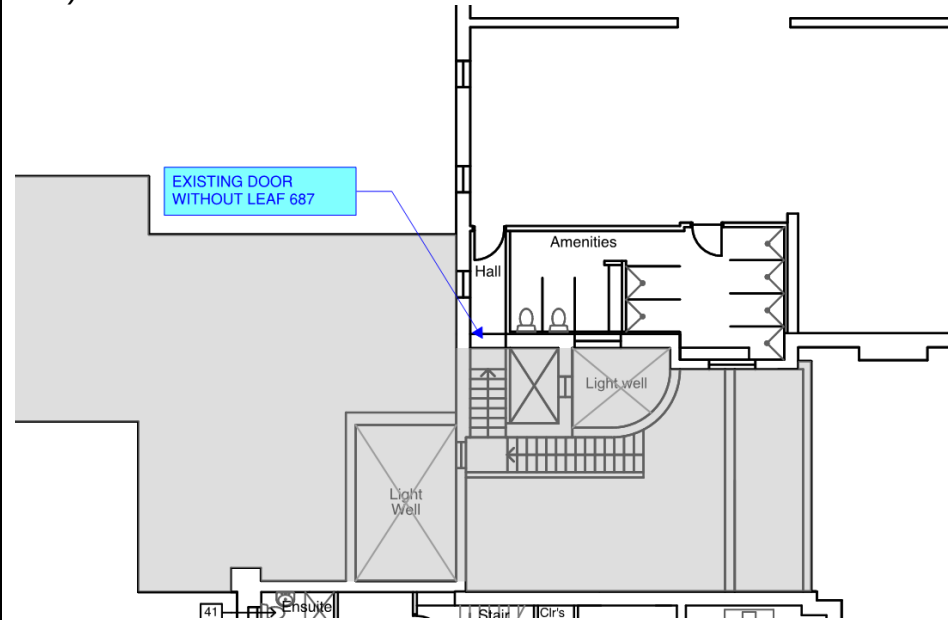
The existing doorway located at the top of fire stair 9 does not contain a door leaf. The proposed development includes construction of a new door leaf. The existing opening (without a leaf) has an unobstructed width of 687 mm.

It is recommended the proposed new fire-resisting doorway be provided with an unobstructed width of 750 mm to comply with NSW D2D9. Enquiries may be required with the structural engineer to ensure the works required to fix the doorway will retain the structural integrity of the existing wall.

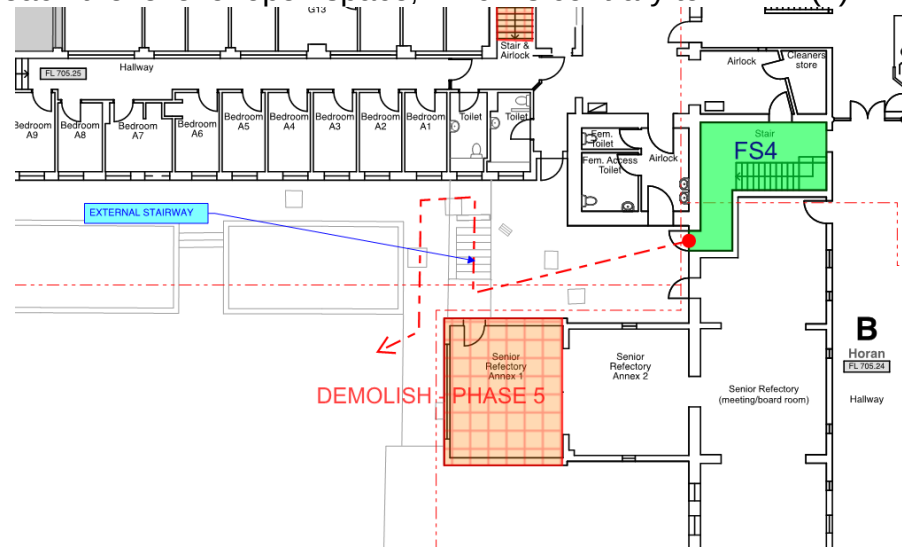
Fire stair 3 and 4 discharge to a level that requires the occupants to use an additional external non-fire-isolated flight of stairs to reach the level of open space, which is contrary to D2D12(2).

It is also recommended the use of additional external stairway by occupants of fire stair 3 and 4 be upgraded to comply with the Performance Requirements of the BCA via a Performance Solution prepared by a Certifier – Fire Safety.
