Geotechnical Investigation Report

Client: Bourke Aboriginal Corporation Health Service (BACHS)

Site Address: 88-96 Mitchell Street, Bourke NSW

Our Reference: 42571-GR01_A

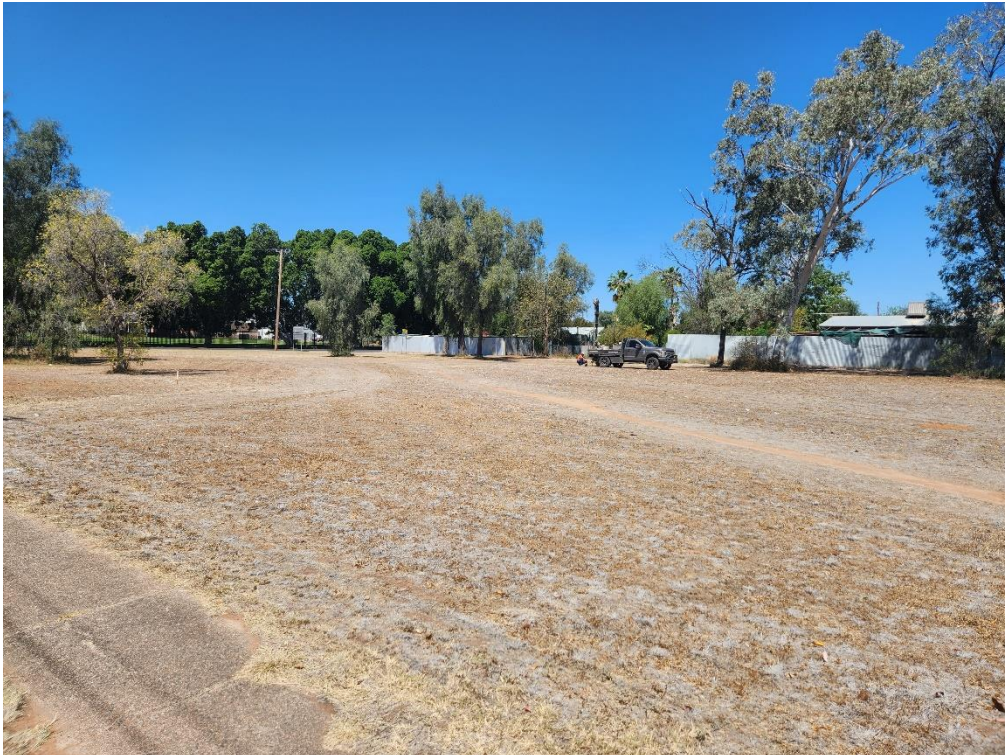
Plate 2 – General view of site facing southeast.

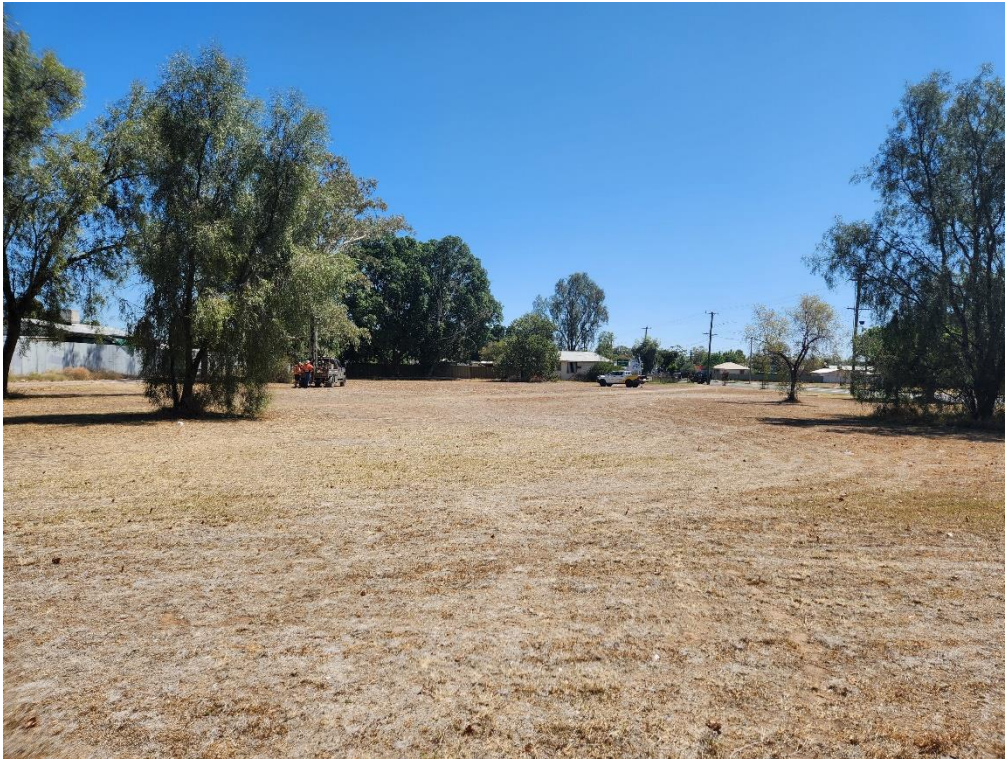
Plate 3 – General view of site facing west.

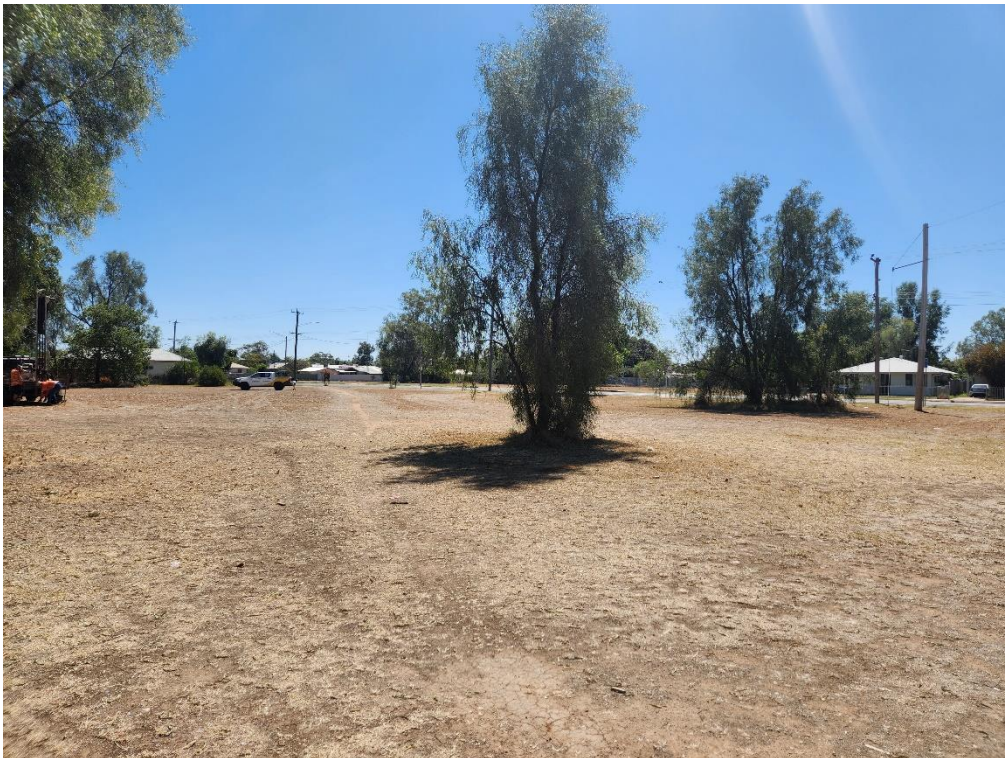
Plate 4 – General view of site facing northwest.

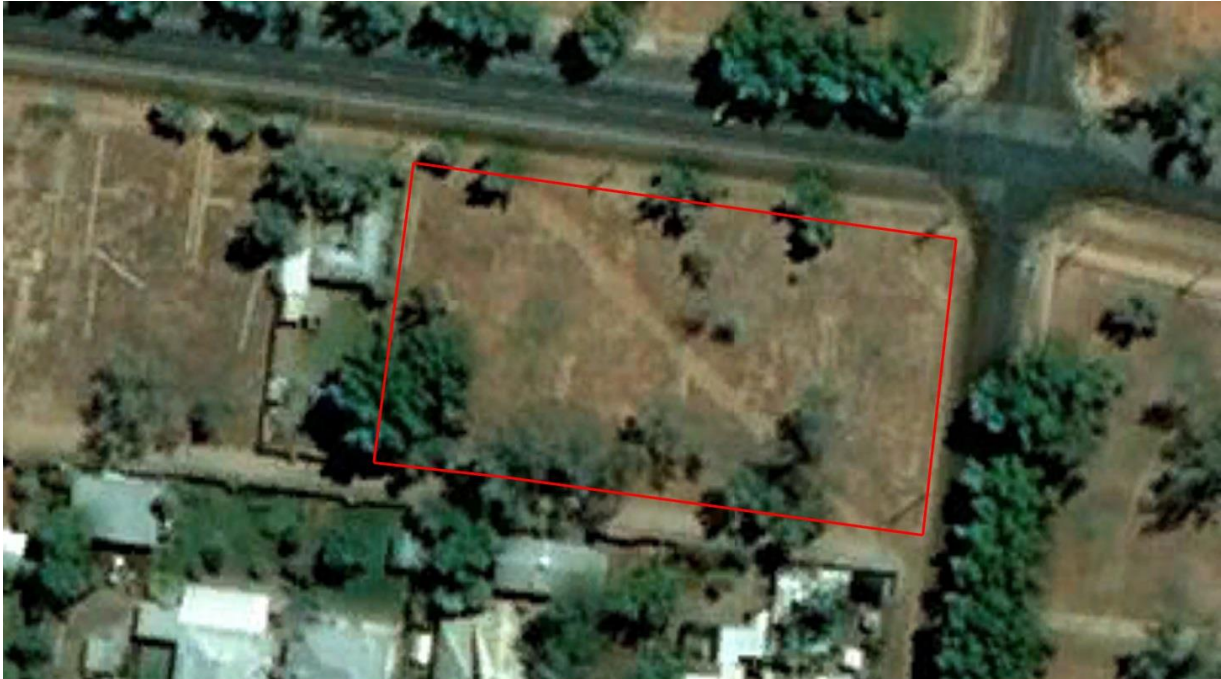
A review of Google Earth imagery of the site indicates that large trees have existed on the site since before an image taken in 2007. Also, during the onsite inspection, it was evident that residential dwellings had previously existed on the site. Fibreboard, brick, house footings and underground pipes were found onsite. The trees are still existing onsite, when removed the excavation should be backfilled with natural material and reinstated in layers to a minimum of 95% Standard Maximum Dry Density. See 2007 aerial image below:

Plate 5 – Aerial Image 2007, Courtesy Google Earth.
