28 November 2024
Reference: RAA10878-1

Clearance Certificate – 22 Wilson Street, Brewarrina NSW 2839

1. Removal work details

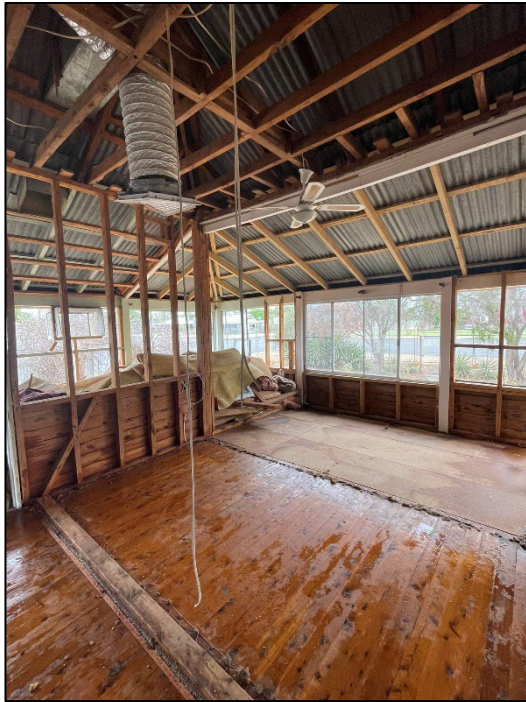
Internal walls and ceilings upon completion of visual clearance inspection.

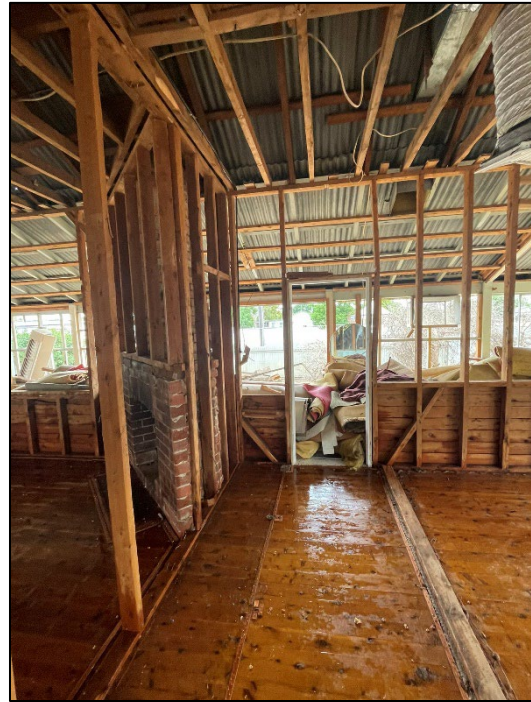
Internal walls and ceilings upon completion of visual clearance inspection.

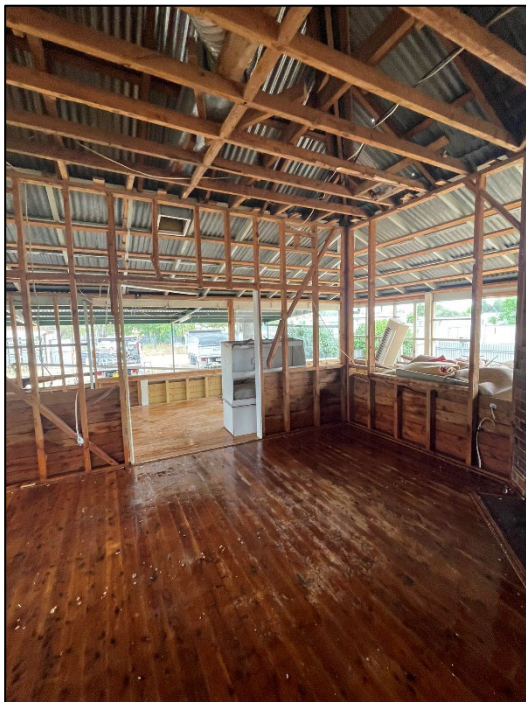
Internal walls and ceilings upon completion of visual clearance inspection.

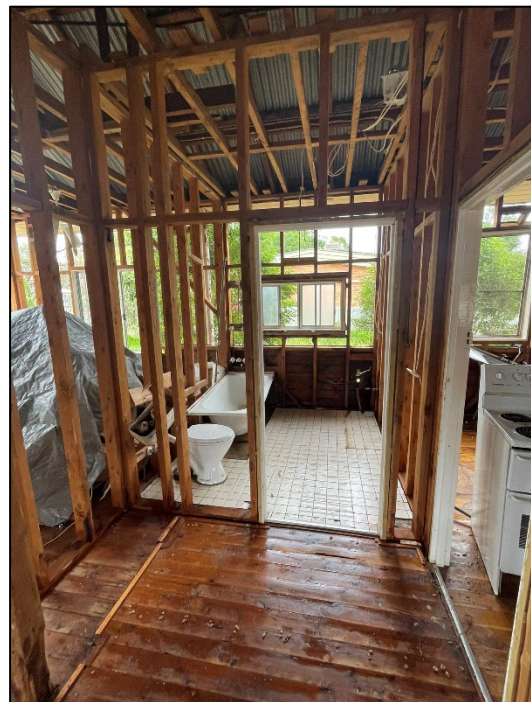
Internal walls and ceilings upon completion of visual clearance inspection.

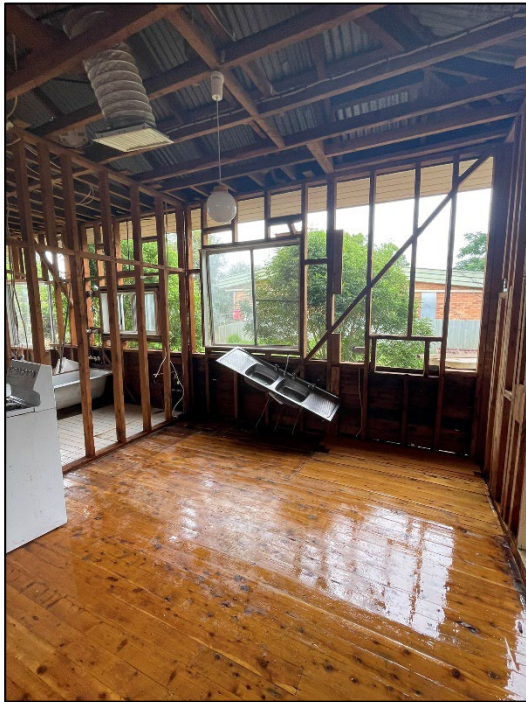
Internal walls and ceilings upon completion of visual clearance inspection.

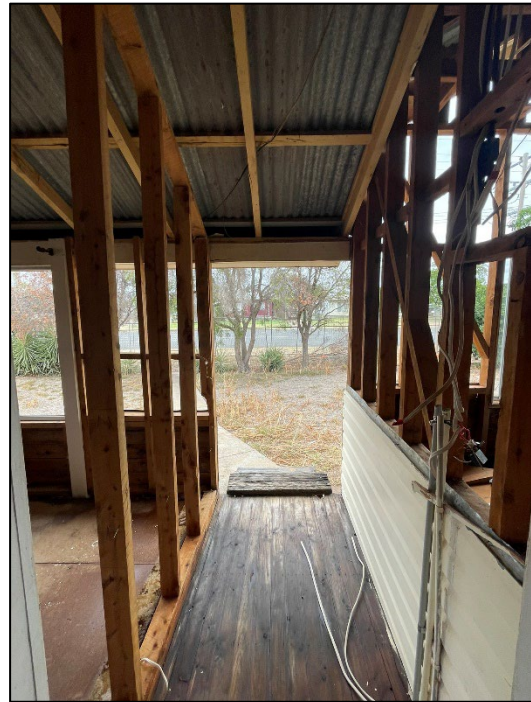
Internal walls, ceilings and external awning upon completion of visual clearance inspection.

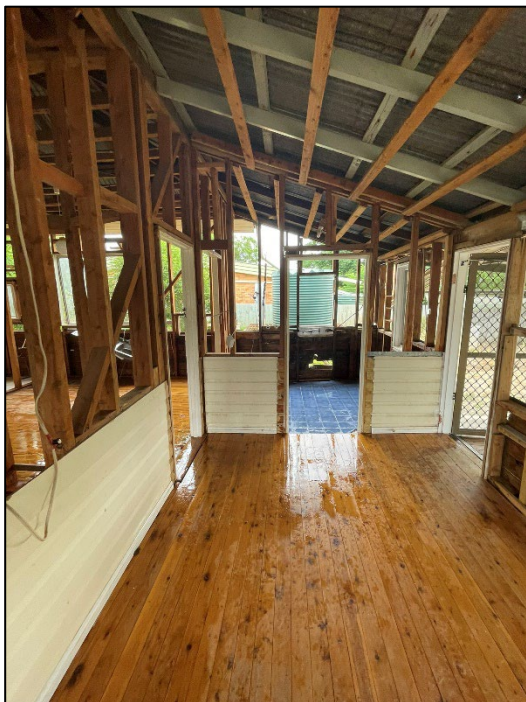
Internal walls and ceilings upon completion of visual clearance inspection.

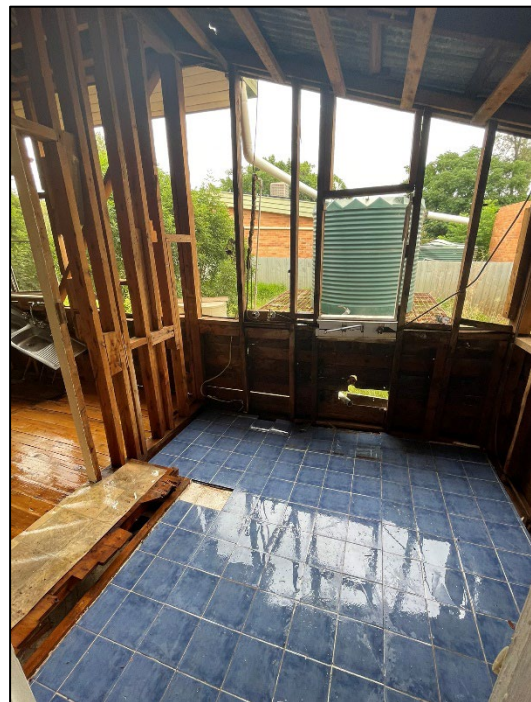
Internal walls and ceilings upon completion of visual clearance inspection.

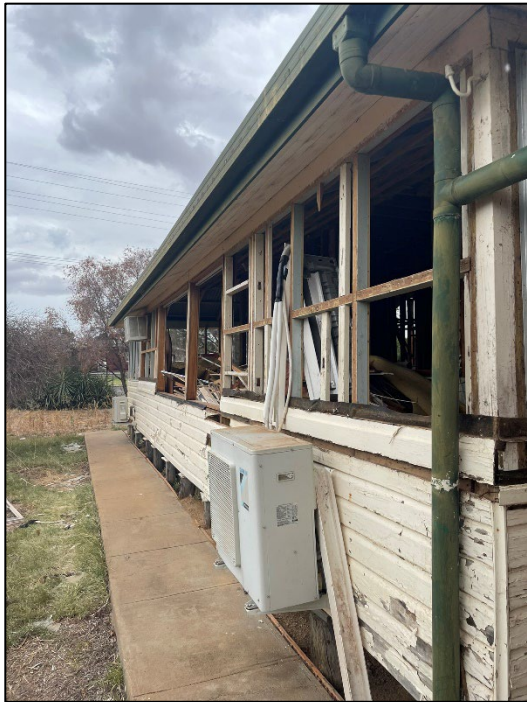
External part walls upon completion of visual clearance inspection.

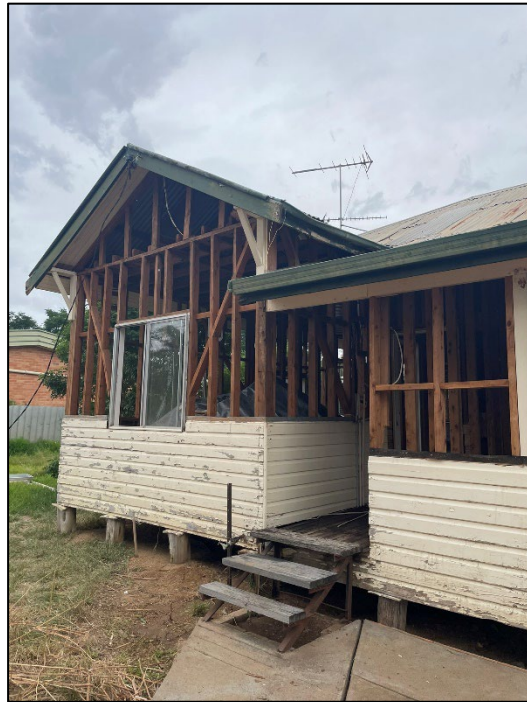
External part walls and gable upon completion of visual clearance inspection.

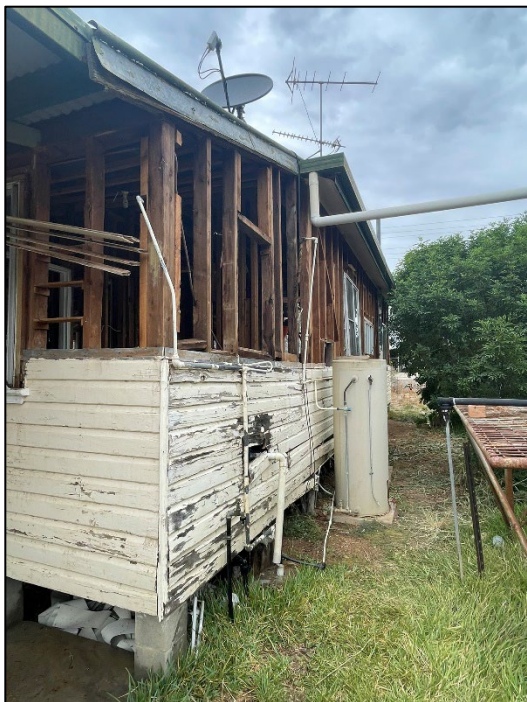
External part walls upon completion of visual clearance inspection.

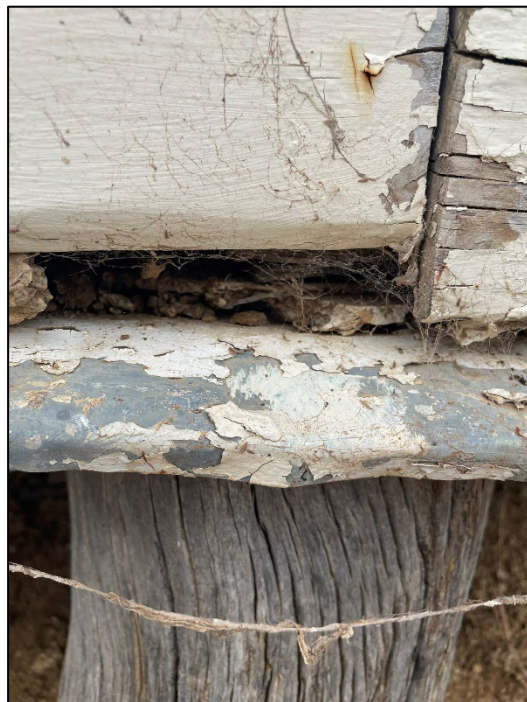
Asbestos cement sheet packers remaining in-situ. Packers must be removed during demolition works.

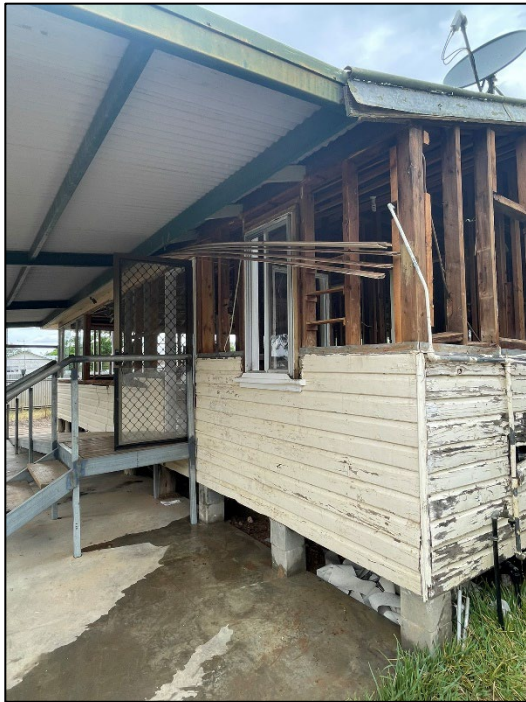
External part walls upon completion of visual clearance inspection.

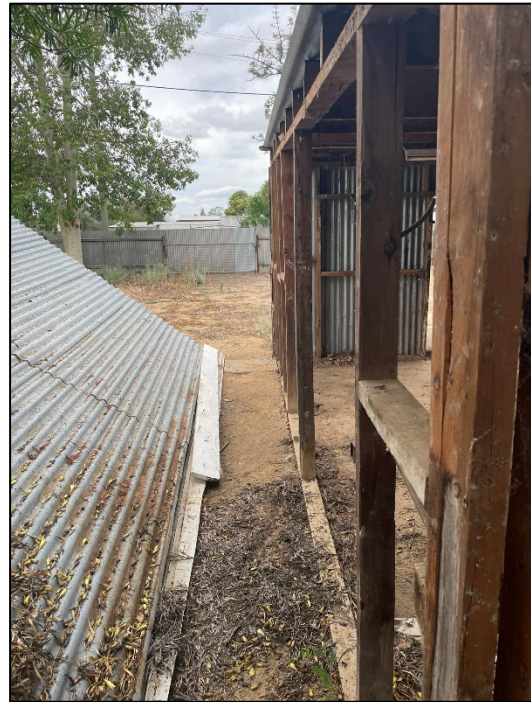
Detached shed external walls completion of visual clearance inspection.

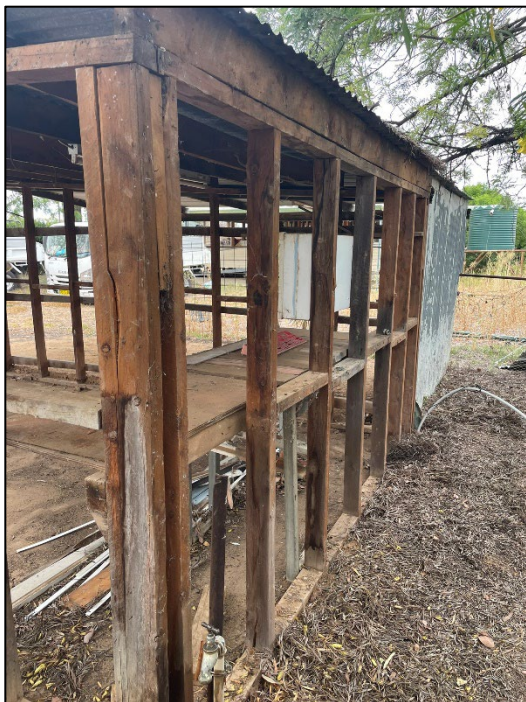
Detached shed external walls completion of visual clearance inspection.

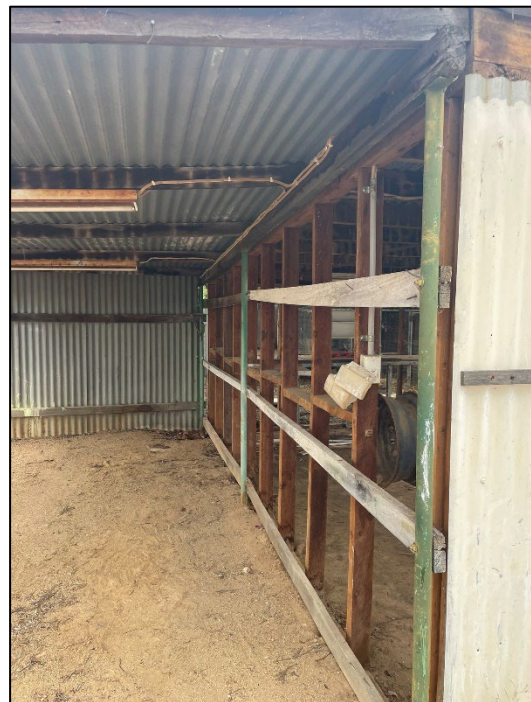
Detached shed external walls completion of visual clearance inspection.
