# Cherrybrook Rezoning Application

## Updated Geotechnical Assessment

Client: Grimshaw Architects Pty Ltd

15-Jun-2016

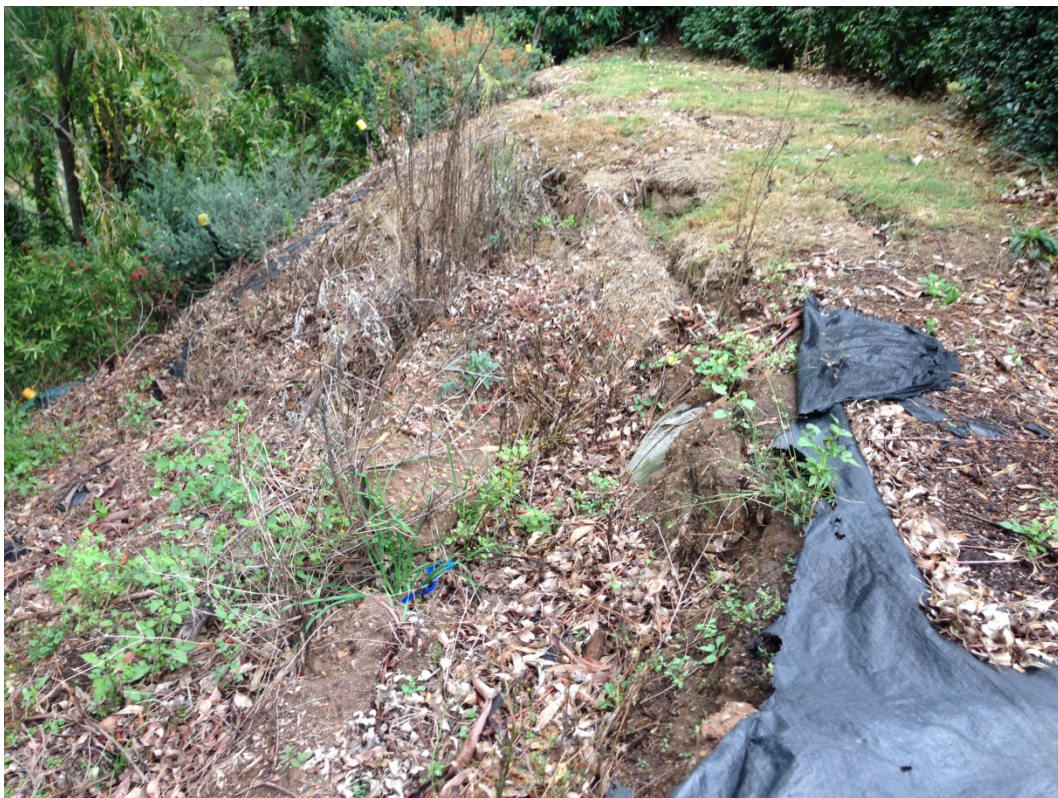
**Figure 12** Tension cracking crest of slope 17 Staley Court

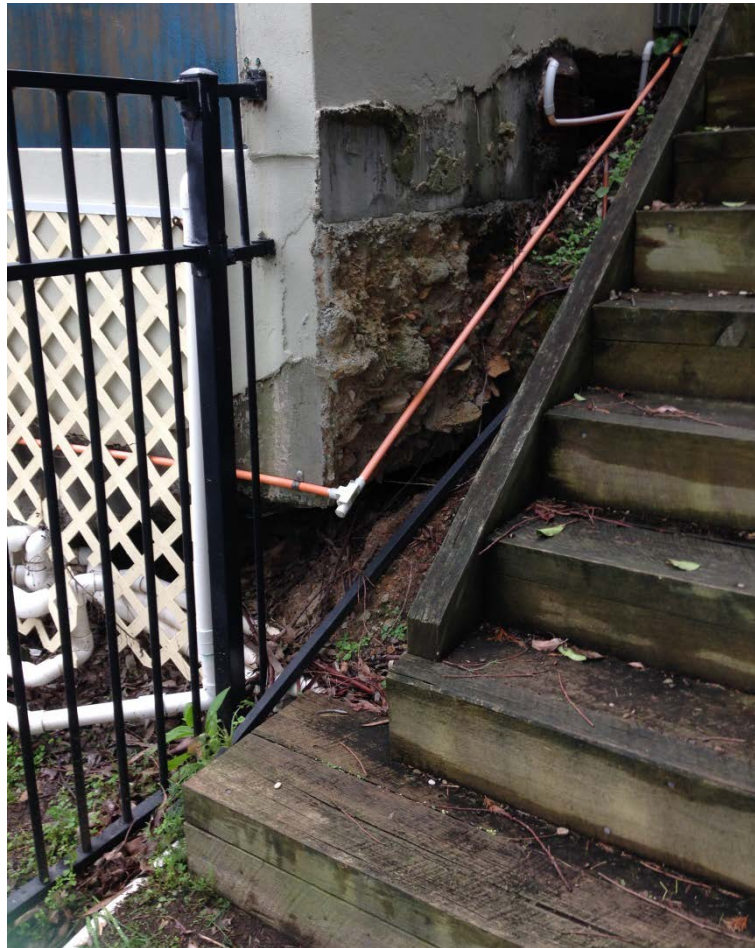
Slight undulations were evident in the back lawn at 19 Staley Court. This is inferred to be due to settlement of fill. Tension cracks were not observed in the back slope below 19 Staley Court. Exposed soil comprised angular gravelly clay. Apparent settlement or removal of soil was observed around the south eastern corner of the swimming pool foundations. Refer to **Figure 13**. The fencing, stairs and bench behind the pool do not exhibit obvious signs of ground movement.

**Figure 13** Loss of soil at base of pool foundation 19 Staley Court

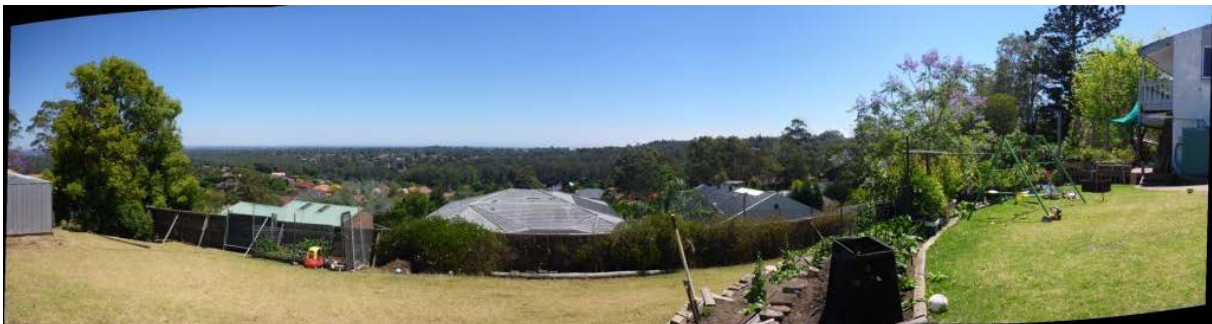
109 Castle Hill Road is situated on the edge of a spur. The terrain drops steeply to the west towards the back of the lots at 6, 8, 10 and 12 Glenhope Road. See **Figure 14** below. Number 4 Glenhope Road is backed by a similar steep slope. Based on the aerial photograph interpretation this has been interpreted as a potential head scarp of a relict landslide.

**Figure 14** Panoramic view at 109 Castle Hill Road, looking west

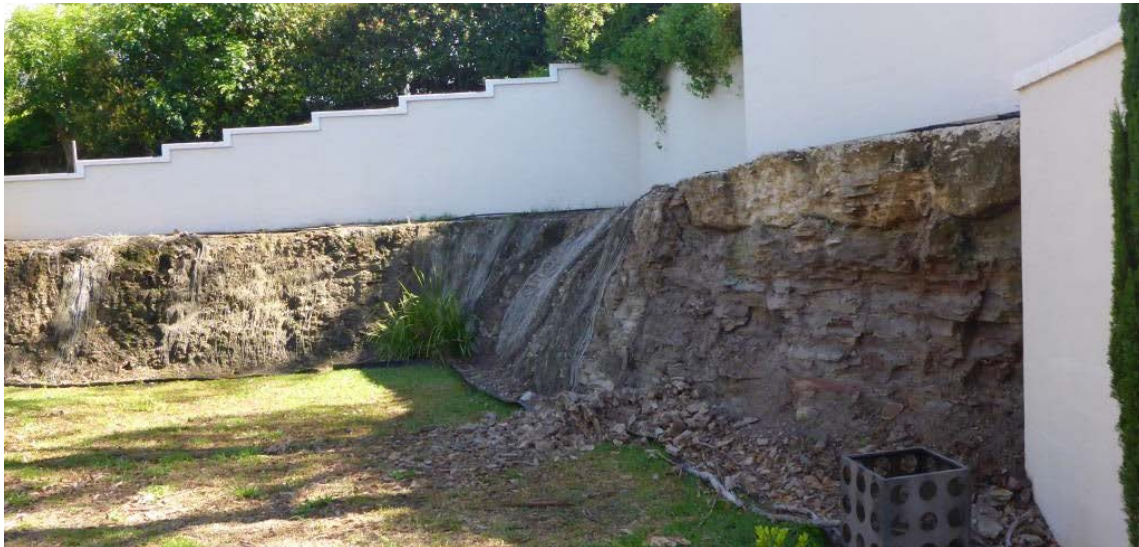
Weathered shale rock was exposed within a cutting at the rear of 4 Glenhope Rd. The rock was thinly bedded at a dip of around  $2^{\circ}$  to the south west. Sub-vertical fractures were observed at around 0.5 m spacing. The surface was oxidised, and a small amount of debris at the base of the slope indicates that fretting has occurred over time. A recent shallow failure had occurred, likely to have been triggered by the heavy rainfall which occurred days before the site visit. See **Figure 15** below.

**Figure 15** Cutting at 4 Glenhope Road

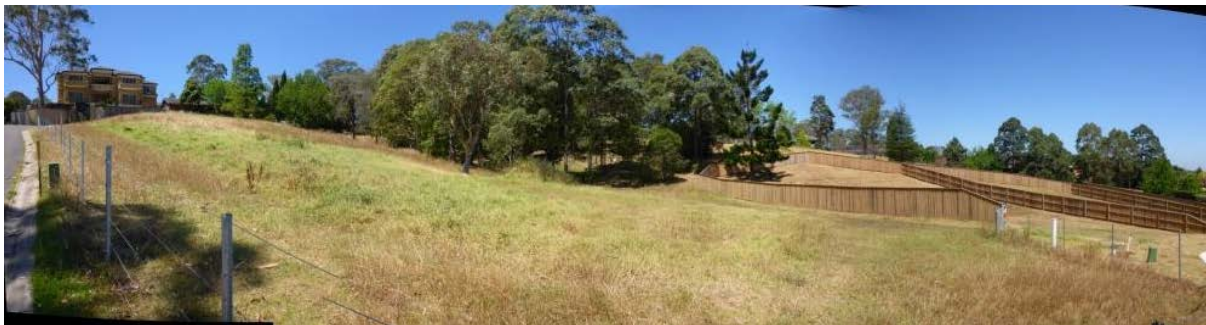
**Figure 16** Panorama view of 9-11 Carioca Court, looking east

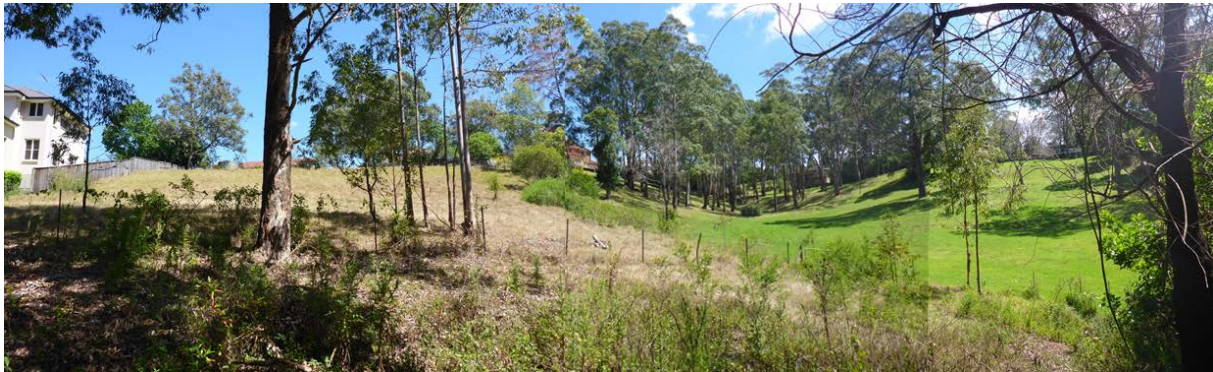
The landform at 6-8 Highs Road and 141-143 Castle Hill Road was observed from the end of Matthew Way. The slopes are undulating and rounded. The properties are vegetated with mown grass and with widely spaced, mainly eucalypt trees. The tree trunks are generally straight, but there is slight curvature of some trunks close to the base of the gully in 6-8 Highs Road.

**Figure 17** Panorama view of 6-8 Highs Road and 141-143 Castle Hill Road
