**Structural Assessment of Building  
223-227 Bronte Road  
Charing Cross**

**Prepared for  
Barbary Coast Investments Pty Ltd  
5/139 Bathurst Street, Sydney**

19.05.16

Our Reference  
16.132  
Computer File  
C:161321905.16

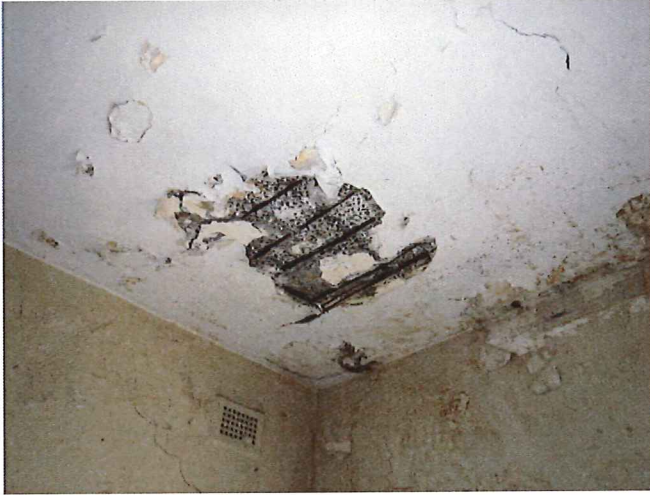
The suspended concrete slabs which form the roof terraces extending over the rear of the lower and upper level apartments are in extremely poor condition. The concrete elements show signs of significant water penetration and concrete cancer. Photographs 9 through 14 show examples of the extent of concrete cancer to the slabs. This was a consistent issue with all the slabs which form the terraces over the apartments.

Photo 13 - Evidence of concrete cancer to suspended slabs. This is a significant issue throughout the building through all concrete slabs.

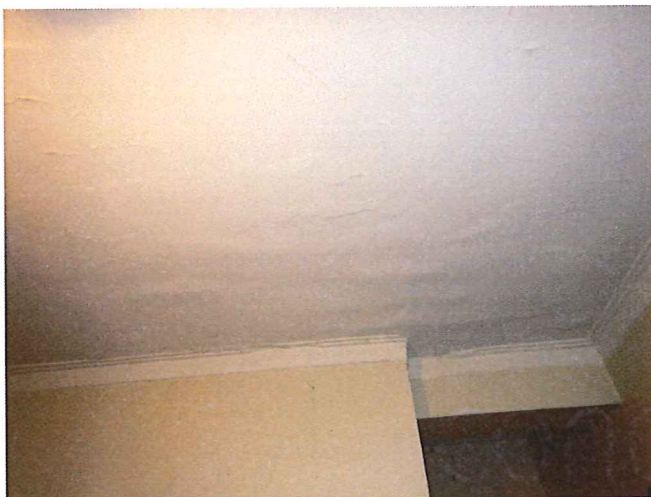
In some of the apartments there were sections of the render to the underside of the slabs that appeared to be concealing additional concrete cancer, however the render had yet to delaminate. As can be seen in attached photographs 15 and 16, the delamination of the render/concrete is only a matter of time.

Photo 15 - The undulations in the render to the underside of the slabs are impacted by concrete cancer and spalling of the concrete is immanent

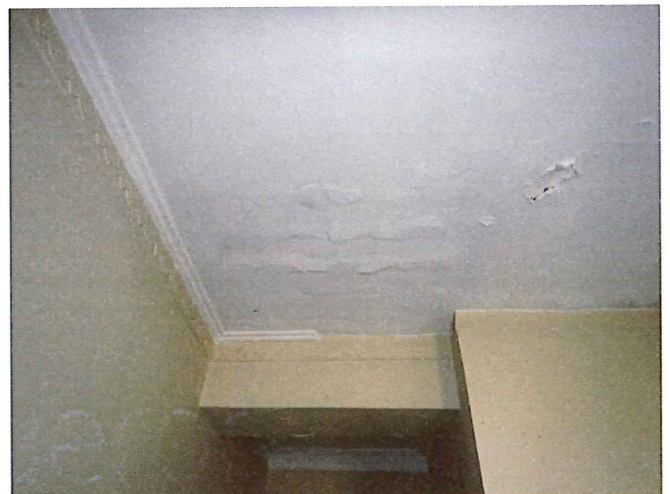
Photo 16 - The undulations in the render to the underside of the slabs are impacted by concrete cancer and spalling of the concrete is immanent

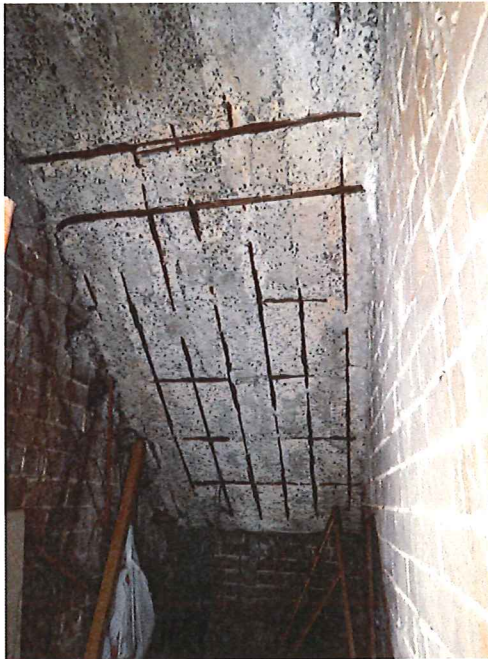
The access to the rear apartments is via a series of reinforced concrete staircases. These staircases are in a severely dilapidated state. Photographs 17 and 18 show evidence of concrete cancer to the staircases. The concrete cancer to the lower staircase is in an extremely advanced state (photograph 17). The damage to the upper level staircase has been repaired in the past, however the concrete structure is likely to have been compromised as a result of the past damage.

Photo 17 - Severe concrete cancer to underside of stair at south western corner of building

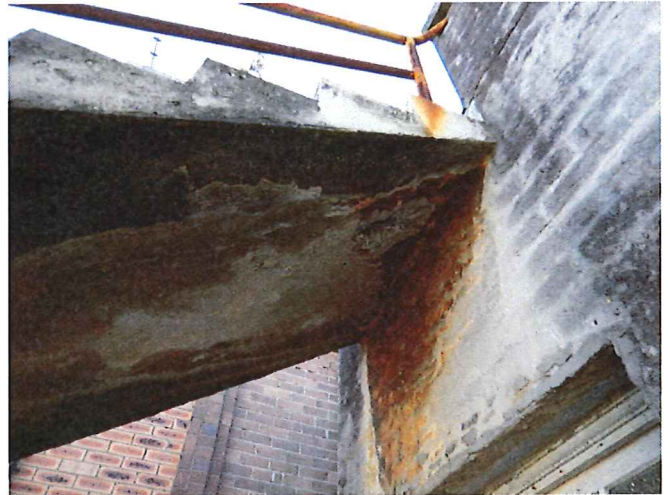
Photo 18 - Evidence of concrete cancer to the underside of the upper level stair leading to the roof top deck

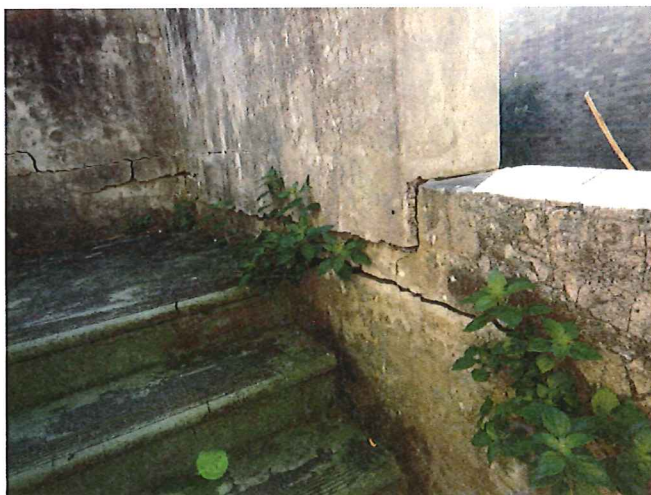
The balustrades to the lower level section of staircase are masonry, and are in extremely poor condition, as can be seen in attached photographs 19 and 20. These balustrades are crumbling due to the impact of time and the environment. It is clear in photographs 19 and 20 that there is foliage growth within the cracks in the masonry balustrades.

Photo 19 - Cracking to masonry balustrade running up external stair

It is our recommendation that access to these areas where the balustrades are falling apart be closed off immediately.

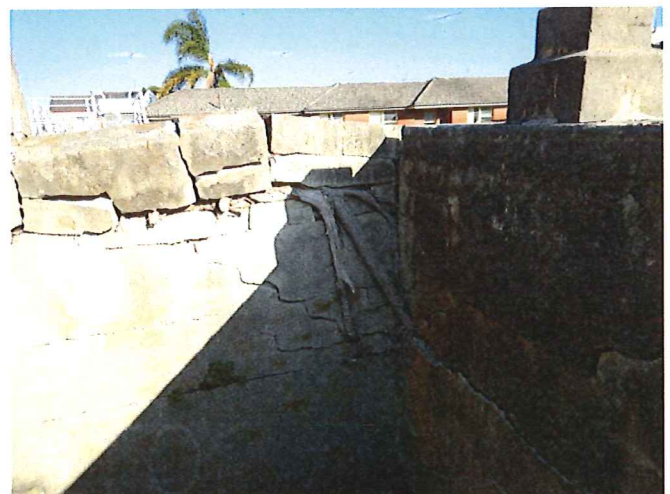
Photo 20 - Cracking to masonry balustrade running up external stair

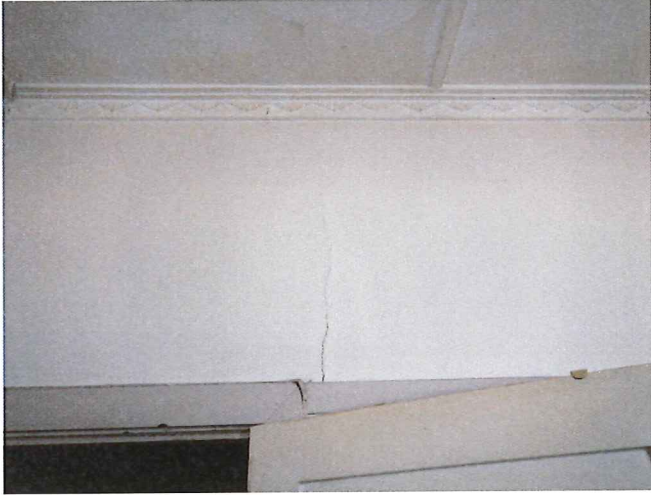
Walls to the upper level apartments were in better condition than the walls to the lower level apartments. The upper level walls over the retail tenancies had some cracks evident. These cracks varied from slight to moderate. Examples of the cracking observed can be seen in attached photographs 25 through 31.

Photo 29 - Evidence of cracking to the internal walls of the upper level apartments

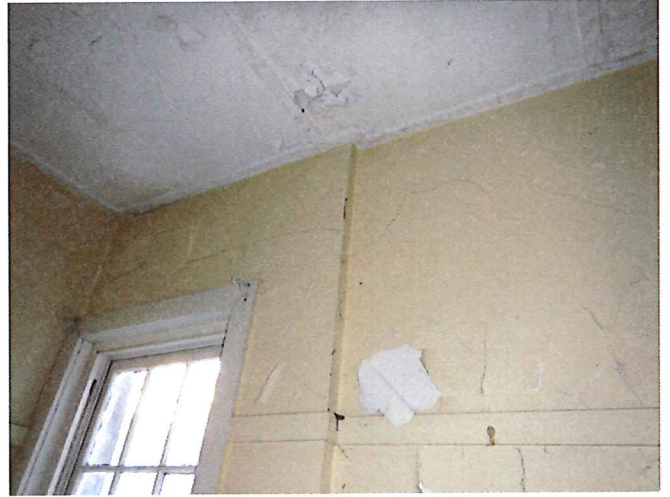
Photo 30 - Evidence of cracking to the internal walls of the upper level apartments

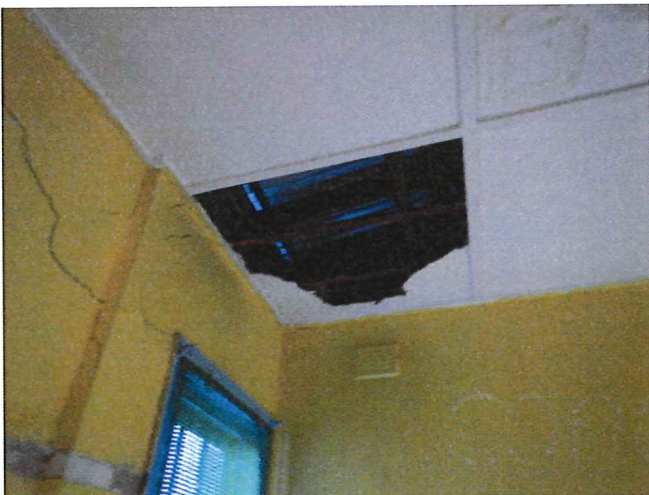
Photo 31 - Damage to roof of upper level apartment

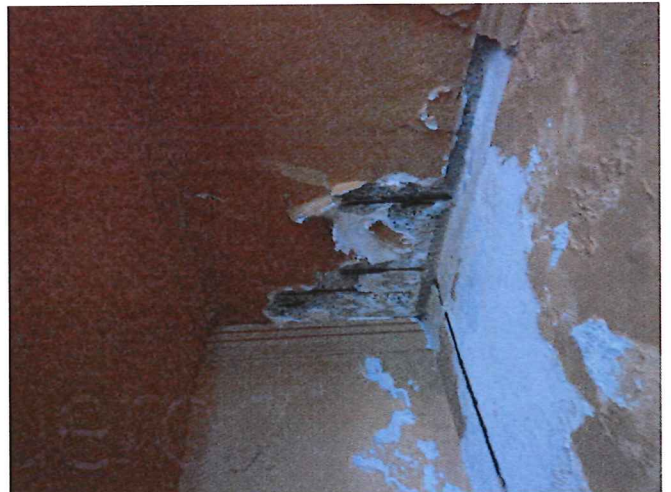
Photo 32 - Damage to roof of upper level apartment

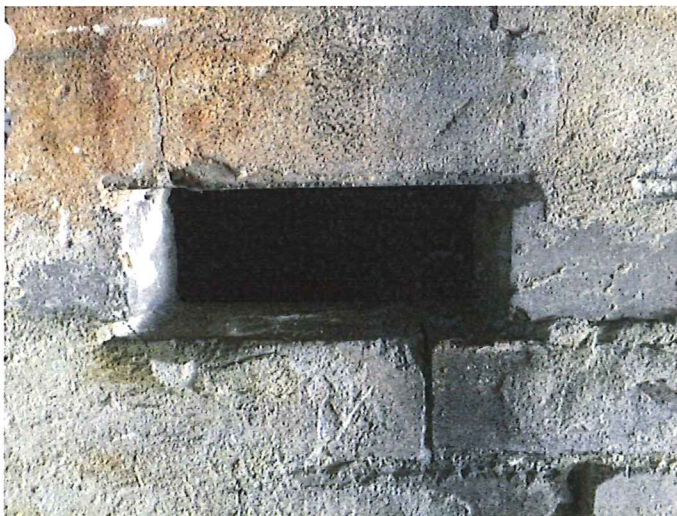
- Based on the information available, it appears that the structure is approximately 80 years old.
- The walls to the building are constructed of masonry with lime mortar. There is significant evidence of deterioration of the lime mortar, as can be seen in attached photographs 5 through 16. In some locations you can simply extract bricks from the wall by pulling on the brick.

Photo 7 - Deteriorated section of internal wall

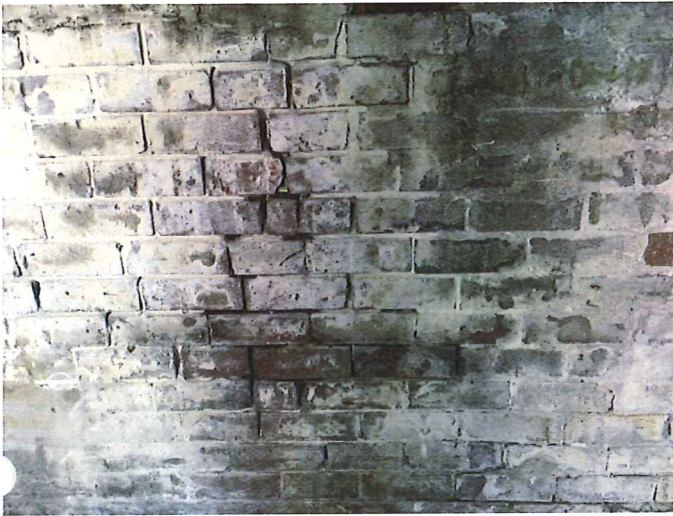
Photo 9 - Deteriorated section of internal wall

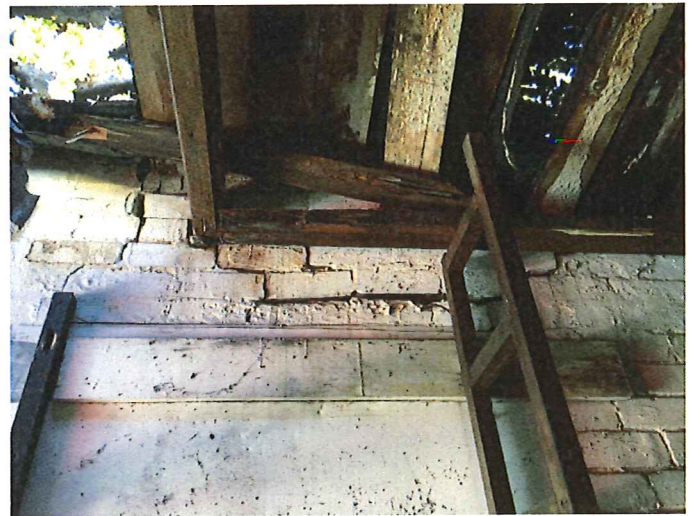
- There was significant damage observed above the window in the northern wall of the building, as can be seen by the exterior in attached photograph 11 and the interior in attached photograph 10. This is a result of significant corrosion in the steel lintel.

Photo 10 - Damage over window as a result of corroded lintel

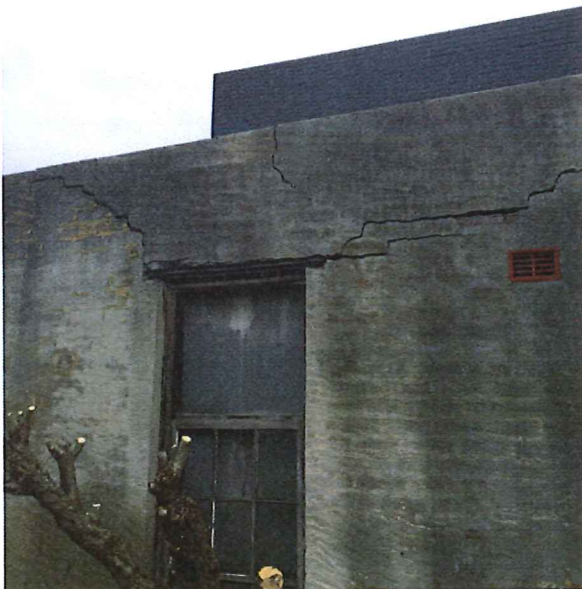
Photo 11 - Damage over window as a result of corroded lintel

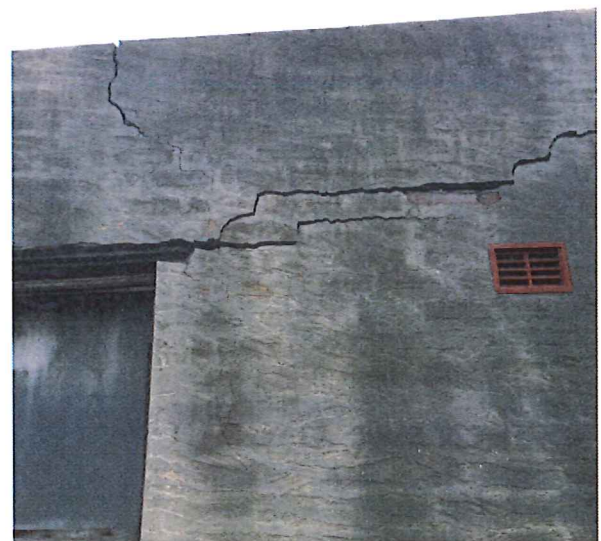
Photo 12 - Damage over window as a result of corroded lintel

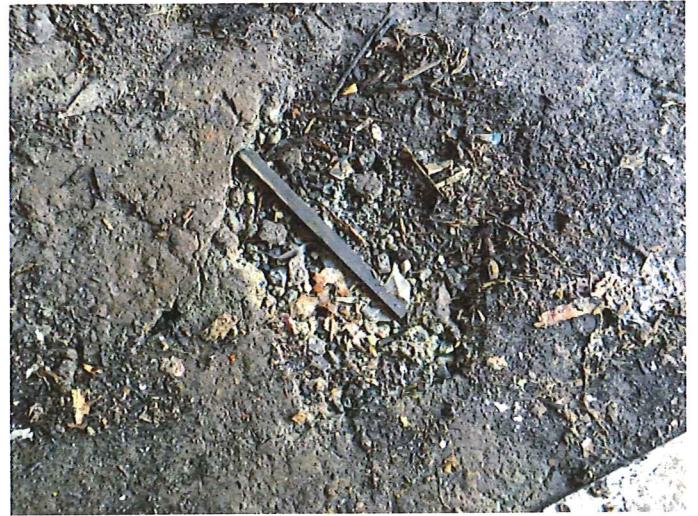
Photo 18 - Damage to ground floor slab

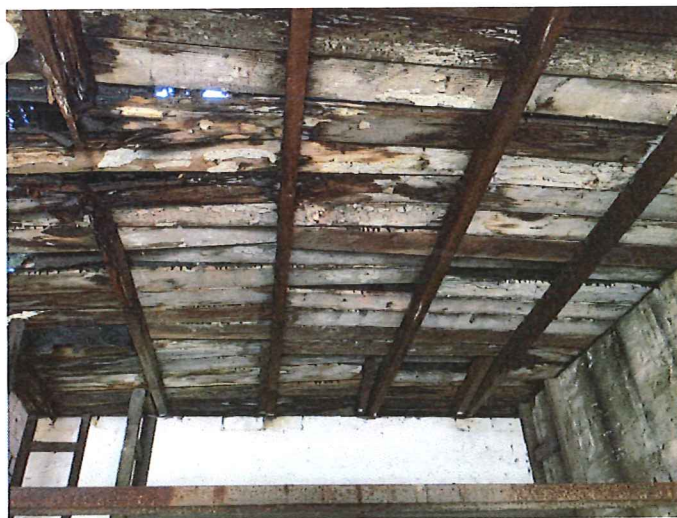
- There is a significant amount of stepped cracking evident within the masonry.
- The roofs of the structures are completely dilapidated, as can be seen in attached photograph 19.

Photo 19 - Significant damage to roof
