## SITE INSPECTION REPORT

Project: Structural Assessment of Building  
223-227 Bronte Road, Charing Cross

Our Reference  
16.132  
Computer File

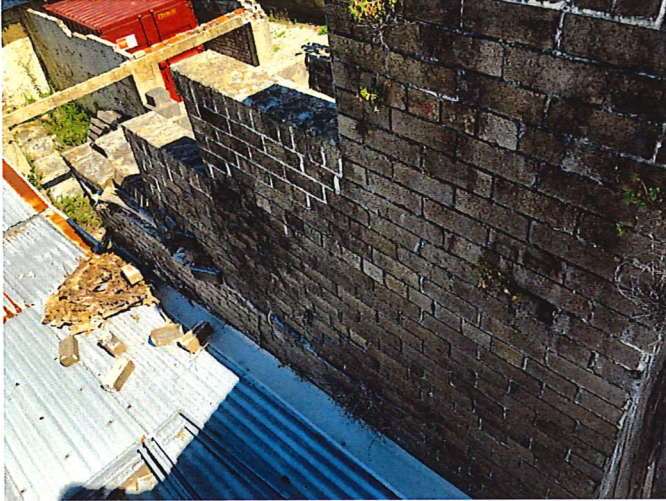
SD noted that the masonry balustrade to the southern access stair to the upper level apartments had deteriorated further since their previous inspection, and noted that some sections of brickwork had fallen onto the roof of the adjacent property. Refer to attached photographs 1 through 4. SD suggested that all sections of loose masonry to the balustrade be removed. Even though the upper levels of the building have been closed off, it is recommended that a temporary balustrade be fixed in place to the edge of the stair to ensure that any people accessing the building for service purposes are protected.

Photo 1 - Note the debris from the crumbling stair balustrade on the roof of the adjacent property

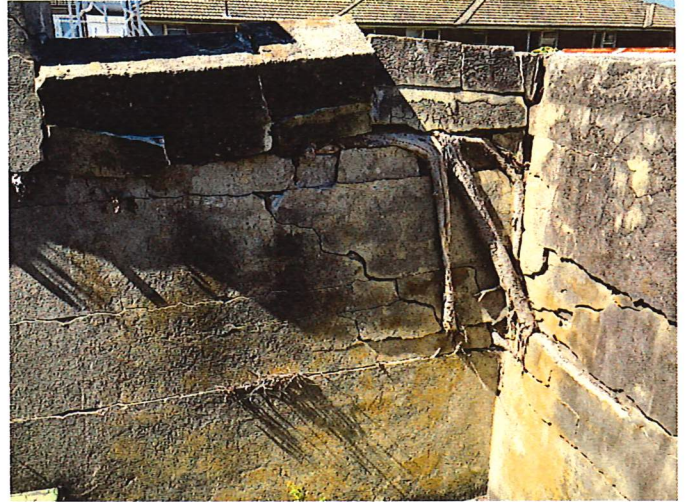
Photo 2 - Deteriorating balustrade

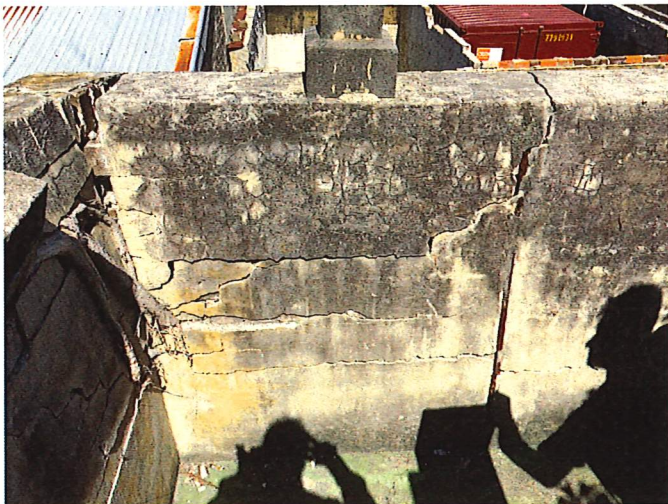
Photo 3 - Deteriorating balustrade

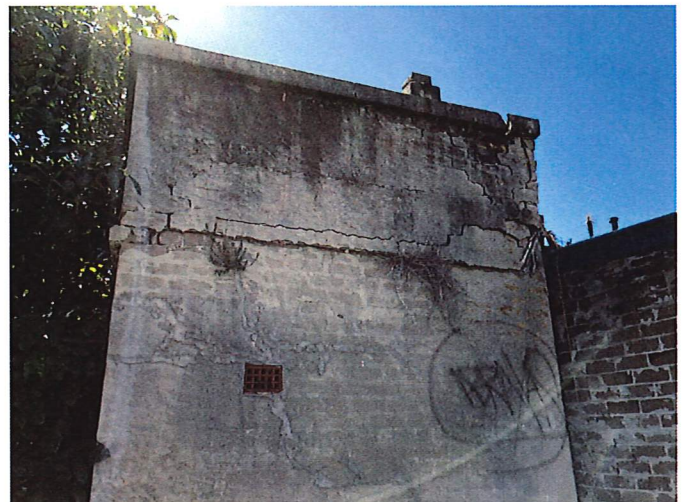
Photo 4 - Deteriorating balustrade

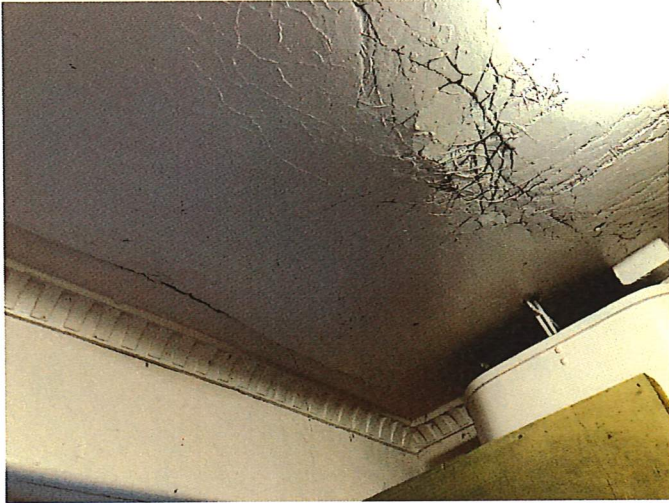
In relation to the tenancy at No. 227, it is noted that they use the toilet at the rear of the tenancy. SD noted that the ceiling in this section of the tenancy had further deteriorated, and suggested that the ceiling be removed. Refer to attached photograph 5.

Photo 5 - Deteriorating ceiling to W/C of retail tenancy at 227 Bronte Rd

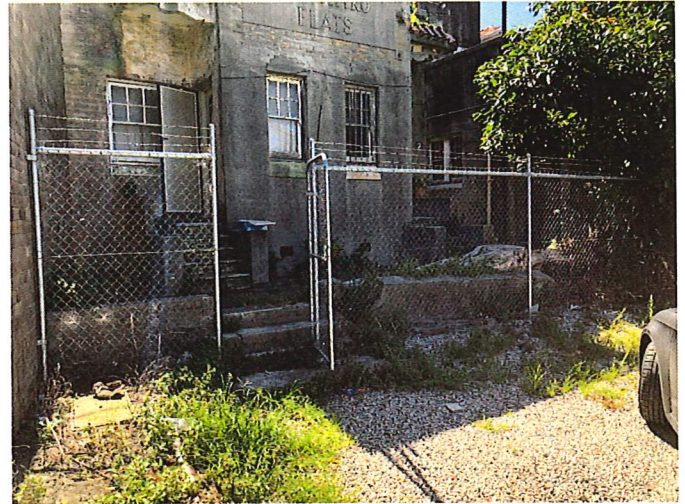
SD noted that a series of chain wire fences and gates had been installed to restrict access to the residential tenancies. SD noted that these should be padlocked at all times. It was noted during the inspection that one of the tenancies was open. SD noted that all these tenancies should be maintained in a locked condition to prevent people accessing the apartments.

Photo 6 - Security fence across rear of residential section of building
