Hazardous Building Materials Report

137-151 Anzac Parade  
Kensington, NSW

Prepared for  
Toga Group

Project 85151.00  
October 2015

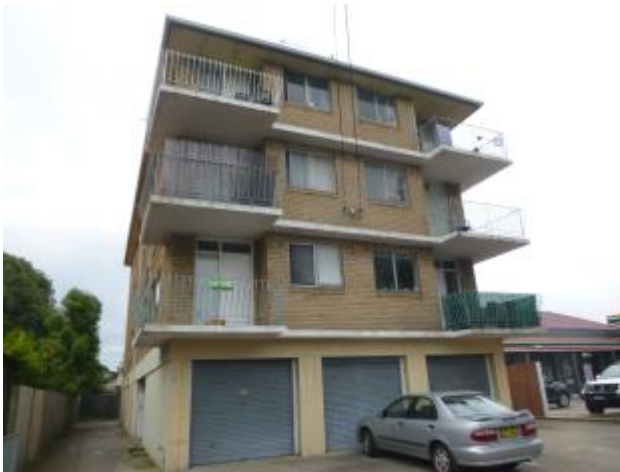
**Figure 1**

137 Anzac Parade is a four level concrete and brick structure with metal framed windows and presumed to have a tiled roof. Presumed asbestos cement is present as soffits to the roof. No access could be afforded to the property. See Figure 1.

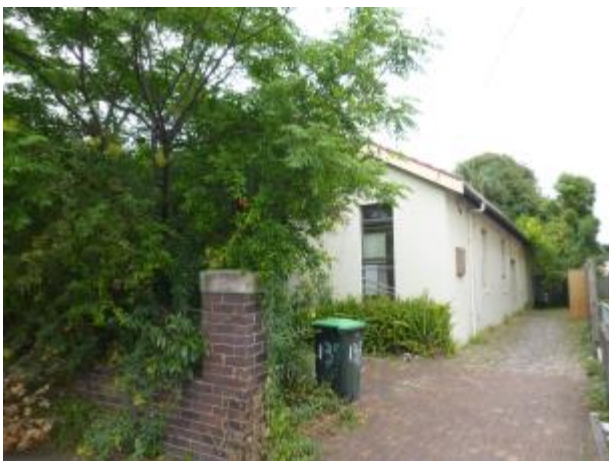
**Figure 2**

139 Anzac Parade is a single level rendered brick structure with wooden eaves, wooden sash windows and a terracotta tiled roof. Presumed asbestos cement is present as under-cloaking and cladding to upper roof gable ends. No access could be afforded to the internals. See Figure 2.

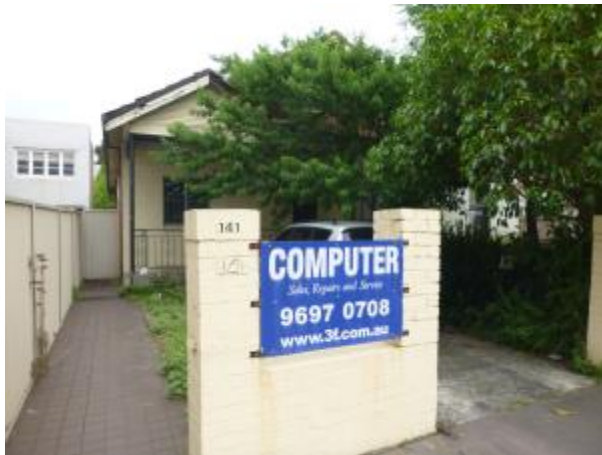
**Figure 3**

141 Anzac Parade is a single level rendered brick structure with wooden eaves, wooden sash windows and a terracotta tiled roof. Presumed asbestos cement is present as lining to the porch canopy and cladding to upper roof gable ends. No access could be afforded to the internals. See Figure 3.

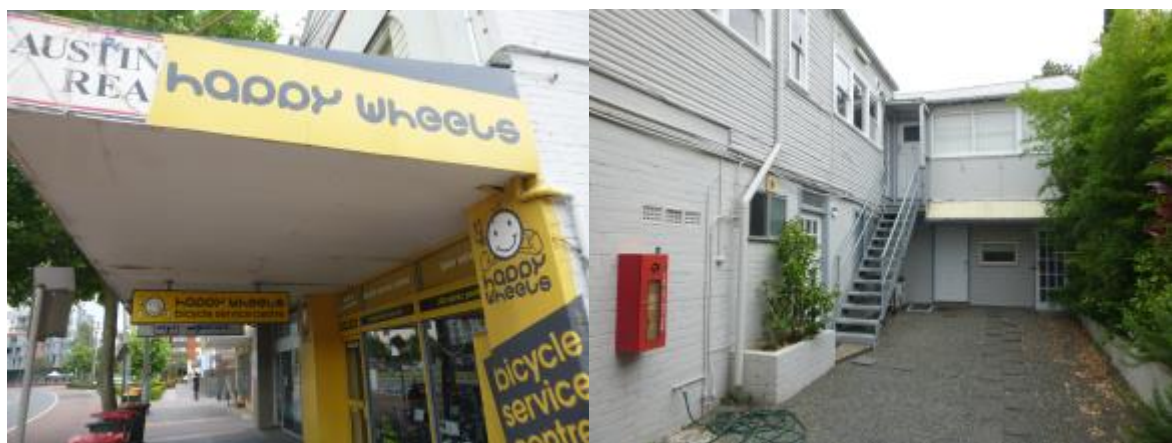
**Figure 4**

143 Anzac Parade is a two level brick structure with a bicycle shop to the street and flats to the rear and first floor with profiled metal roofing throughout. Presumed asbestos cement is present as lining to the shop canopy and cladding to ground and first floor flats. No access could be afforded to the internals. See Figure 4.

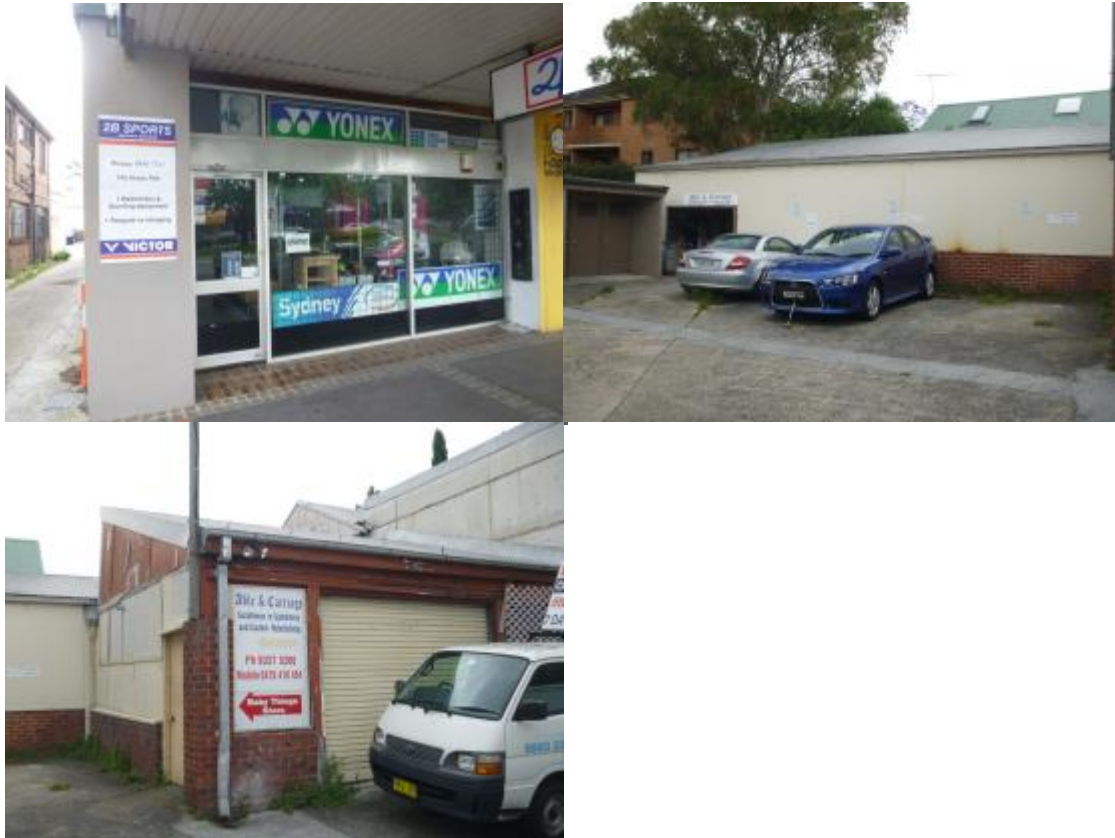
**Figure 5**

145 Anzac Parade is a two level brick structure abutted to 143 with a badminton sports shop to the street and flats to the rear and first floor with profiled metal roofing throughout. Presumed asbestos cement is present as cladding to the two rear units ('Able Carriage' and Unit 3 (Large Garage)) accessed via side alley. No access could be afforded to the internals. See Figure 5.

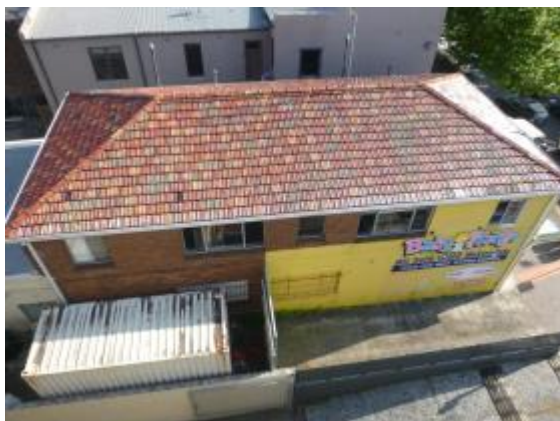
**Figure 6**

145A Anzac Parade is a two level brick structure with a terracotta tiled roof. The ground floor has a child car seat fitting shop ('Baby Things') with offices above. Presumed asbestos cement is present as eaves to the roof. No access could be afforded to the property. See Figure 6.

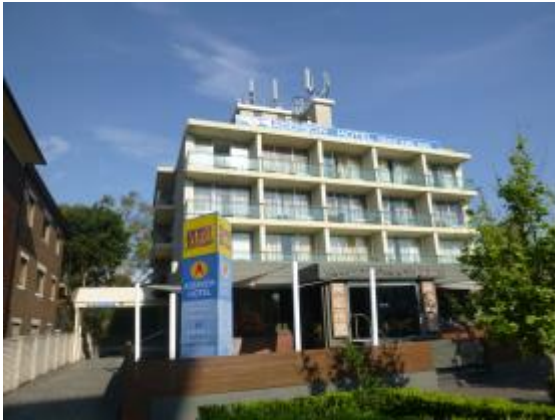
Figure 7

147 - 151 Anzac Parade is a four level concrete, rendered brick and brick structure with metal framed windows and a split-level flat concrete roof incorporating lift motor room, AC plant and antennae. Internals are predominantly brick, rendered brick and concrete slab throughout. The basement is mainly car parking and storage with a boiler room and laundry. Vermiculite spray coating is thought to be present to all structural steel beams on the ground floor which houses the Hotel reception and a (currently closed) Chinese Restaurant. All first to third floor bedrooms and communal areas are carpeted except bathrooms which have ceramic floor tiles. Suspended ceilings are present only in bathrooms and on the ground floor. See Figure 7.
