**One Investment Management Pty Ltd AFT  
The Recap IV Management No. 4 Trust**

**Preliminary Site Investigation**

4 – 6 Bligh Street, Sydney NSW

25 July 2017

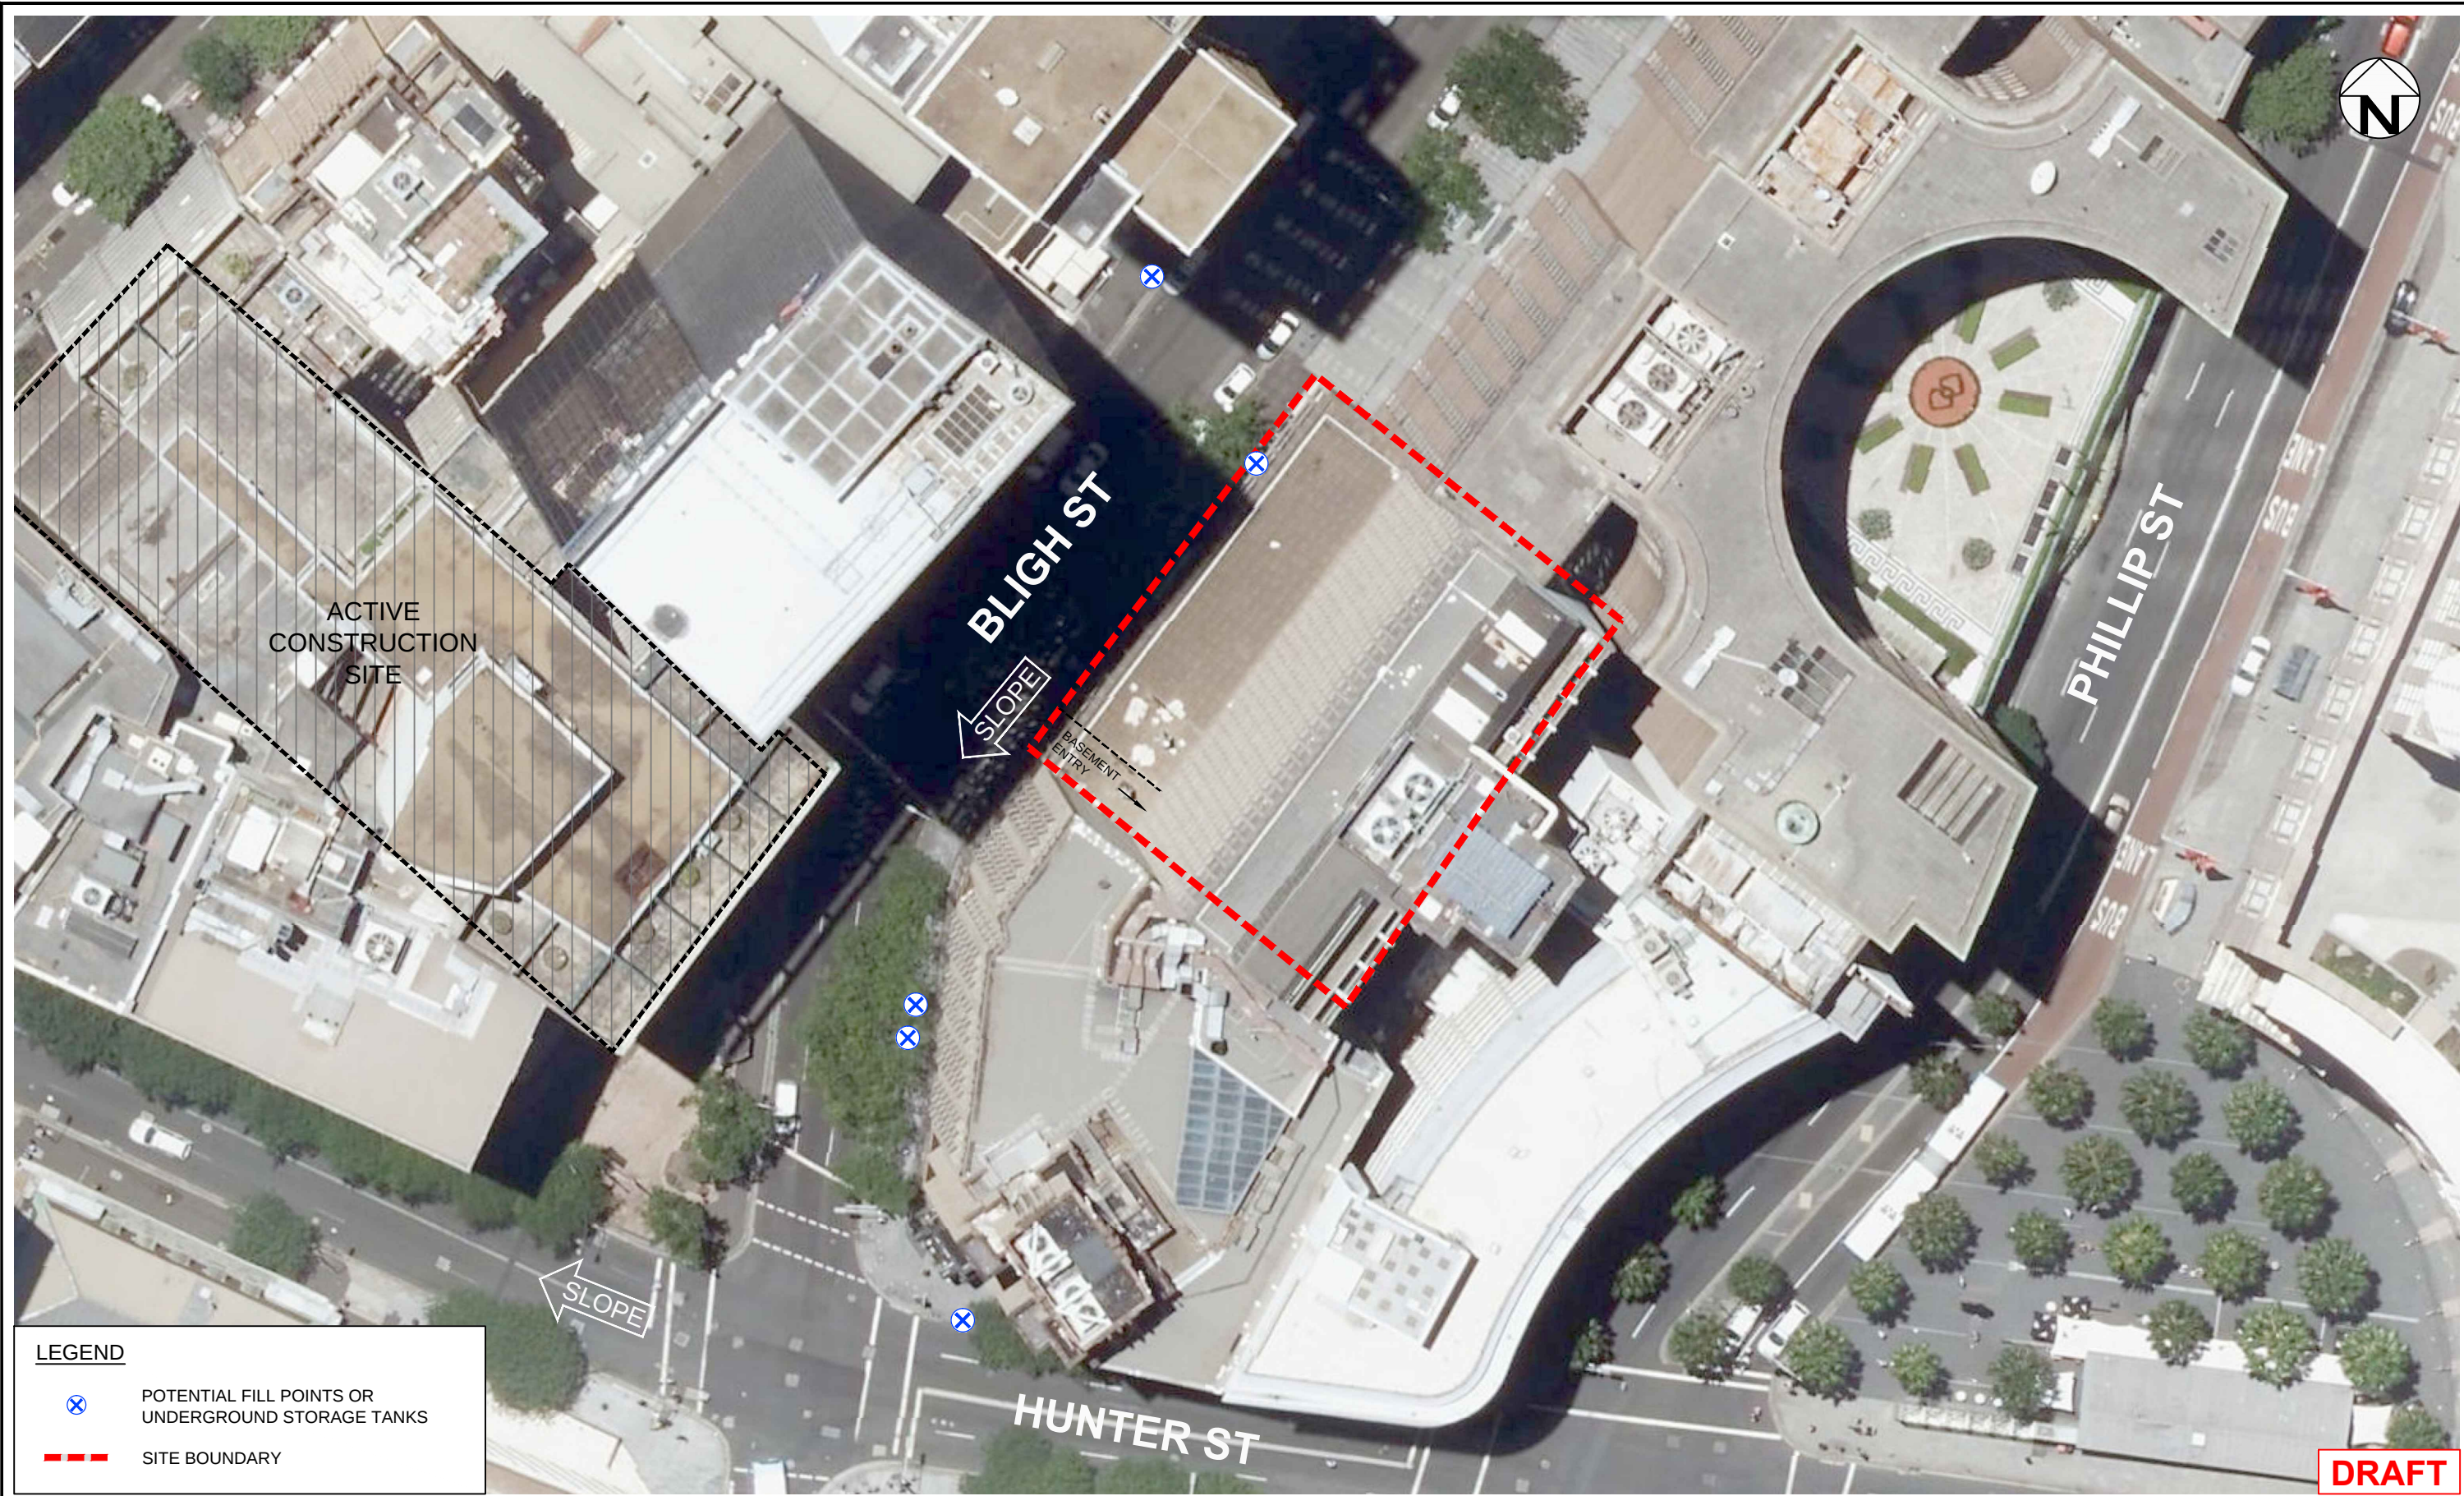
- Four suspected tank access or tank fill points were observed on the footpath of Hunter and Bligh Street (refer Figure 2), indicating that an underground petroleum storage systems (UPSS) are (or had been) present at the site.

POTENTIAL FILL POINTS OR UNDERGROUND STORAGE TANKS

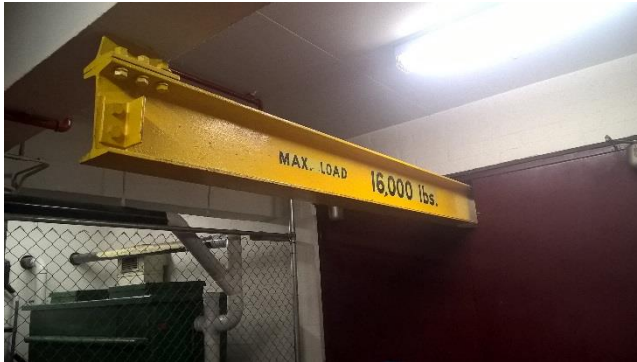
**Photograph 3:**

- A possible hoist system (max load 16,000 lbs) was observed within the basement carpark. Access to one side was only available (Photograph 3).
- An inspection of foot paths surrounding the site and adjoining buildings identified flush fitting steel caps within the footpath at four separate locations along Hunter Street and Bligh Street which are commonly identified as fill points for underground storage tanks (USTs), with one being identified within the north western corner of the site (Photograph 9). The location of the steel caps are provided on Figure 2.

Possible hoist system observed within the basement car park

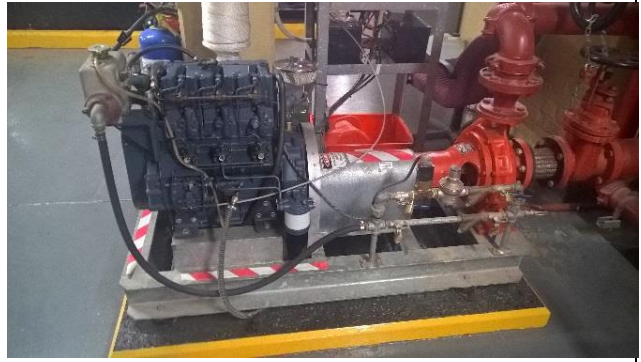
**Photograph 4:**

- Multiple pumps, compressors and refrigeration units were observed within the plant room, the majority of which were installed within bunding. Evidence of former leakages was noted although such was contained within the bunding (Photographs 4 – 8).

A pump located within the basement plant room with fuel lines and oil filters observed and placed on bunding.

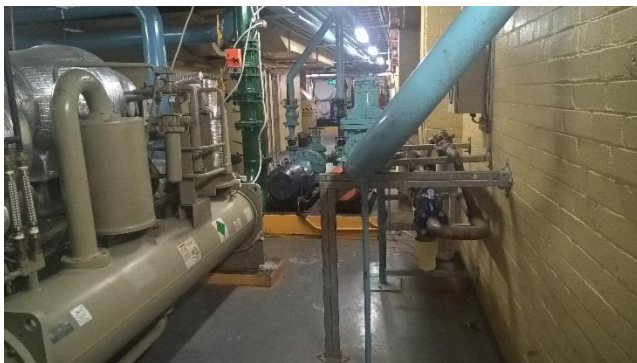
**Photograph 5:**

Plant infrastructure located within the basement plant room.

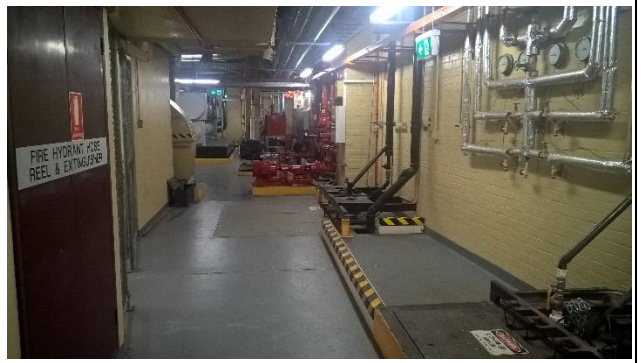
**Photograph 6:**

- The concrete of the basement plant room was observed to be in good condition, with no signs of cracking observed (Photograph 6). Drains were observed, which likely flowed into the separator pits, however, this was not evident (Photograph 8).

Plant equipment and underground storage pits located within the basement plant room.

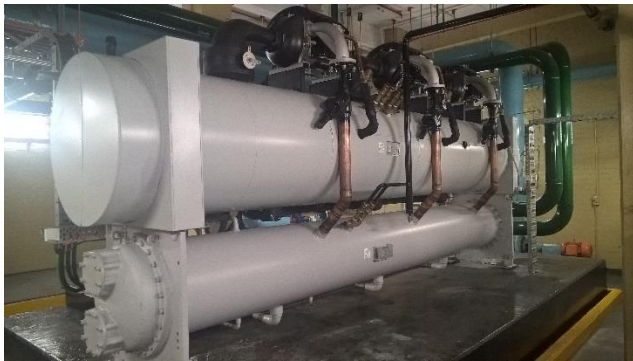
**Photograph 7:**

Compressor / refrigerant unit observed on bunding within the basement plant room.

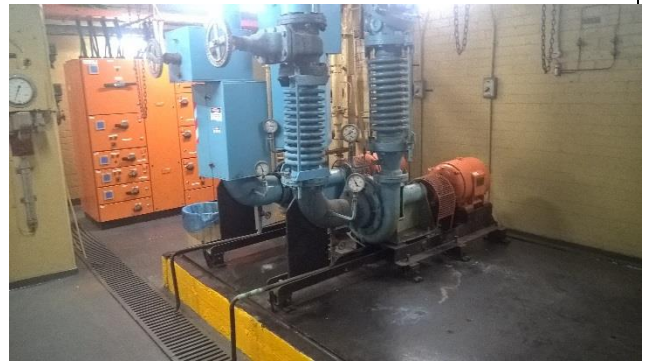
**Photograph 8:**

Plant equipment installed on bunding and a drain within the basement floor.

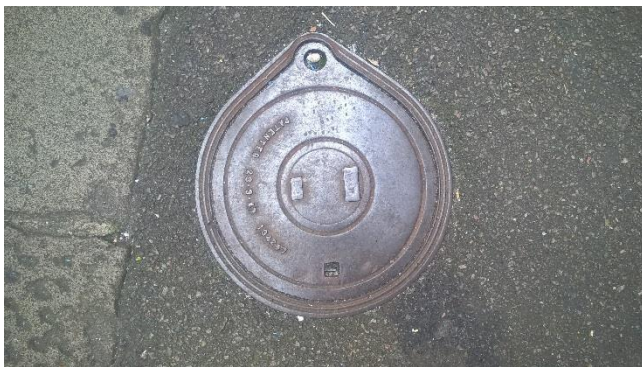
**Photograph 9:**

Building management representatives were not aware of underground storage tanks (UST) being present within the building, yet suspected fill points were noted along Bligh and Hunter Streets. These fill points were considered to be an indicator that tank(s) are, or have been present within the building. Records provided by SafeWork NSW indicate no licenses to store dangerous goods (i.e. fuels) had been issued to the property, although it is noted that not all tanks were licensed historically. The presence of UST within the site remains a data gap.

Potential underground storage tank cap observed on the footpath of Bligh Street within the north west corner of the site.

- **Detailed Site Investigation (DSI)** –to effectively characterise the site. The DSI will aim to assess the condition of site soils and groundwater and the suitability for the use as commercial and residential land. Coffey notes that this investigation can be undertaken in conjunction with geotechnical works, with soil and groundwater samples collected from geotechnical boreholes, where possible.
