## Hazardous Building Materials Report

Sites 1 and 2  
Cnr Todman Ave & Anzac Parade  
Kensington  
NSW

Prepared for  
Toga Group

Project 84823.01  
April 2015

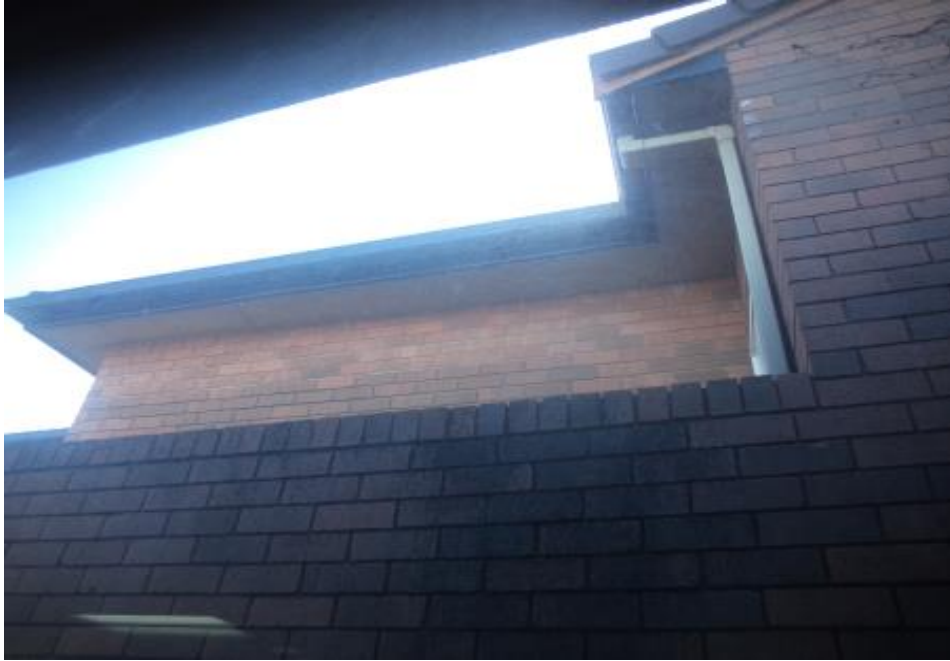
Photo 1 - 111, External, presumed asbestos-containing cement eaves.

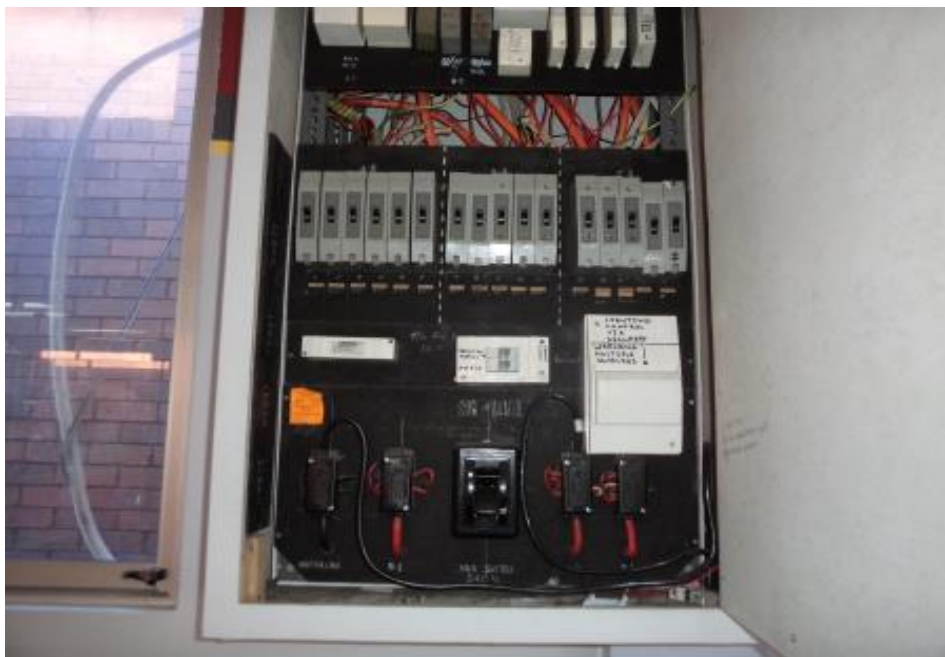
| Location, Description / Product Type and Extent | Sample No | Photo No | Asbestos Type | Friability Status | Condition | Surface Treatment | Material Assessment score | Likelihood of Access or Disturbance. | Priority Risk Score | Recommendation (A1 - A4)* | Comments / Action |
|---|---|---|---|---|---|---|---|---|---|---|---|
| 113-115 Snap Fitness Gym, Level 1, electrical cupboard 'Lebah' asbestos electrical boards, poor condition dust and debris present. (~2 x 0.5m <sup>2</sup> ). | V.O | 2 | Assume amphibole | Bonded | Good | Unsealed | 9 | Medium | 15 | A2 | Remove dust and debris and seal damaged board. Leave in-situ, affix asbestos warning labels, manage and re-inspect. |

Photo 2 - 113-115 Internal, level 1, asbestos backing boards and presumed cement linings.

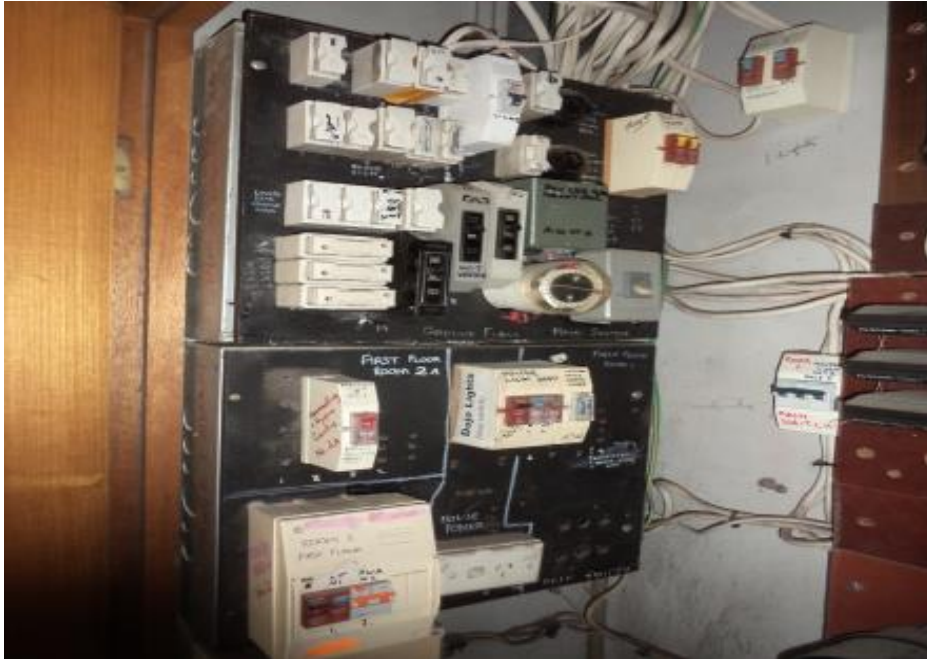
Photo 3 - 117-119 Internal, ground floor, asbestos backing boards.

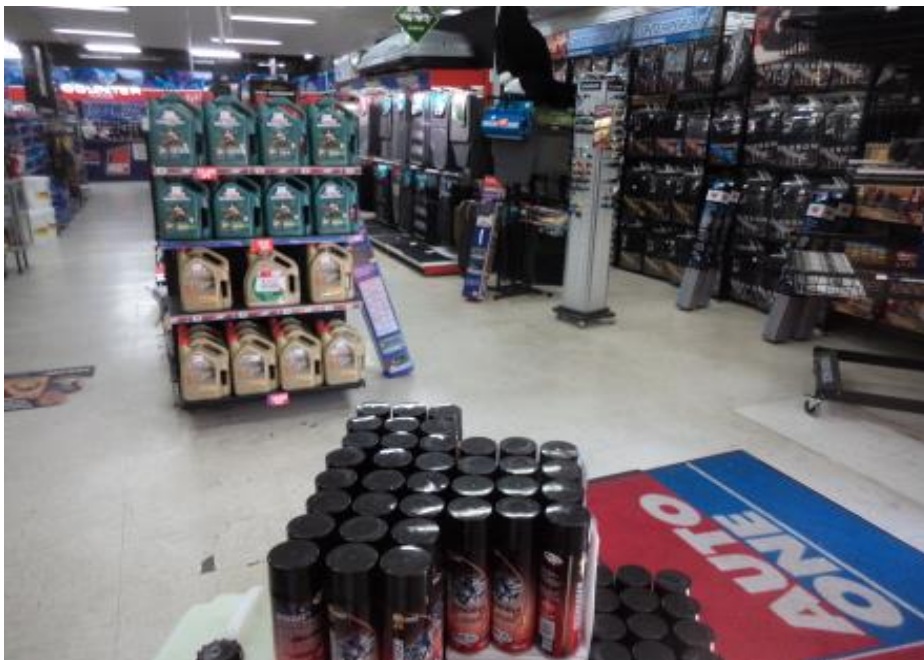
Photo 4 - 117-119 Internal, ground floor, presumed asbestos floor tiles.

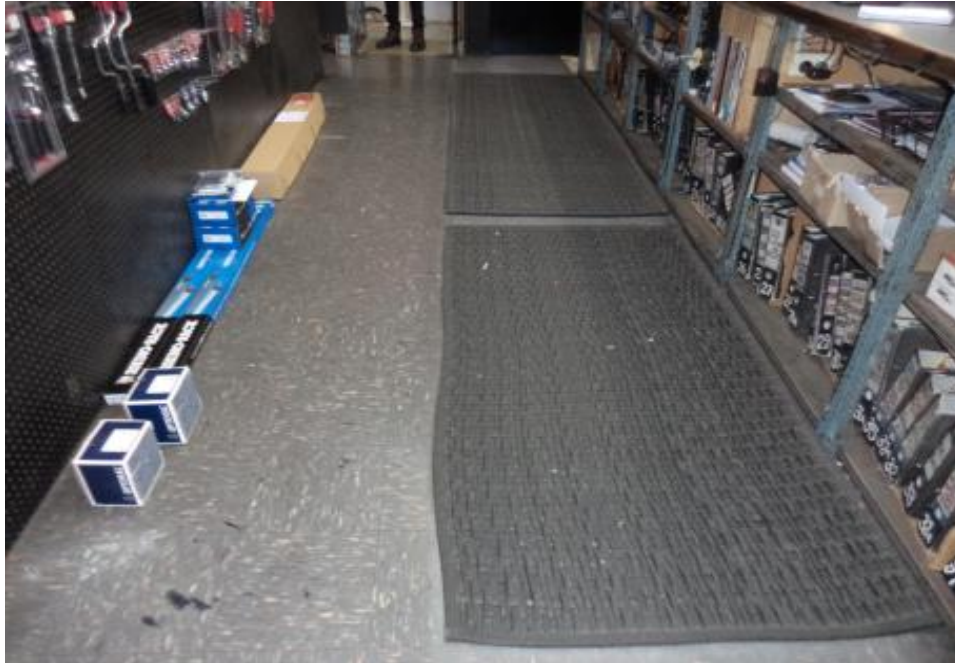
Photo 5 - 117-119 Internal, ground floor, presumed asbestos floor tiles.

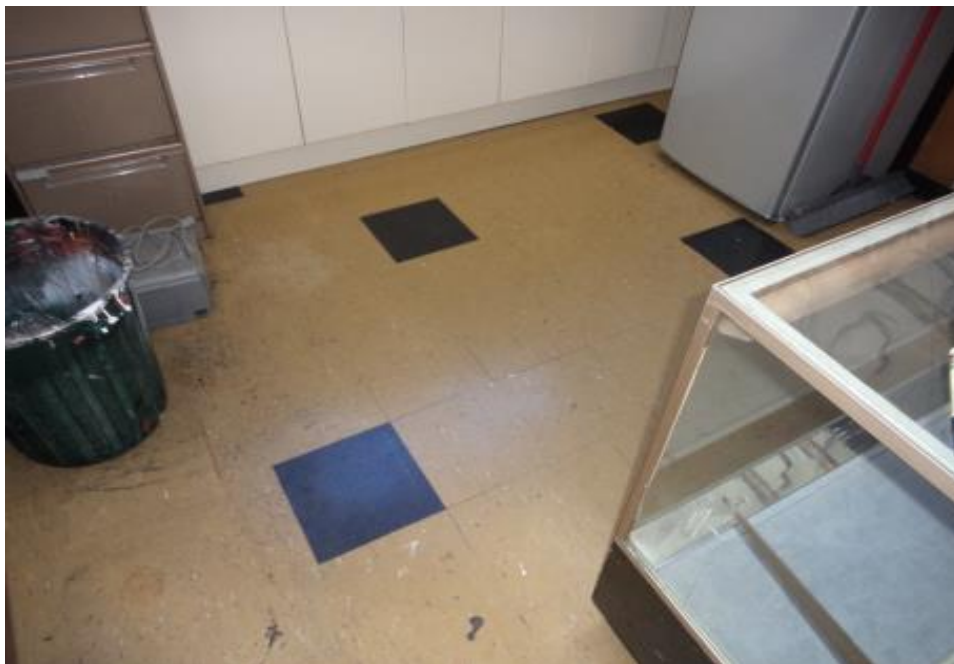
Photo 6 - 117-119 Internal, ground floor, presumed asbestos floor tiles.

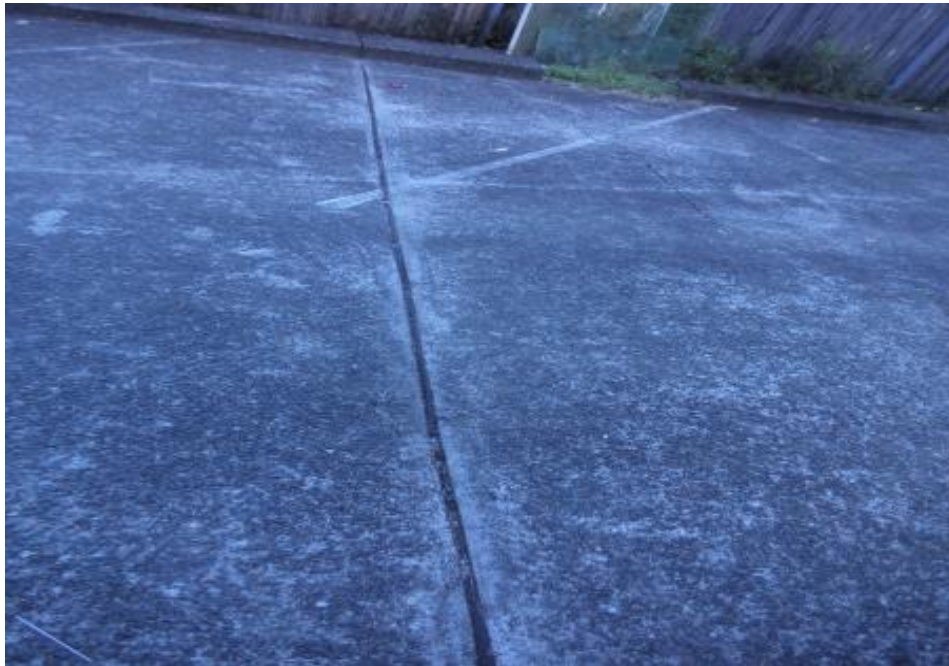
Photo 7 - 117-119 External, presumed asbestos bituminous expansion joints to concrete slab.

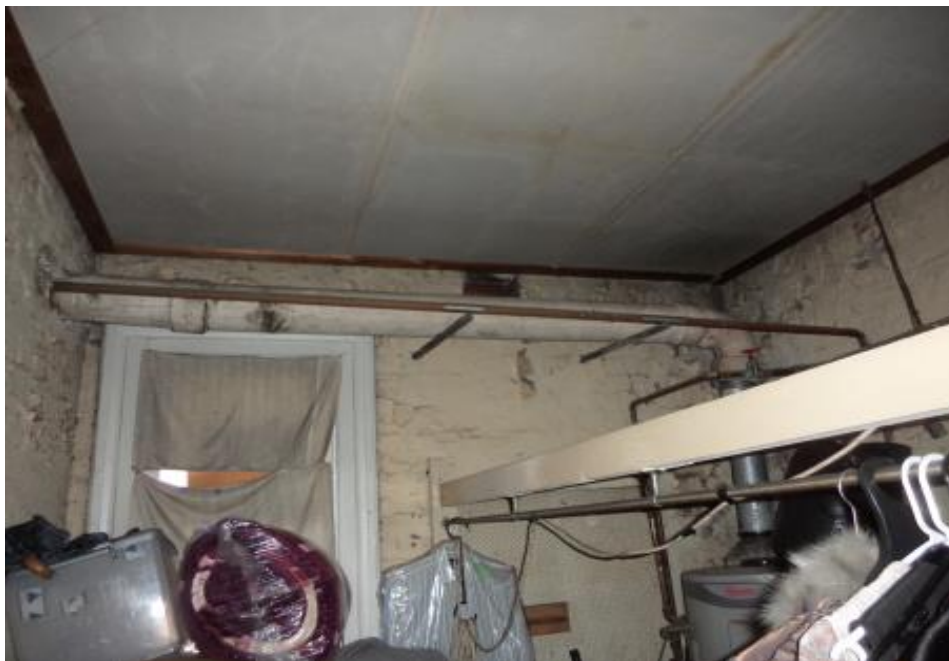
| Location and description | Sample ID | % Lead | Photo No. | Condition | Likelihood of disturbance | Recommendation |
|---|---|---|---|---|---|---|
| 121-123 Launderette, Ground Level, rear rooms, suspect flaking paint systems to walls and ceiling (~3 x 12m <sup>2</sup> ). | Visual observation | Assume +ve | Ref 8 | Av | Med | Remove prior or during major demolition/ refurbishment works without discharge to the environment. Should the material not be affected by any proposed works, leave and maintain in good condition. |
| 121-123 Unit 2, Level 1, suspect flaking paint systems to ceilings throughout (~80m <sup>2</sup> ). | Visual observation | Assume +ve | Ref 8 | Av | Low | Remove prior or during major demolition/ refurbishment works without discharge to the environment. Should the material not be affected by any proposed works, leave and maintain in good condition. |

| Location and description | Sample ID | % Lead | Photo No. | Condition | Likelihood of disturbance | Recommendation |
|---|---|---|---|---|---|---|
| 121-123 Unit 1, Level 1, suspect flaking paint systems to ceilings throughout (~80m <sup>2</sup> ). No access assume same as unit 2. | Visual observation | Assume +ve | Ref 8 | Av | Low | Remove prior or during major demolition/ refurbishment works without discharge to the environment. Should the material not be affected by any proposed works, leave and maintain in good condition. |

| Location and description | Sample ID | Photo No. | Friability | Condition | Surface Treatment | Likelihood of disturbance | Recommendation |
|---|---|---|---|---|---|---|---|
| 123 Launderette, Ground Level, rear store, SMF insulation to Rheem HWU. | Visual observation | Ref 8 | No | Good | Yes | Low | Remove prior to major demolition/ refurbishment works. Should the material not be affected by any proposed works, leave and maintain in good condition. |

Photo 8 - 123, Ground floor, presumed asbestos flue, asbestos ceiling lining above Rheem HWU.

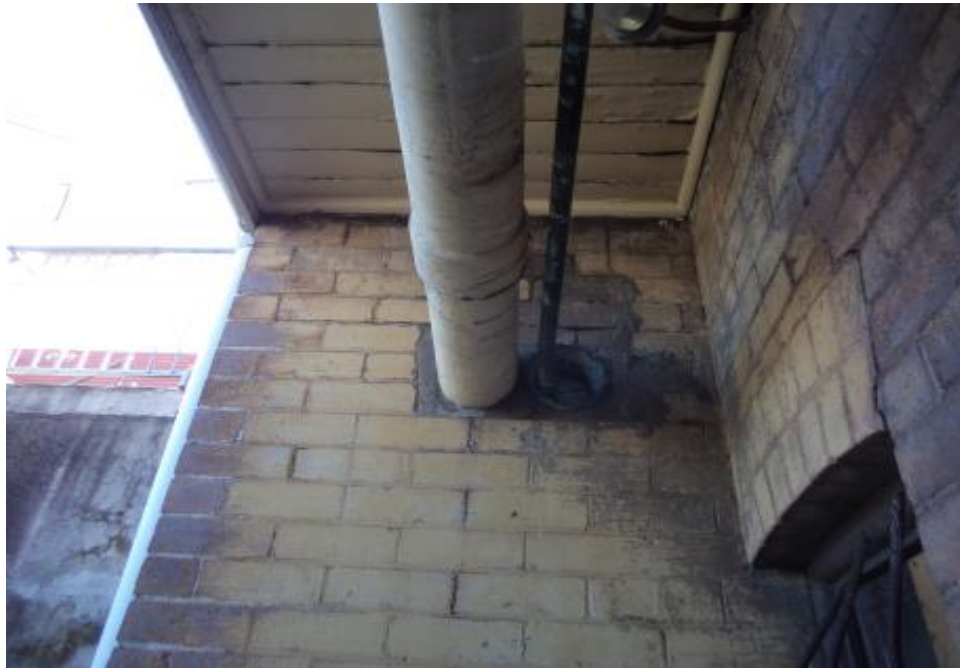
Photo 9 - 123, External, presumed asbestos flue and penetration.

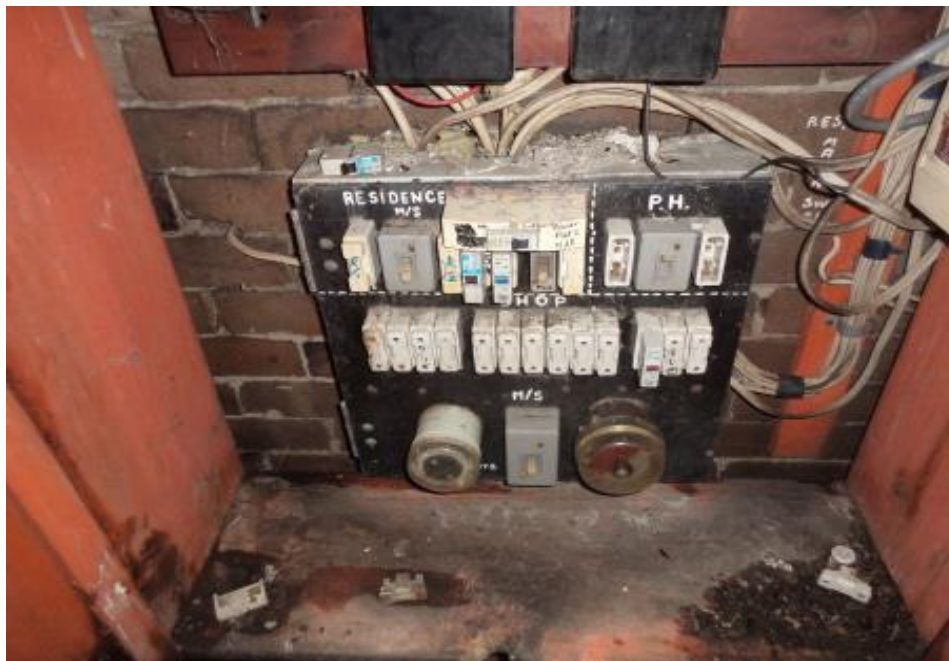
Photo 10 - 123 External, ground floor, presumed asbestos backing board.

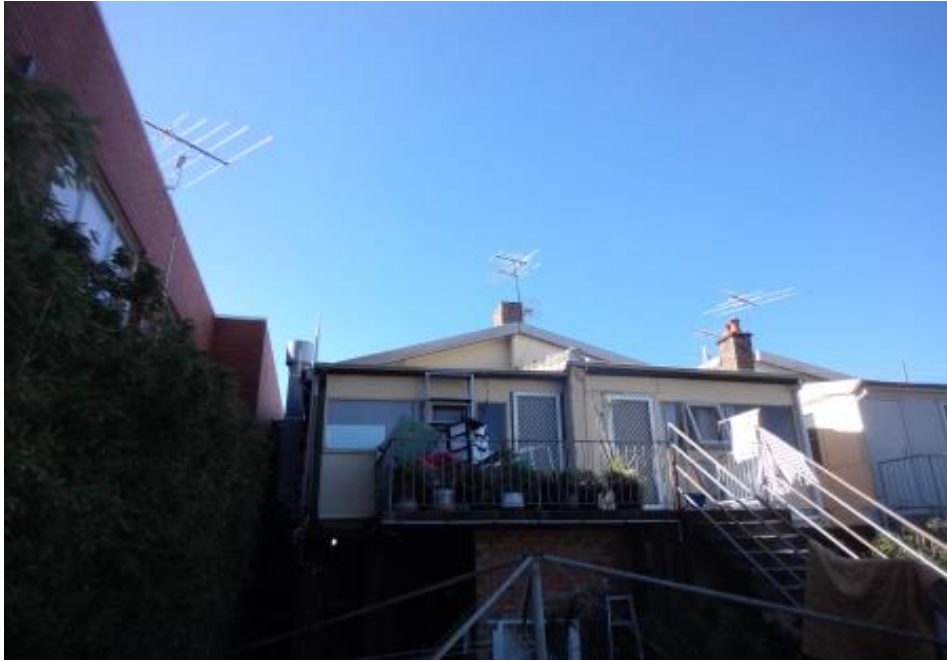
Photo 11 - Units 1 & 2, presumed asbestos cladding and gable end to roof.

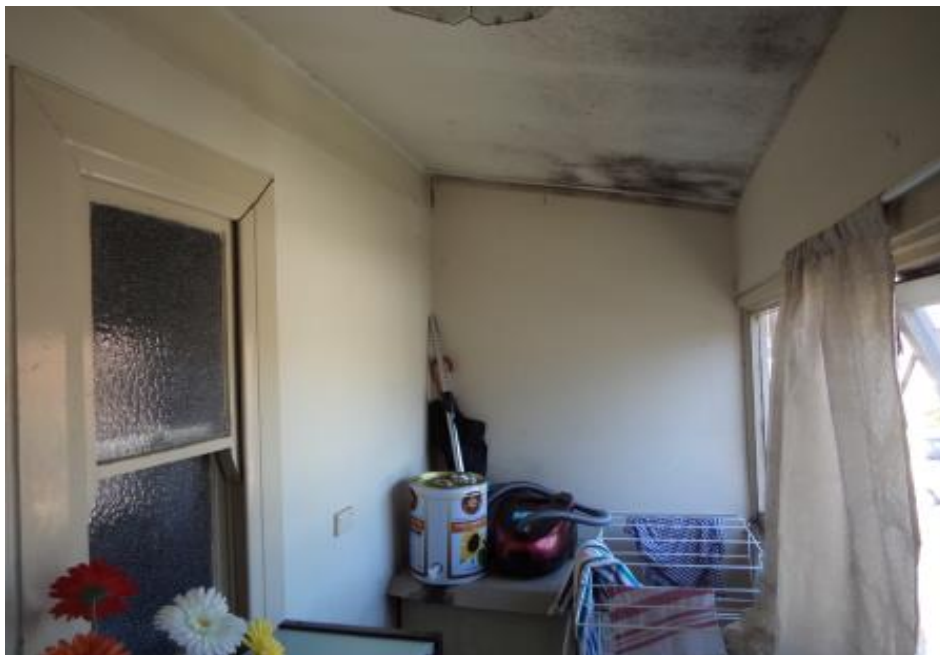
Photo 12 - Unit 2, presumed asbestos cement ceiling and wall linings.

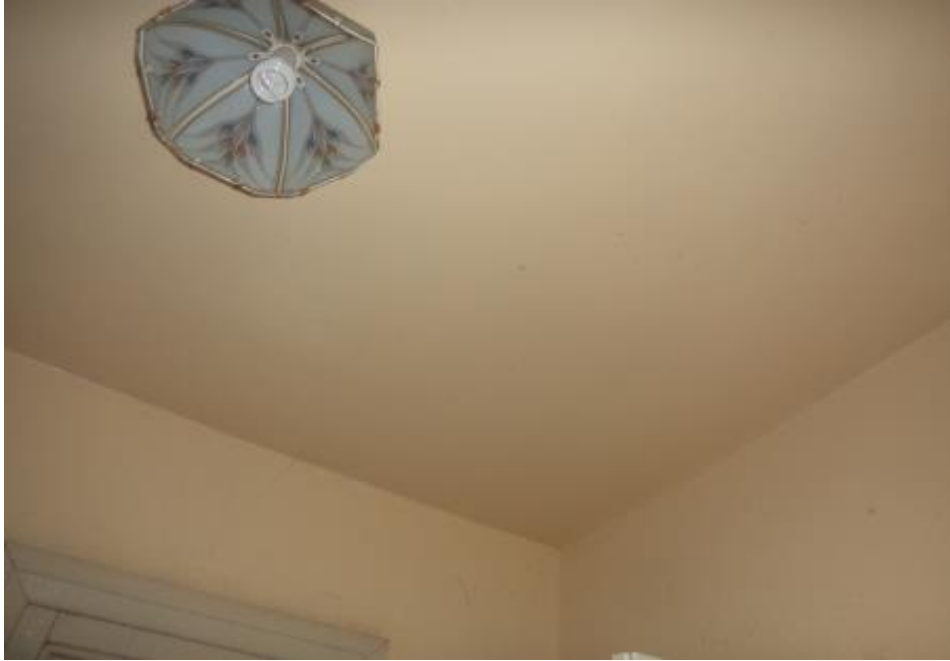
Photo 13 - Unit 2, presumed asbestos cement ceiling and wall linings.

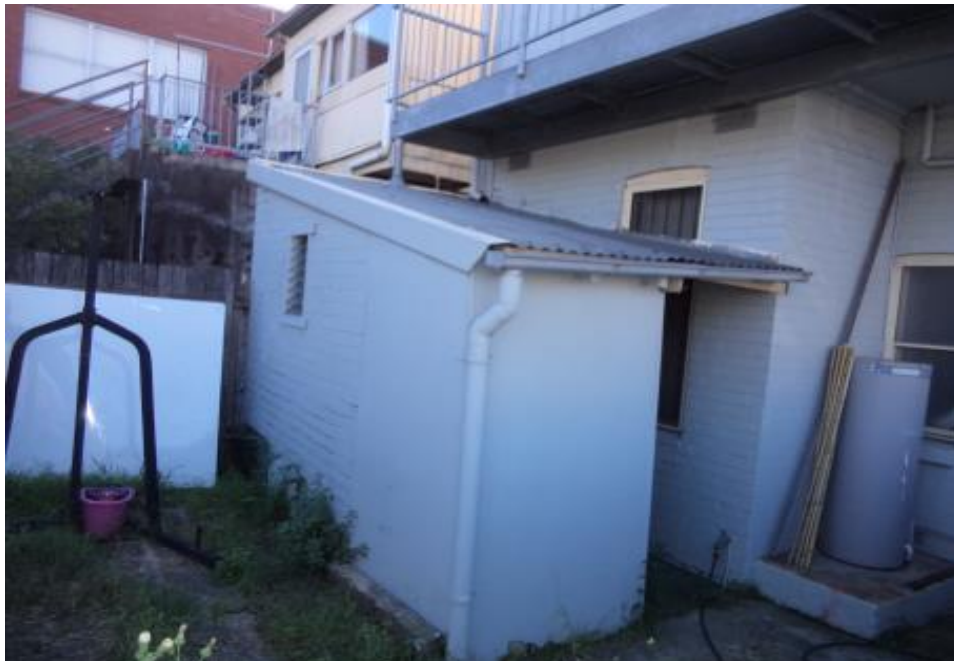
| Location and description | Sample ID | Photo No. | Friability | Condition | Surface Treatment | Likelihood of disturbance | Recommendation |
|---|---|---|---|---|---|---|---|
| 125 Maths not squiggles, ground floor, external, SMF insulation to Rheem HWU. | Visual observation | Ref 14 | No | Good | Yes | Low | Remove prior to major demolition/ refurbishment works. Should the material not be affected by any proposed works, leave and maintain in good condition. |

Photo 14 - 125, External, presumed asbestos cement cladding to utility room.

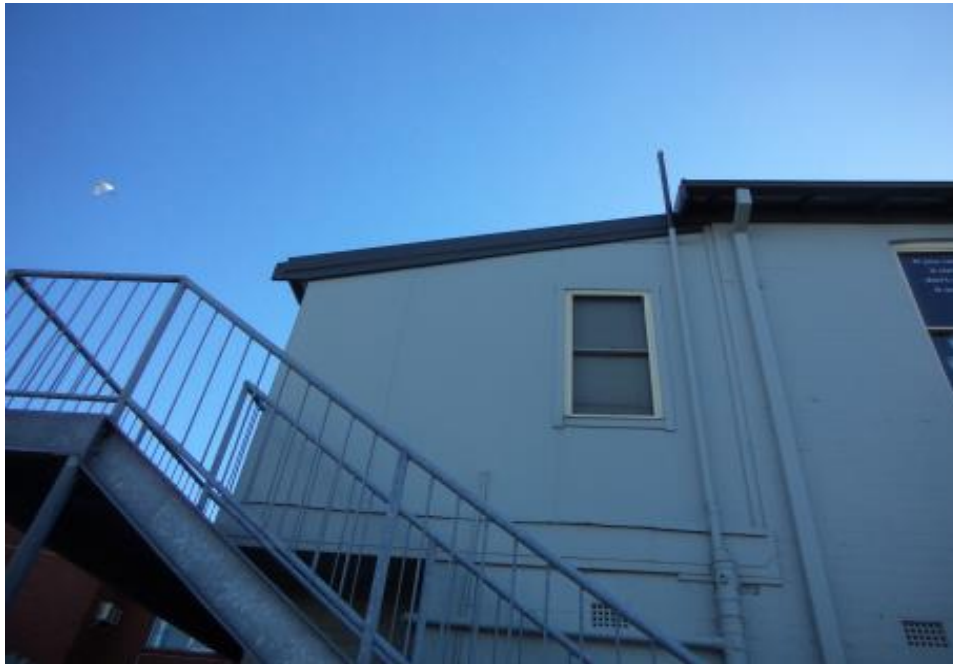
Photo 15 - 125, External, presumed asbestos cement cladding to level 1 rear extension.

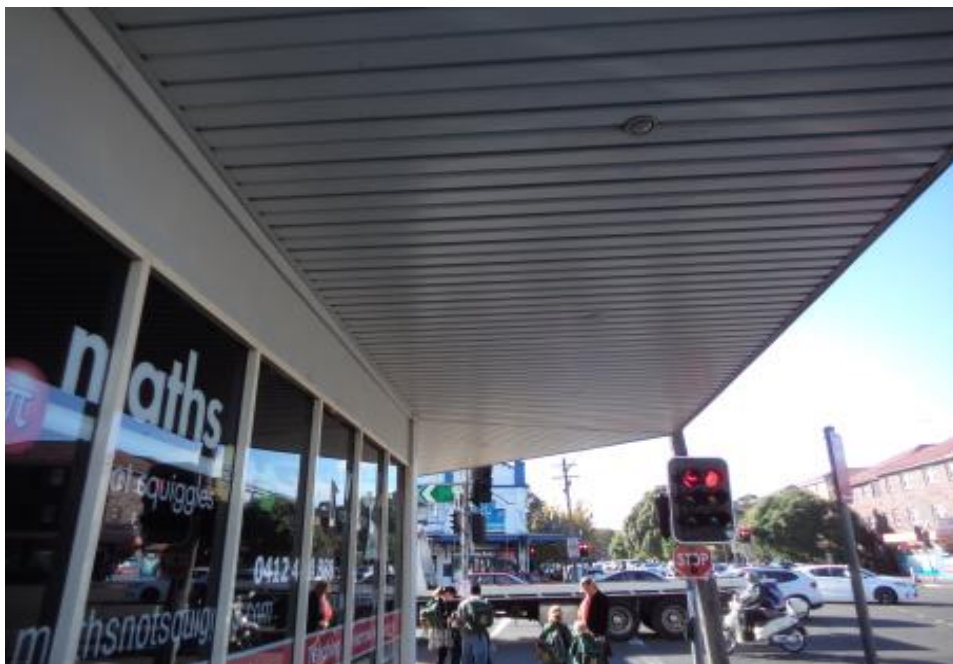
Photo 16 - 125, External, presumed asbestos cement panels over windows.

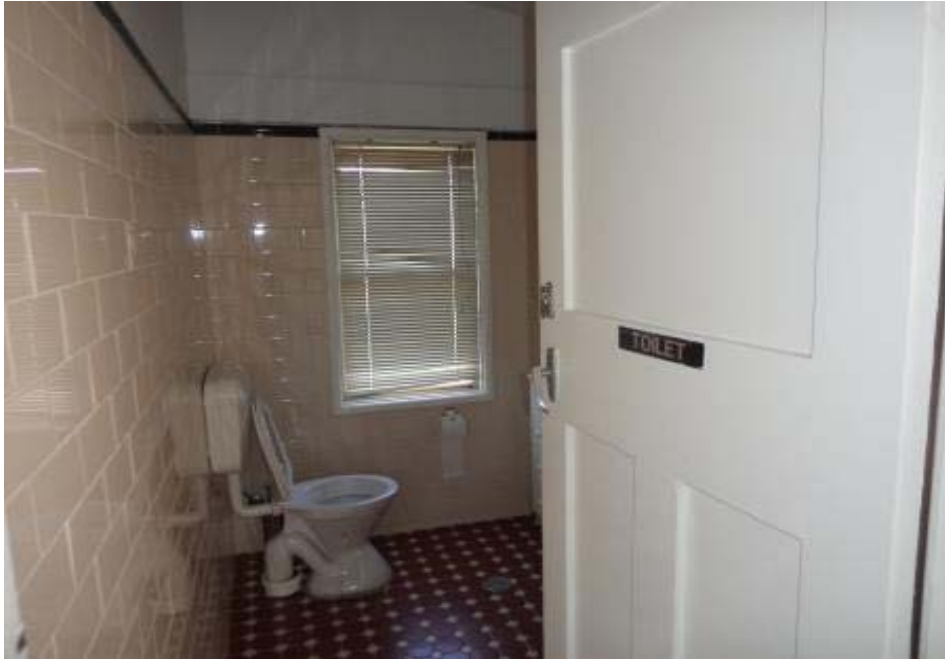
Photo 17 - 125, Internal, Level 1, presumed asbestos cement wall & ceiling linings in bathroom.

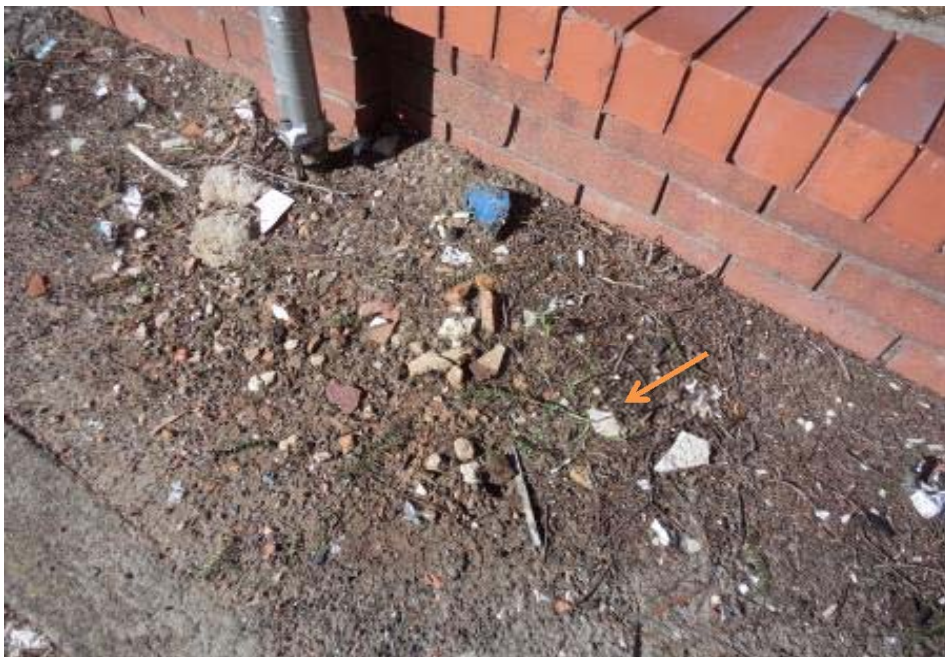
Photo 18 - Externals, Auto-one car park, flower bed, presumed asbestos cement fragments.

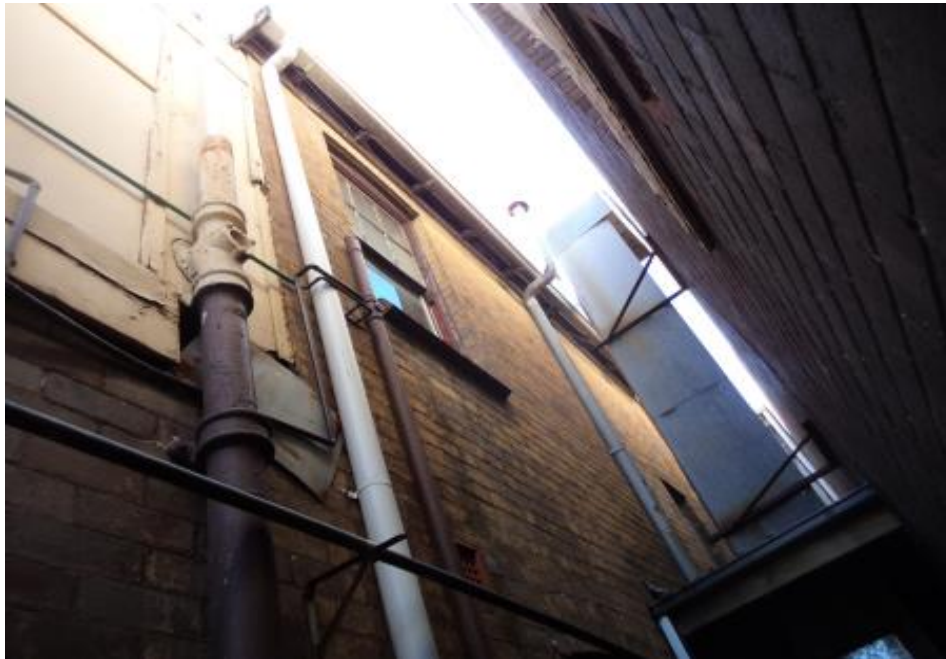
| Location and description | Sample ID | % Lead | Photo No. | Condition | Likelihood of disturbance | Recommendation |
|---|---|---|---|---|---|---|
| 121-123 Launderette, Ground Level, external, suspect flaking paint systems to walls, windows and downpipes (~100m <sup>2</sup> ). | Visual observation | Assume +ve | 19 | Av | Low | Remove prior or during major demolition/ refurbishment works without discharge to the environment. Should the material not be affected by any proposed works, leave and maintain in good condition. |
| 121-123 Units 1 & 2, Level 1, suspect flaking paint systems to cement sheet cladding to rear extension / entrances (~42m <sup>2</sup> ). | Visual observation | Assume +ve | Ref 19 | Av | Low | Remove prior or during major demolition/ refurbishment works without discharge to the environment. Should the material not be affected by any proposed works, leave and maintain in good condition. |

Photo 19 - 121-123, External, flaking paint systems.

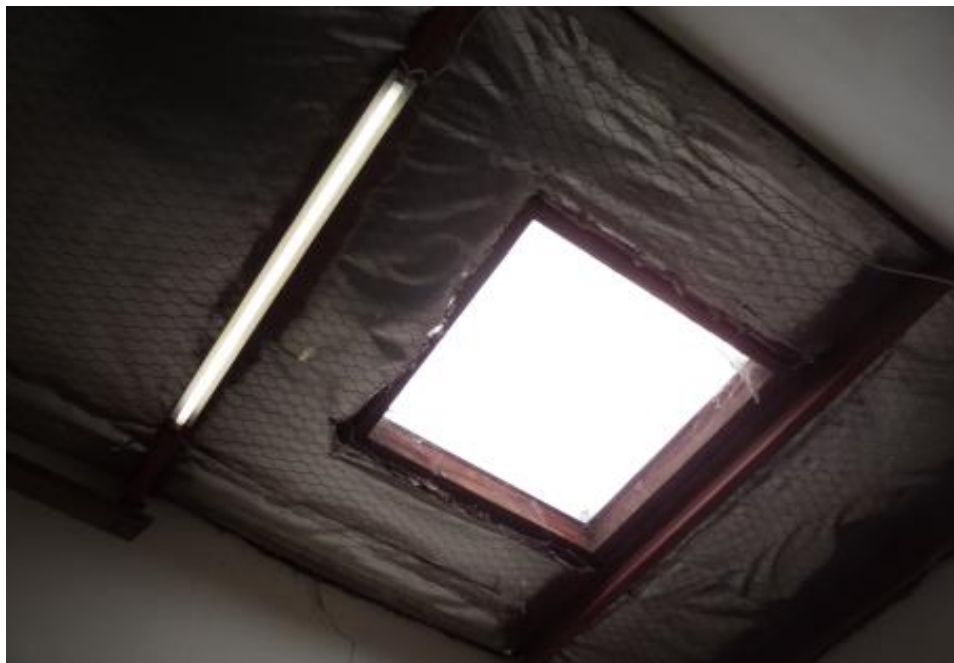
| Location and description | Sample ID | Photo No. | Friability | Condition | Surface Treatment | Likelihood of disturbance | Recommendation |
|---|---|---|---|---|---|---|---|
| 113-115 Snap Fitness Gym, Level 1, presume SMF sarking to roof, (~570m <sup>2</sup> ). | Visual observation | Ref 20 | No | Good | Yes | Low | Remove prior to major demolition/ refurbishment works. Should the material not be affected by any proposed works, leave and maintain in good condition. |
| 117-119 Various tenancies, Level 1, presume SMF sarking to roof, (~600m <sup>2</sup> ). | Visual observation | 20 | No | Good | Yes | Low | Remove prior to major demolition/ refurbishment works. Should the material not be affected by any proposed works, leave and maintain in good condition. |

Photo 20 - 117-119, SMF sarking to roof.
