09 November 2012

STOCKLAND CORRIMAL NSW 2518

Stage 1 Preliminary Site Investigation

Report Number. 127613103-009-R-Rev0

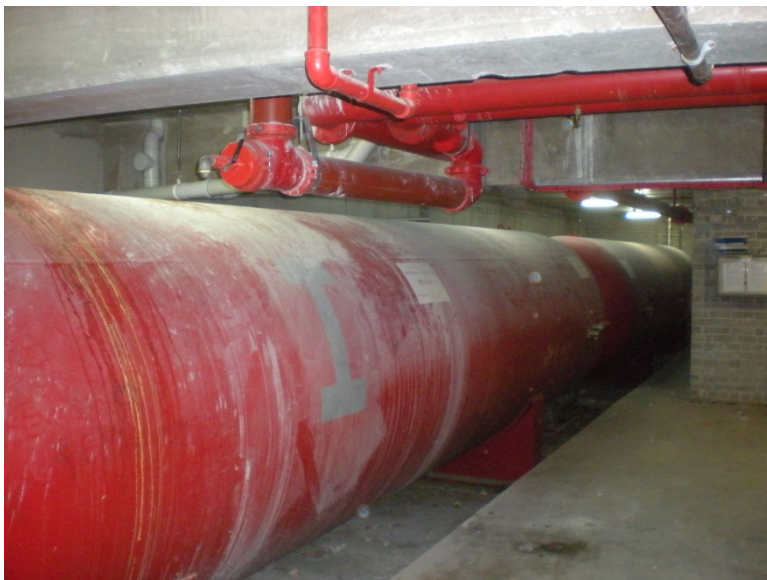
Presence of Above Ground Storage Tanks	<p>Two large above ground pressure vessel tanks were observed in the fire control room. The tanks were historically used to store water for the shopping centre sprinkler system. Signage on the tanks indicates that they were decommissioned in June 2001.</p> <p>As mentioned above the diesel powered generator located in the Woolworths loading and storage area contains a 100 L inbuilt diesel tank.</p>
Presence of Underground Storage Tanks	There are four underground grease traps in the shopping centre. These were reported to be routinely serviced and emptied by Sita Environmental. The location and size of the tanks was not determined during the site visit.
Details of Waste Handling	Solid waste – cardboard, plastics and general refuse are collected by SITA Environmental. Grease traps emptied by SITA Environmental.
Evidence of Burying or Burning of Waste	It is understood that there has not previously been any burning or burying of wastes at the site. No evidence of burying or burning of waste was noted during the site inspection.

Figure 1: Decommissioned fire water ASTs

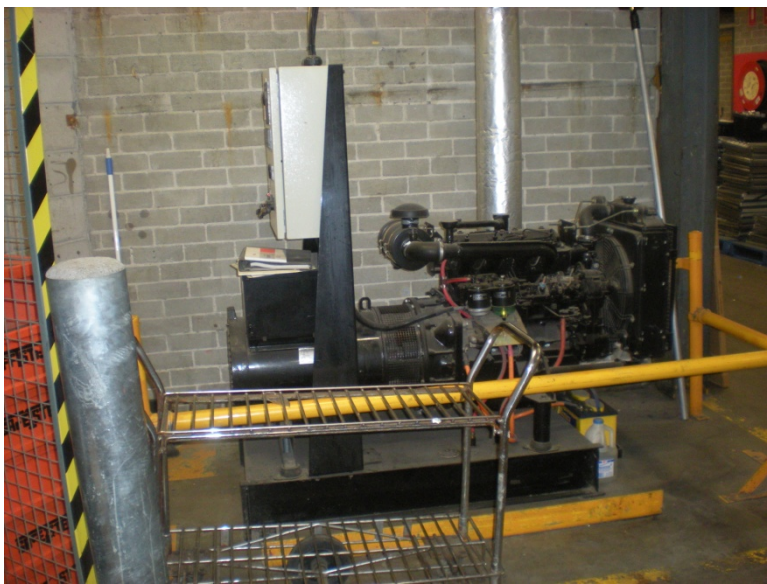
Figure 2: Diesel powered back-up generator in Woolworths loading dock

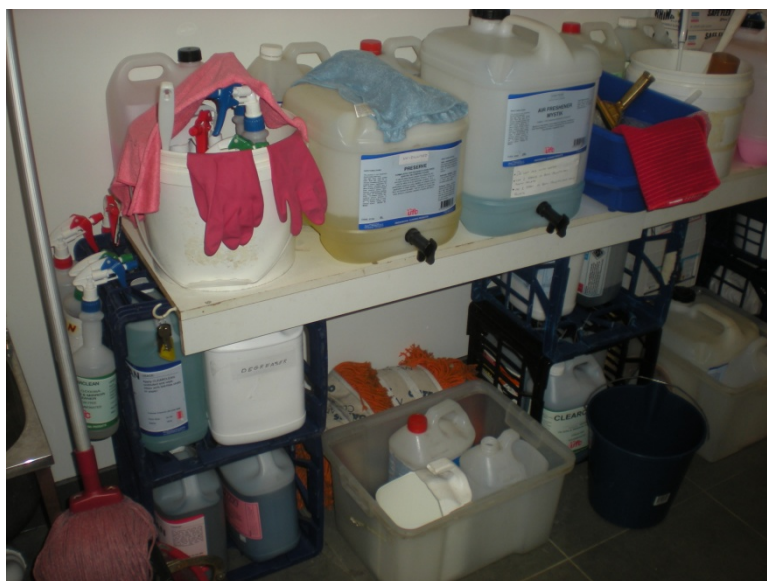
Figure 3: Storage of cleaning chemicals in cleaner's storage cupboard

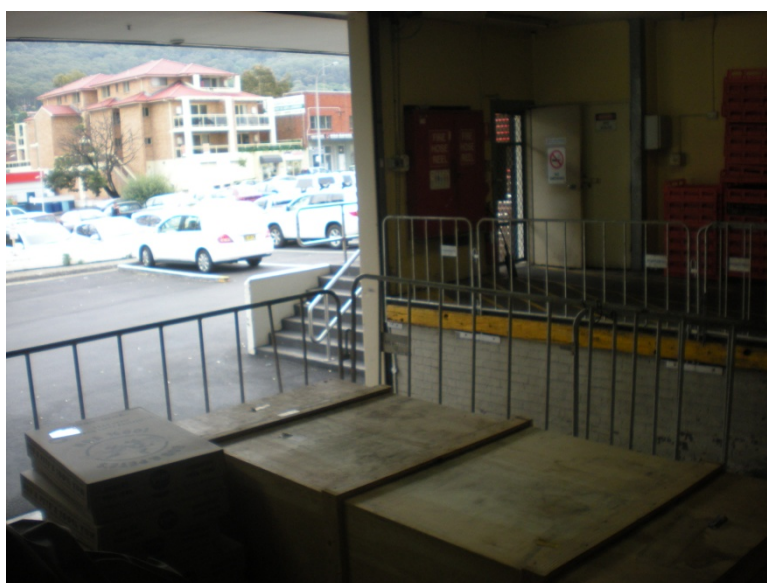
Figure 4: View of main loading dock

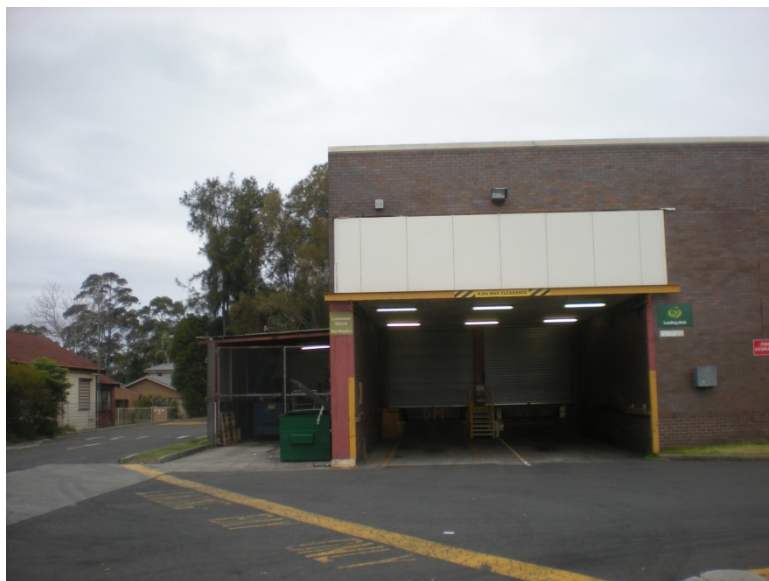
Figure 5: View of Woolworths loading dock

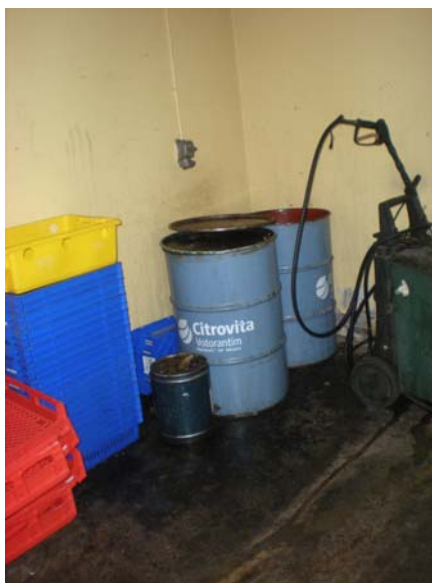
Evidence of Contamination	<p>Oil staining was observed on concrete hard standing associated with the main shopping centre loading dock. The source of the staining was observed to be a 20 L oil storage drum not stored within a bunded area. The stained concrete surface was the elevated part of the loading dock situated approximately 2m above ground level. It was not confirmed, but likely that the oil is used for the hydraulics in a cardboard compactor.</p> <p>Two 205 L drums were observed to be staged next to the 20 L oil drum. It is</p>

Item	Details
	<p>understood that the drums are used to contain used cooking oil and the contents are removed routinely by SITA. The drums were not within a bunded area.</p> <p>There was no other apparent visual or olfactory evidence of potential soil and groundwater contamination noted during the site inspection or mentioned by the site representative.</p>
Topography and Surface Water Drainage	<p>As detailed above there is an apparent step change in topography from north to south.</p> <p>Stormwater is captured by a drainage system which connects into the local council stormwater network.</p>
Potential Asbestos Containing Materials	<p>The interviewee indicated that a building materials inspection has been undertaken. This report was not available for review. It was mentioned that the report indicated the presence of asbestos containing materials in the ceiling of the main shopping centre loading dock and a number of backing boards for switch gear. Information on the condition of these materials was not provided or discussed.</p>

Figure 5: Storage of used cooking oil and 20L drum of Caltex Meropa synthetic oil. Staining on concrete hardstand at main loading dock.

Item	Details
	<p>(loading platform) area. Surface staining was observed around the drum. The storage area was not bunded. In order to limit the potential for migration of oil should there be any future releases it is suggested that the oil is stored in an area that has some form of secondary containment.</p> <p>Used cooking oil is currently stored in a drum on site prior to removal. In order to prevent spillages a suggested improvement is the replacement of the drum with a purpose built above ground storage tank that has secondary containment.</p>
Sources (Potential Areas of Concern)	<p>Based on the findings of the desktop study and site inspection, the following Potential Areas of Concern were identified:</p> <ul style="list-style-type: none"> ■ Oil staining associated with low volume storage of Caltex Meropa Synthetic oil. ■ Diesel powered back-up generator at Woolworths. ■ Unknown condition of transformers located within site boundary.

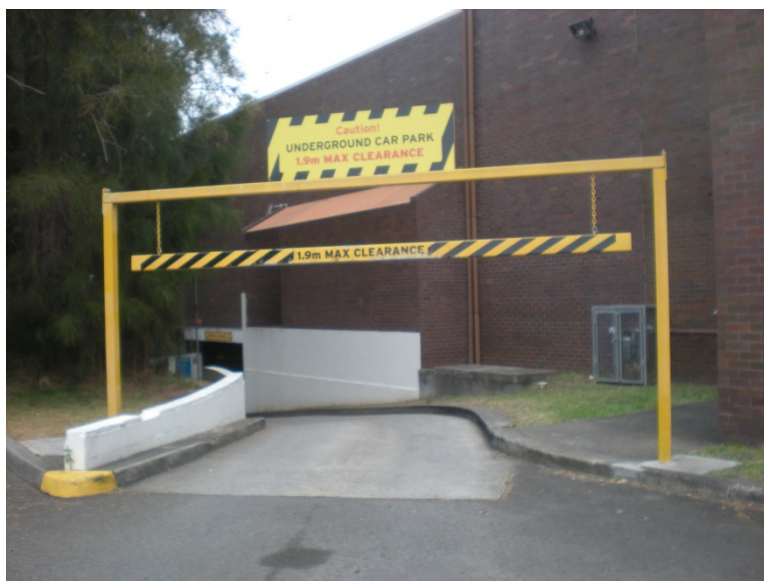
Figure 6: View looking towards driveway to underground (covered) parking.
