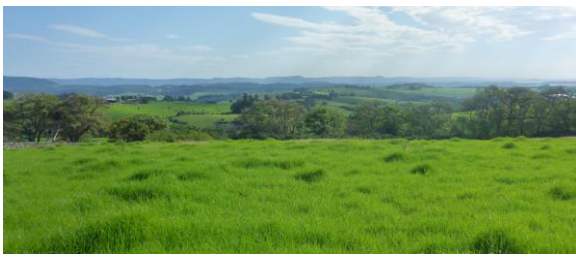
Figure 1-1 View from the south west corner of the site looking north

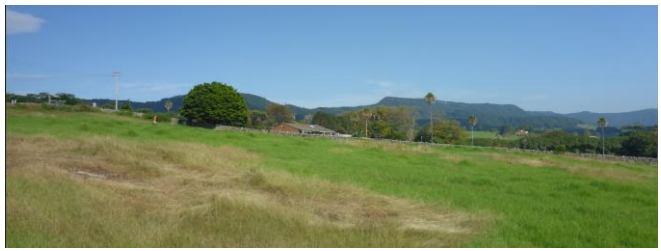
Figure 1-2 South west corner of site looking south west

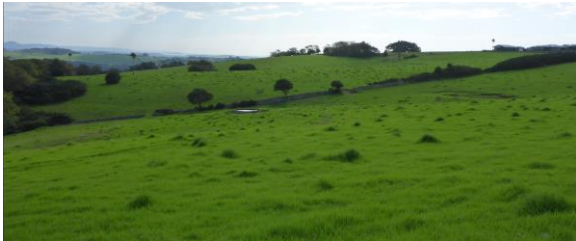
Figure 1-3 View from the south west corner of the site looking north

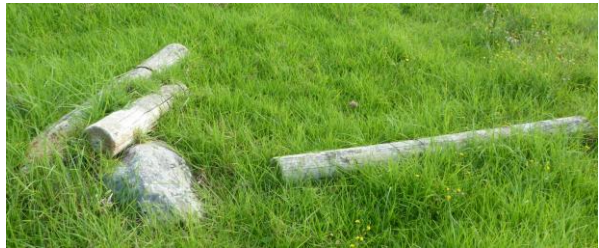
Figure 1-4 Treated pine fencing posts on site

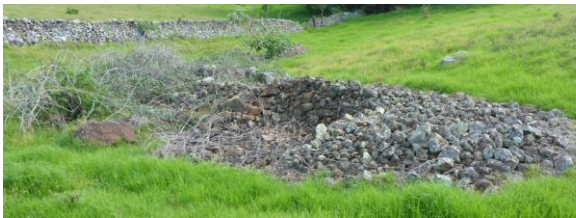
Figure 1-5 Rock stockpile

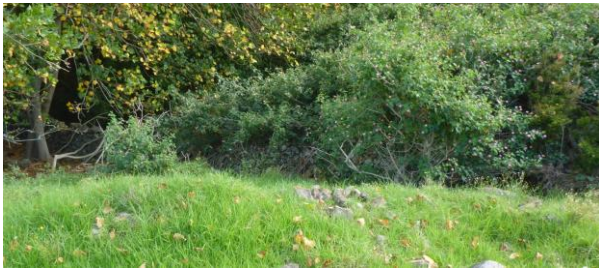
Figure 1-6 Dense vegetation and weeds

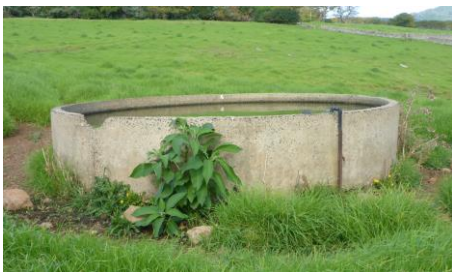
Figure 1-7 Stock watering facility

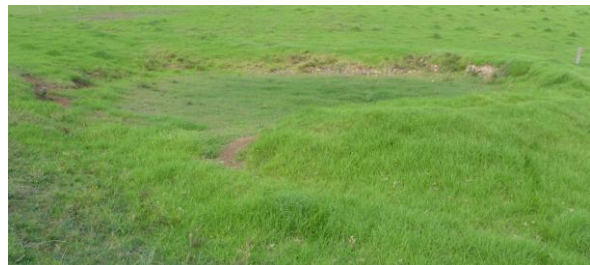
Figure 1-8 Small earth dam southern portion of the site

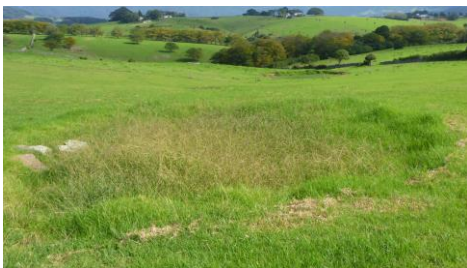
Figure 1-9 Earth dams southern portion of site

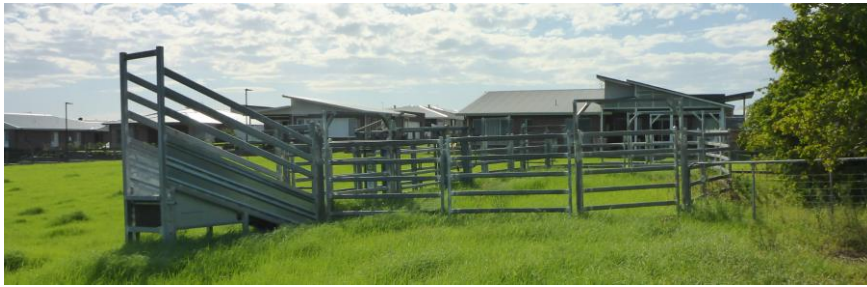
Figure 1-10 Stock loading facility on site

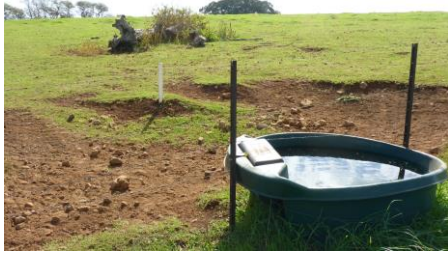
Figure 1-11 Stock watering facility

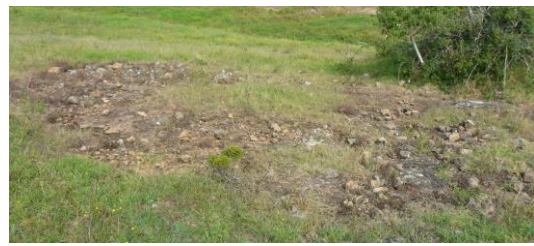
Figure 1-12 Exposed natural rock outcrop near centre of site

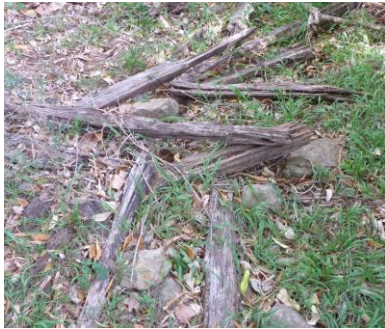
Figure 1-13 Fence posts on site

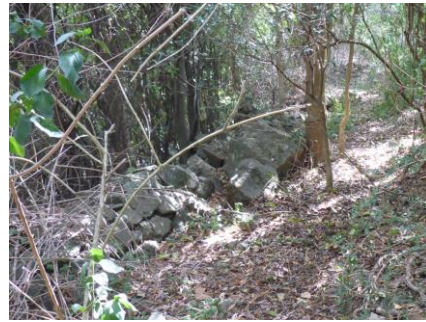
Figure 1-14 Piles of local rock on site

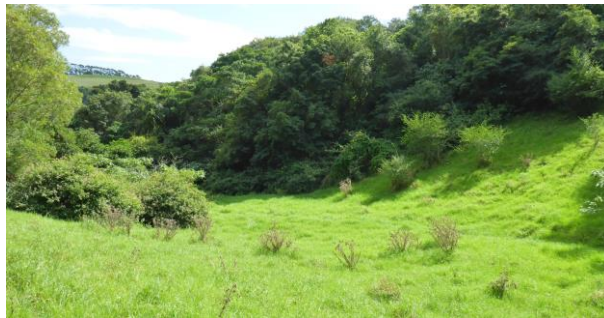
Figure 1-15 Drainage channel northern portion of site

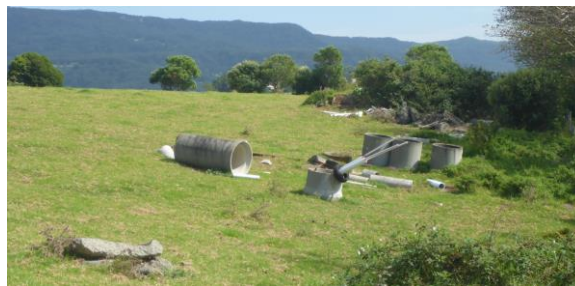
Figure 1-16 Building materials near centre of site
