Client Backsaddle Pty Ltd			
		Project Backsaddle Geotechnical Site Walkaround			
		Title Photo 1-2		Project No: 8201806901	Size A4

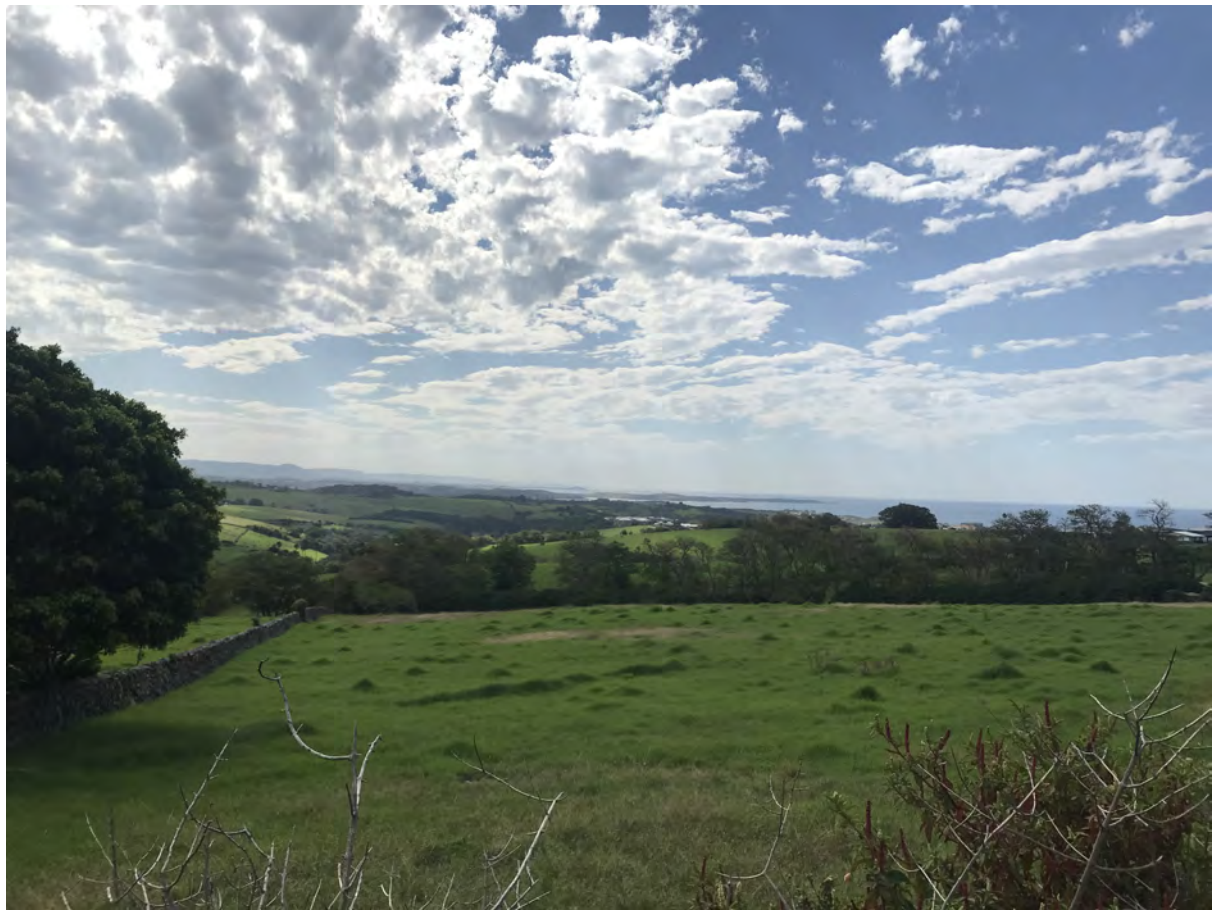
Photo 1 - South of site looking north

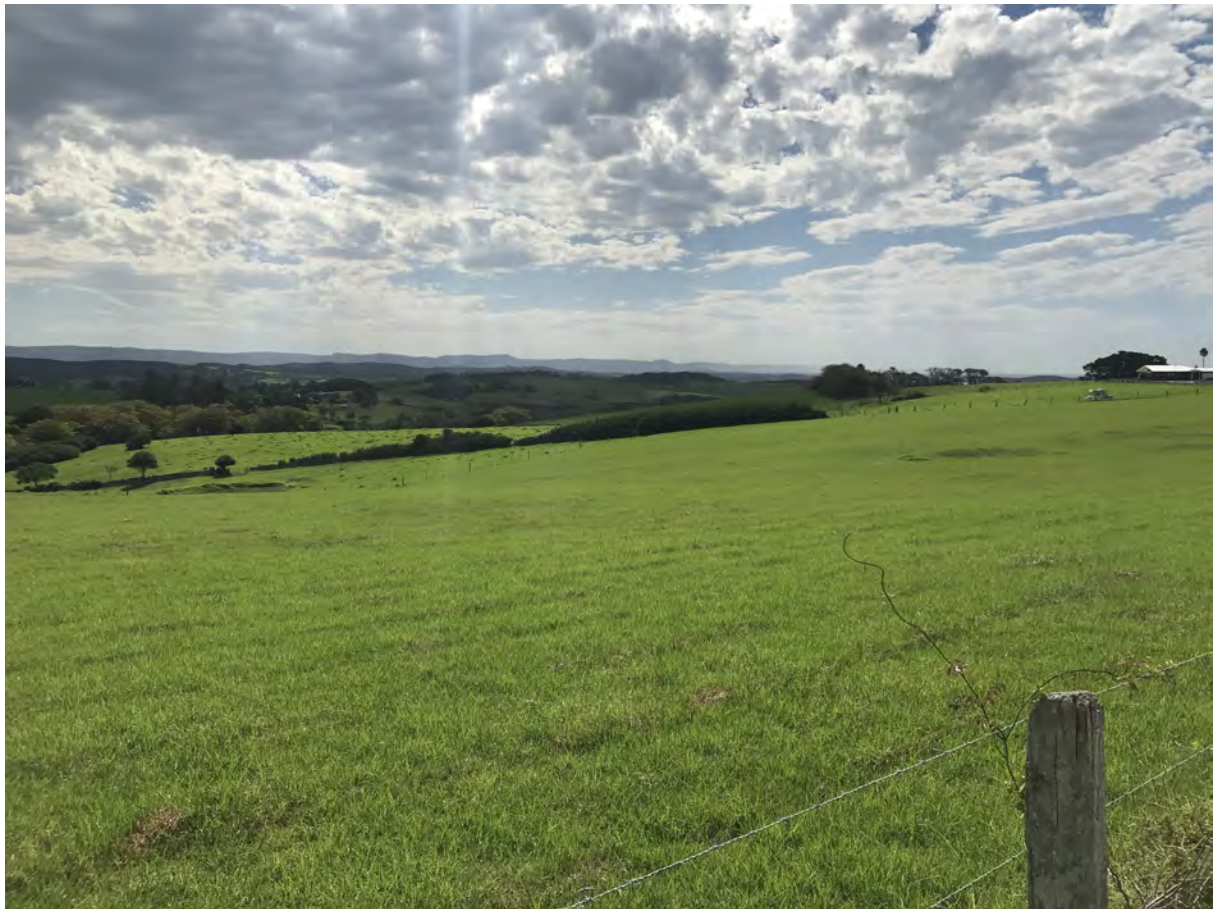
Photo 2 - Grass plateau looking north west

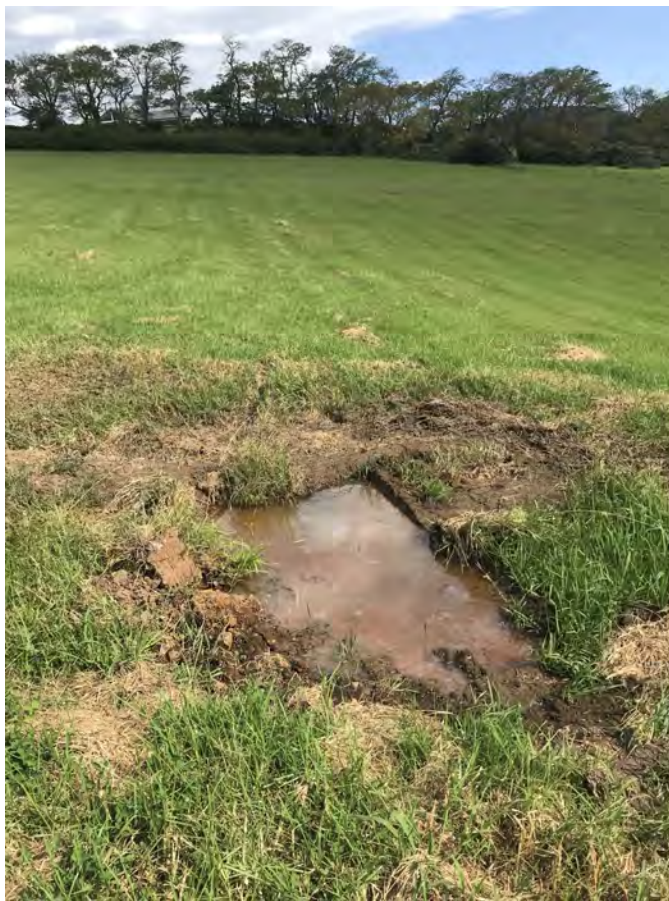
Photo 3- Burst pipe in southern portion of site

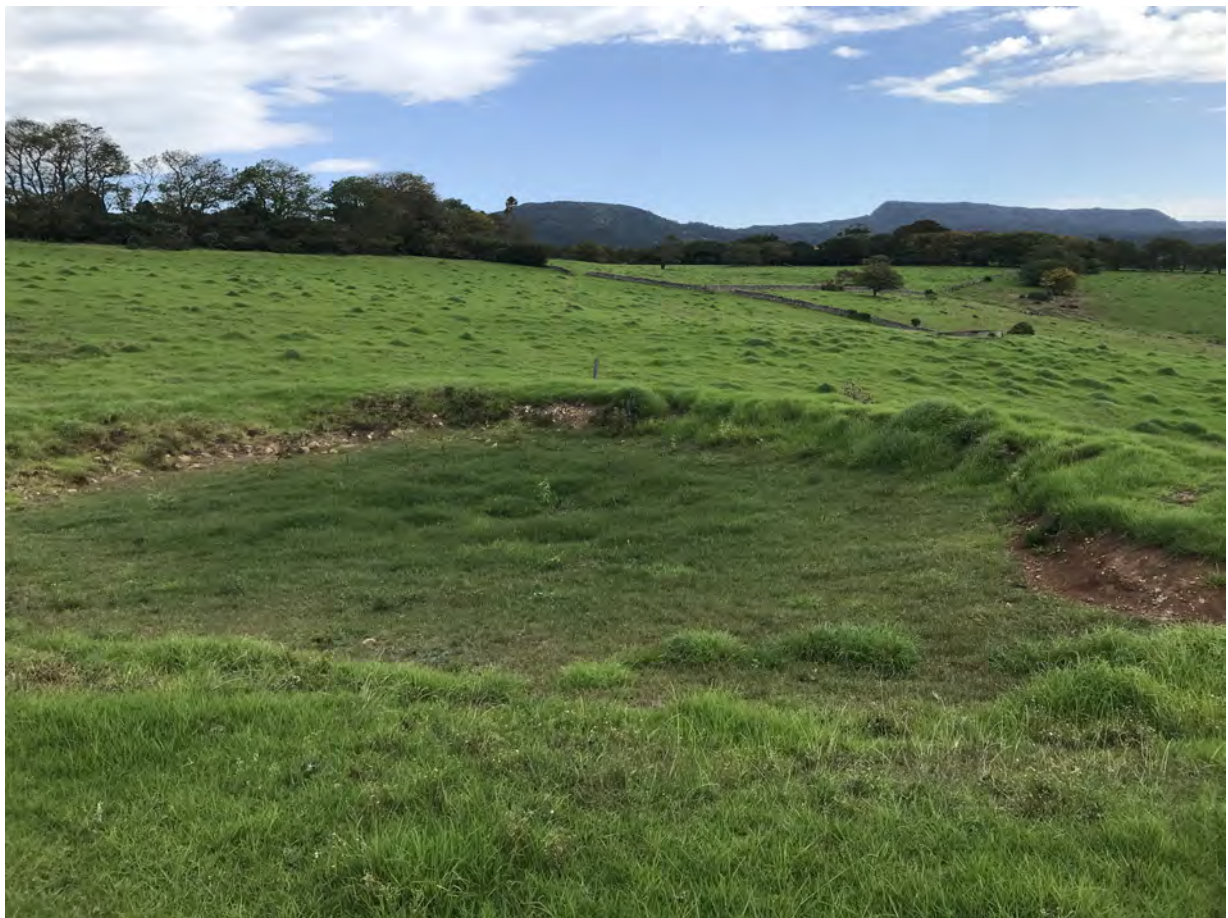
Photo 4 - Earth dam in southern portion of site

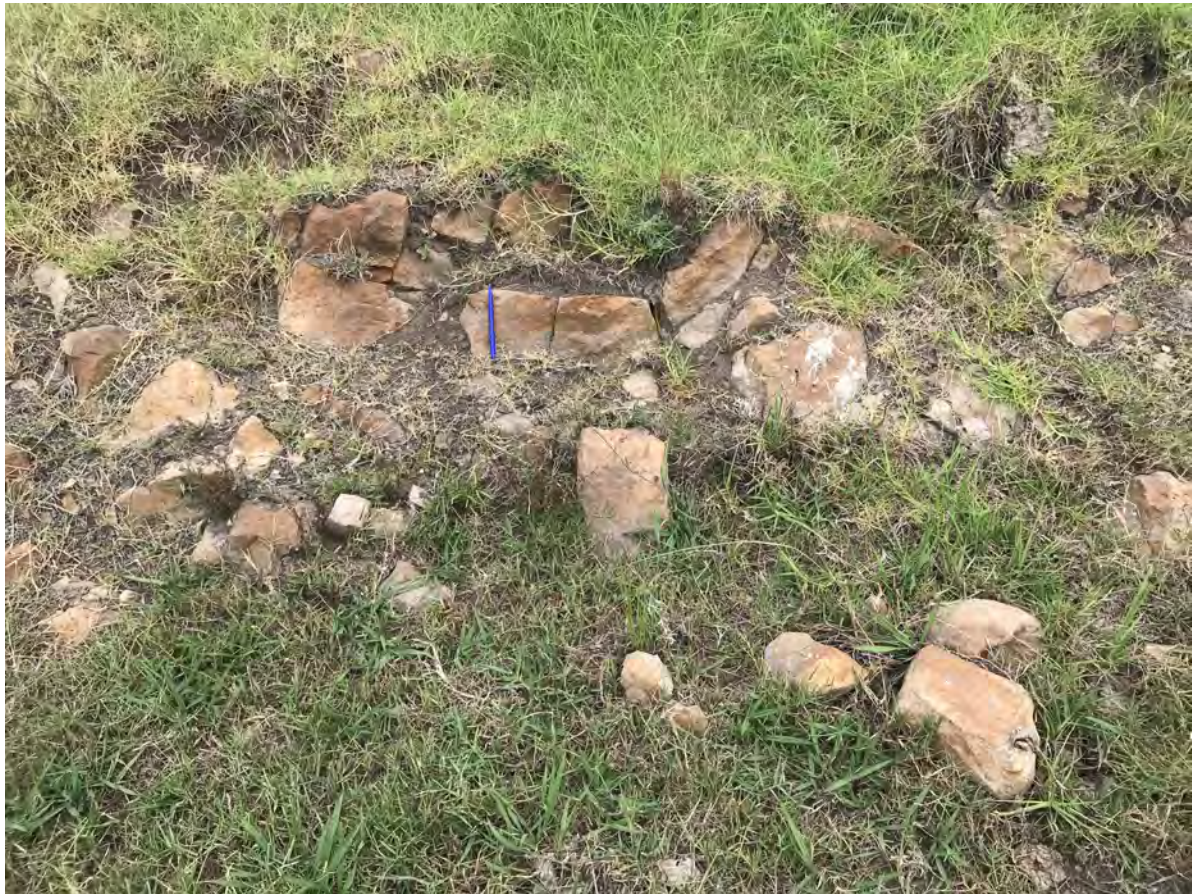
Photo 5 - Latite/residual soil exposed in dam wall

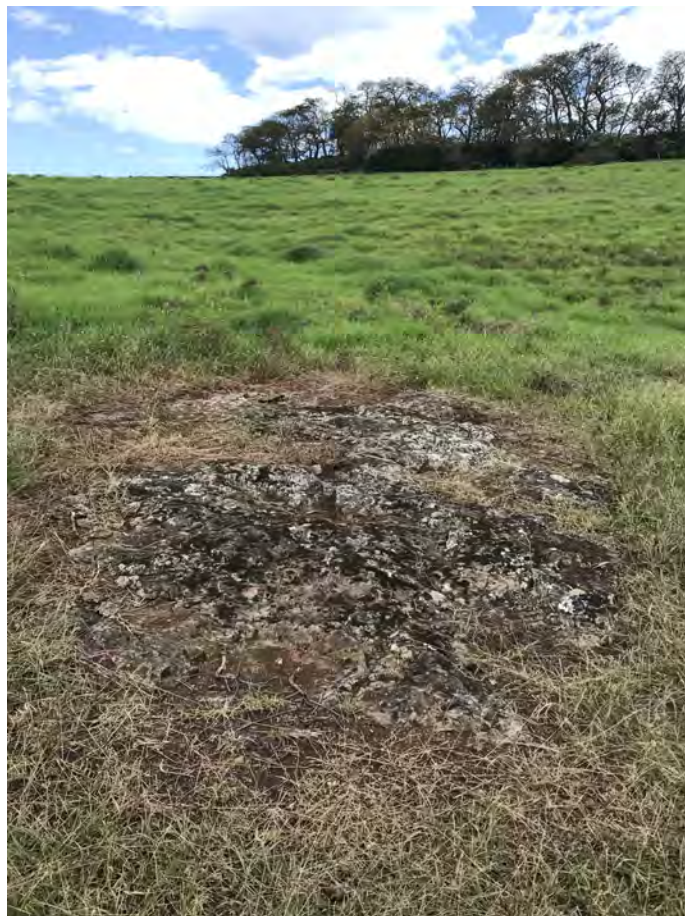
Photo 6 - Latite outcrop

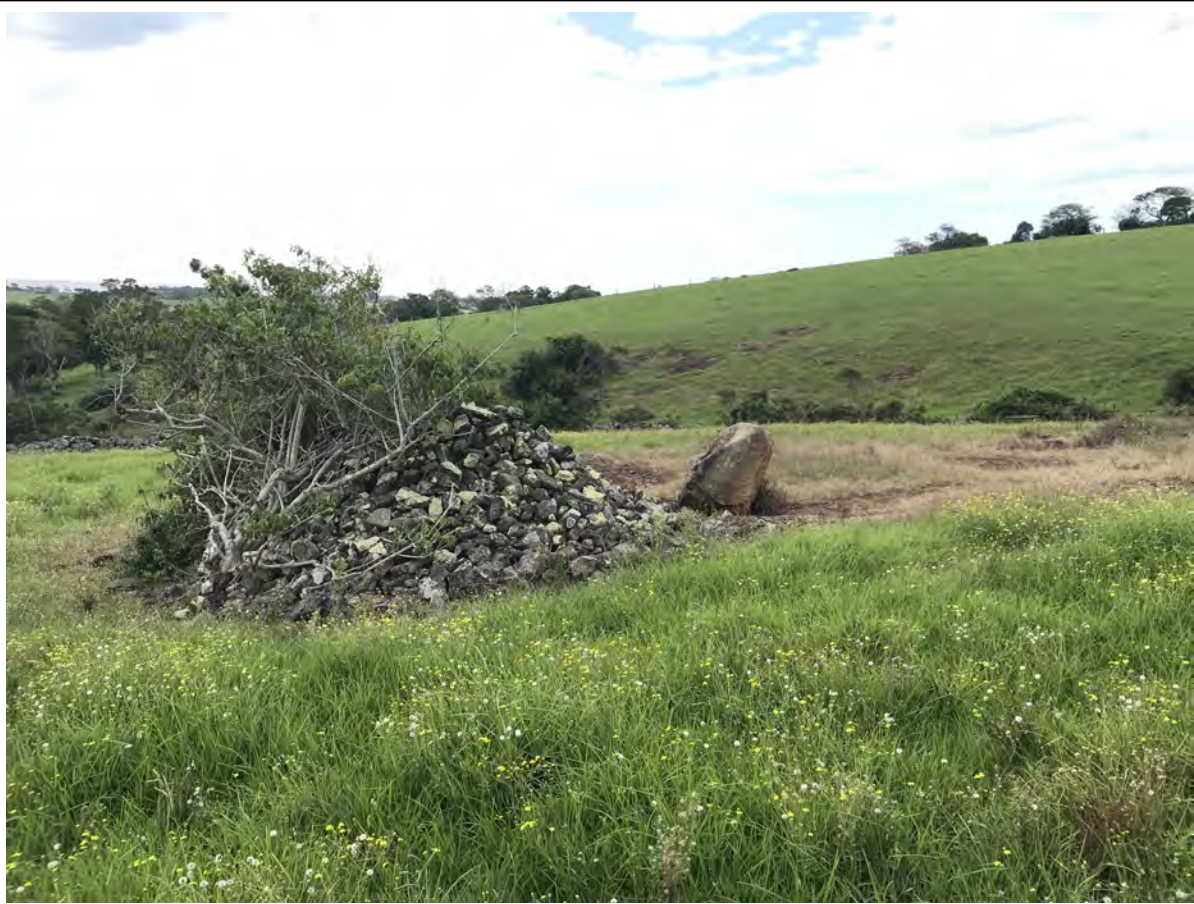
Photo 7 - Rock fill pile

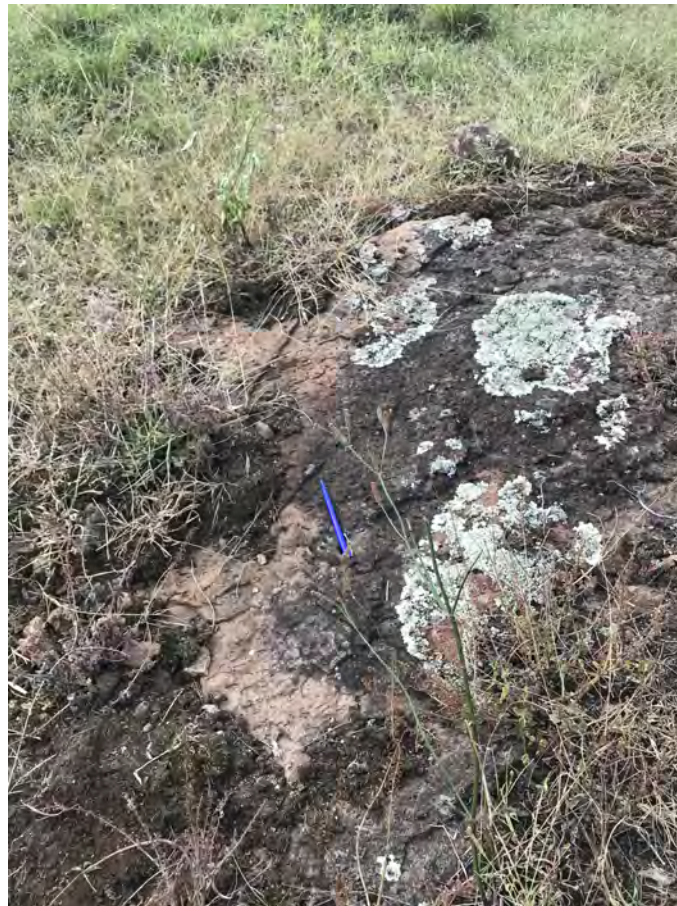
Photo 8 - Latite outcrop

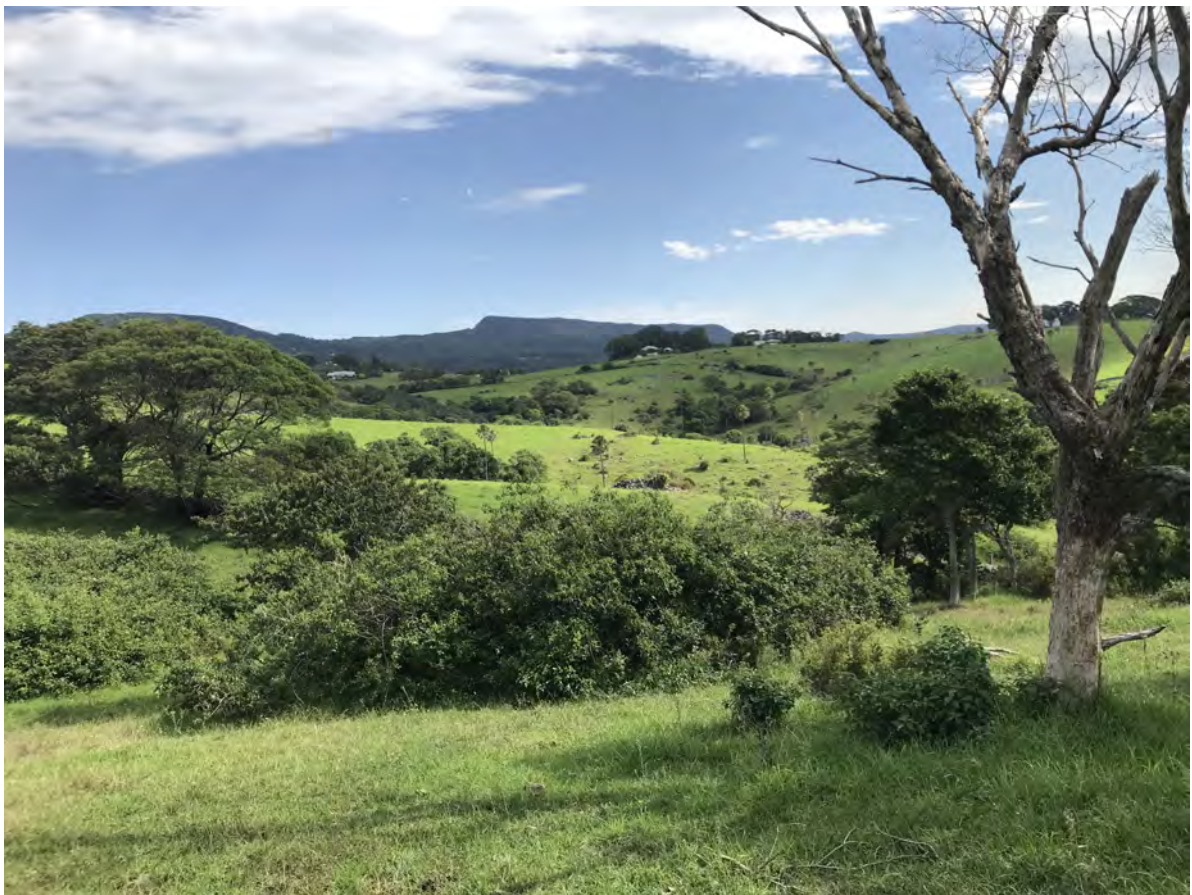
Photo 9 - Western boundary of site looking out to Spring Creek Catchment

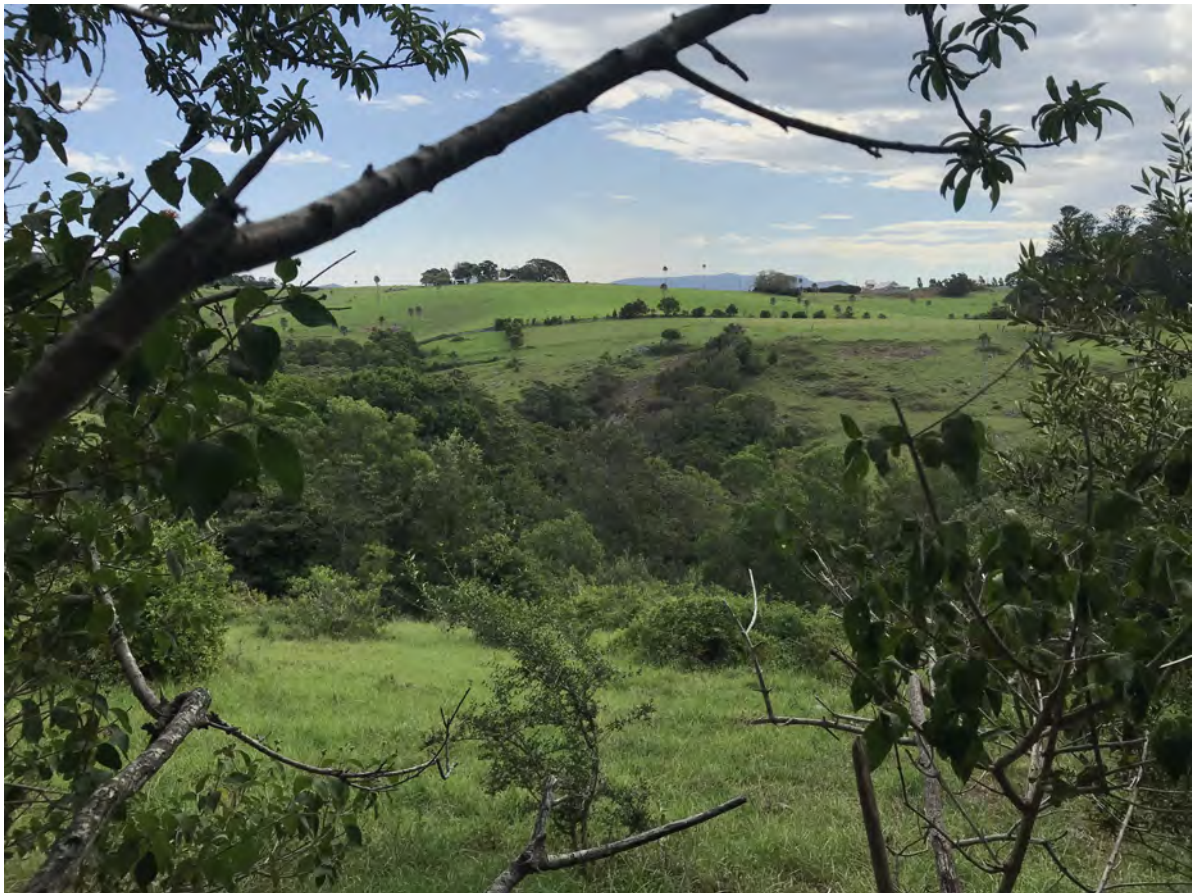
Photo 10 - Western boundary of site looking out to Spring Creek Catchment

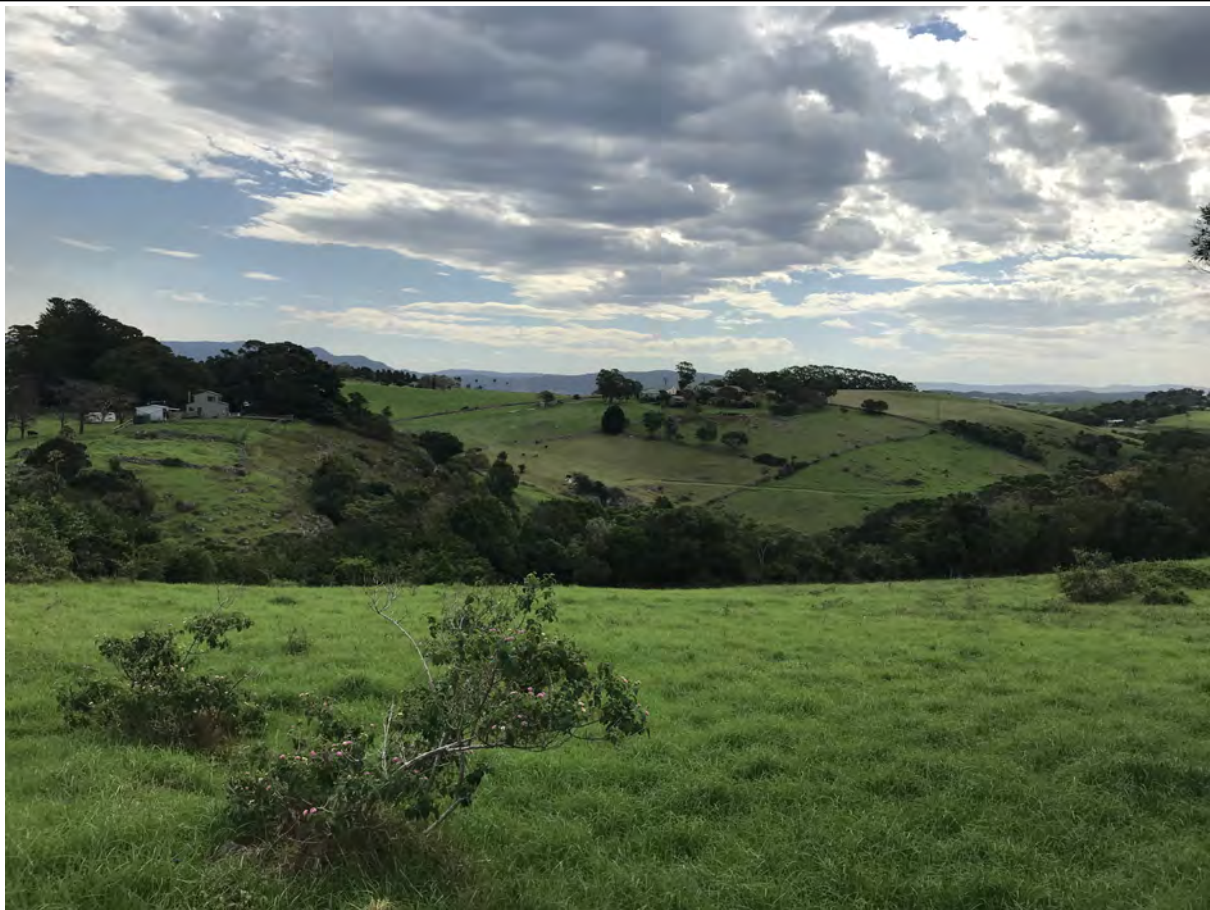
Photo 11 - Looking west to Spring Creek Catchment

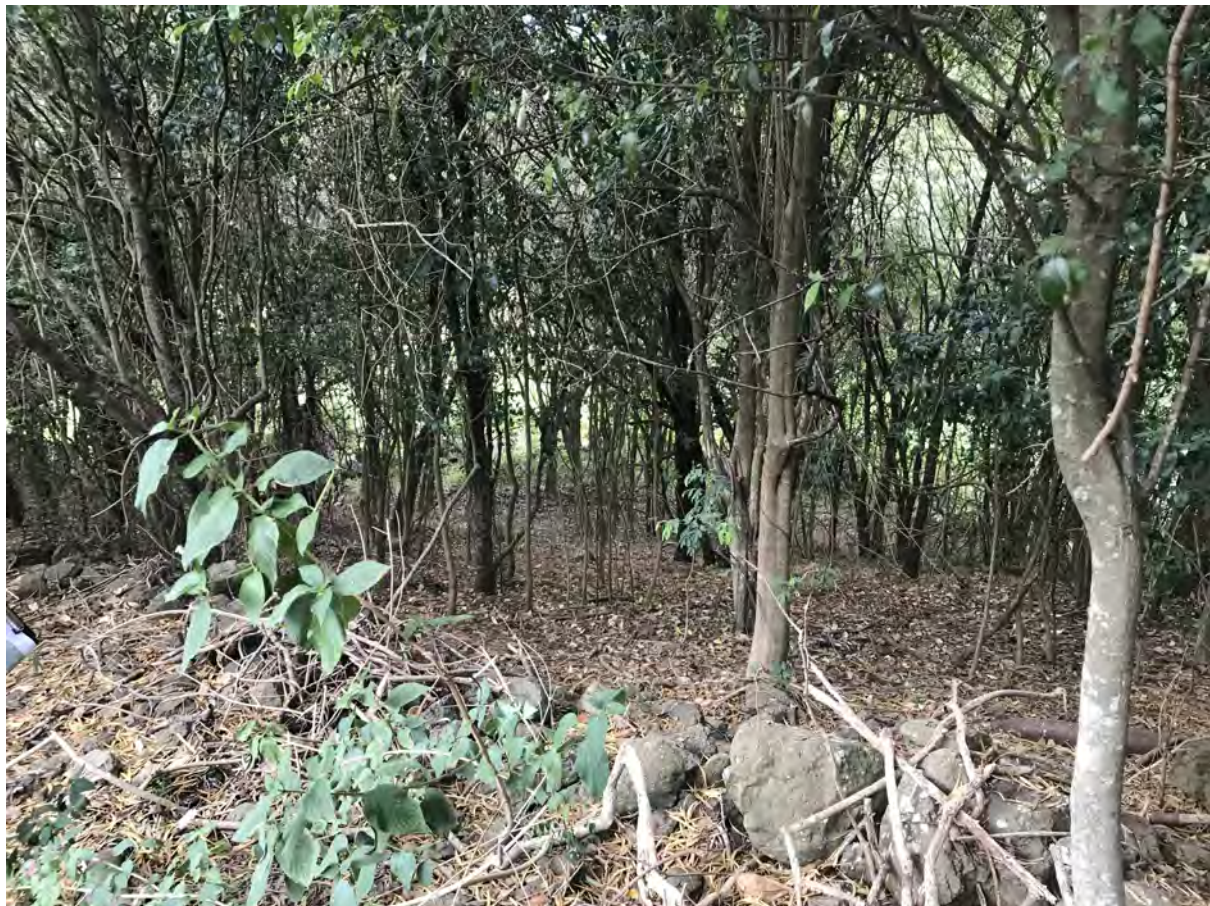
Photo 12 - North dipping vegetated slope in northern portion of site

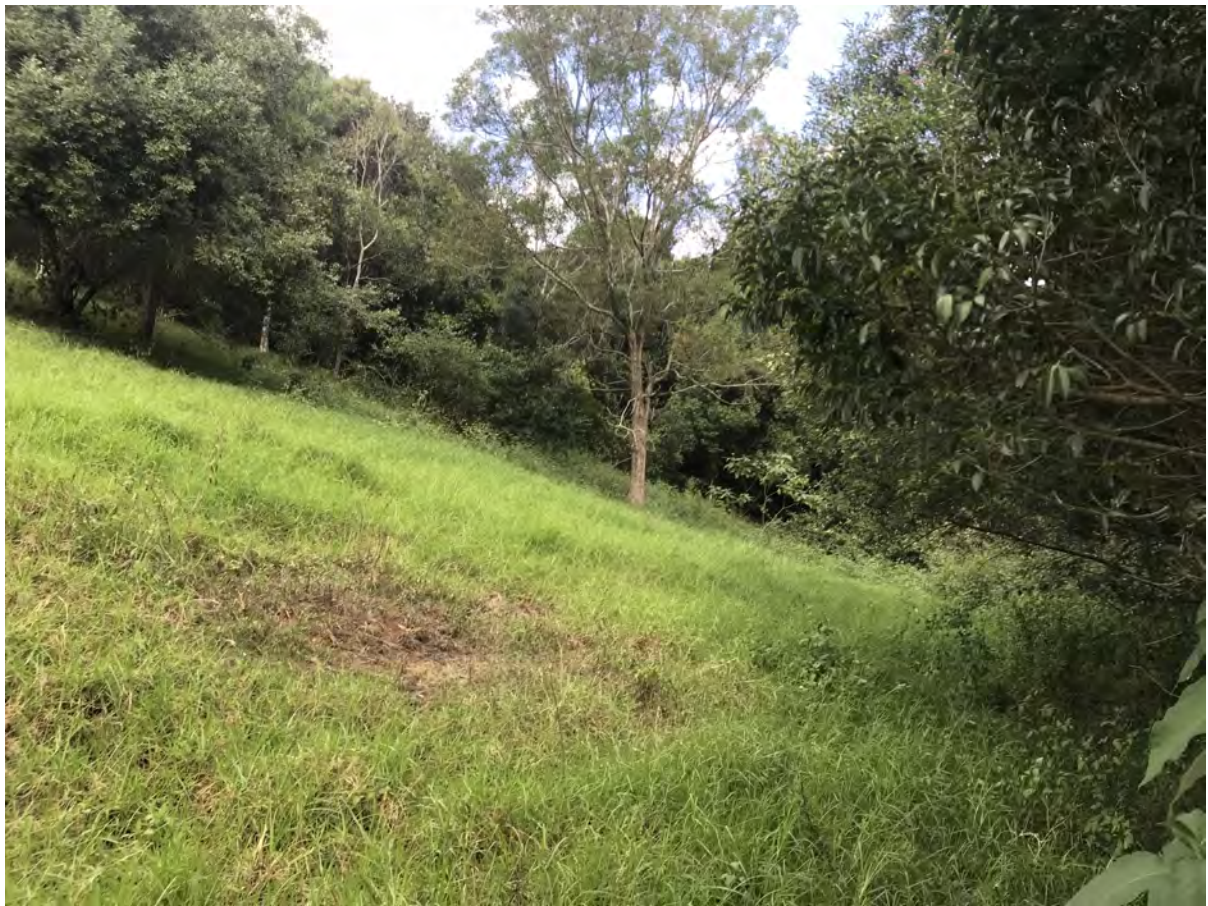
Photo 13 - steeper south west dipping slope in northern portion of site taken looking south east

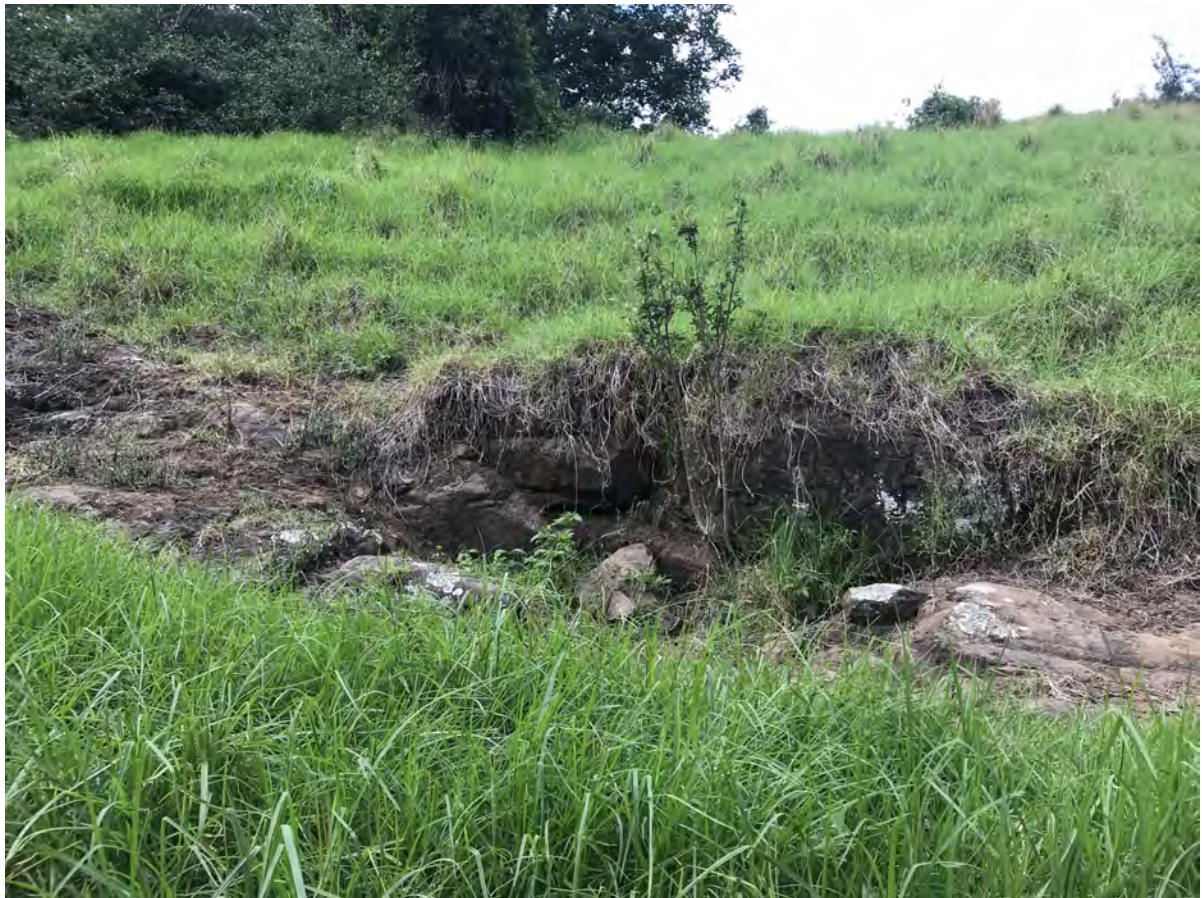
Photo 14 - Latite outcrop in northern creek

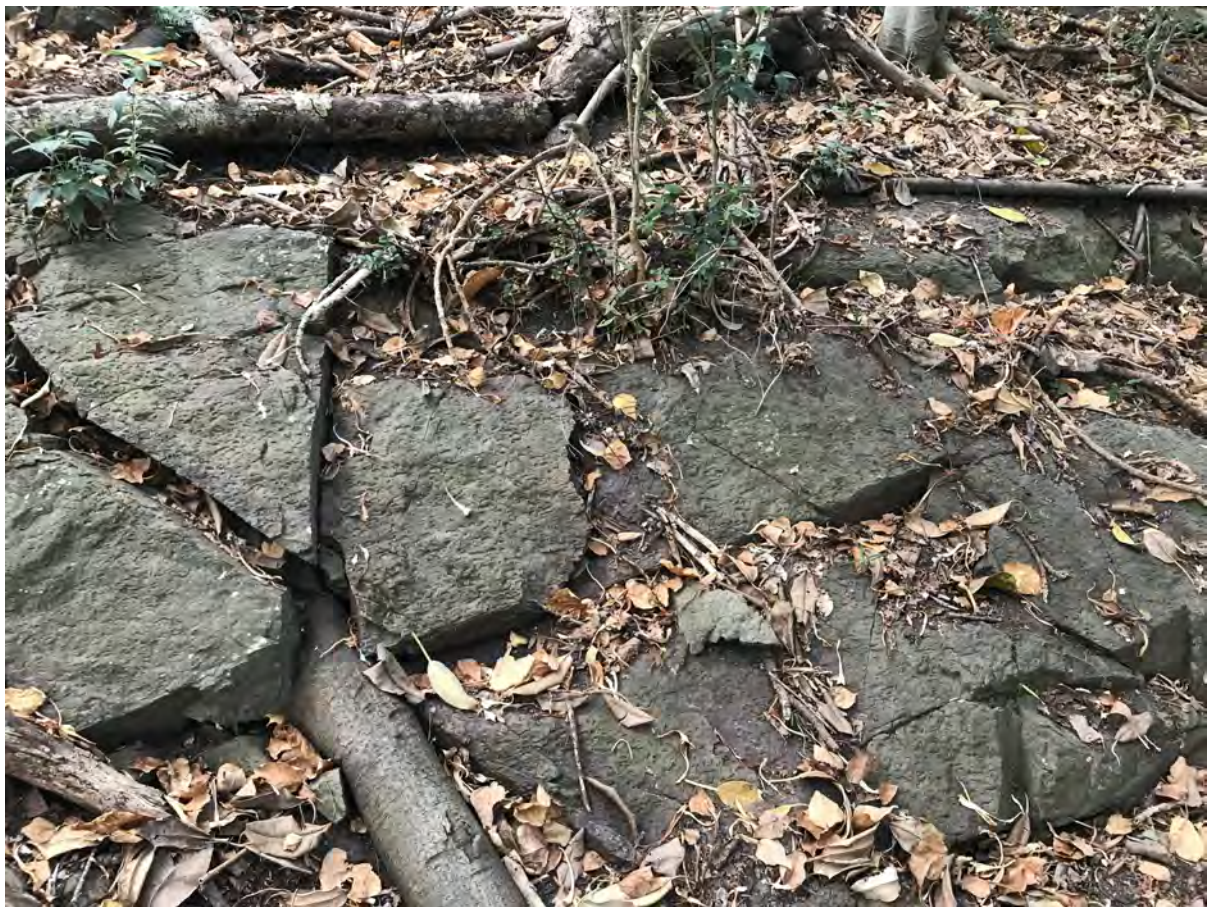
Photo 15 - Latite outcrop in creek

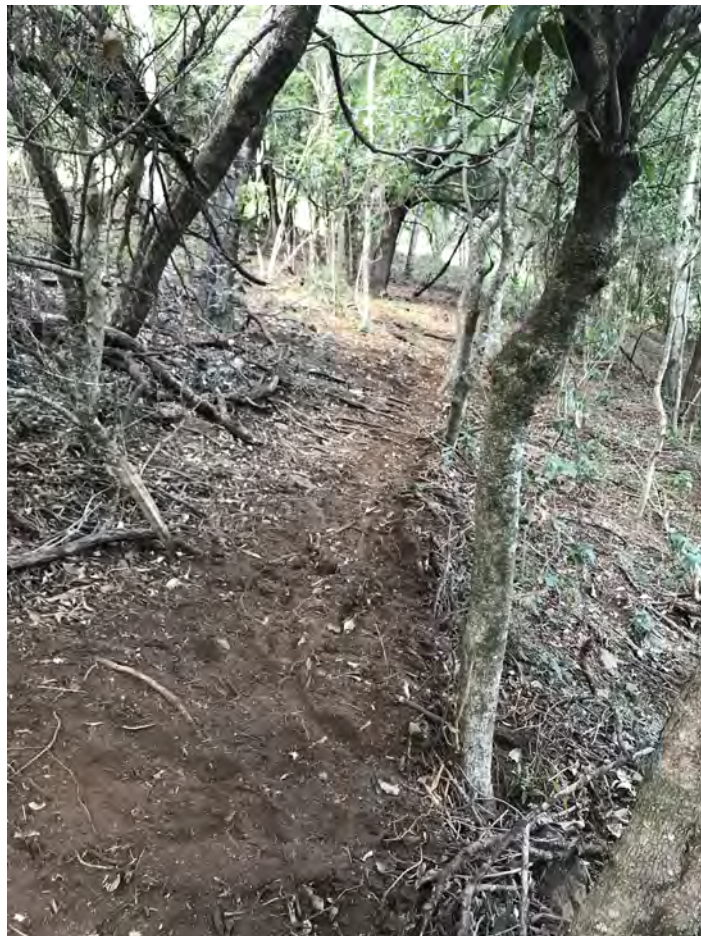
Photo 16 - Animal trails along northern bank of creek

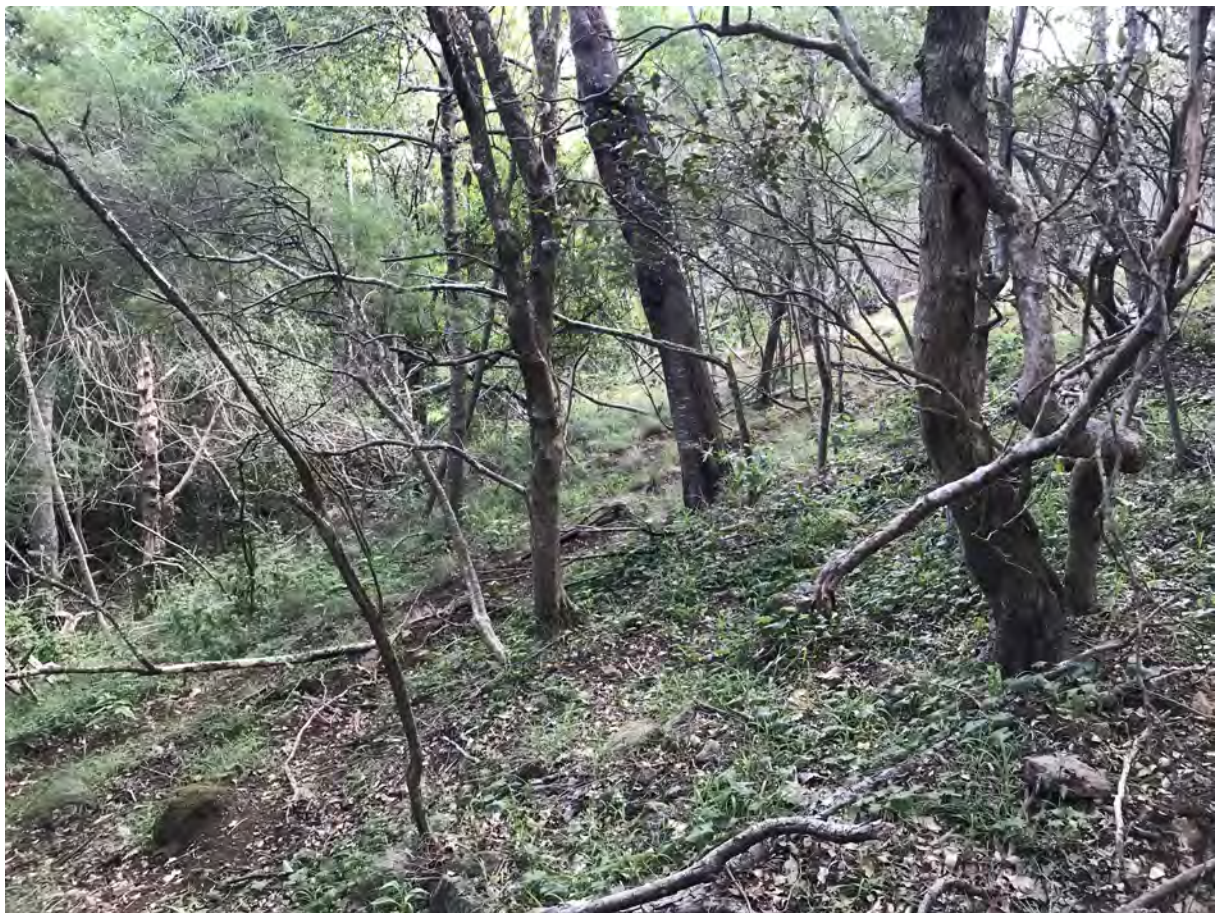
Photo 17 - steep vegetated creek side in northern portion of site showing some indication of soil creep

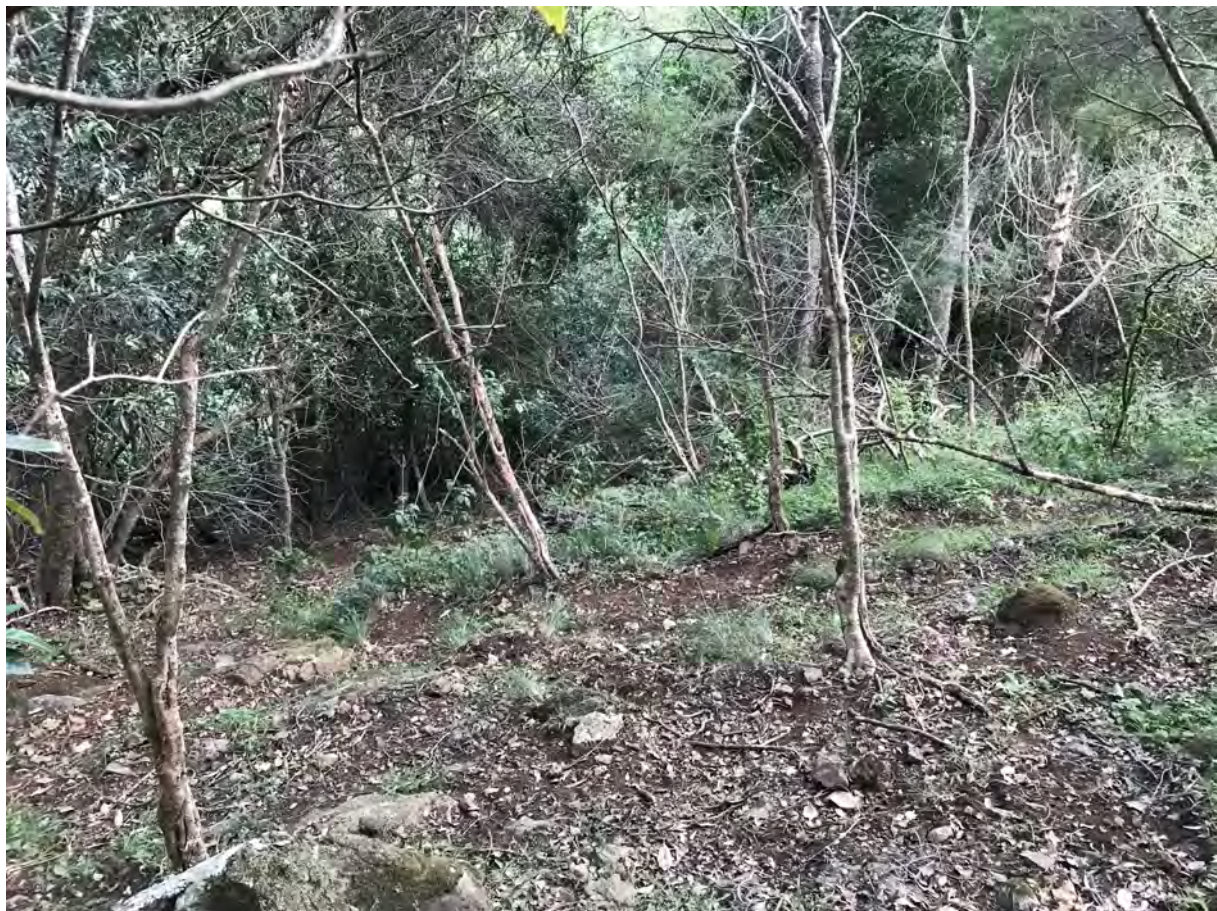
Photo 18 - steep vegetated creek side in northern portion of site showing some indication of soil creep

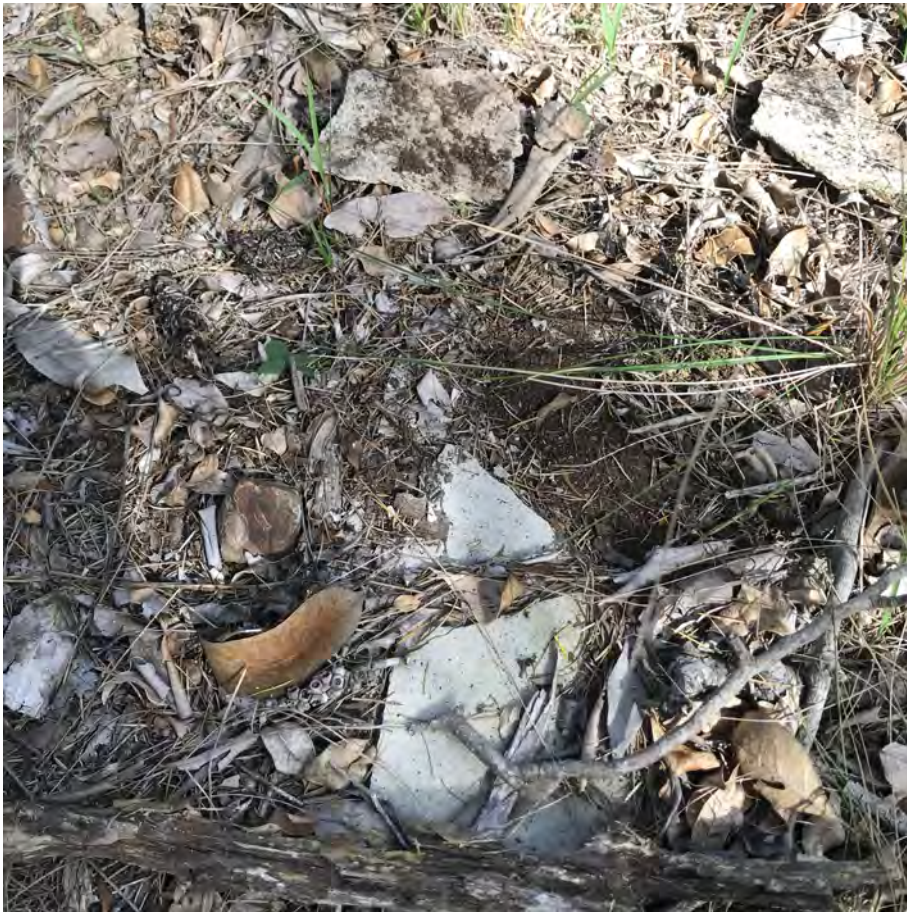
Photo 19 - Discarded building material north west corner

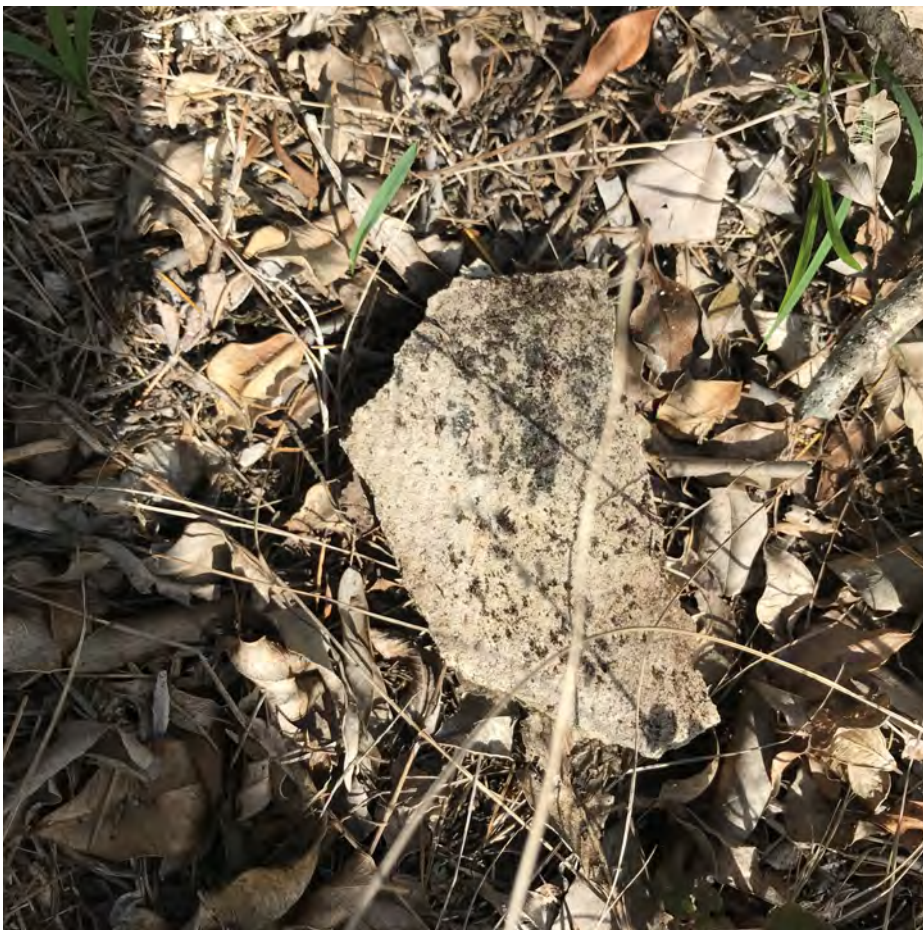
Photo 20 - Discarded building material north west corner

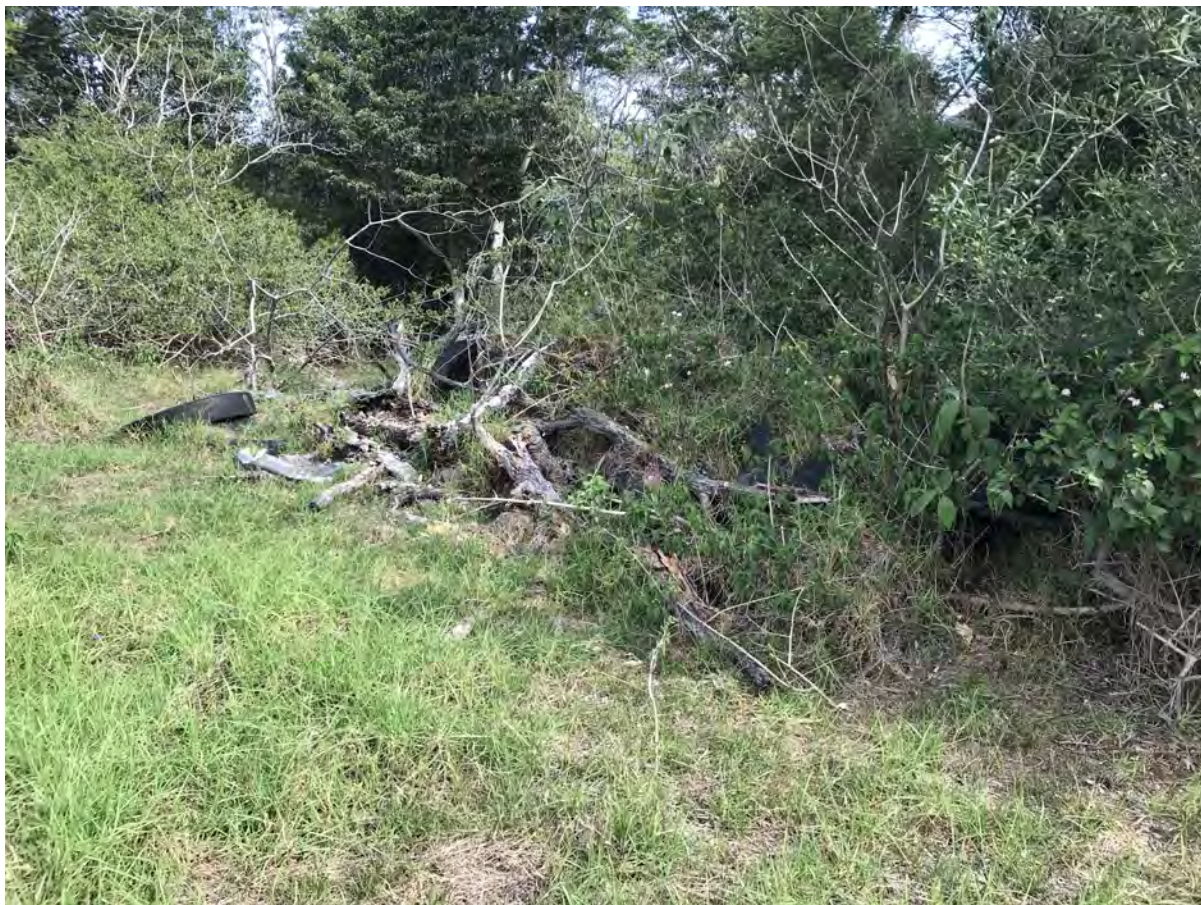
Photo 21 - discarded rubbish north west corner

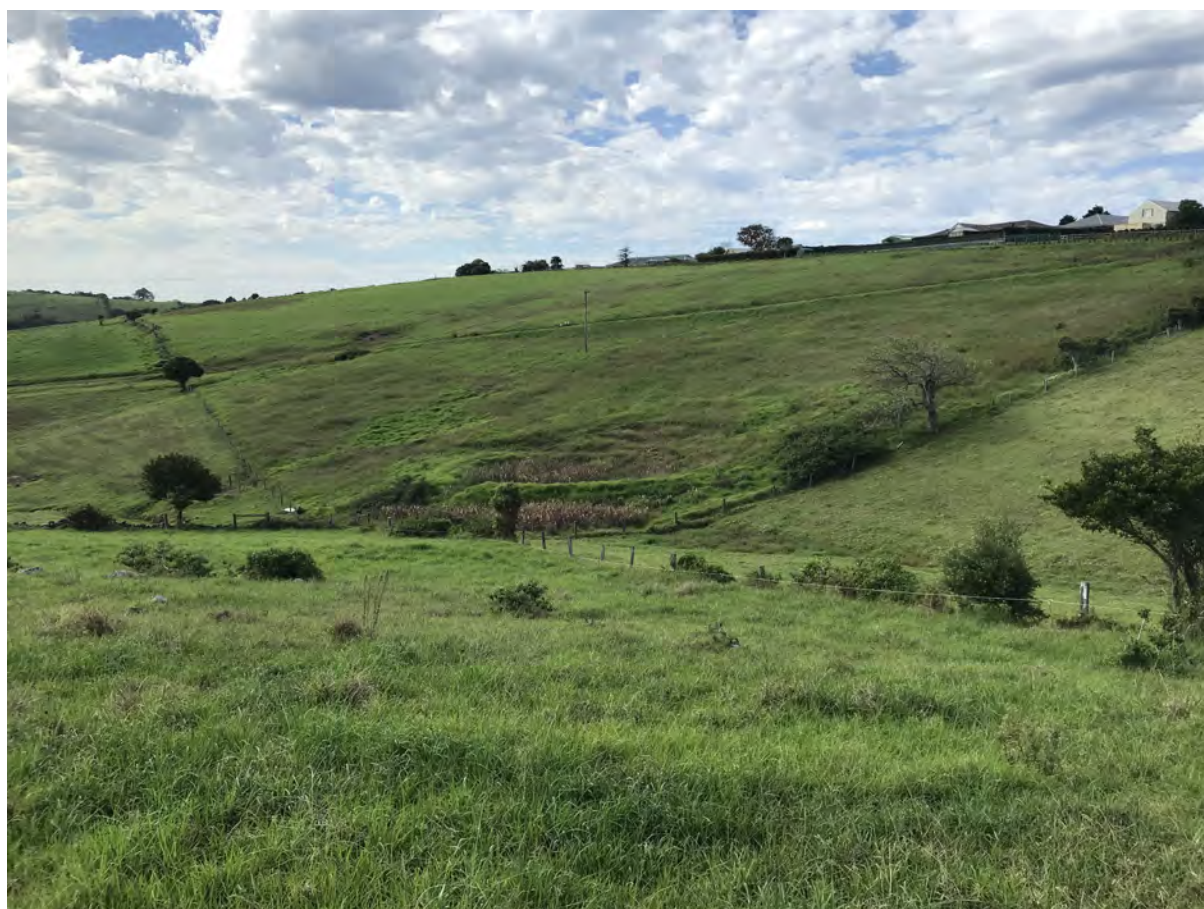
Photo 22 - northern extent of site looking north

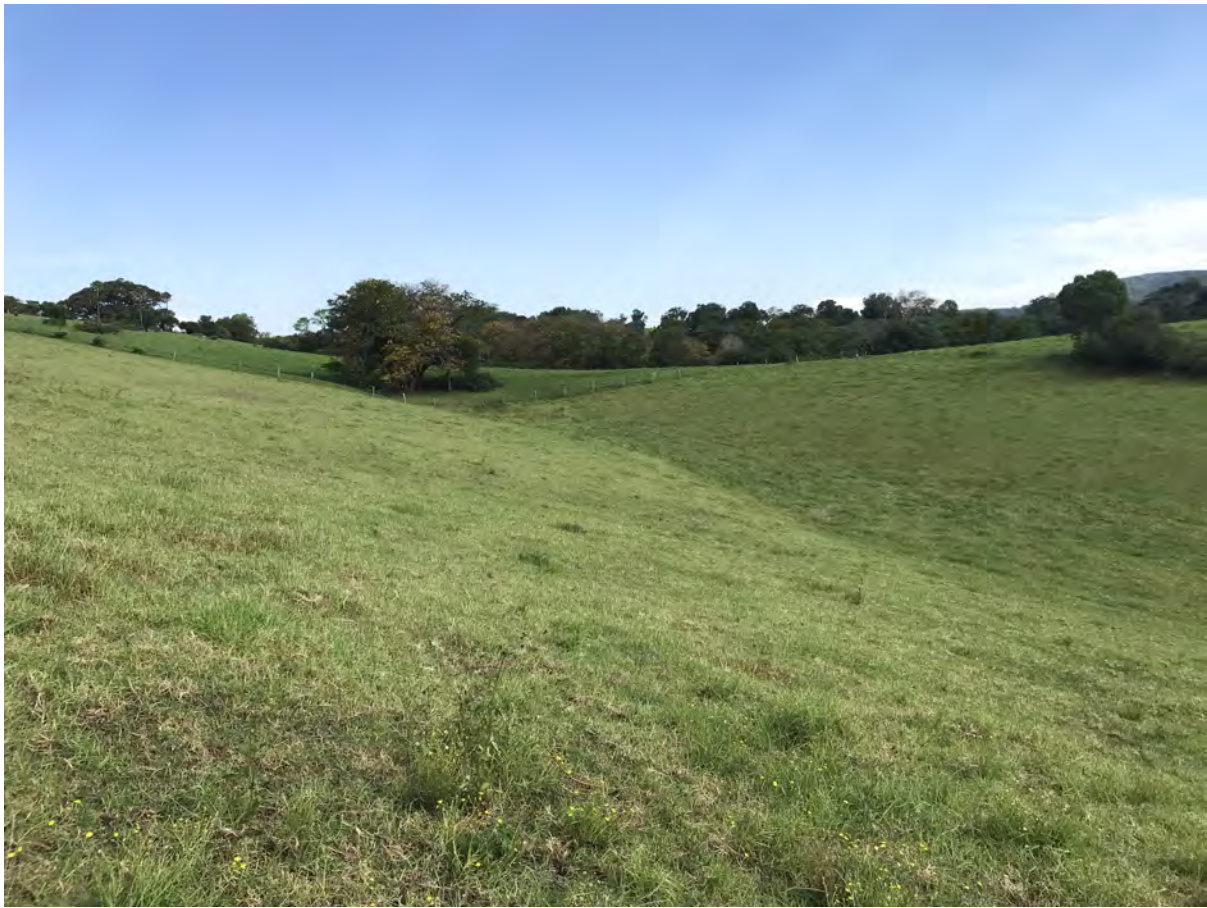
Photo 23 - Northern portion of site looking south
