Arboricultural Impact Assessment

**Lot 2051 DP812614
1a Little Alfred Street, North Sydney**

Date: **16th November 2017**
File Reference: 20181384.1

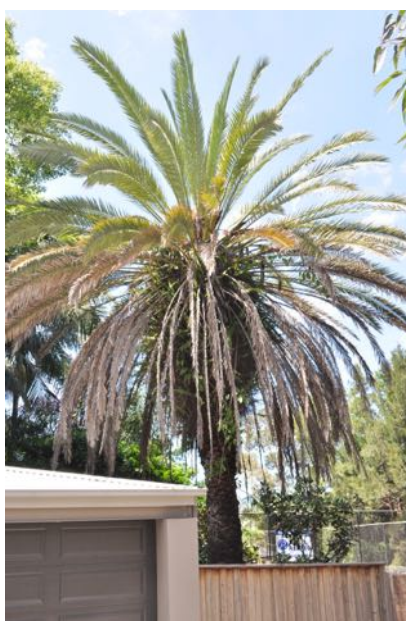
Figure 3. Tree no. 1 *Phoenix canariensis* (Canary Island Date Palm)

This exotic palm is located in the northern adjoining property being 1 Whaling Road. It is mature in age and in good health and condition with a 'TreeAZ' rating of 'A'. This tree has a life expectancy of 40+yrs.

The palm is located within 1m to the existing brick retaining wall, which will remain. Therefore there will be no proposed impacts to the palms root system.

The canopy may require tying back to the boundary to prevent damage to the fronds.

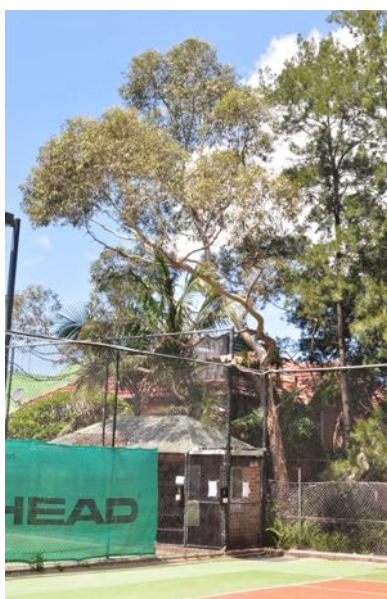
Figure 4. Tree no. 7

- 5.1.4.1 This native tree is located in the adjoining park being 1a Whaling Road. It is young in age and in adequate health and condition with a 'TreeAZ' rating of 'A'. There are no significant defects or issues visible. This tree has a life expectancy of 15-40 years.

- 5.1.4.2 The trunk is located approximately 3.3m from the edge of the low brick wall followed by a foot path and brick club house then tennis court extending away from the trunk. Given the grassed area to the south and the sealed surfaces to the north that inhibit moisture and air from penetration the root zone the likelihood of roots under these areas are slim. Therefore the impact to its root system is likely to be minimal.

- 5.1.4.4 A 2nd order limb extends over the tennis court fence and clubhouse by approximately 3m at approximately 3.5-4m high. Pruning of the canopy is required for the construction of level 1 with associated scaffolding. This will require in the removal of the highlighted limb resulting in a canopy loss of approximately 30-40%.

- 5.1.4.3 During the demolition of the courts and structures care must be given to remove the brick and paving by hand then the area should be inspected for roots and protected accordingly.

- Recommendations
 - Remove existing concrete slabs and structures and inspect for location of roots
 - Prune a 2nd order limb that extends over the boundary fence by approximately 3m at approximately 3.5-4m high resulting in the removal of approximately 30-40% of the canopy

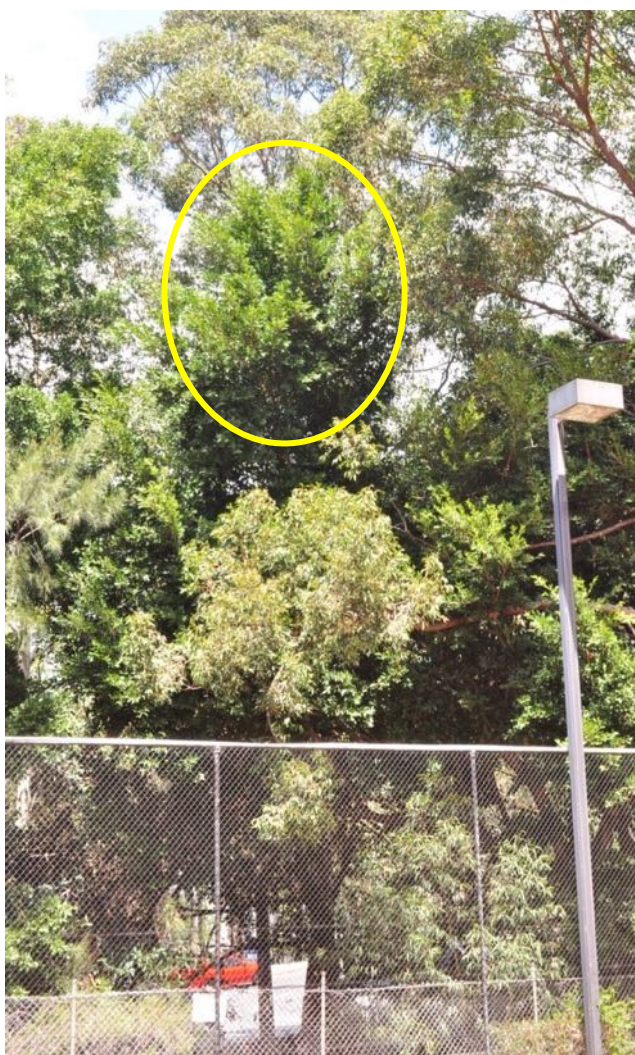
Figure 6. Tree no. 8 Pruning

- 5.1.5.1 This native tree is located in the adjoining park being 1a Whaling Road. It is semi mature in age and in adequate health and condition with a 'TreeAZ' rating of 'A'. There are no significant defects or issues visible and it has a life expectancy of 40+ years.

- 5.1.5.2 The trunk is located approximately 3.7m from the edge of the low brick wall followed by a footpath and then tennis court. There are open areas to the south, east and west allowing for root system occupation. Given the size and characteristics of this species the presence of roots under these surfaces may be possible. Therefore during demolition of the structure care must be given during removal of the sealed surfaces for root system inspection.

- 5.1.5.3 The canopy extends towards the tennis court fence. Pruning of the canopy is required for the construction of level 1 with scaffolding. This is likely to require in the removal of numerous 5th-6th order branches resulting in a canopy loss of approximately less than 10%.

- Recommendations
 - Remove existing concrete slabs and structures and inspect for location of roots
 - Prune 5th-6th order limbs that extend over the boundary fence by approximately 1m resulting in the removal of approximately 10% of the canopy
 - All pruning must be in accordance with AS4373-2007 *Pruning amenity trees* to achieve construction clearance
 - Apply tree protection methods (sect.7)

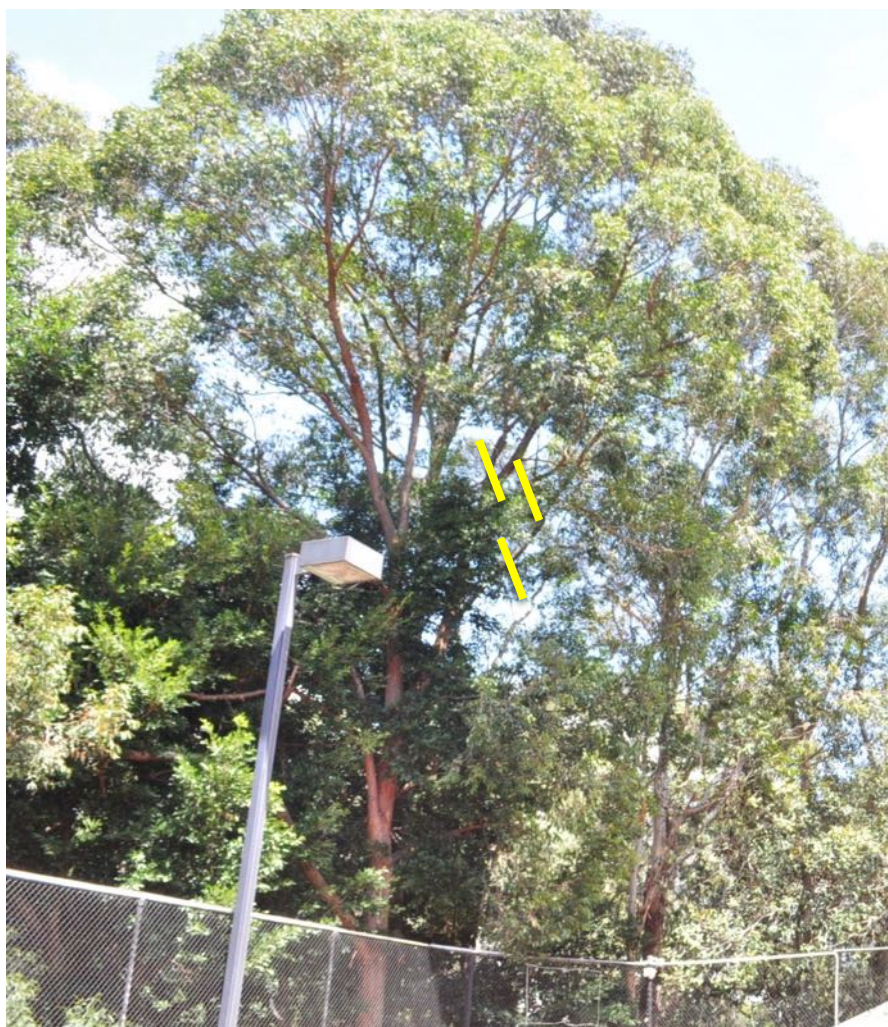
Figure 7. Tree no. 9 Pruning

- 5.1.6.1 This native tree is also located in the adjoining park being 1a Whaling Road. It is mature in age and in adequate health and condition with a 'TreeAZ' rating of 'A'. There are no significant defects or issues visible though there is a self corrected bend in the trunk at approximately 1m high. This tree has a life expectancy of 40+ years.

- 5.1.6.2 The trunk is located approximately 1.5m from the edge of the low brick wall followed by a footpath and then tennis court. There are open areas to the south, east and west allowing for root system occupation. Once again given the size of this species the presence of roots under these surfaces is possible. Therefore during demolition of the structure care must be given during removal of the sealed surfaces for root system inspection.

- 5.1.6.3 The canopy for this tree also extends over the tennis court fence, which is likely to require pruning for the 1st and 2nd floor construction. Inspection of specific branches for pruning was difficult. Therefore it is estimated that the tree will require the pruning of 3rd order branches resulting in a canopy loss of approximately 25%.

- Recommendations
 - Remove existing concrete slabs and structures and inspect for location of roots
 - Prune 3rd order limbs that extend over the boundary fence by approximately 1m resulting in the removal of approximately 25% of the canopy
 - All pruning must be in accordance with AS4373-2007 *Pruning amenity trees* to achieve construction clearance
 - Apply tree protection methods (sect.7)

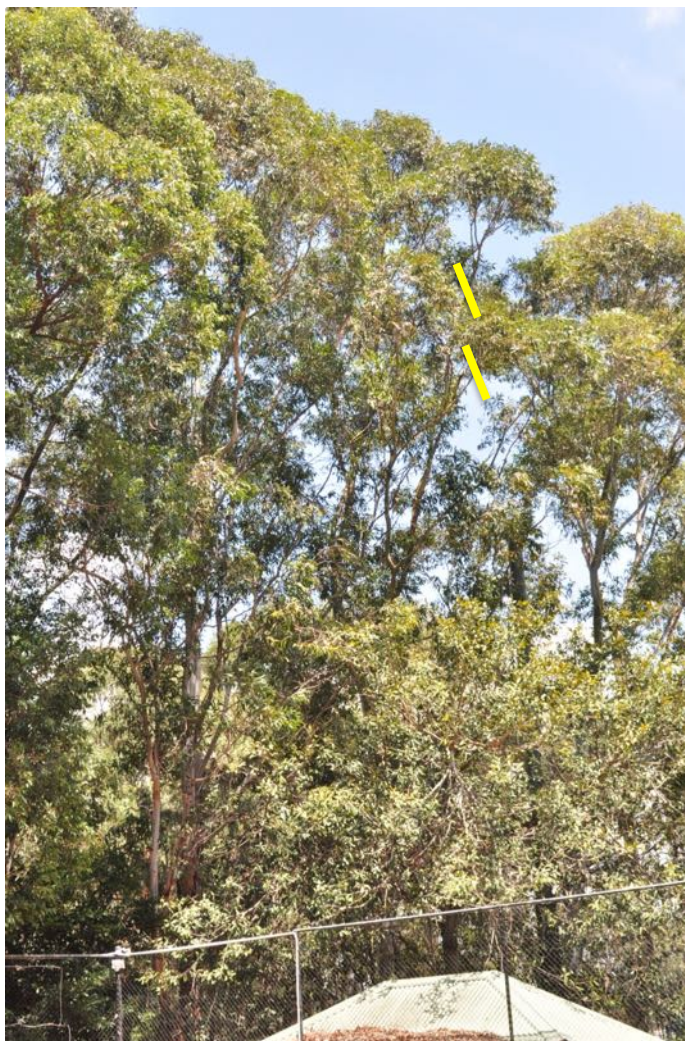
Figure 8. Tree no. 10 Pruning

- 5.1.7.1 This native tree is also located in the adjoining park being 1a Whaling Road. It is semi mature in age and in adequate health and condition with a 'TreeAZ' rating of 'A'. There are no significant defects or issues visible and it has a life expectancy of 40+ years.

- 5.1.7.2 The trunk is located approximately 4.7m from the edge of the low brick wall followed by a footpath and then tennis court. There are open areas to the south, east and west once again, allowing for root system occupation. The likelihood of significant roots under the sealed surface at this distance is unlikely.

- 5.1.7.3 The canopy extends towards the tennis court fence. Pruning of the canopy is required for the construction of level 1 with associated scaffolding. Once again the inspection of specific branches to prune was not possible. Therefore it is estimated that the tree will require in the removal of numerous 4th-5th order branches resulting in a canopy loss of approximately less than 10%.

- Recommendations
 - Remove existing concrete slabs and structures and inspect for location of roots
 - Prune numerous 4th-5th order limbs that extend over the boundary fence by approximately 1m resulting in the removal of approximately 10% of the canopy

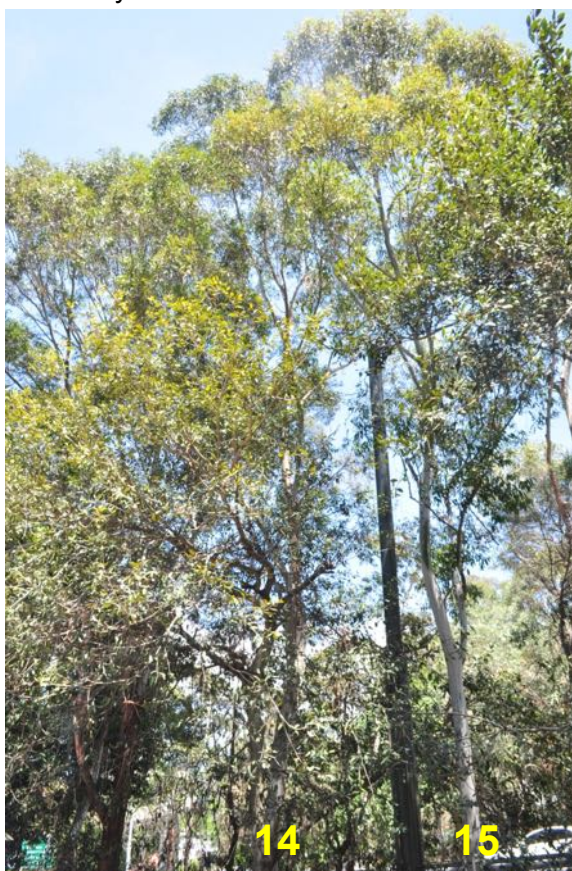
Figure 9. Tree no. 14 *Ficus rubiginosa* (Port Jackson Fig) and tree no. 16 *Eucalyptus saligna* (Sydney Blue Gum)

- 5.1.11.1 This native tree is located in the adjoining park being 1a Whaling Road. It is semi mature in age and in adequate health and condition with a 'TreeAZ' rating of 'A'. Once again there are no significant defects or issues visible other than pruning events and this tree has a life expectancy of 40+ years.

- 5.1.11.2 The trunk is located approximately 1m from the edge of the low brick wall followed by the car parking area. There are open areas to the south, east and west allowing for root system occupation. Given the size and characteristics of this species the presence of roots under these surfaces may be possible. Therefore, as with tree no. 8, during demolition of the structure care must be given during removal of the sealed surfaces for root system inspection.

- 5.1.11.3 The canopy extends over the boundary fence. Pruning of the canopy will be required for the construction of the ground level for the proposed development. This will require in the removal of the numerous 3rd and higher order branches resulting in a canopy loss of approximately 30%.

- 5.1.13.1 This is another native tree and once again is located in the adjoining park being 1a Whaling Road. It is semi mature in age and in adequate health and condition with a 'TreeAZ' rating of 'A' with no significant defects. The lower trunk has some canker formation, which is localised disruption of the cambial layer. This tree has a life expectancy of 40+ years.

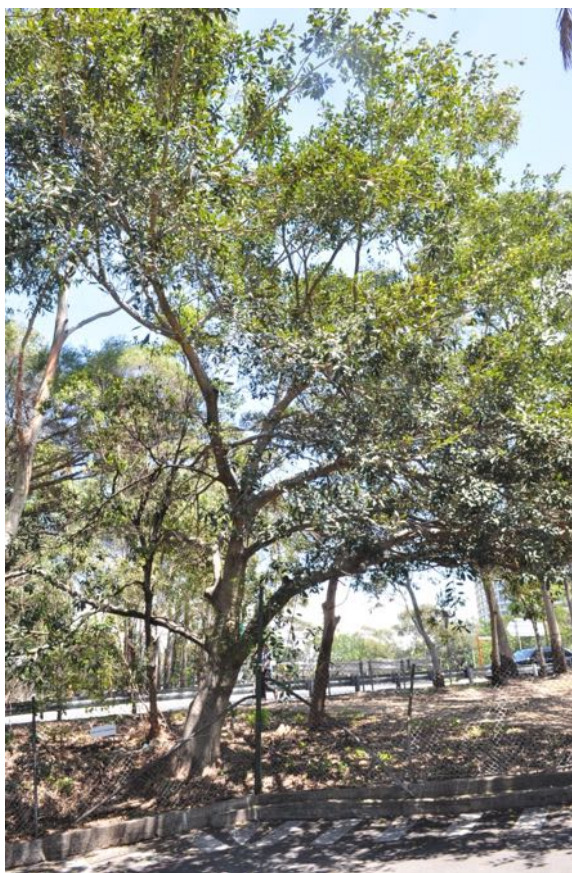
Figure 11. Tree no. 17

- 5.1.14.1 This native tree is located in the adjoining park being 1a Whaling Road. It is semi mature in age and in adequate health and condition with a 'TreeAZ' rating of 'A' with no significant defects or issues visible other than pruning events. This tree has a life expectancy of 40+ years.

- 5.1.14.2 The trunk is located within 1m to the edge of the low brick wall followed by the car parking area. There are open areas to the south, east and west allowing for root system occupation. Once again given the size and characteristics of this species the presence of roots under these surfaces may be possible. Therefore, as with other trees located close to the boundary fence, during demolition of the structure care must be given during removal of the sealed surfaces for root system inspection.

- 5.1.14.3 This canopy also extends over the boundary fence. Pruning of the canopy will be required for the construction of the ground level for the proposed development. This will require in the removal of at least two (2) 2nd order branches resulting in a canopy loss of approximately 30%.
