Sealark Road, Callala Bay NSW Lot 5 DP 1225356  
Report on Geotechnical Investigation

Our Ref: TERRA19258.Rep1.Rev1

21 August 2019

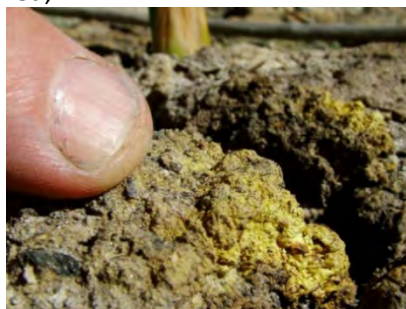
Image 1: Example of Jarosite staining

- To facilitate off-site disposal, all material for offsite disposal should be treated at a rate of 3kg/tonne, with the lime mixed well into the spoil. For small volumes of spoil and for ease of treatment and disposal, spoil can be contained and treated within skip bins. Verification testing should be undertaken to confirm the acid generating capacity of the spoil has been adequately neutralised prior to off-site disposal.
- If the soils are to be stockpiled on site for a period exceeding 2 weeks, further advice shall be sought from a competent ASS professional. Stockpiles shall be observed for obvious signs of oxidation, such as jarosite staining (an example is shown in image 1). Advice should be sought from an environmental professional if such staining or signs of oxidation are observed;

- Excavated soil that is to remain on the site shall be treated at a rate of 2kg/tonne.
- Materials excavated for service trenches etc, should be replaced within 48 hours.
- The sides and bases of excavations should be treated with lime (sprinkled across the exposed faces). In the case of the sedimentation basin, the sides should be lined with clay soils with a neutral pH or alternatively, they could be lined with a layer of crushed concrete.

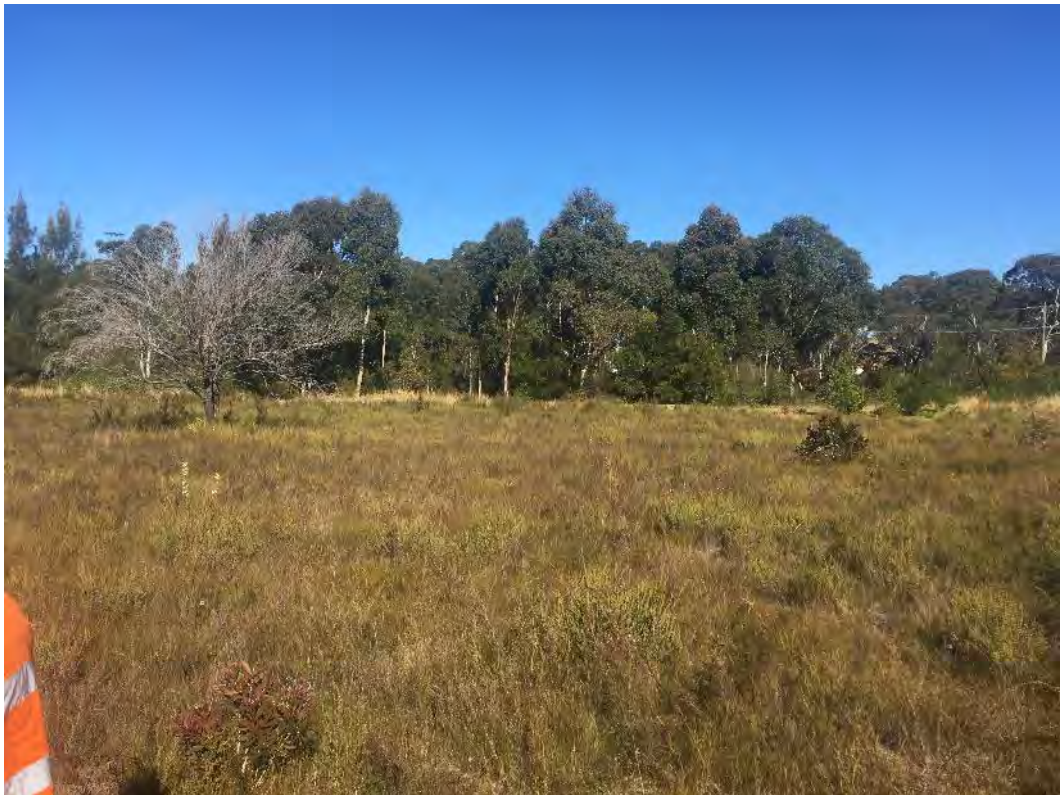
Photograph 2: View of northern portion of site looking east from around lot 9. Creek is located along and east of tree line.

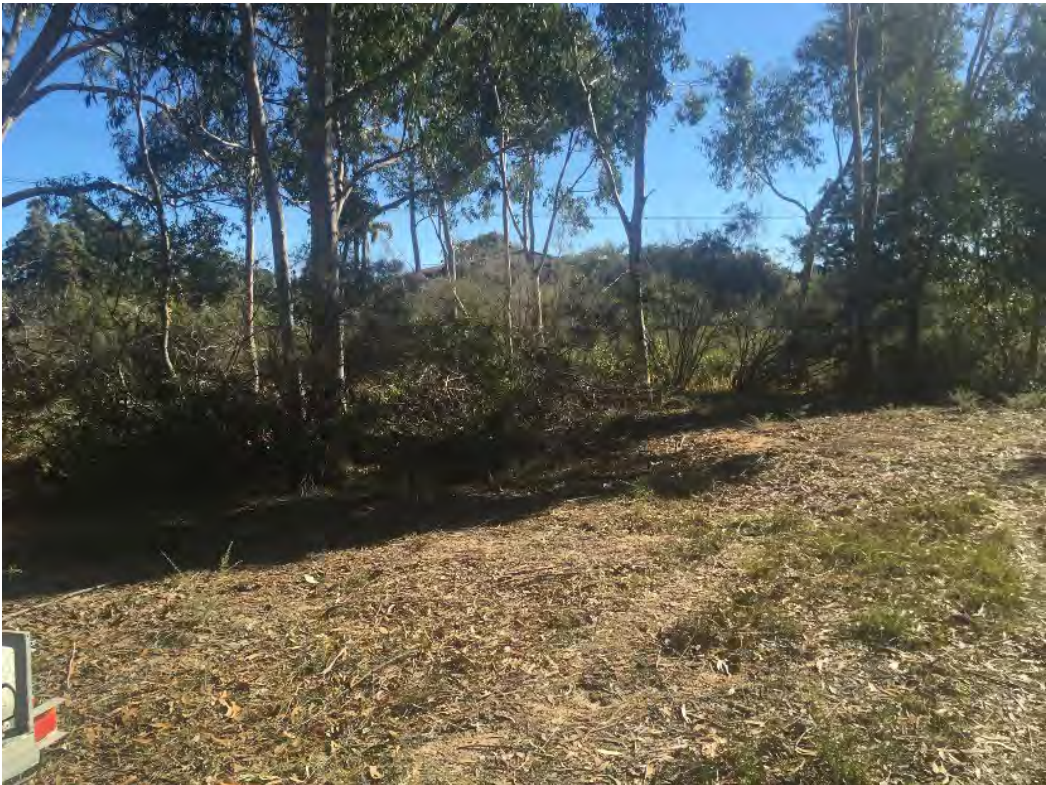
Photograph 7: View of south-western part of the site, looking north west from lot 13. A creek is visible amongst the bushes towards the centre of the image.

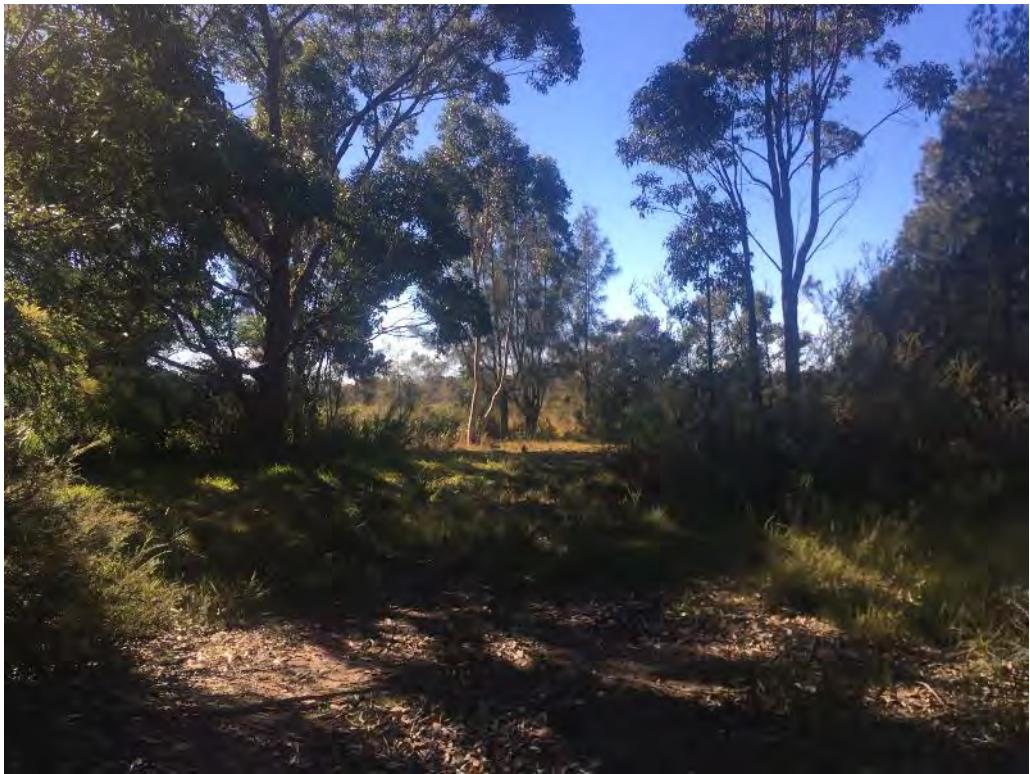
Photograph 12: Slight clearing to the north east of creek.

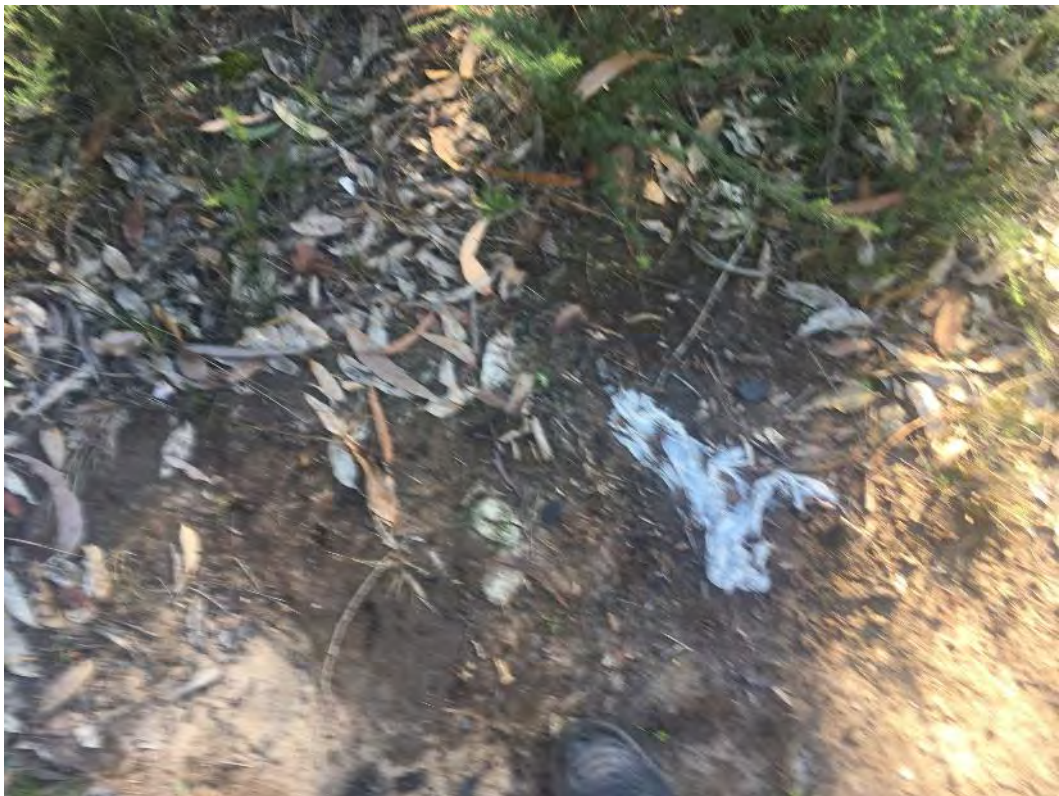
Photograph 13: Minor rubbish found on the surface, within the south-western corner of the site (plastic, glass bottles, tin cans).

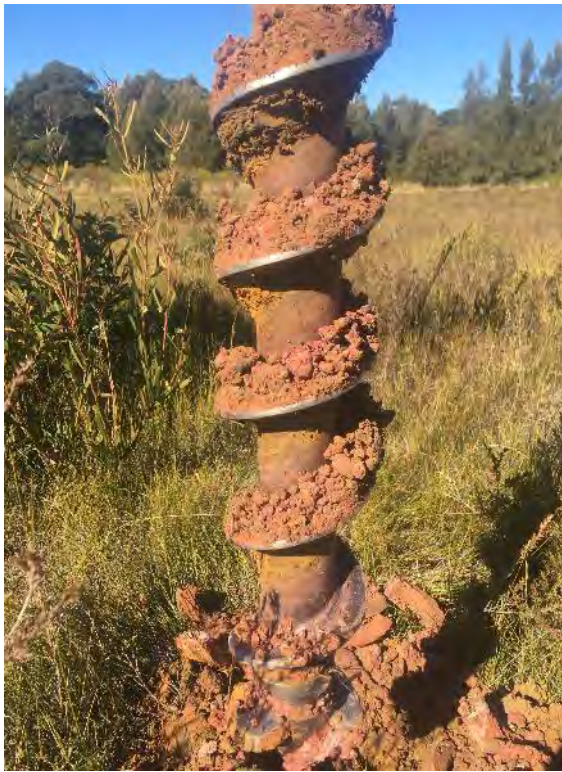
Photograph 16: Residual to extremely weathered material encountered at 1.5m depth typically found in test locations across the site.

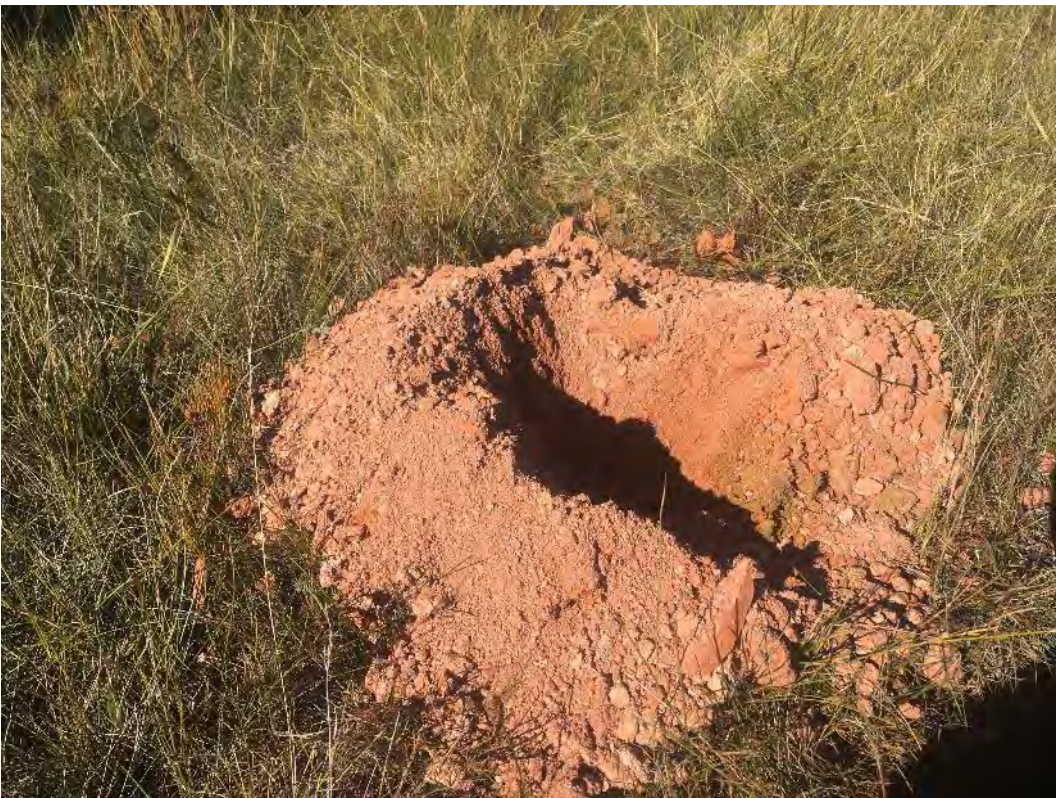
Photograph 17: Residual to extremely weathered material encountered at 1.5m depth typically found in test locations across the site.
