Date: 4th July 2022 Ref: 2205_c_ 67-73 Lords Road, Leichhardt, NSW Arboricultural Assessment.

Phase: Council Submission - Planning Proposal.

67-73 Lords Road, Leichhardt, NSW 2040 Consulting Arboricultural Assessment Report.

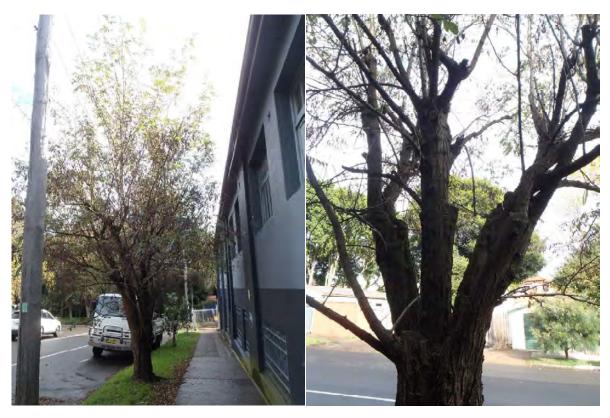
Figure 4. Photo showing T16, Robinia street tree. The pruning and thorns on epicormic shoots are visible.

- 6.11 The proposed removal of T16, a *Robinia pseudoacacia* (False Robinia) located within the street verge of Lords Road whilst not hinging or contingent on this planning proposal, is proposed as it is seen as an opportunity for replacement to a more suitable, and native tree planting along the street verge of Lords Road. This would be considered a more beneficial outcome for both parties (council and adjacent site owner).

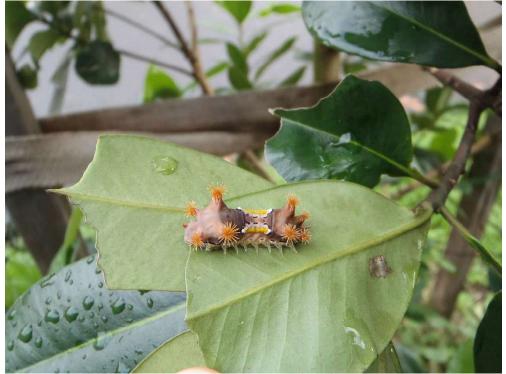
Figure 5. Photo showing The Doratifera vulnerans (Mottled cup moth caterpillar – venomous and native) on T17 and T18, new Tristaniopsis laurina (Water Gum) juvenile street trees.

- 6.12 T17 and T18 are both newly planted *Tristaniopsis laurina* (Water Gum). These juvenile street verge plantings are proposed for retention and protection with tree protection fencing during construction. It should be noted that the presence of *Doratifera vulnerans* (Mottled cup moth caterpillar venomous and native) and their pupae were present and browsing on the leaves. Provided the trees receive good water, soil nutrition and suitable protection including protection of the soil during any development, it is believed that the trees will be able to naturally overcome the cup moth caterpillar outbreak as they grow and mature. (*Refer to Figure 5 and 6, Chapter 8 below*).

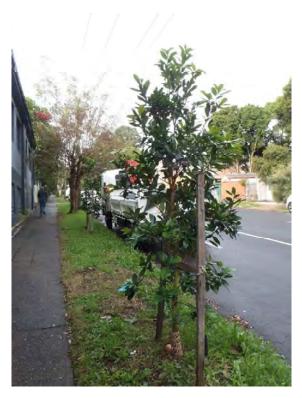
Figure 6. Photo showing The cup moth on T17 and T18, new Tristaniopsis laurina (Water Gum) juvenile street trees. T16 is in the background. Overhead powerlines just visible above these trees.

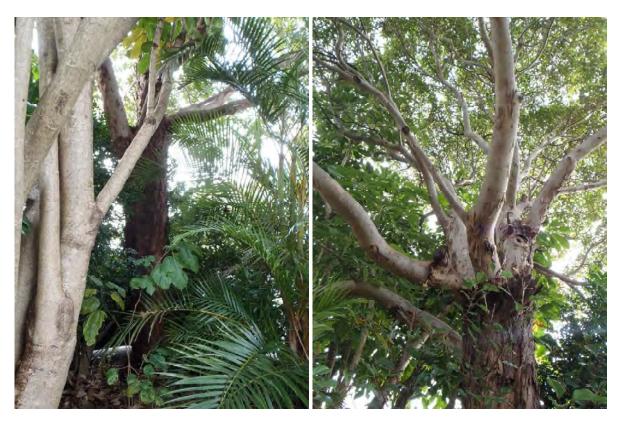
Figure 9. T1, Brush box with Schefflera growing close to it (photo on the left). Photo on the right shows T1 has previously been lopped/topped at approximately 4m high with the new branches growing from one node.

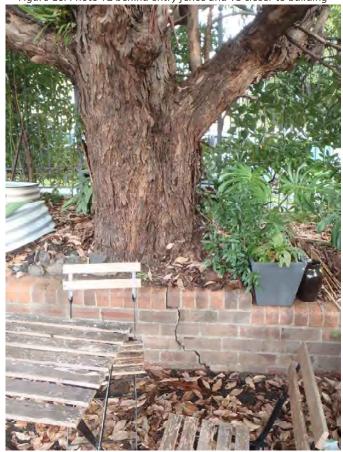
Figure 11. Photo T2. View looking south. Crack in brick wall. Hard pave surface where table/chairs are placed.

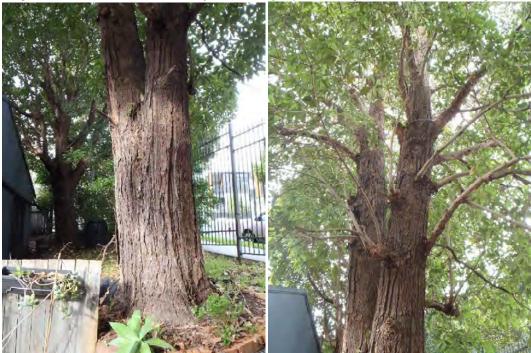
Figure 13. Photo T3 – co-dominant form

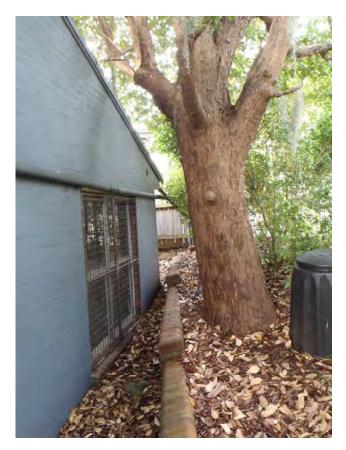
Figure 14. Photo T4. Brick wall displacement visible in photo.

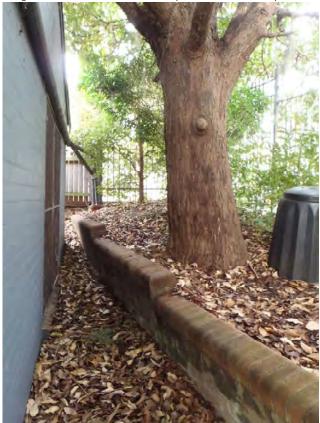
Figure 15. Photo T4. Brick wall displacement visible in photo.

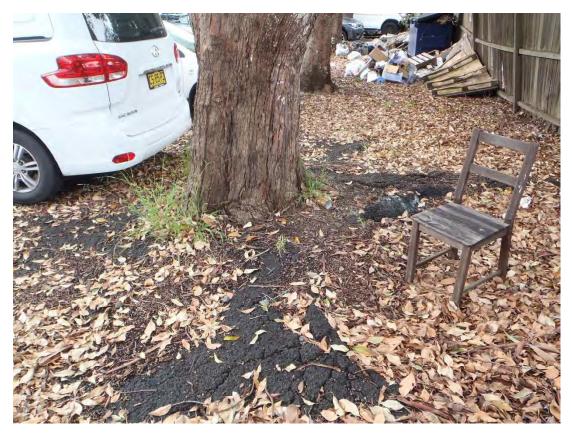
Figure 18. Trees 7-15 all within asphalt. Much displacement of the hard pave around the root crown base, rubbish dumped and cars parking.

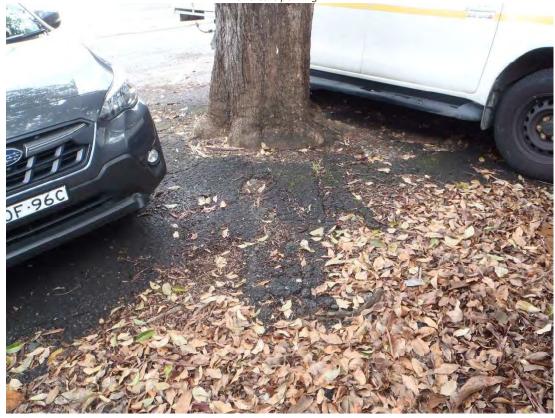
Figure 19. Trees 7-15 all within asphalt. Much displacement of the hard pave around the root crown base, rubbish dumped and cars parking.

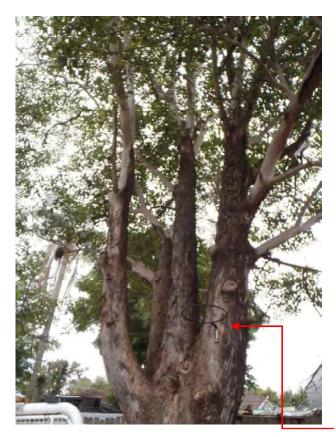
Figure 20. Trees T11 with netball hoop drilled into the tree (at red arrow)

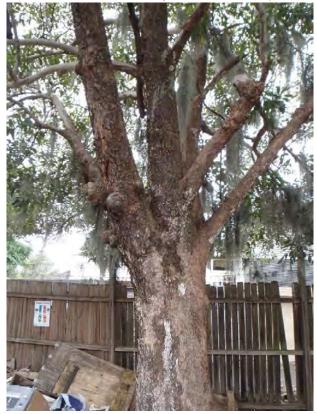
Figure 21. Tree T9. Slight stunting to tree. Rubbish dumped at base. Davies Lane in background. Tillandsia growing on limbs.

Fungal mycelia present on trunk. Vertical split in trunk (refer next photo)

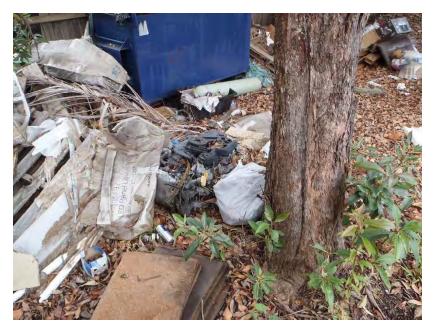
Figure 22. Tree T9. Slight stunting to tree. Rubbish dumped at base. Davies Lane in background. Tillandsia growing on limbs.

Fungal mycelia present on trunk. Vertical split in trunk.

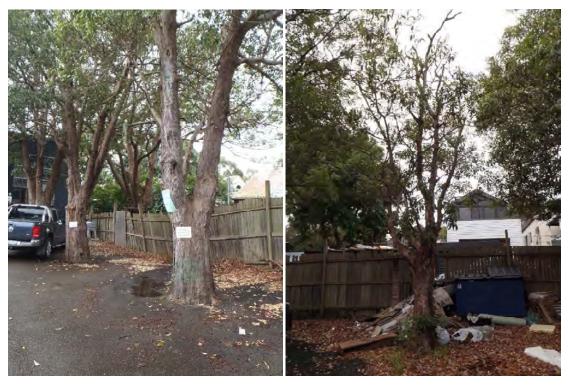
Figure 23. Tree T13 with two signs nailed into trunk and hard pave up to base of T13, T14, and T15 in background. Photo on right is T10 in very poor form

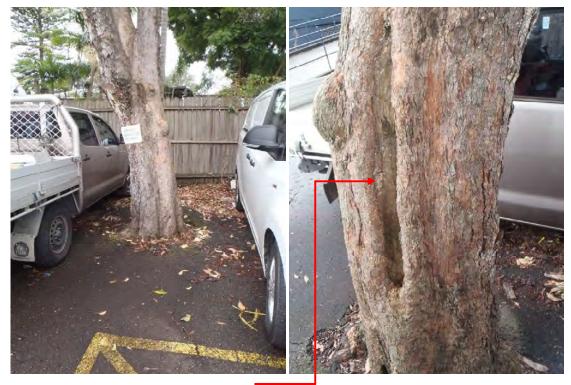
Figure 24. Tree 12 with decay on both sides of trunk. Asphalt up to base of tree and car parking either side.

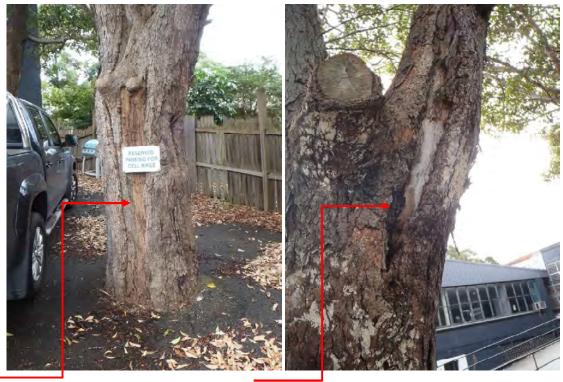
Figure 25. Tree 14 with decay on trunk and sign and asphalt up to base of tree and car parking either side.

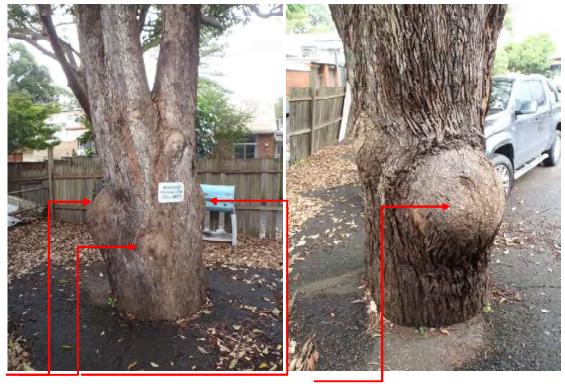
Figure 26. Tree 15 with several large limb scars at 1m above asphalt. It is suspected that this tree was lopped /topped at this height and the remaining trunks regrew. There is a lack of root crown base taper at the collar where asphalt has been laid of the trunk, indicating higher ground level than was existing.
