Initial Geotechnical Assessment

ROGANS HILL PARK, 1020 MELIA COURT, CASTLE HILL, NSW

Report reference number: SYDGE321033-AC

8 November 2023

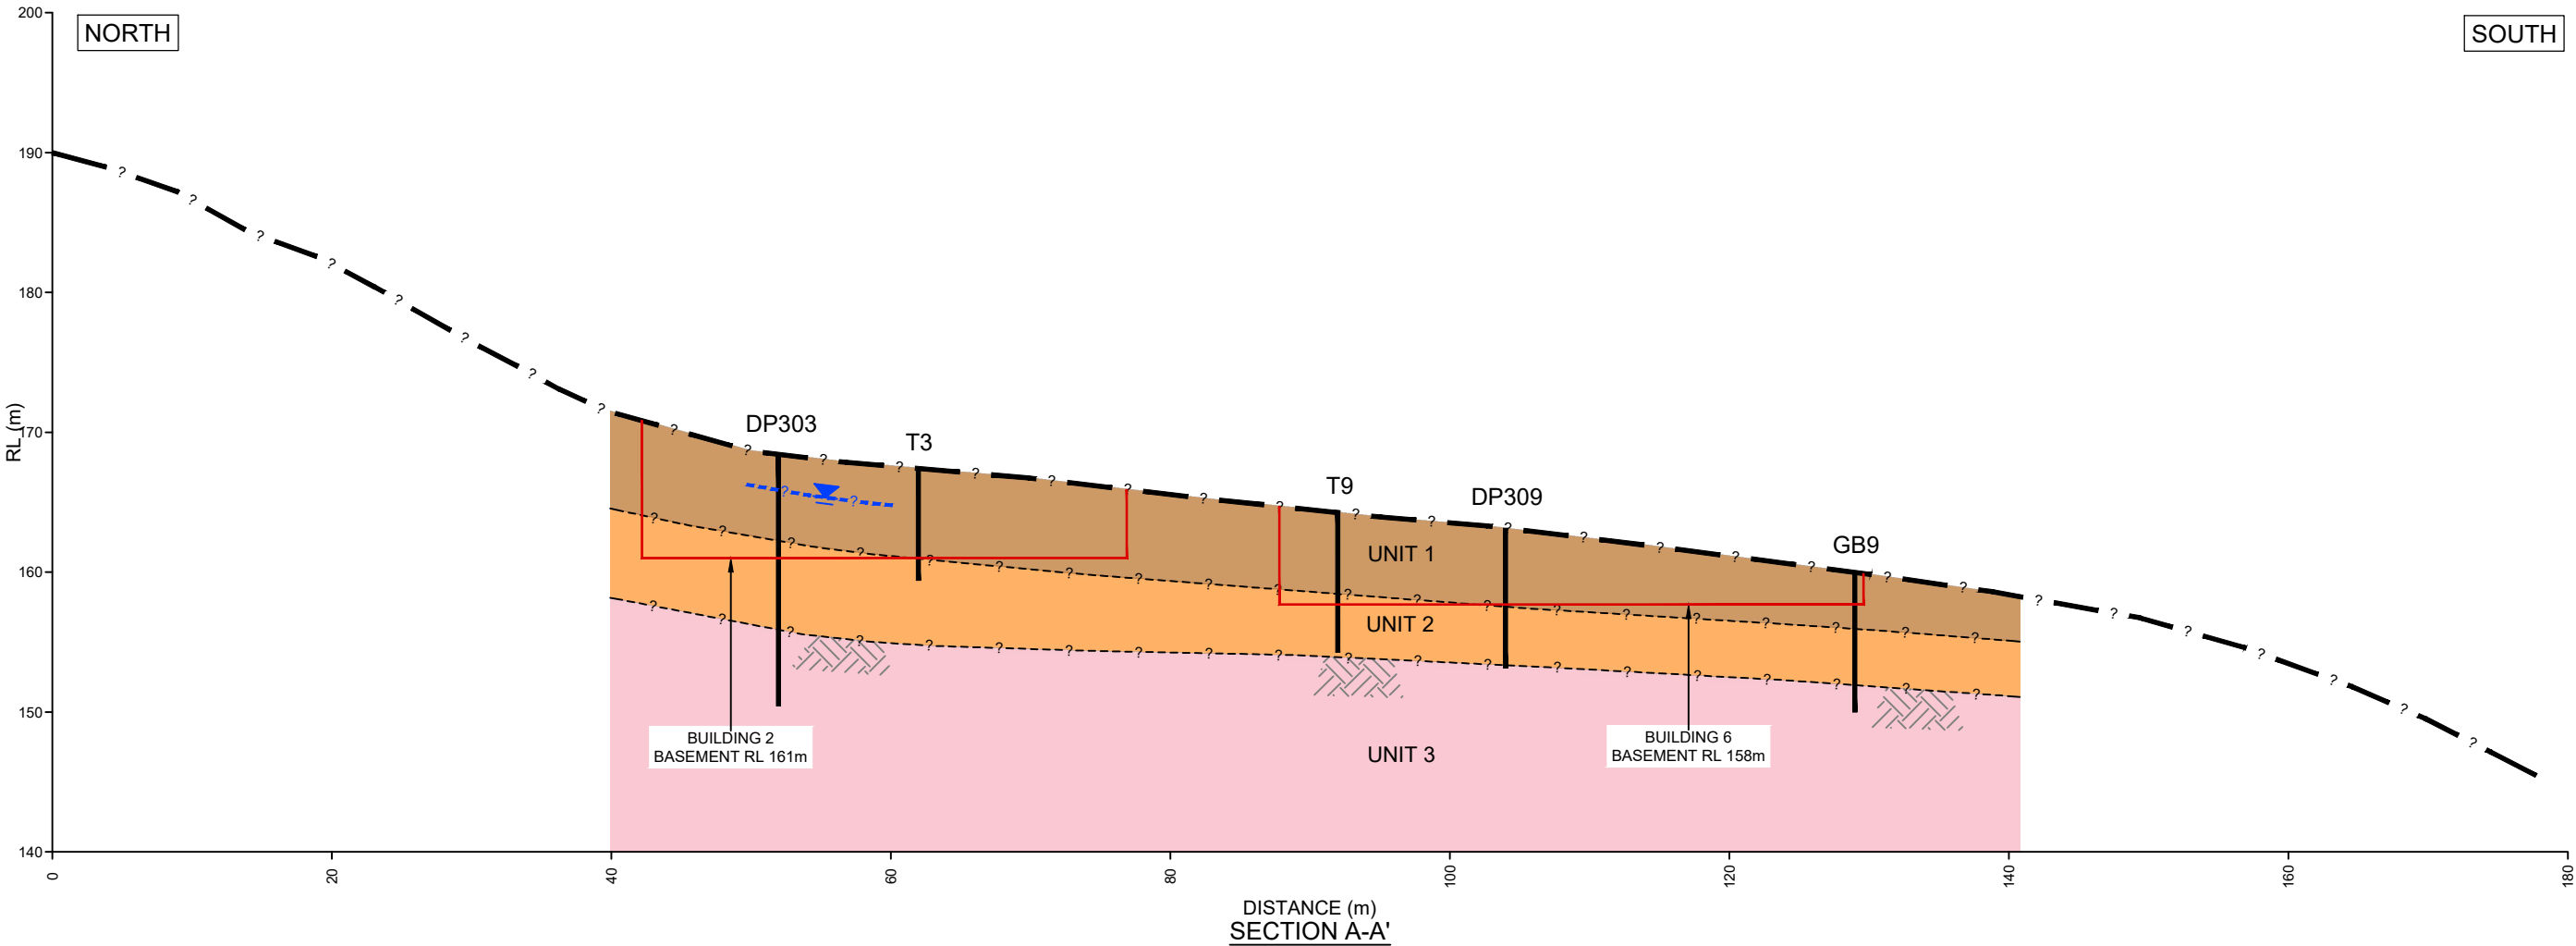
The attached Figures 4, 5 and 6 present our summary sketch long sections through the subject site developed from the available survey, borehole, and test pit information together with our observations on site. These sketch sections show that there is currently no ground information for both the northern and southern thirds of site. However, in the central third of the site ground conditions are expected to comprise;

Silty clays; 5m (upslope) to 3m (down slope) of silty clays. The investigation to date has not clearly defined whether these soils are residual or colluvium, it is expected that there will be varying degrees of each throughout the site.

Extremely to highly weathered shale, of between 4m to 6m thickness. This material has been assessed to be typically of extremely low to very low strength, and in places highly fractured with numerous clay seams and sub horizontal jointing.

Slightly weathered to fresh shale and laminite, underlies the soils and weathered rock at depth of between 8m to 13m across the central part of site, i.e. below an approximate level of RL155m to RL160m AHD dipping east to west across the central section of site. This shale was of medium and high strength.

Land slip surface, while the soil and weathered rock may actually contain numerous slide planes, it should be assumed that the overall slide surface exists at the weathered rock/slightly weathered rock interface. Back analysis by others suggest that the friction angle of this slide surface could range from 10.5° to 16°
