Preliminary Site Investigation

1020 Melia Court, Castle Hill NSW

Castle Hill Glen Pty Ltd

Reference: 754-SYDGE321033-AB

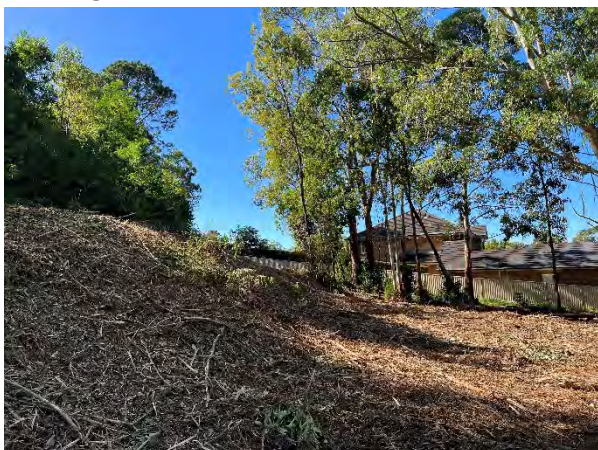
Photograph 3

04.05.2023 – Site looking east, showing eastern boundary fence with residential properties beyond, and sloping to the north

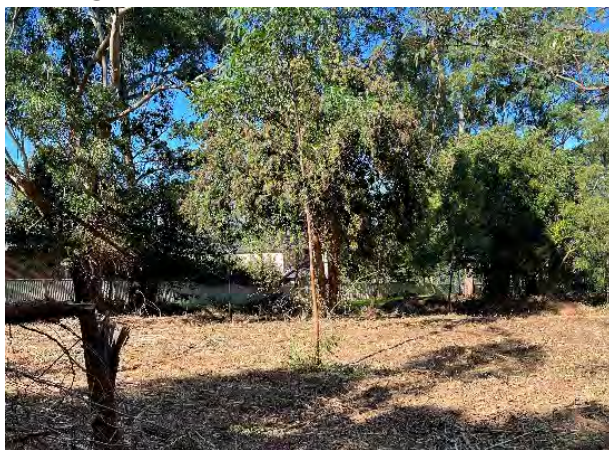
Photograph 4

04.05.2023 – Site showing eastern boundary fence with residential properties beyond

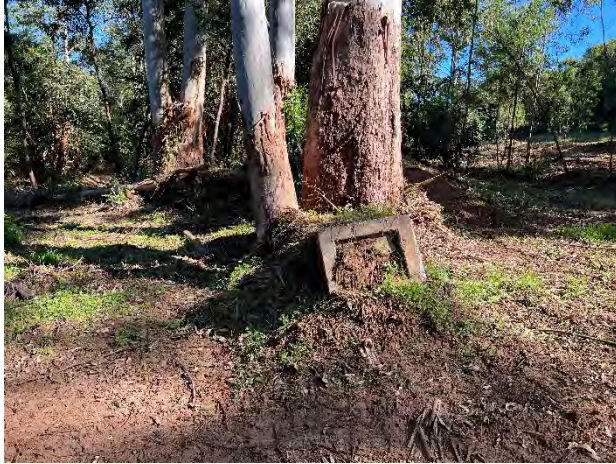
Photograph 7

04.05.2023 – Large concrete block, looking south – along the southern boundary of Lot 1021

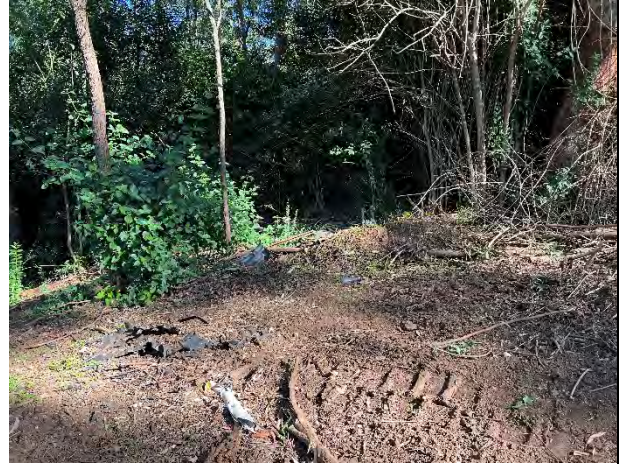
Photograph 8

There was some evidence of dumping of building materials over the fences along the eastern boundary from the residential properties such as glass, solar pool heating piping and metal. No other evidence of fly-tipped wastes was observed. No indications of heavily stained or odorous soil were noted. Similarly, no evidence of current or former fuel/chemical storage areas were observed. Building debris suspected to contain asbestos

04.05.2023 – Small collection of rubbish along southern boundary of Lot 1021

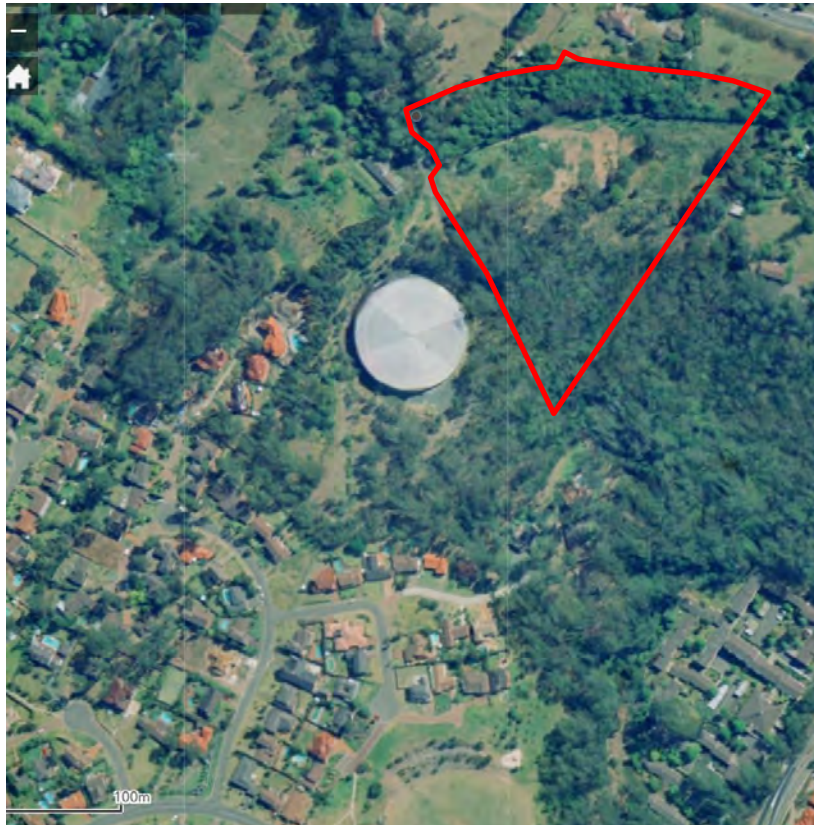
Photograph 7: 1994

Two aerial photographs (1994 and 1998) show indications of clearance or disturbance of the vegetated ground surface. Due to the known landslip hazard on the site, this could potentially be evidence of landslip.

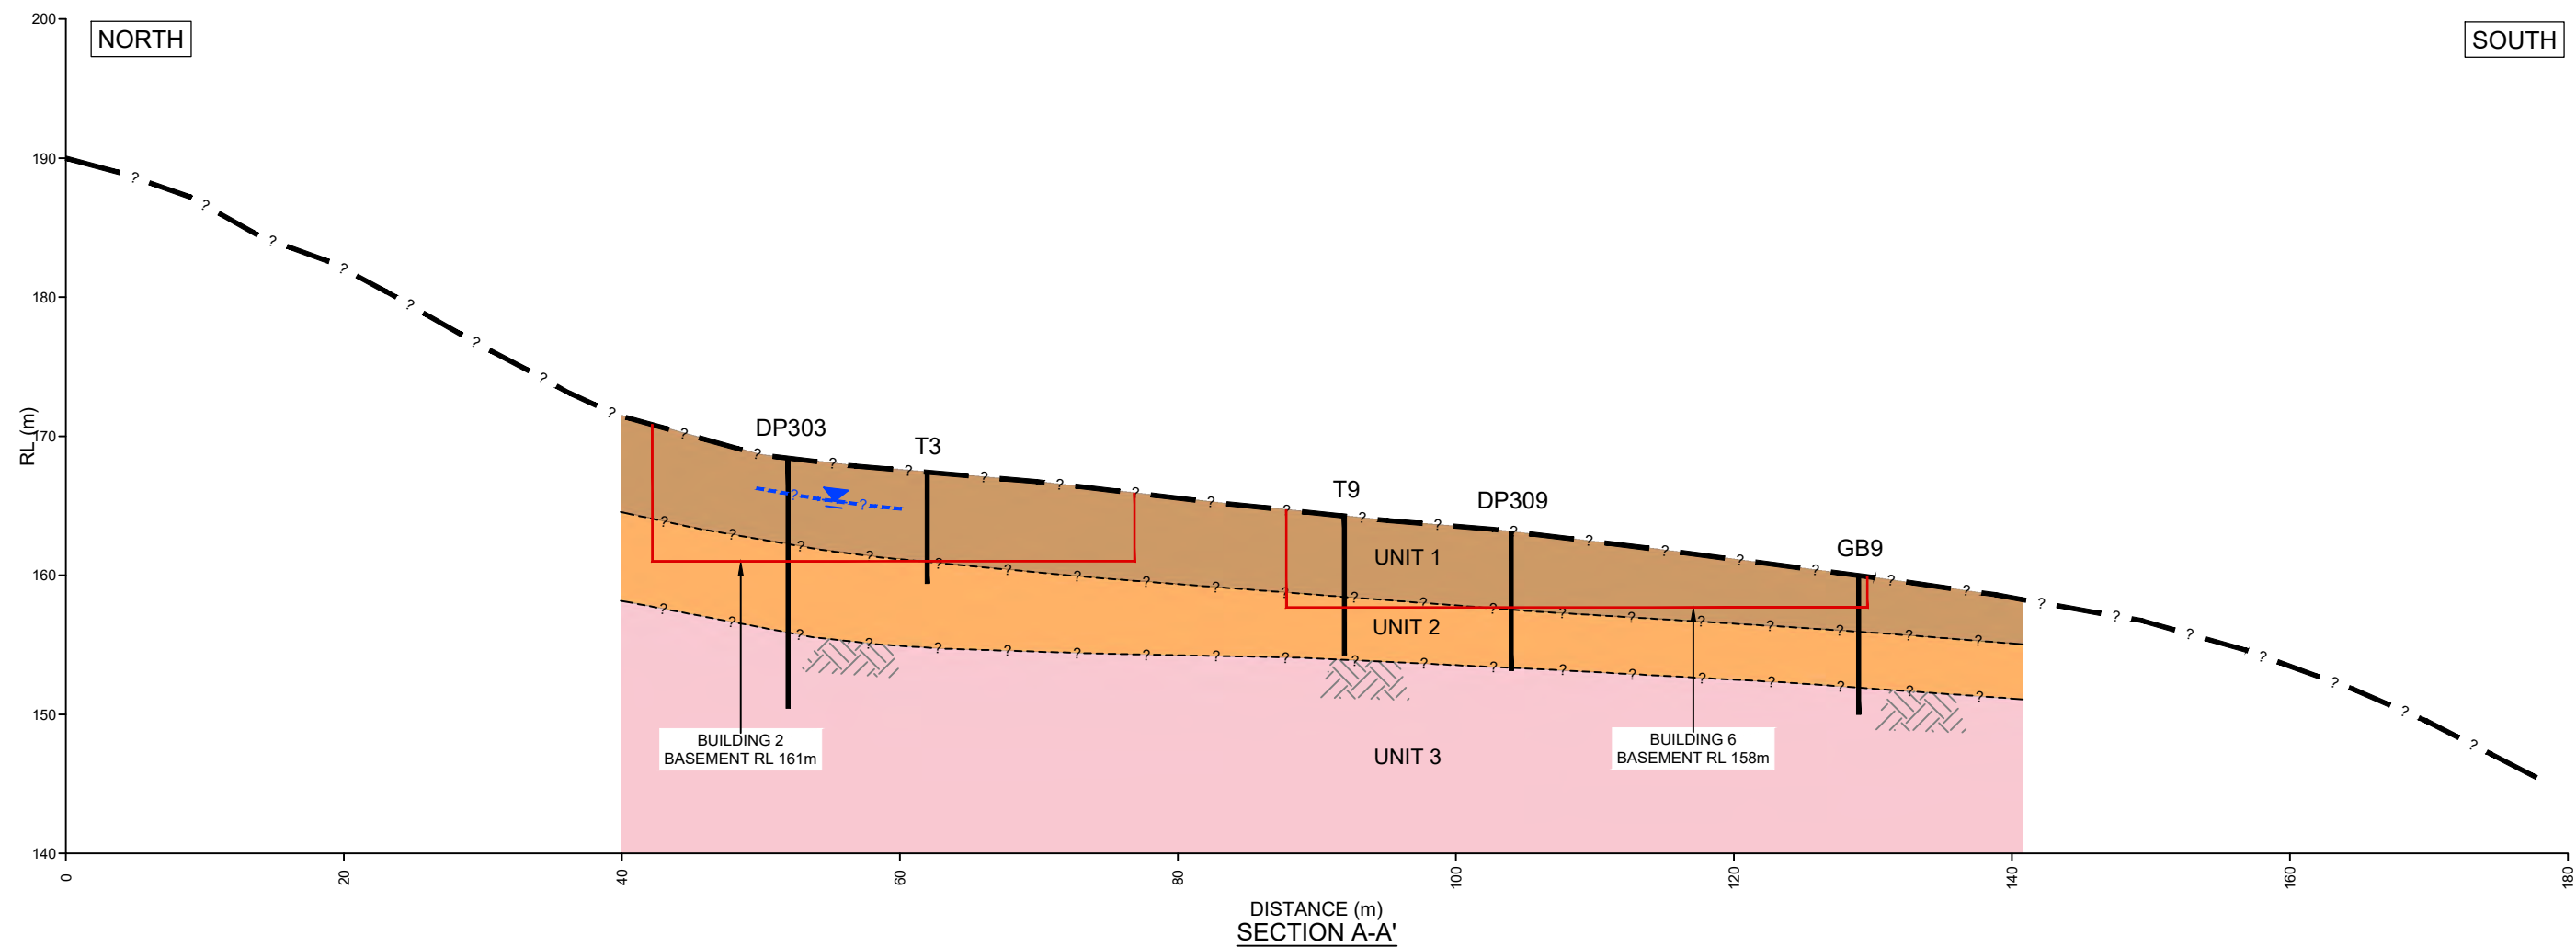
The attached Figures 4, 5 and 6 present our summary sketch long sections through the subject site developed from the available survey, borehole, and test pit information together with our observations on site. These sketch sections show that that there is currently no ground information for both the northern and southern thirds of site. however, in the central third of the site ground conditions are expected to comprise;

Land slip surface, while the soil and weathered rock may actually contain numerous slide planes, it should be assumed that the overall slide surface exists at the weathered rock/slightly weathered rock interface. Back analysis by others suggests that the friction angle of this slide surface could range from 10.5° to 16°
