Report on
Preliminary Site Investigation (Contamination)

Proposed Rezoning
Sub-Precinct 5, South Creek West, NSW

Prepared for
Boyuan Bringelly Pty Ltd

Project 92225.04
December 2022

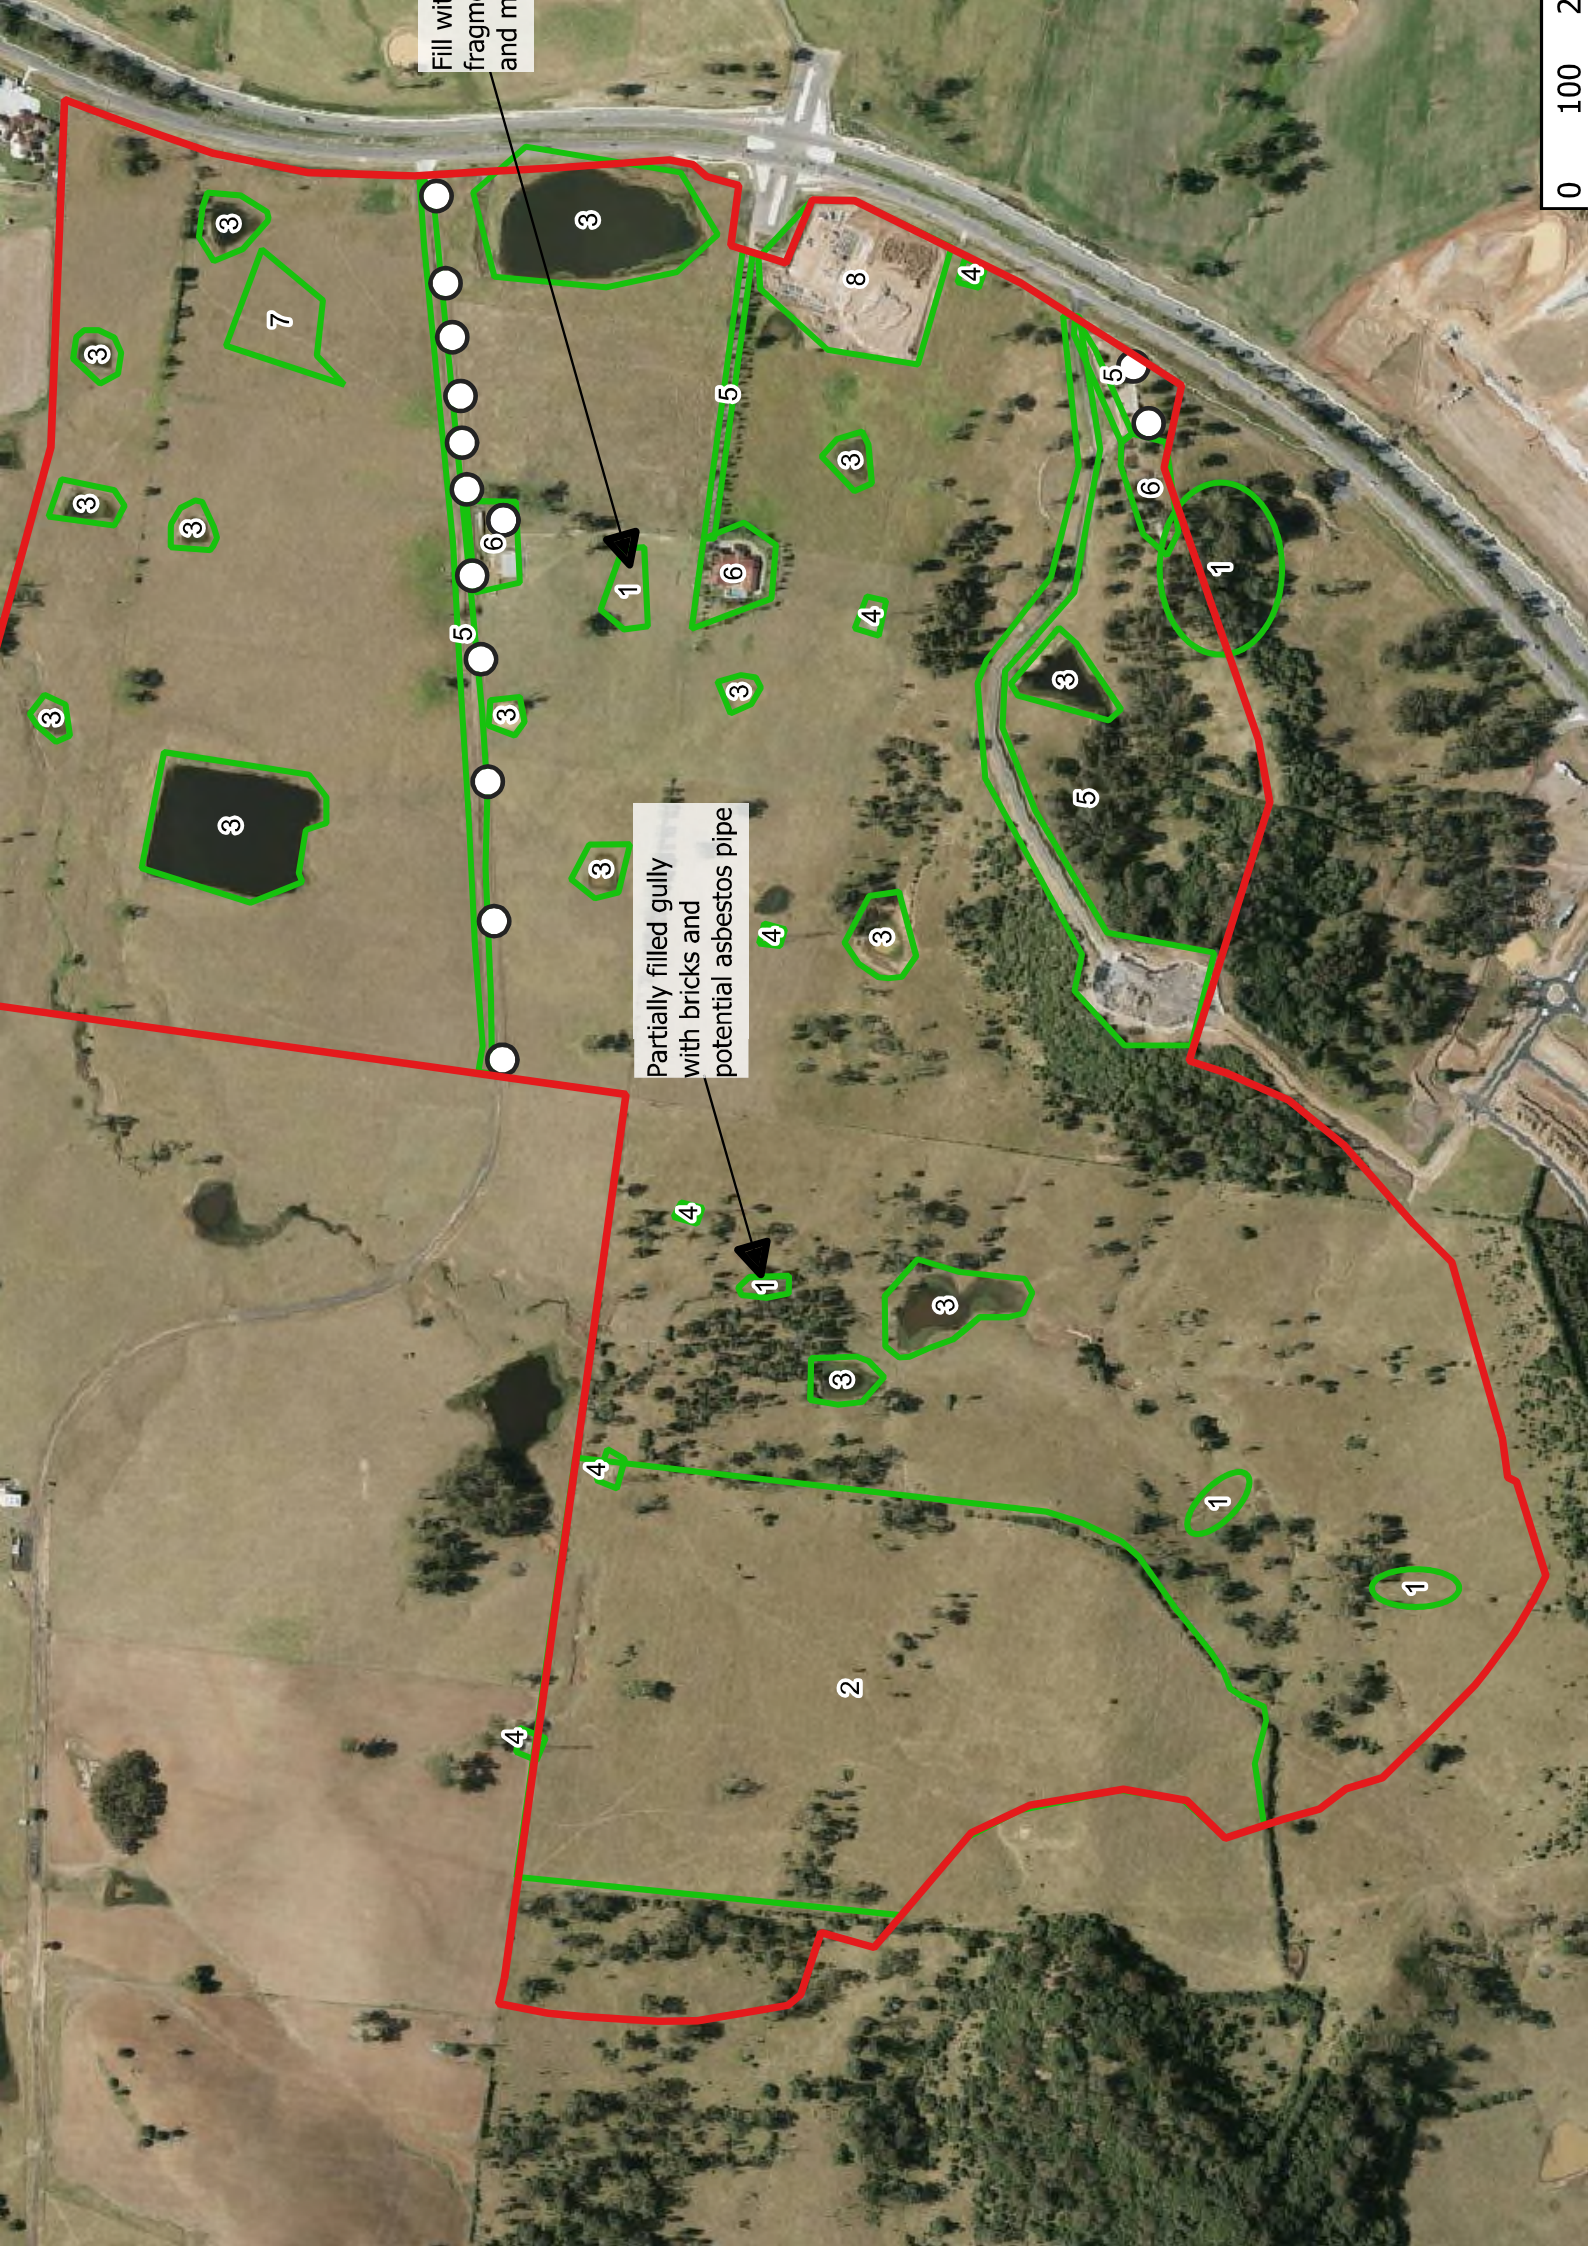
Fill with fragm and m

Partially filled gully with bricks and potential asbestos pipe

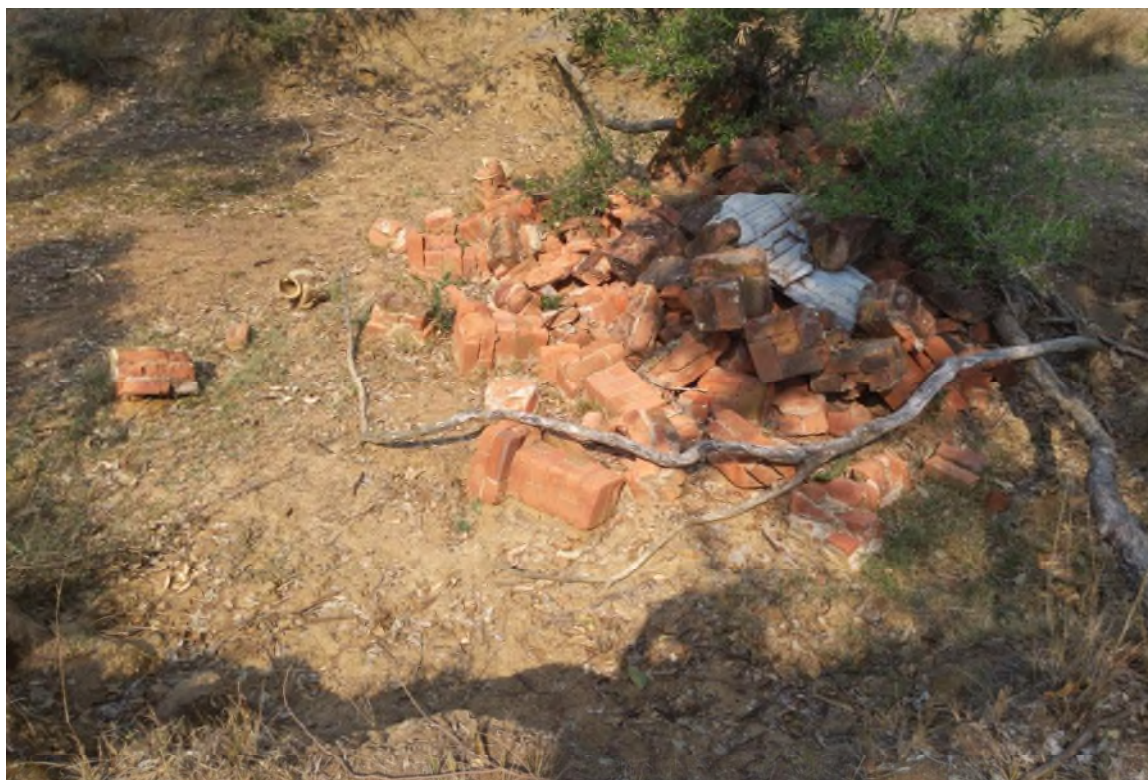
Photo 4 - Observed Fly Tipping

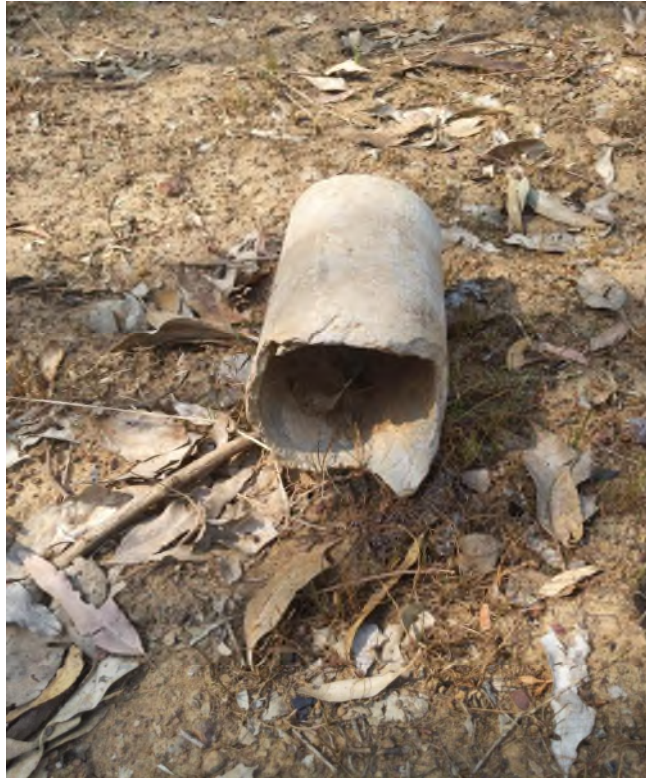
Photo 5 - Potential ACM Pipe

A hazardous building survey is also recommended to identify any hazardous building materials prior to any maintenance or site redevelopment.
