Report on  
Stability Assessment

Proposed Residential Subdivision  
South Creek West, Precinct 5, Cobbitty

Project 92225.06  
March 2023

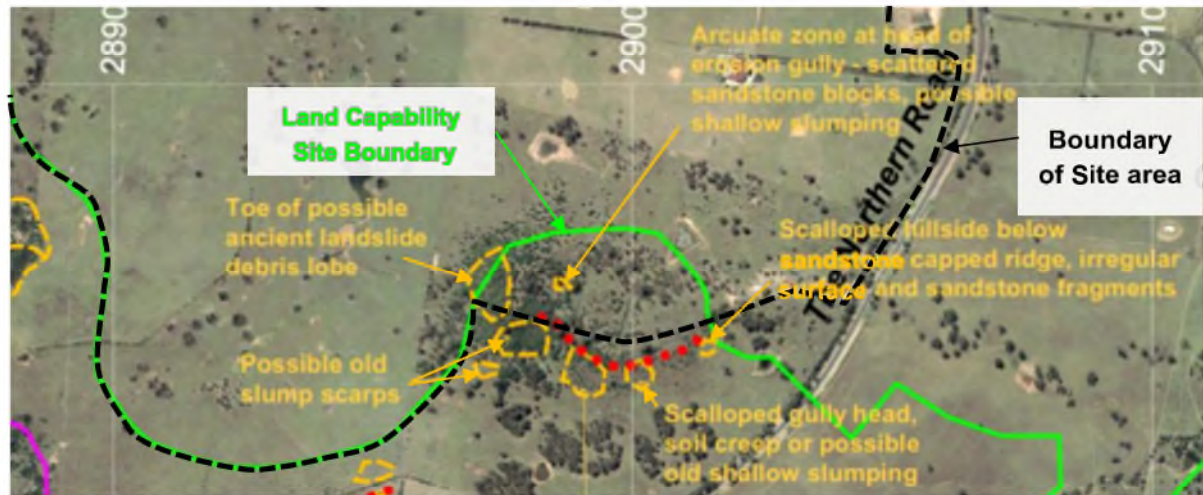
**Figure 2: Excerpt of slope instability mapping from DP's Land Capability Study (DP, 2007).**

- deep-seated hillslope instability affects the upper slopes of the ridgeline (near the southern site boundary), which is considered to be a major constraint to development;
- observed or inferred surficial soil creep, and possible ancient slumping of residual soils, was present in over-steepened gullies and steeper ridgelines below mapped (or interpreted) un-named sandstone members of the Bringelly Shale geological formation (outcropping to the south of the site area: denoted using red dotted lines in Figure 2);
- potential soil creep, shallow slump instability of soil, and erosion features are likely to impose constraints to development (minor to intermediate), including for residential and infrastructure development in both current landslide (movement-affected) areas, and bordering areas with equivalent topography and stratigraphy.

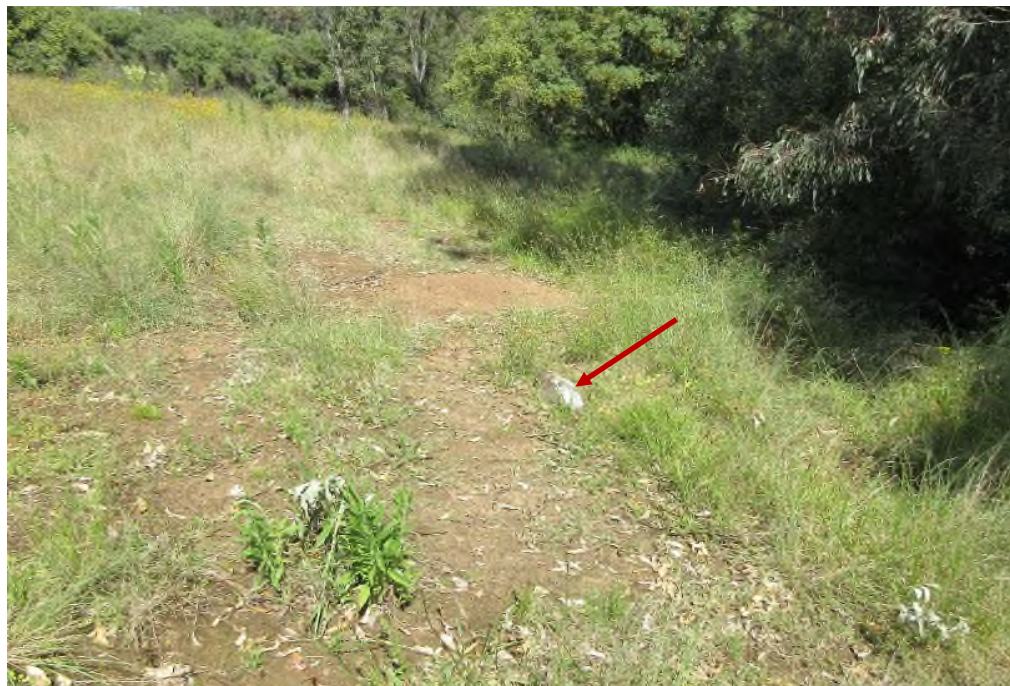
Photo 6 - Sandstone boulders partially buried within the slope (inferred colluvial soil).
