Report on  
Preliminary Site Investigation (Contamination)

Catherine Field Planning Proposal  
Charlesworth Close, Springfield Road, Camden Valley  
Way & Catherine Field Road, Catherine Field NSW

Project 208526.00  
April 2022

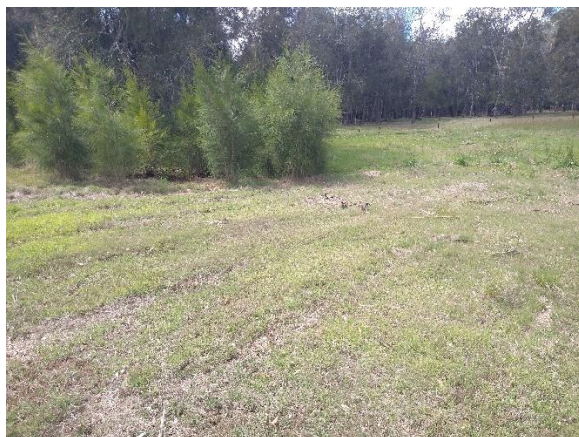
- Lot 11/House No. 60:
  - o The south-eastern half of the large farm dam is included in the lot boundary. The ground surrounding the dam within Lot 11 was covered with grass; some patchy areas where grass cover was sparser was observed (Figure 2) and may indicate the presence of a change in the soil type (eg., fill).

**Figure 2: Patches of sparser grass cover near dam (Lot 11)**

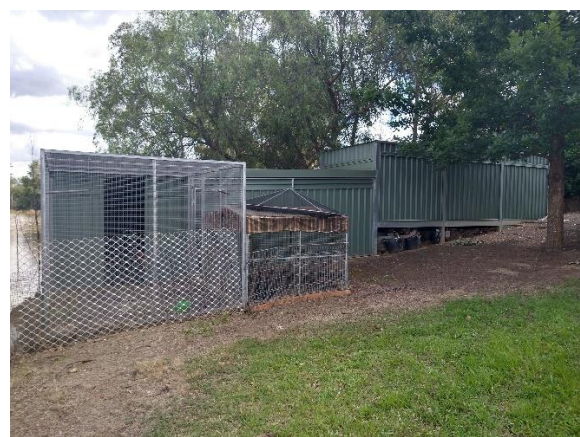
- o A metal and chain link structure south-west of the house next to the dam was observed, likely used to house animals (potentially an aviary – Figure 3).

**Figure 3: Metal and chain link shelter (likely aviary – Lot 11)**

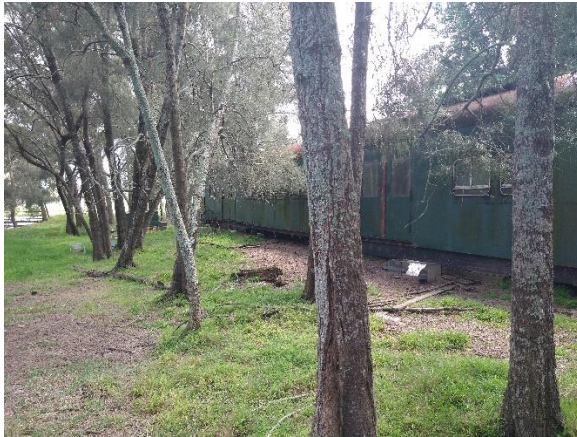
- o A rusted disused train carriage was located next to the farm dam (Figure 4), which was placed here by the occupants of the lot.
  - o Minor anthropogenic non-soil debris was observed across the site, including metal, terracotta pipes, wood, wooden sump pallets. A steel and wood shelter were observed on an island in the dam which may be remnants of an old well. A rusted half-drum was also observed, possibly being an old barbeque (BBQ).

**Figure 4: Train carriage near farm dam (Lot 204)**

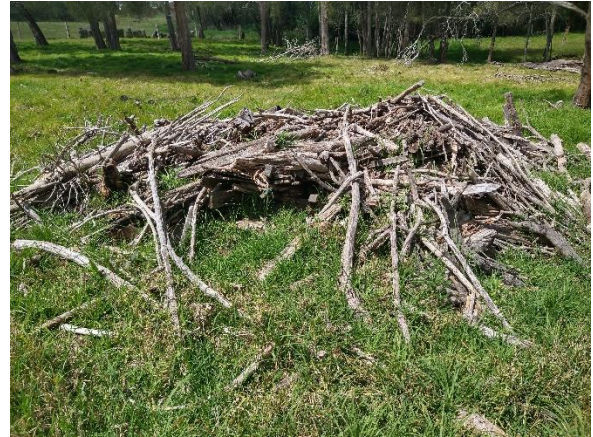
- o Two stockpiles of wood and timber were present in the north-eastern portion of the site (Figure 5).

**Figure 5: Stockpile of timber and wood (Lot 204)**

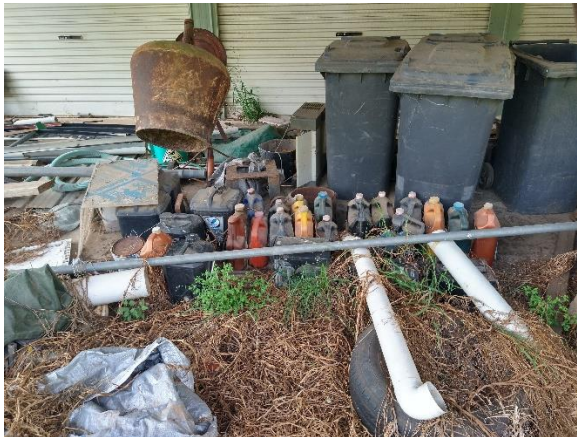
- o Two large metal sheds were located in the north-eastern portion of the site, and a caravan (likely disused) was stored adjacent. Several small (1 litre) containers of fuel were observed on a concrete platform next to (south) of the easternmost shed (Figure 6); the concrete platform appeared to slope towards likely unconsolidated ground cover which was covered in dense grass at the time of inspection. Discarded electrical appliances and wooden pallets were also observed nearby. Immediately east of the easternmost shed, three loose possible asbestos containing materials (ACM) pipes were observed (Figure 7), their coating in poor condition.

**Figure 6: Storage of fuel/oil containers on sloped concrete ground (Lot 204)**

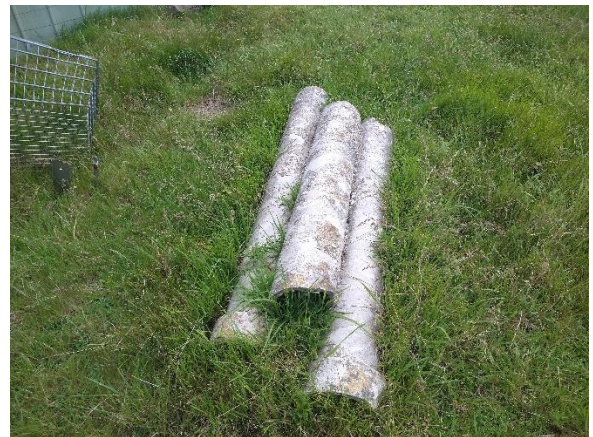
**Figure 7: Three loose suspected ACM pipes (Lot 204)**

- S7: Asbestos pipes from historical rural residential/pastoral land use – loose ACM pipes were observed on site and were commonly used for drainage for private residences in the region.

Additionally, given the presence of suspected hazardous building materials in houses and sheds on site, DP recommends that a hazardous building materials (HAZMAT) survey is completed prior to the demolition of structures. Demolition of structures containing hazardous building materials should be carried out by a licenced asbestos removal contractor (if required).

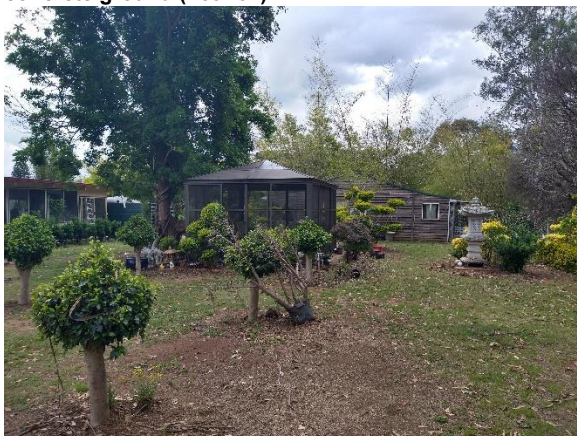
- o The septic system for the house was located south of the main residence.
  - o Much of the garden area to the north, east and north-west of the house appeared to be used as a nursery (Figure 8). Storage of plant pots and other gardening related supplies was observed in this area of the site (Figure 9).

**Figure 8: Possible nursery land use surrounding residence (Lot 4)**

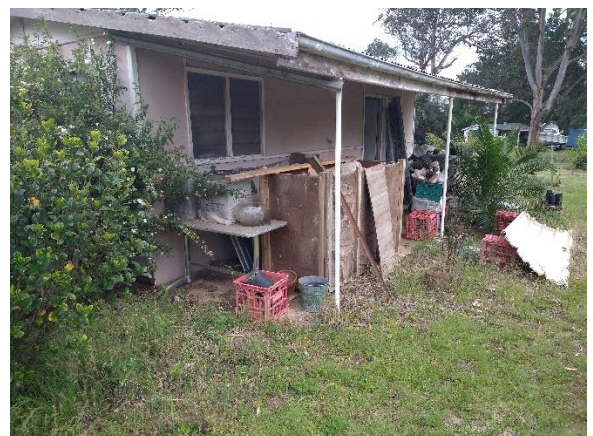
**Figure 9: Storage of materials at rear of residence**
