Project 217600.02
25 August 2023
R.001.Rev1
GAR

Cover Letter - Summary of Contamination Investigation
Proposed Aland Leppington - Civic Centre
Lots 1 & 2 DP 812366, Rickard Road, Leppington NSW

Project 217600.00
October 2022

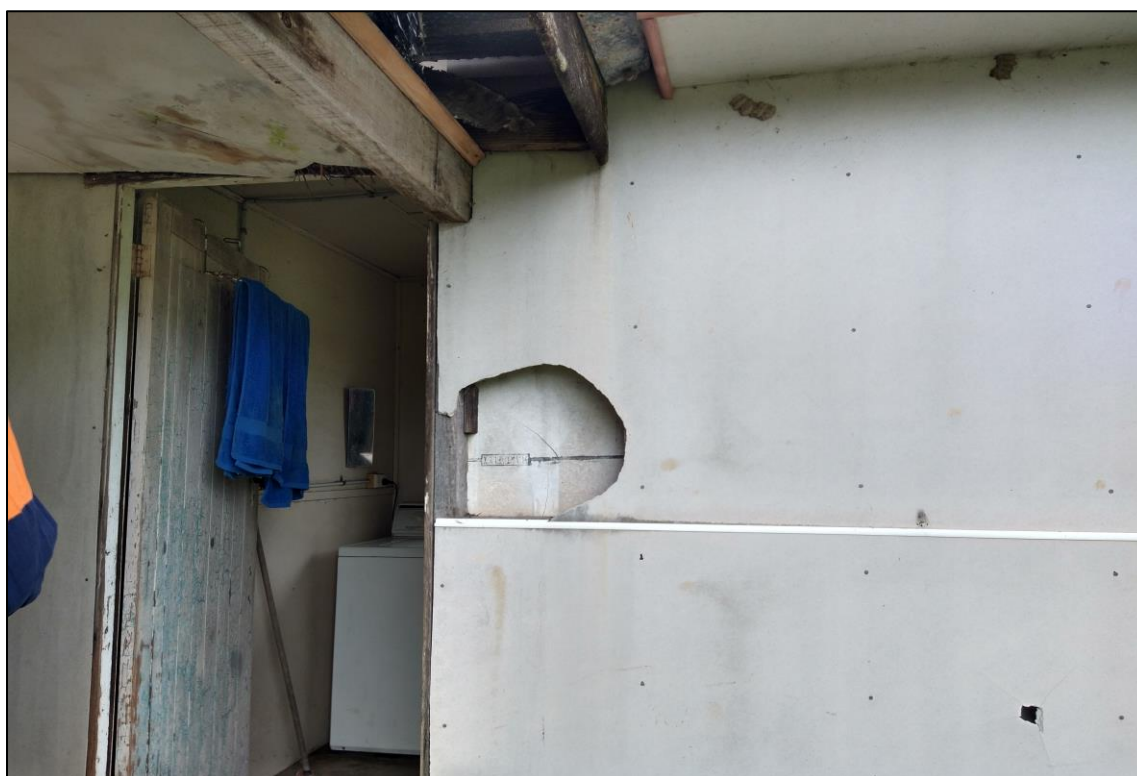
- Houses and metal sheds were observed in the south eastern portion of Site A, suspected to be partly constructed of hazardous building materials, such as asbestos-containing materials (Photographs 1 to 3);

Photograph 2 - 'Hardiflex' fibre material, suspected to contain ACM, used in laundry in south eastern portion of Site A.

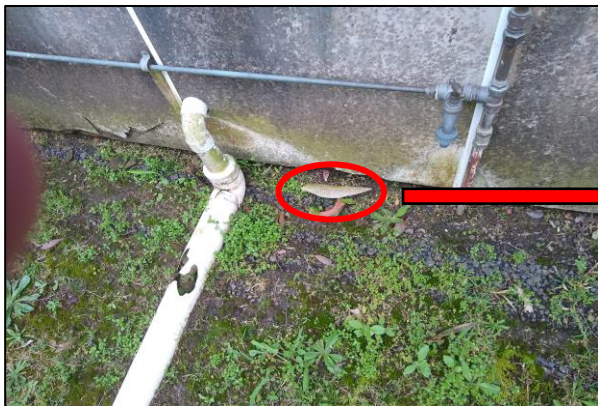
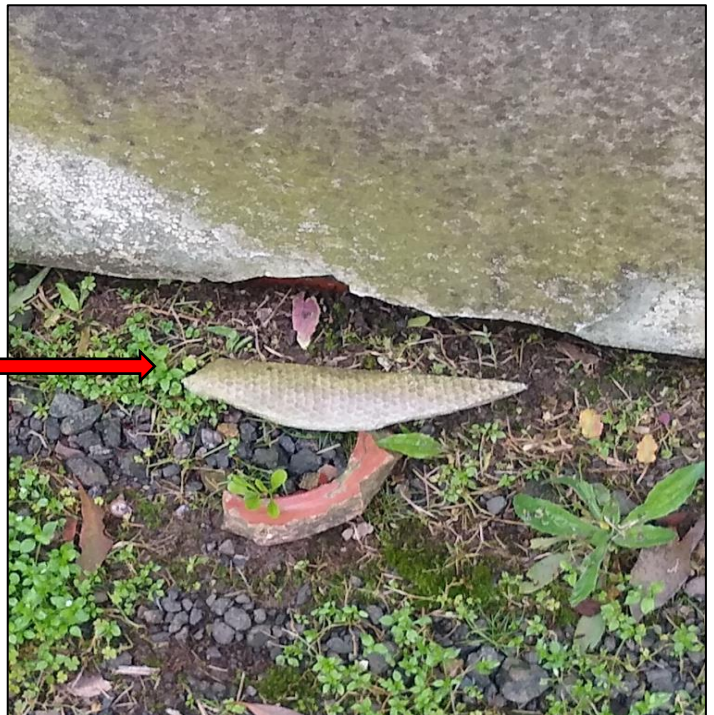
Photograph 3 - Suspected fragment of ACM observed in the south eastern portion of Site A.

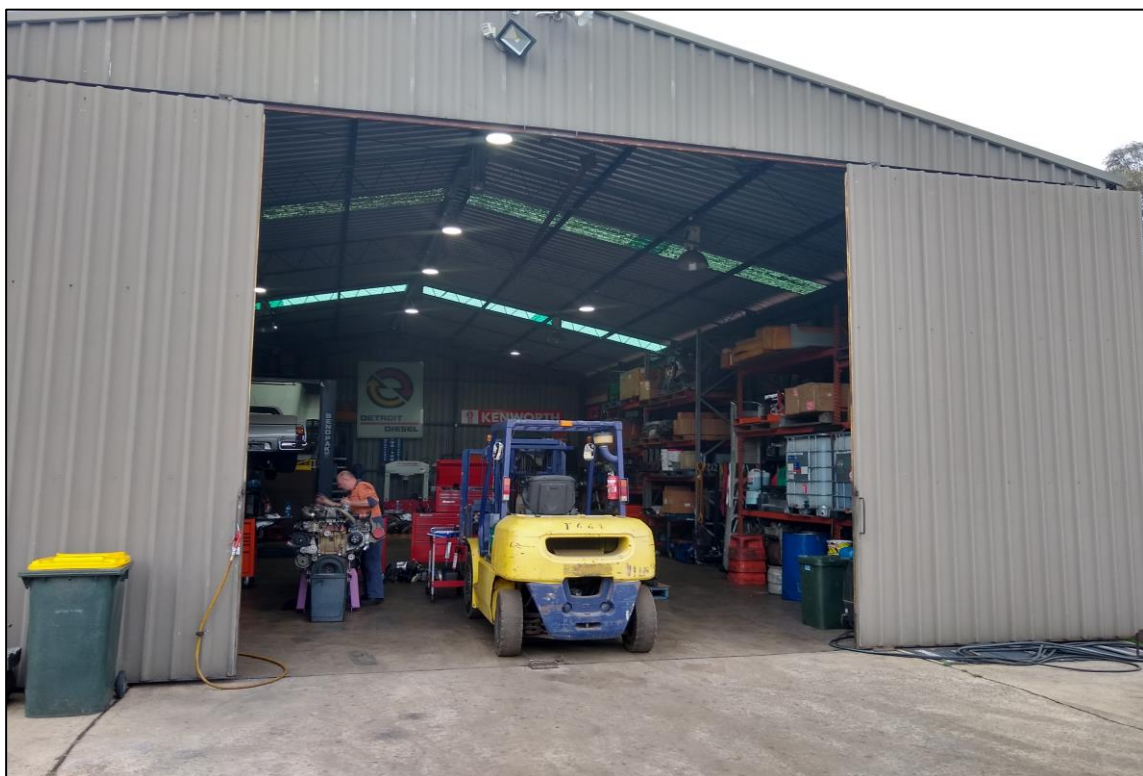
- The south eastern corner also comprised a large metal shed built on a concrete slab, which was primarily used as a garage for private truck maintenance and repairs. The shed also contained intermediate bulk containers (IBC), some containing engine oils, and smaller containers for storage of fuels and chemicals (Photograph 4);

Photograph 4 - Large metal shed used as a garage for truck maintenance and repairs, containing intermediate bulk containers (IBC) and smaller fuels and chemical storage.

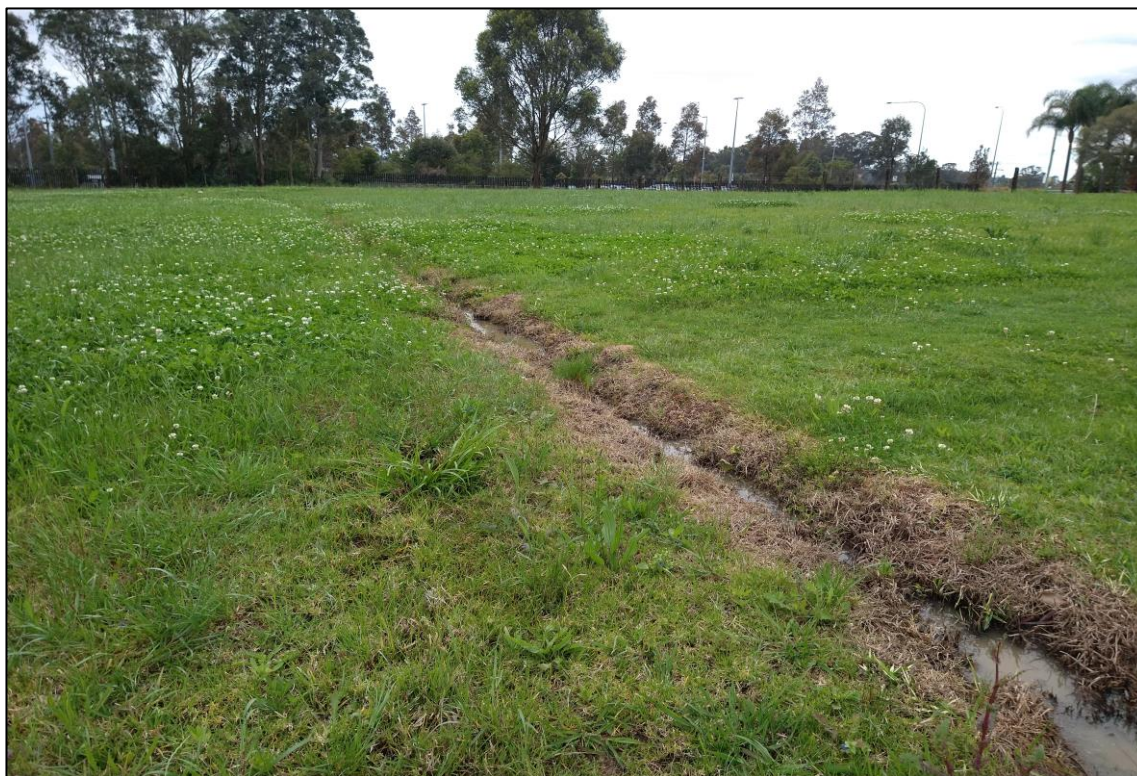
Photograph 11 - Drainage channel observed in the eastern half of the Site A.

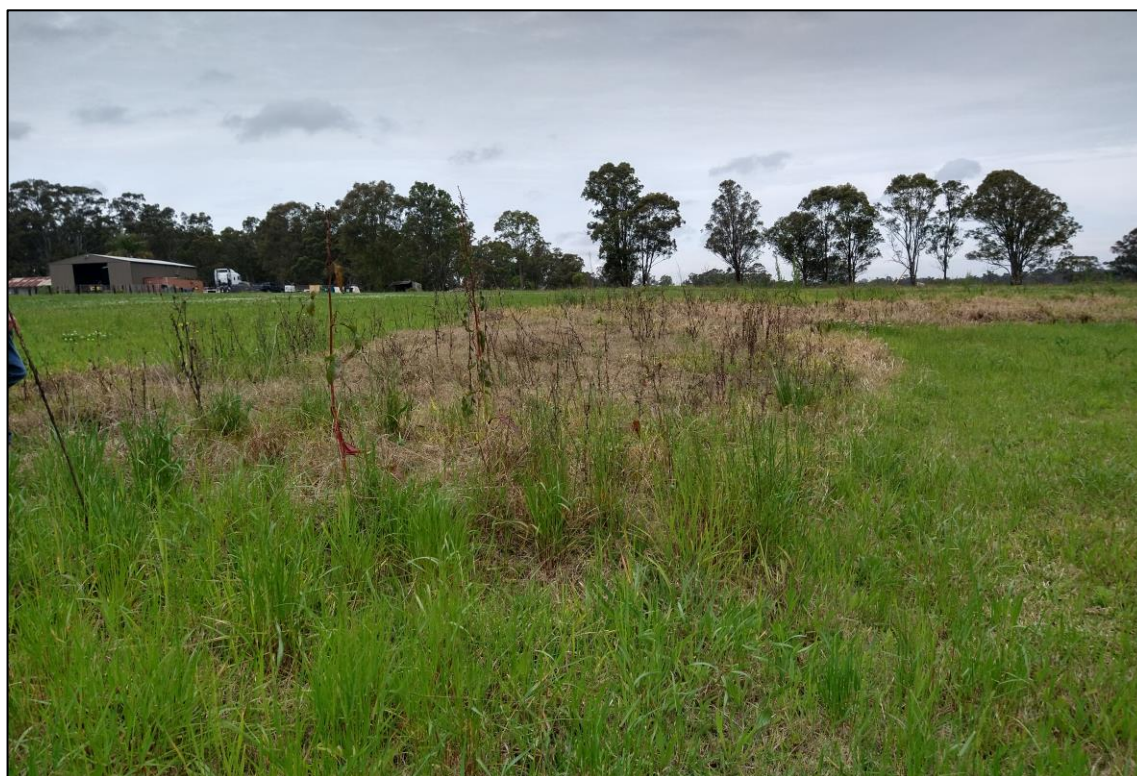
Photograph 12 - Potential fill, as indicated by slightly elevated areas of ground, located in the central portion of Site A.
