Project 217600.02
25 August 2023
R.002.Rev1
GAR

Cover Letter - Summary of Contamination Investigation
Proposed Aland Leppington Residential Core
Lots 37 & 38A Deposited Plan 8979, Rickard Road, Leppington NSW

Project 217600.00
October 2022

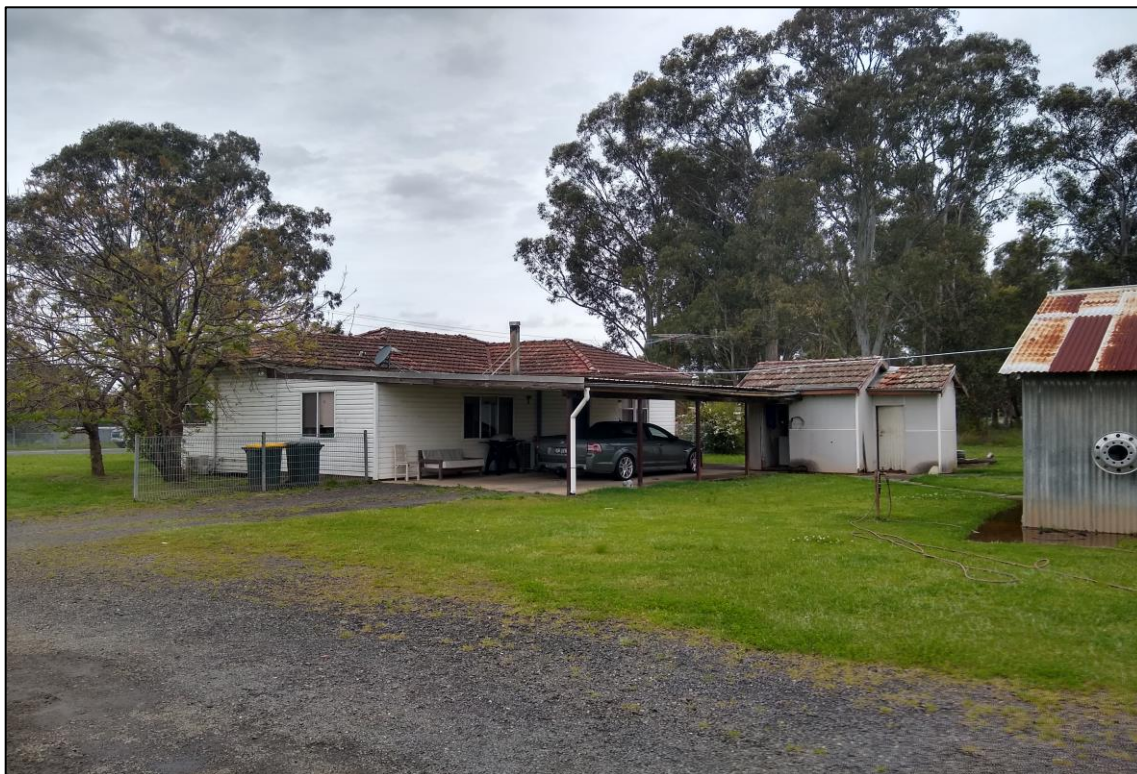
- Houses and metal sheds were observed in the south eastern portion of Site A, suspected to be partly constructed of hazardous building materials, such as asbestos-containing materials (Photographs 1 to 3);

Photograph 1 - Buildings in south eastern portion of Site A, suspected to be partially constructed of asbestos containing material (ACM).

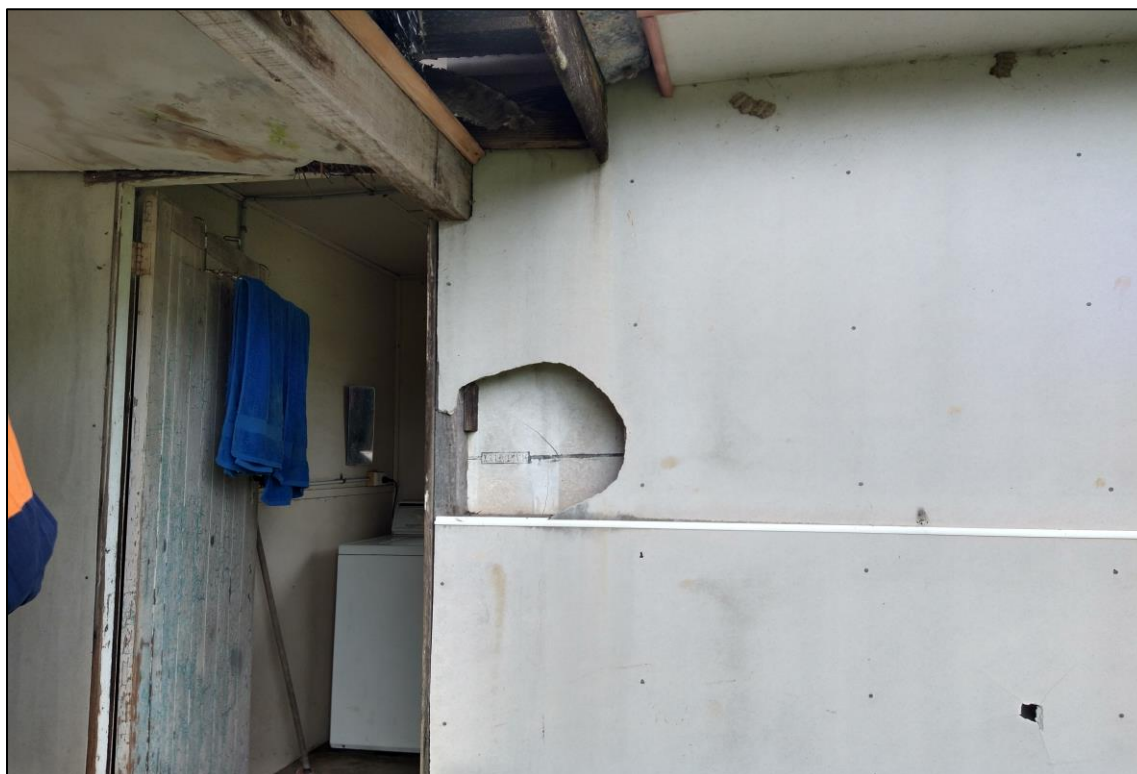
Photograph 2 - 'Hardiflex' fibre material, suspected to contain ACM, used in laundry in south eastern portion of Site A.

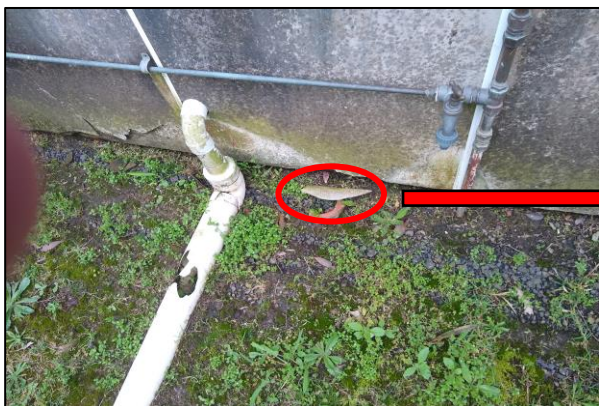
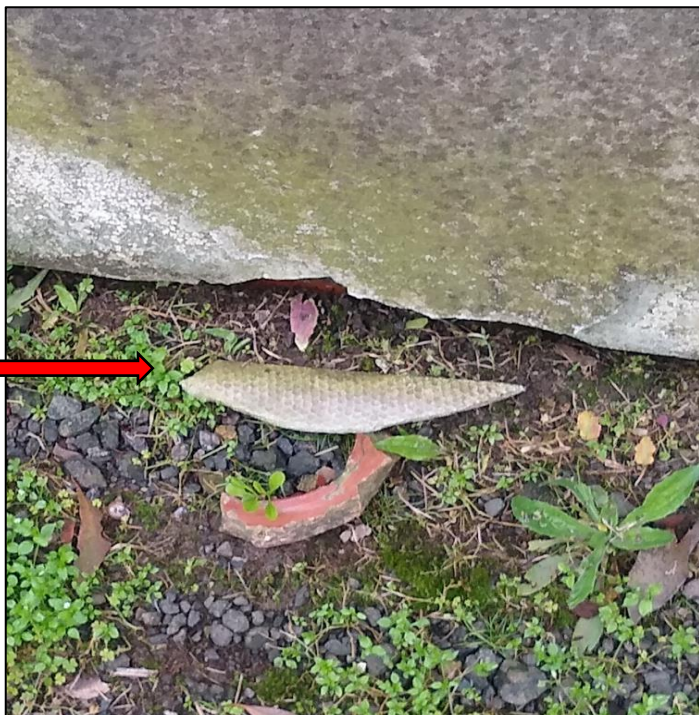
Photograph 3 - Suspected fragment of ACM observed in the south eastern portion of Site A.

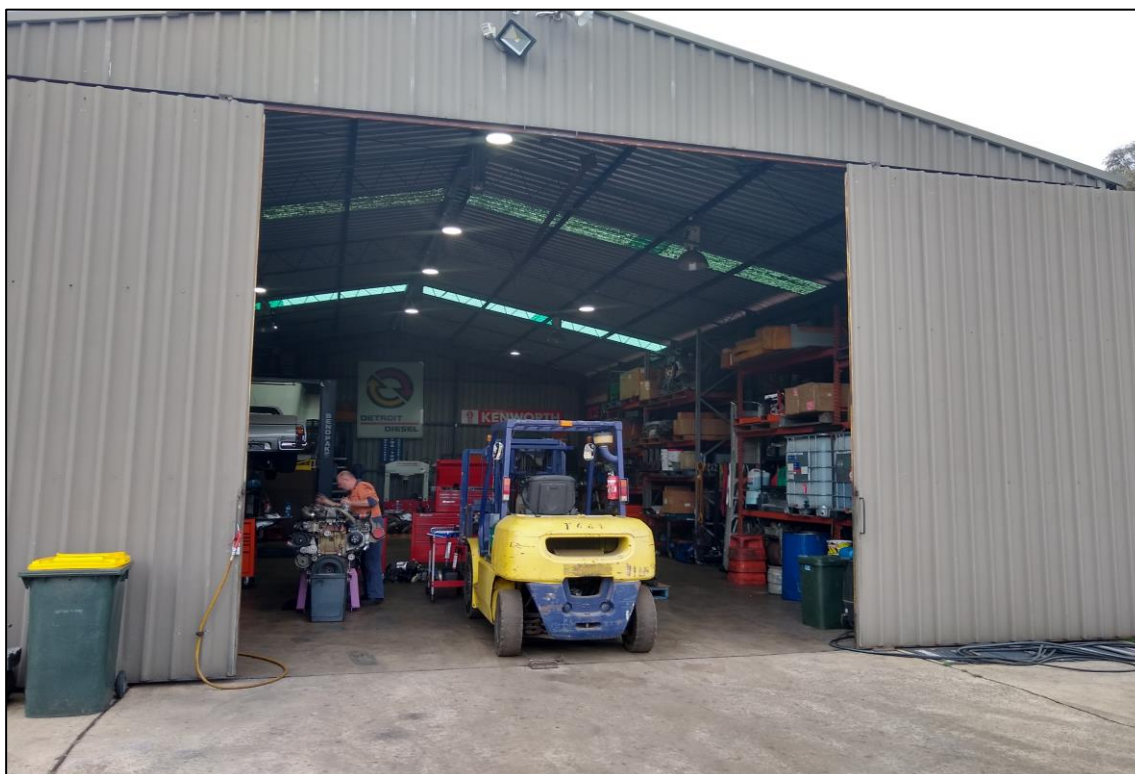
- The south eastern corner also comprised a large metal shed built on a concrete slab, which was primarily used as a garage for private truck maintenance and repairs. The shed also contained intermediate bulk containers (IBC), some containing engine oils, and smaller containers for storage of fuels and chemicals (Photograph 4);

Photograph 4 - Large metal shed used as a garage for truck maintenance and repairs, containing intermediate bulk containers (IBC) and smaller fuels and chemical storage.

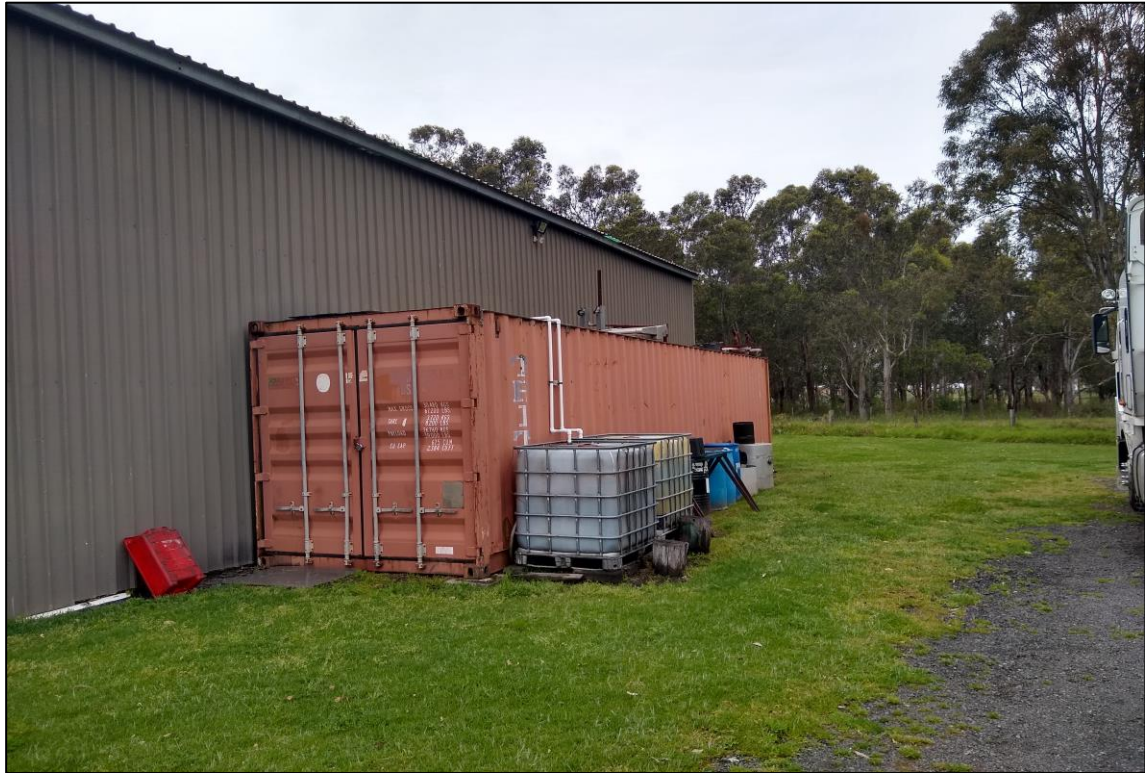
Photograph 5 - A shipping container, additional IBCs, jerry can and oil drums located in the south eastern portion of Site A.

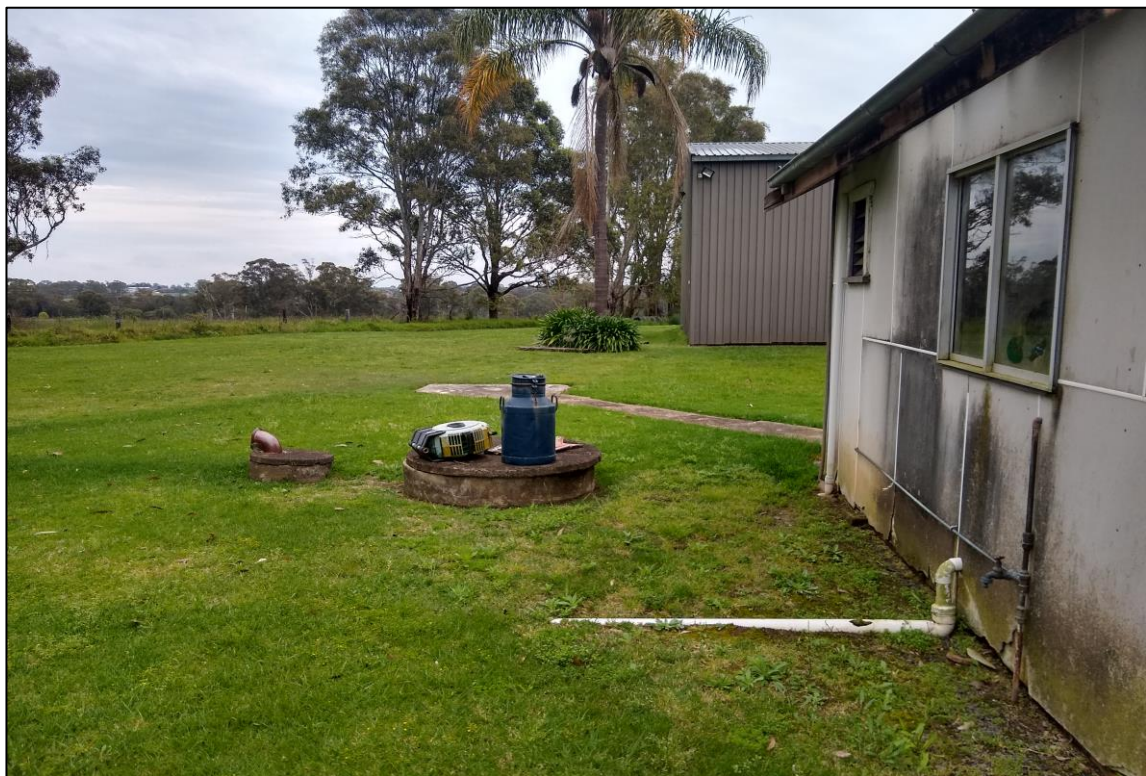
- A septic tank was identified in the south eastern corner of Site A, appearing to be connected to a nearby PVC pipe, which was in poor condition (Photograph 6). Another septic tank was also identified in the eastern area of Site A (Photograph 7);

Photograph 6 - Septic tank identified in the south eastern corner of Site A, appearing to be connected to a nearby PVC pipe, which was in poor condition.

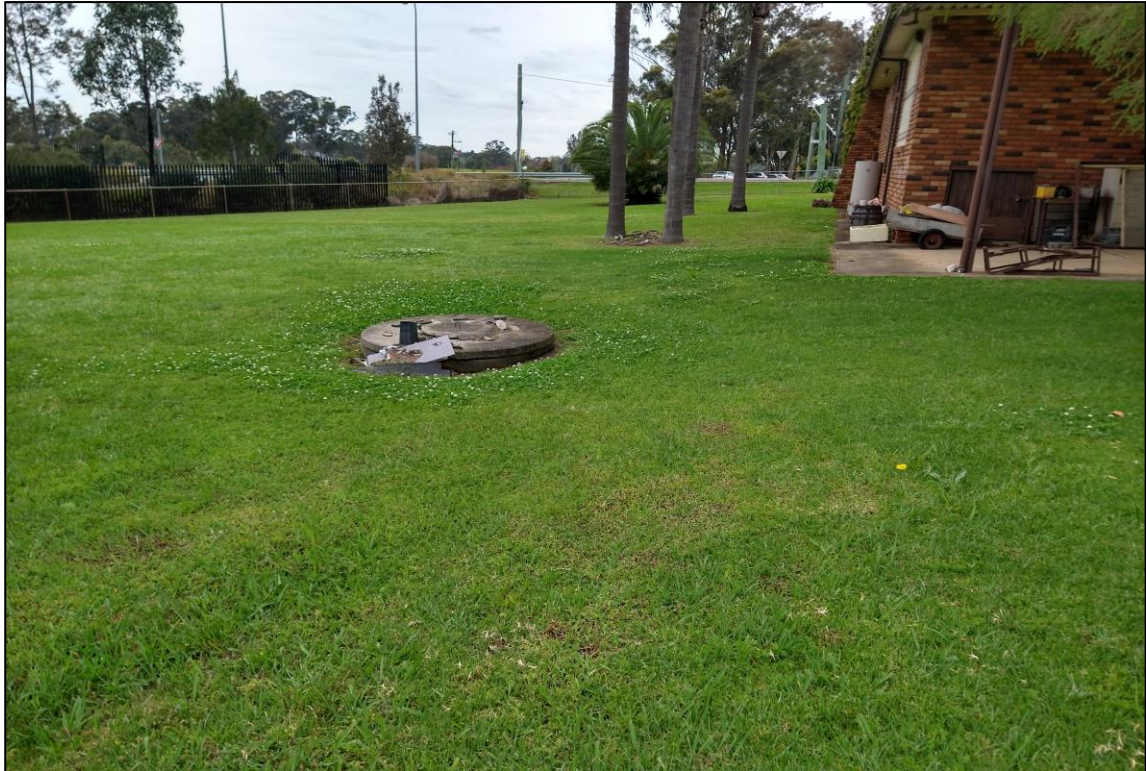
Photograph 7 - Septic tank located in the eastern area of Site A.

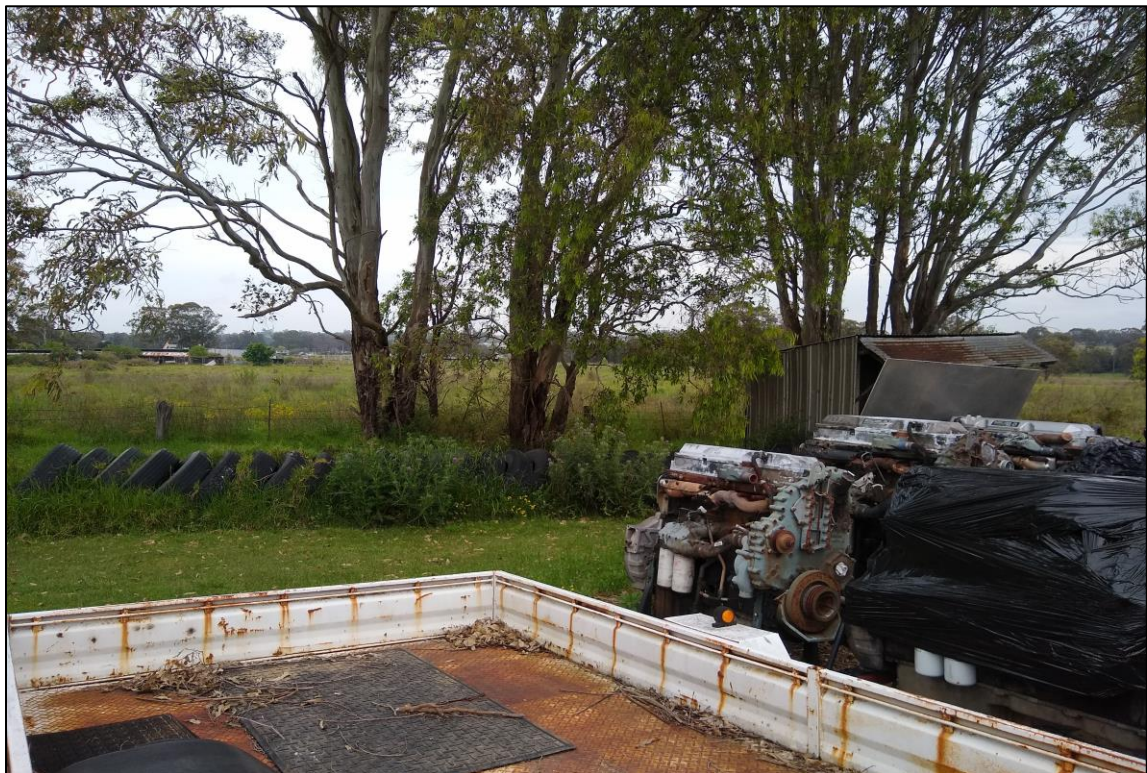
Photograph 8 - Rubber tyres, a metal shed and various machinery parts were aligned along the southern eastern boundary of Site A.

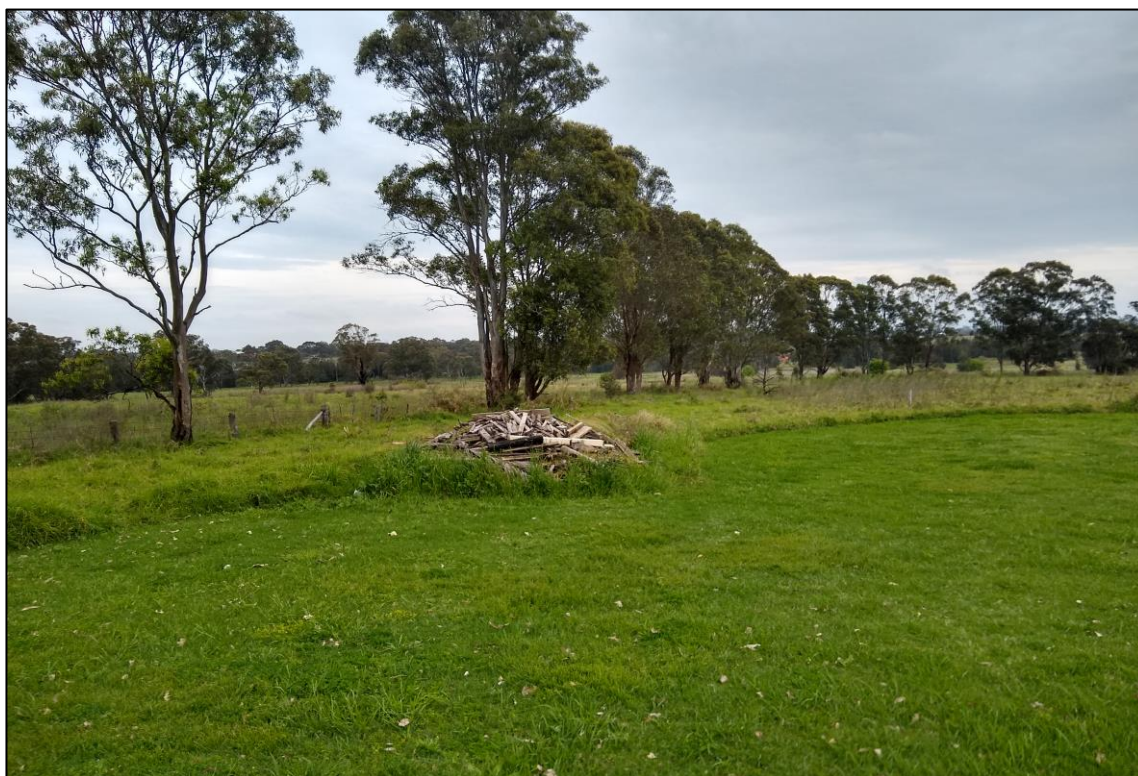
Photograph 9 - Timber stockpile located in the south eastern area of Site A.

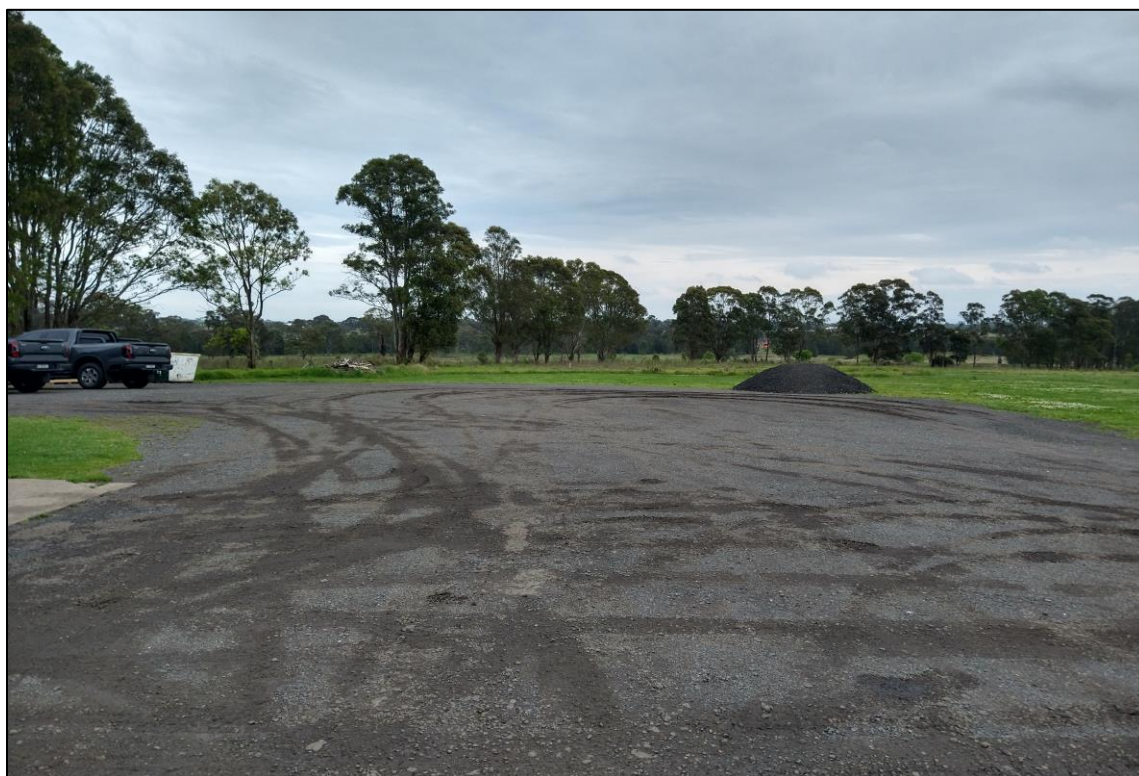
Photograph 10 - Stockpiled quarried material located in the south eastern area of Site A.

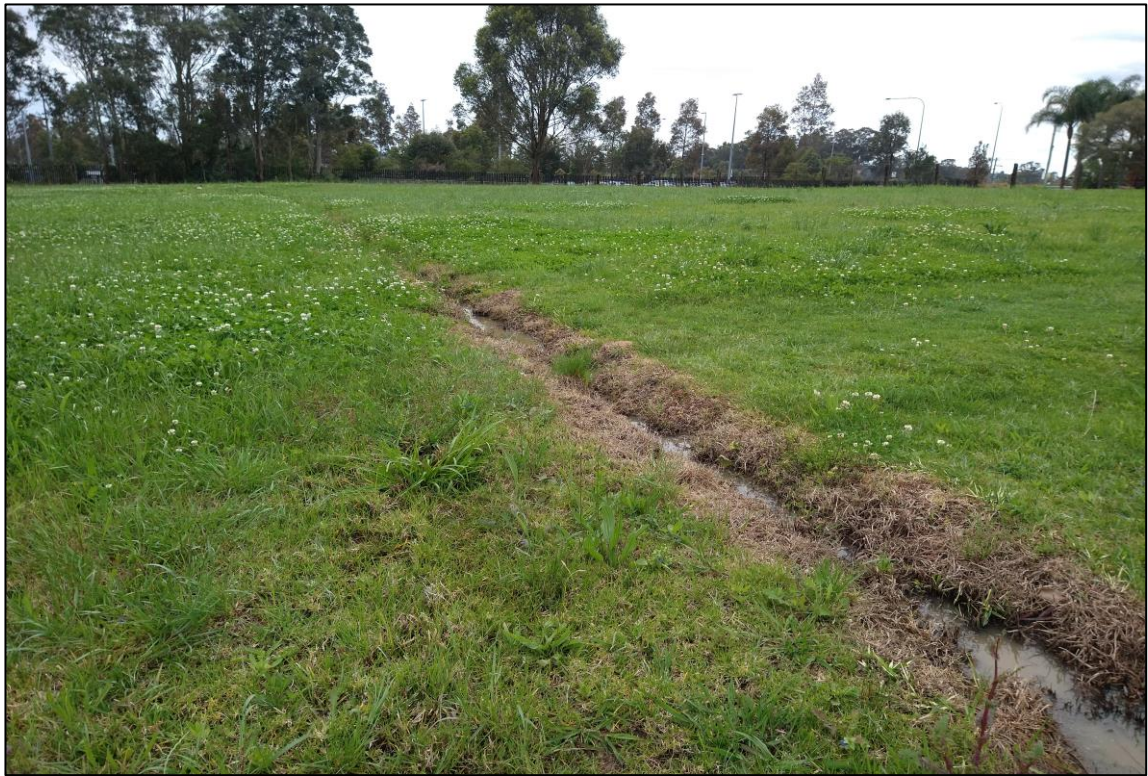
Photograph 11 - Drainage channel observed in the eastern half of the Site A.

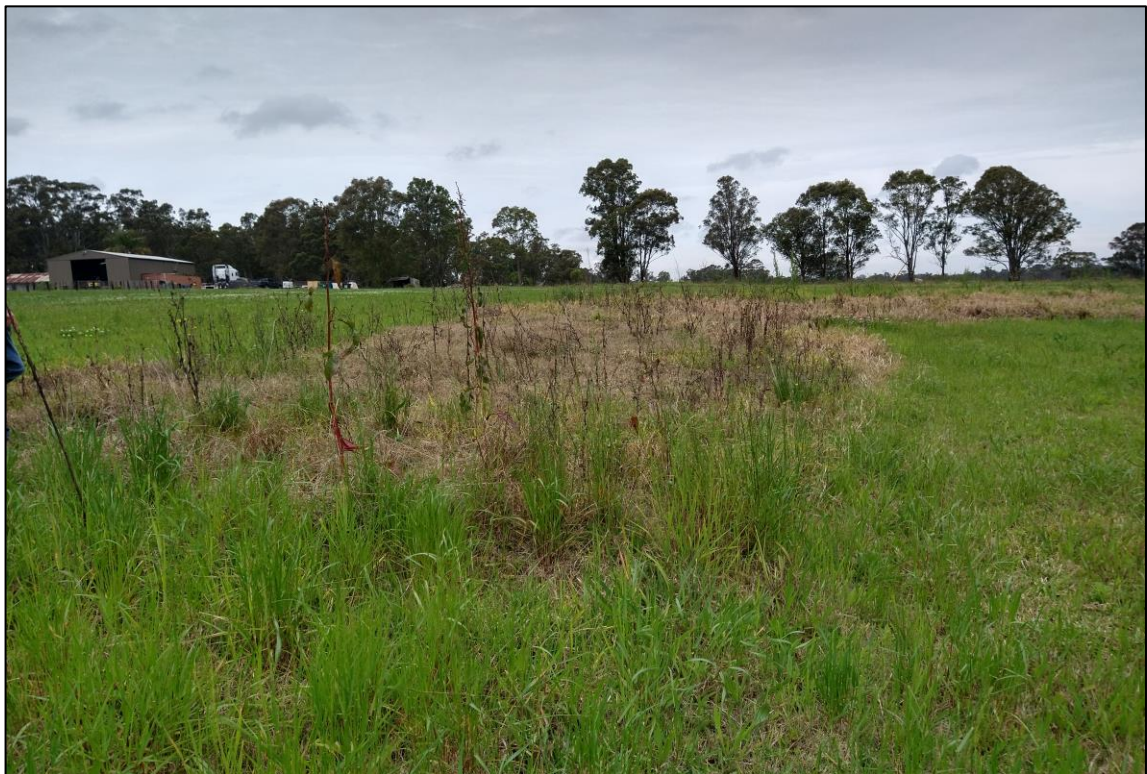
- A drainage channel, running a few metres long on a vertical axis, was observed in the eastern half of the site (Photograph 11); and
- Potential fill, as indicated by slightly elevated areas of ground, was identified in the central portion (Photograph 12).

Photograph 12 - Potential fill, as indicated by slightly elevated areas of ground, located in the central portion of Site A.

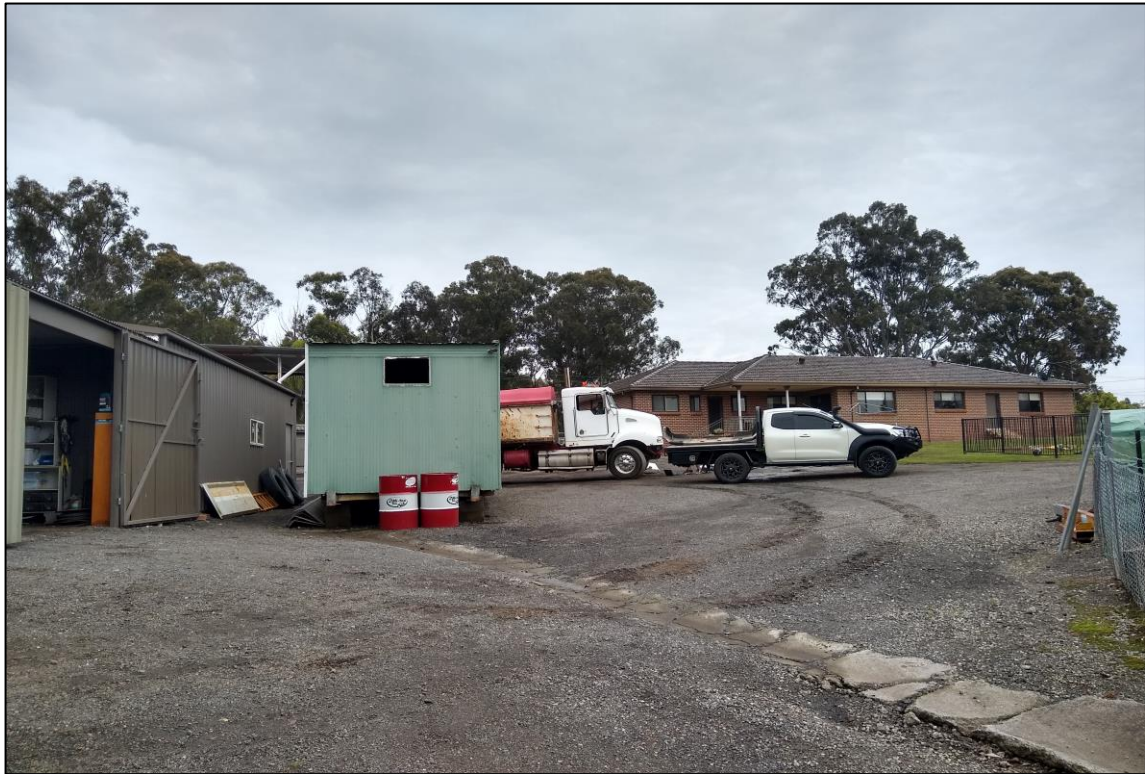
- Houses and metal sheds were observed in the north western and south western portions of the site, with some structures suspected of being partially constructed of hazardous building materials, such as asbestos-containing materials (Photographs 13 to 15, Appendix C of the PSI);

Photograph 13 - Houses and sheds in north western portion of Site B, potentially containing ACM.

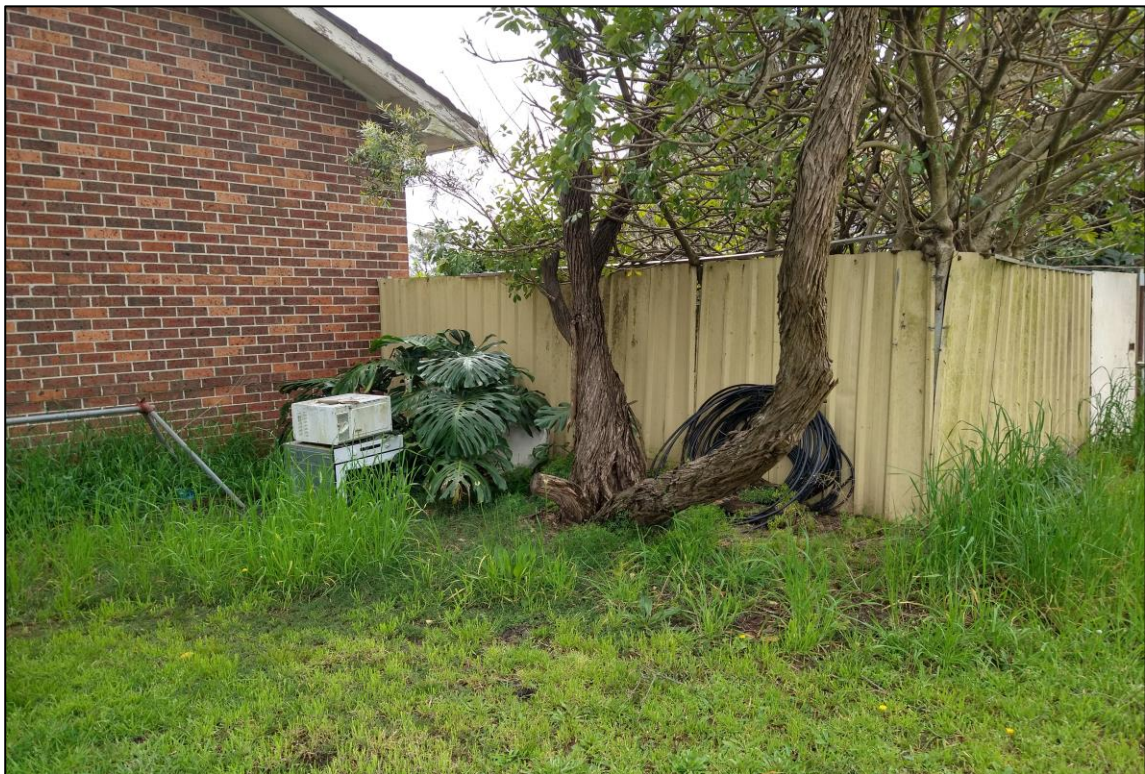
Photograph 14 - Houses and sheds in south western portion of Site B, potentially containing ACM.

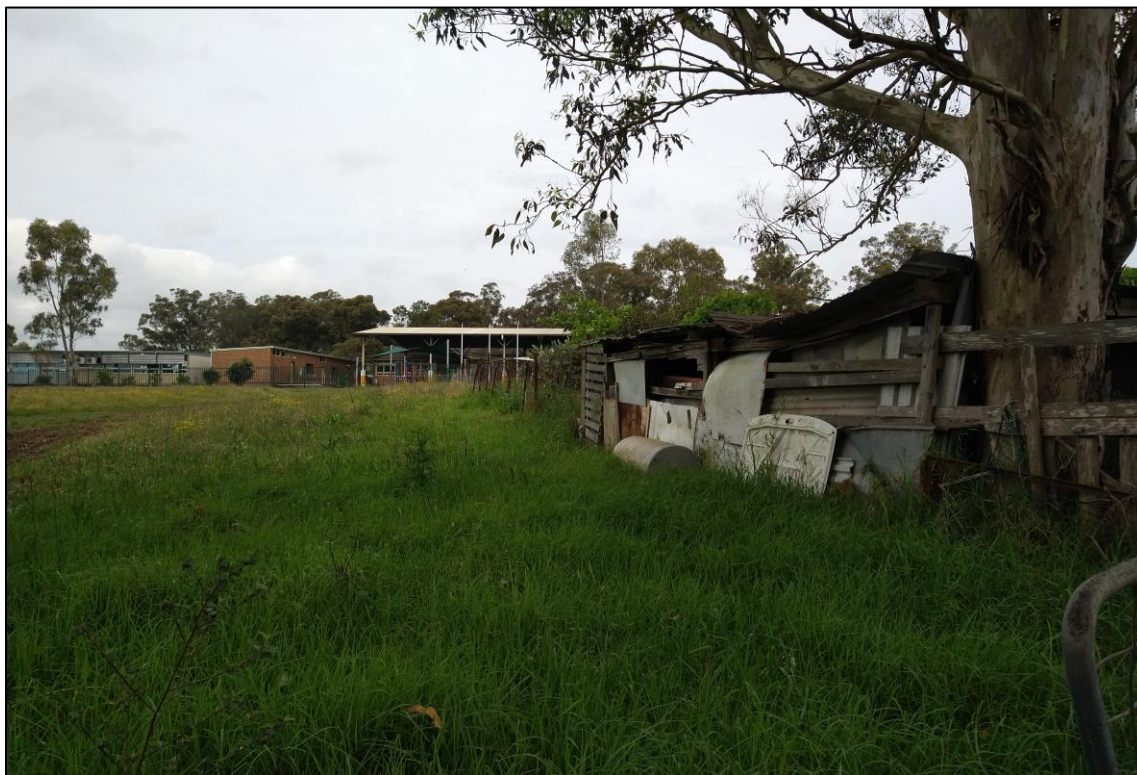
Photograph 15 - Sheds in south western portion of Site B, potentially containing ACM.

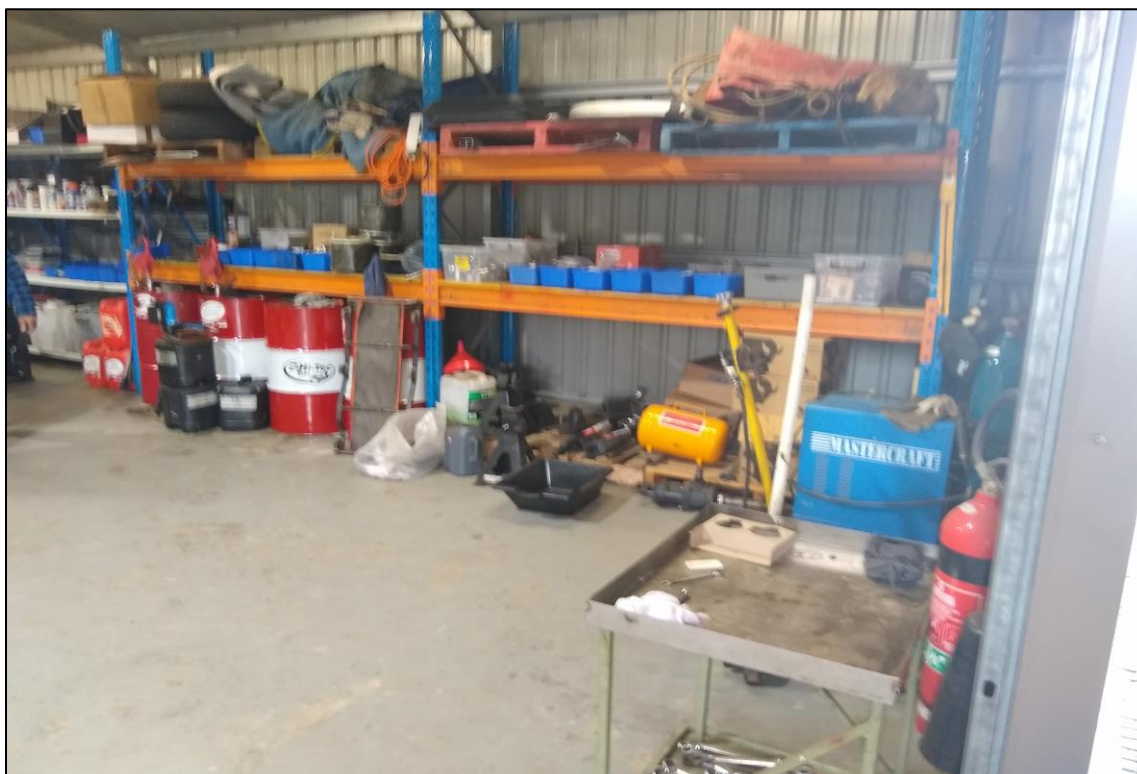
Photograph 16 - Large metal shed used as a garage for truck maintenance and service, containing oil drums and smaller fuels and chemical storage.

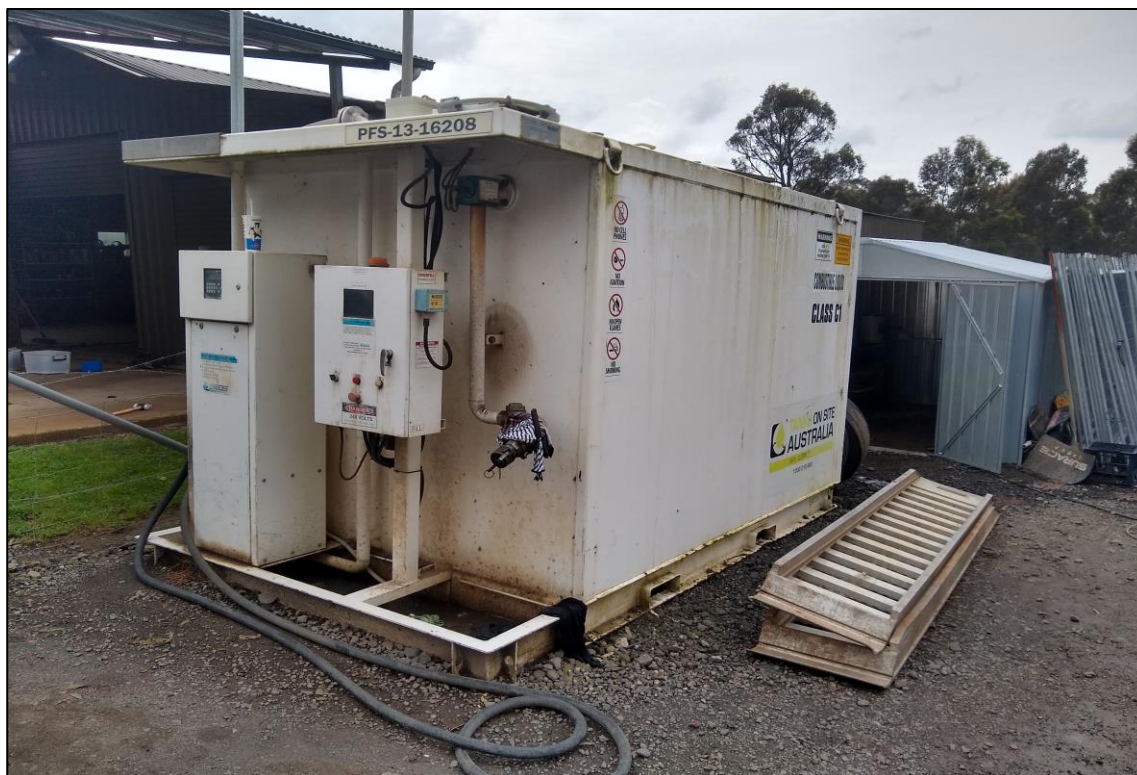
Photograph 17 - A 13,000 L above ground storage tank (AST) used for the storage of diesel was present directly south of the large shed.

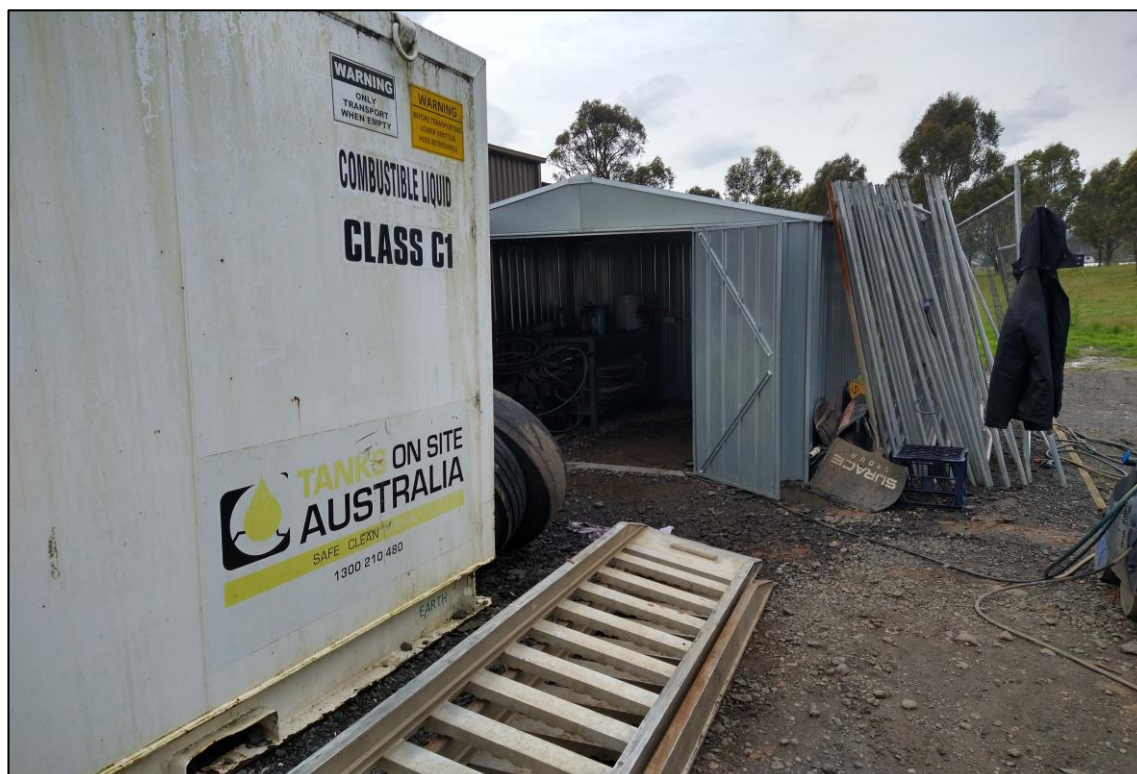
- A smaller metal shed, with no flooring and containing an oil drum, was observed directly east of the AST on Lot 37 (Photograph 18, Appendix C of the PSI);

Photograph 18 - Metal shed with oil drum observed directly east of the AST.

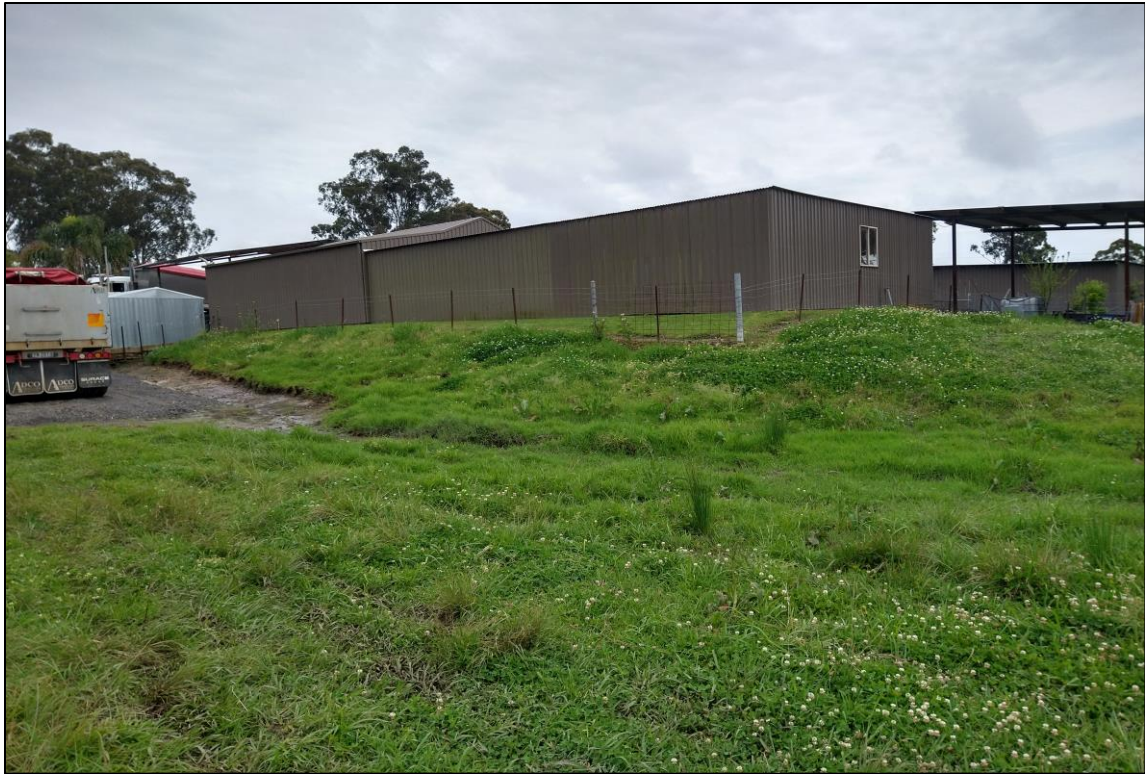
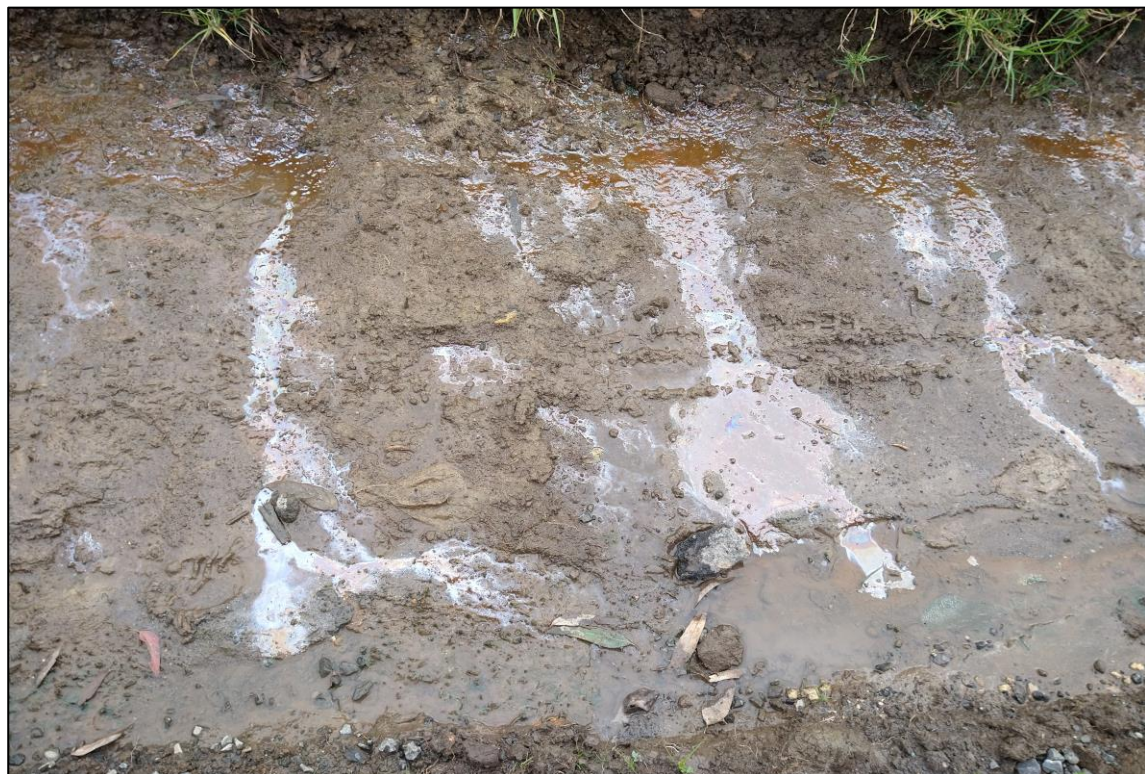
- A smaller metal shed, with no flooring and containing an oil drum, was observed directly east of the AST (Photograph 18);
- East of the smaller metal shed was a small drainage line, which consisted of water run-off with an oily sheen, likely to be either from the AST or nearby truck washing activities (Photographs 19 and 20);

Photograph 19 - Drainage line with water run-off containing an oily sheen.

Photograph 20 - Drainage line with water run-off containing an oily sheen.

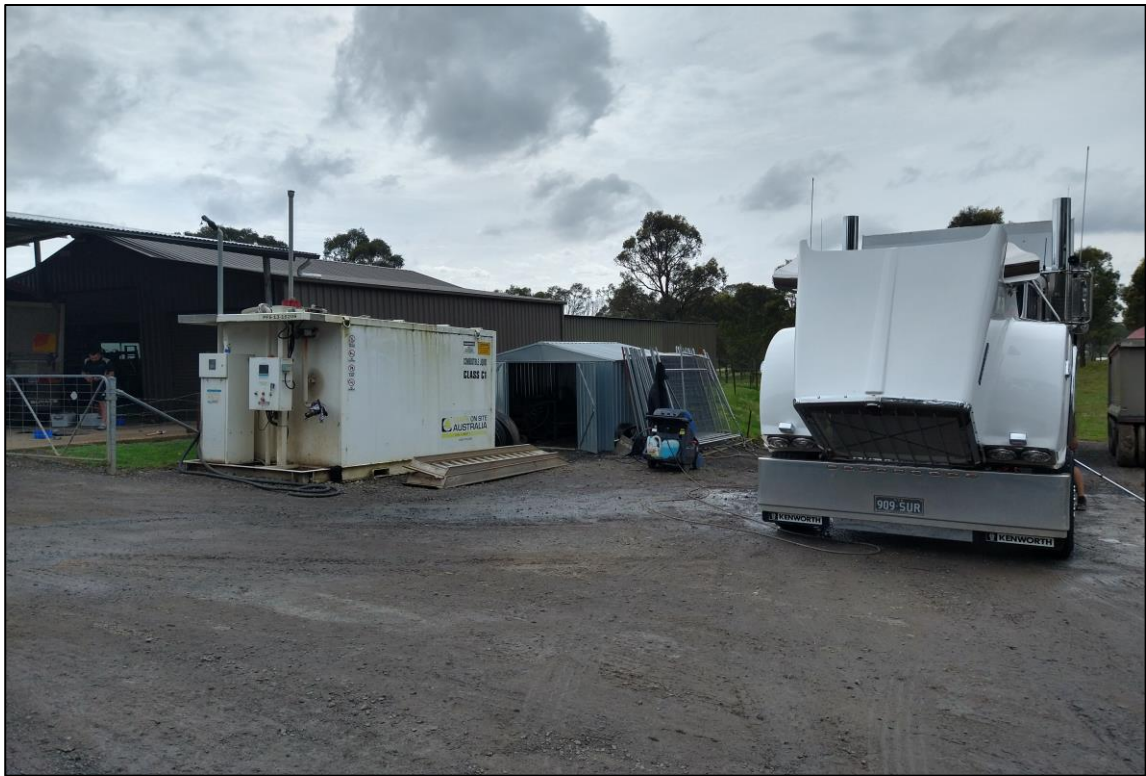
- Detergent and chemical run-off as a result of upkeep, washing and cleaning of trucks on Lot 37 was also observed in the vicinity (Photograph 21, Appendix C of the PSI);

Photograph 21 - Detergent and chemical run-off as a result of upkeep, washing and cleaning of trucks.

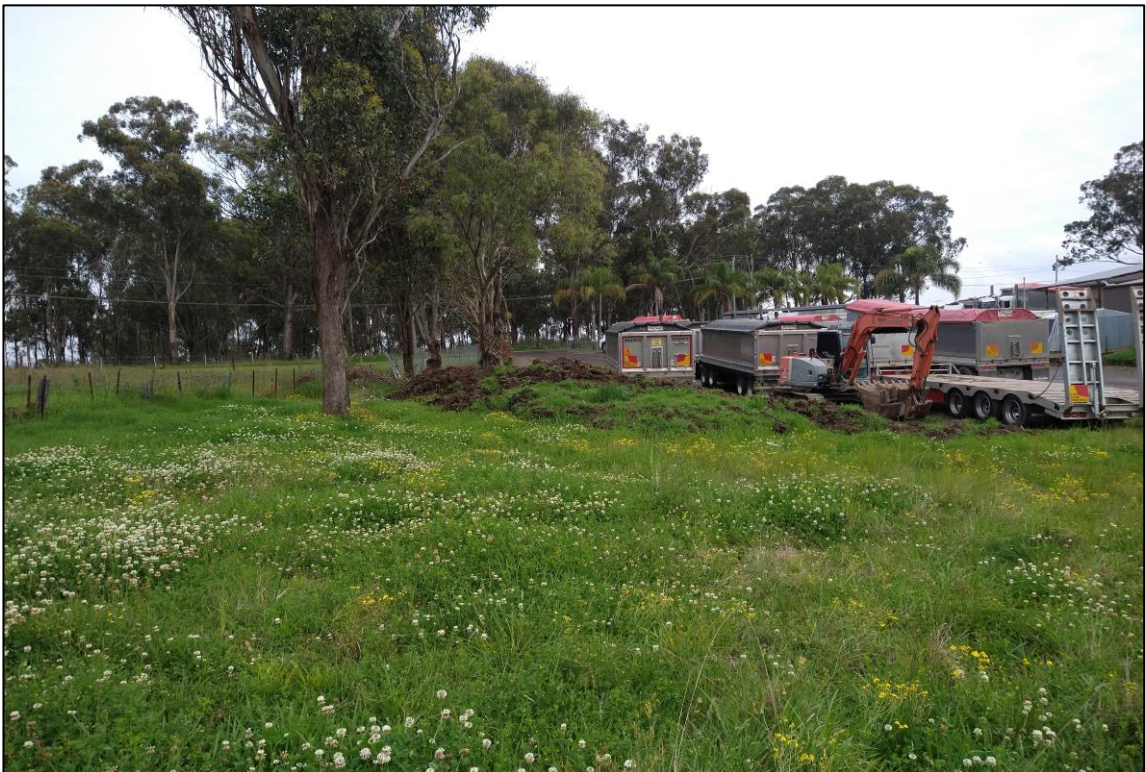
- Detergent and chemical run-off as a result of upkeep, washing and cleaning of trucks was also observed in the vicinity (Photograph 21);
- A stockpile comprising approximately 100 m³ of brown silty clay material (approximate stockpile dimensions of 20 m length, 5 m width, 1 m height), which was overgrown with grass, was identified (Photograph 22);

Photograph 22 - Stockpiled material comprising approximately 100 m³ brown silty clay material (approximate dimensions of 20 m length, 5 m width, 1 m height).

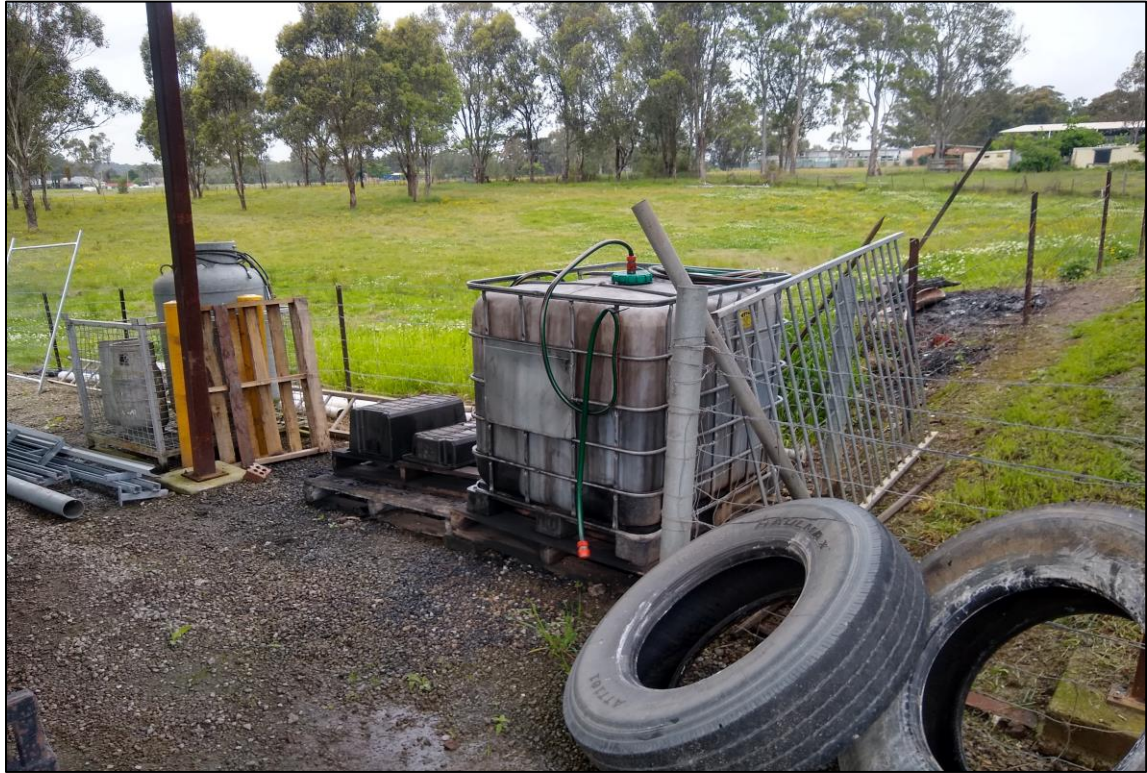
Photograph 23 - An IBC containing oil/fuel, liquefied petroleum gas cylinders identified in the north western area of Site B.

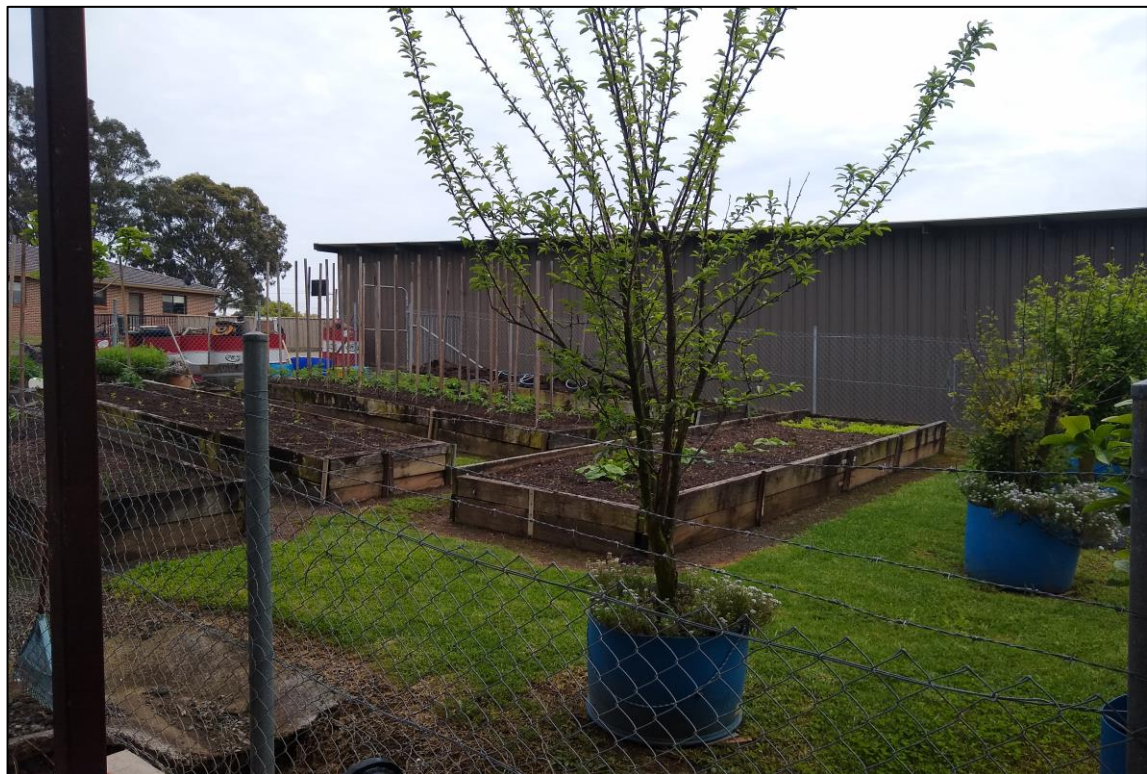
Photograph 24 - Small vegetable garden, which indicated potential use of pesticides, alongside another metal shed, which may house other chemicals/fuels was observed in the north western portion of Site B.
