Project 217600.02
25 August 2023
R.002.Rev1
GAR

Cover Letter - Summary of Contamination Investigation
Proposed Aland Leppington Residential Core
Lots 37 & 38A Deposited Plan 8979, Rickard Road, Leppington NSW

Project 217600.00
October 2022

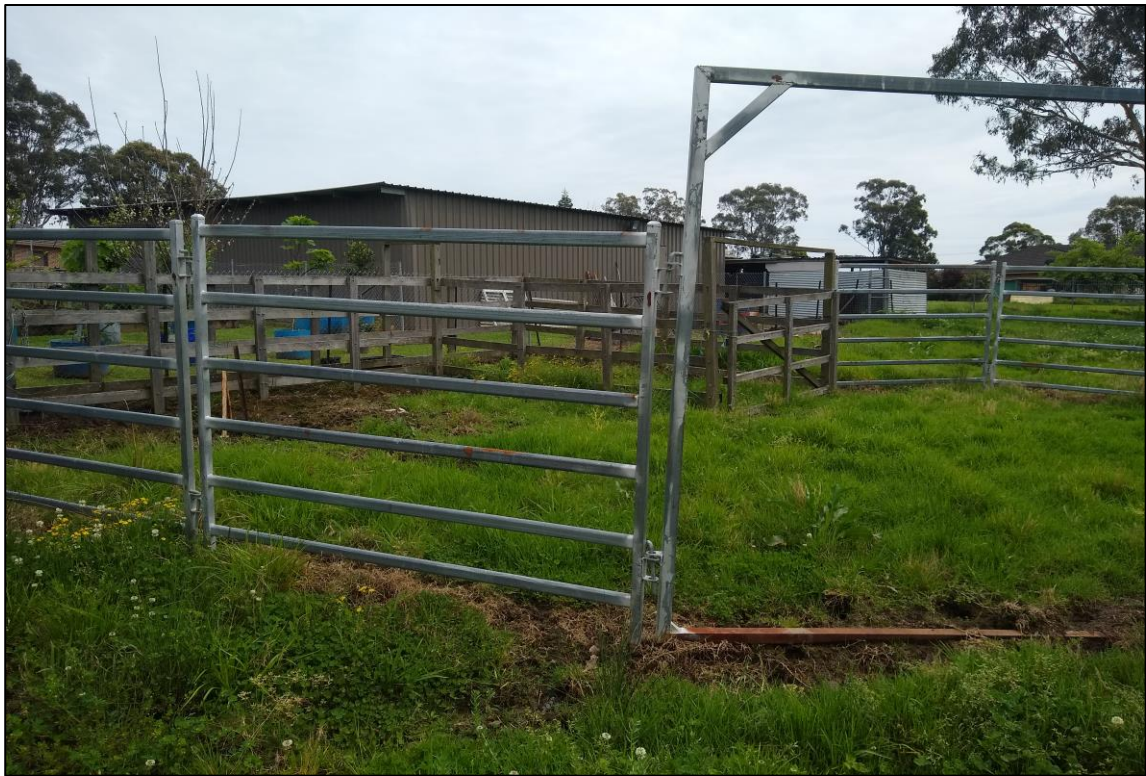
Photograph 25 - Animal stockyard located adjacent to the small vegetable garden.

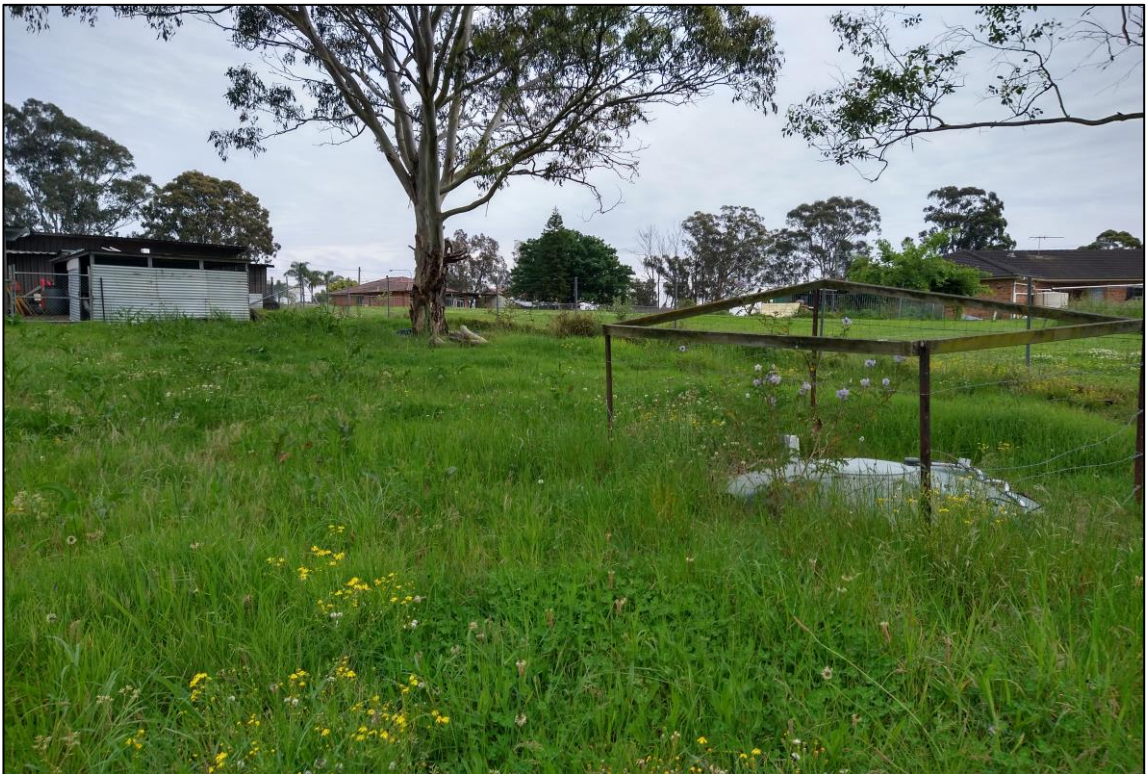
Photograph 26 - Septic tank located in the north western portion of Site B.

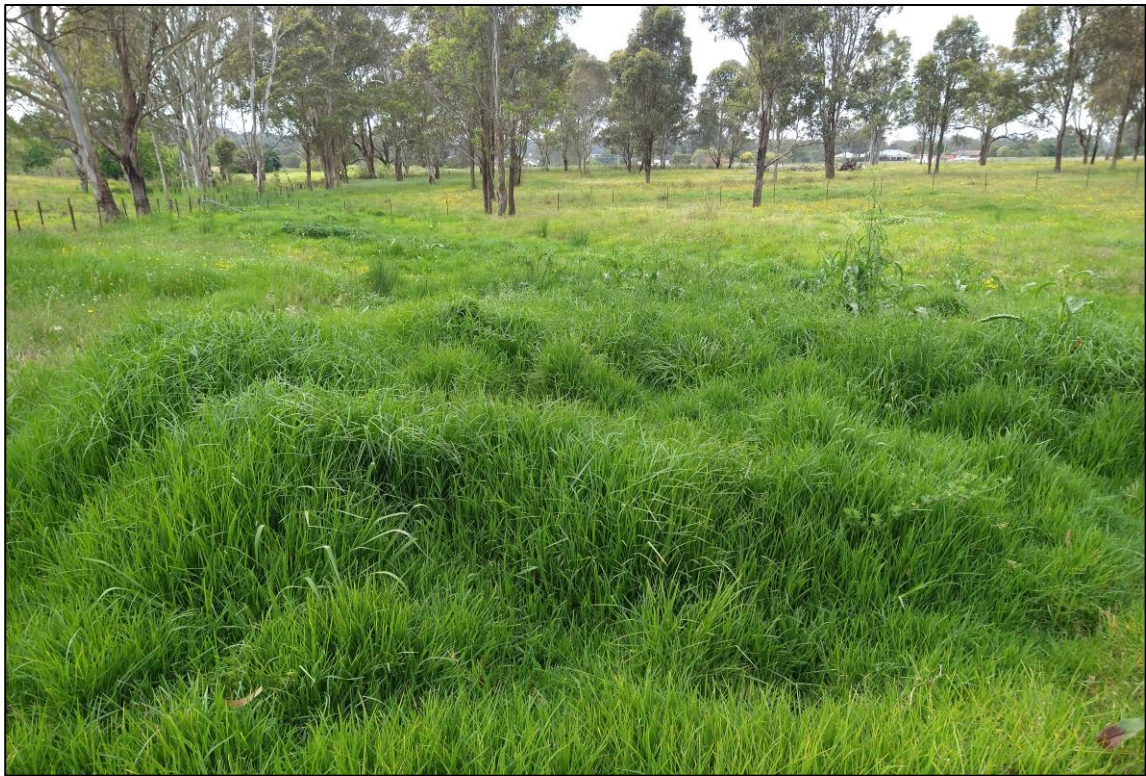
- A septic tank was observed in the north western portion on Lot 37 (Photograph 26). Approximately 20 m east of this, the grass cover appeared to have increased in height, density, and a darker green pigment than the grass on the remaining areas of the property. This is likely to be as a result of direct nutrient overflow from the septic tank (Photograph 27, Appendix C of the PSI);

- An animal pen/stockyard was present adjacent to the small vegetable garden (Photograph 25);
- A septic tank was observed in the north western portion (Photograph 26). Approximately 20 m east of this, the grass cover appeared to have increased height, density, and a darker green pigment than the grass on the remaining areas of Site B. This is likely to be as a result of direct nutrient overflow from the septic tank (Photograph 27);

Photograph 27 - Grass cover with increased height, density and a deeper green pigment, likely to be as a result of nutrient overflow from the septic tank in Site B.

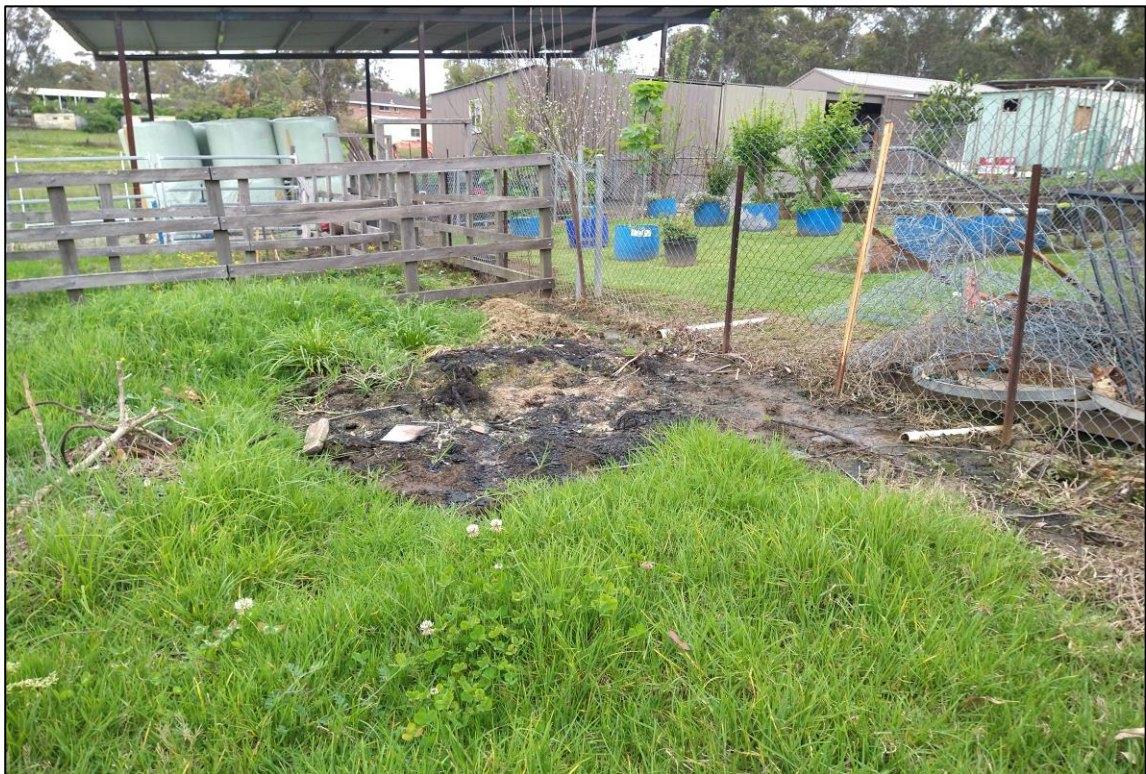
Photograph 28 - Ground disturbance in the north western area of the site, where unknown materials appeared to have been previously burnt.

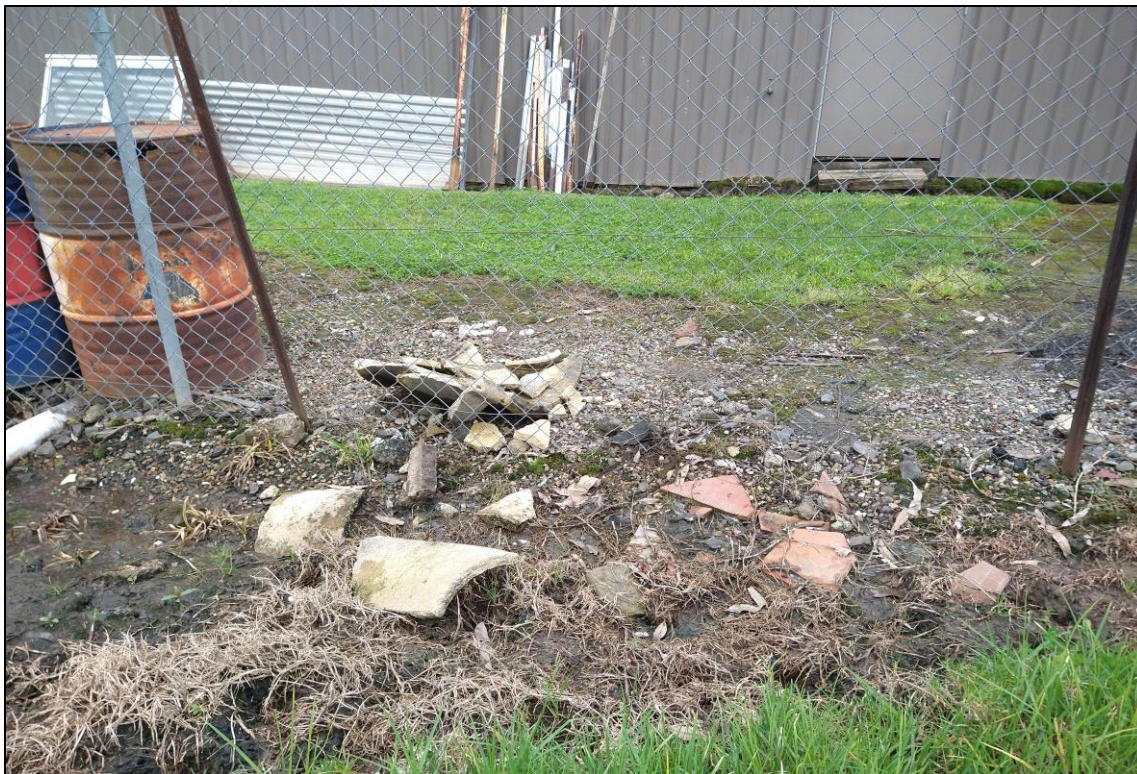
- Minor ground disturbance was also identified in the north western portion of Lot 37, where unknown materials appeared to have been previously burnt on site (Photograph 28). Trace building and demolition waste including fragments of concrete pipe, clay tiles and brick, and oil drums, were in proximity (Photographs 29, 30 and 31, Appendix C of the PSI);

- Minor ground disturbance was also identified in the north western portion, where unknown materials appeared to have been previously burnt on site (Photograph 28). Trace building and demolition waste including fragments of concrete pipe, clay tiles and brick, and oil drums, were in proximity (Photographs 29, 30 and 31);

Photograph 29 - Trace fragments of concrete pipe and clay tiles observed in the north western portion of Site B.

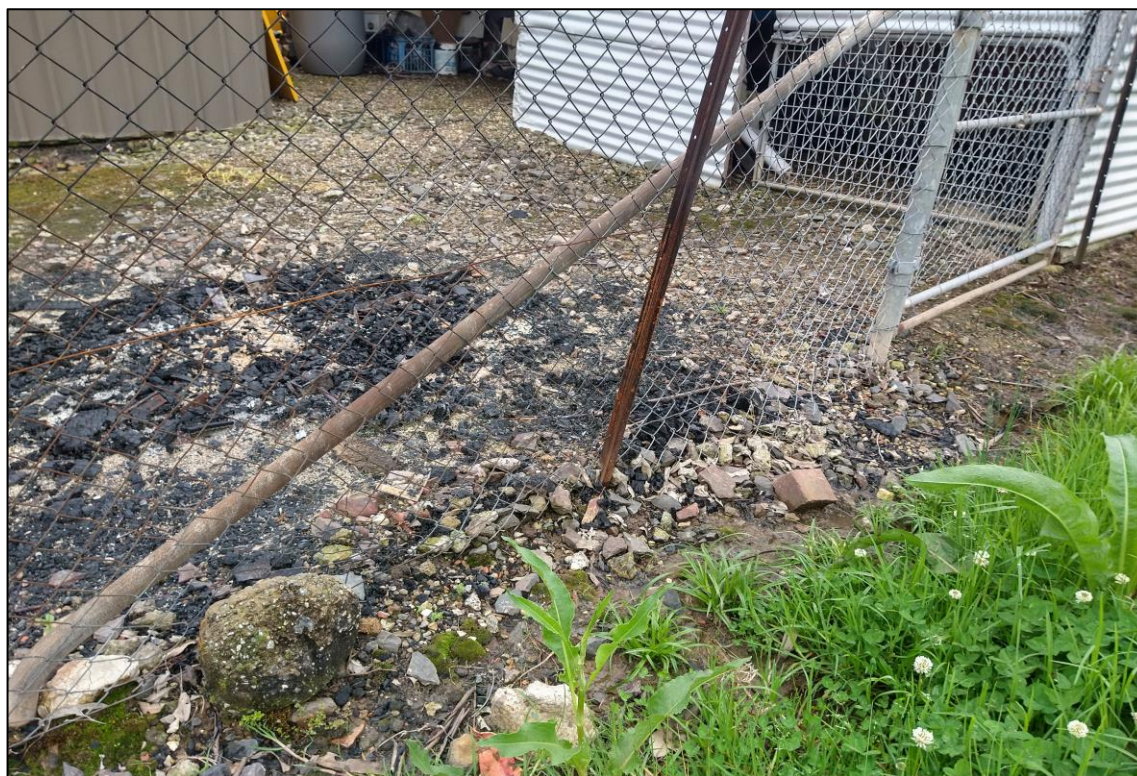
Photograph 30 - Trace brick observed in the north western portion of Site B.

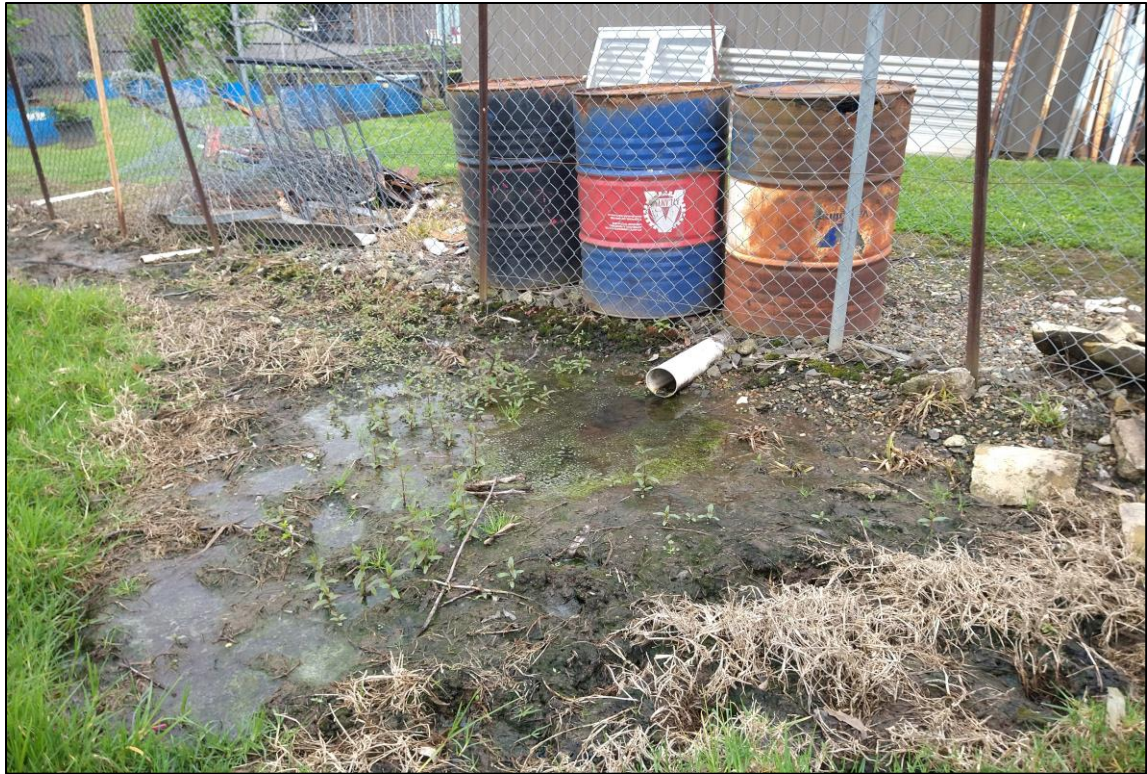
Photograph 31 - Oil drums observed in the north western portion of Site B.

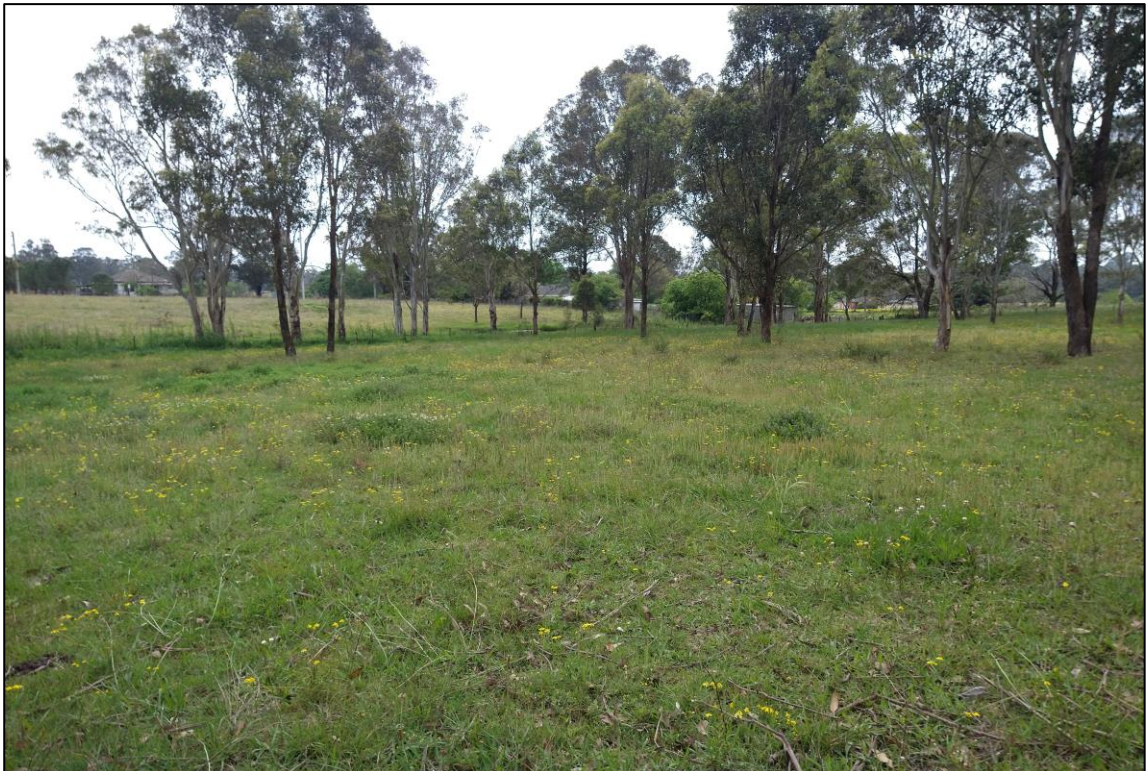
- Potential fill was observed in the northern portion of the site on Lot 37, as indicated by slightly elevated ground levels (Photograph 32, Appendix C of the PSI);

- Potential filling was observed in the northern portion of Site B, as indicated by slightly elevated ground levels (Photograph 32);
- Two timber stockpiles, one consisting of wood (Photograph 33), the other of processed timber (Photograph 34), were observed in the north eastern portions of Site B;

Photograph 32 - Potential filling observed in the northern portion of Site B, as indicated by slightly elevated ground levels.

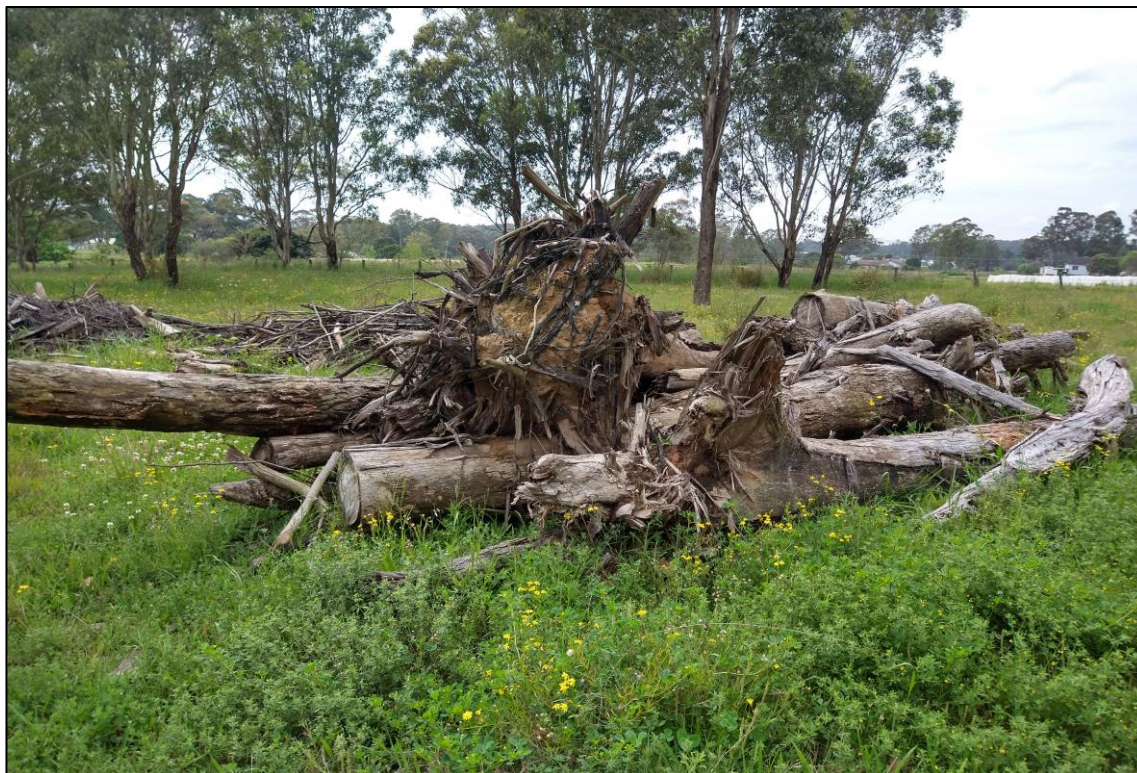
- Two timber stockpiles, one consisting of tree trunks and roots (Photograph 33, Appendix C of the PSI), the other of processed timber (Photograph 34, Appendix C of the PSI), were observed in the north eastern portions of the site;

Photograph 33 - Wood stockpile observed in the north eastern portion of Site B.

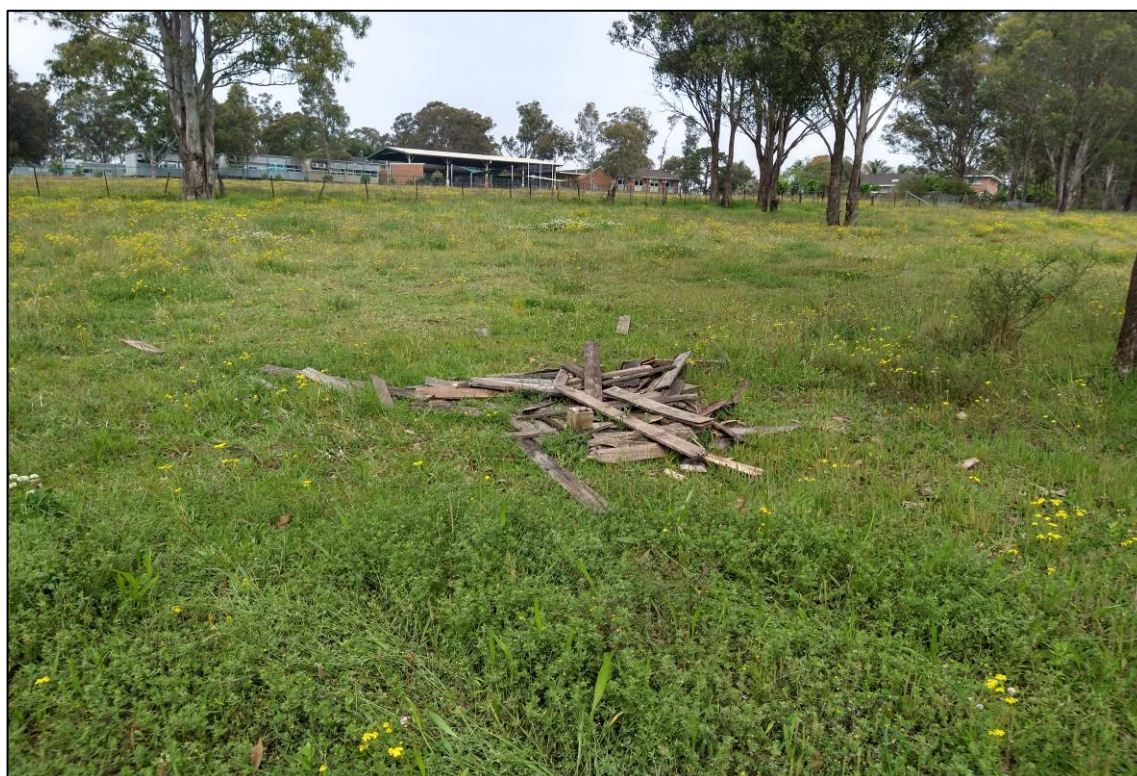
Photograph 34 - Processed timber stockpile observed in the north eastern portion of Site B.

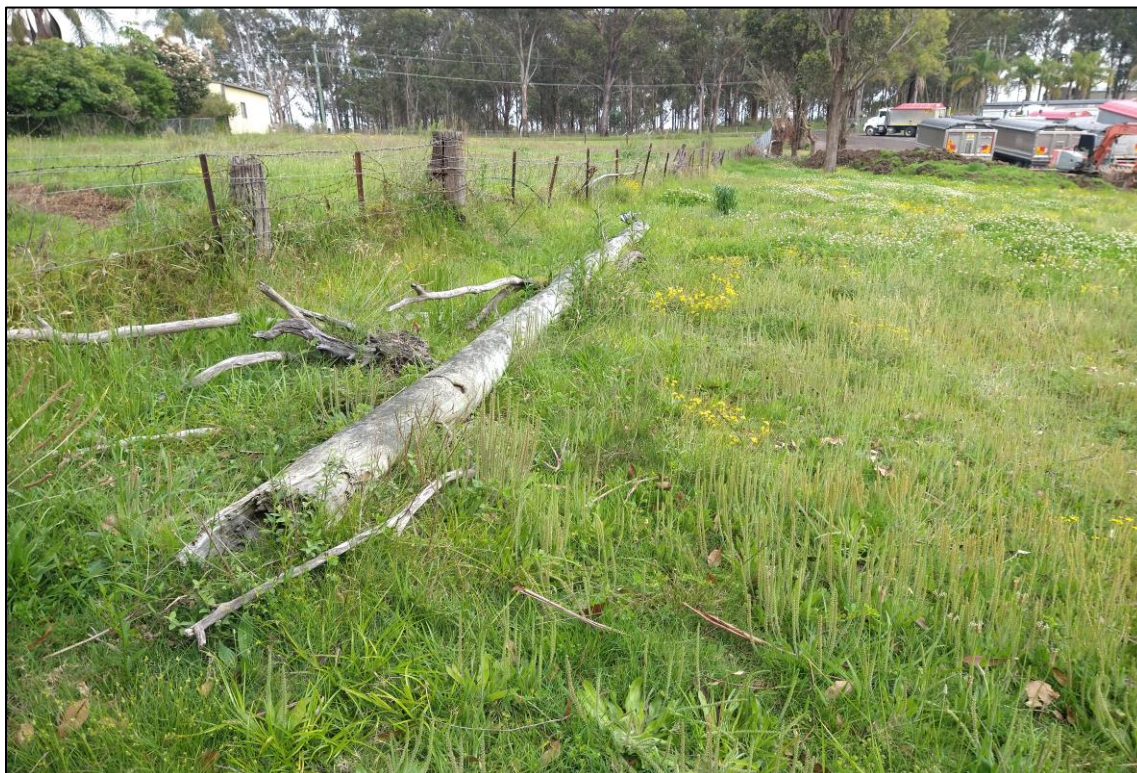
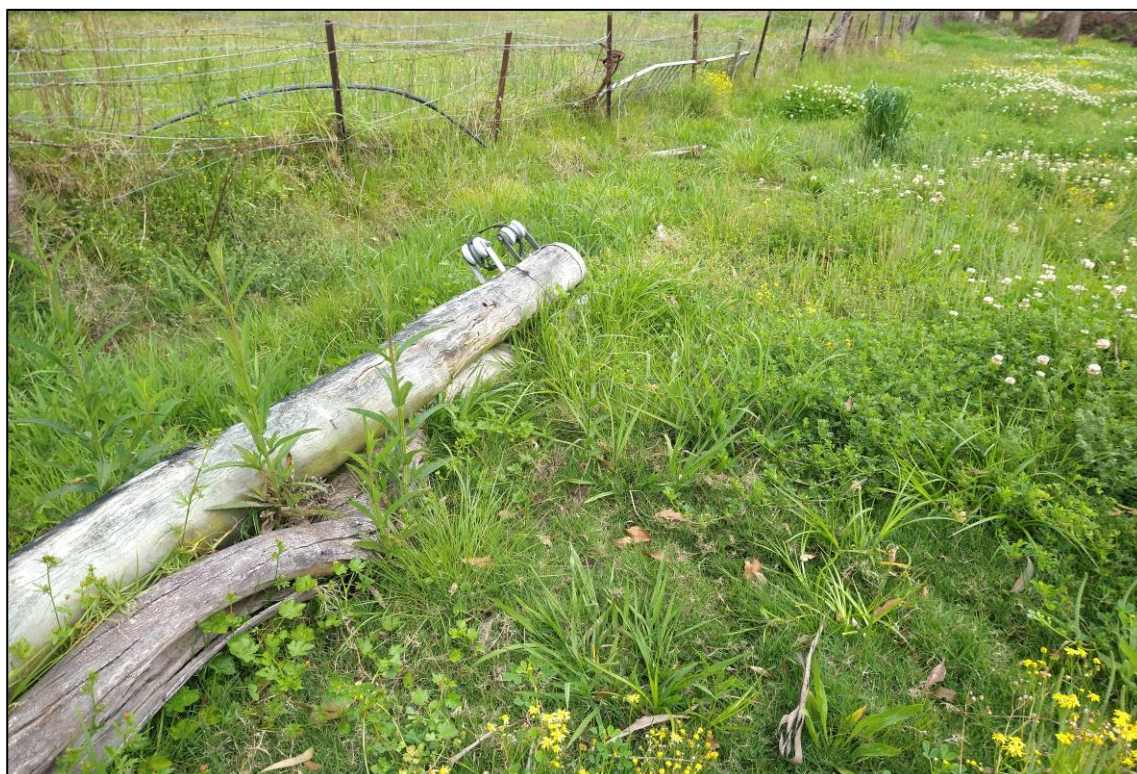
- A decommissioned power pole which was removed from the ground was observed to be laying horizontally in the north western portion (Photographs 35 and 36, Appendix C of the PSI);

- A decommissioned power pole which was removed from the ground was observed to be laying horizontally in the north western portion (Photographs 35 and 36);

Photograph 35 - Decommissioned power pole which was removed from the ground and found laying horizontally in the north western area of Site B.

Photograph 36 - Decommissioned power pole which was removed from the ground and found laying horizontally in the north western area of Site B.

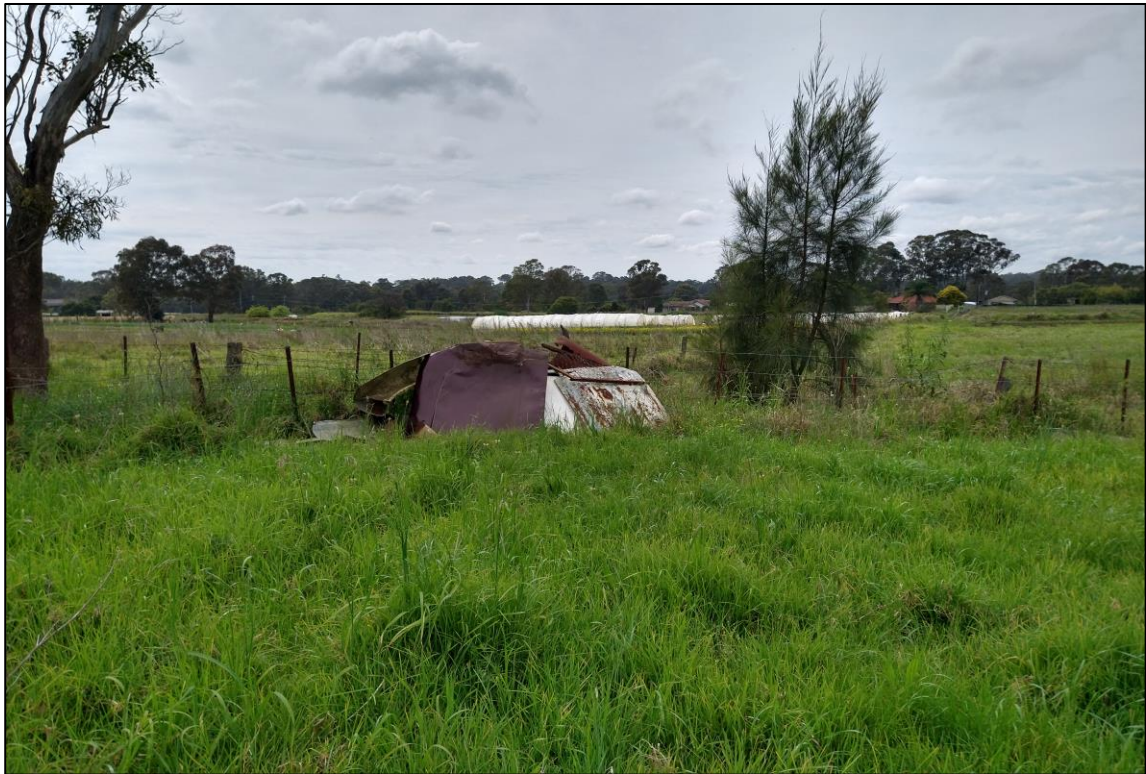
Photograph 37 - Stockpiled scrap metal material was identified in the eastern area of Site B.

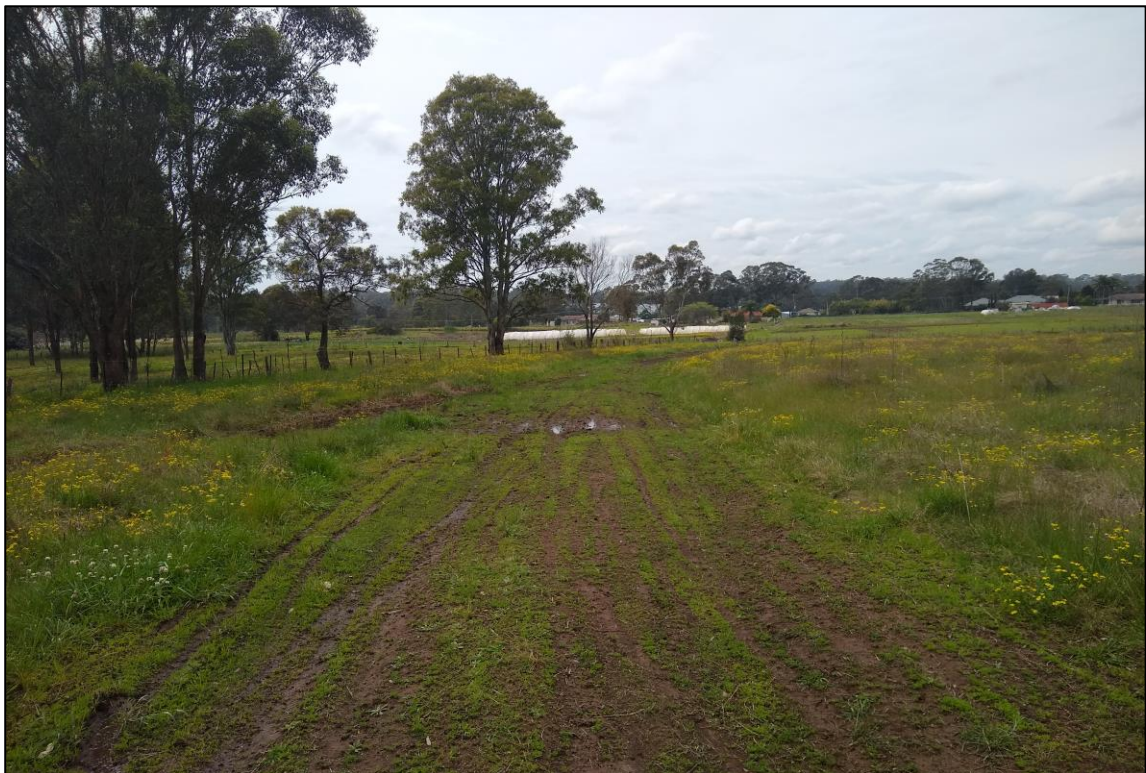
Photograph 38 - Ground disturbances, likely to be as a result of motorbike riding activities, was apparent in the southern portion.

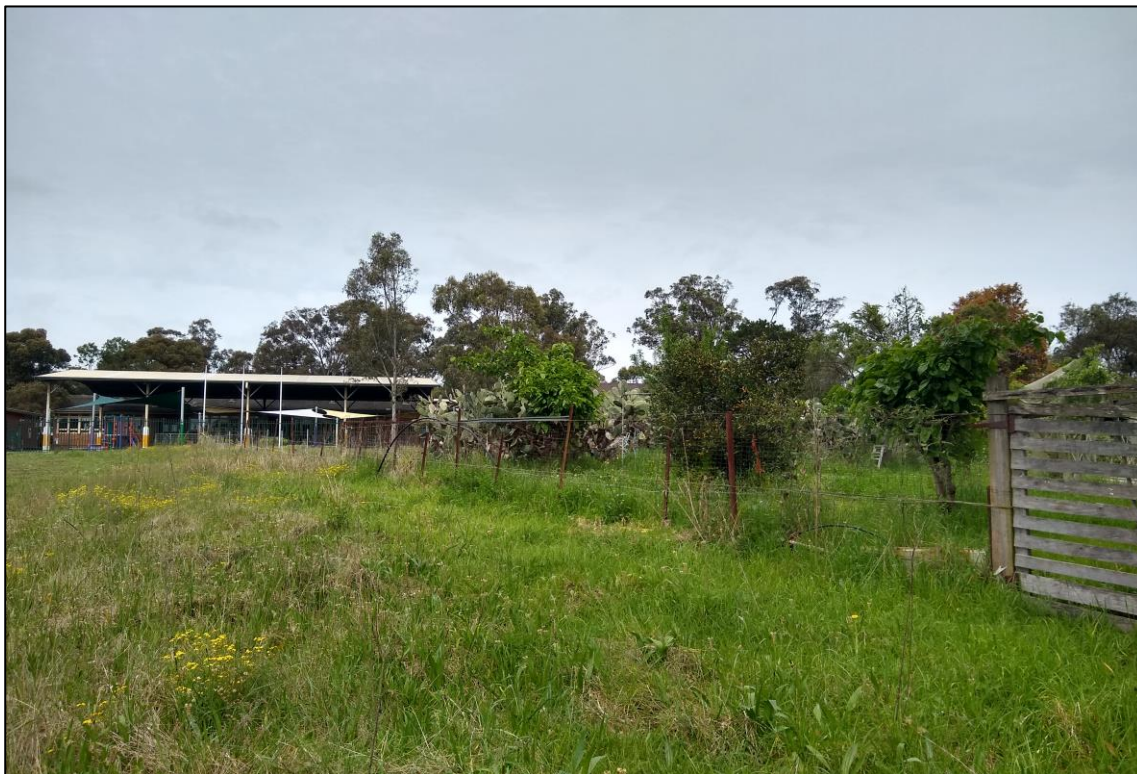
Photograph 39 - Small plant nursery, including the growth of multiple Prickly Pear plants, indicating potential pesticide usage, identified in the south western portion of Site B.

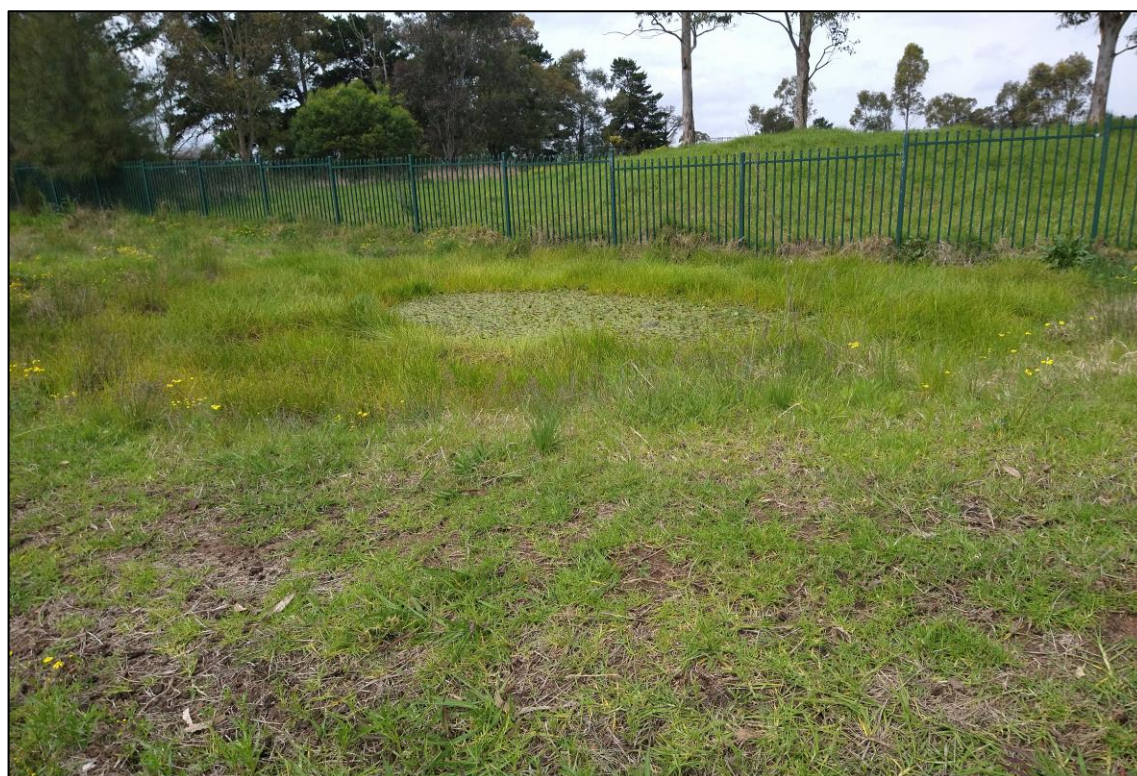
- A small farm dam was observed along the southern boundary in the south eastern portion of Lot 38A (Photograph 40, Appendix C of the PSI).

- A small farm dam was observed along the southern boundary in the south eastern portion (Photograph 40).

Photograph 40 - Small farm dam observed along the southern boundary in the south eastern corner of Site B.
