Report on
Preliminary Site Investigation (Contamination)

Proposed Appin (Part 2) Precinct
Appin NSW

Prepared for
Walker Corporation Pty Ltd

Project 76589.18
October 2024

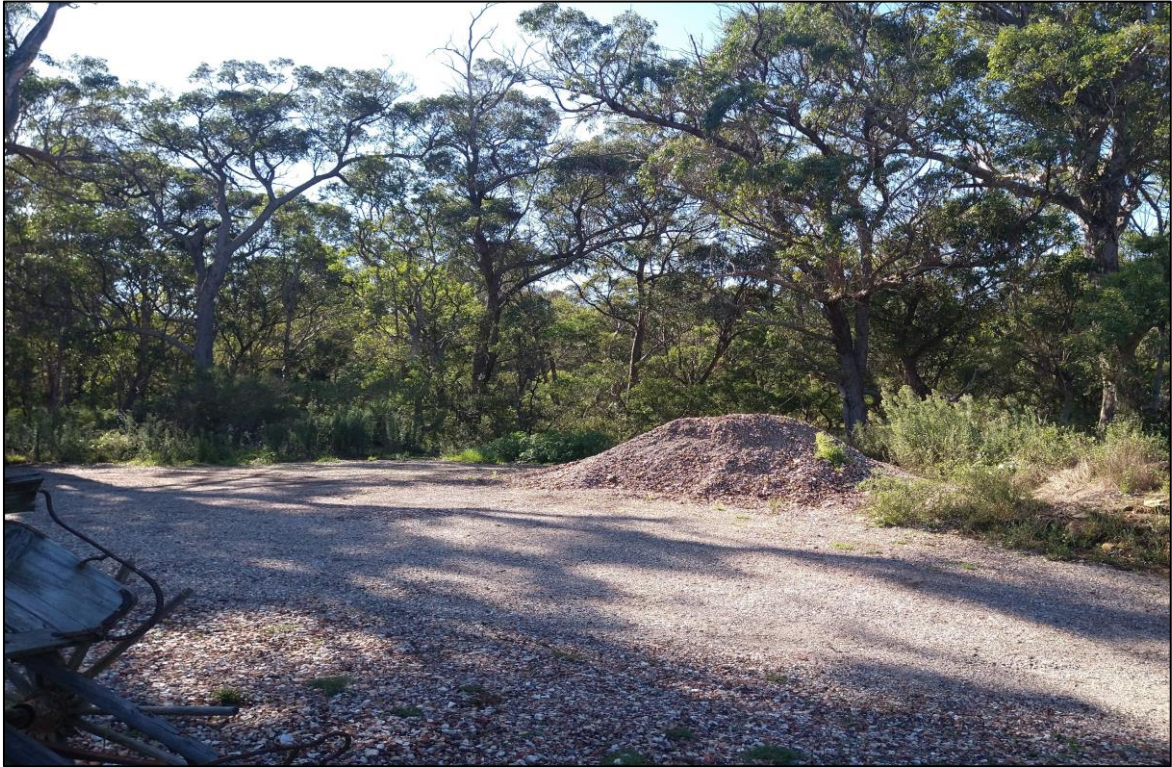
- The following was observed in the north-eastern and eastern portions of Lot 32, and Lot 1 DP1000355:
 - o Two stockpiles of quarried materials (MRP 122) and one stockpile of crushed gravel and cobble material (MRP 123);

Photograph 1 - Stockpile of crushed gravel and cobble material (MRP 123).

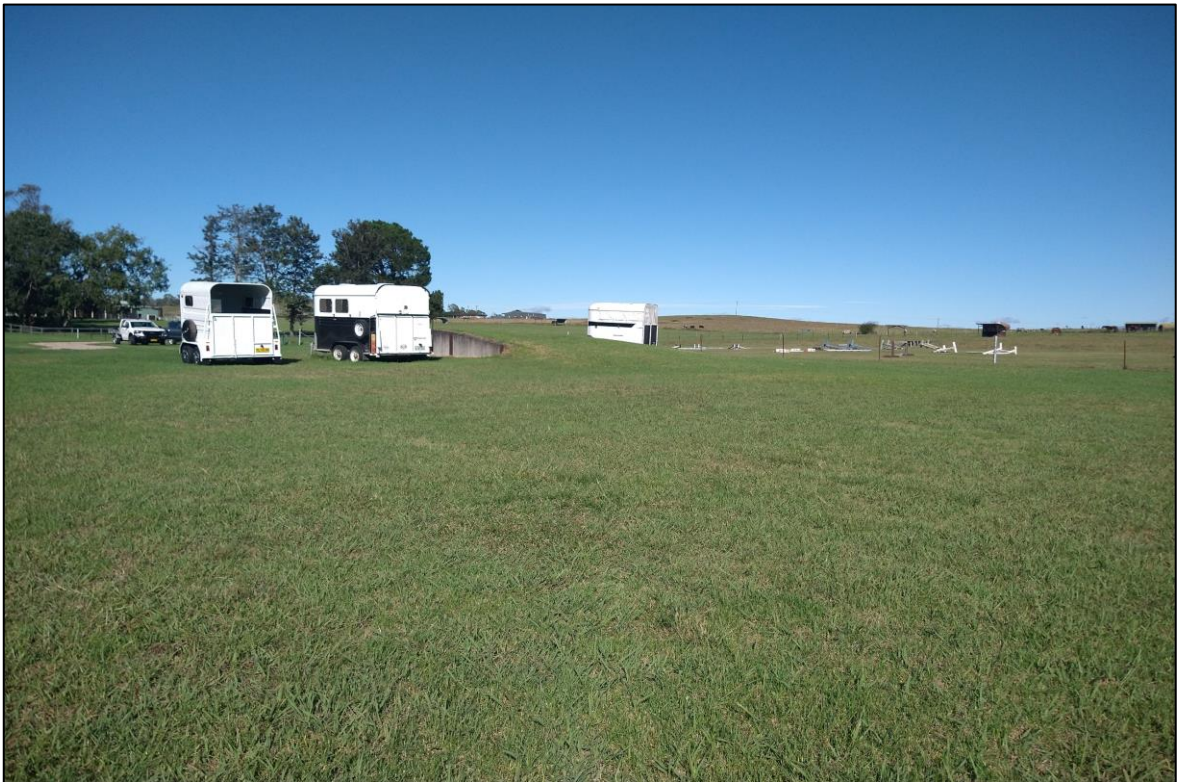
Photograph 2 - Raised area of possible fill, likely to be utilised as a ramp with caravan trailers and horse jump equipment present in the surrounds (MRP 126).

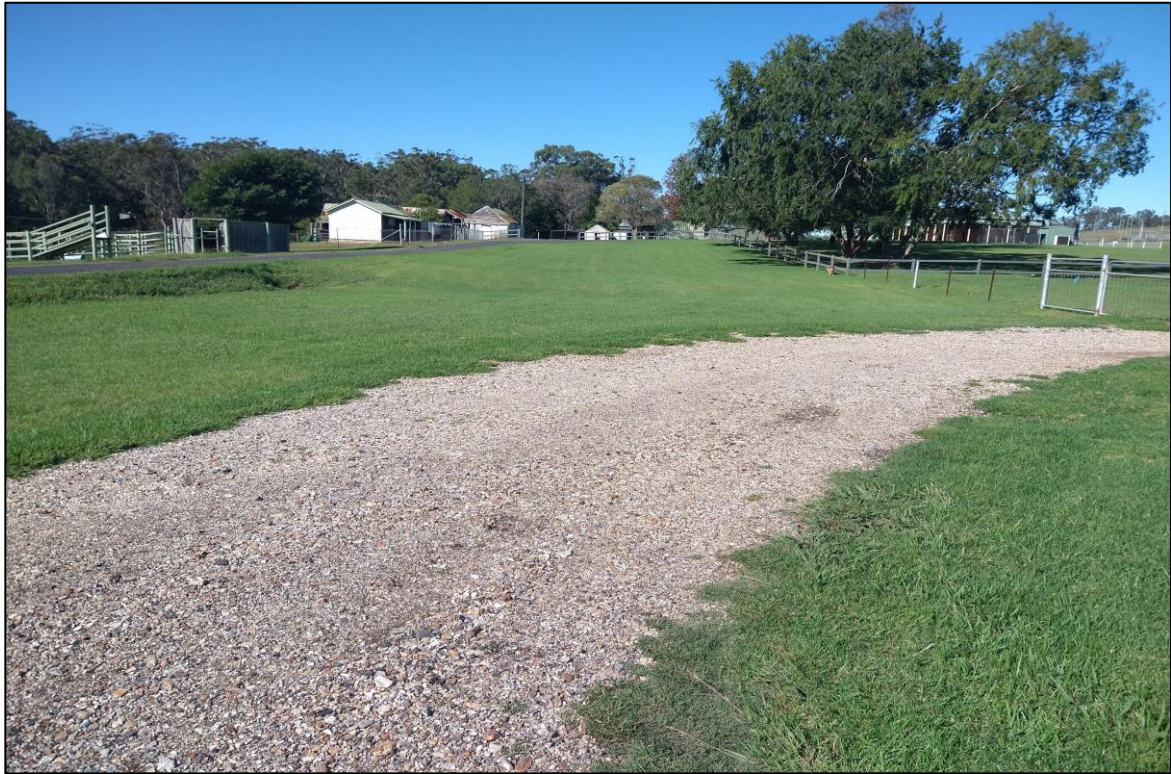
Photograph 3 - Unsealed road adjoining Macquariedale Road.
comprised gravelly fill material (MRP 127)

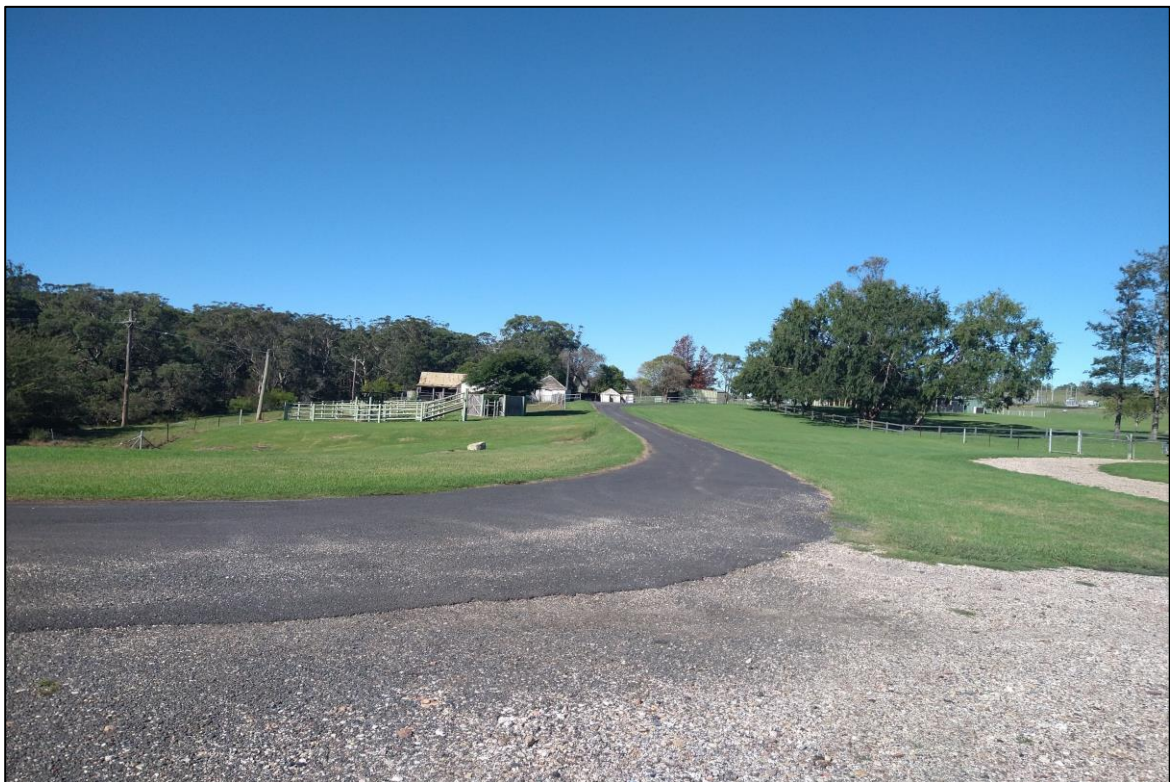
Photograph 4 - Unsealed road adjoining Macquariedale Road comprised.
crushed rock fill material (MRP 128)

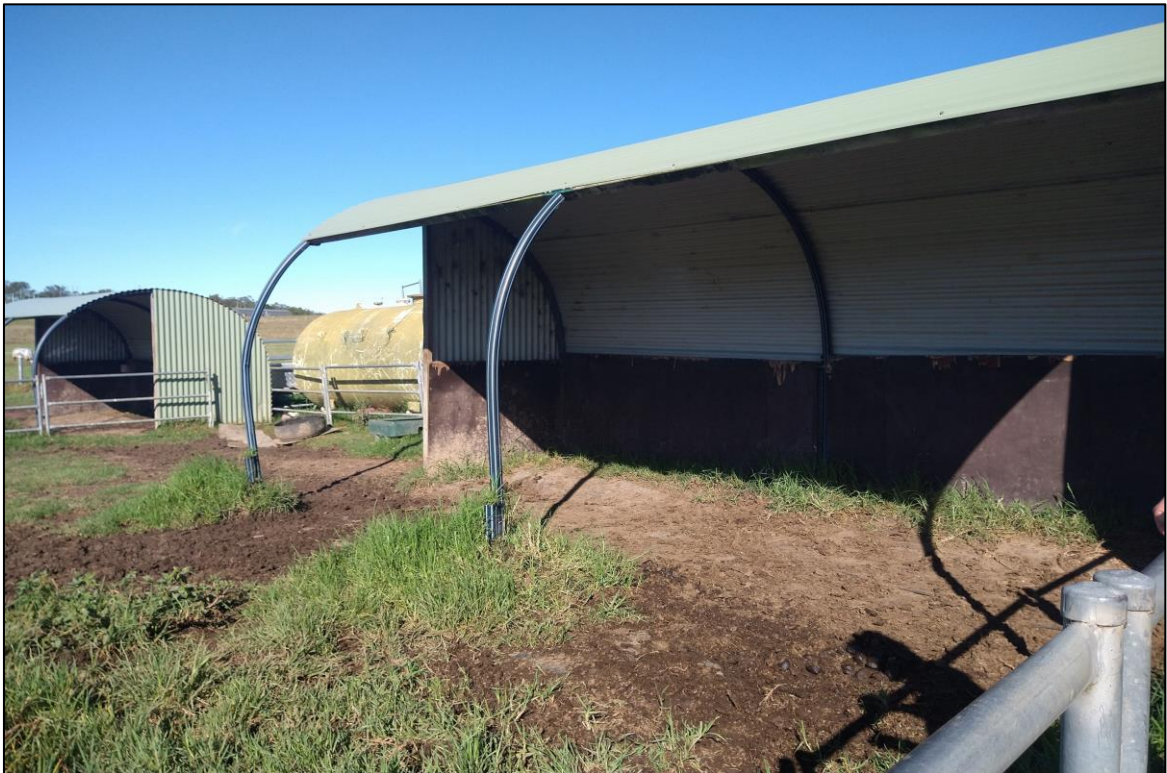
- o Horse/animal pens and associated horse shelters comprising metal sheeting with unsealed flooring (KFR 277; MRP 130) were observed in the eastern portion of Lot 32. Two former fuel storage tanks were also present, one (MRP131) in the vicinity of MRP130, the other (MRP132; KFR 279) approximately 130 m south-west, both of which were reutilised for water pumping and storage for animal drinking purposes; and

Photograph 6 - Proposed Appin (Part 2) Precinct 6 - Horse pens and shelters with metal sheeting with unsealed flooring.
(MRP 130)

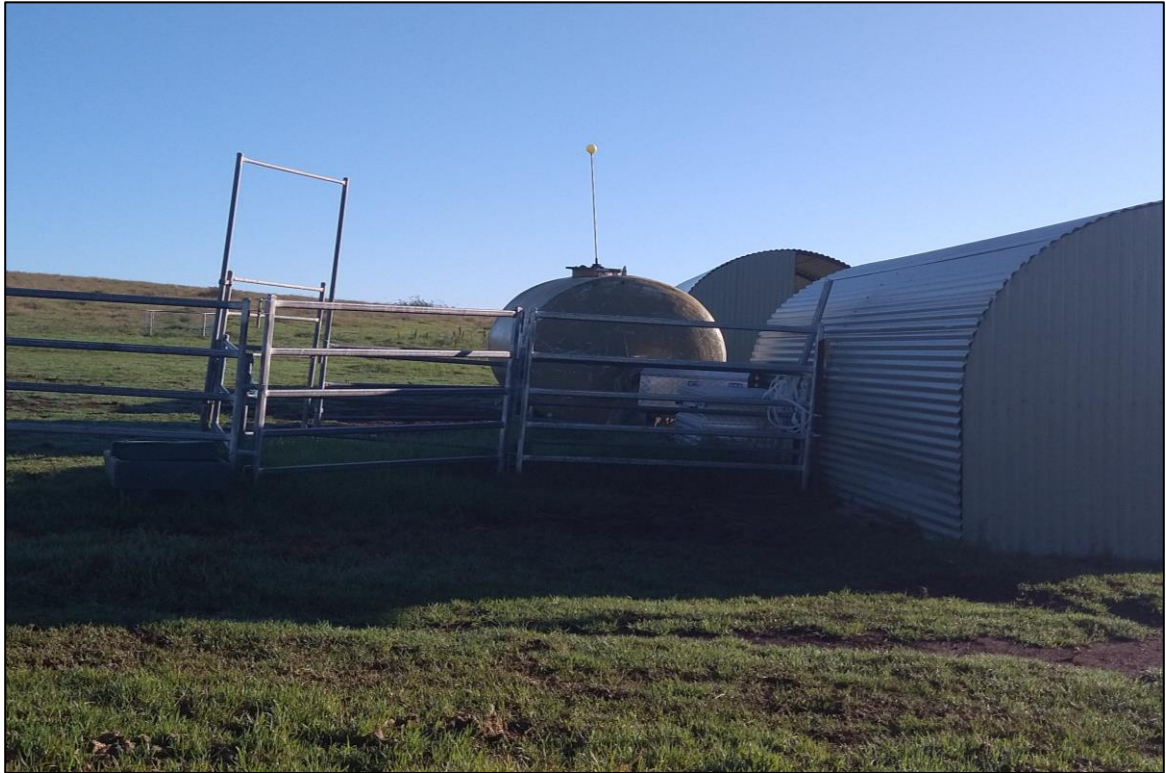
Photograph 7 - Former fuel storage tank reutilised for water pumping and storage for farm animals (MRP 131).

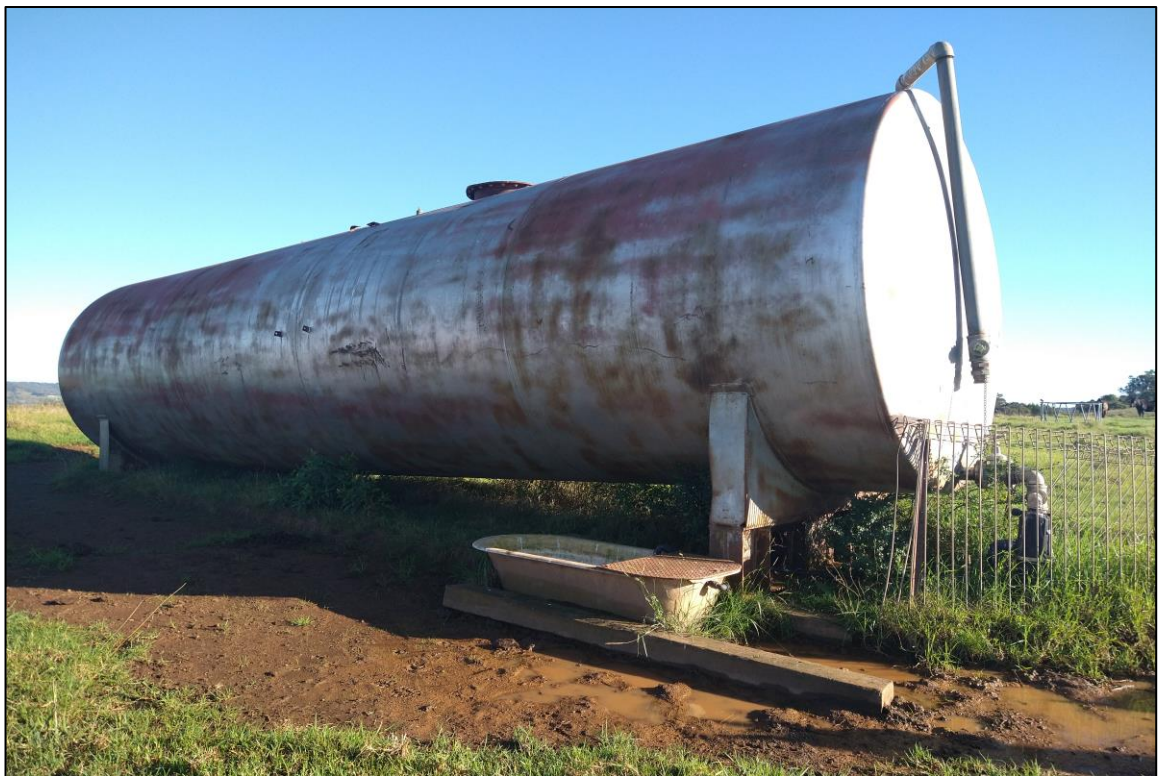
Photograph 8 - Former fuel storage tank reutilised for water pumping and storage.
for farm animals (MRP132)

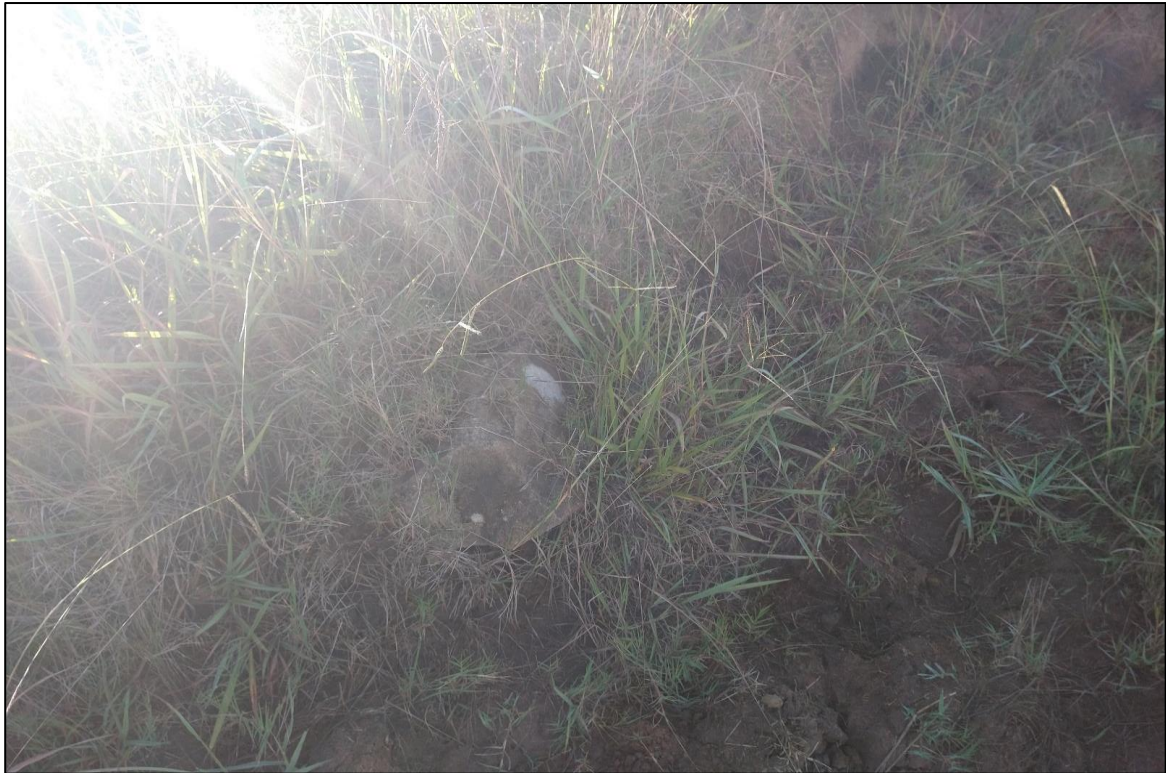
Photograph 9 - Sandstone boulders present within dam embankment (MRP 121).

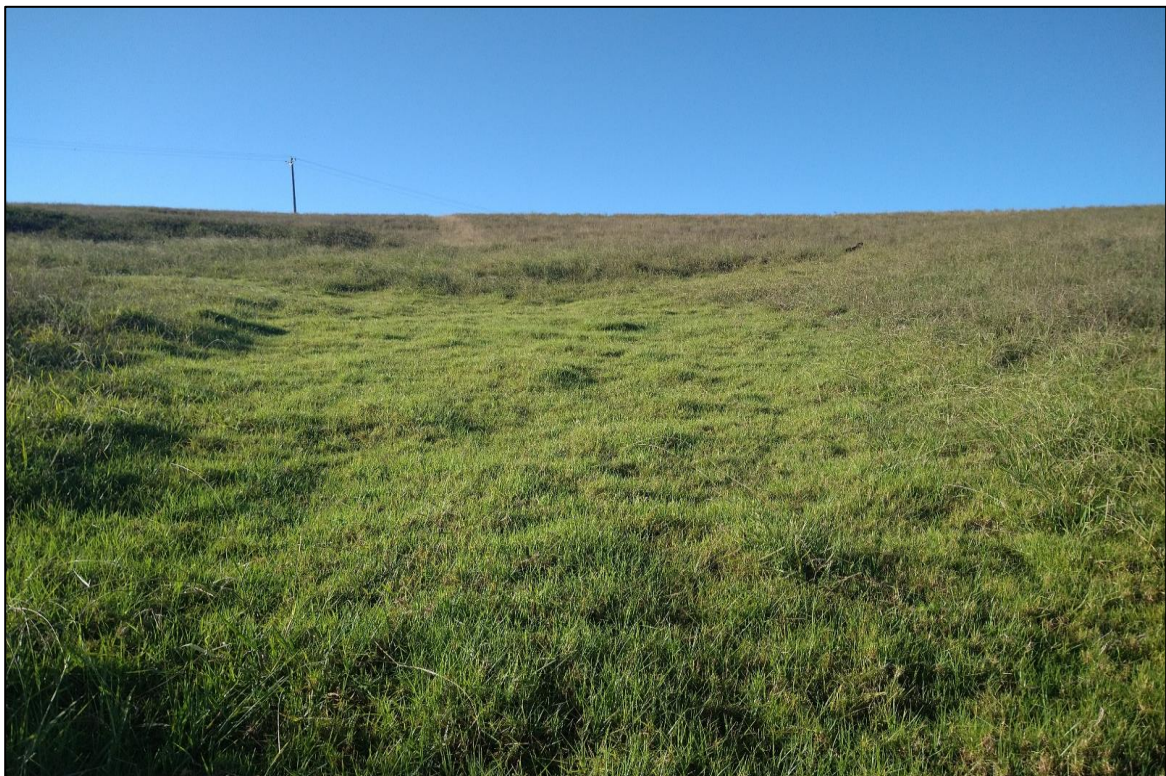
Photograph 10 - Possible fill gully in central portion of Lot 32 DP736923 (MRP 134).

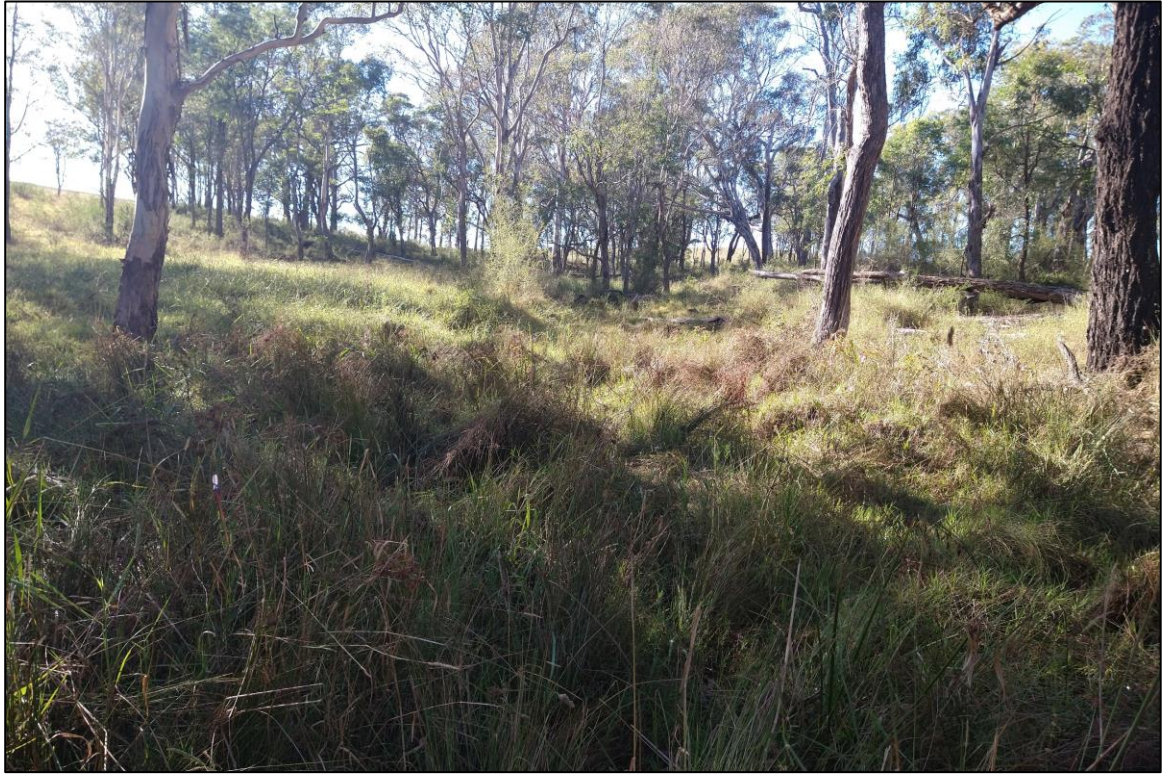
Photograph 11 - Possible fill gully in western portion of Lot 32 DP736923.
(MRP 134)

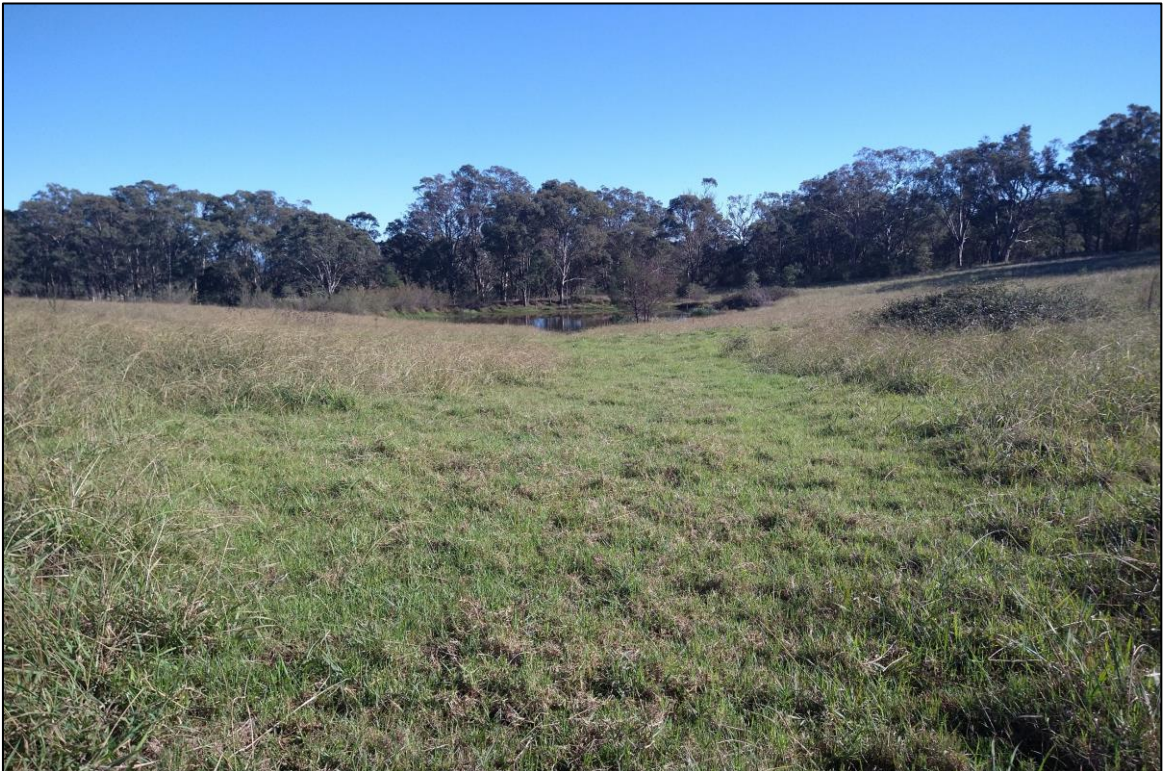
Photograph 12 - Possible fill gully in northern portion of Lot 32 DP736923.
(MRP 134)

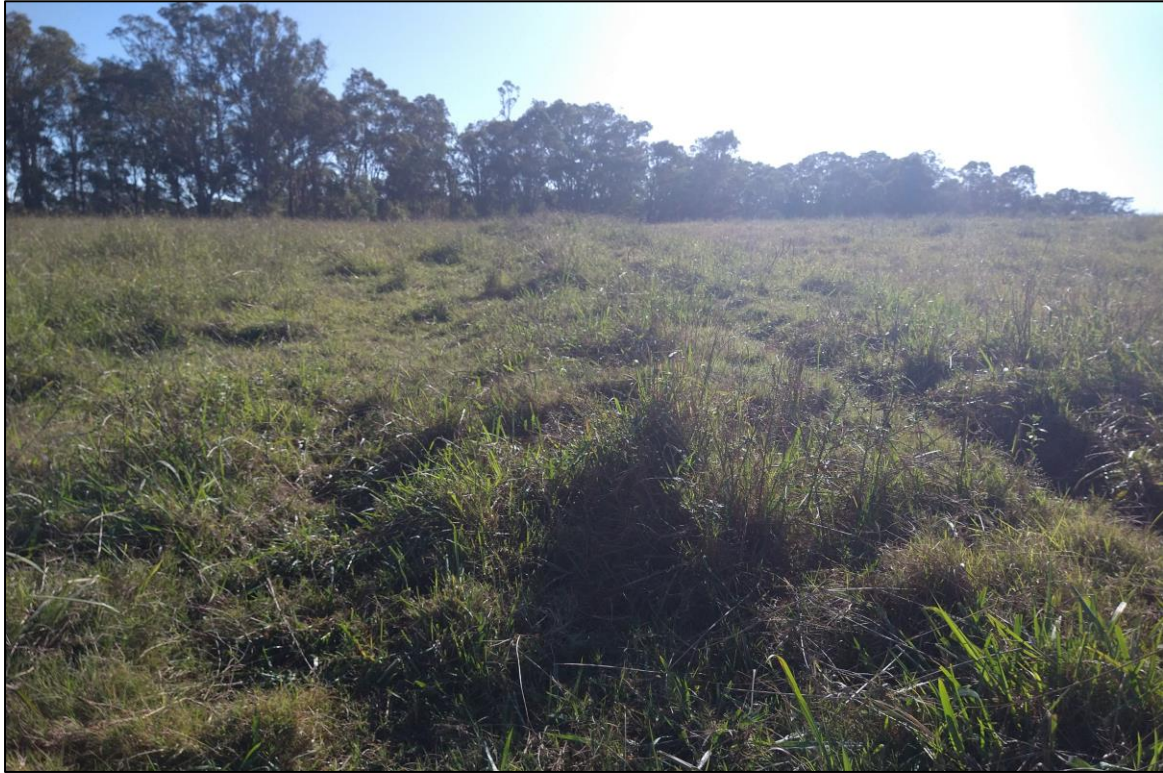
- In the northern portion of Lot 32, a raised area, i.e., a berm, was observed, however, was identified as likely comprising natural soil and rock material (MRP 135);

Photograph 13 - Berm in north-western portion of Lot 32 DP736923.
(MRP 135)

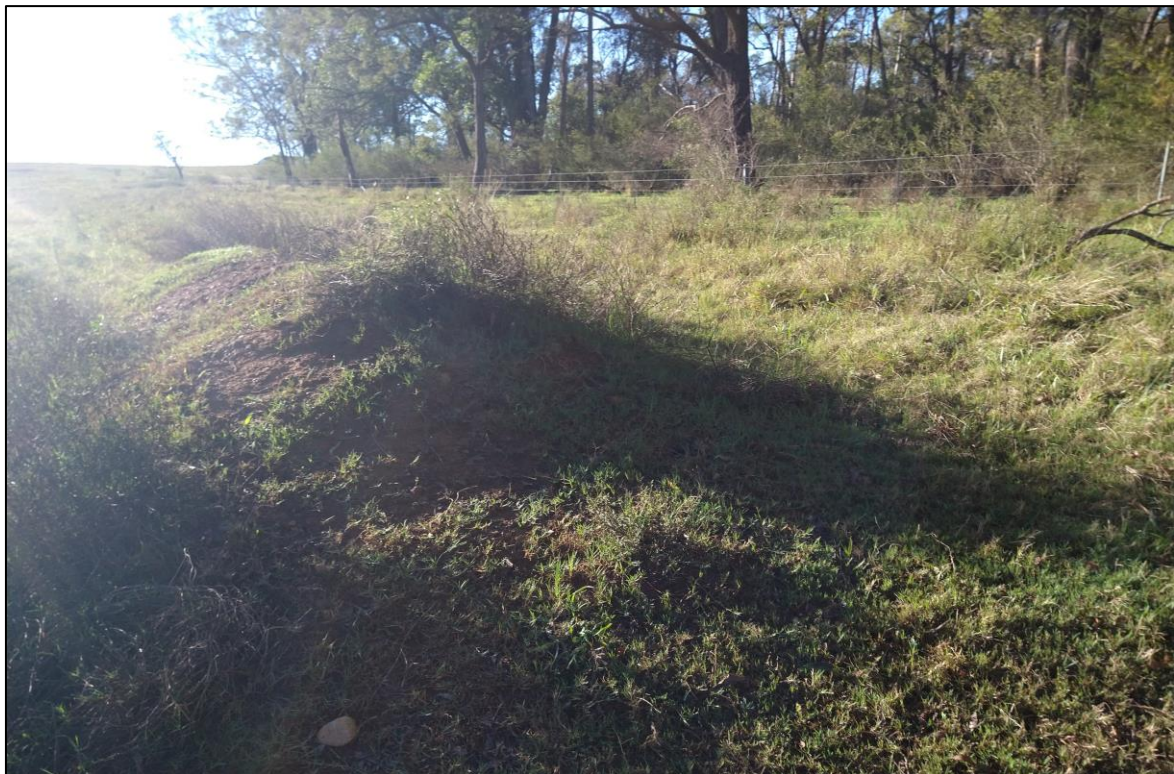
- An area of 'cut and fill' was observed in the south-western portion of Lot 32 (MRP 136), whereby possible fill material was stockpiled adjacent to the area it was cut;

Photograph 14 - Area of fill observed in the south-western portion of Lot 32 DP736923.
(MRP 136)

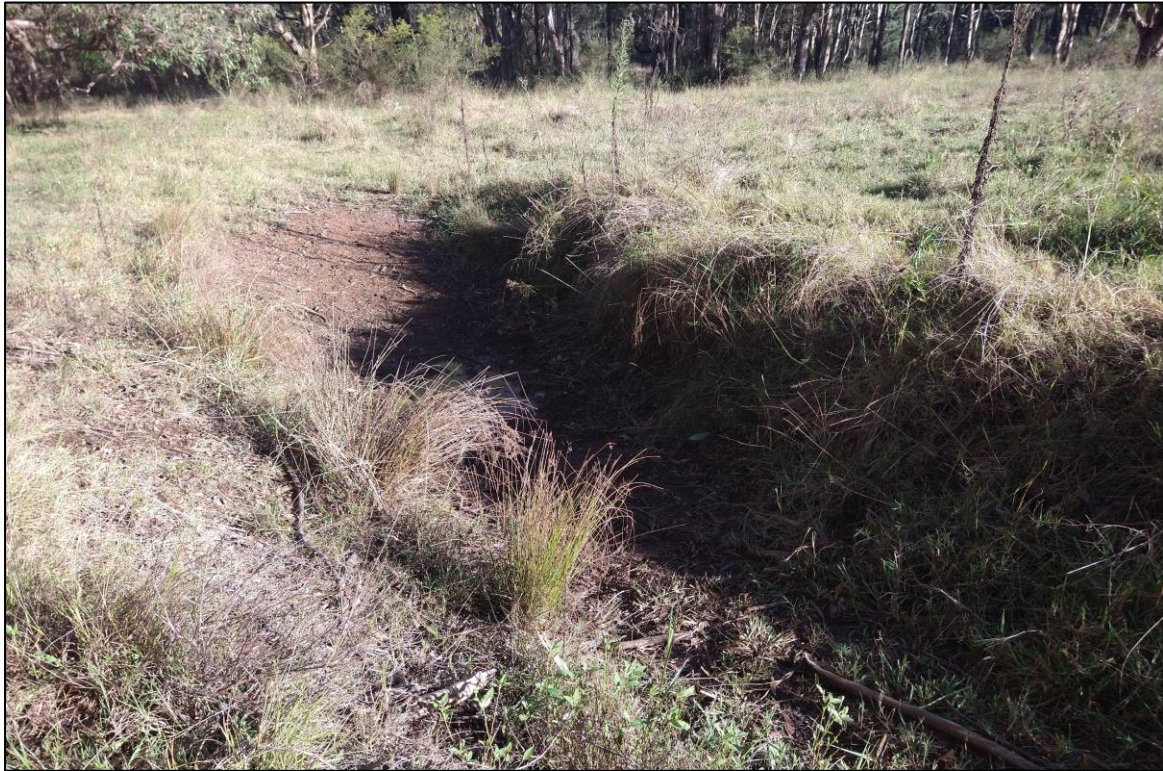
Photograph 15 - Cut area observed in the south-western portion of Lot 32 DP736923 (MRP 136).

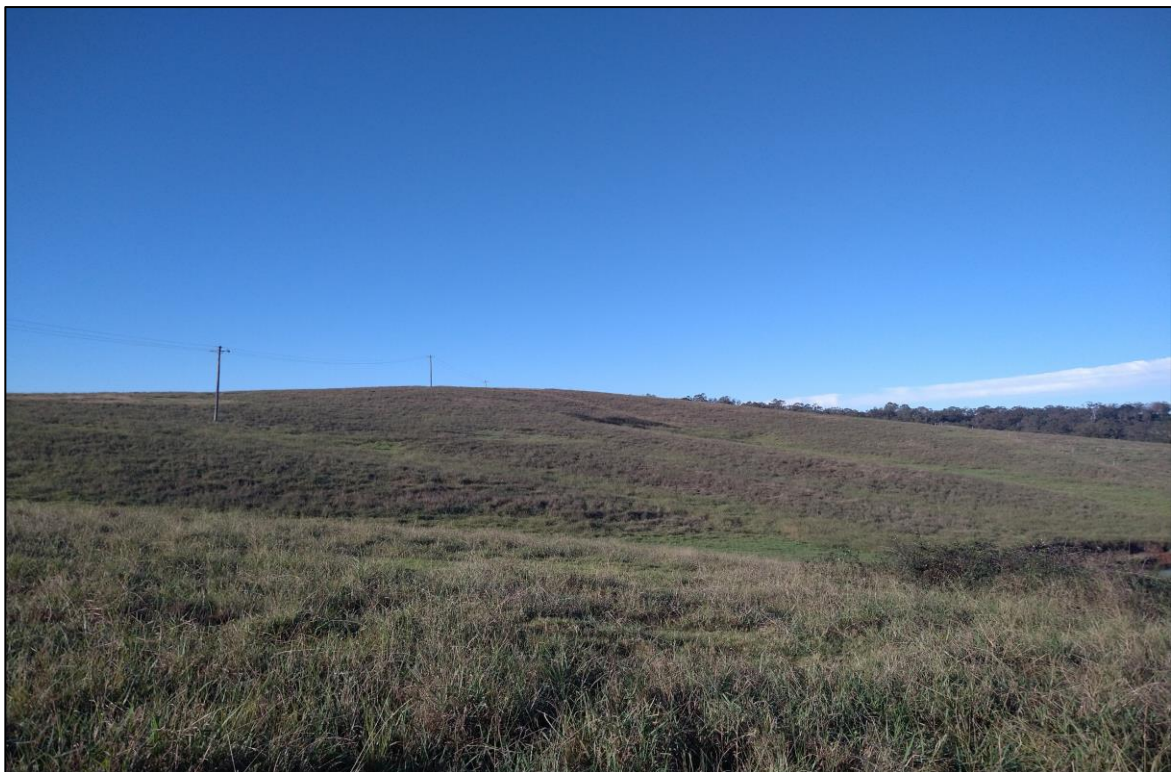
Photograph 16 - Timber power poles observed in the central portion of Lot 32 DP736923 (MRP 137).

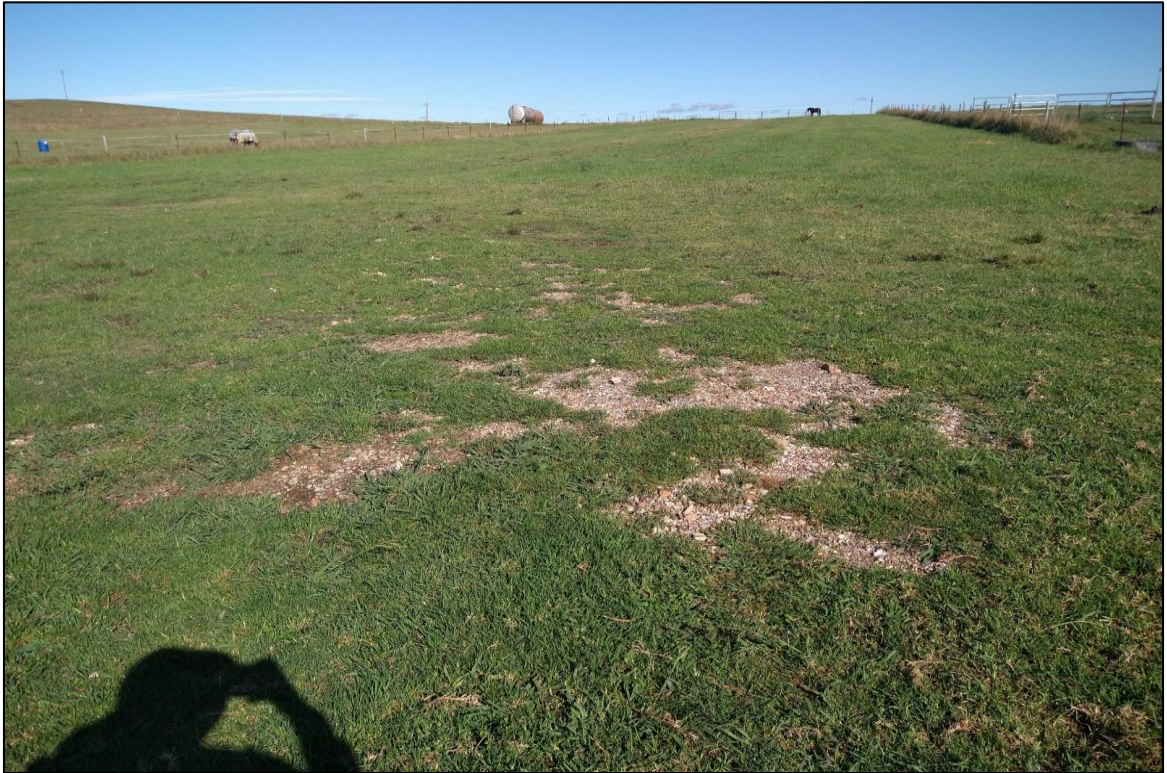
Photograph 17 - Exposed crushed rock fill material in the eastern portion of Lot 32 DP736923 (MRP 138).

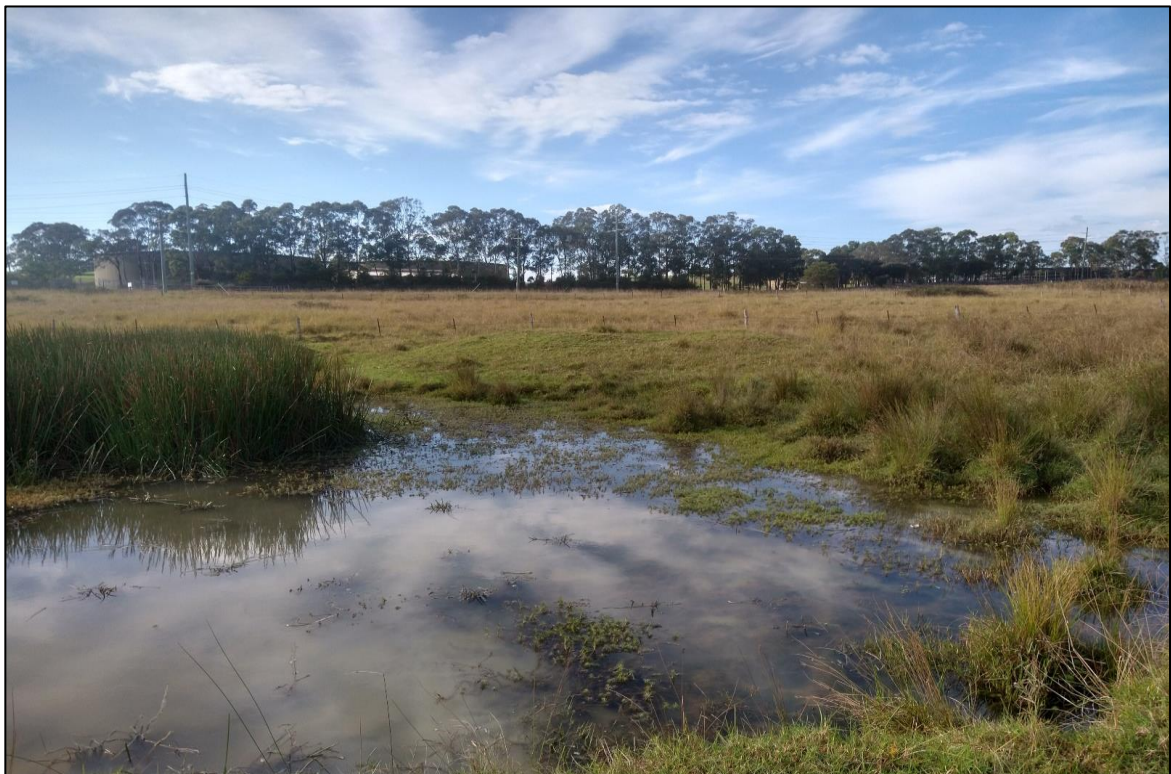
Photograph 18 - Farm dam located in north-eastern portion of Lot 3 DP804375.
(MRP 139a).

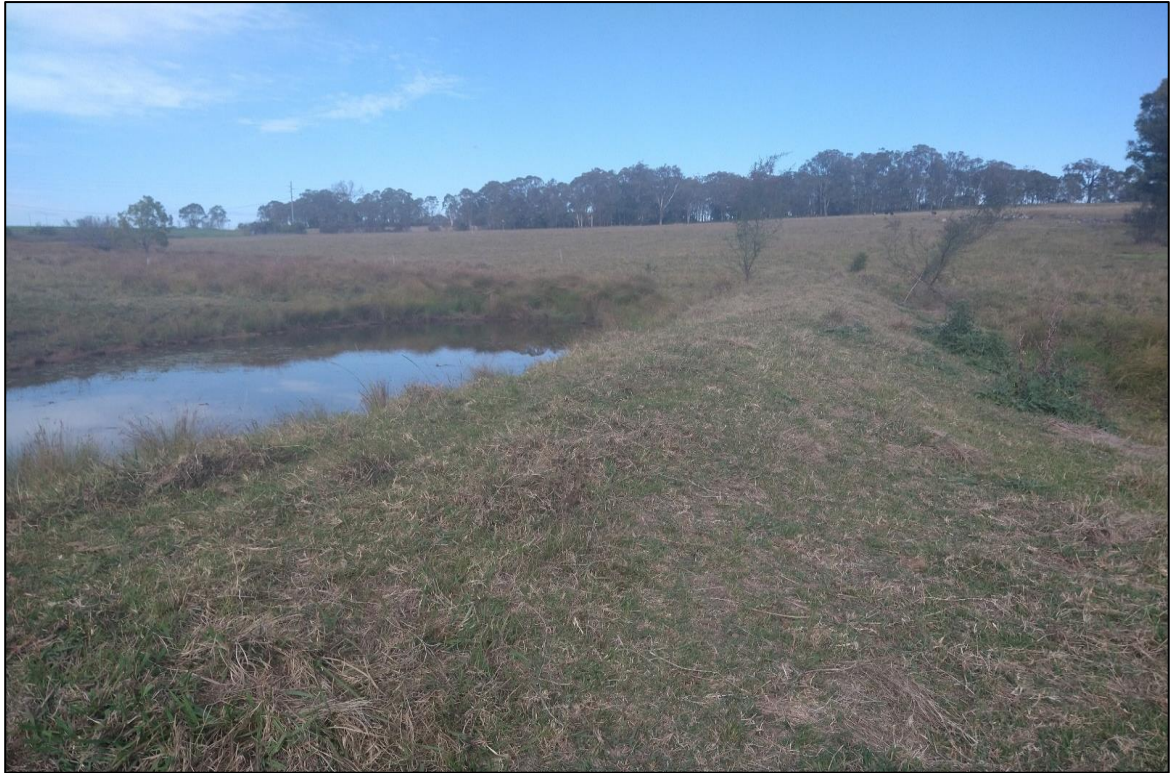
Photograph 19 - Farm dam located in south-eastern portion of Lot 3 DP804375.
(MRP 139b).

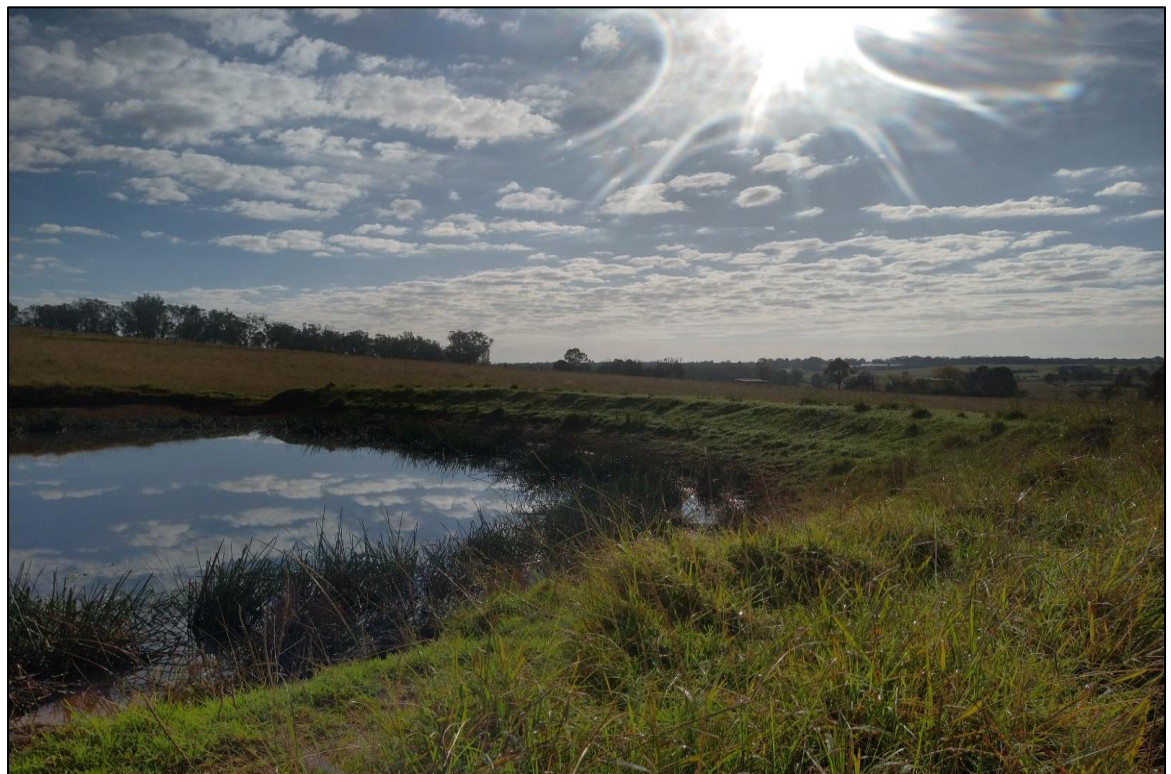
Photograph 20 - Farm dam located in north-western portion of Lot 3 DP804375.
(MRP 140).

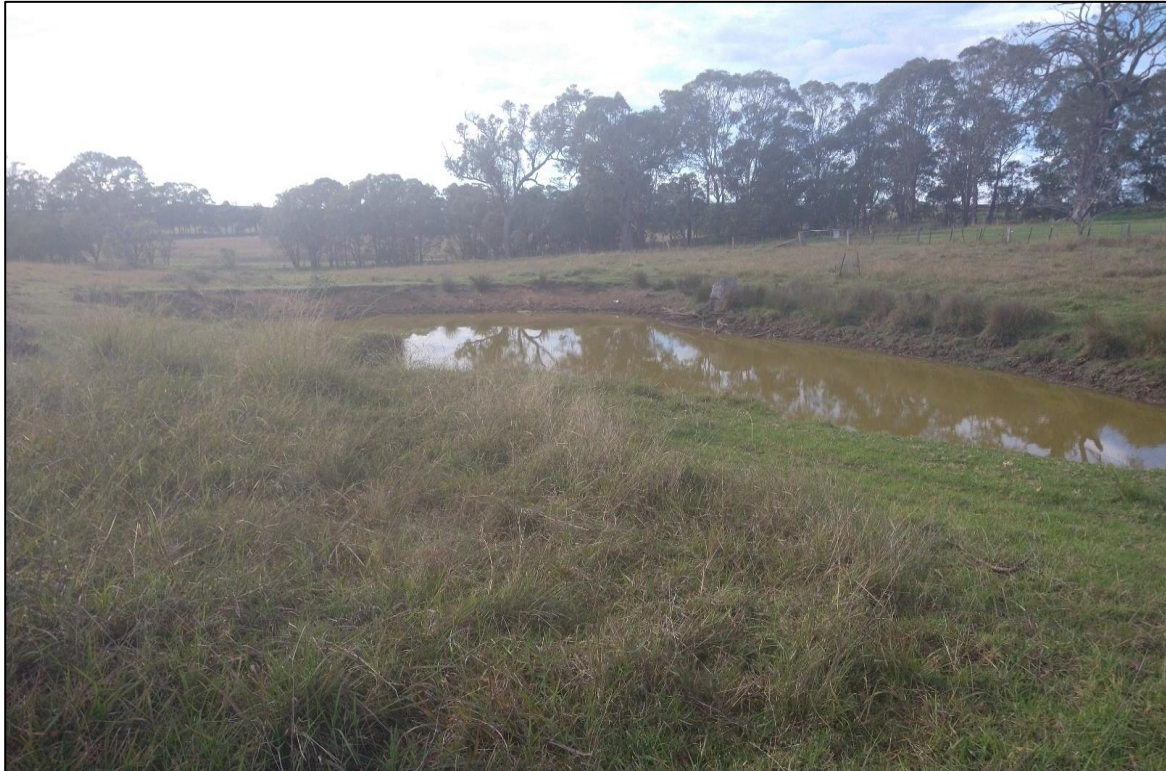
Photograph 21 - Farm dam located in eastern portion of Lot 3 DP804375.
(MRP 143).

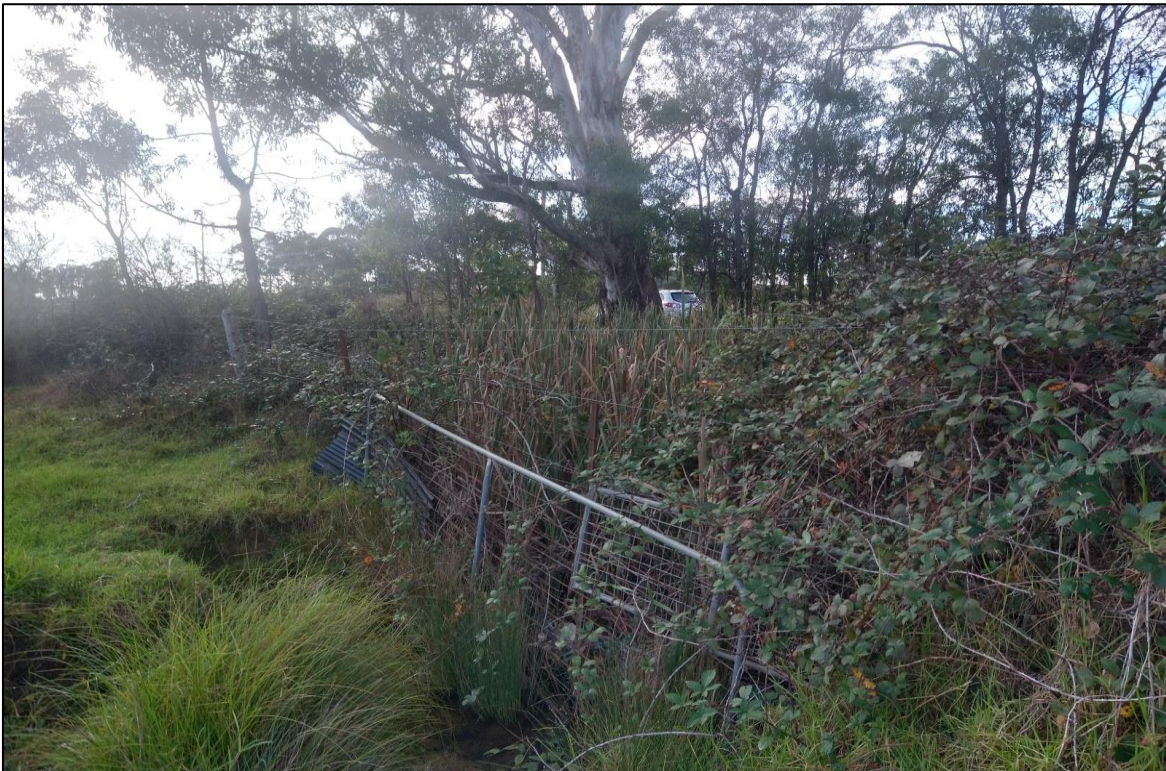
Photograph 22 - Farm dam located in eastern portion of Lot 3 DP804375.
(MRP 145; limited access).

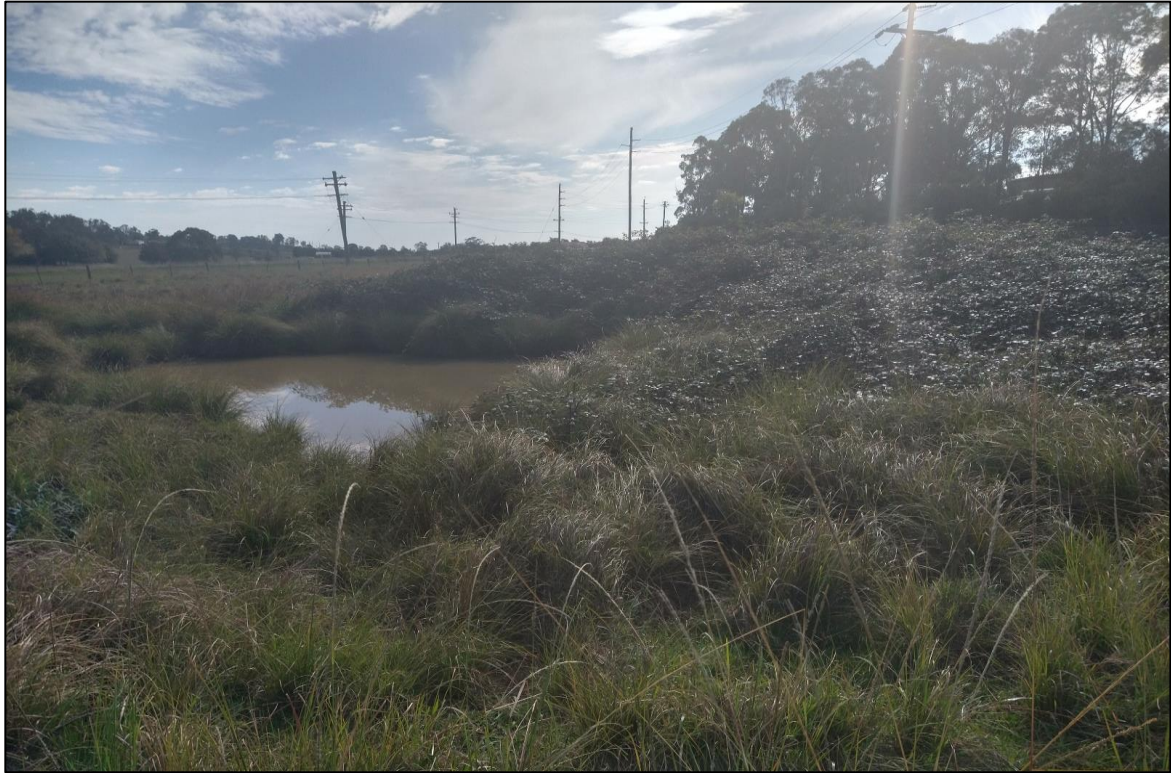
Photo 23 - Farm dam located in eastern portion of Lot 3 DP804375 (MRP 149).

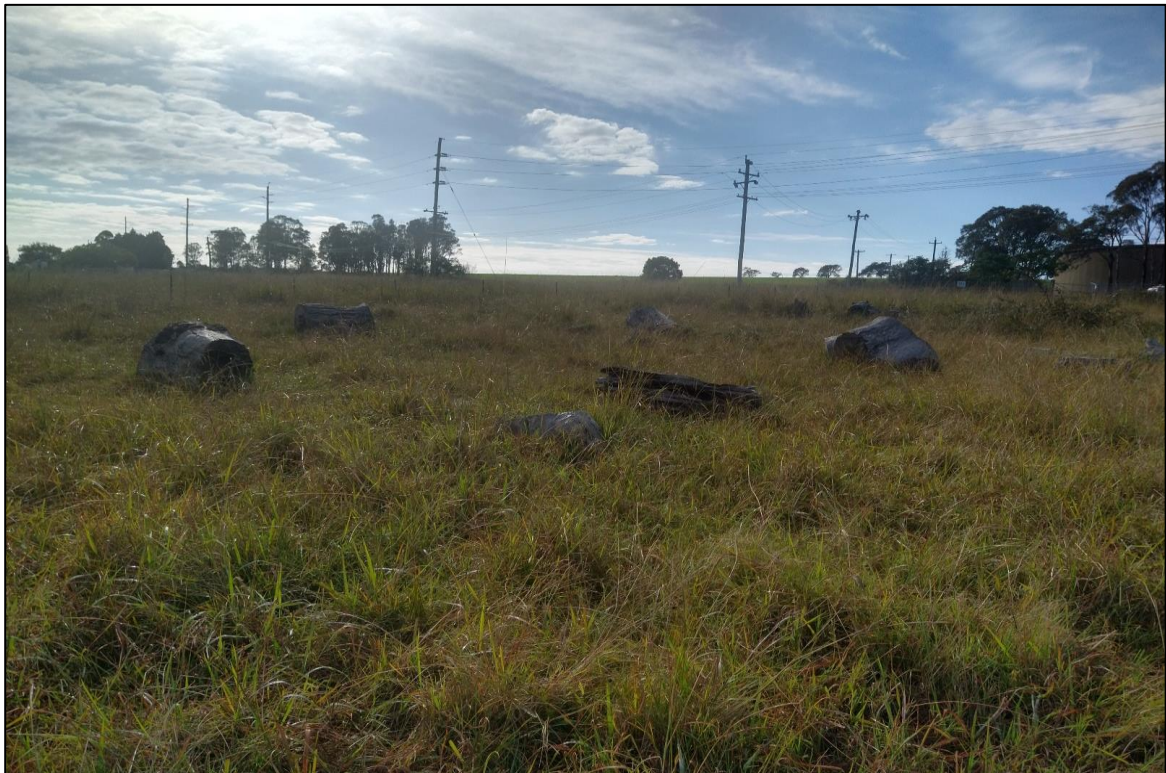
- Chopped tree trunks (organic material) were observed to be lain in the eastern (MRP 141, KFR 271) and southern portions (KFR 284) of Lot 3. At 284, trace geotextile fabric and scrap metal were also observed;

Photograph 24 - Chopped tree trunks observed in the eastern portion of Lot 3 DP804375 (MRP 141).

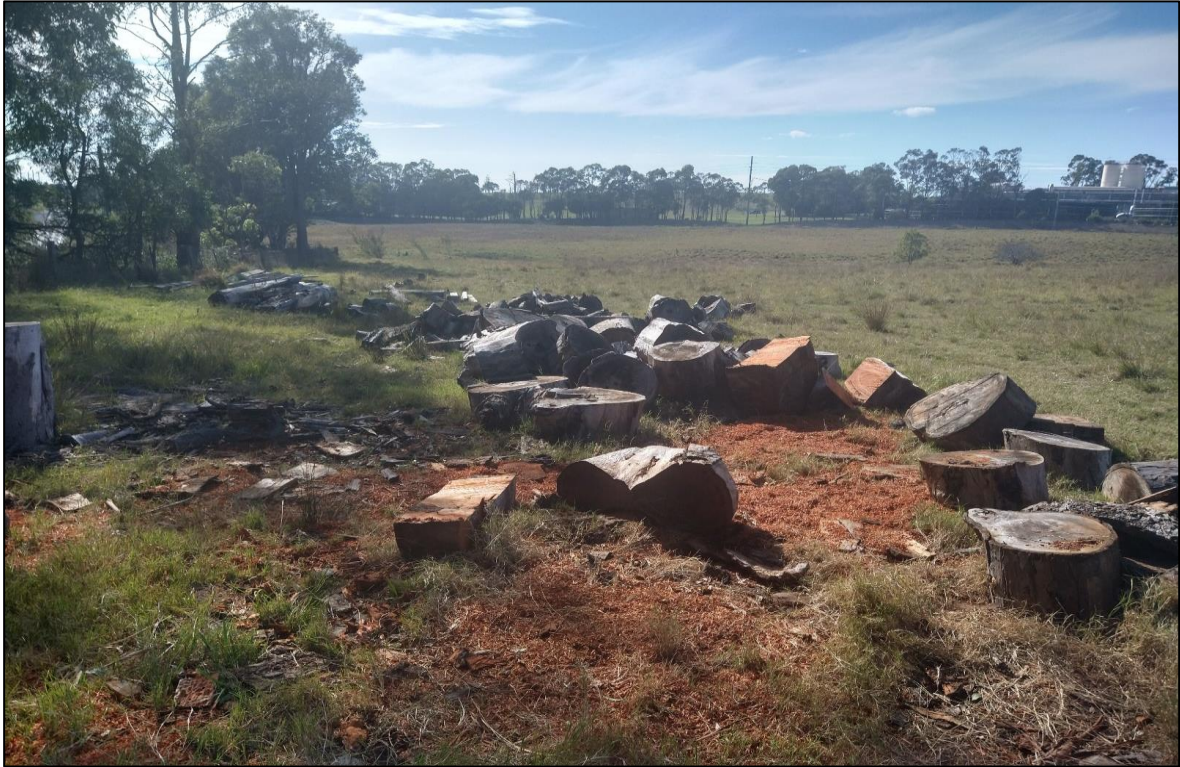
Photograph 25 - Chopped tree trunks observed in the southern portion of Lot 3 DP804375 (Key Feature Reference 284).
