Report on
Preliminary Site Investigation (Contamination)

Proposed Appin (Part 2) Precinct
Appin NSW

Prepared for
Walker Corporation Pty Ltd

Project 76589.18
October 2024

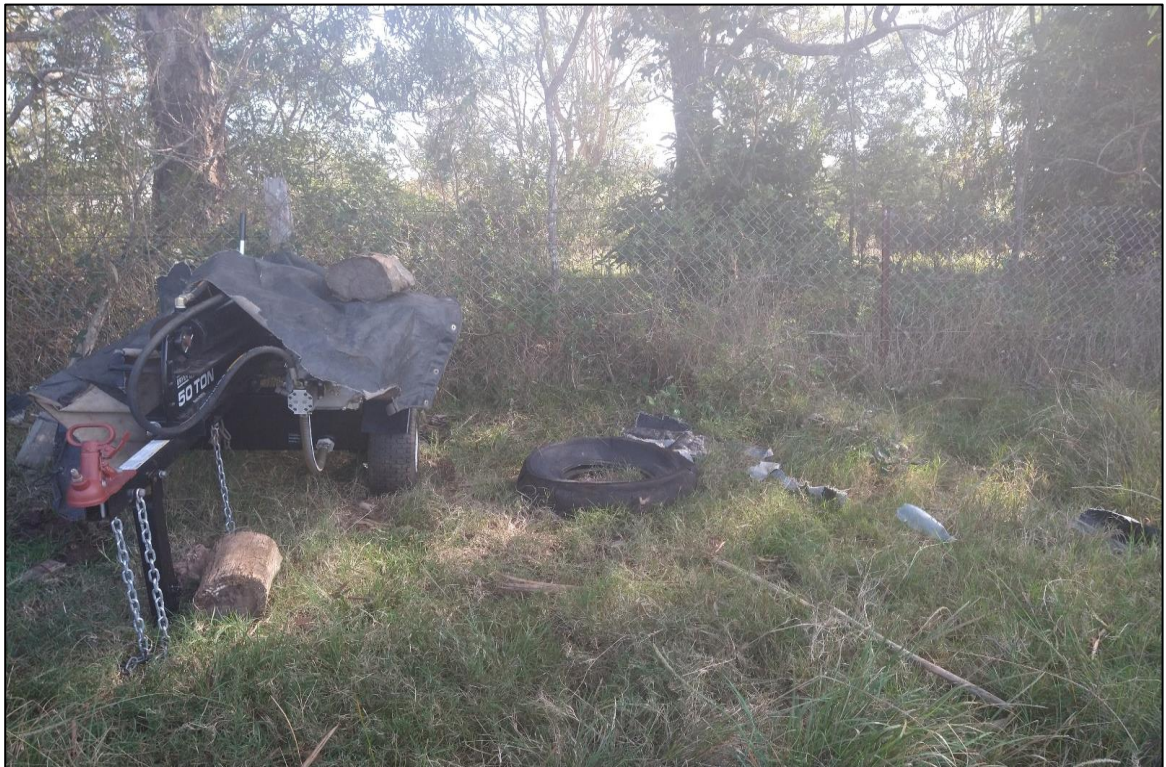
- Chopped tree trunks (organic material) were observed to be lain in the eastern (MRP 141, KFR 271) and southern portions (KFR 284) of Lot 3. At 284, trace geotextile fabric and scrap metal were also observed;

Photograph 26 - Trace geotextile fabric and metal scrap observed in the southern portion of Lot 3 DP804375 (Key Feature Reference 284).

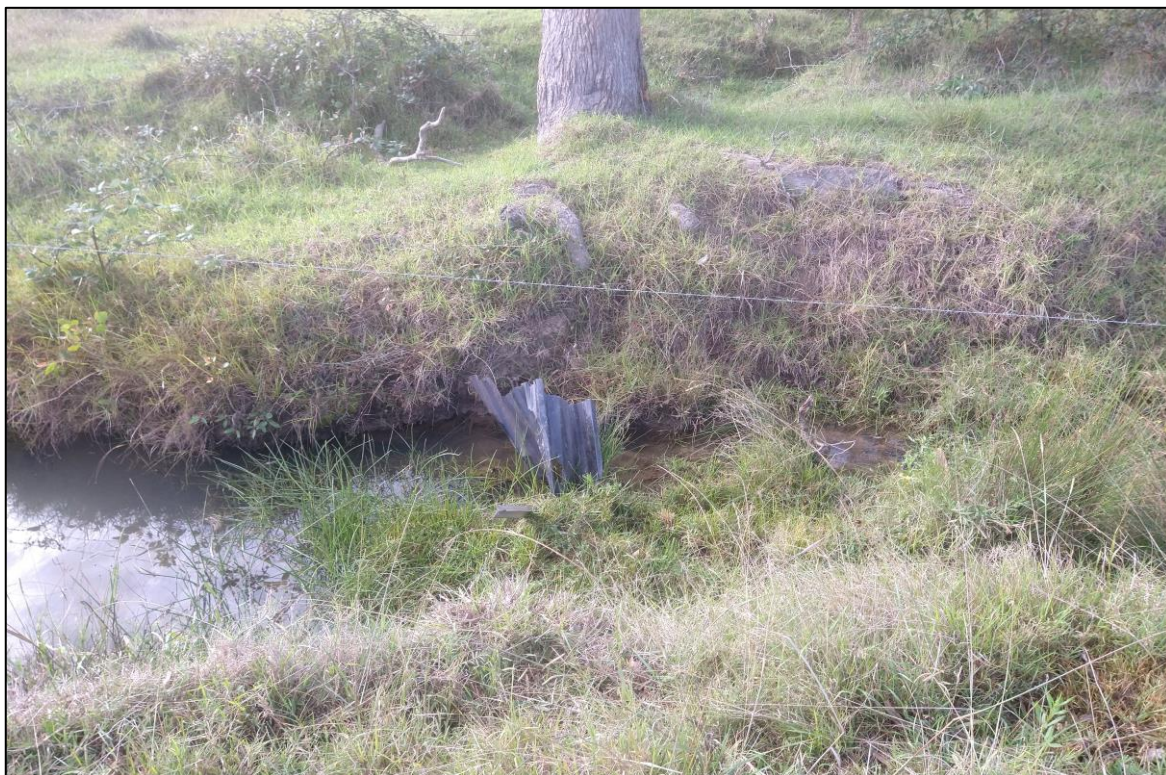
- Gully/creek lines were observed in the eastern and northern portions of Lot 3, where trace refuse material in the form of metal sheeting/scraps (MRP 142), and a glass bottle (MRP 144) were identified;

Photograph 27 - Gully/creek located in the eastern portion of Lot 3 DP804375, where metal sheeting was found (MRP 142).

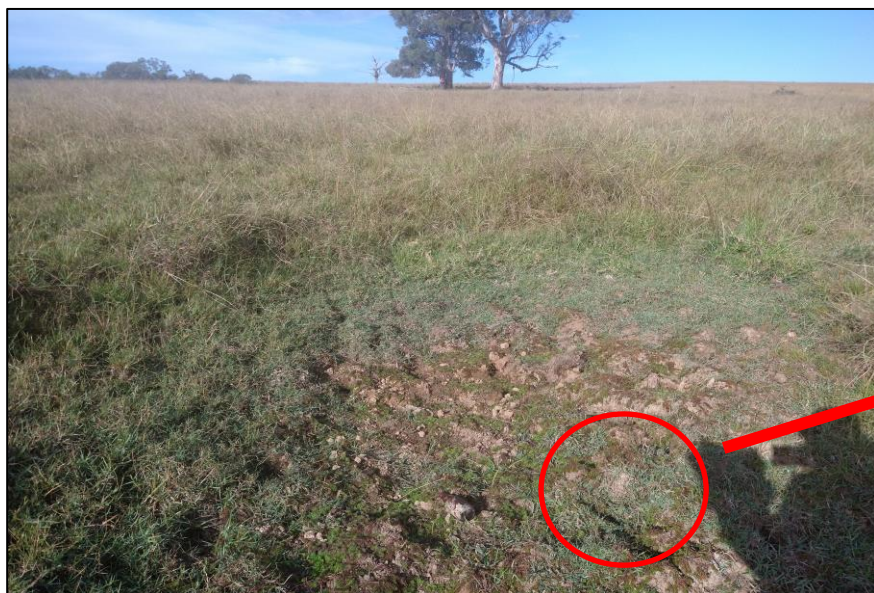
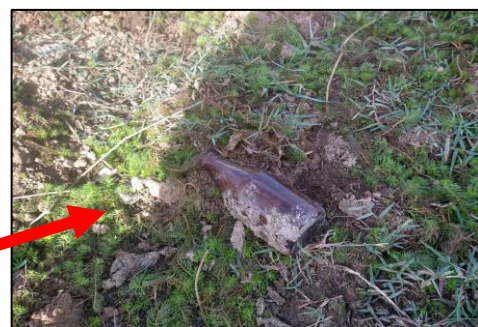
Photograph 28 - Gully observed in the northern portion of Lot 3 DP804375, where trace glass was found (MRP 144).

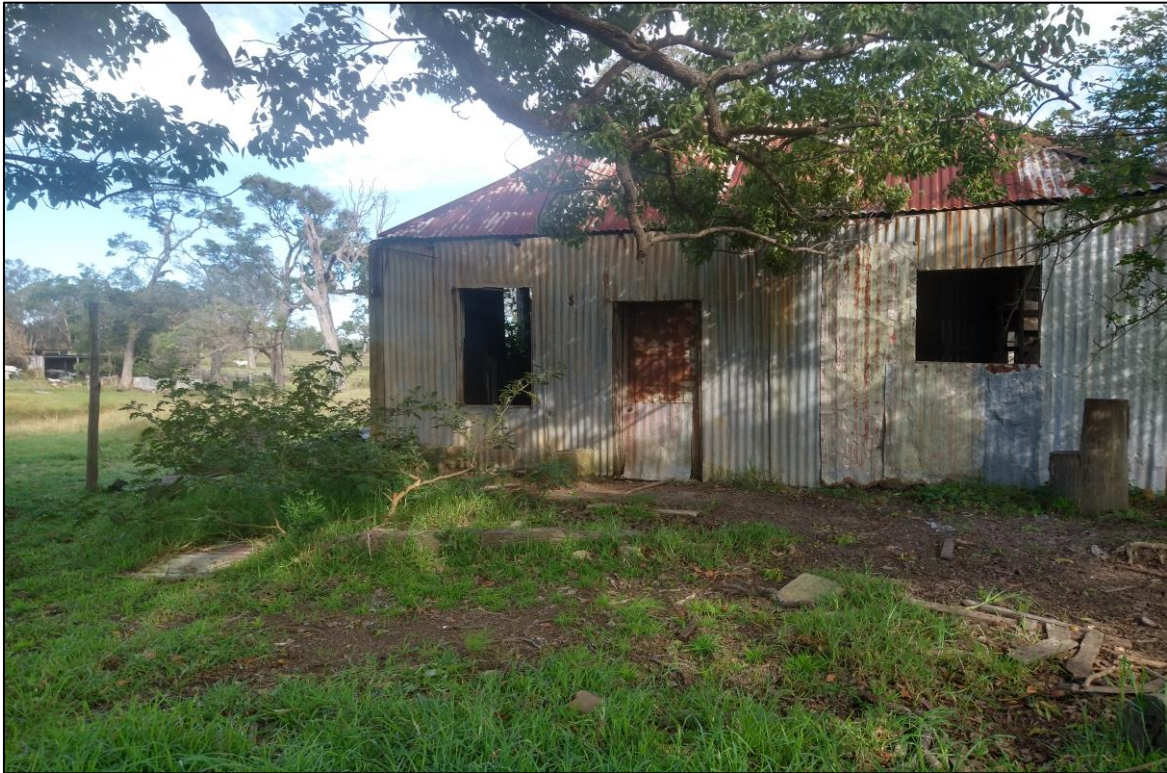
- A dilapidated shed constructed of metal corrugated sheeting on an unsealed soil base was observed and refuse material (metal, timber, plastic) and building demolition waste (bricks) was found inside the shed and/or in the immediate surroundings (MRP 146, KFR 273b);

Photograph 29 - Dilapidated shed constructed of metal corrugated sheeting on an unsealed soil base observed in Lot 3, DP804375 (MRP 146).

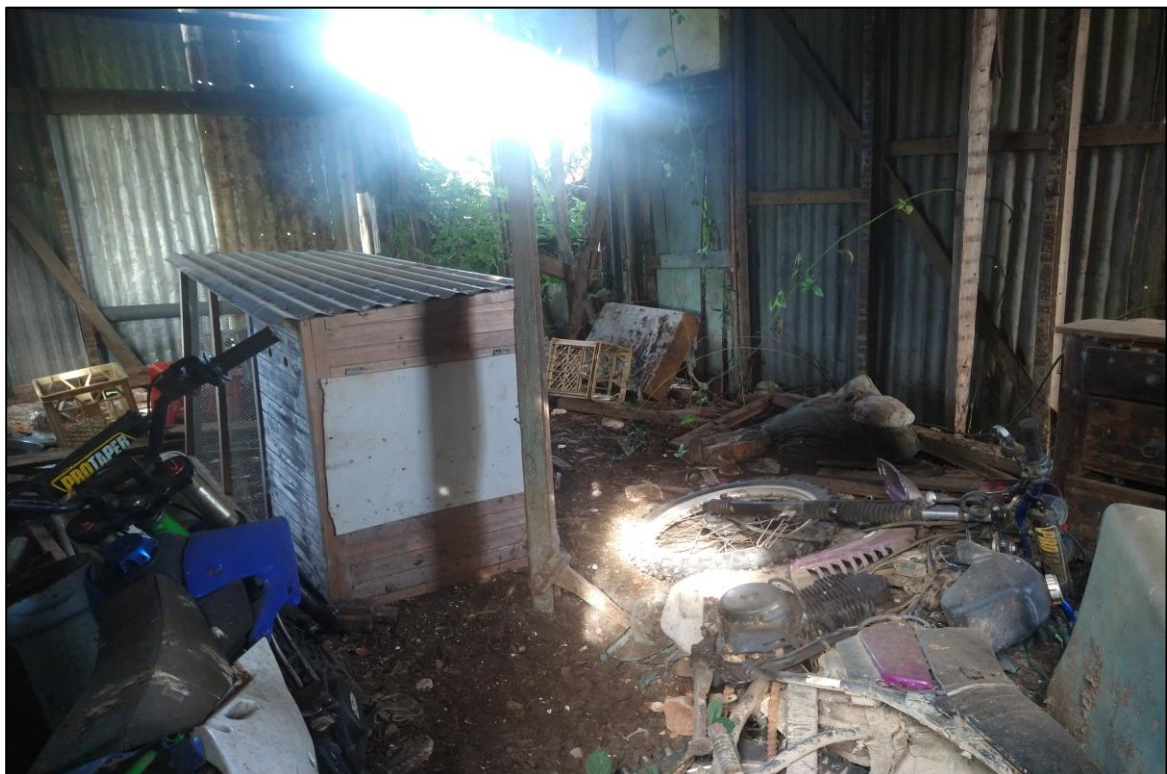
Photograph 30 - Refuse material (metal, timber, plastic) and building demolition waste (bricks) observed inside of shed (MRP 146).

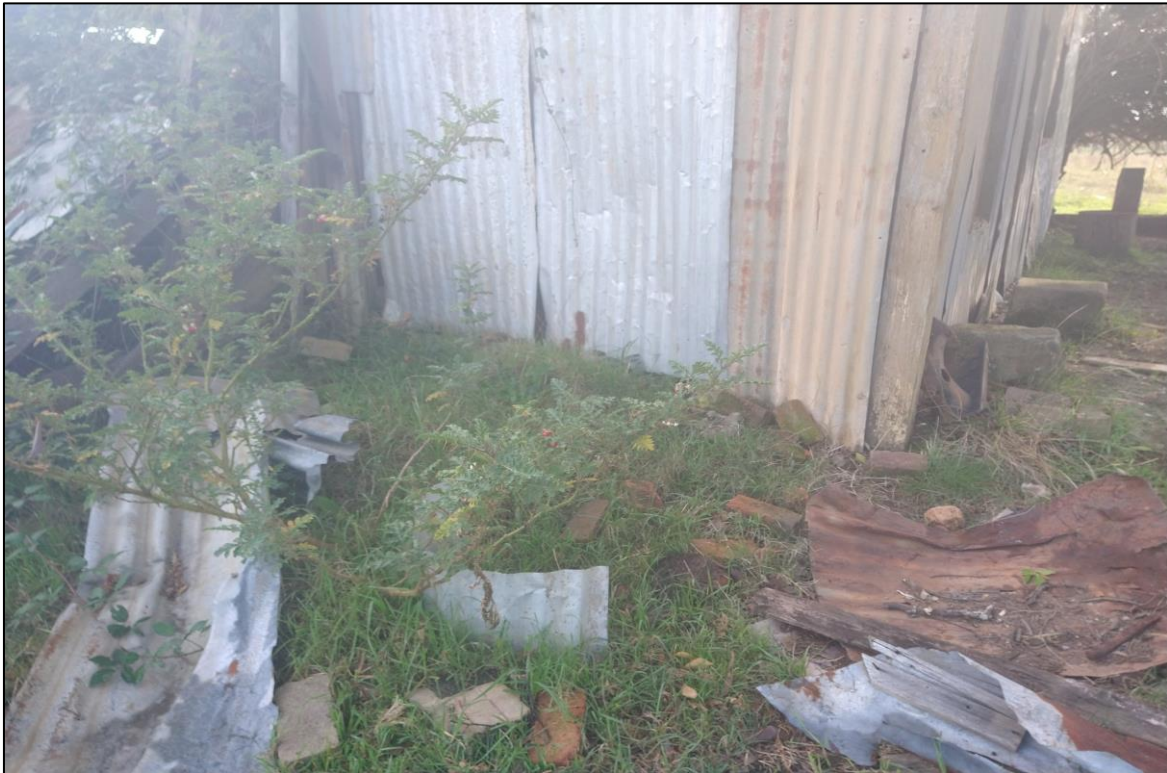
Photograph 31 - Refuse material (metal, timber, plastic) and building demolition waste (bricks) observed outside of shed (MRP 146).

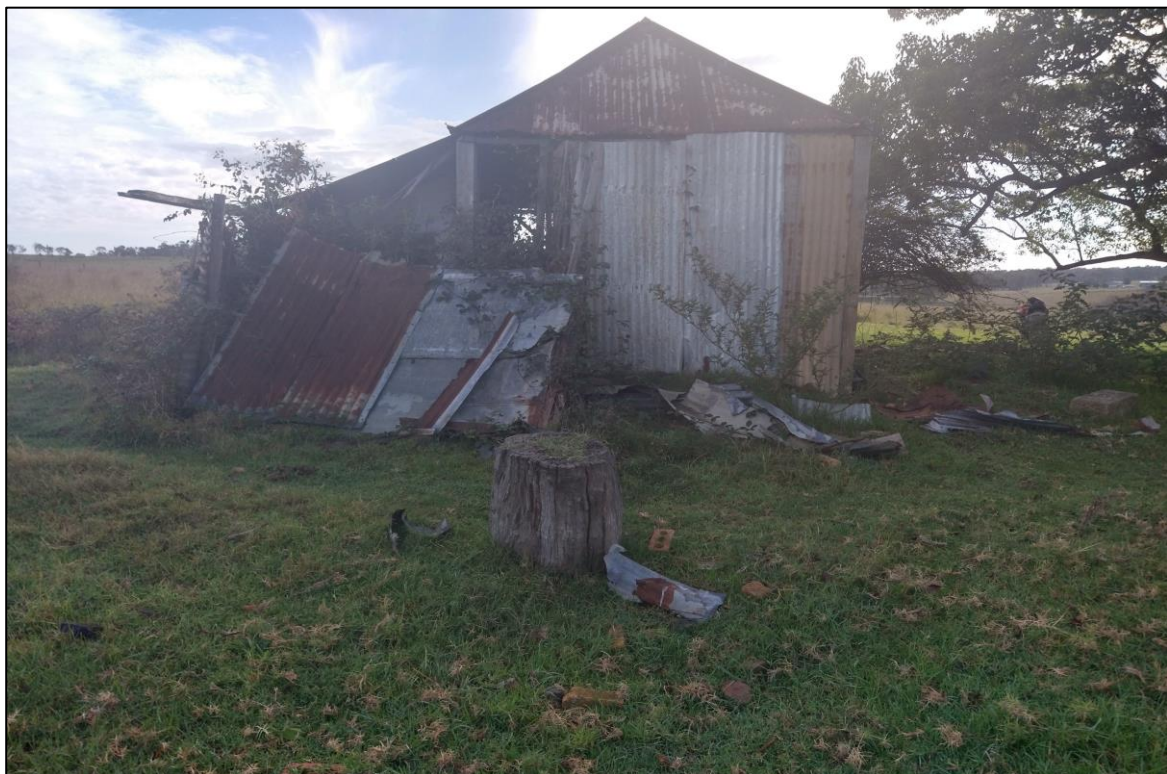
Photograph 32 - Refuse material (metal, timber, plastic) and building demolition waste (bricks) observed outside of shed (MRP 146).

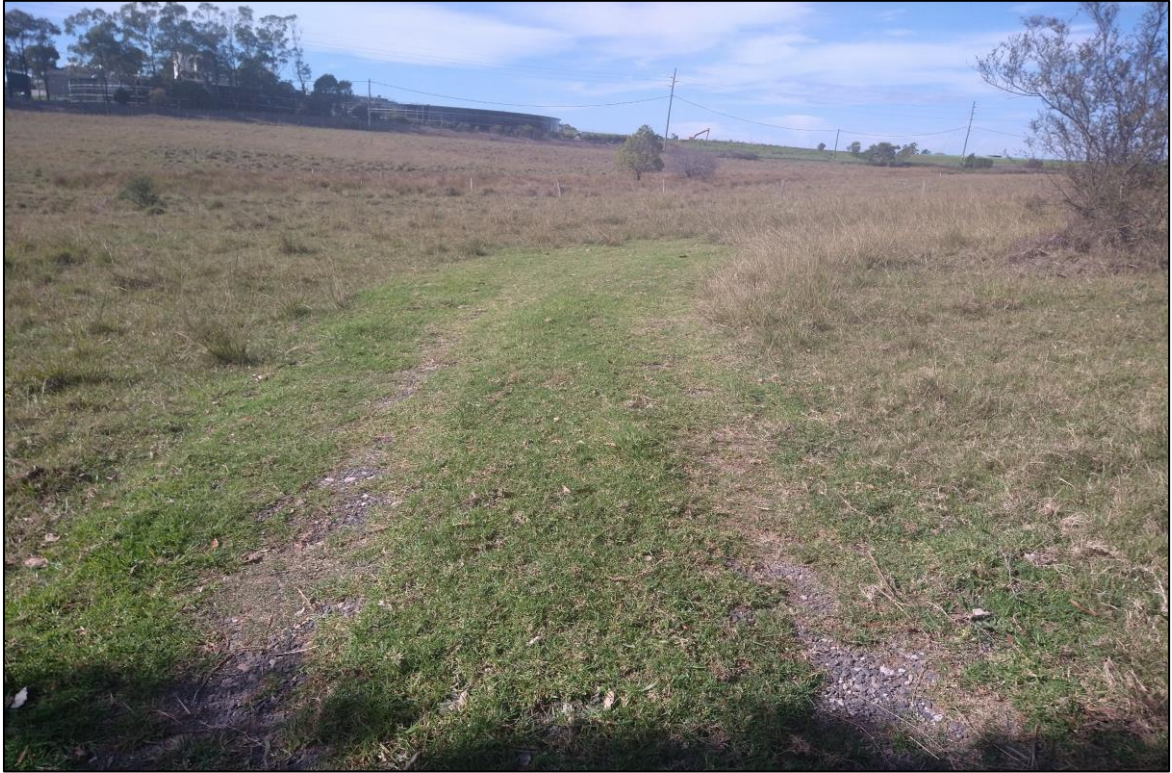
- Exposed gravelly fill material was observed in the eastern portion of Lot 3 (MRPs 147 and 148 – adjoining an unsealed gravelly driveway);
- An old, empty, corroded oil drum was visible in the eastern portion of Lot 3 (MRP 150);

Photograph 33 - Exposed gravelly fill material adjoining unsealed driveway.
(MRP 147).

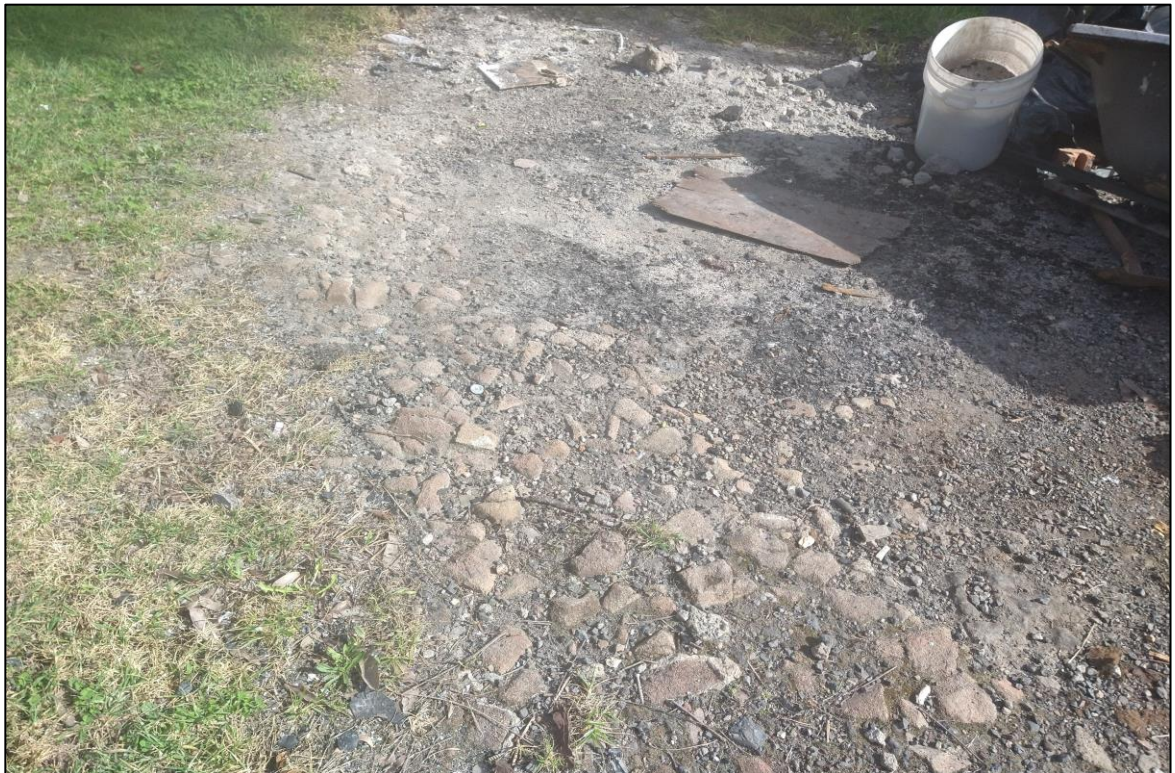
Photograph 34 - Exposed gravelly fill material (MRP 148).

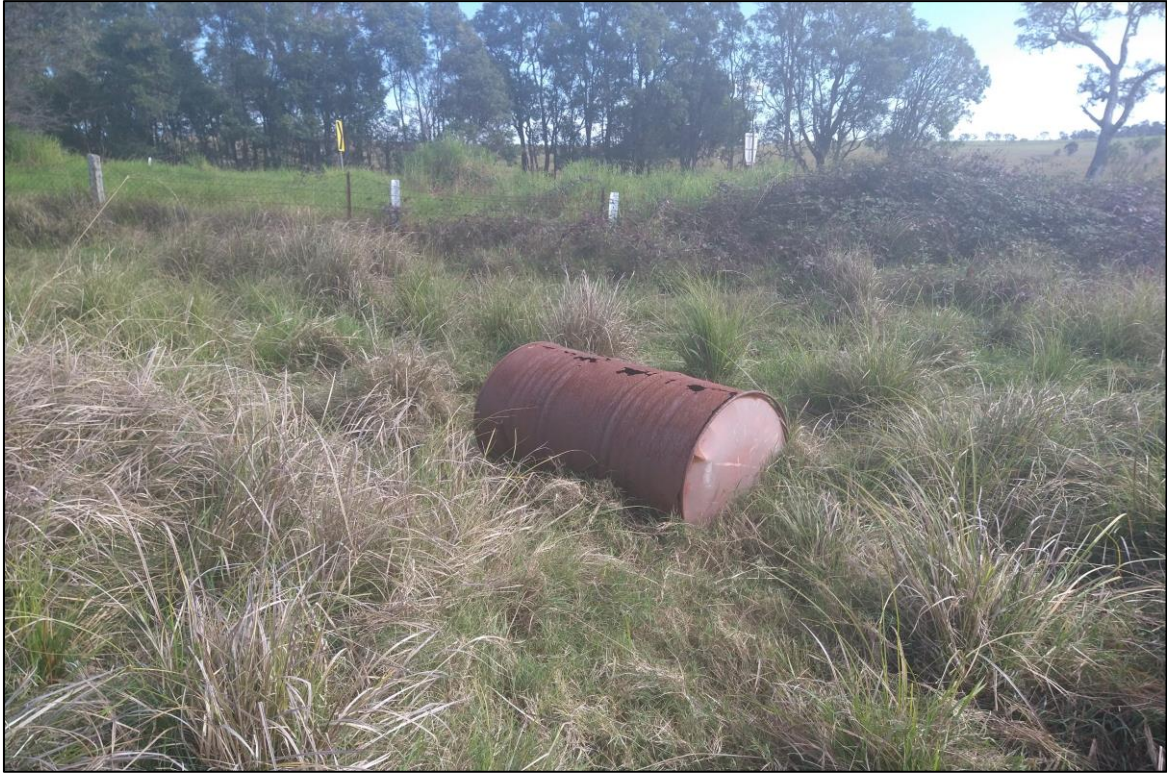
Photograph 35 - Old oil drum located in the eastern portion of Lot 3 DP804375 (MRP 150).

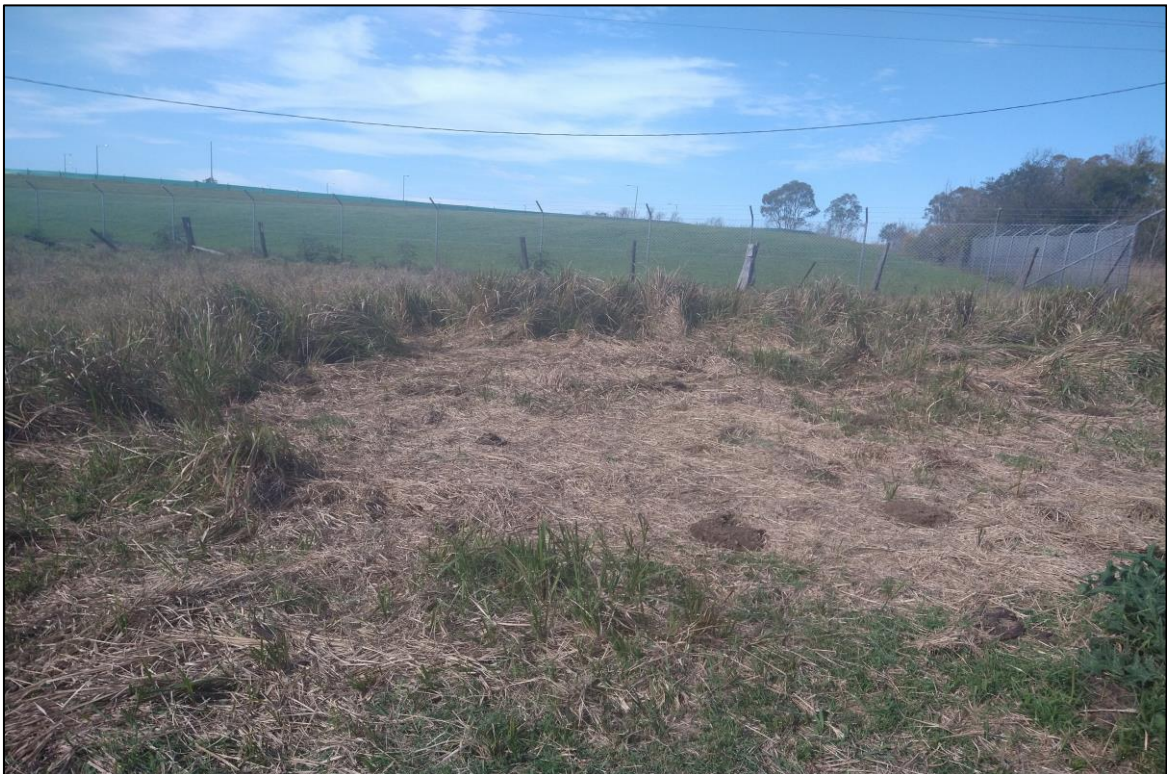
- Ground disturbance was observed in the southern portion of Lot 3 (MRP 151); and
- An area of fly-tipping/dumped refuse material including timber, geotextile fabric, metal scraps, plastic and building demolition waste including concrete and bricks was identified in the southern portion of Lot 3 (MRP 152).

Photograph 36 - Ground disturbance observed in the southern portion of Lot 3 DP804375 (MRP 151).

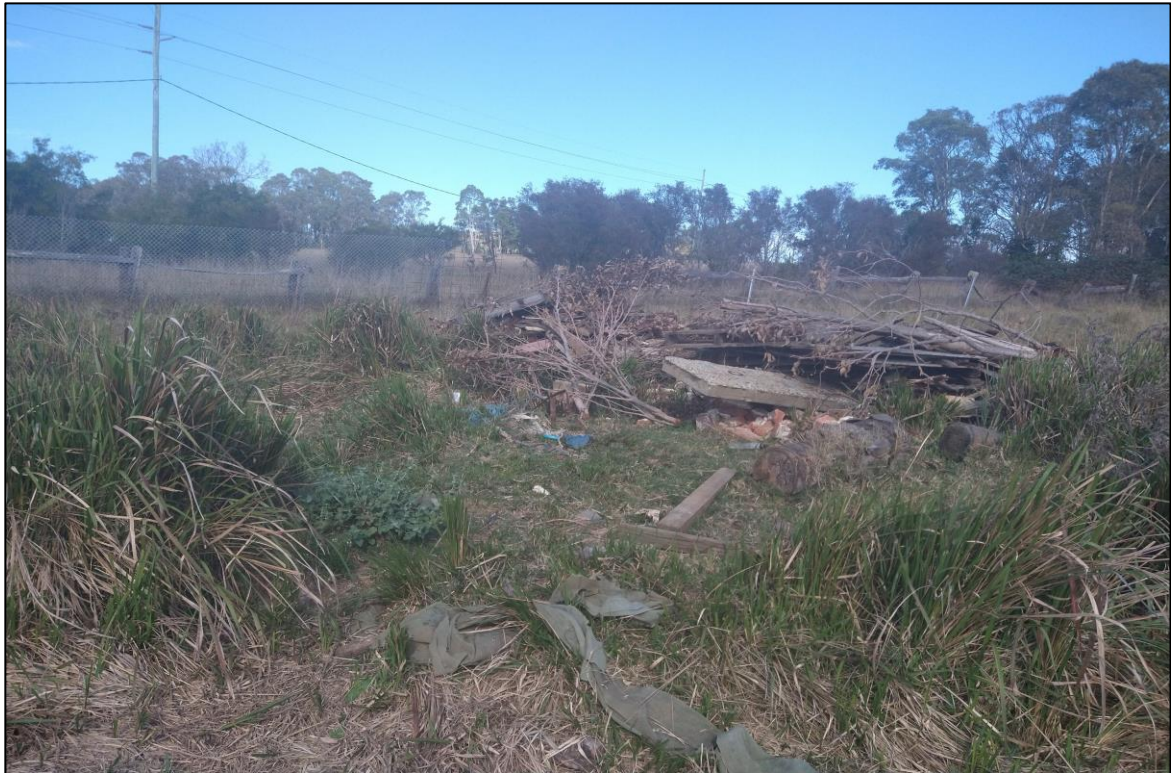
Photograph 37 - Fly-tipping of refuse material and building demolition waste observed in the southern portion of Lot 3 DP804375 (MRP 152).

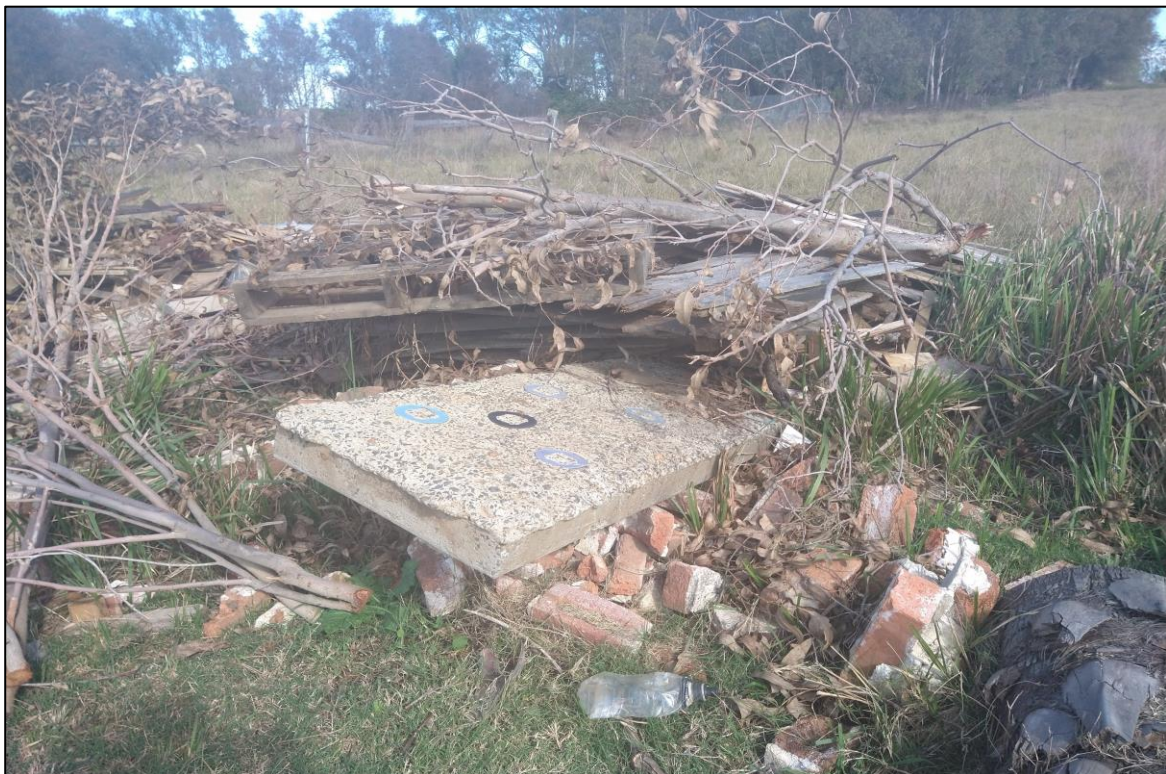
Photograph 38 - Fly-tipping of refuse material and building demolition waste observed in the southern portion of Lot 3 DP804375 (MRP 152).
