Report on  
Preliminary Site Investigation (Contamination)

Proposed Appin (Part 2) Precinct  
Appin NSW

Prepared for  
Walker Corporation Pty Ltd

Project 76589.18  
October 2024

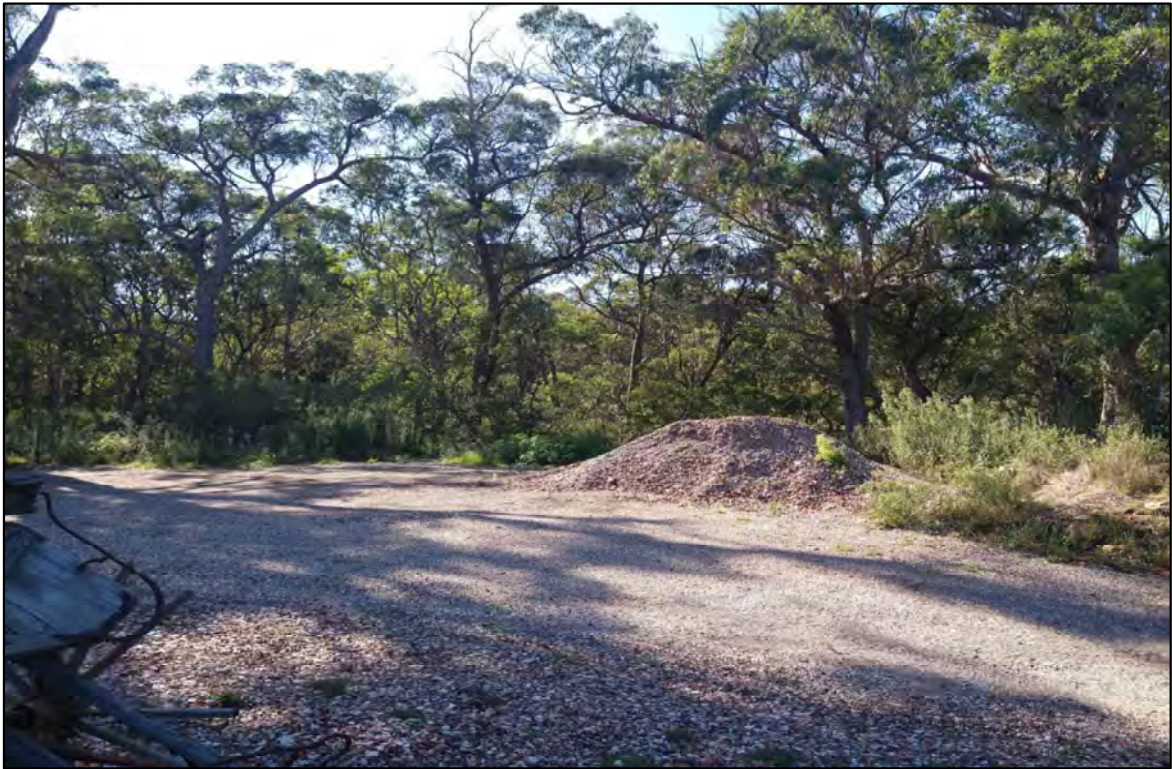
- The following was observed in the north-eastern and eastern portions of Lot 32, and Lot 1 DP1000355:
  - o Two stockpiles of quarried materials (MRP 122) and one stockpile of crushed gravel and cobble material (MRP 123);

Photograph 1 - Stockpile of crushed gravel and cobble material (MRP 123).

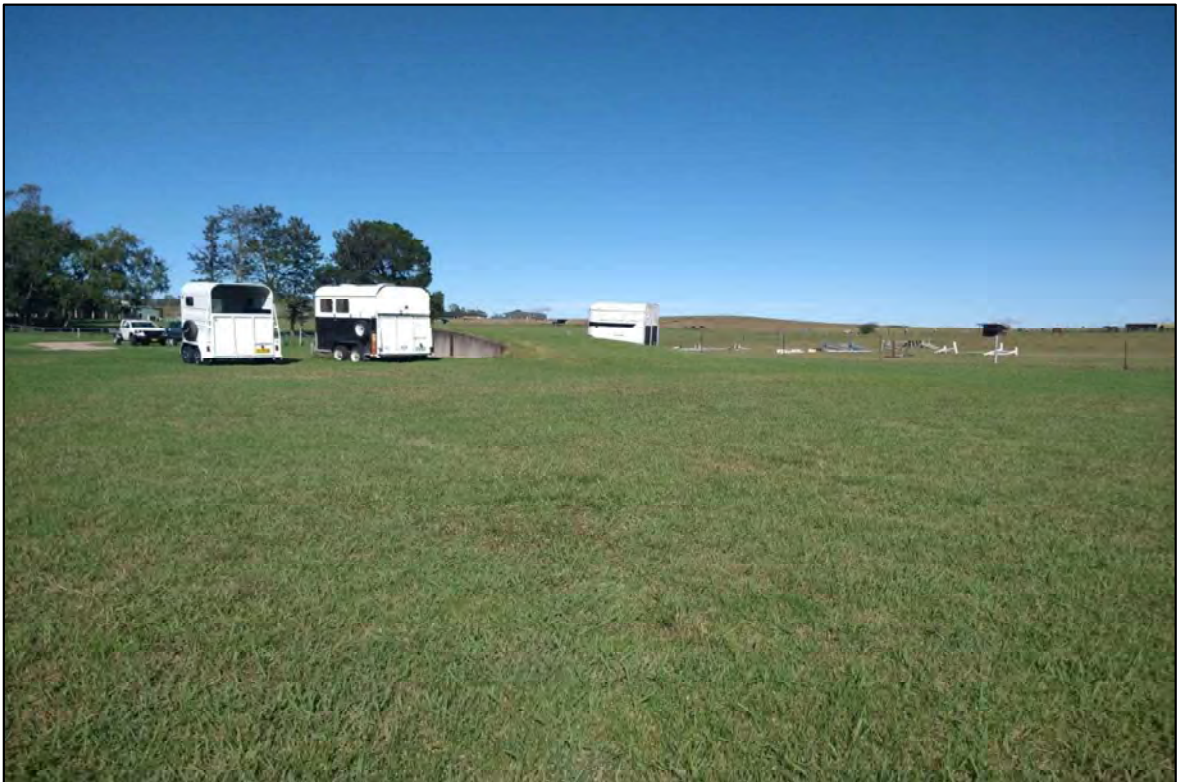
Photograph 2 - Raised area of possible fill, likely to be utilised as a ramp with caravan trailers and horse jump equipment present in the surrounds (MRP 126).

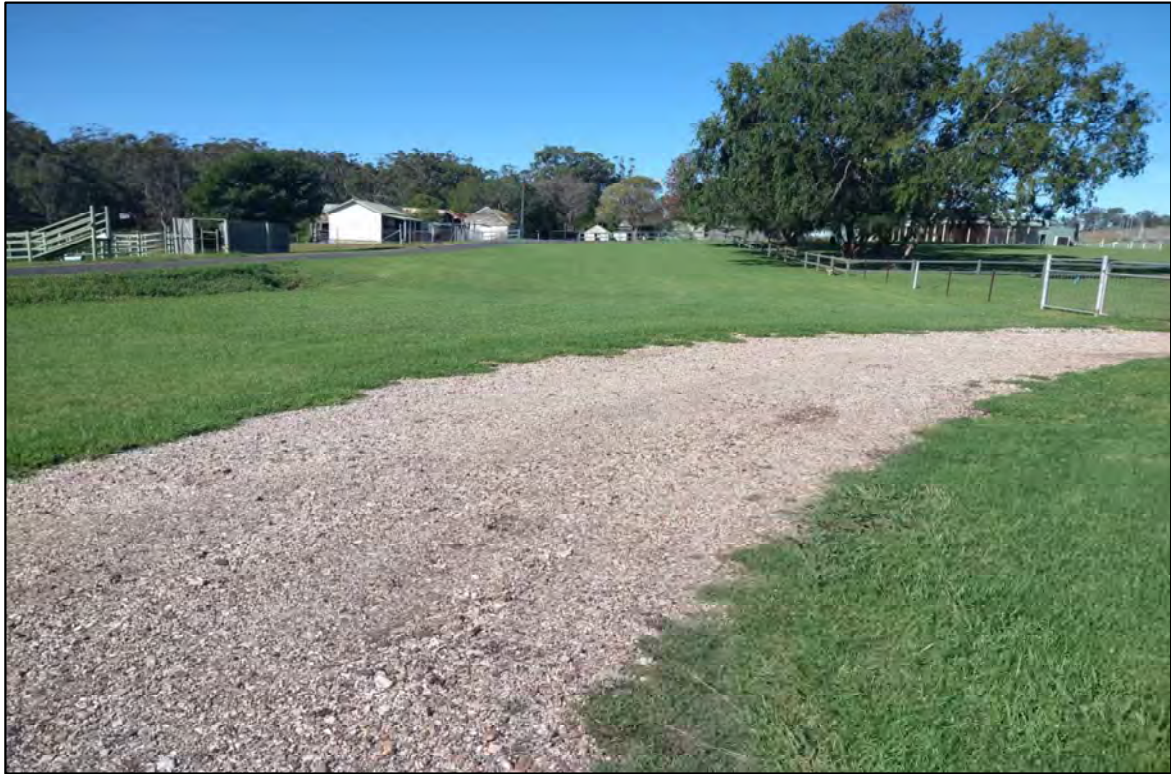
Photograph 3 - Unsealed road adjoining Macquariedale Road.  
comprised gravelly fill material (MRP 127)

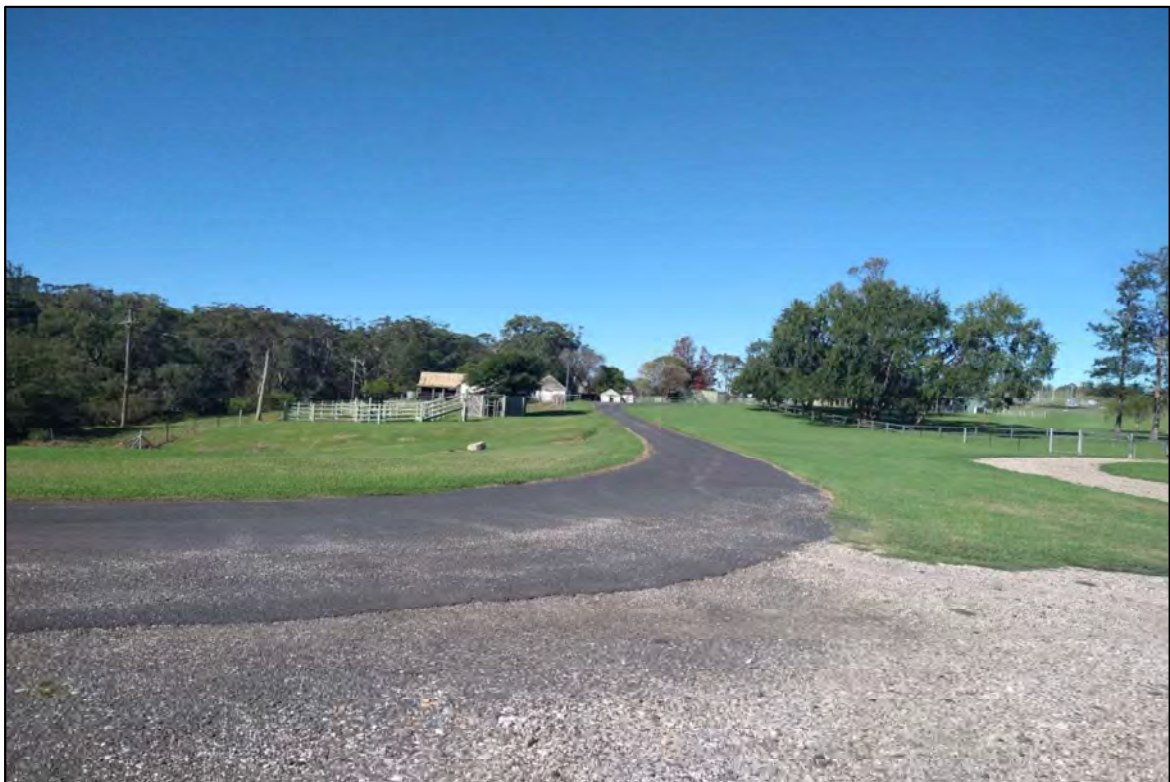
Photograph 4 - Unsealed road adjoining Macquariedale Road comprised.  
crushed rock fill material (MRP 128)

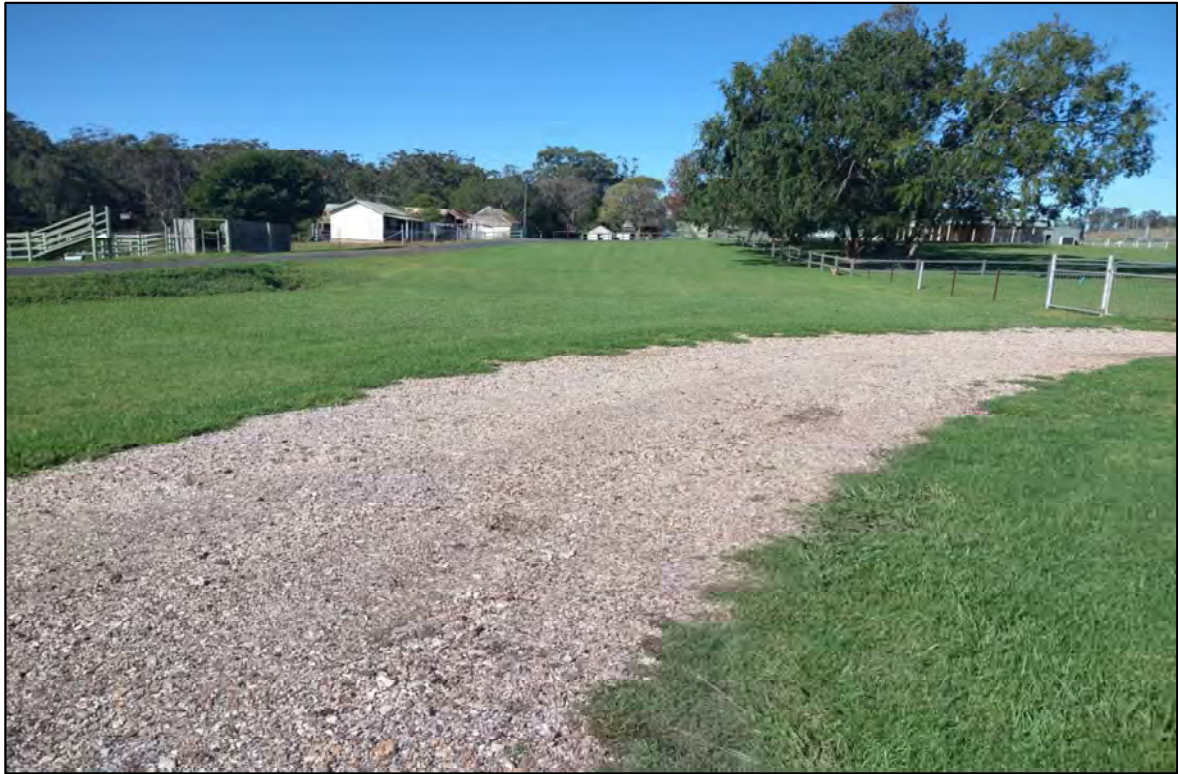
Photograph 5 - Residential dwellings and associated structures.  
(MRP 129)

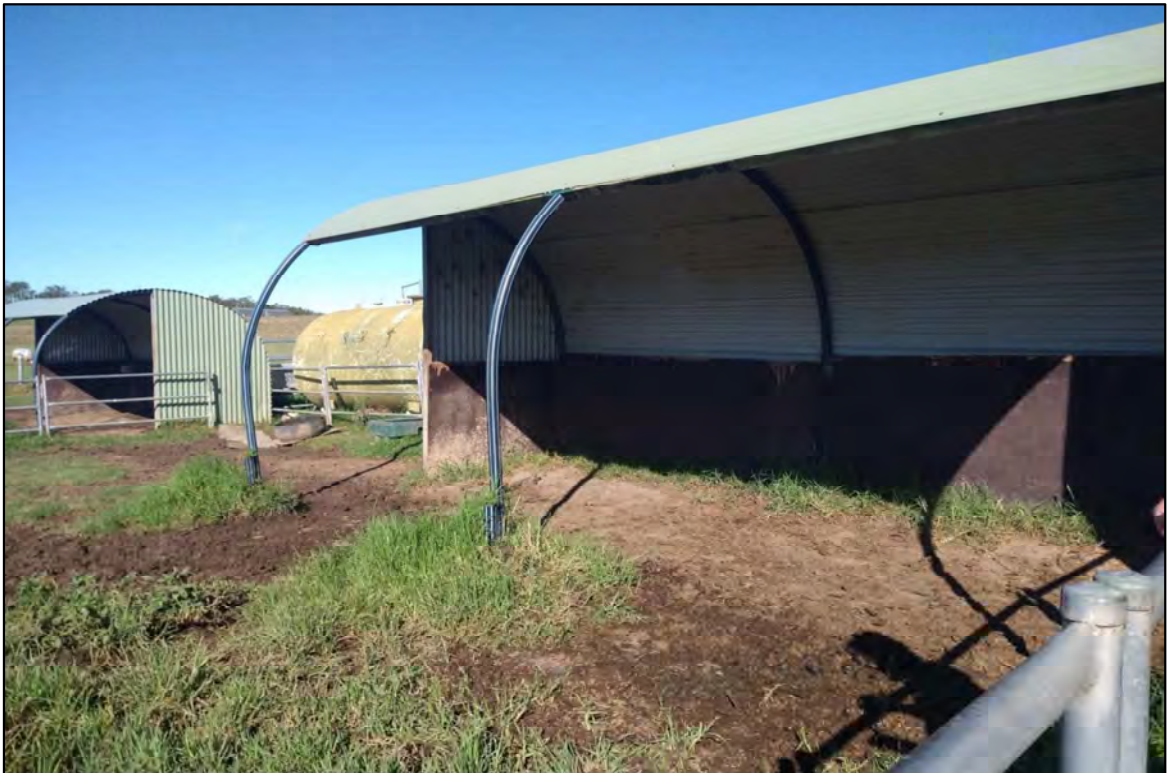
- o Horse/animal pens and associated horse shelters comprising metal sheeting with unsealed flooring (KFR 277; MRP 130) were observed in the eastern portion of Lot 32. Two former fuel storage tanks were also present, one (MRP131) in the vicinity of MRP130, the other (MRP132; KFR 279) approximately 130 m south-west, both of which were reutilised for water pumping and storage for animal drinking purposes; and

Photograph 6 - Proposed Appin (Part 2) Precinct 6 - Horse pens and shelters with metal sheeting with unsealed flooring.  
(MRP 130)

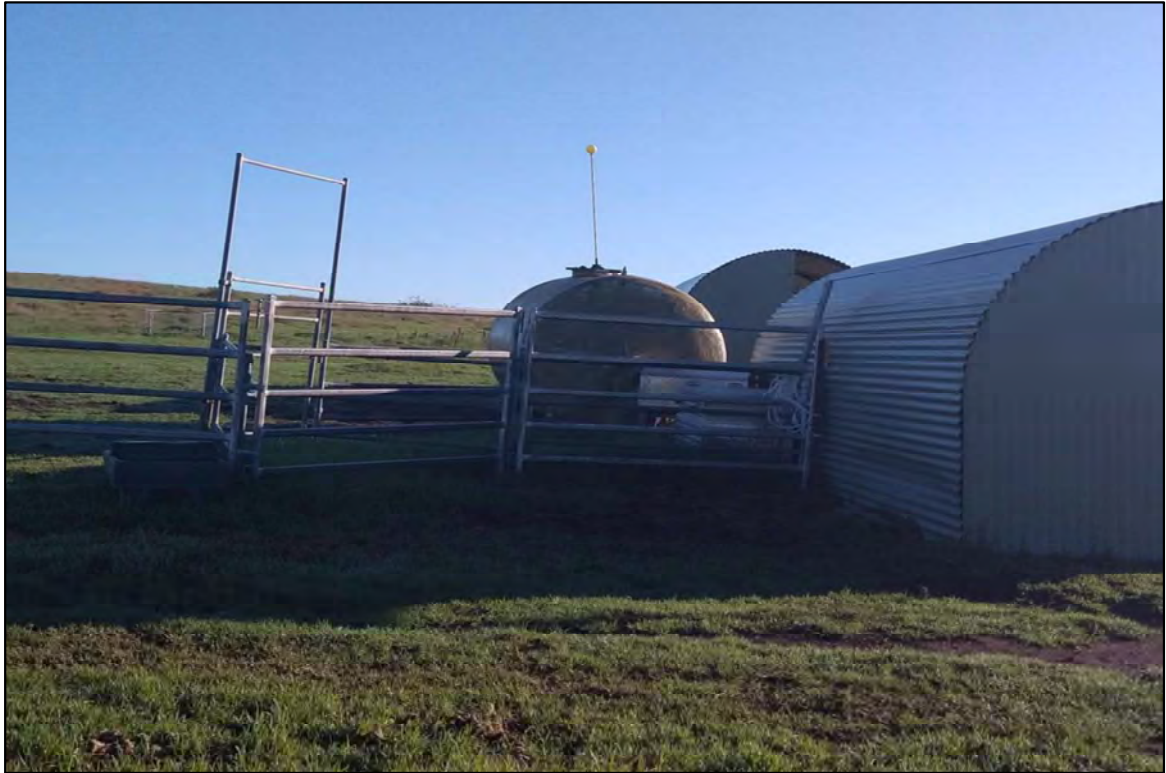
Photograph 7 - Former fuel storage tank reutilised for water pumping and storage for farm animals (MRP 131).

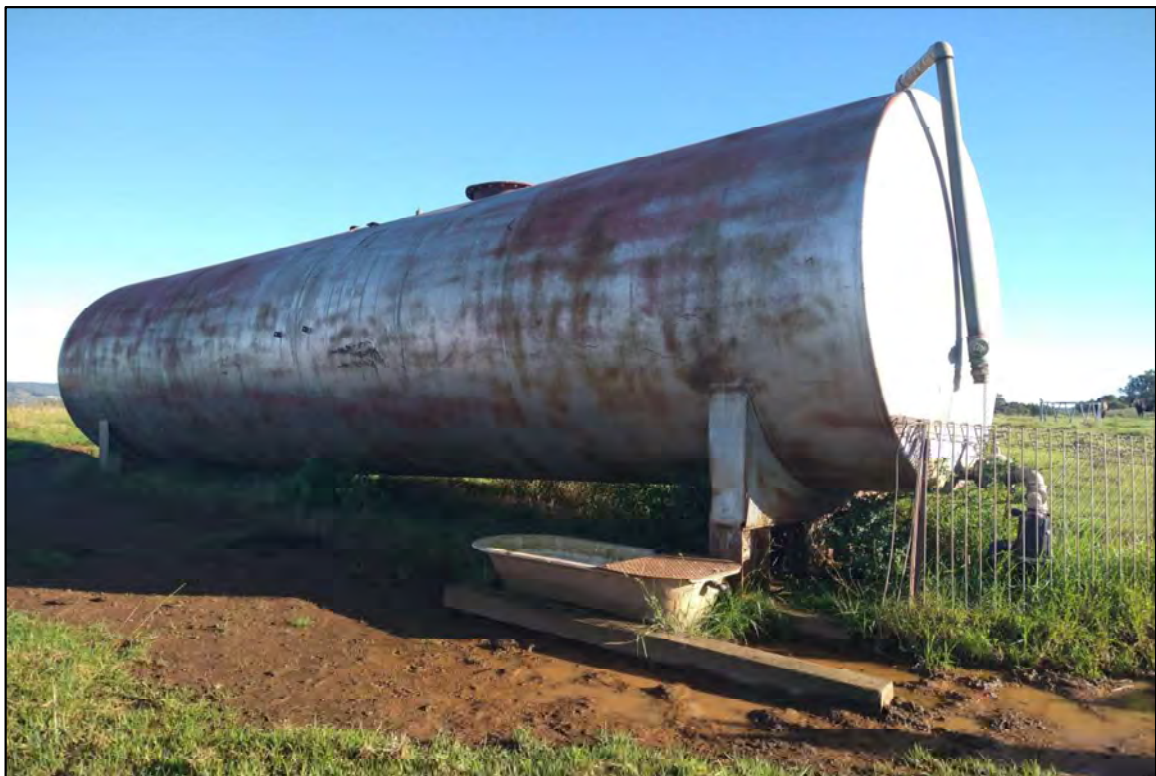
Photograph 8 - Former fuel storage tank reutilised for water pumping and storage.  
for farm animals (MRP132)

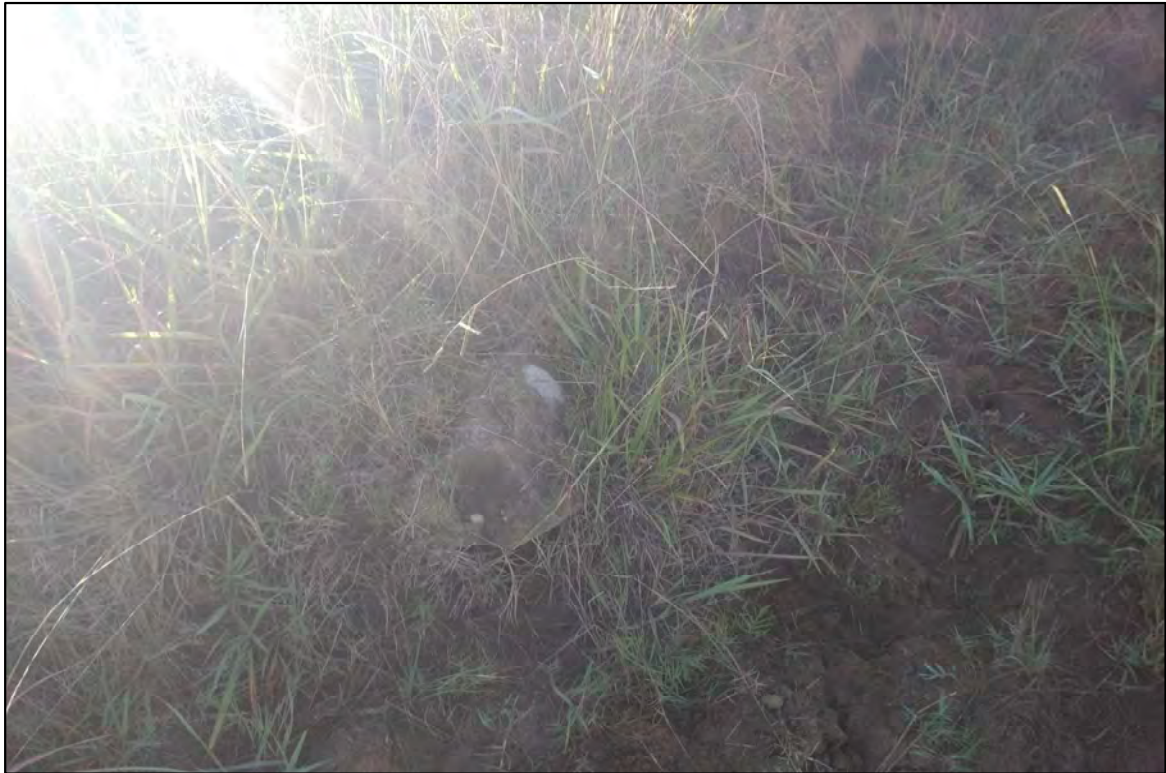
Photograph 9 - Sandstone boulders present within dam embankment (MRP 121).

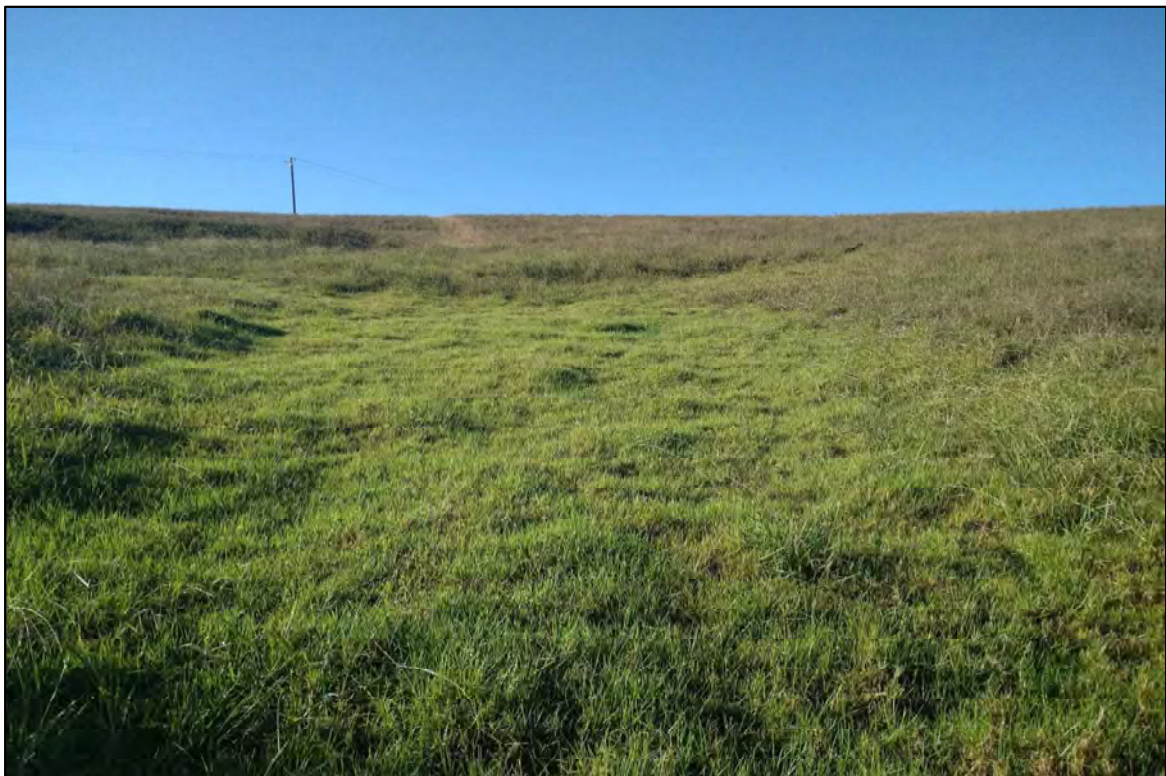
Photograph 10 - Possible fill gully in central portion of Lot 32 DP736923 (MRP 134).

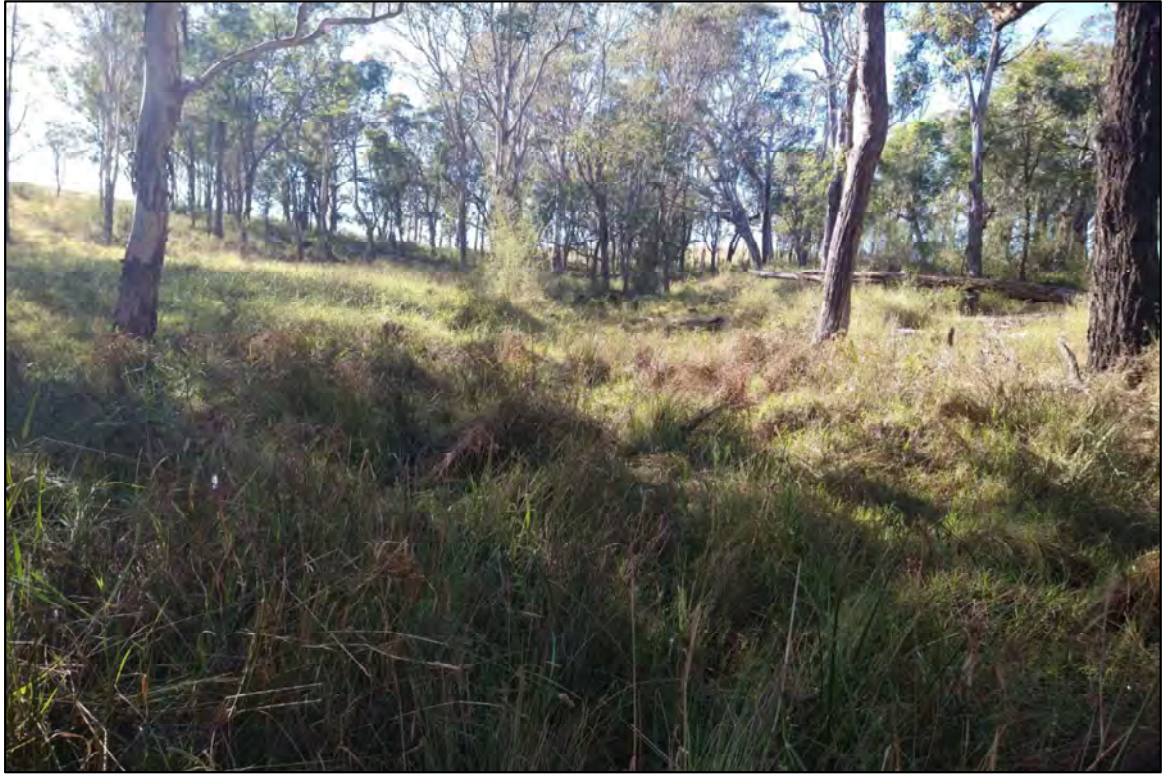
Photograph 11 - Possible fill gully in western portion of Lot 32 DP736923.  
(MRP 134)

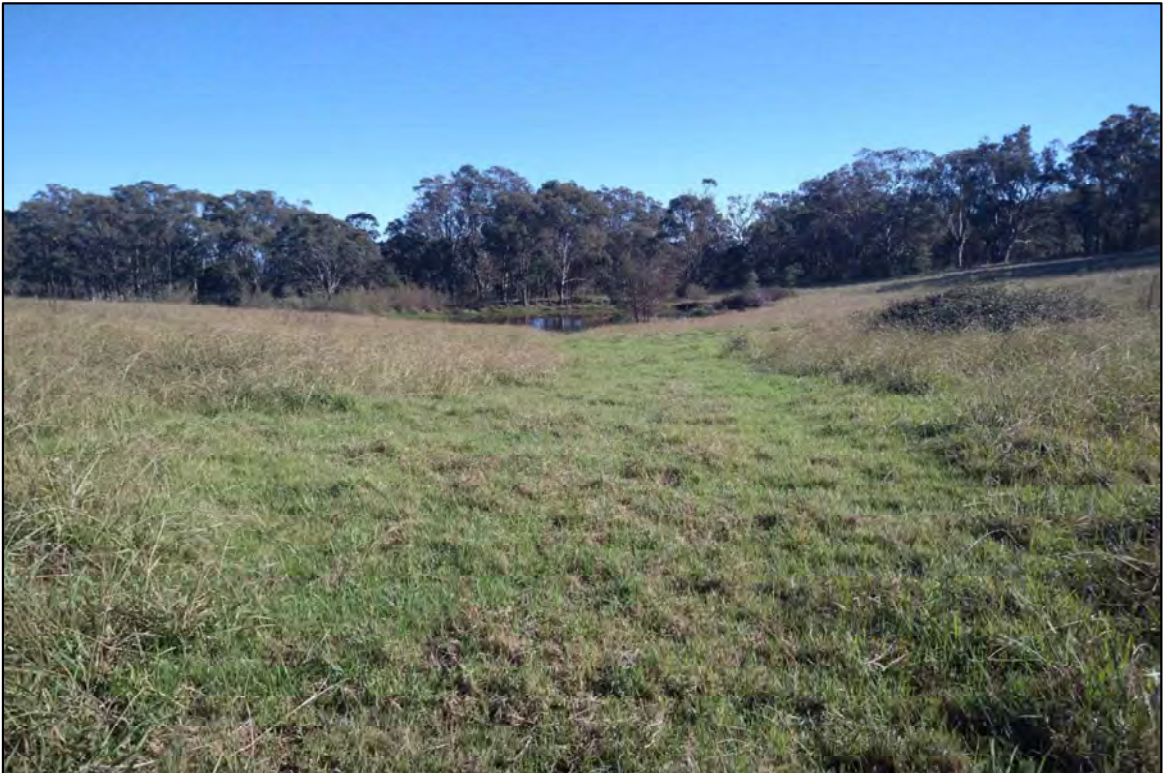
Photograph 12 - Possible fill gully in northern portion of Lot 32 DP736923.  
(MRP 134)

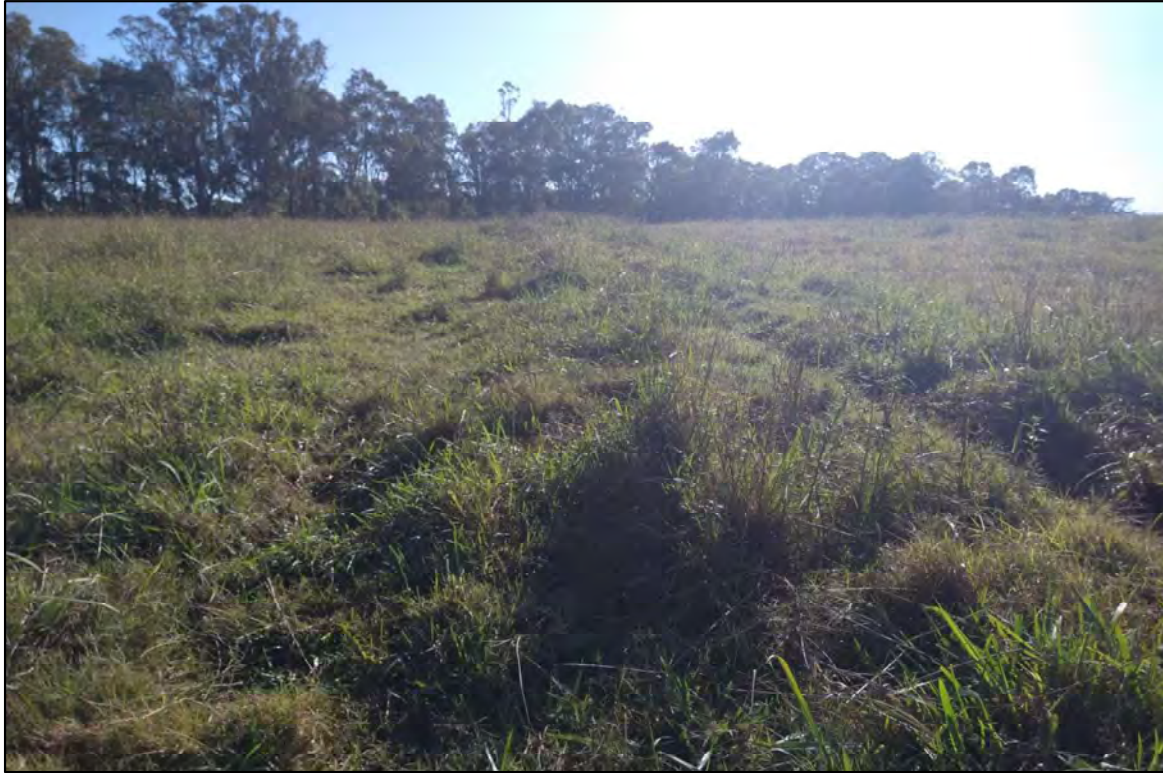
- In the northern portion of Lot 32, a raised area, i.e., a berm, was observed, however, was identified as likely comprising natural soil and rock material (MRP 135);

Photograph 13 - Berm in north-western portion of Lot 32 DP736923.  
(MRP 135)

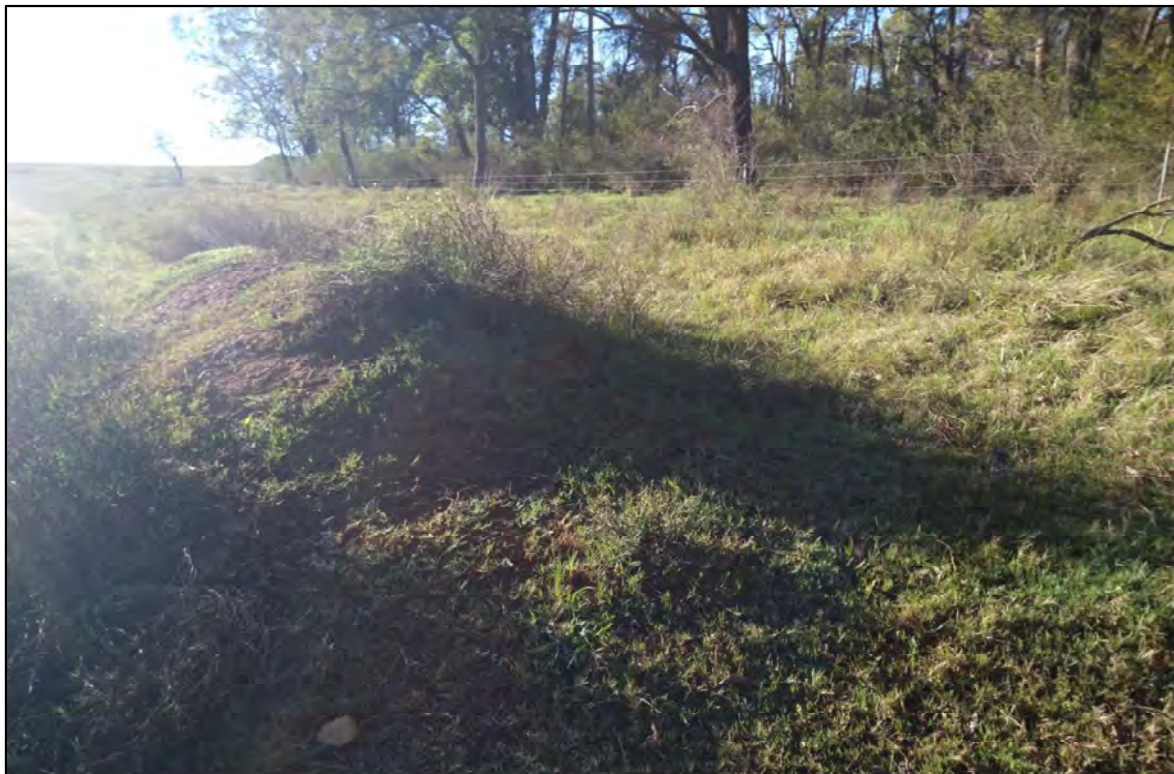
- An area of 'cut and fill' was observed in the south-western portion of Lot 32 (MRP 136), whereby possible fill material was stockpiled adjacent to the area it was cut;

Photograph 14 - Area of fill observed in the south-western portion of Lot 32 DP736923.  
(MRP 136)

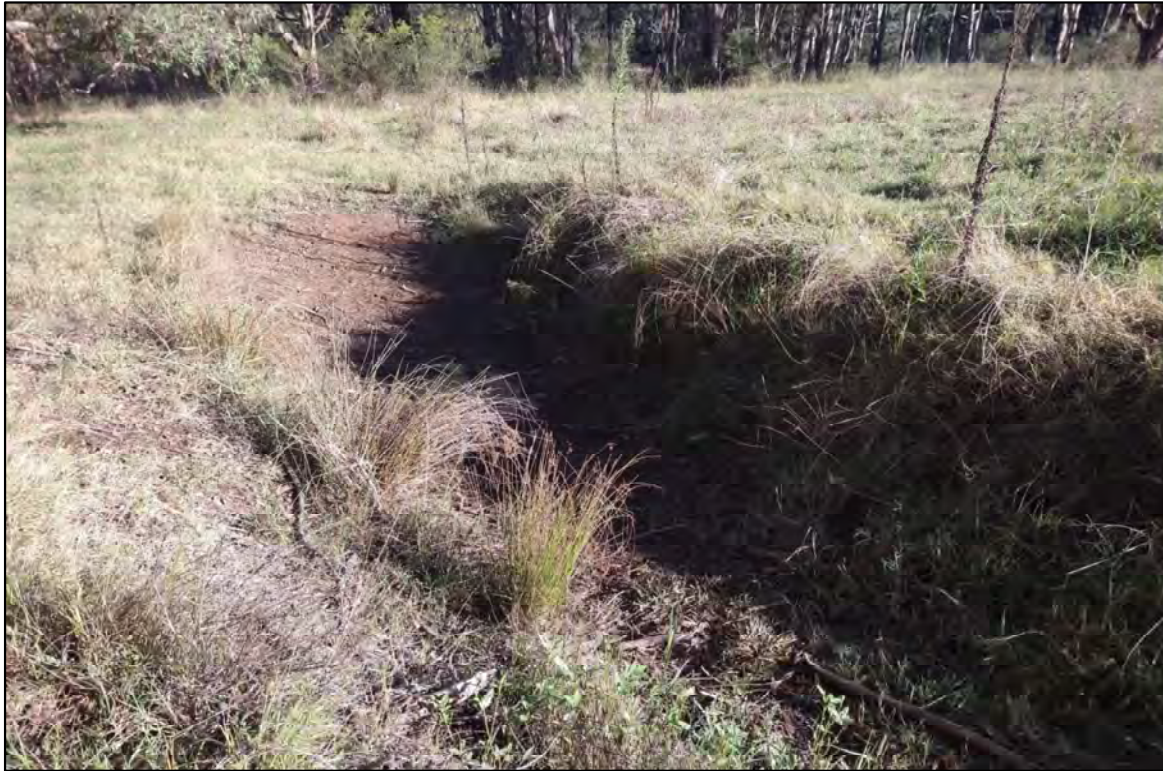
Photograph 15 - Cut area observed in the south-western portion of Lot 32 DP736923 (MRP 136).

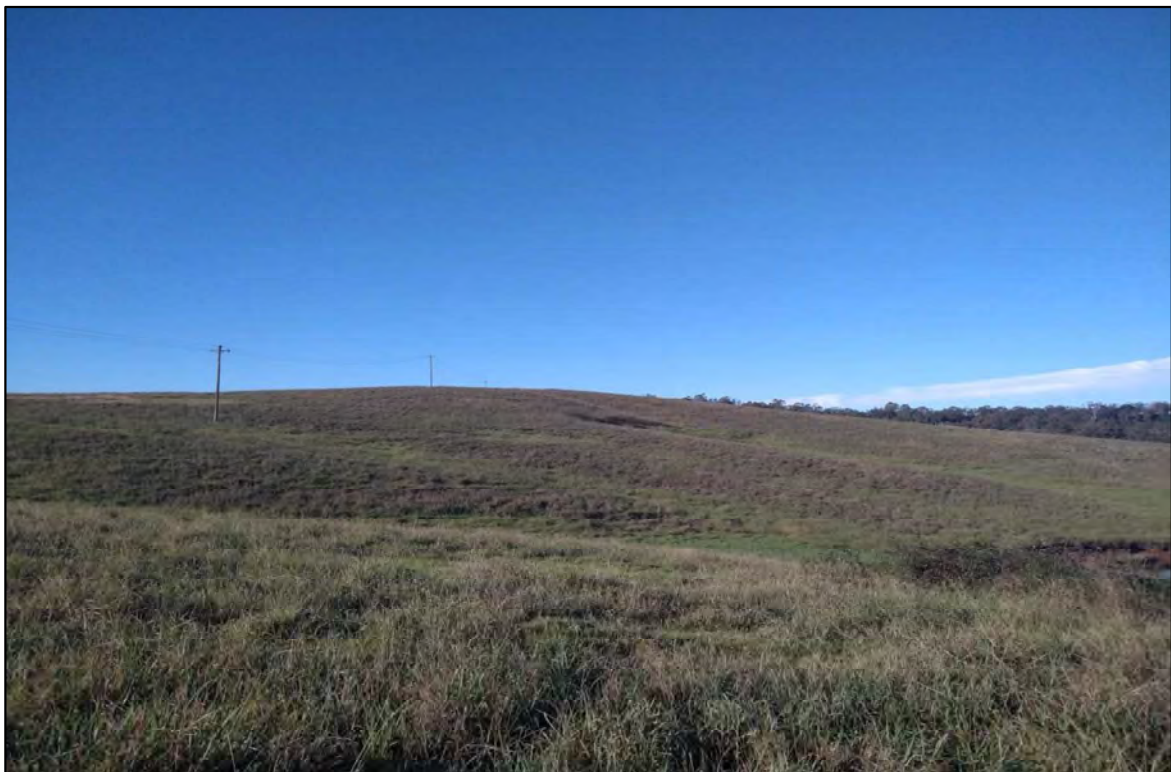
Photograph 16 - Timber power poles observed in the central portion of Lot 32 DP736923 (MRP 137).

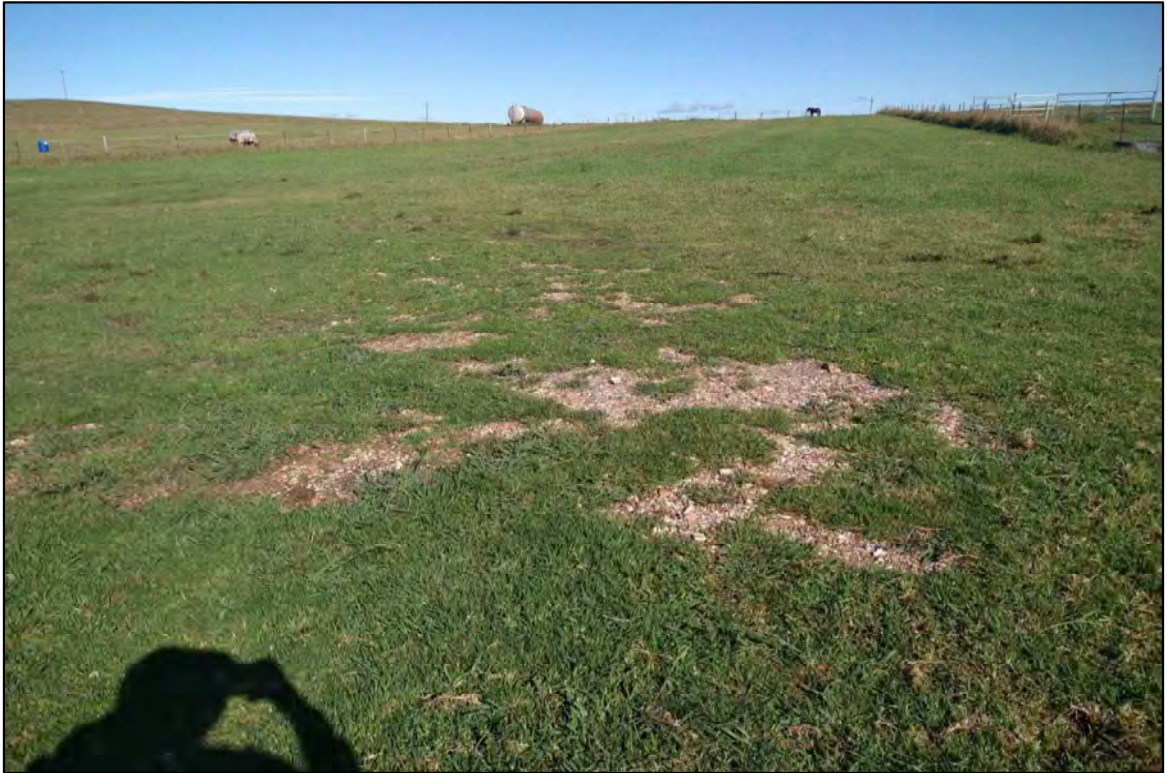
Photograph 17 - Exposed crushed rock fill material in the eastern portion of Lot 32 DP736923 (MRP 138).

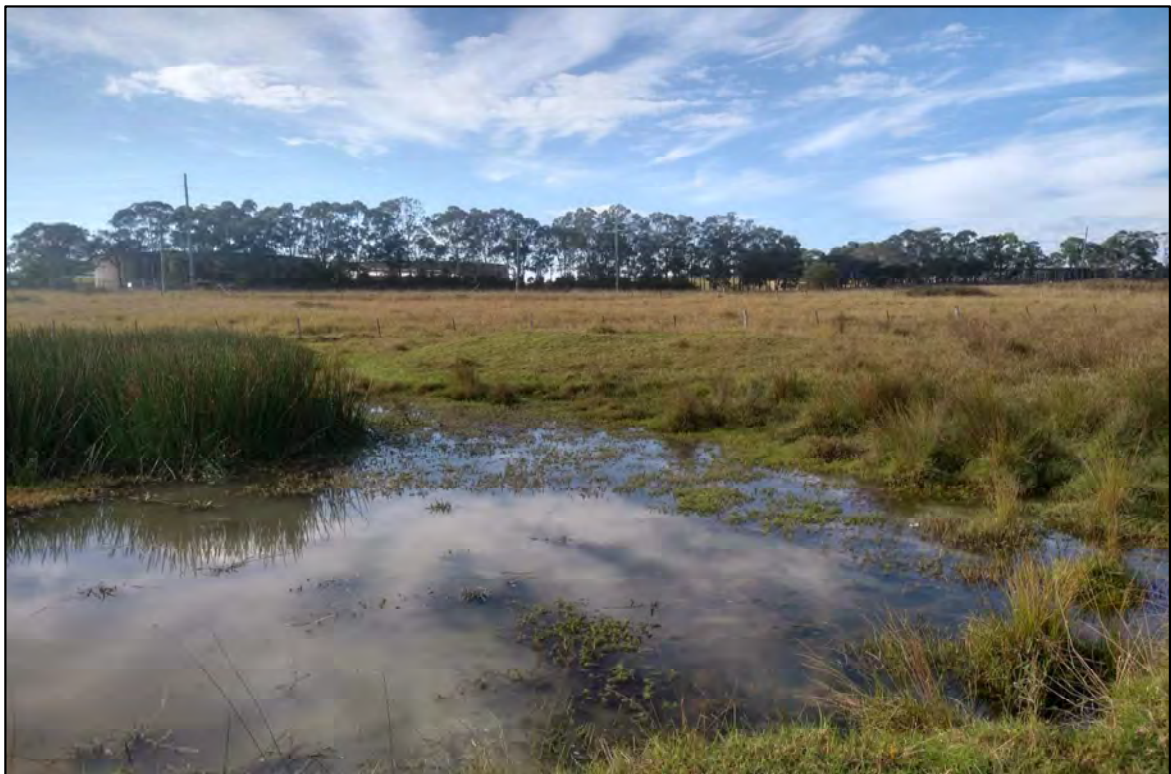
Photograph 18 - Farm dam located in north-eastern portion of Lot 3 DP804375.  
(MRP 139a).

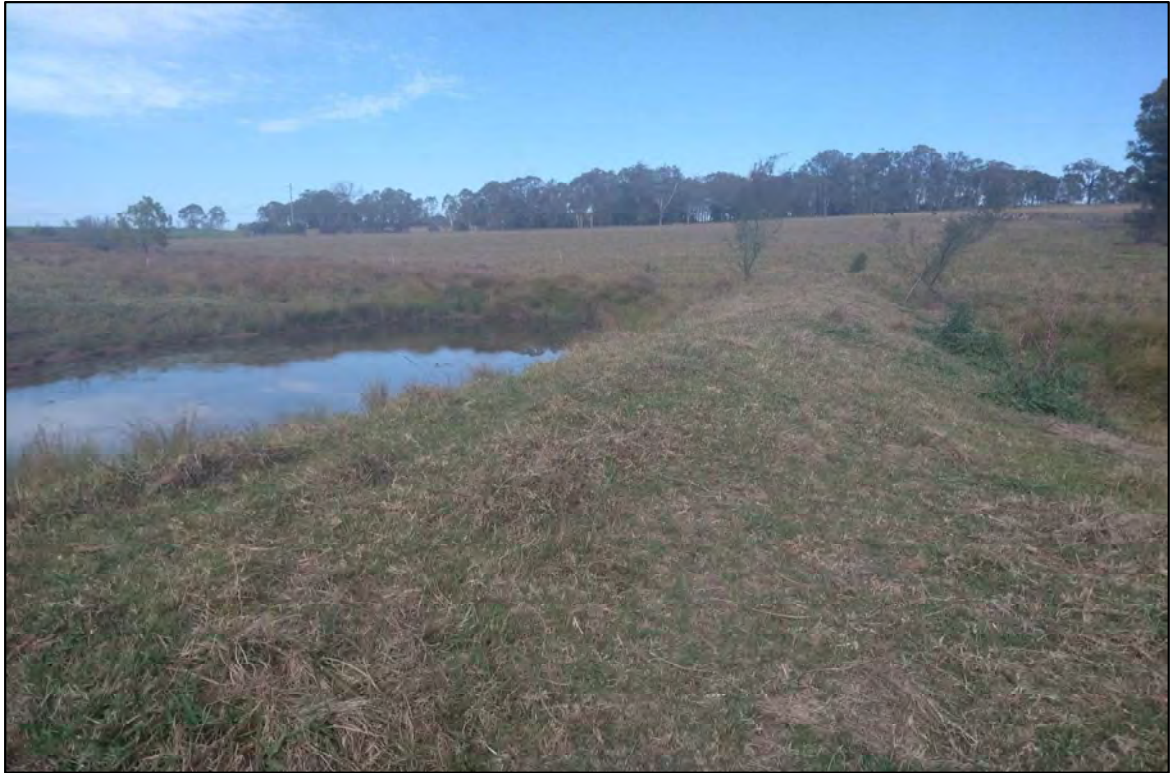
Photograph 19 - Farm dam located in south-eastern portion of Lot 3 DP804375.  
(MRP 139b).

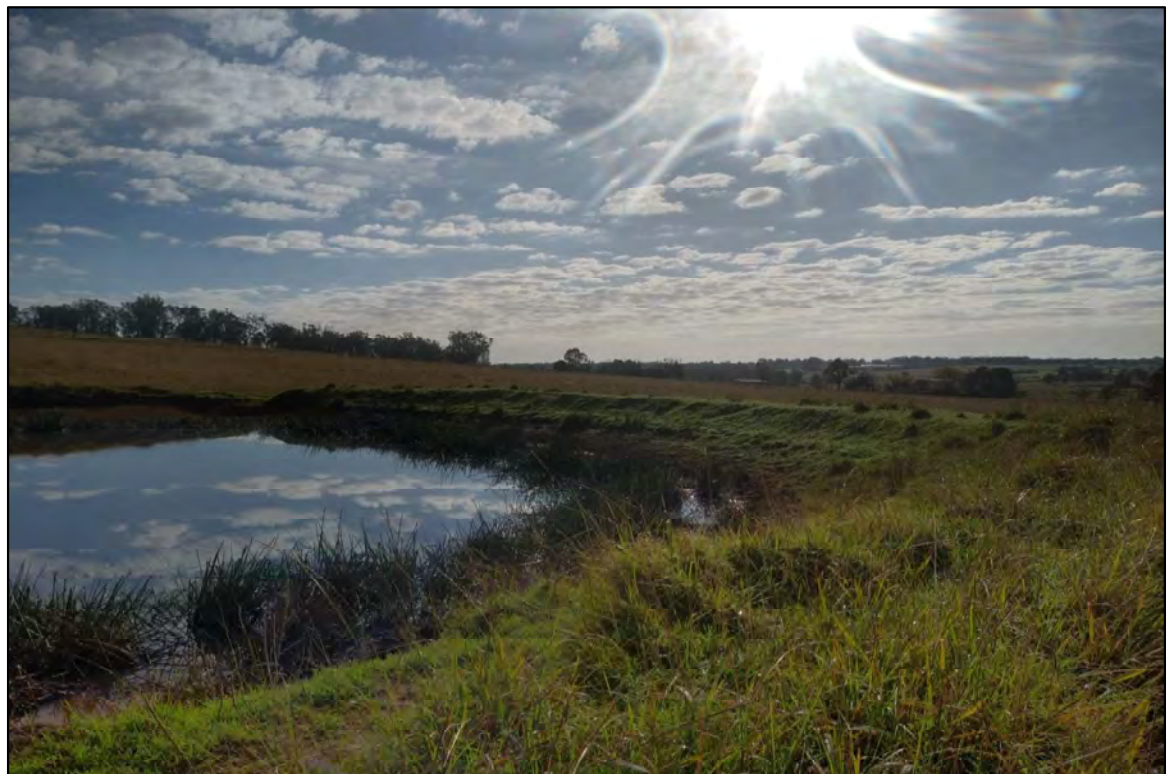
Photograph 20 - Farm dam located in north-western portion of Lot 3 DP804375.  
(MRP 140).

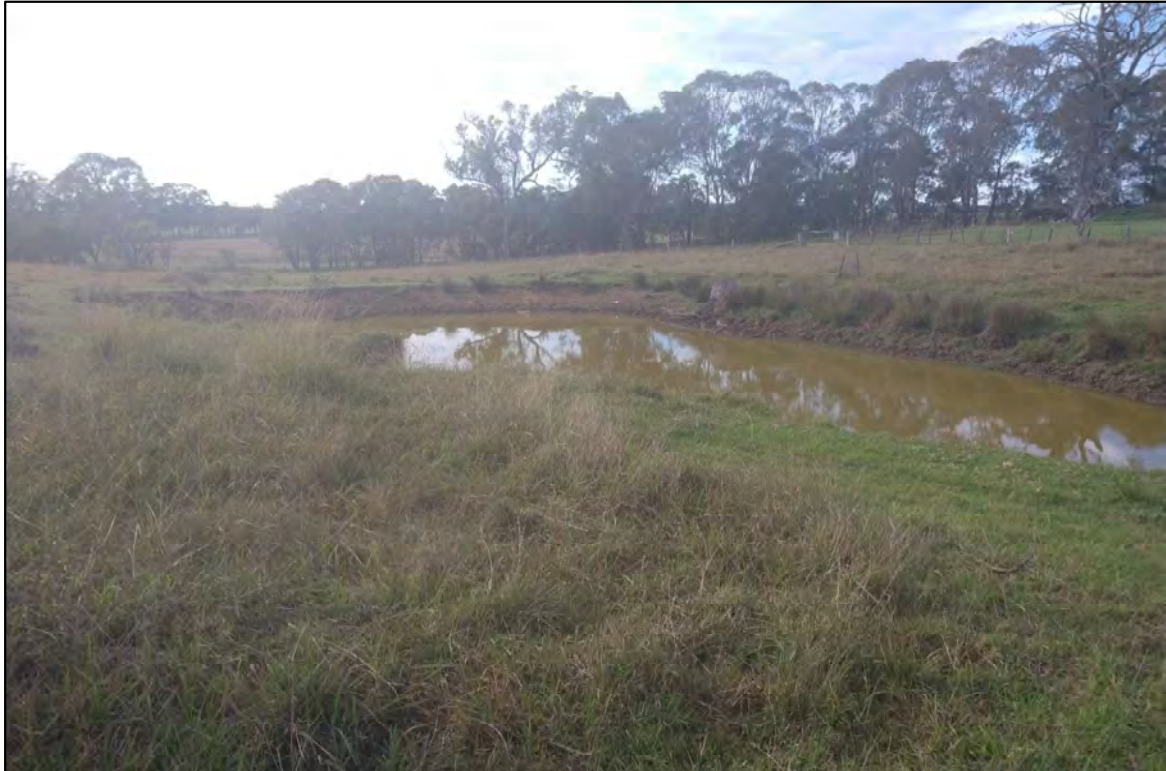
Photograph 21 - Farm dam located in eastern portion of Lot 3 DP804375.  
(MRP 143).

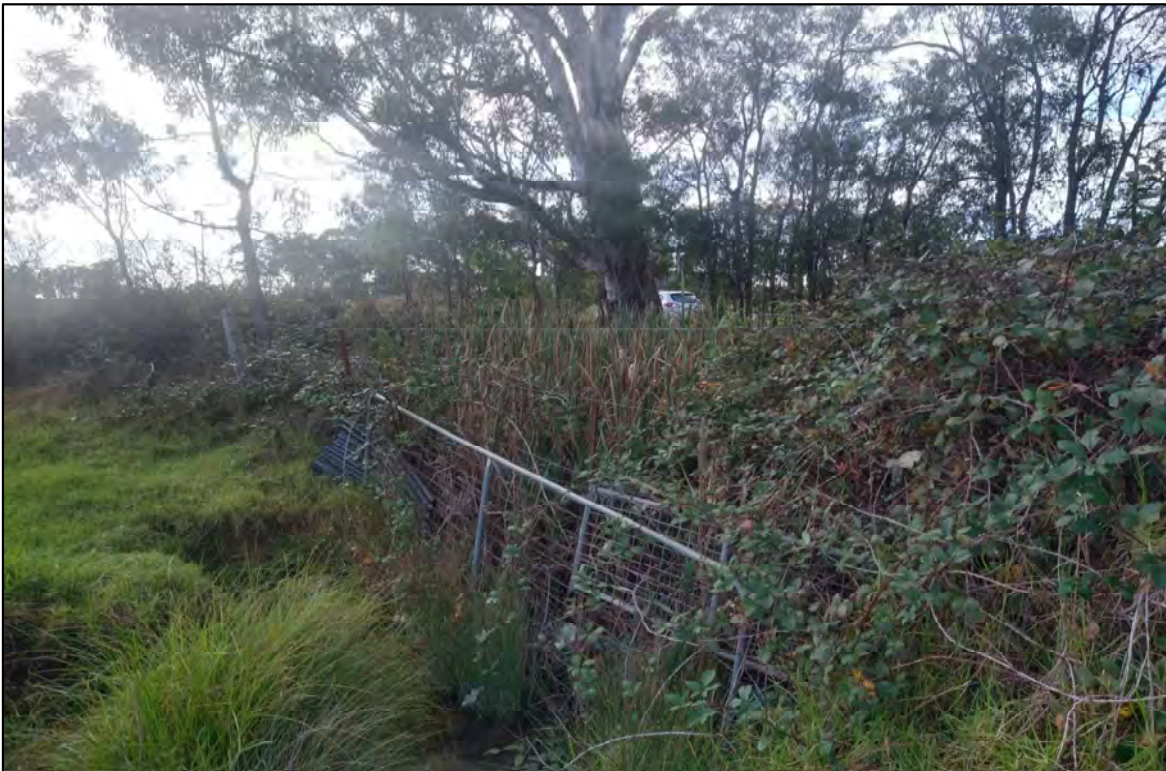
Photograph 22 - Farm dam located in eastern portion of Lot 3 DP804375.  
(MRP 145; limited access).

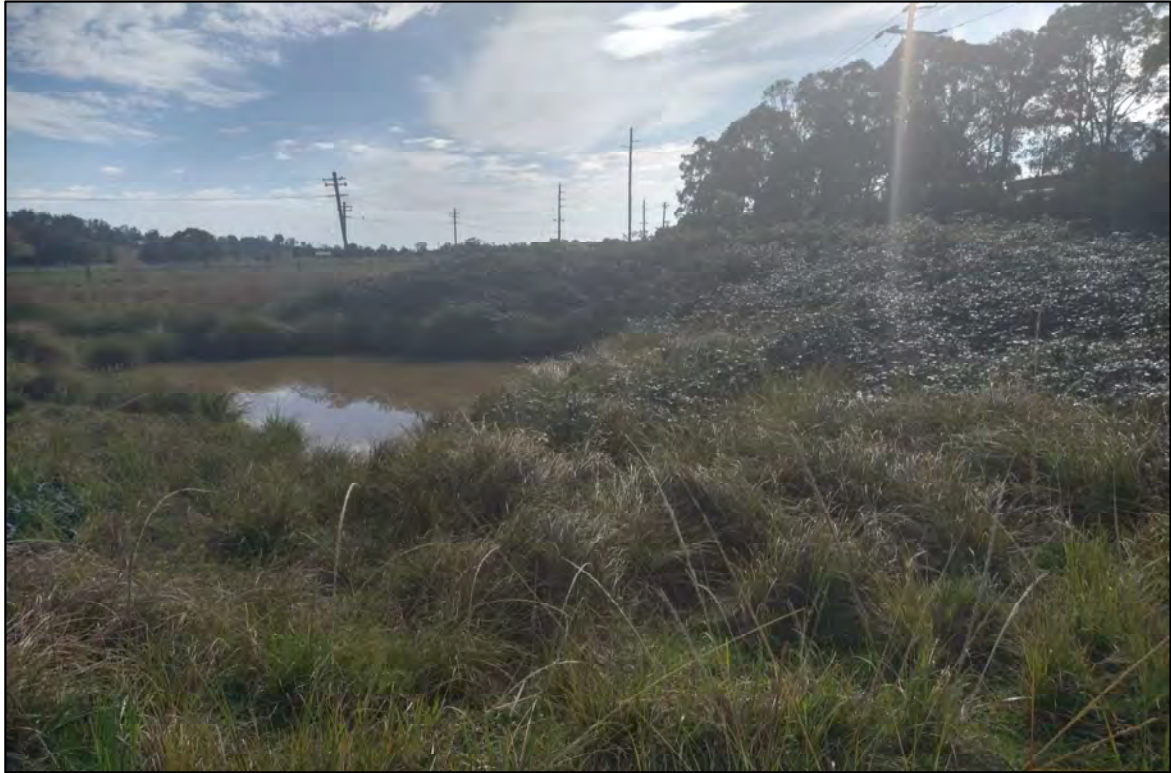
Photo 23 - Farm dam located in eastern portion of Lot 3 DP804375 (MRP 149).

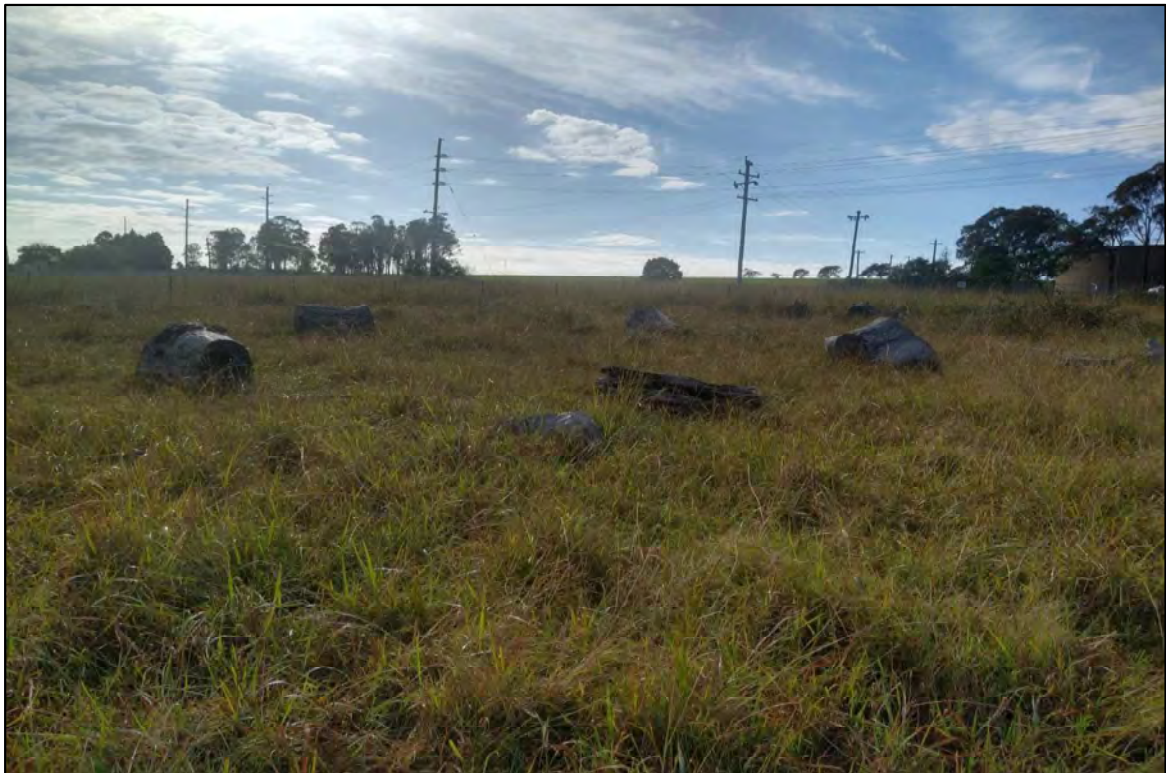
- Chopped tree trunks (organic material) were observed to be lain in the eastern (MRP 141, KFR 271) and southern portions (KFR 284) of Lot 3. At 284, trace geotextile fabric and scrap metal were also observed;

Photograph 24 - Chopped tree trunks observed in the eastern portion of Lot 3 DP804375 (MRP 141).
