Report on  
Preliminary Site Investigation (Contamination)

Proposed Appin (Part 2) Precinct  
Appin NSW

Prepared for  
Walker Corporation Pty Ltd

Project 76589.18  
October 2024

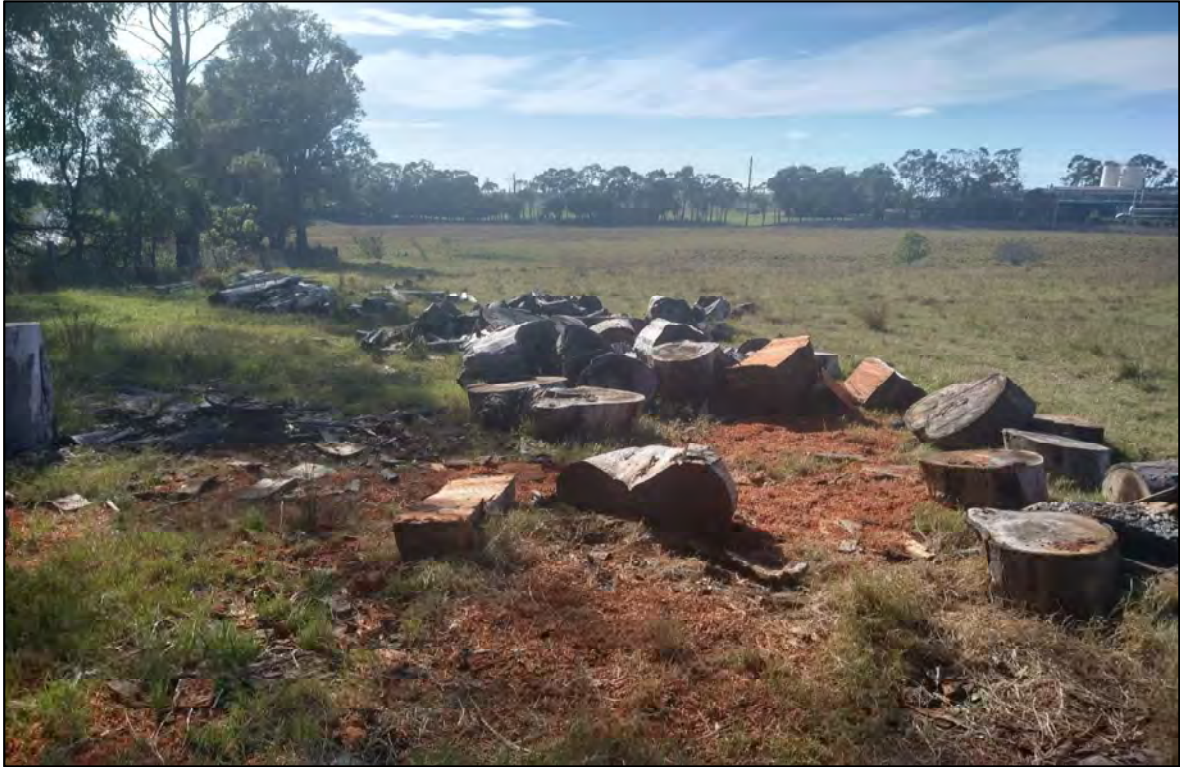
- Chopped tree trunks (organic material) were observed to be lain in the eastern (MRP 141, KFR 271) and southern portions (KFR 284) of Lot 3. At 284, trace geotextile fabric and scrap metal were also observed;

Photograph 25 - Chopped tree trunks observed in the southern portion of Lot 3 DP804375 (Key Feature Reference 284).

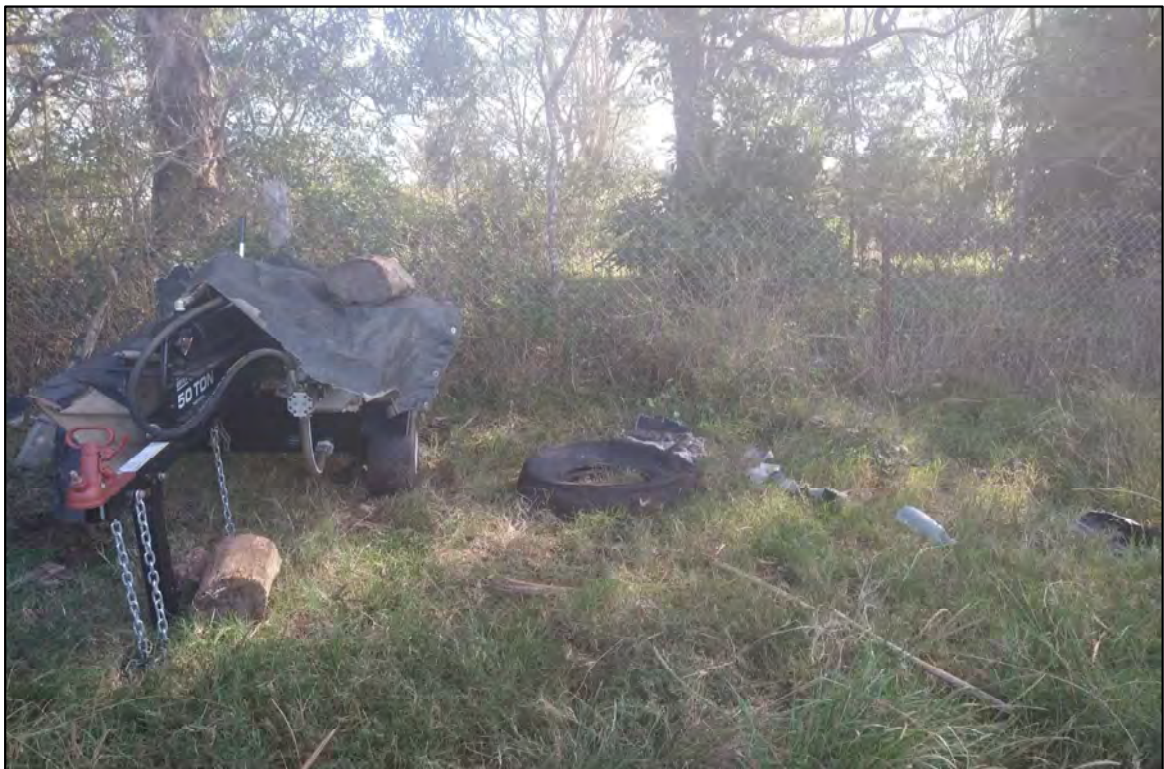
Photograph 26 - Trace geotextile fabric and metal scrap observed in the southern portion of Lot 3 DP804375 (Key Feature Reference 284).

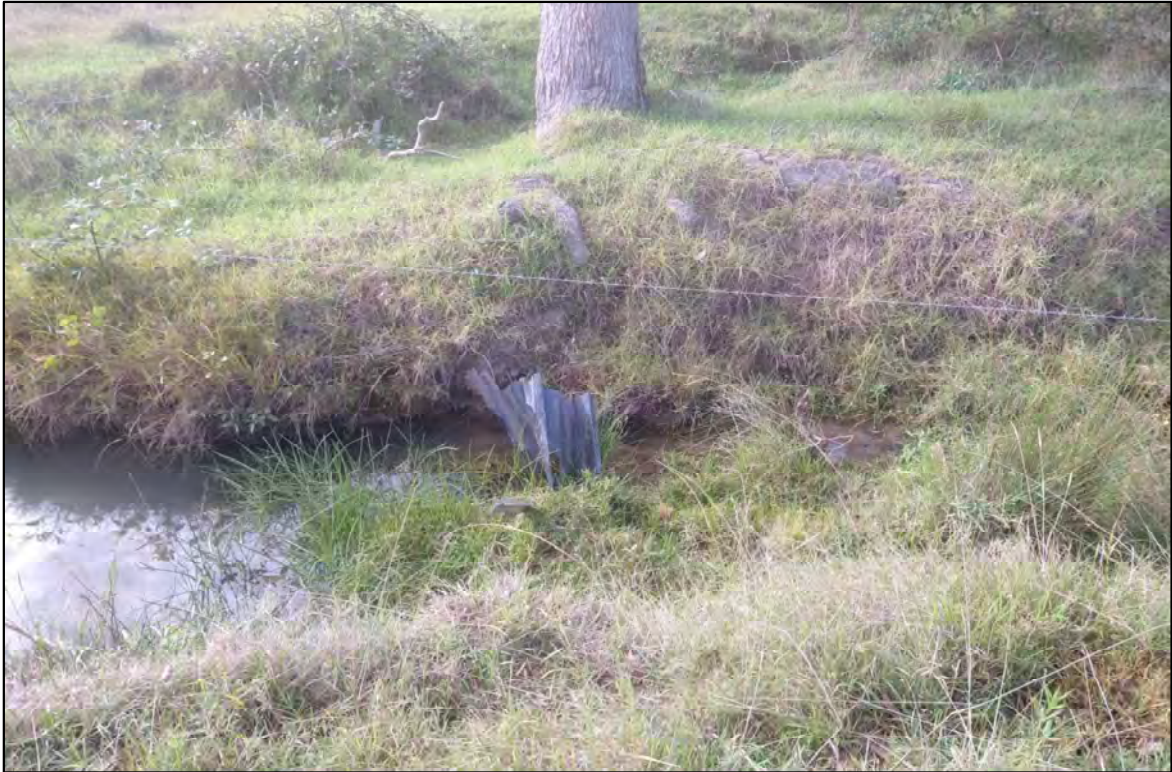
- Gully/creek lines were observed in the eastern and northern portions of Lot 3, where trace refuse material in the form of metal sheeting/scraps (MRP 142), and a glass bottle (MRP 144) were identified;

Photograph 27 - Gully/creek located in the eastern portion of Lot 3 DP804375, where metal sheeting was found (MRP 142).

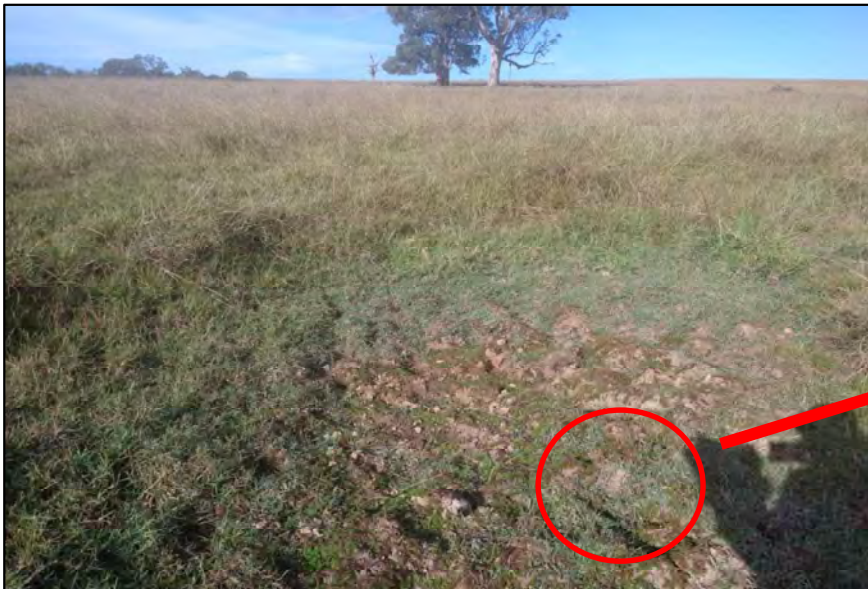
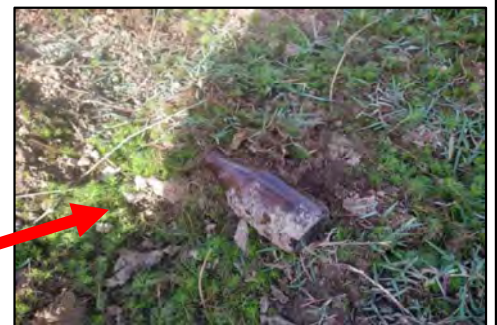
Photograph 28 - Gully observed in the northern portion of Lot 3 DP804375, where trace glass was found (MRP 144).

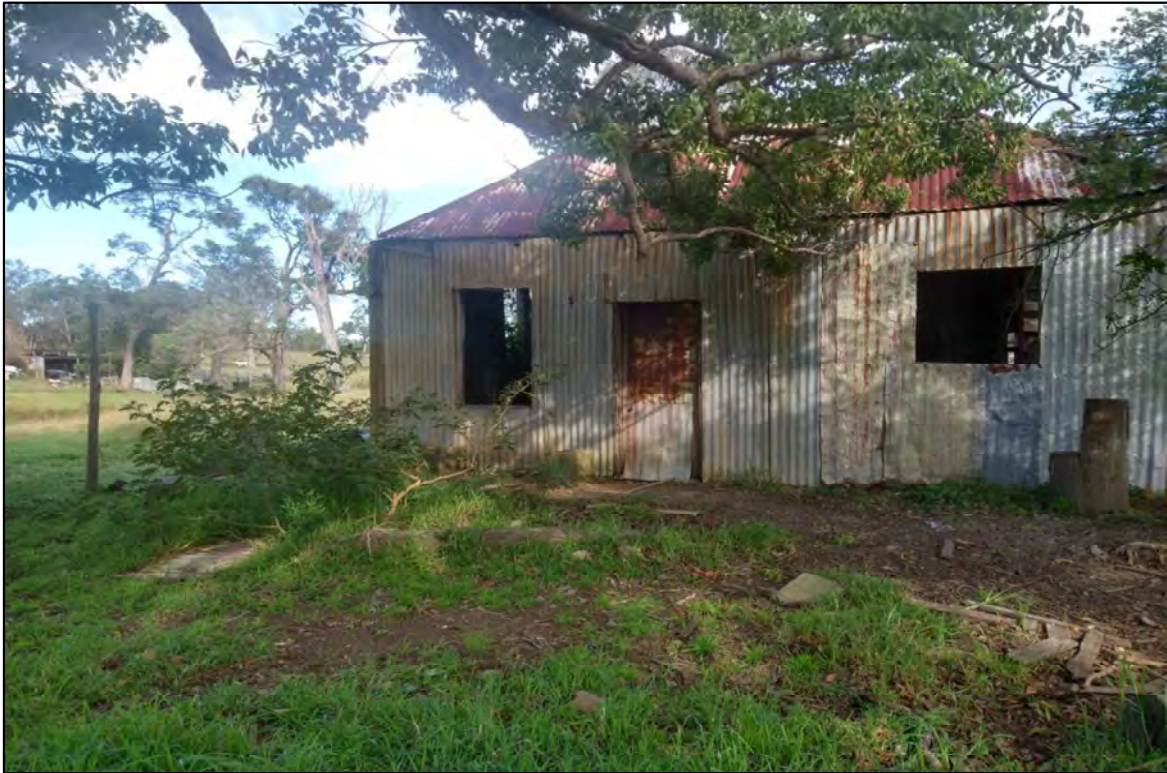
- A dilapidated shed constructed of metal corrugated sheeting on an unsealed soil base was observed and refuse material (metal, timber, plastic) and building demolition waste (bricks) was found inside the shed and/or in the immediate surroundings (MRP 146, KFR 273b);

Photograph 29 - Dilapidated shed constructed of metal corrugated sheeting on an unsealed soil base observed in Lot 3, DP804375 (MRP 146).

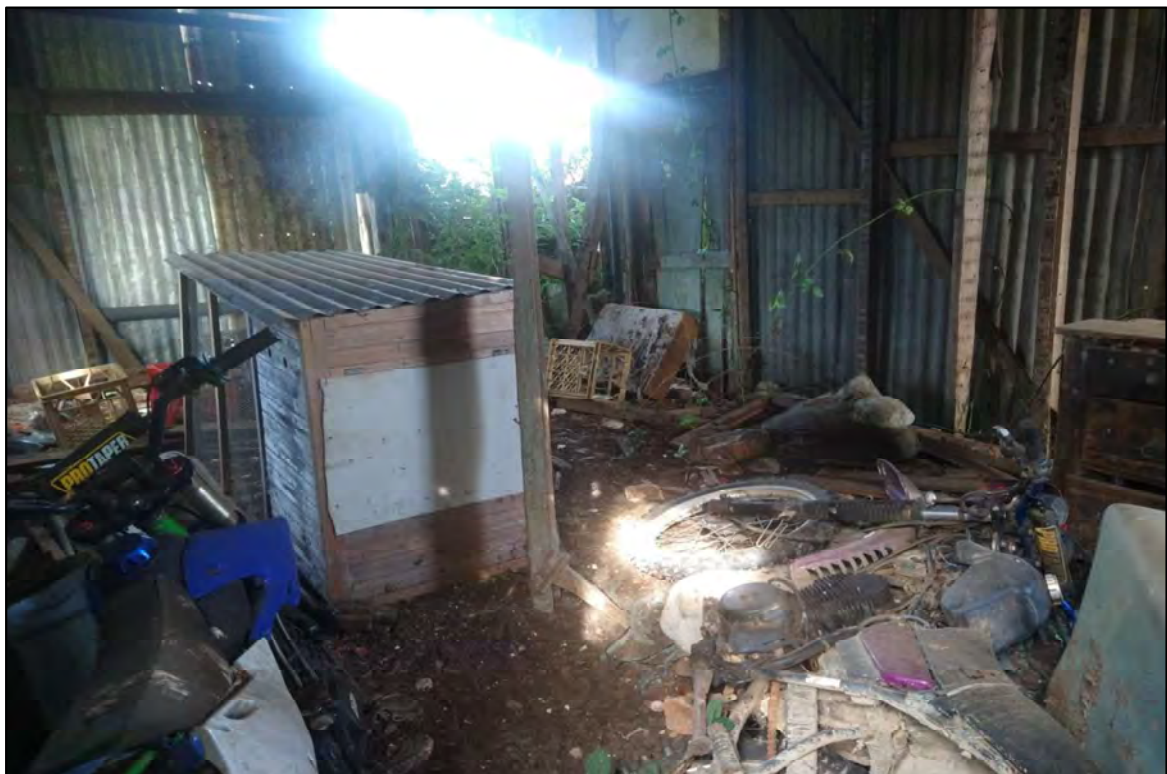
Photograph 30 - Refuse material (metal, timber, plastic) and building demolition waste (bricks) observed inside of shed (MRP 146).

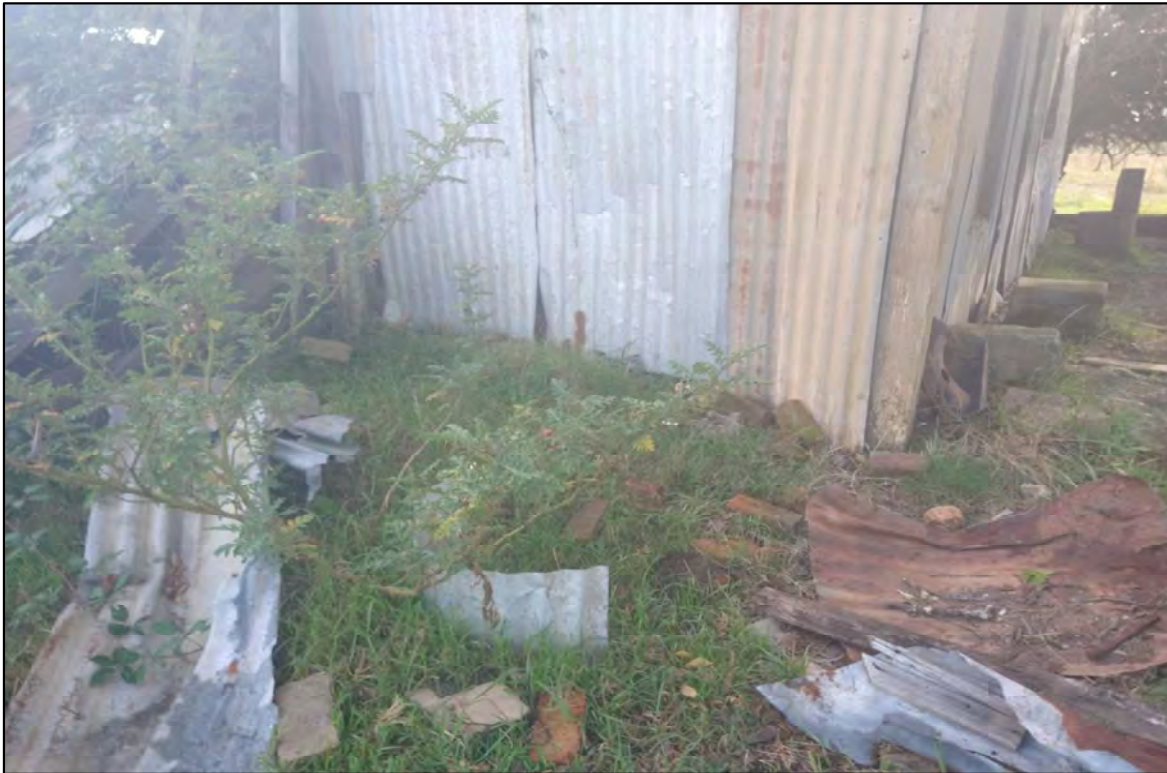
Photograph 31 - Refuse material (metal, timber, plastic) and building demolition waste (bricks) observed outside of shed (MRP 146).

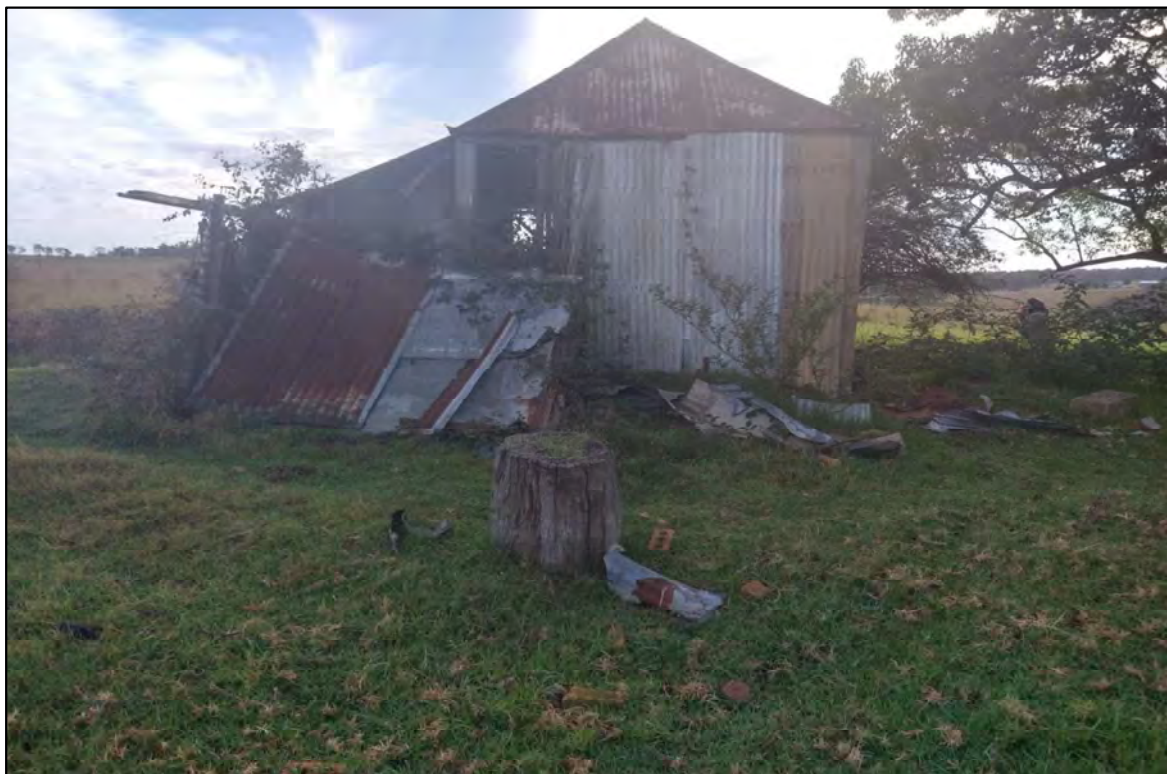
Photograph 32 - Refuse material (metal, timber, plastic) and building demolition waste (bricks) observed outside of shed (MRP 146).

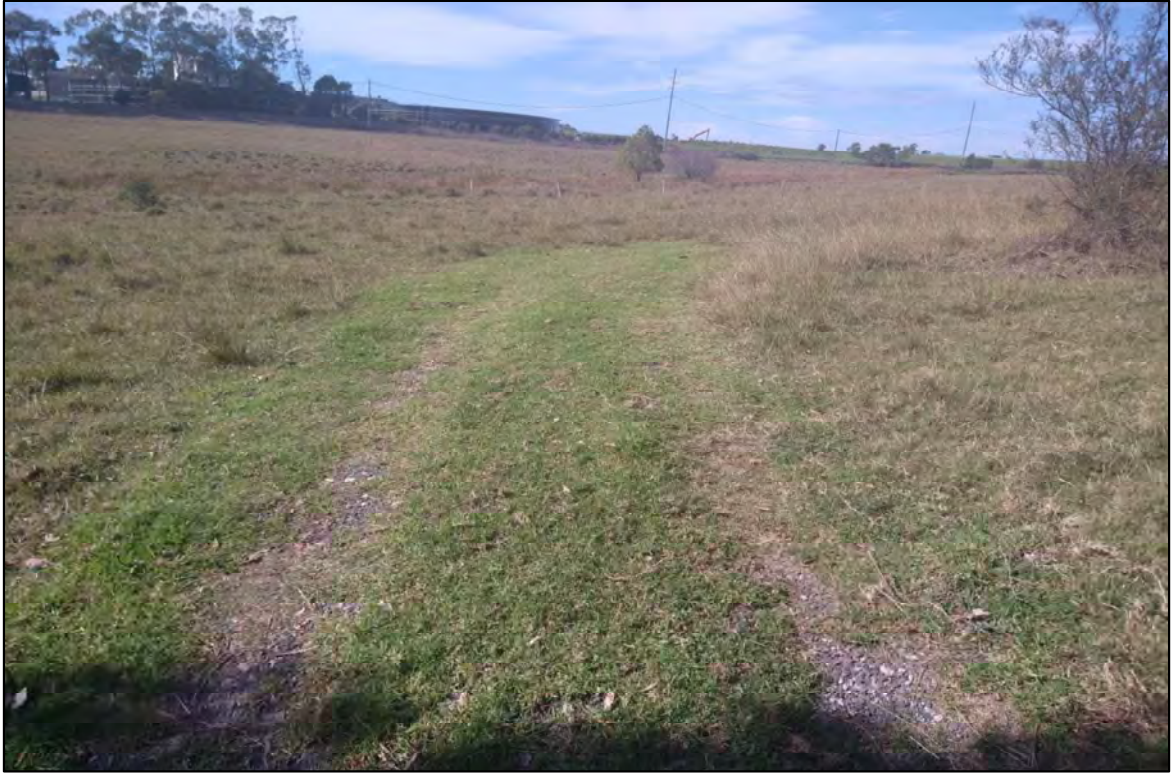
- Exposed gravelly fill material was observed in the eastern portion of Lot 3 (MRPs 147 and 148 – adjoining an unsealed gravelly driveway);
- An old, empty, corroded oil drum was visible in the eastern portion of Lot 3 (MRP 150);

Photograph 33 - Exposed gravelly fill material adjoining unsealed driveway.  
(MRP 147).

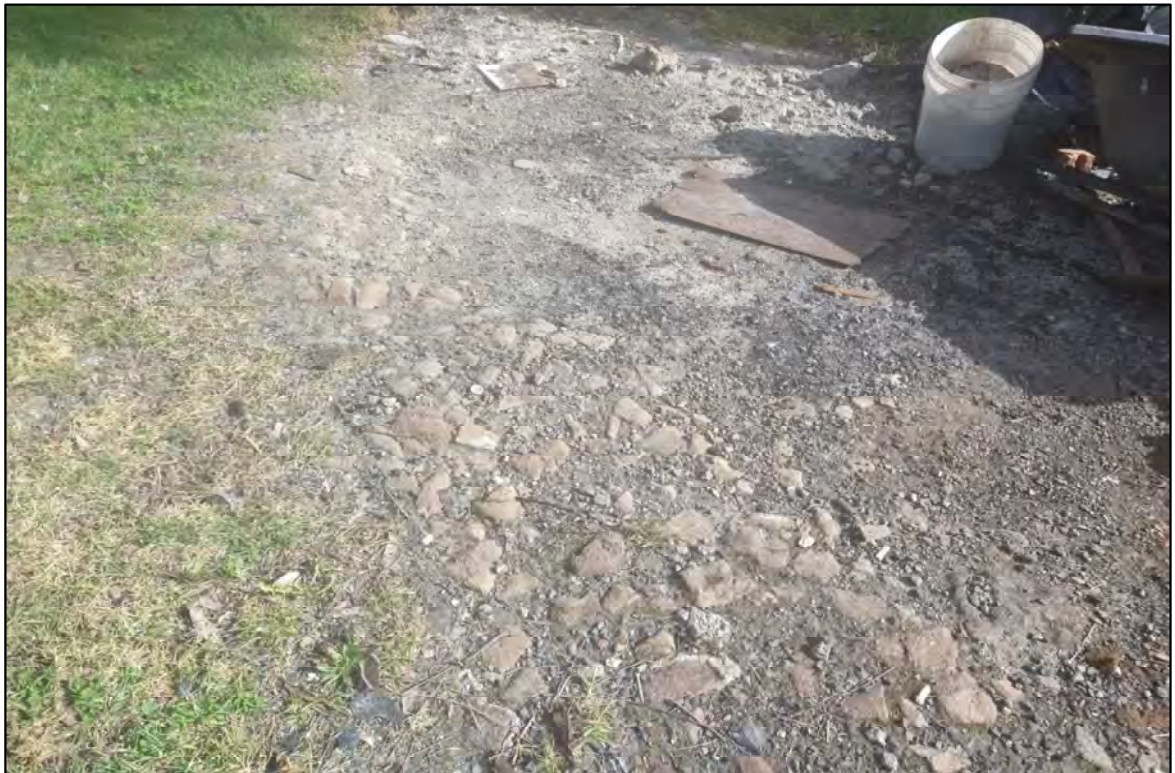
Photograph 34 - Exposed gravelly fill material (MRP 148).

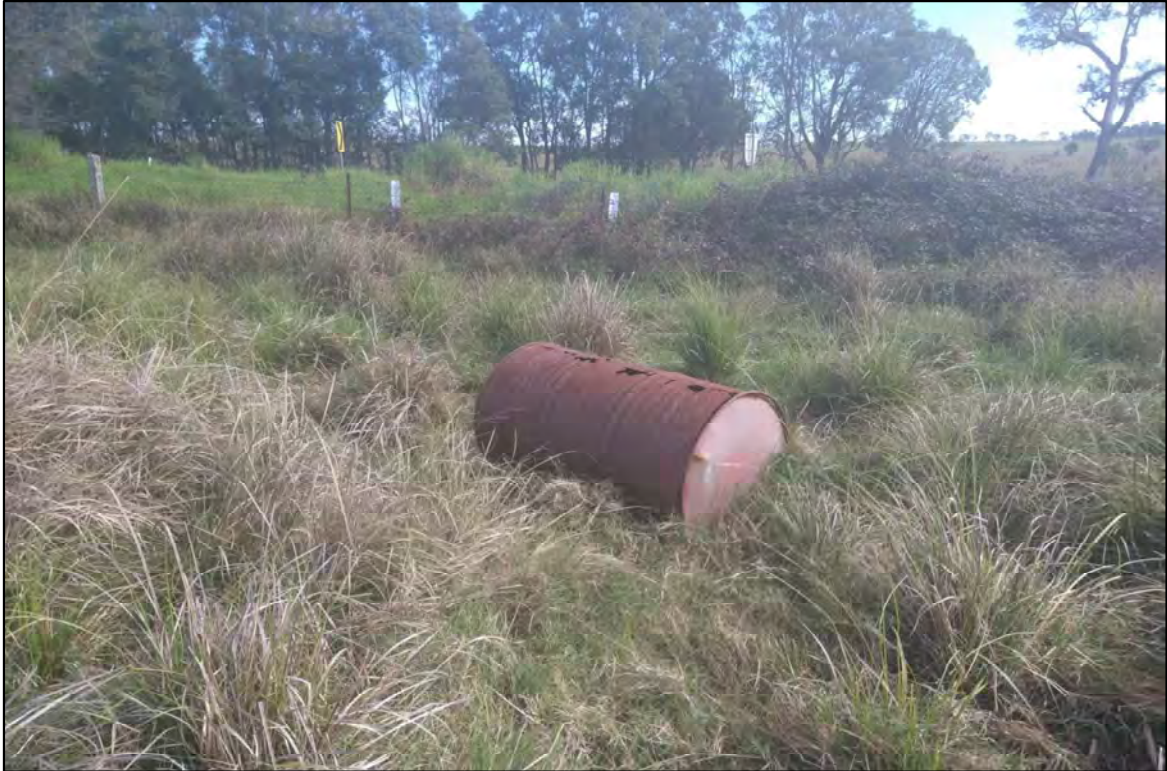
Photograph 35 - Old oil drum located in the eastern portion of Lot 3 DP804375 (MRP 150).

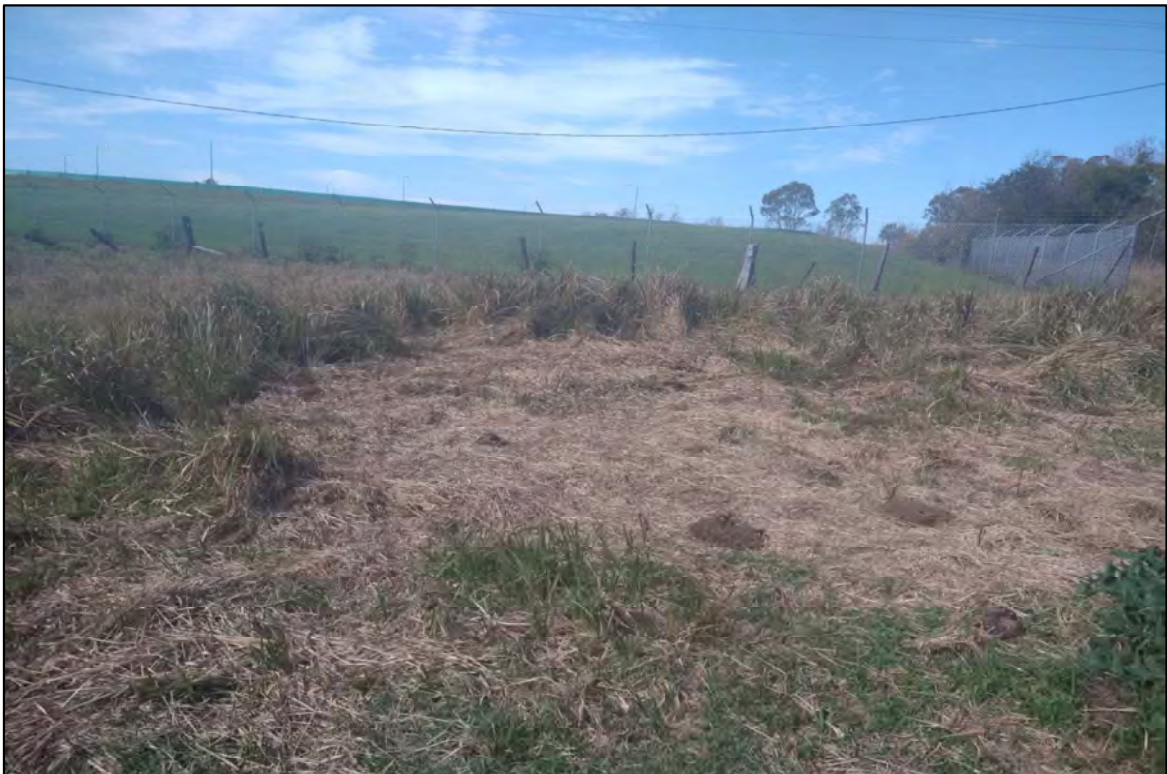
- Ground disturbance was observed in the southern portion of Lot 3 (MRP 151); and
- An area of fly-tipping/dumped refuse material including timber, geotextile fabric, metal scraps, plastic and building demolition waste including concrete and bricks was identified in the southern portion of Lot 3 (MRP 152).

Photograph 36 - Ground disturbance observed in the southern portion of Lot 3 DP804375 (MRP 151).

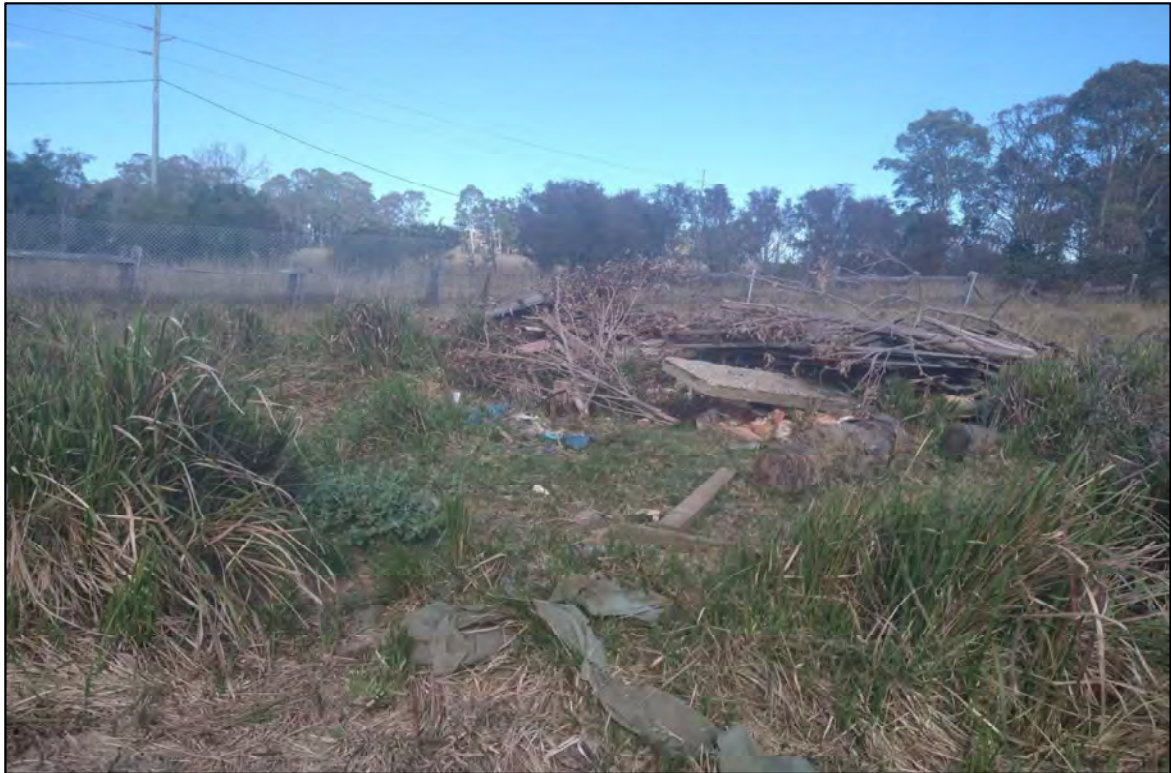
Photograph 37 - Fly-tipping of refuse material and building demolition waste observed in the southern portion of Lot 3 DP804375 (MRP 152).

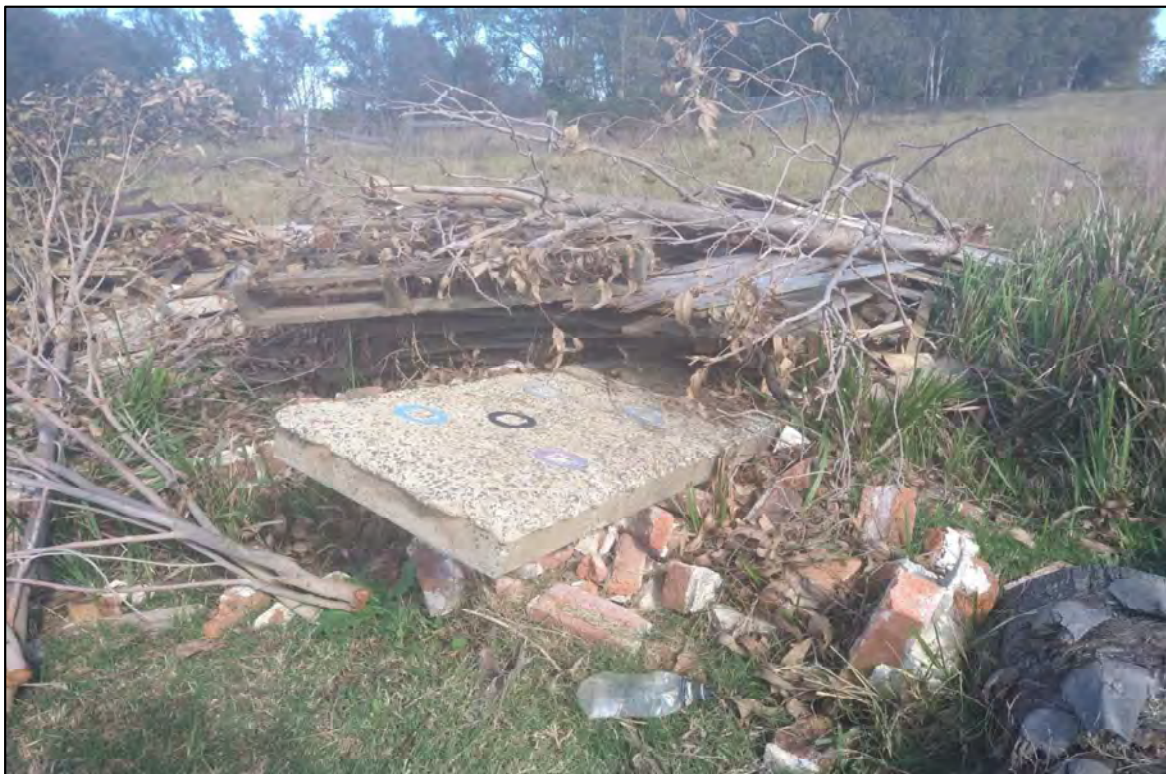
Photograph 38 - Fly-tipping of refuse material and building demolition waste observed in the southern portion of Lot 3 DP804375 (MRP 152).
