**PRELIMINARY  
GEOTECHNICAL ASSESSMENT REPORT**

1455 & 1475 BURRAGORANG ROAD & 1838 BARKERS LODGE ROAD  
OAKDALE NSW

PREPARED FOR  
COLLIERS INTERNATIONAL ENGINEERING & DESIGN  
REPORT ID: E23010OAK-R02F (REV 1)

**Date:** 3<sup>rd</sup> March 2024

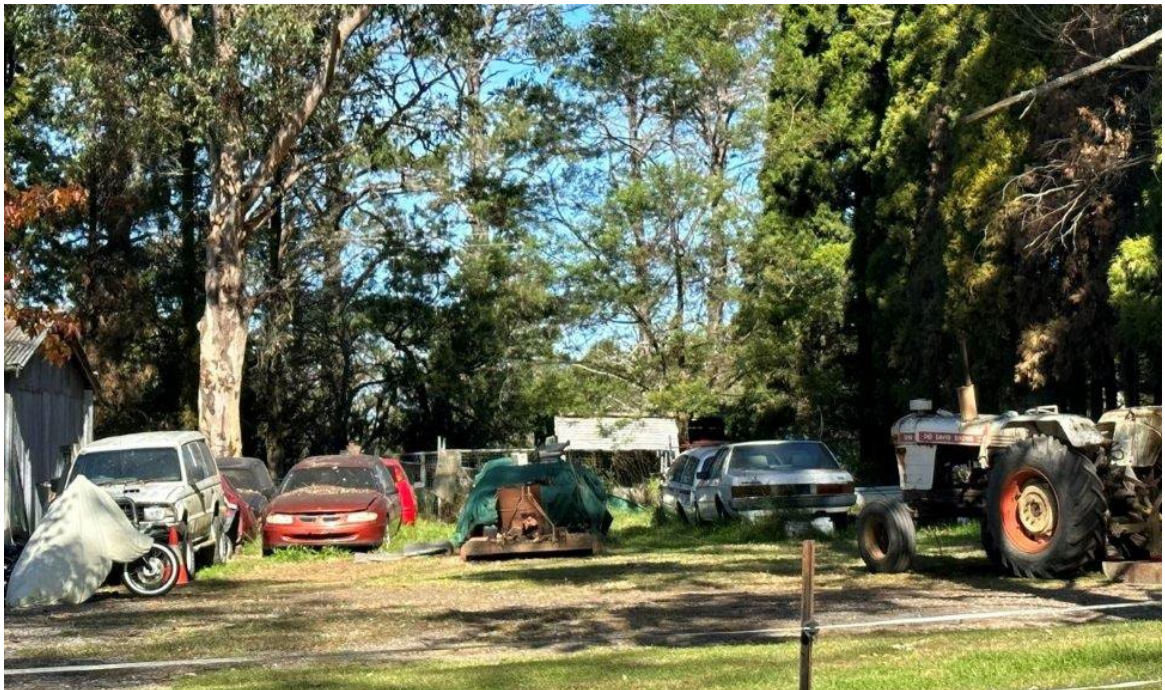
**Plate 2:** Some of the derelict vehicles to the east of the garage/shed. The timber framed and metal clad animal shelter is in the background.

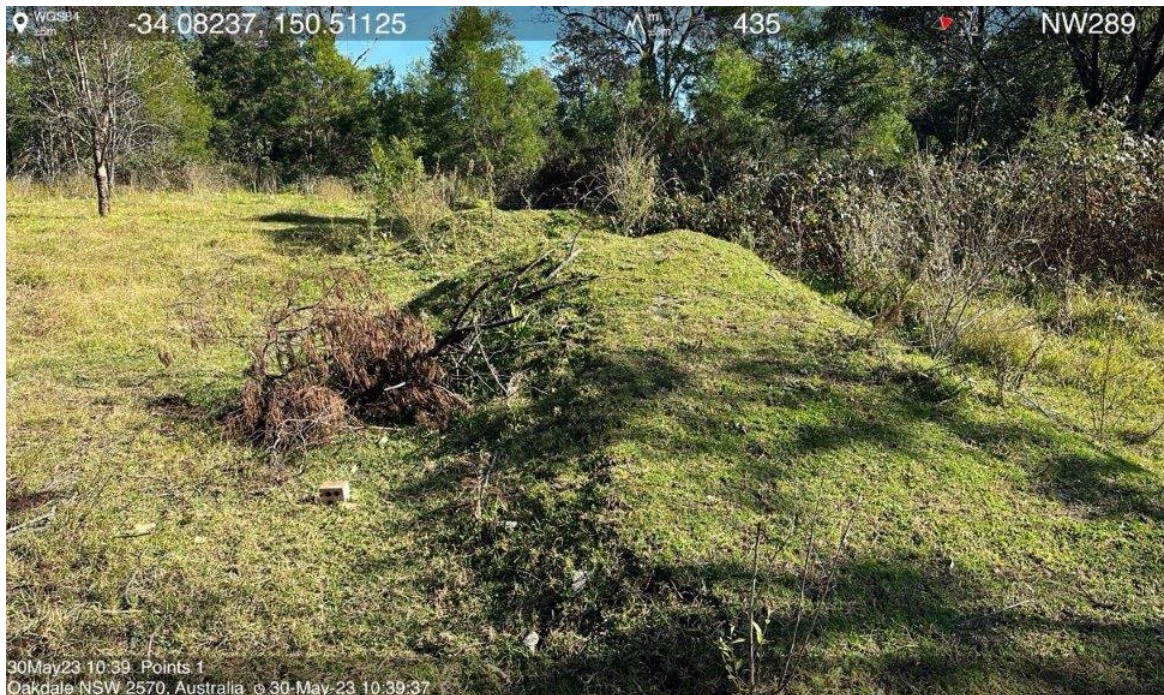
**Plate 5:** View to the west showing the stockpile on Lot 6 containing potential ACM.

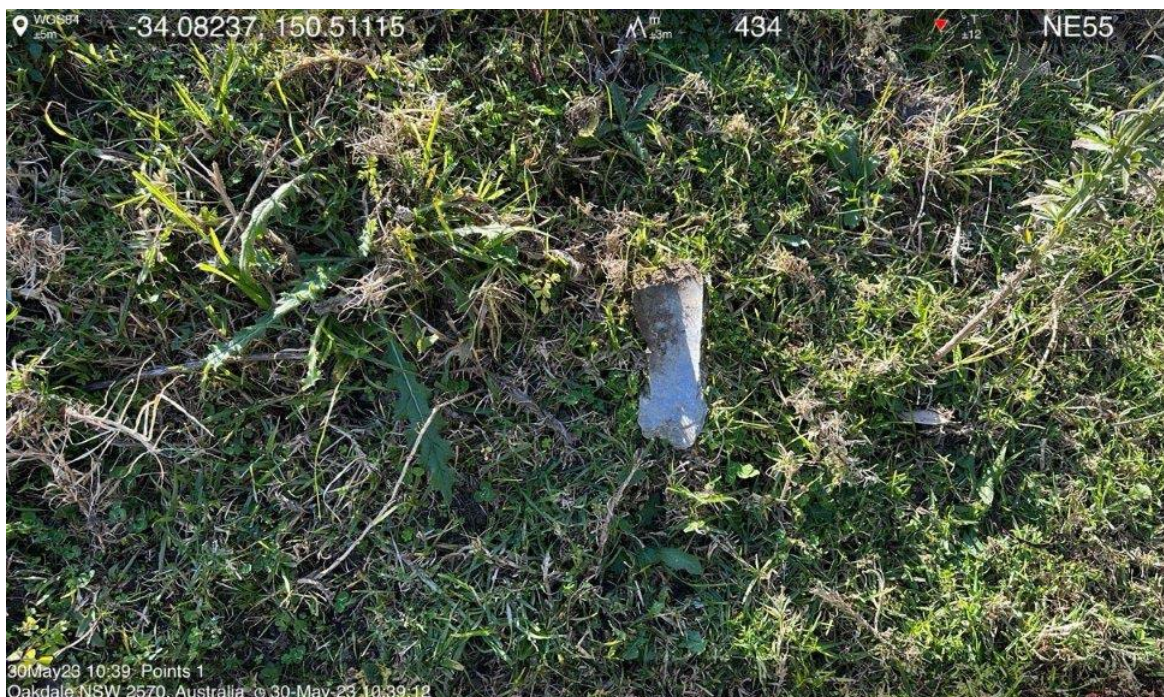
**Plate 6:** Example of potential ACM on the stockpile on Lot 6.

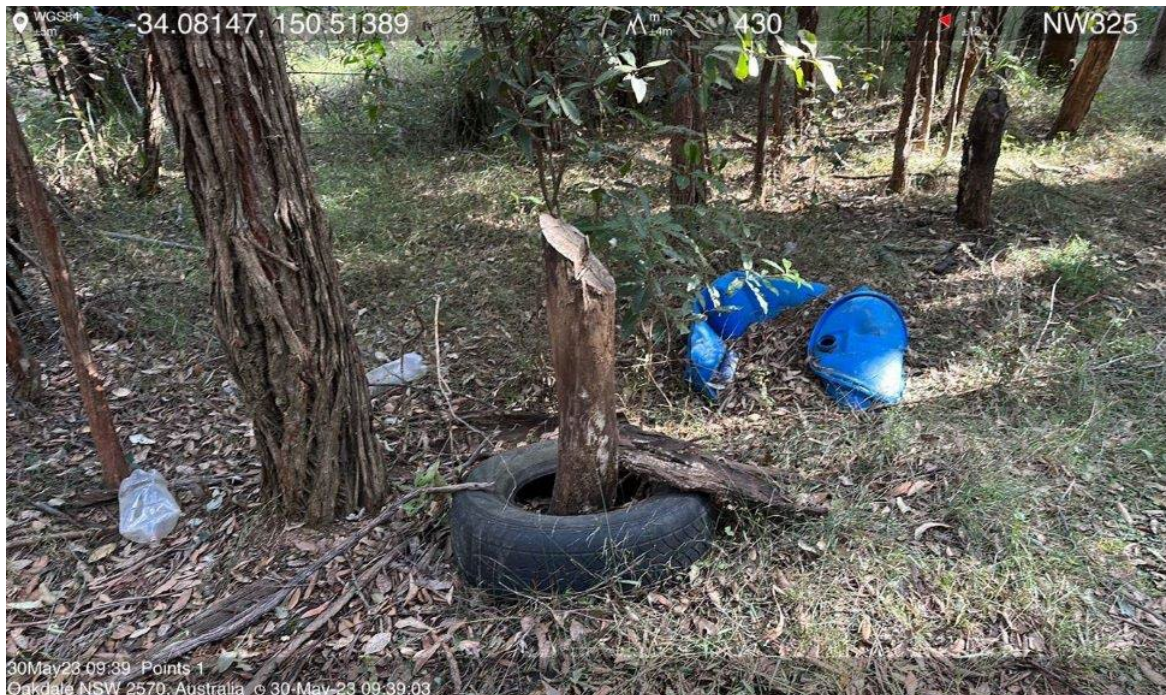
**Plate 11:** Example of car Tyres and plastic within the forest.

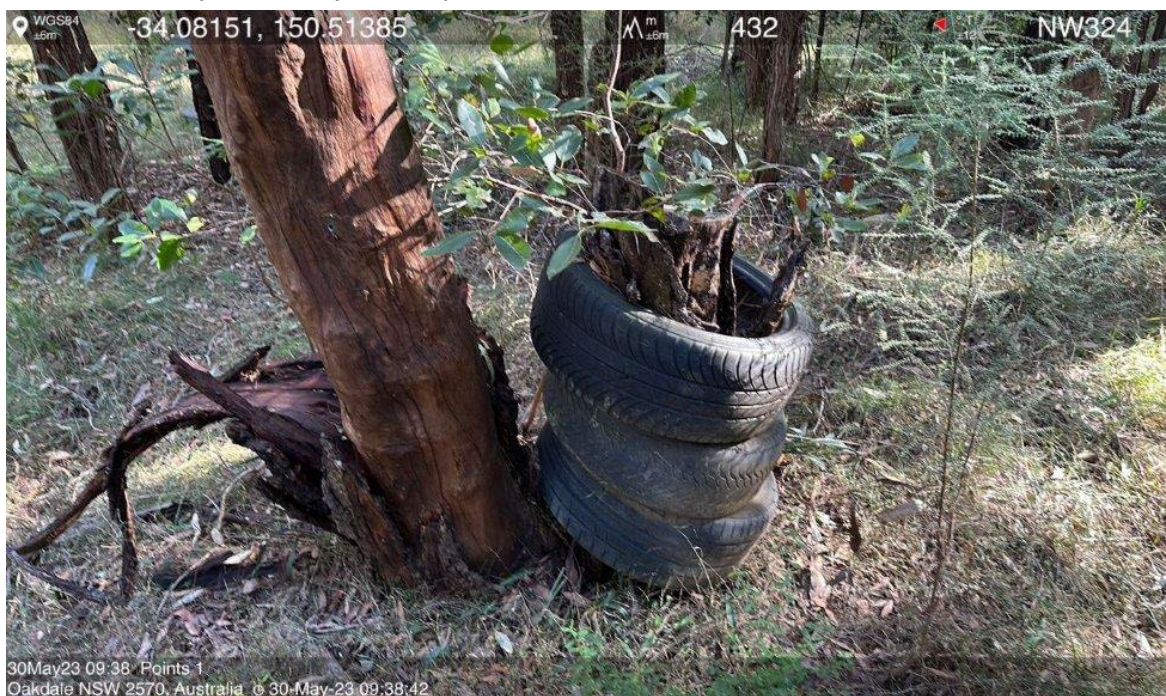
**Plate 12:** Example of car Tyres within the forest.

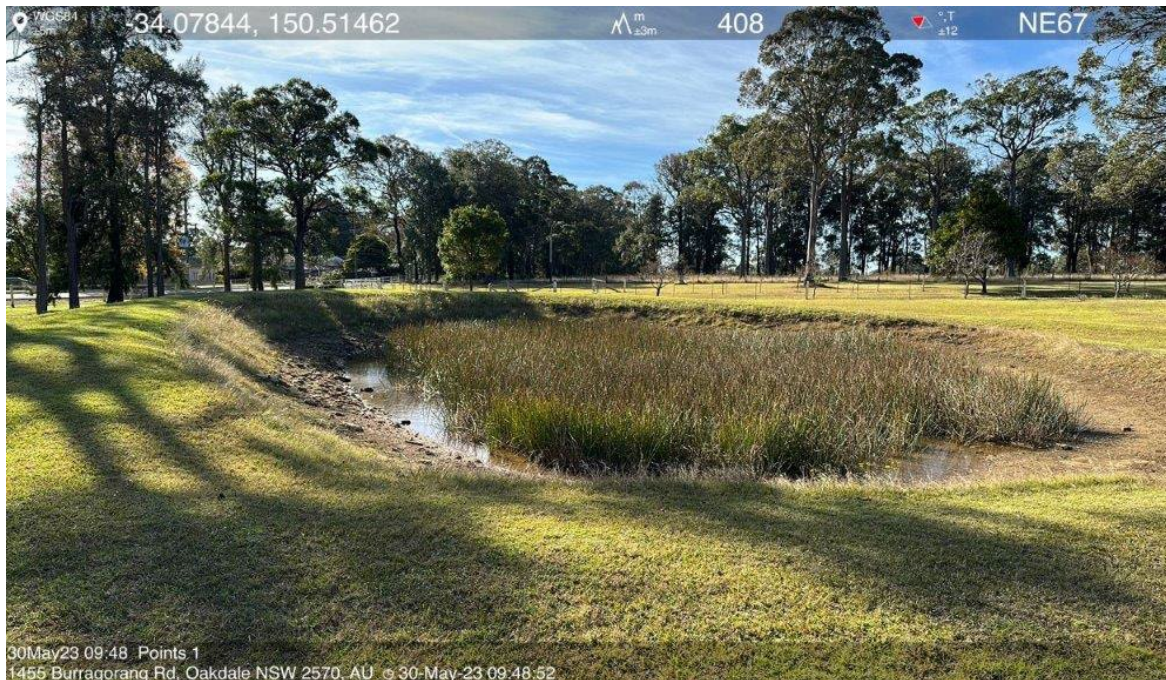
In the north-western corner of this allotment was a farm dam which appeared to have been constructed through local cut and fill earthworks. This is supported by our observations of the exposed banks which revealed a mixture clay and shale, which is local to this part of Sydney, and no visible foreign matter. Elsewhere, most of the property is predominately covered by grass with some sporadic trees.

**Plate 16:** View to the north showing the farm dam on Lot 2.

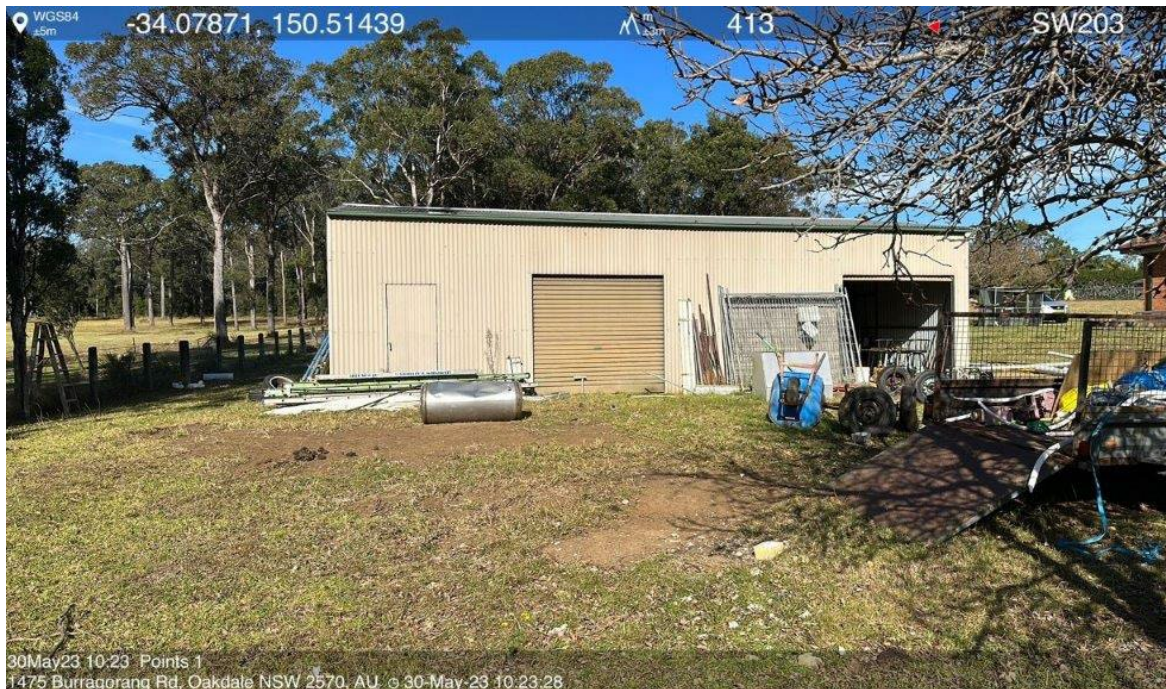
**Plate 23:** View to the south showing the garage/shed and scattered debris on Lot 1.

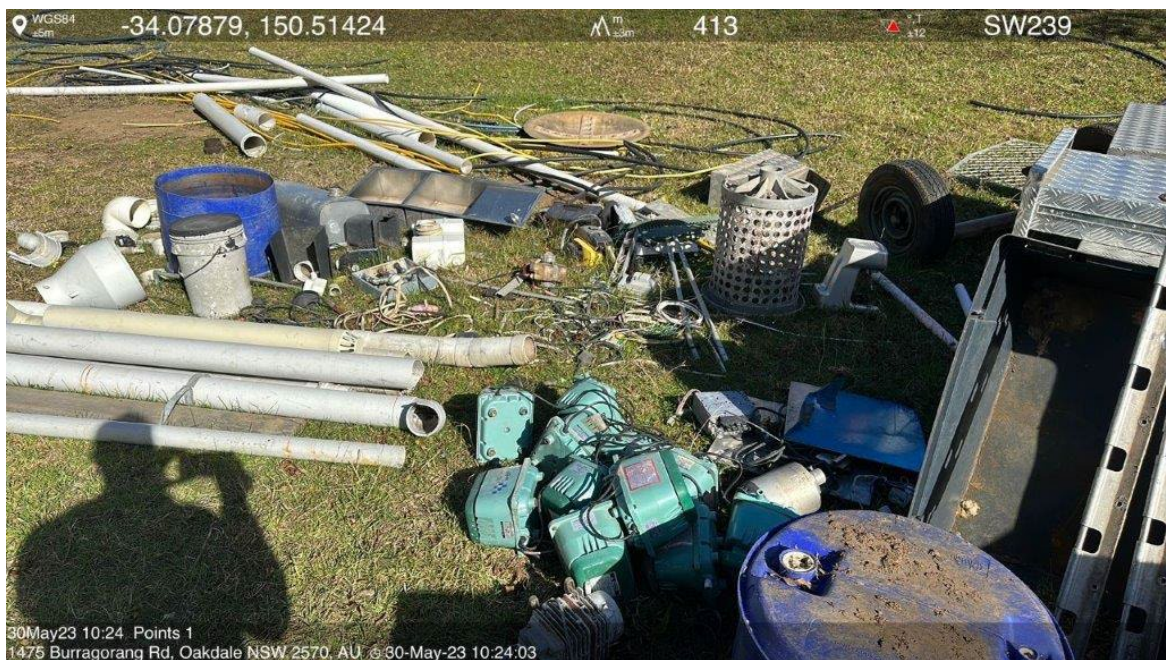
**Plate 24:** Example of scattered debris adjacent to the garage/shed on Lot 1.

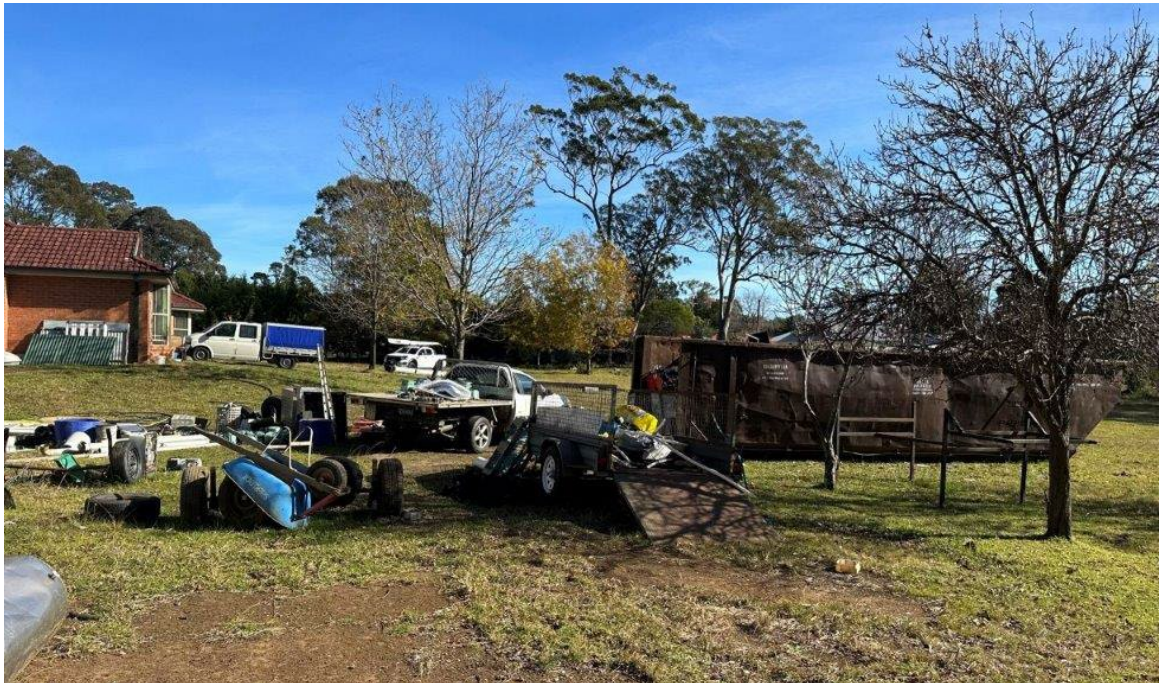
**Plate 25:** Example of scattered debris adjacent to the garage/shed on Lot 1.

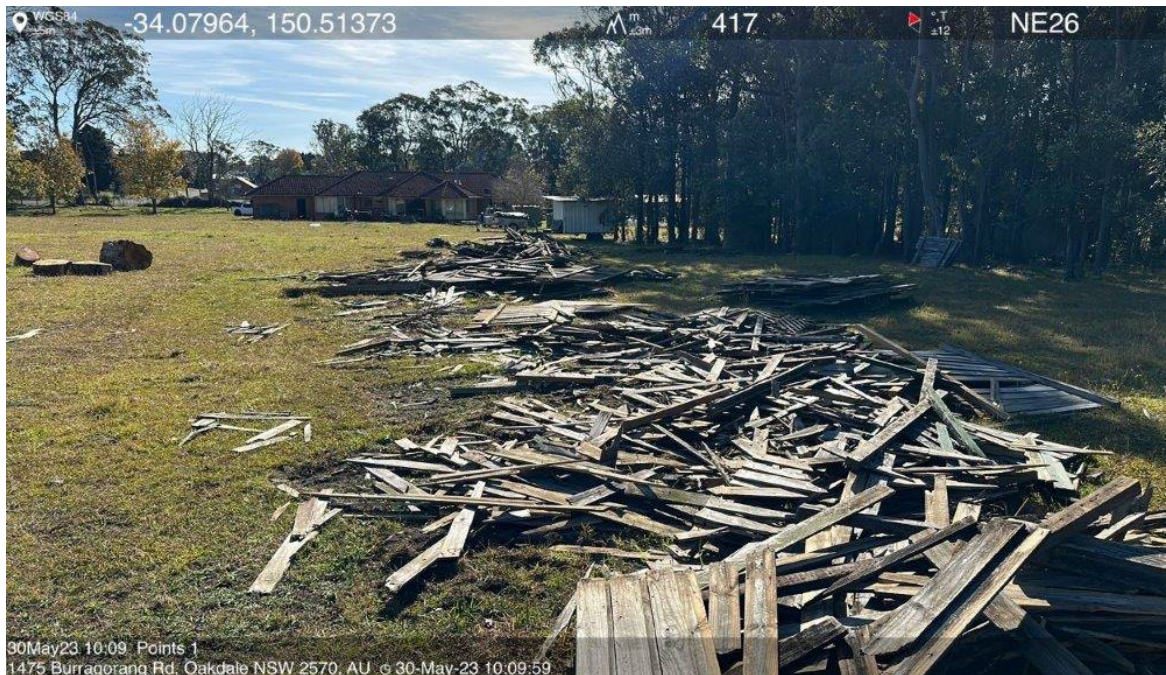
**Plate 29:** Scattered piles of timber fence palings at the rear of Lot 1.

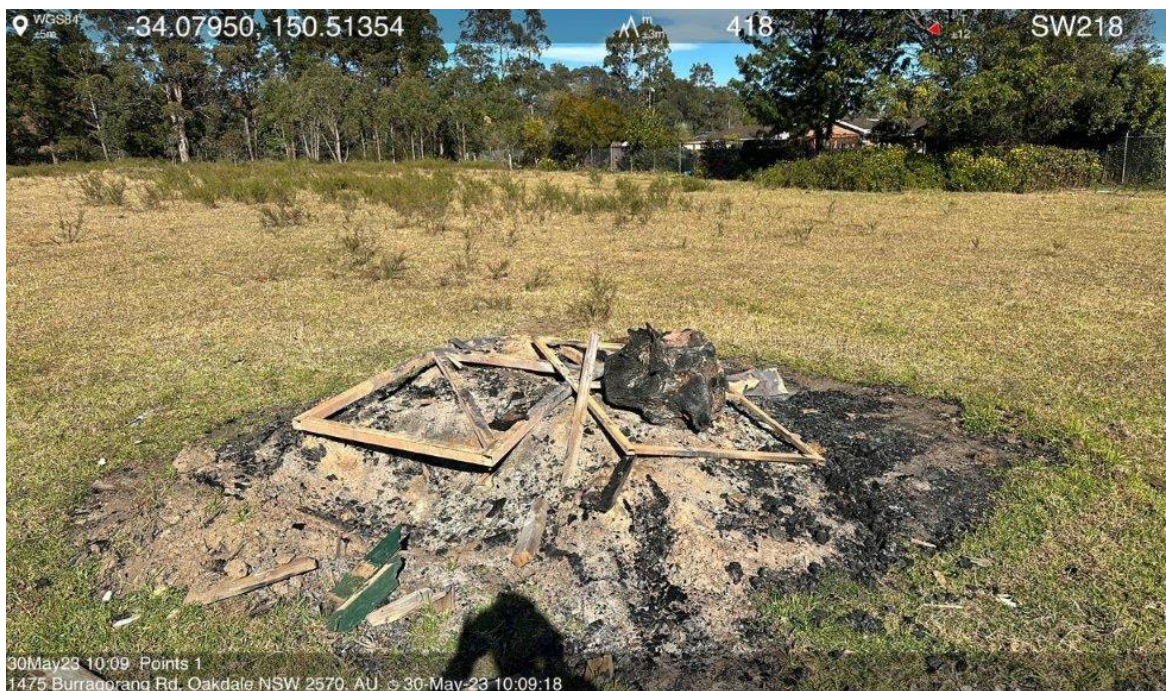
**Plate 30:** Burnt pile of timber at the rear of Lot 1.
