# Arboricultural Impact Assessment

Somewhere Landscape Architects

Chatswood Golf Course

128 Beaconsfield Rd, Chatswood NSW 2067

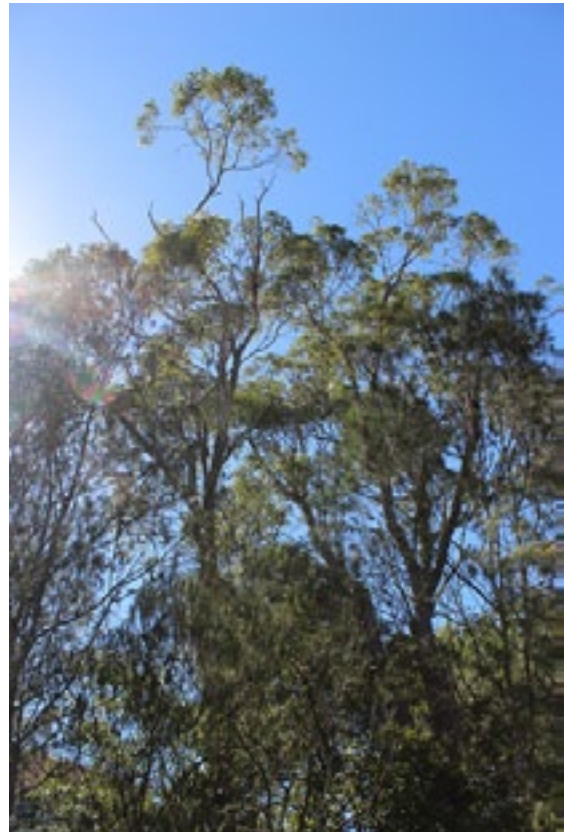
Figure Three - Trees 2 - viewed from western side. This image also shows the thick undergrowth of casuarinas (Shrublike) growing around the base of this tree.

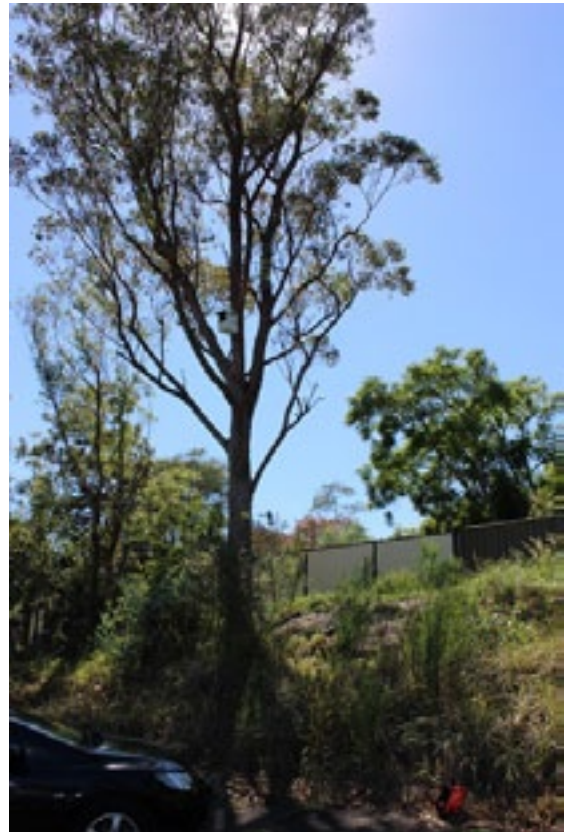
Figure Seven - Tree 6 viewed from western side, showing the overall height and canopy spread. There is also a nest box in this tree

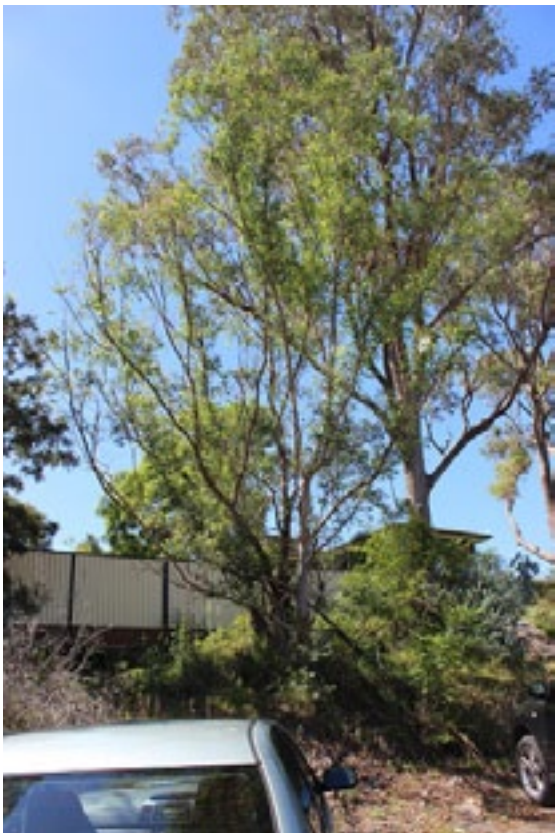
Figure Eight - Tree 7 - viewed from western side. Shows overall height and spread of the canopy which is formed by suckers. The tree has been cut off at base and is reshooting.

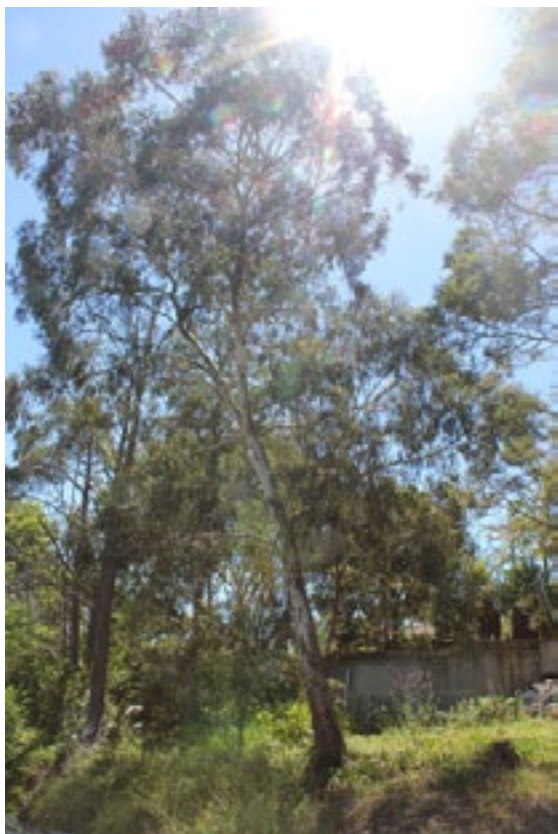
Figure Ten - Tree 10 viewed from western side.  
This tree is growing on a northwesterly lean

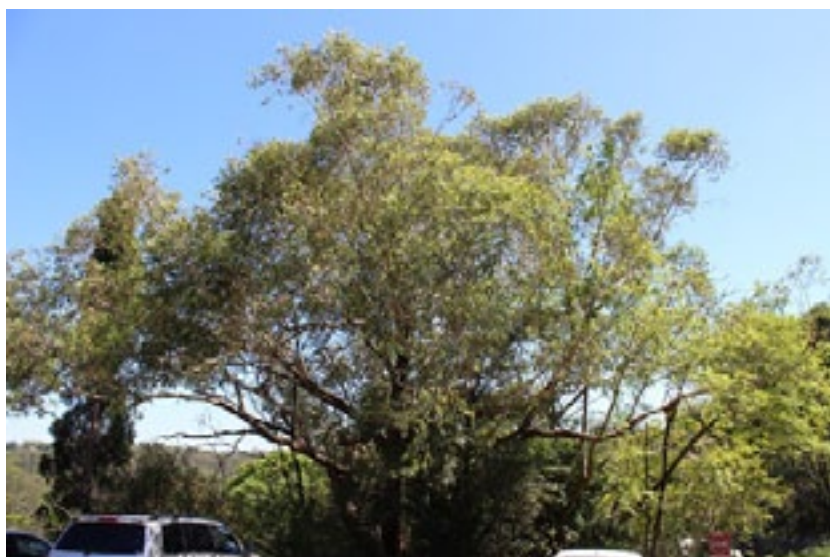
Figure Eleven - Tree 11 viewed from eastern side. This tree has 3 main trunks which start almost at ground level. This tree is growing at the top of the bank on the very edge of the car park area.

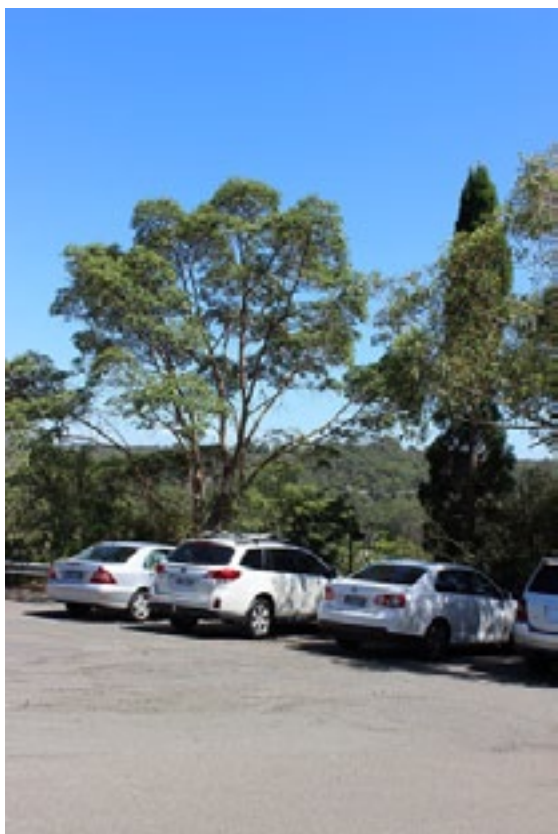
Figure Twelve - Tree 12 viewed from eastern side.  
This tree is growing approximately 500mm from top of the bank

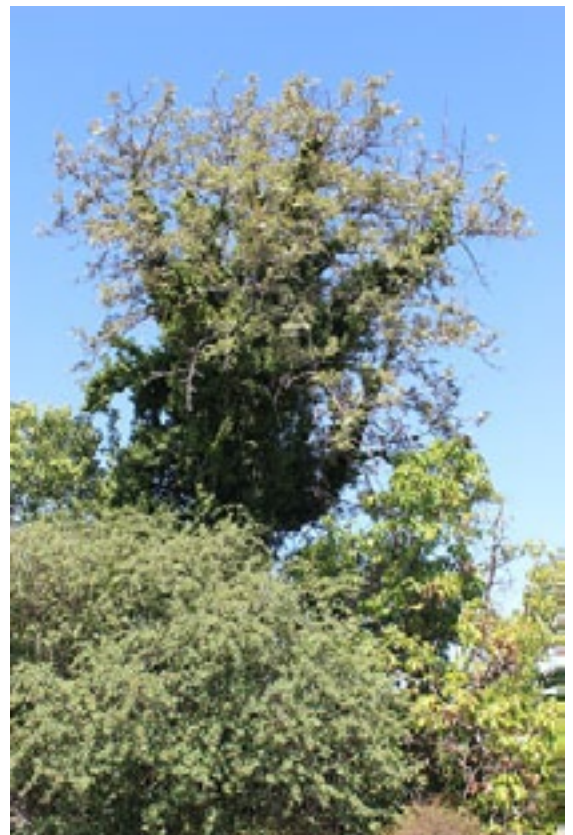
16	<i>Grevillea robusta</i>	Planted	Mature	15	N= 5 S= 5 E= 5 W= 5	Ap- prox 60	Ap- prox 60	D	3	12	The tree trunk and part of canopy is covered in ivy - this needs to be removed. Poor health and condition
17	<i>Eucalyptus spp</i>	Planted	Mature	13	N= 3 S= 4 E= 4 W= 3	60	70	C	4	6	No signs of pests or diseases. Fair health and condition. Good vigour.
18	<i>Eucalyptus spp</i>	Planted	Mature	13	N= 3 S= 4 E= 4 W= 3	60	70	C	4	6	No signs of pests or diseases. Fair health and condition. Good vigour.
19	<i>Pinus spp</i>	Planted	Mature	9	N= 3 S= 4 E= 4 W= 3	45	60	C	4	7	No signs of pests or diseases. Good health and condition. Good vigour.
20	<i>Jacaranda mimosifolia</i>	Planted	Mature	11	N= 8 S= 8 E= 6 W= 6	50	61	D	4	8	No signs of pests or diseases. Good health and condition. Good vigour. Good form and habit - has a elkhorn growing in it.
21	<i>Liquidamber styraciflua</i>	Planted	Mature	18	N= 5 S= 5 E= 5 W= 5	50	60	C	4	13	No signs of pests or diseases. Good health and condition. Good vigour.

Figure Seventeen - This image shows Tree 16 viewed from western side. There is a large amount of ivy growing through canopy. This Ivy needs to be removed.

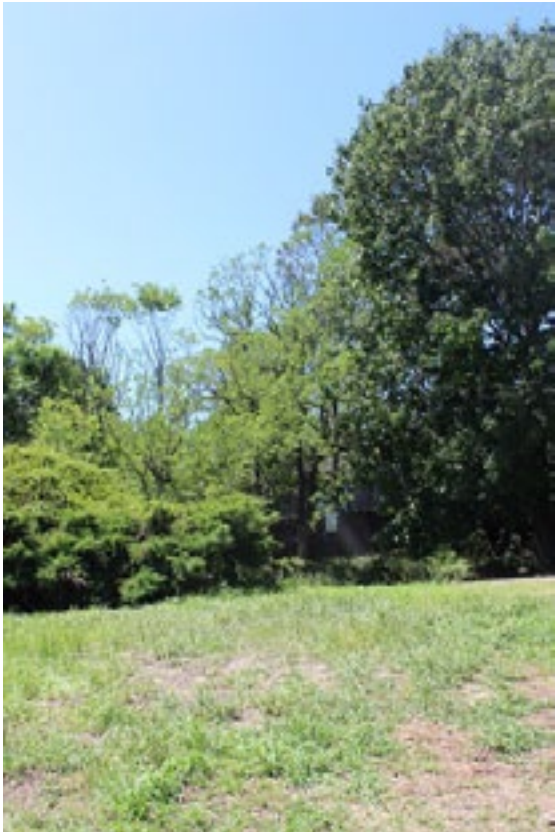
Figure Twenty-Two - Tree 22- viewed from western side. Shows overall height and spread of the canopy as well as the surrounding suckering Robinias

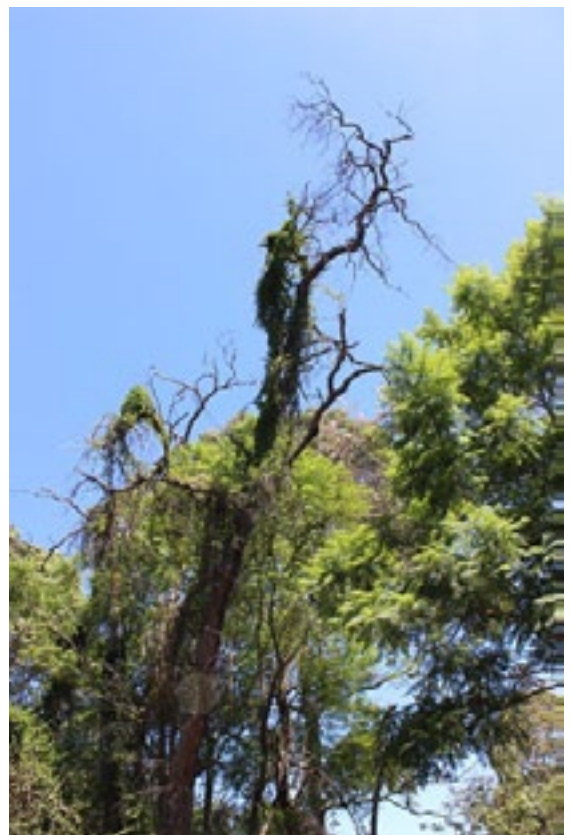
Figure Twenty-Five - Tree 25 and 26 - viewed from western side. Tree 25 is dead.

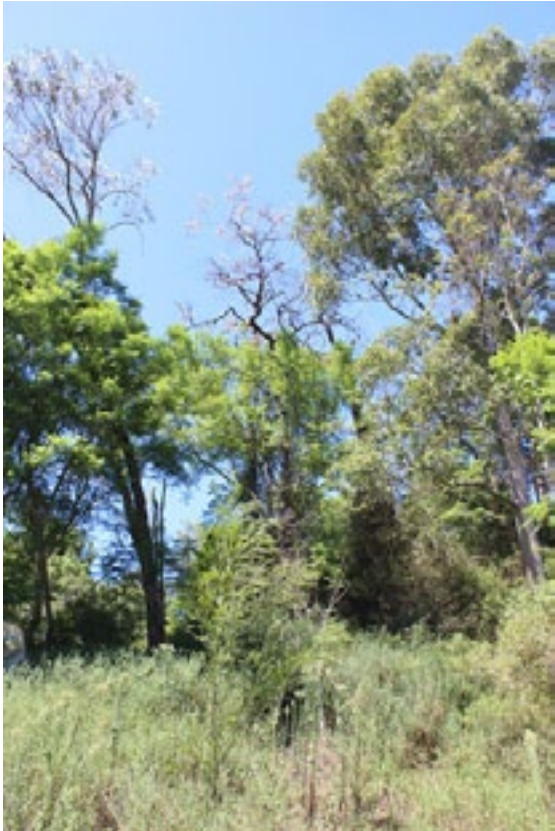
Figure Thirty - Tree s 35 (dead) and 36 - viewed from western side. Shows overall height and spread of the canopy.

Tree No.	Construction Tolerance	TPZ (mR)	SRZ (mR)	% Incursion to root zone and or canopy	Retention Value	Likely Impact HS/S/M/L	Recommendation
35	P	-	-	100% Incursion to TPZ and SRZ	Low	REMOVE	REMOVE DEAD
36	P	3.3	1.95	0% Incursion to TPZ and SRZ	Medium	No Impact	This tree has a moderate retention value
37	P	-	-	REMOVE	low	REMOVE	REMOVE DEAD
38	H	-	-	REMOVE	low	REMOVE	REMOVE DEAD
39	P	-	-	REMOVE	low	REMOVE	REMOVE DEAD
40	P	-	-	REMOVE	low	REMOVE	REMOVE DEAD
41	P	5.4	2.5	30% Incursion to TPZ 20% Incursion to SRZ	Medium - High	High Impact to TPZ and SRZ	This tree has a medium high retention value.
42	P	5.4	2.5	100% Incursion to TPZ and SRZ	Medium - High	Very High Impact	This tree has a moderate high retention value.
43	P	6	2.7	100% Incursion to TPZ and SRZ	High	Very High Impact	This tree has a high retention value.
44	P	5.4	2.5	100% Incursion to TPZ and SRZ	Medium - High	Very High Impact	This tree has a medium to high retention value.

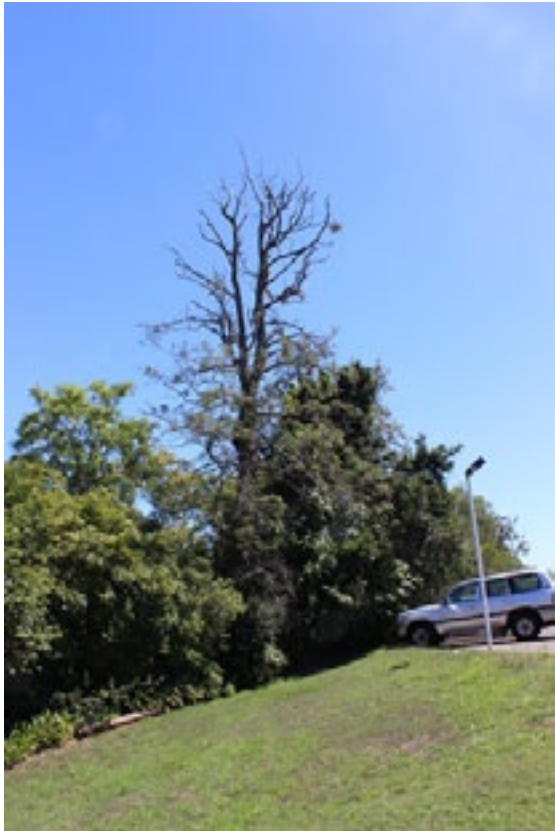
Group 11 - *Grevillea Robusta* - LOW retention value termite attacking trunk - REMOVE - as discussed on site

Figure Forty - Six- Group 11 viewed from southern side - this tree is dying and there are signs of termite.

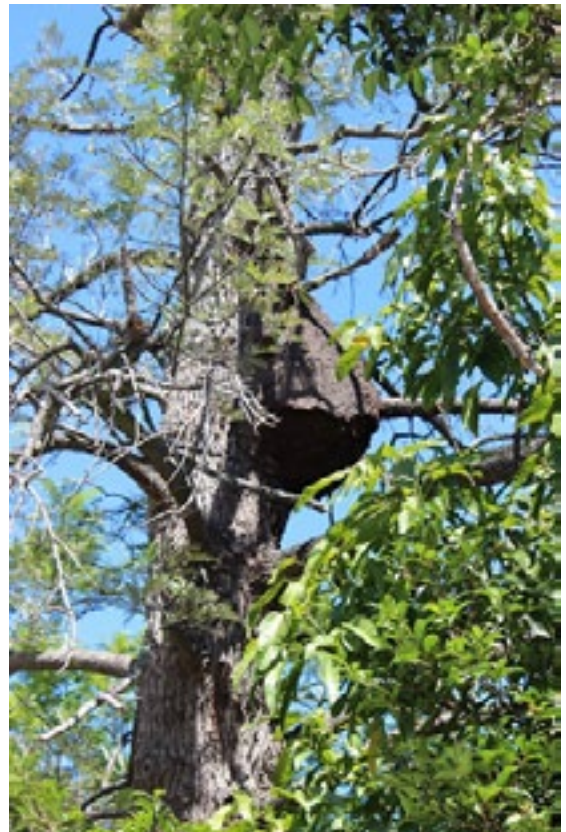
Figure Forty - Seven - A close of the termites nest in Group 11
