# Geotechnical Assessment Report

**72 Glendower Street, Gilead NSW 2560**

A201021.1744.00 vf | Date: 29 October 2021

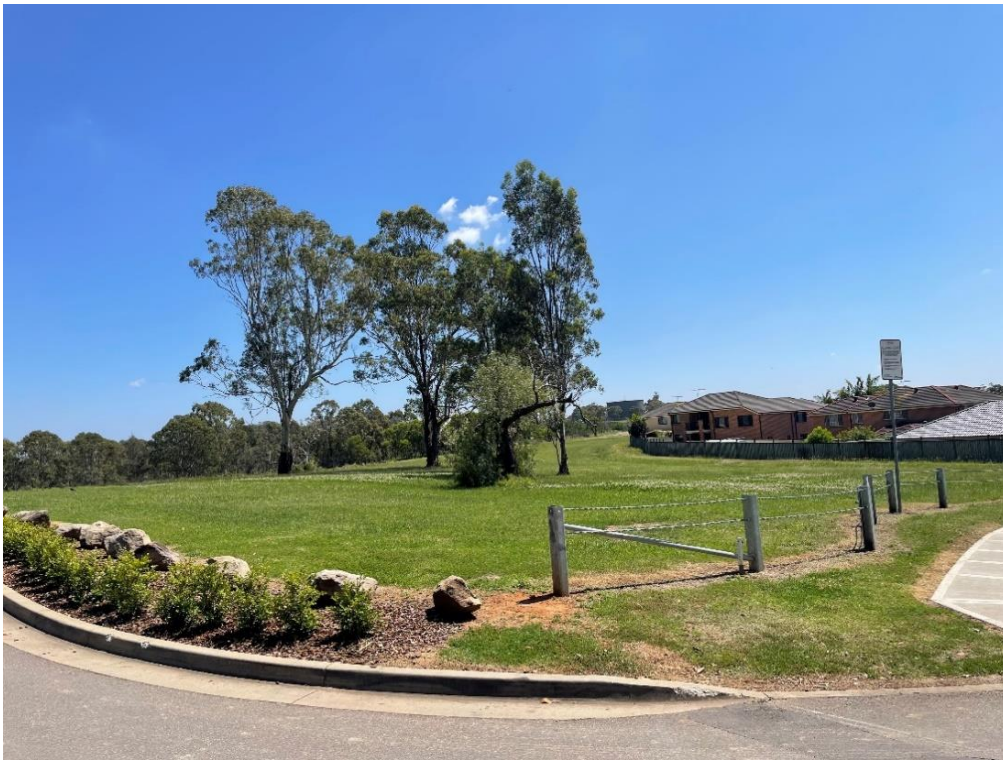
Lot 19 comprises of relatively flat terrain and naturally sloping downwards towards the south with a gentle slope less than 5° (see Photo 1). Lot 19 is naturally slopped toward the northeast and eastern boundary lines, where surface-water flows into existing stormwater drainage outlets. There are two stormwater drainage outlets at the boundary of Lot 19, including an outlet located at the eastern corner of Lot 19 (Photo 2) as well as an outlet at the eastern boundary adjacent to Glendower Street and the northeast corner of Lot 19 (Photo 3)

**Photo 1:** General view (southeast – northwest) of Lot 19, from the corner of Charley Crescent and Glendower Street. Note residential properties on the northeast of Lot 19. Also, note medium-size trees within Lot 19

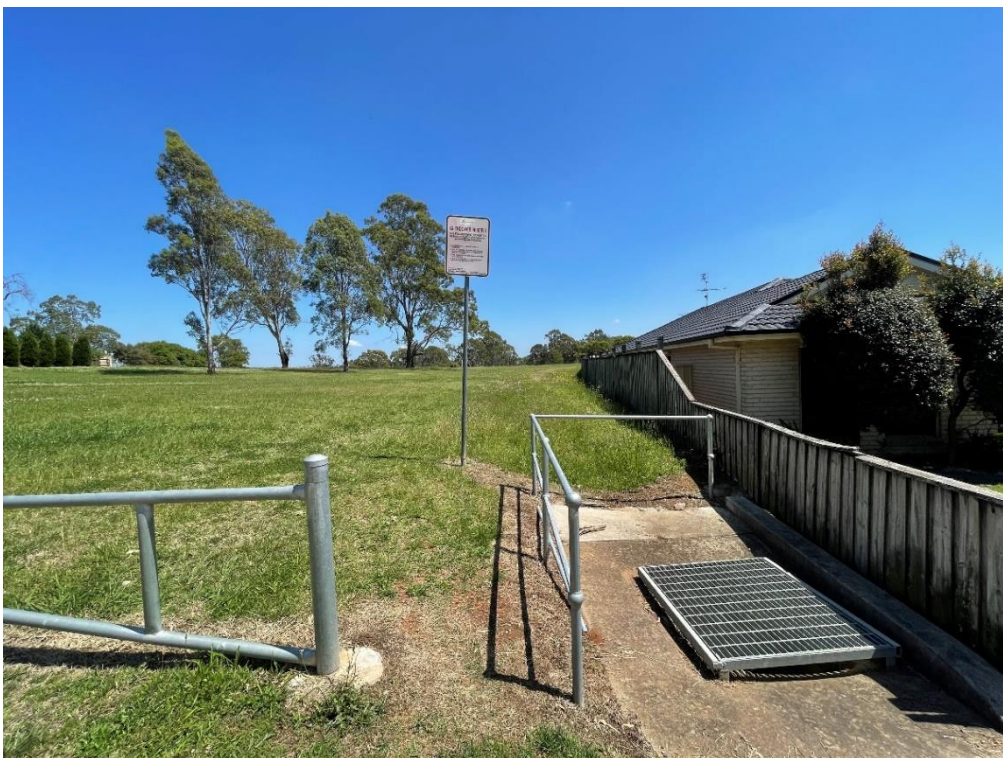
**Photo 2:** View (southeast–northwest) from Glendower Street to the west boundary of Lot 19. Note a stormwater drain located at the eastern corner of Lot 19 behind residential properties. Also, note scattered medium-size trees within Lot 19.

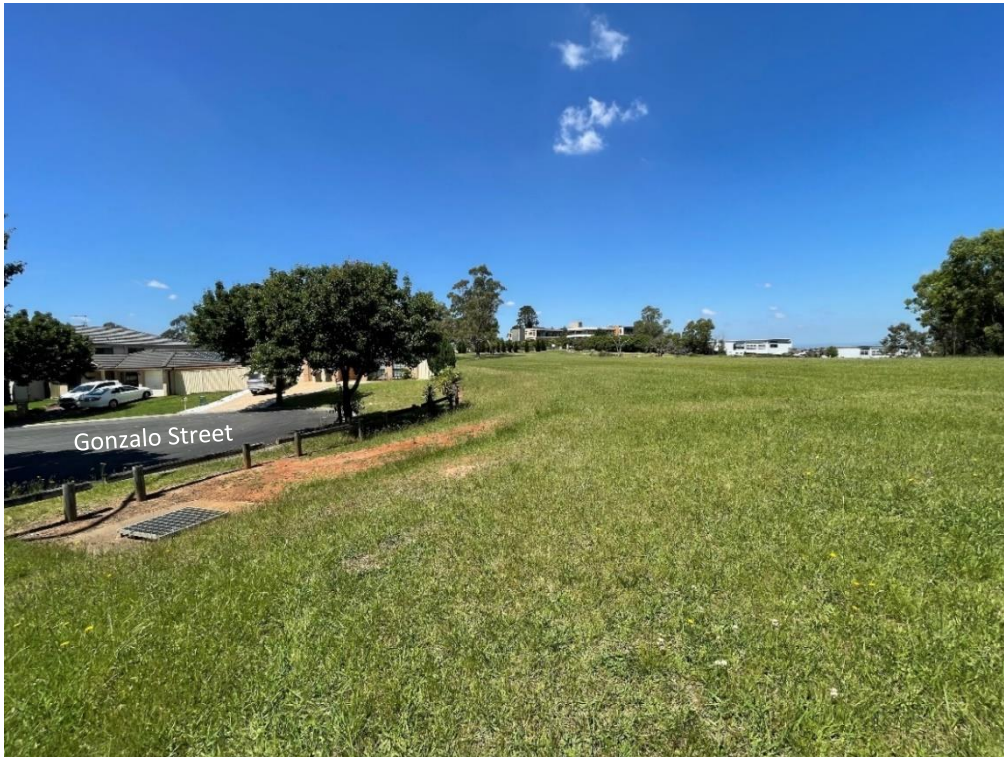
**Photo 3:** View (north – south) of Lot 19. Note existing stormwater drainage outlet, which is located at the eastern boundary adjacent to Glendower street and the northeast corner of Lot 19.

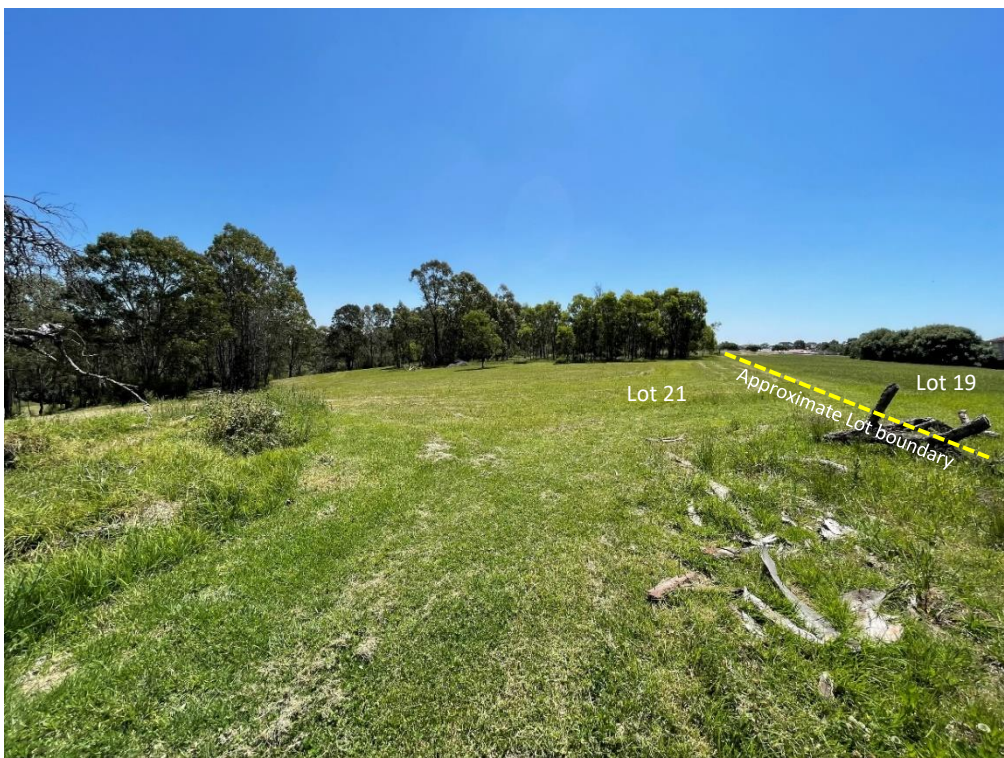
**Photo 4:** View (south – north) of the relatively flat terrain from the eastern end of Lot 21

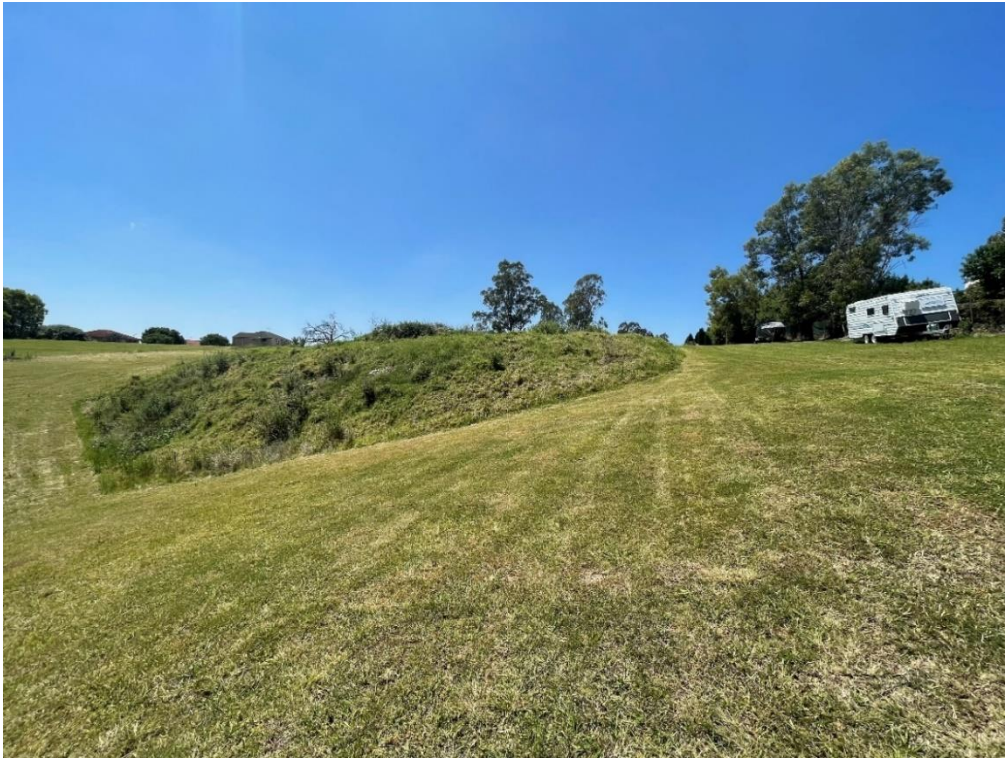
There is a gentle to moderate slope, which is located at the southeast boundary of lot 21 adjacent to the southwestern boundary of Lot 19 (Photo 5). A section with moderate slope was observed with this area that slopes towards the west side of Lot 21.

**Photo 5:** View (west – east) of the moderately sloping area located at the southeast boundary of lot 21.

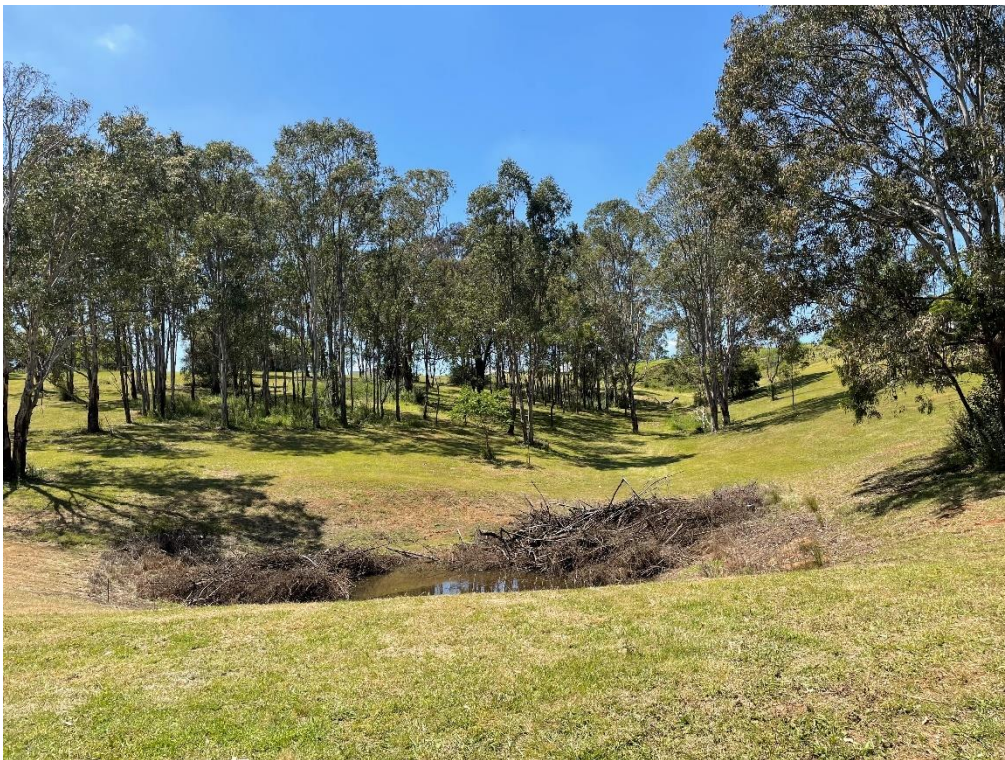
**Photo 6:** View (southwest–northeast) of an existing dam and surrounding gently to moderately sloping terrain located roughly in the middle of Lot 21. Note small to medium size trees within Lot 21

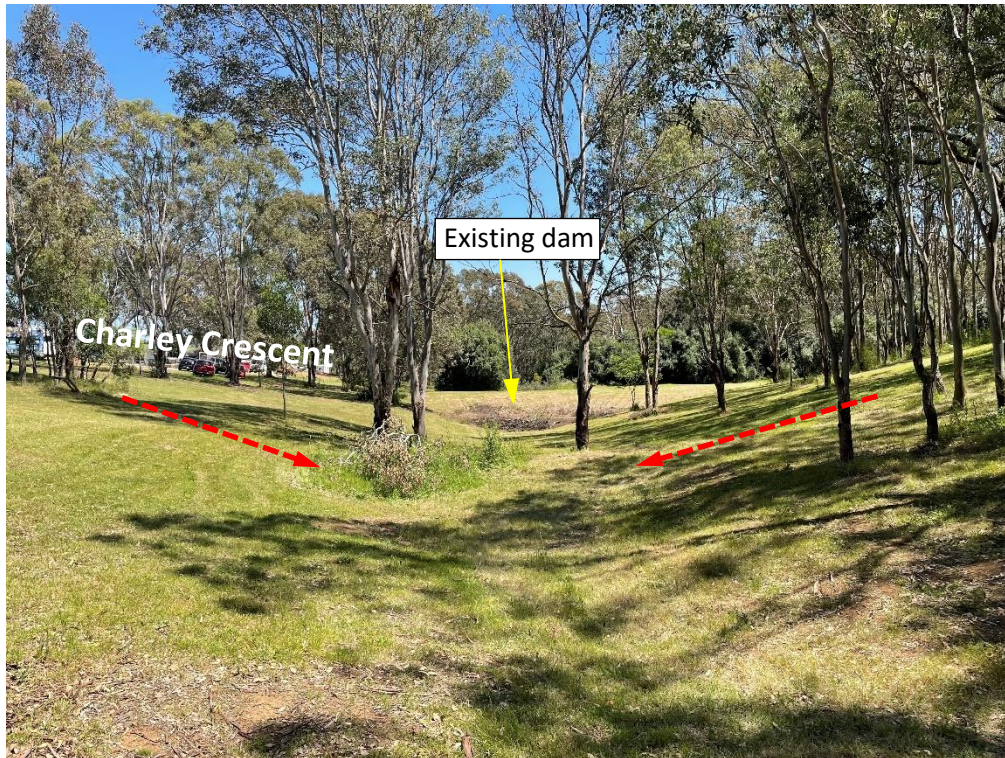
**Photo 7:** View (east – west) of an existing dam and surrounding moderately sloping terrain located approximately in the middle of Lot 21.

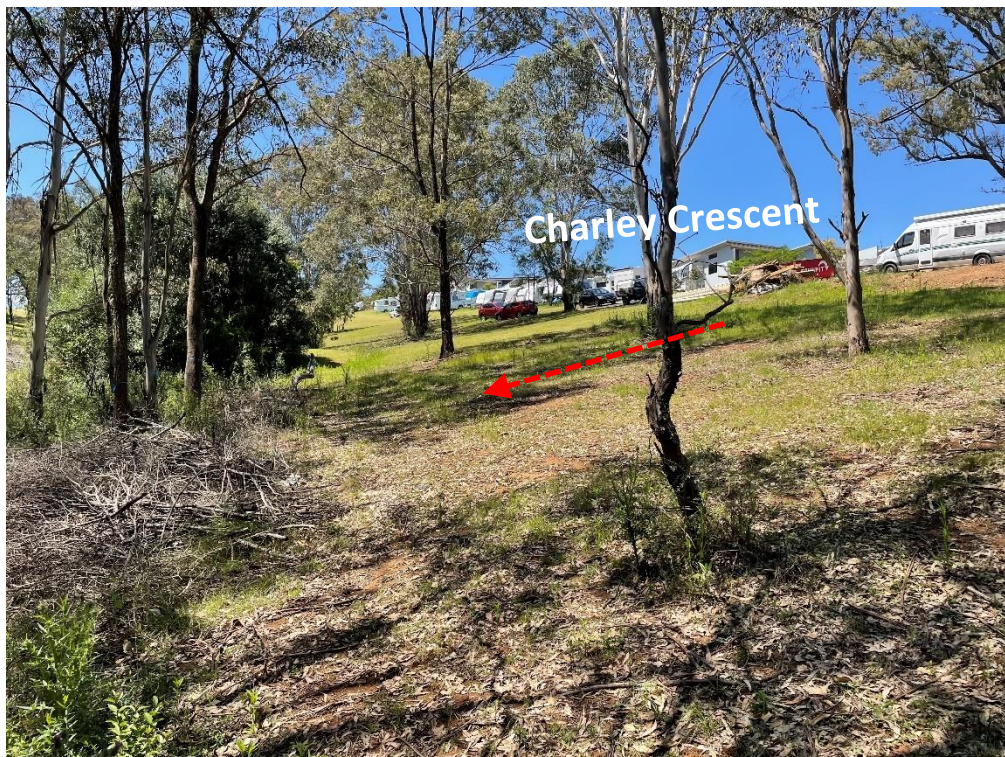
**Photo 8:** View (north – east) of moderately sloping area located at the southern boundary of Lot 21. Note small to medium size trees on the slope
