# **ARBORICULTURAL IMPACT ASSESSMENT**

**14 HAMILTON ROAD  
ALBION PARK NSW 2527**

Prepared for LandTeam Australia Pty Ltd

**JULY 2019**

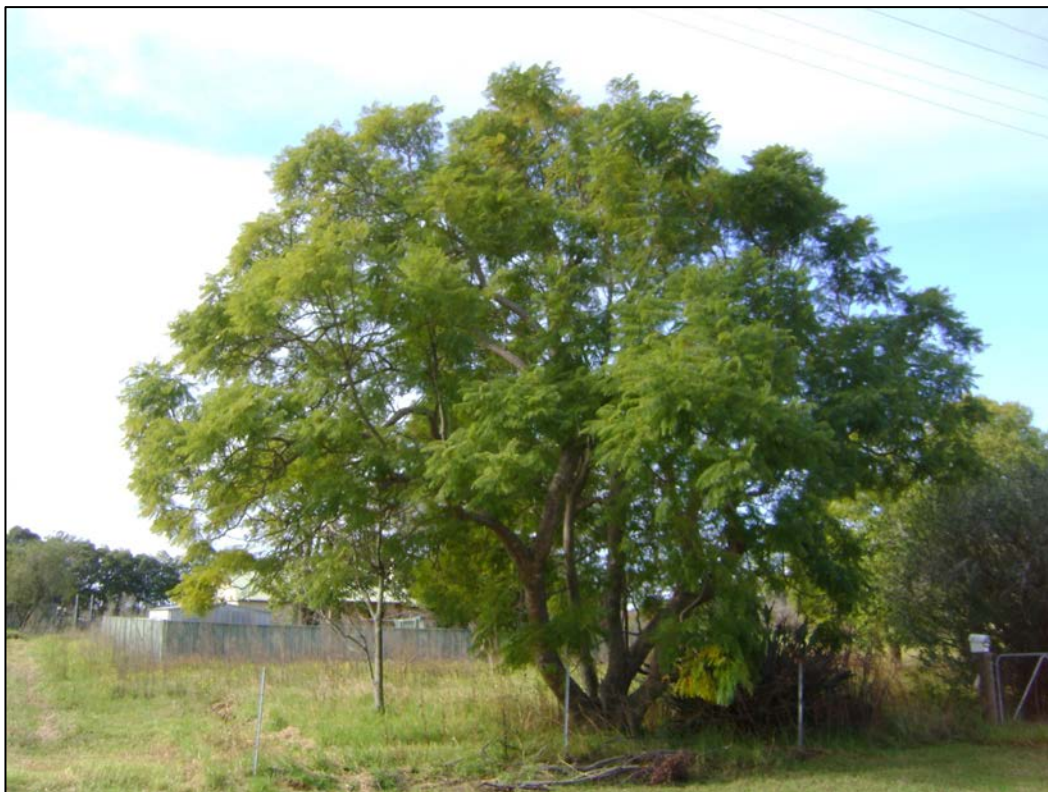
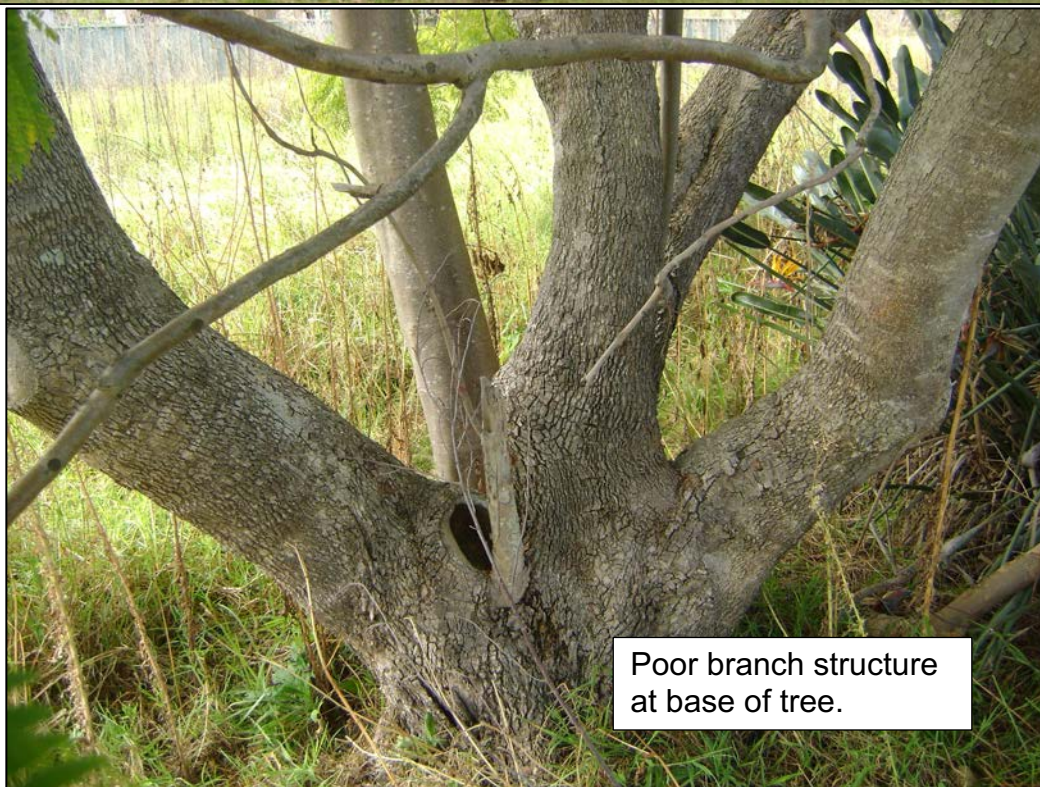
Photos 1 & 2 – Tree 1 – *Jacaranda mimosifolia* (Jacaranda)

This fully mature Jacaranda displays fair health and vigour but has poor shape and structure. This is a multi-trunked tree that has an exposed root system. Suckering trunks and major branches are growing from the base of tree. There is included bark visible at the major trunk union. The tree has some dead wood and suckering 2<sup>nd</sup> order branches. Previous branch failures were noted at the time of inspection.

This tree been given a SULE rating of 3b and SRIV rating of MGVP-6. These low retention values are reflective of the current condition of this tree. This tree is suitable for short-term retention only.

Tree #	Botanic Name			Common Name			Age Class
1	Jacaranda mimosifolia			Jacaranda			M
Height (m)	Spread (m)	DBH (cm)	Crown Class	Crown Aspect	Crown Ratio	SULE Rating	SRIV Rating
10	10	50 multi-trunk	D	SYM	P 80%	3b	MGVP-6
Fair health and vigour. Poor shape and structure. Multi-trunked trees. Suckering trunks / major branches growing from base of tree. Included bark at major trunk union. Some dead wood. Suckering 2 <sup>nd</sup> order branches. Previous branch failures. Exposed root system. Low retention value.						TPZ 6.0	SRZ 2.5
Tree #	Botanic Name			Common Name			Age Class
2	Nerium oleander			Oleander			M
Height (m)	Spread (m)	DBH (cm)	Crown Class	Crown Aspect	Crown Ratio	SULE Rating	SRIV Rating
4	6	multi-stem	D	SYM	P 80%	3b	MLVP-2
Fair health and vigour. Poor shape and structure. Multi-stemmed large shrub. Overgrown and uncared for. Undesirable species. Poor position on the lot. Low retention value. Suggest removal.						TPZ 3.6	SRZ 2.0

This tree is located within Lot 22 of the proposed subdivision. Given the current condition of this tree and its short-term retention value, it is my suggestion that this tree is removed and replaced with a new tree in a suitable location.

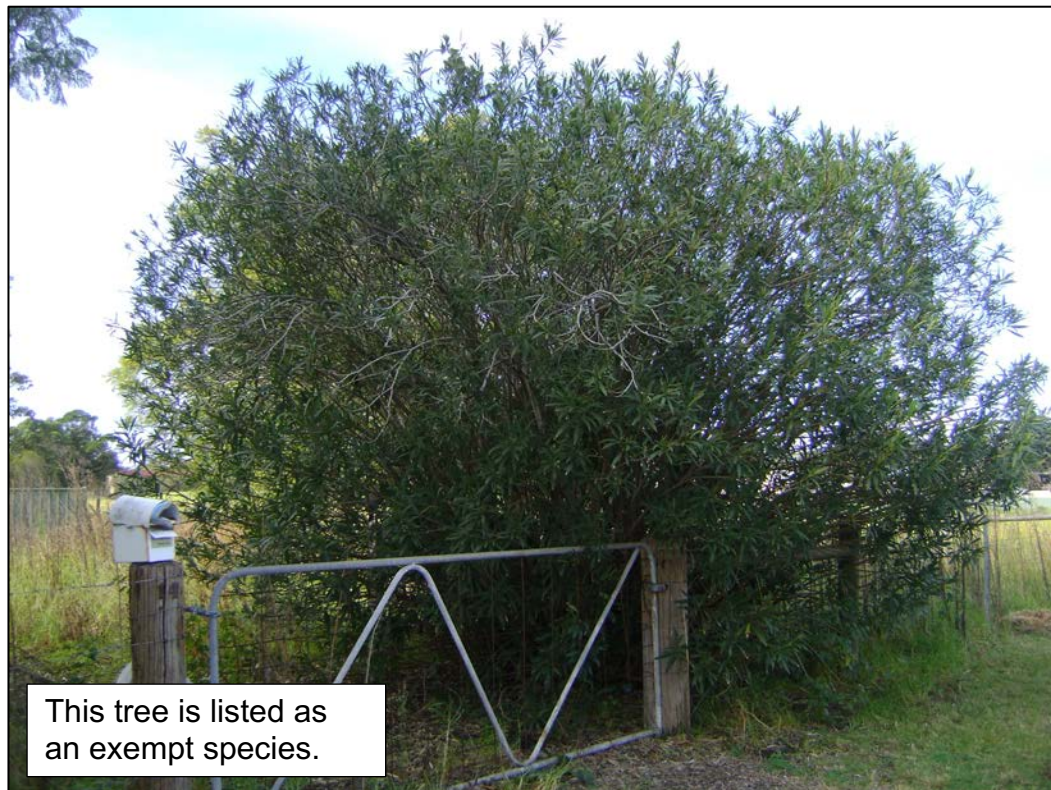
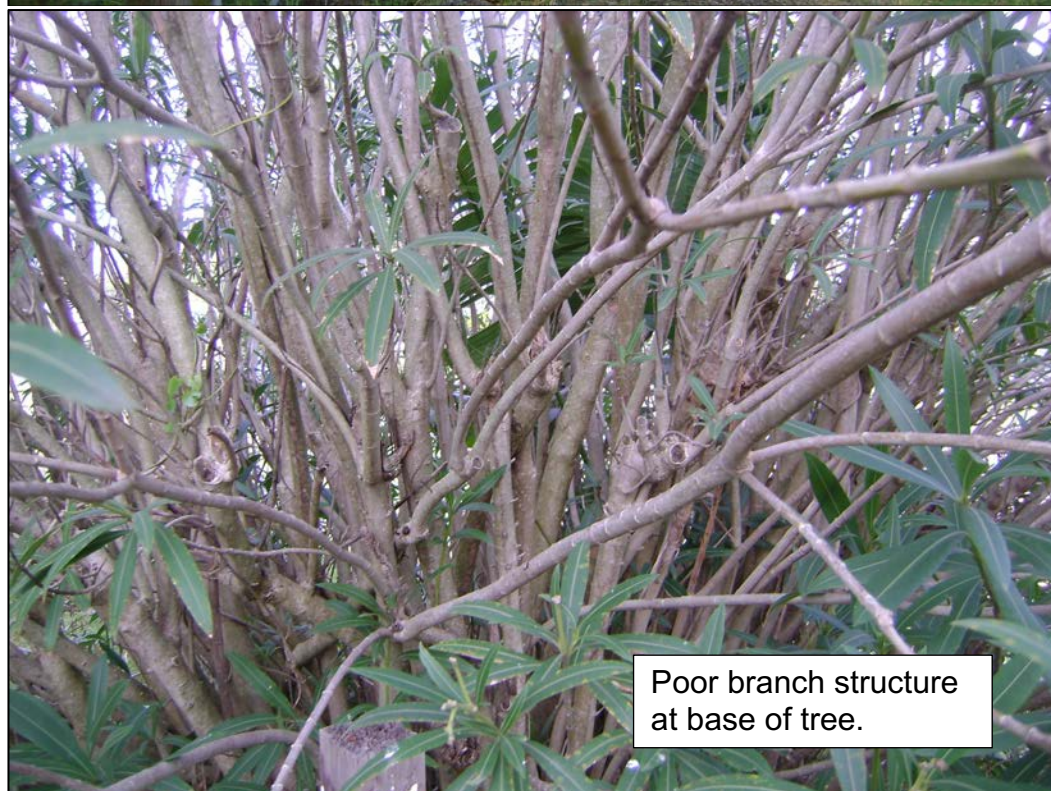
**Photos 3 & 4 – Tree 2 – *Nerium oleander* (Oleander)**

This large shrub displays fair health and vigour but has poor shape and structure. It is a multi-stemmed shrub that is overgrown and uncared for. This is an exempt tree species as listed by Shellharbour City Council. This shrub is suggested for removal.

The large shrub has been given a SULE rating of 3b and SRIV rating of MLVP-2. These low retention values support the suggested removal of this tree.

This shrub is located within Lot 22 of the proposed subdivision. Given the exempt species status of this shrub and its low retention value, this shrub should be removed and replaced with a more suitable tree species.

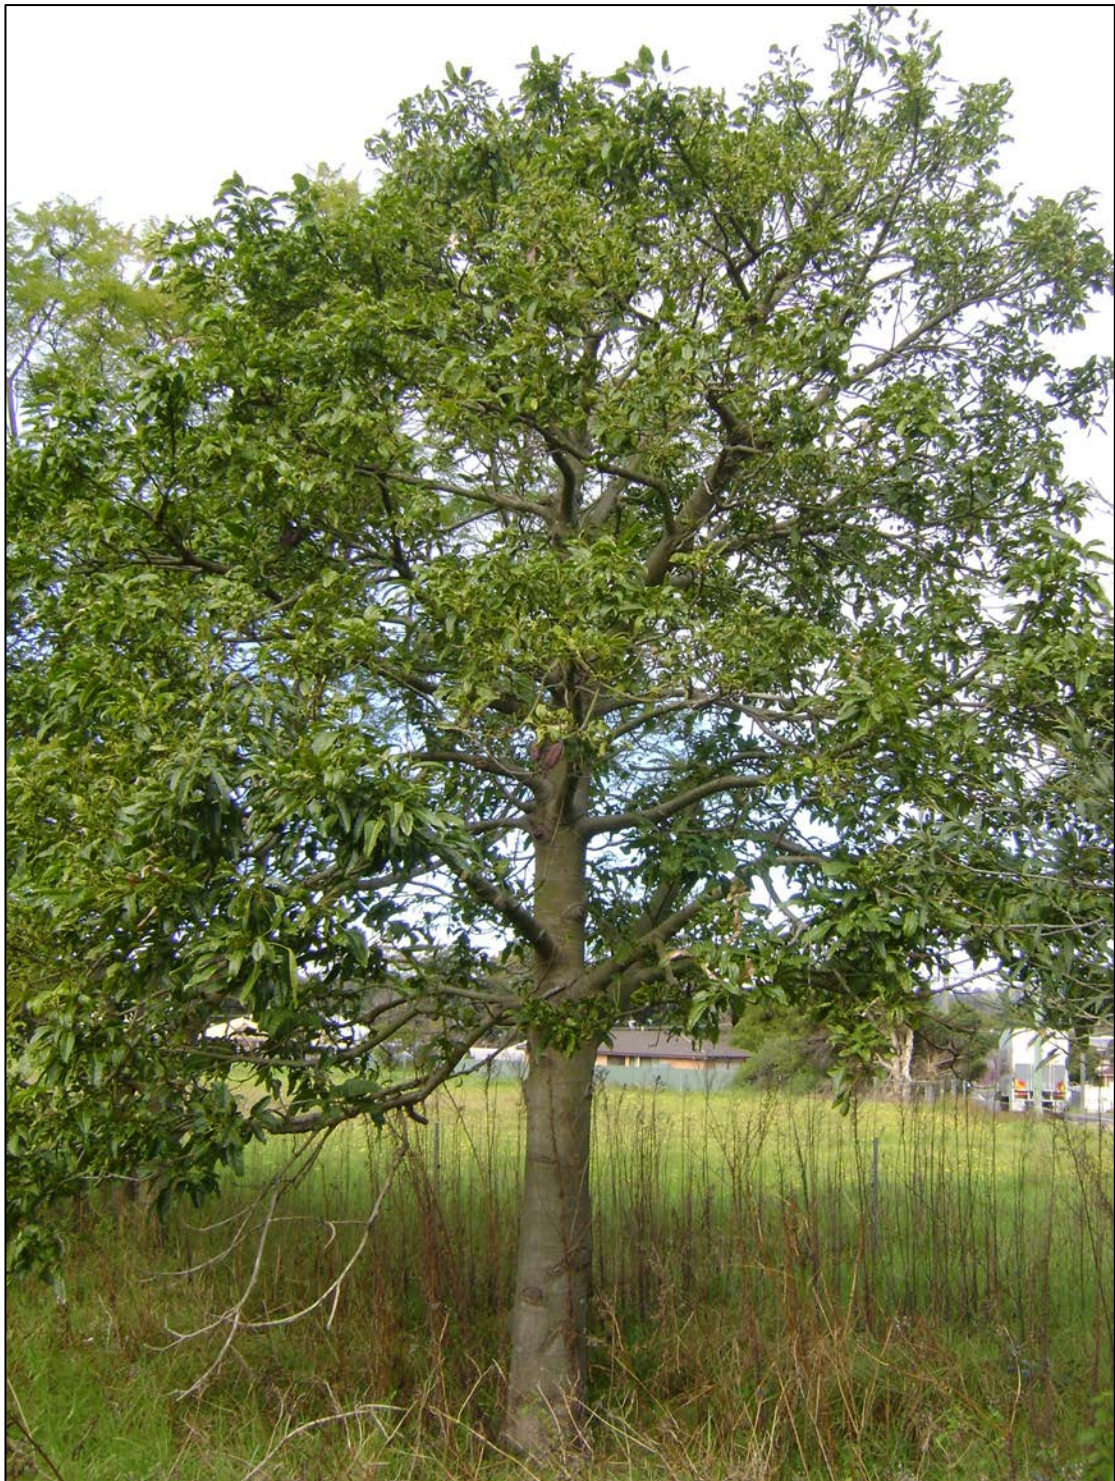
**Photo 5 – Tree 3 – *Brachychiton acerifolius* (Illawarra Flame Tree)**

This mature tree displays fair shape and structure but has poor health and vigour. The tree is struggling from the recent extended period of dry weather. Crown development is poor (crown ratio 40%). The tree has some dead wood. A long-term tree care program would need to be implemented if this tree was to be retained.

This tree is located within Lot 22 of the proposed subdivision. In my opinion this tree should be removed and replaced with a new tree at a suitable location within the proposed subdivision.

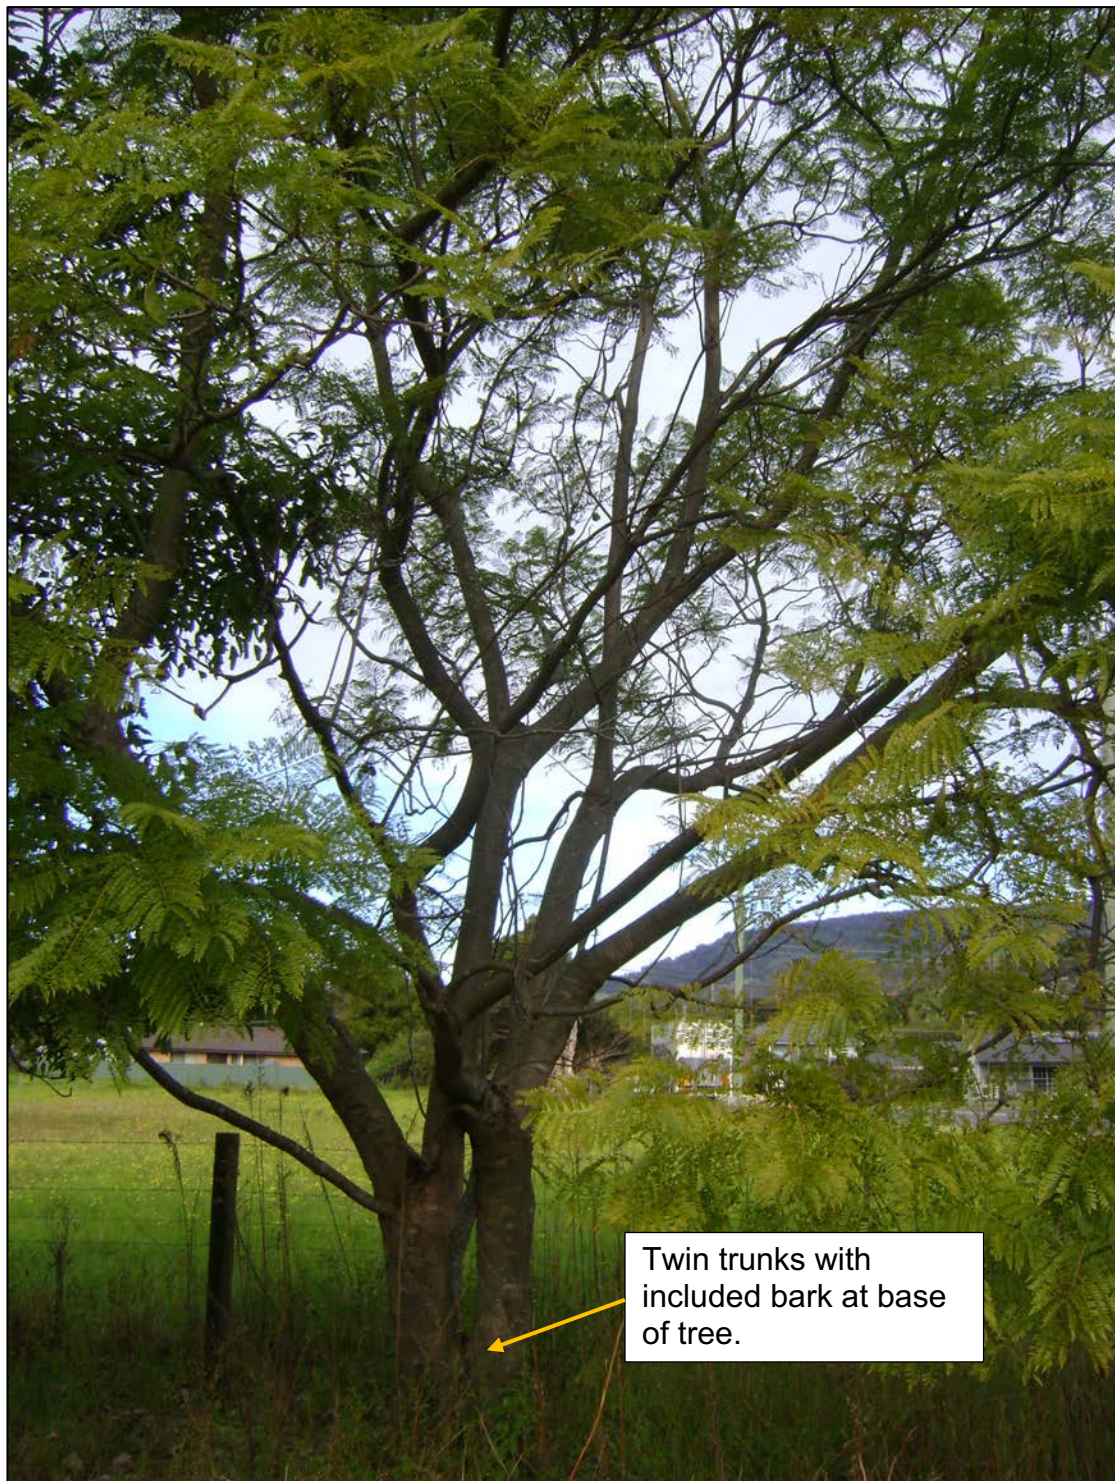
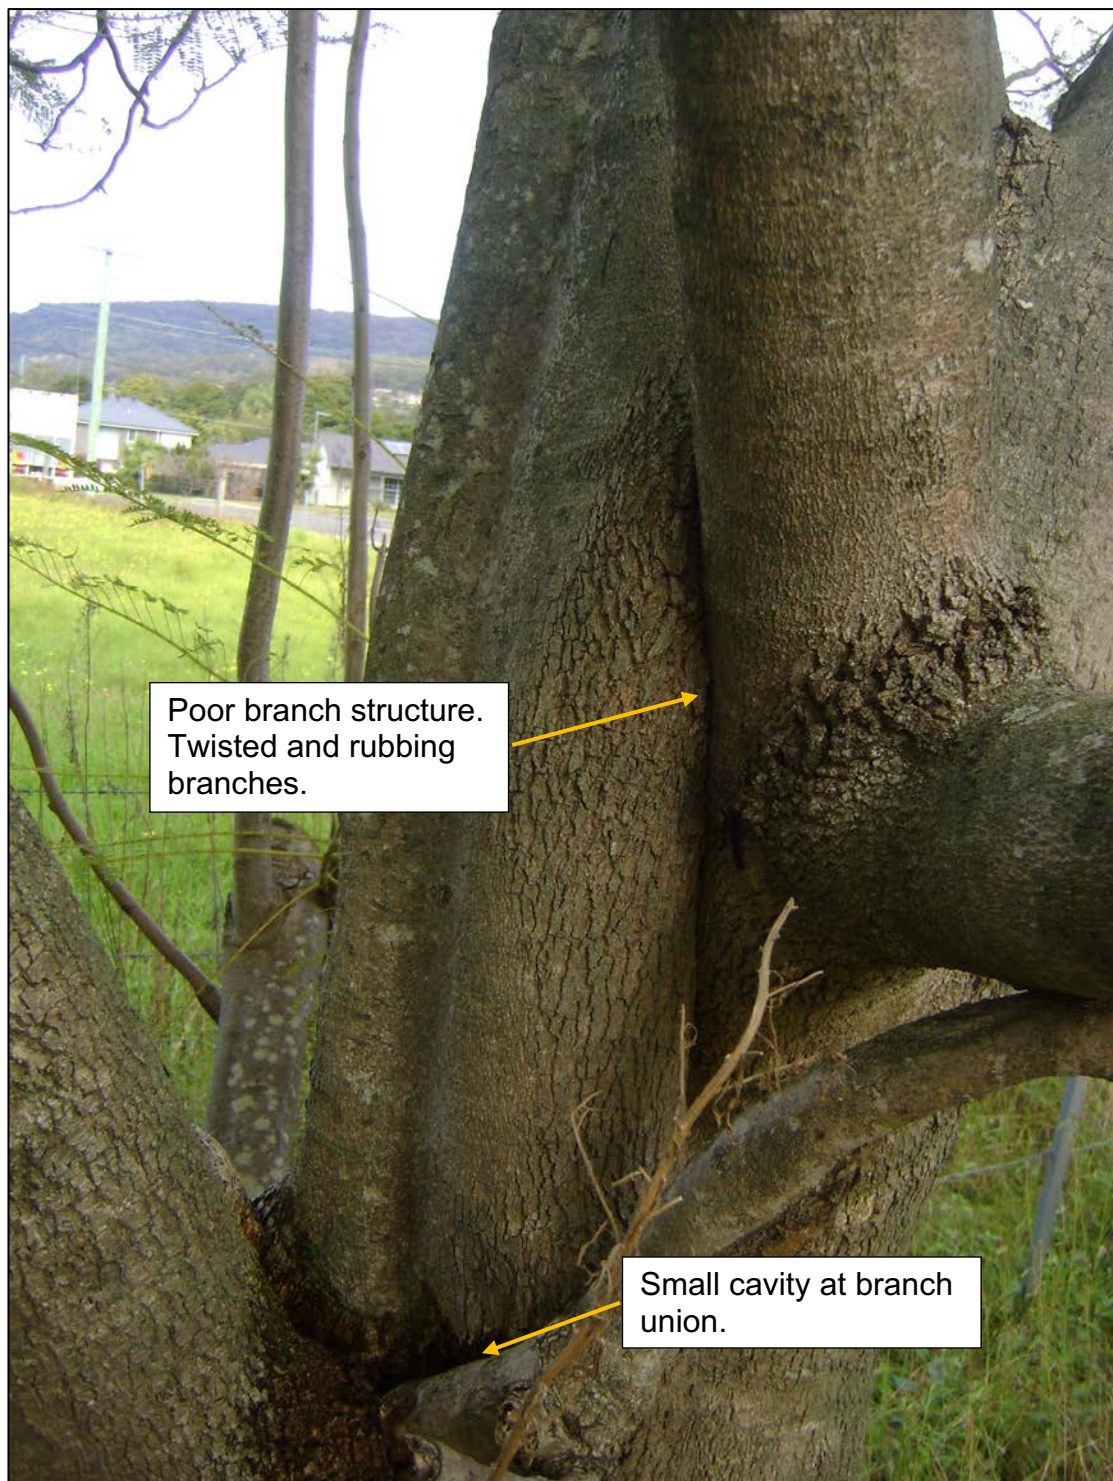
**Photo 6 – Tree 4 – *Jacaranda mimosifolia* (Jacaranda)**

This mature tree displays poor health, vigour, shape and structure. The tree has a crown bias to the west due to crowded growing conditions. The tree has a bifurcated (twin) trunk with included bark at a height of 0.5m above existing ground level. The tree has small cavities and twisted, rubbing branches. There is dead wood within the crown and dieback of 2<sup>nd</sup> and 3<sup>rd</sup> order branches. This tree is suggested for removal.

This tree is located in Lot 21 of the proposed subdivision. In my opinion this tree should be removed and replaced with a new tree at a suitable location within the proposed subdivision.

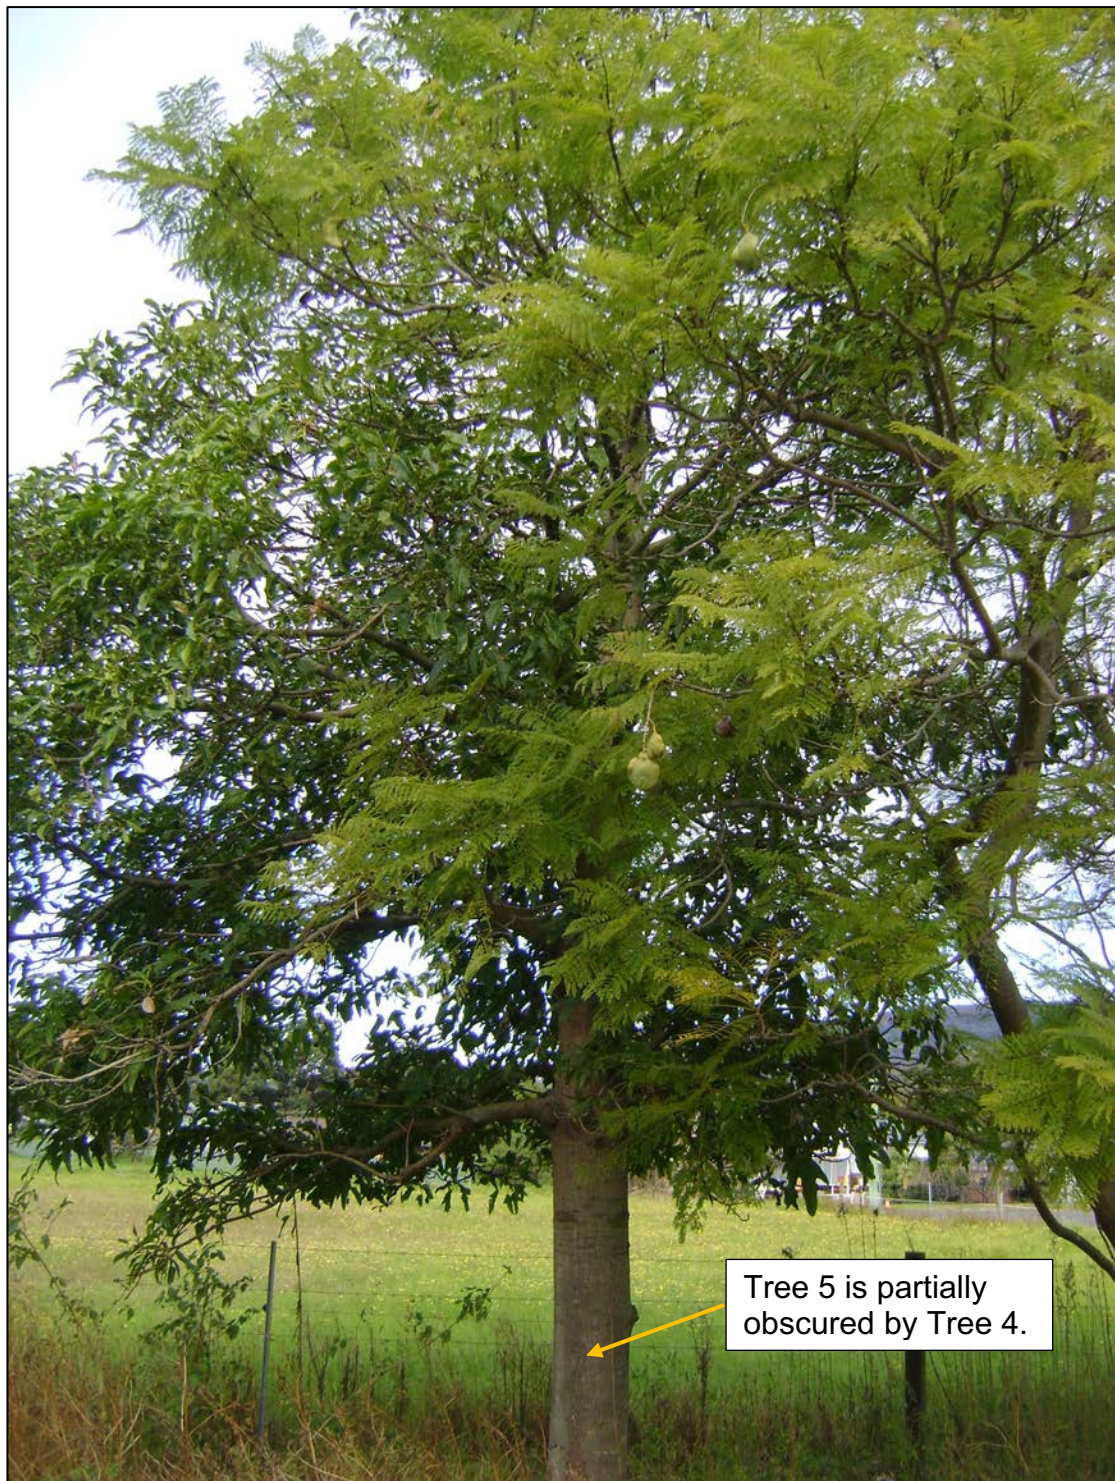
**Photo 8 – Tree 5 – *Brachychiton acerifolius* (Illawarra Flame Tree)**

This mature tree displays fair health, vigour, shape and structure. The tree has a crown bias to the east due to crowded growing conditions. This tree appears to be drought affected. The crown ratio is 40%. The health of tree could be improved with implementation of long-term tree care program.

Tree #	Botanic Name			Common Name			Age Class
5	Brachychiton acerifolius			Illawarra Flame Tree			M
Height (m)	Spread (m)	DBH (cm)	Crown Class	Crown Aspect	Crown Ratio	SULE Rating	SRIV Rating
8	5	30	C	EAST	P 40%	3d	MLVF-4
Fair health, vigour, shape and structure. Crown bias to the east due to crowded growing conditions. Tree appears to be drought affected. Crown ratio is 40%. Health of tree could be improved with long-term tree care program. Low retention value. Consider removal.						TPZ 3.6	SRZ 2.0

This tree is located in Lot 21 of the proposed subdivision. Given that this tree is only suitable for short-term retention, it is my opinion this tree should be removed and replaced with a new tree at a suitable location within the proposed subdivision.

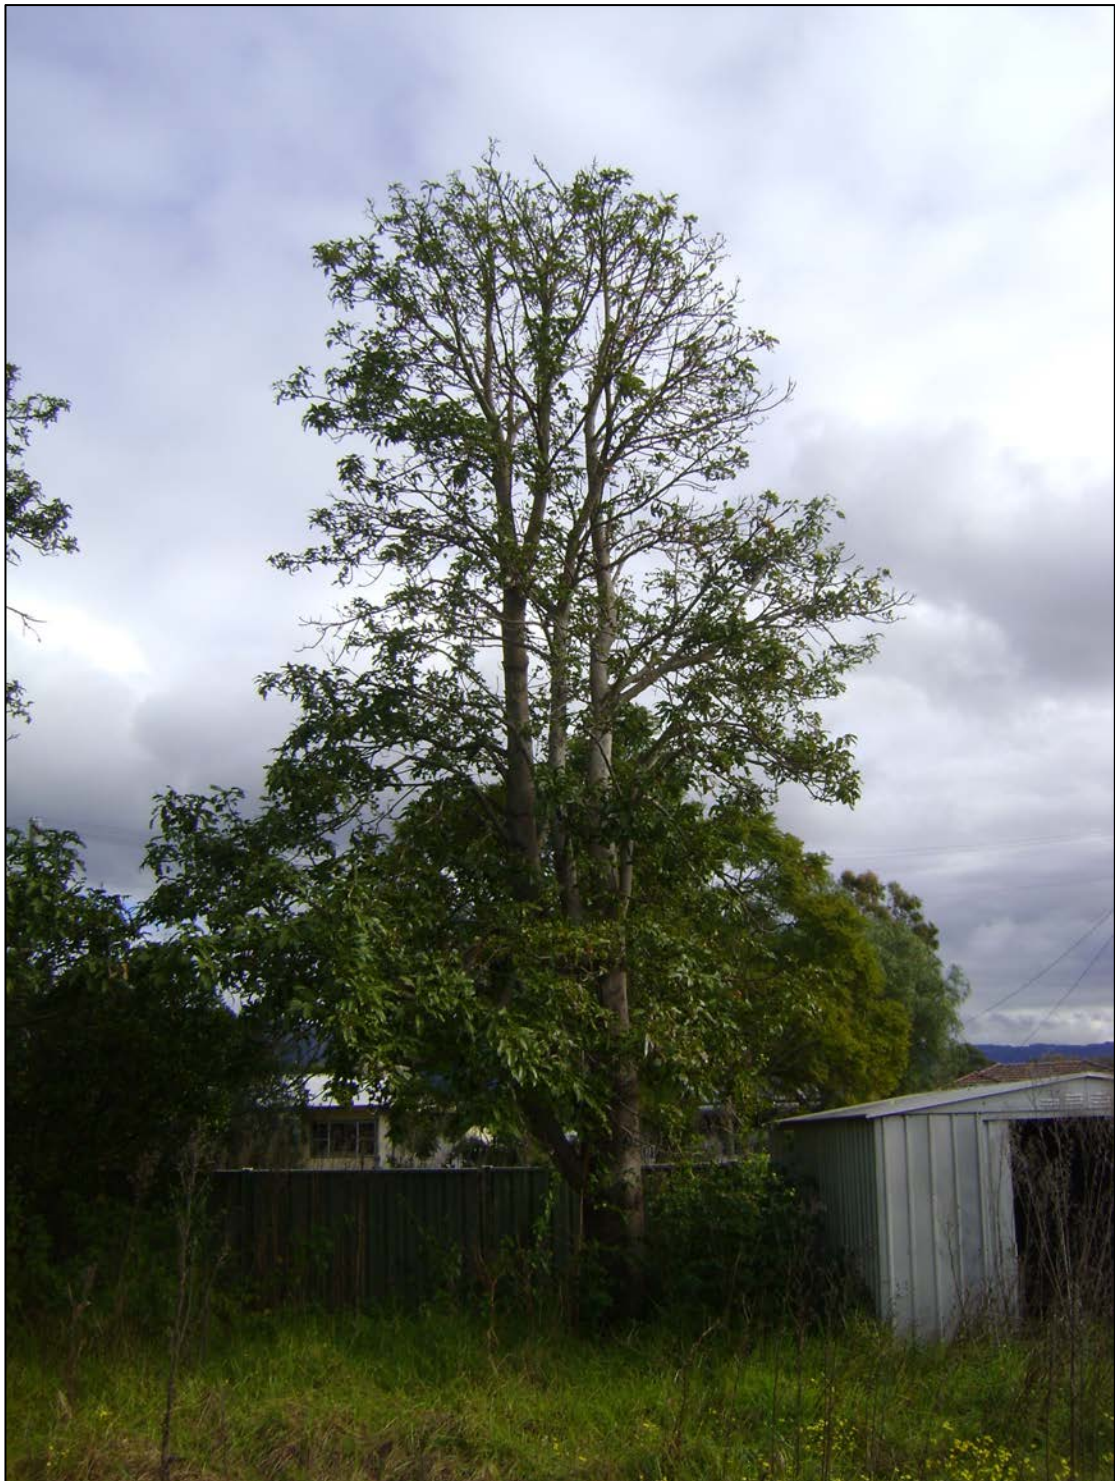
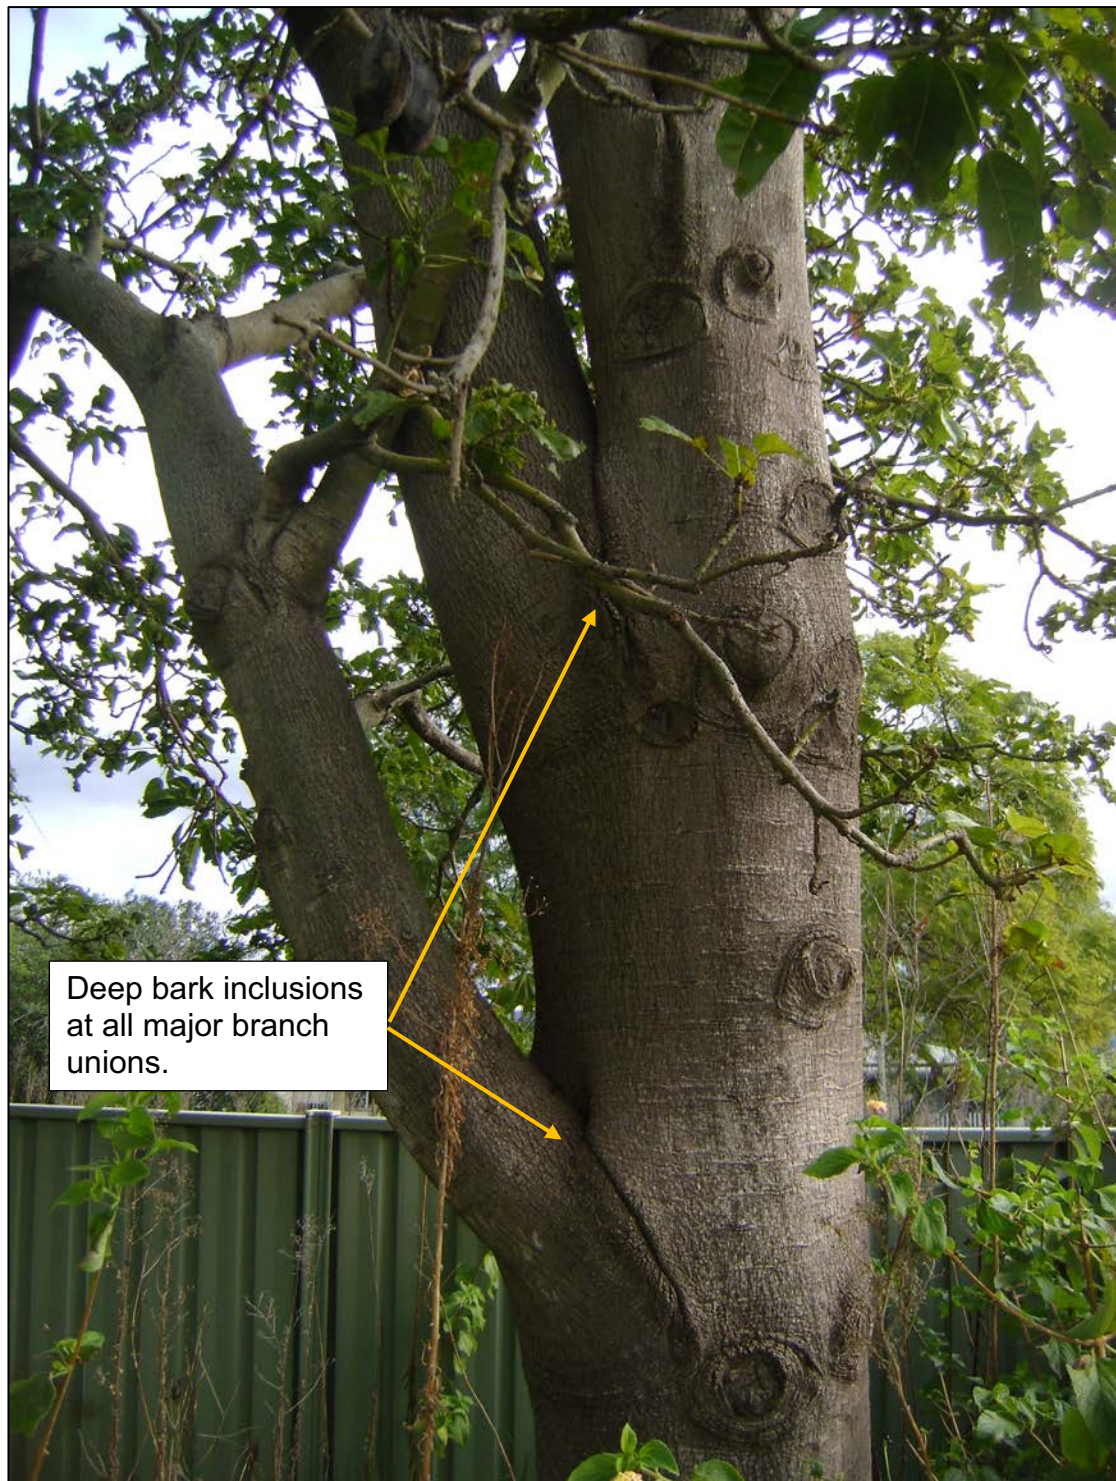
**Photo 9 – Tree 6 – *Brachychiton acerifolius* (Illawarra Flame Tree)**

This is an over-mature tree that displays poor health, vigour, shape and structure. The tree crown has sparse foliage (crown ratio is less than 15%). There are significant bark inclusions at the major trunk and branch unions throughout the tree. This tree has potential for major limb failure and is nearing death. It is suggested for removal.

Tree #	Botanic Name			Common Name			Age Class
6	Brachychiton acerifolius			Illawarra Flame Tree			O
Height (m)	Spread (m)	DBH (cm)	Crown Class	Crown Aspect	Crown Ratio	SULE Rating	SRIV Rating
10	5	48	D	SYM	S < 15%	4a	OLVP-0
Over-mature tree with poor health, vigour, shape and structure. Sparse foliage (crown ratio is less than 15%). Major bark inclusions at major trunk and branch unions throughout tree. Potential for major limb failure. Low retention value. Tree is nearing death. Suggest removal.						TPZ	SRZ

Note: Sparse crown development. This aged tree is in decline.

This tree is located in the middle of Lot 23 of the proposed subdivision. This tree should be removed and replaced with a new tree at a suitable location within the proposed subdivision.

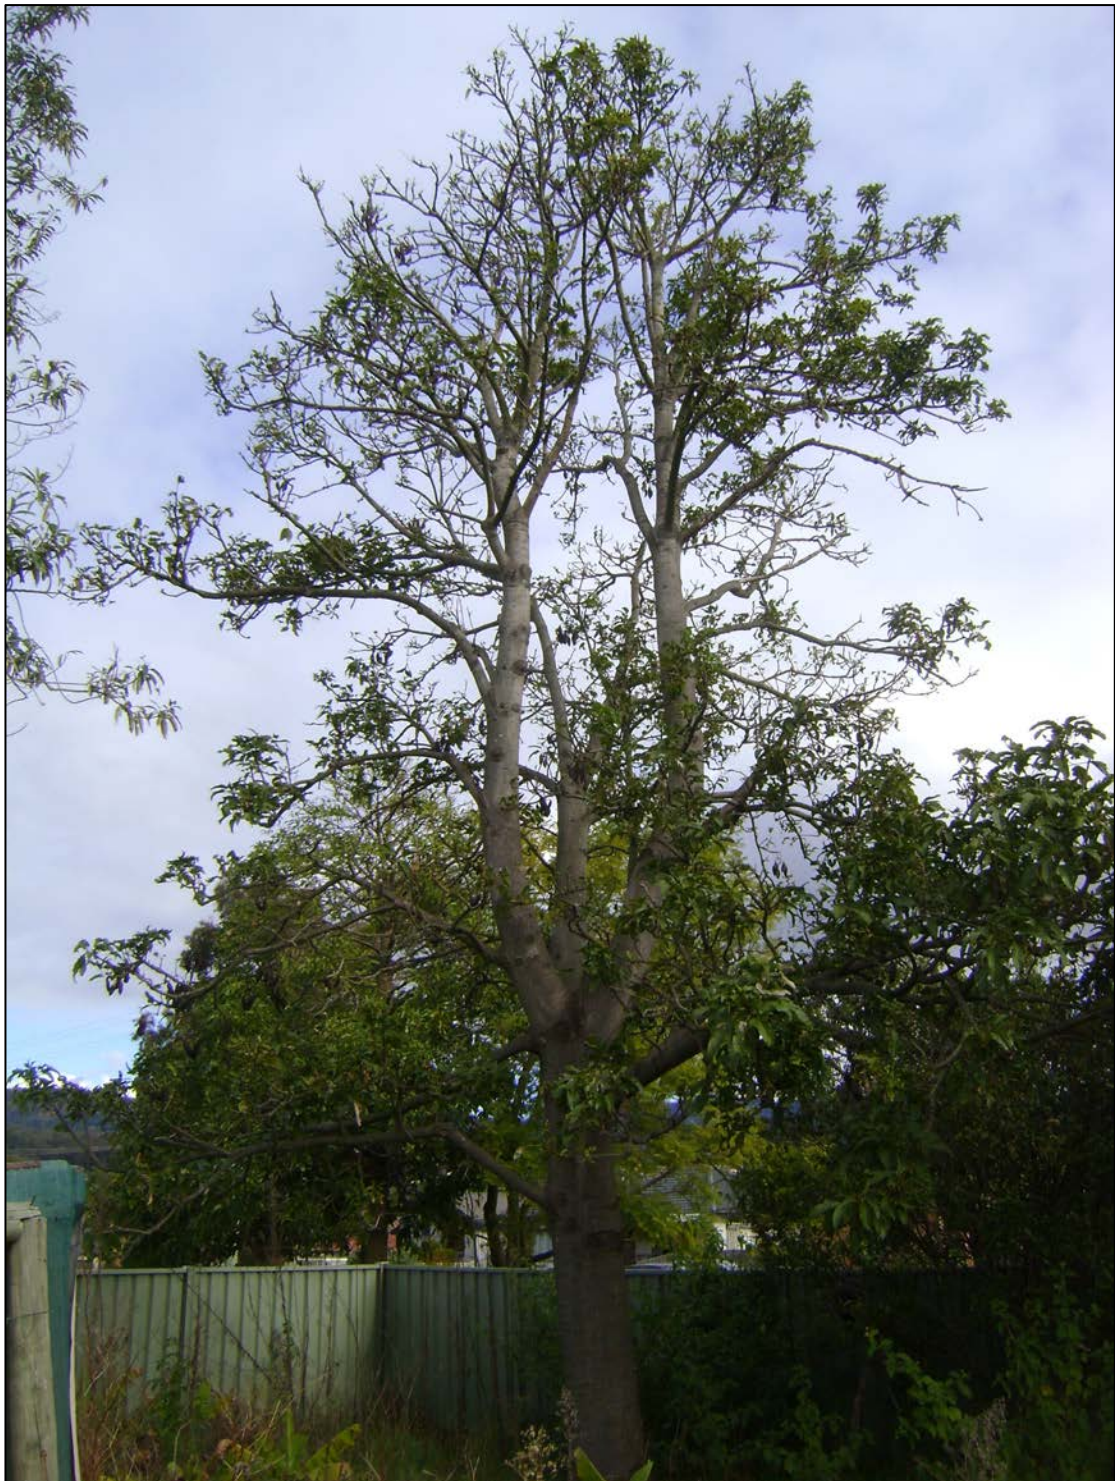
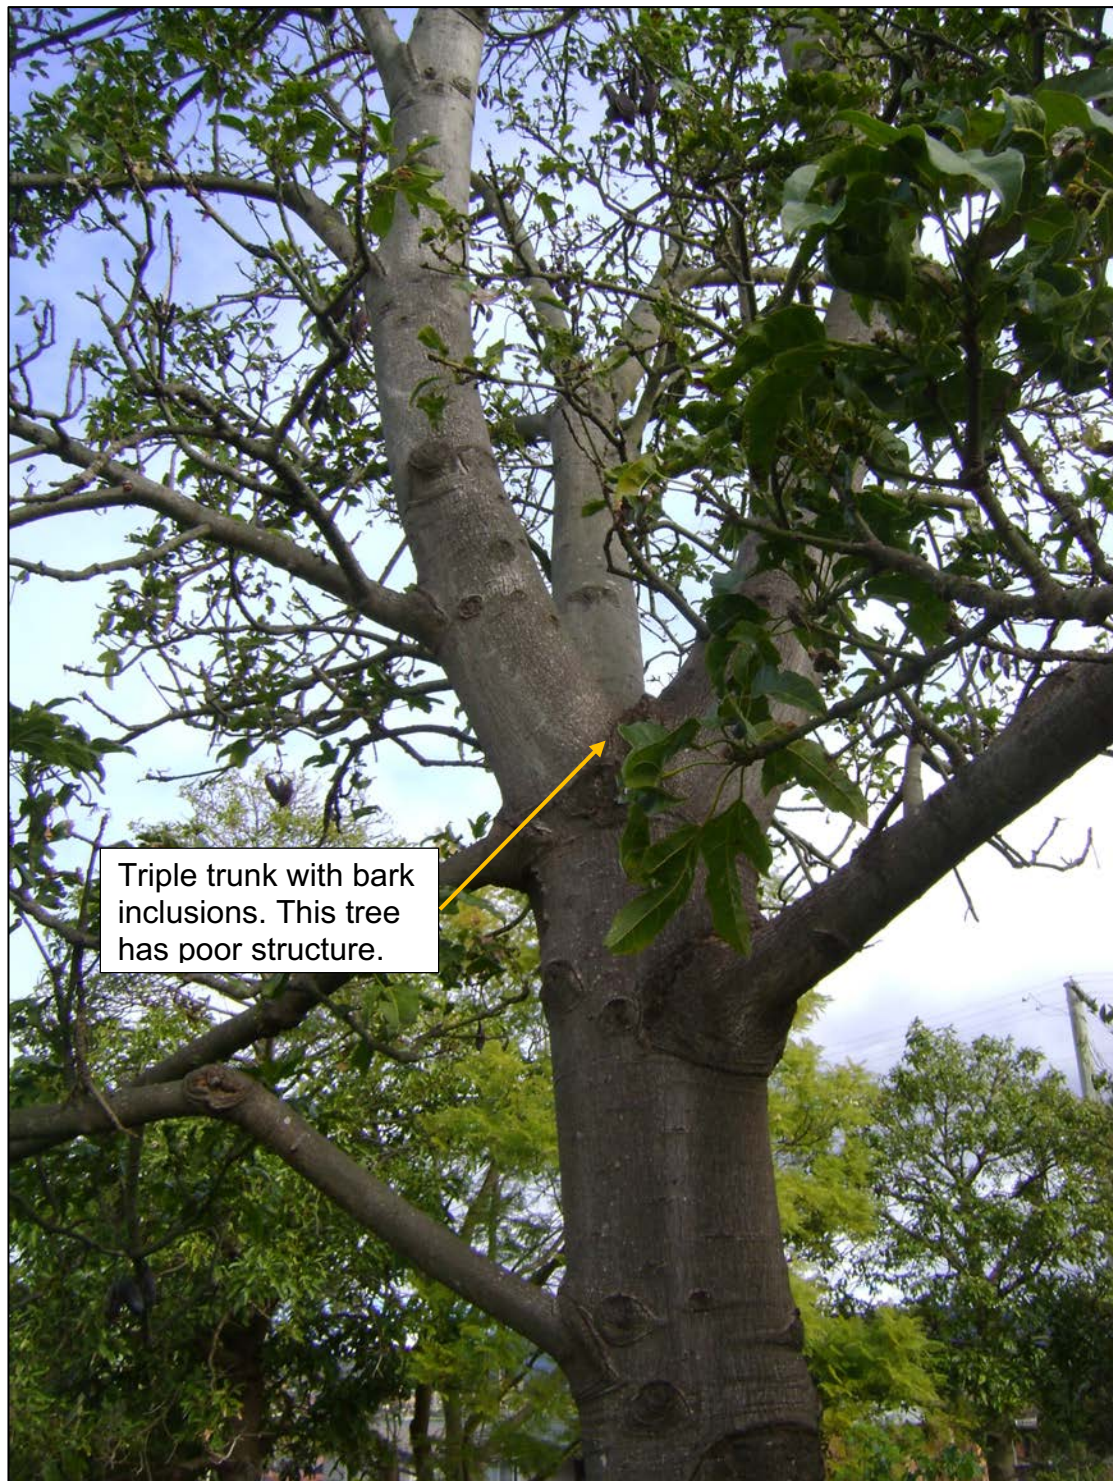
**Photo 11 – Tree 7 – *Brachychiton acerifolius* (Illawarra Flame Tree)**

This is an over-mature tree that displays poor health, vigour, shape and structure. The tree crown has sparse foliage (crown ratio is less than 15%). This tree has a triple-trunk at a height of 4m above existing ground level. Previous branch failures were noted at the time of tree inspection. Similar to Tree 6, this tree is nearing death. It is suggested for removal.

5.8	2.5
Tree #	Botanic Name			Common Name			Age Class
7	Brachychiton acerifolius			Illawarra Flame Tree			O
Height (m)	Spread (m)	DBH (cm)	Crown Class	Crown Aspect	Crown Ratio	SULE Rating	SRIV Rating
10	5	39	D	SYM	S < 15%	4a	OLVP-0
Over-mature tree with poor health, vigour, shape and structure. Sparse foliage (crown ratio is less than 15%). Triple trunk @4m. Previous branch failures. Low retention value. Tree is nearing death. Suggest removal.						TPZ	SRZ

Note: Sparse crown development. This aged tree is in decline.

This tree is located within Lot 23 of the proposed subdivision. This tree should be removed and replaced with a new tree at a suitable location within the proposed subdivision.

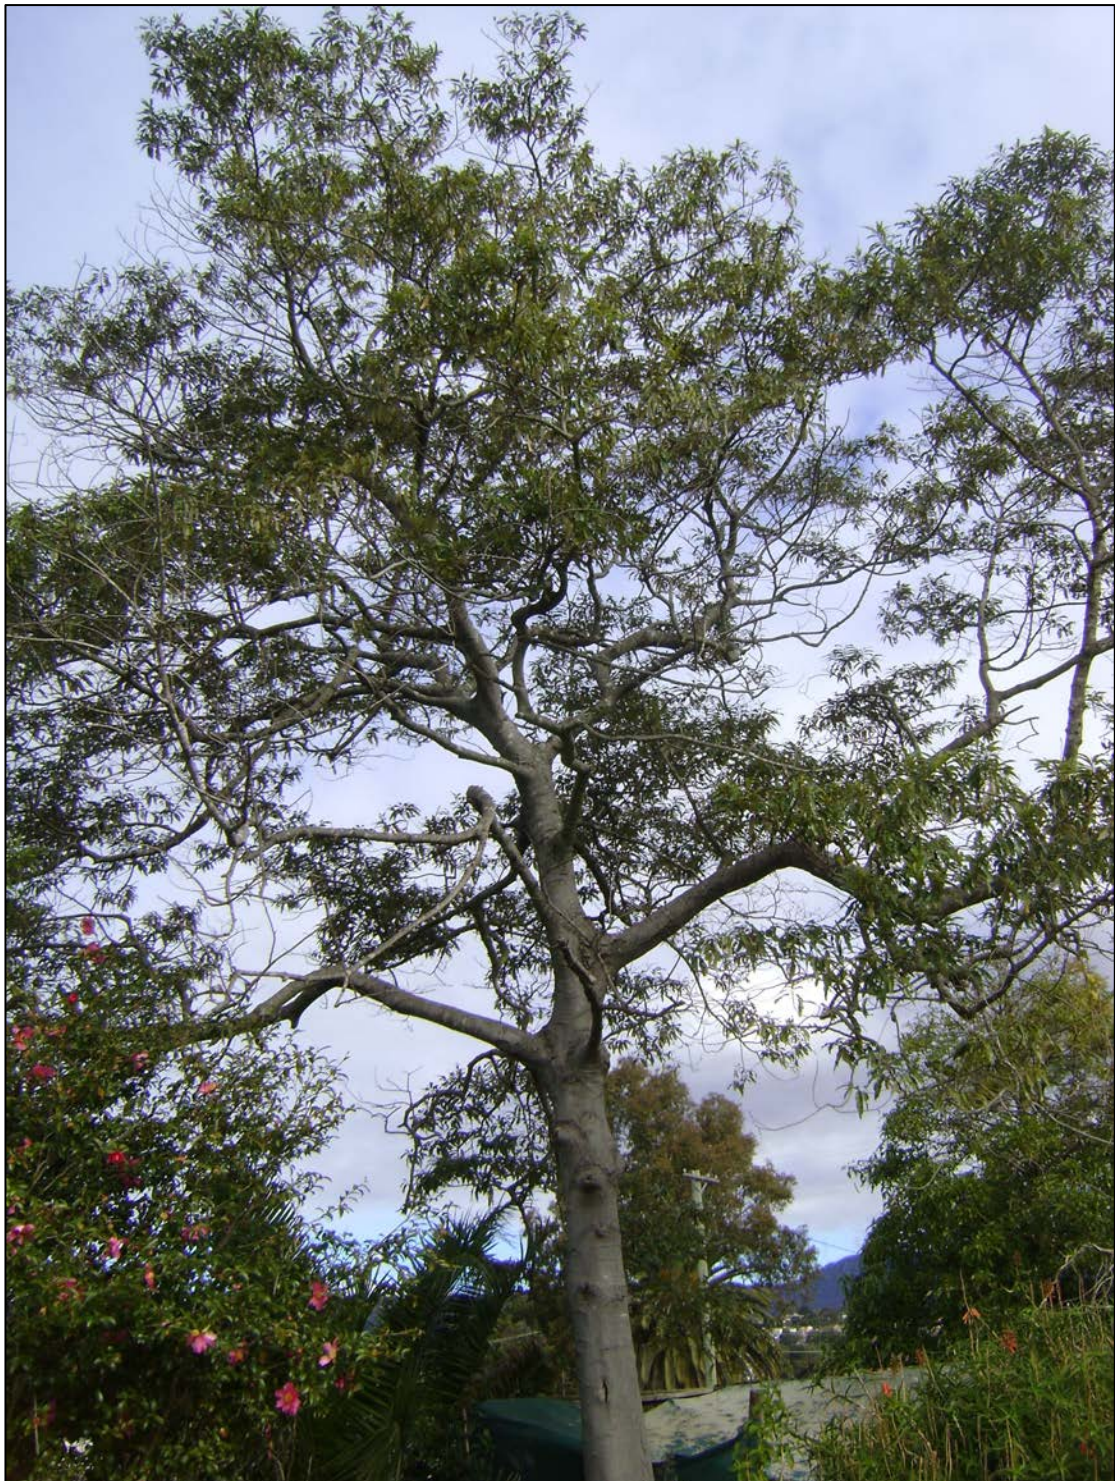
**Photo 13 – Tree 8 – *Alphitonia excelsa* (Red Ash)**

This is an over-mature tree that displays poor health and vigour. Shape and structure are best described as fair. There is a history of previous branch failures. Dieback of branches in the lower half of crown is clearly visible. Foliage within the tree crown is sparse (crown ratio is less than 20%). Similar to Trees 6 & 7, this tree is nearing death. It is suggested for removal.

4.7	2.3
Tree #	Botanic Name			Common Name			Age Class
8	Alphitonia excelsa			Red Ash			O
Height (m)	Spread (m)	DBH (cm)	Crown Class	Crown Aspect	Crown Ratio	SULE Rating	SRIV Rating
10	8	35	D	SYM	S < 20%	4a	OLVF-2
Over-mature tree that displays poor health and vigour. Fair shape and structure. Previous branch failures. Dieback of branches in lower half of crown. Low retention value. Tree is nearing death. Suggest removal.						TPZ	SRZ

Note: Sparse crown development. This aged tree is in decline.

This tree is located within Lot 24 of the proposed subdivision. This tree should be removed and replaced with a new tree at a suitable location within the proposed subdivision.

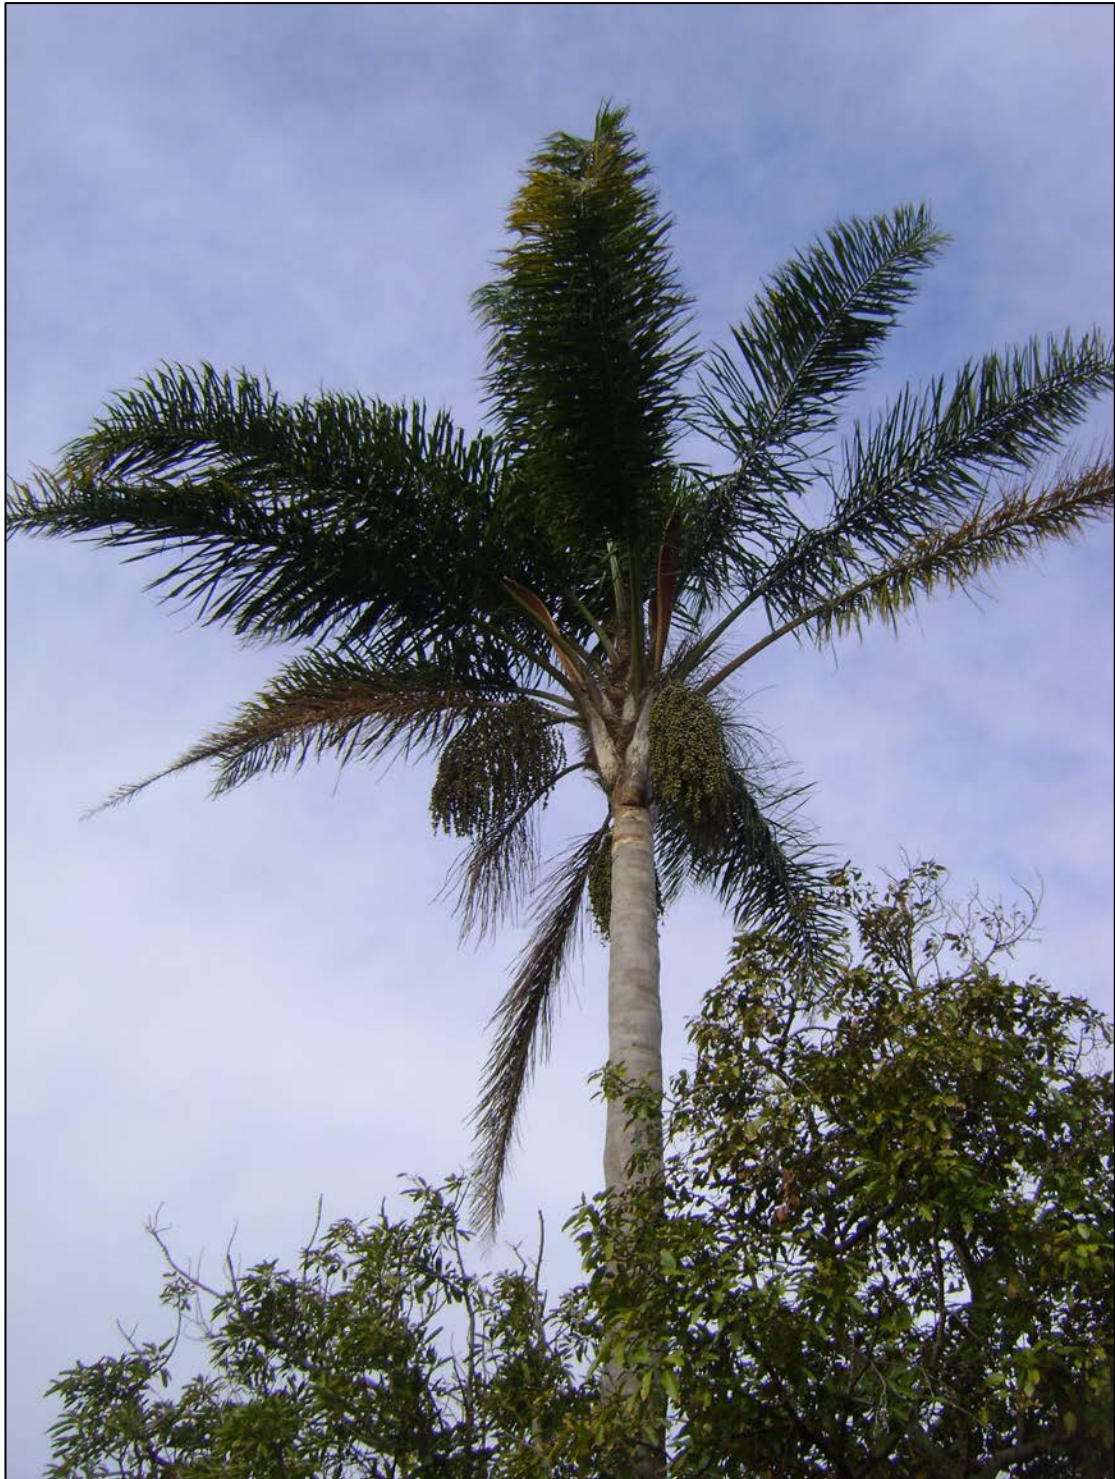
**Photo 14 – Tree 9 – *Syagrus romanzoffiana* (Queen or Cocos Palm)**

This palm tree displays good health, vigour, shape and structure. The palm tree had no visible defects at the time of inspection. This tree is listed by Shellharbour City Council as an exempt tree species. It should be considered for removal.

This tree has been given a SULE rating of 2b and SRIV rating of MGVG-10. These high tree retention ratings reflect the current condition of this tree. They do not reflect the exempt status of this tree.

4.2	2.3
Tree #	Botanic Name			Common Name			Age Class
9	Syagrus romanzoffiana			Queen or Cocos Palm			M
Height (m)	Spread (m)	DBH (cm)	Crown Class	Crown Aspect	Crown Ratio	SULE Rating	SRIV Rating
12	4	30	D	SYM	F	2b	MGVG-10
Palm tree that displays good health, vigour, shape and structure. No visible defects. Exempt species. Low retention value. Consider removal.						TPZ	SRZ

Note: This tree is listed as an exempt species.

This tree is located within Lot 24 of the proposed subdivision. If this tree is removed, then it should be replaced with a new tree at a suitable location within the proposed subdivision.
