# **ARBORICULTURAL IMPACT ASSESSMENT**

**14 HAMILTON ROAD  
ALBION PARK NSW 2527**

Prepared for LandTeam Australia Pty Ltd

**JULY 2019**

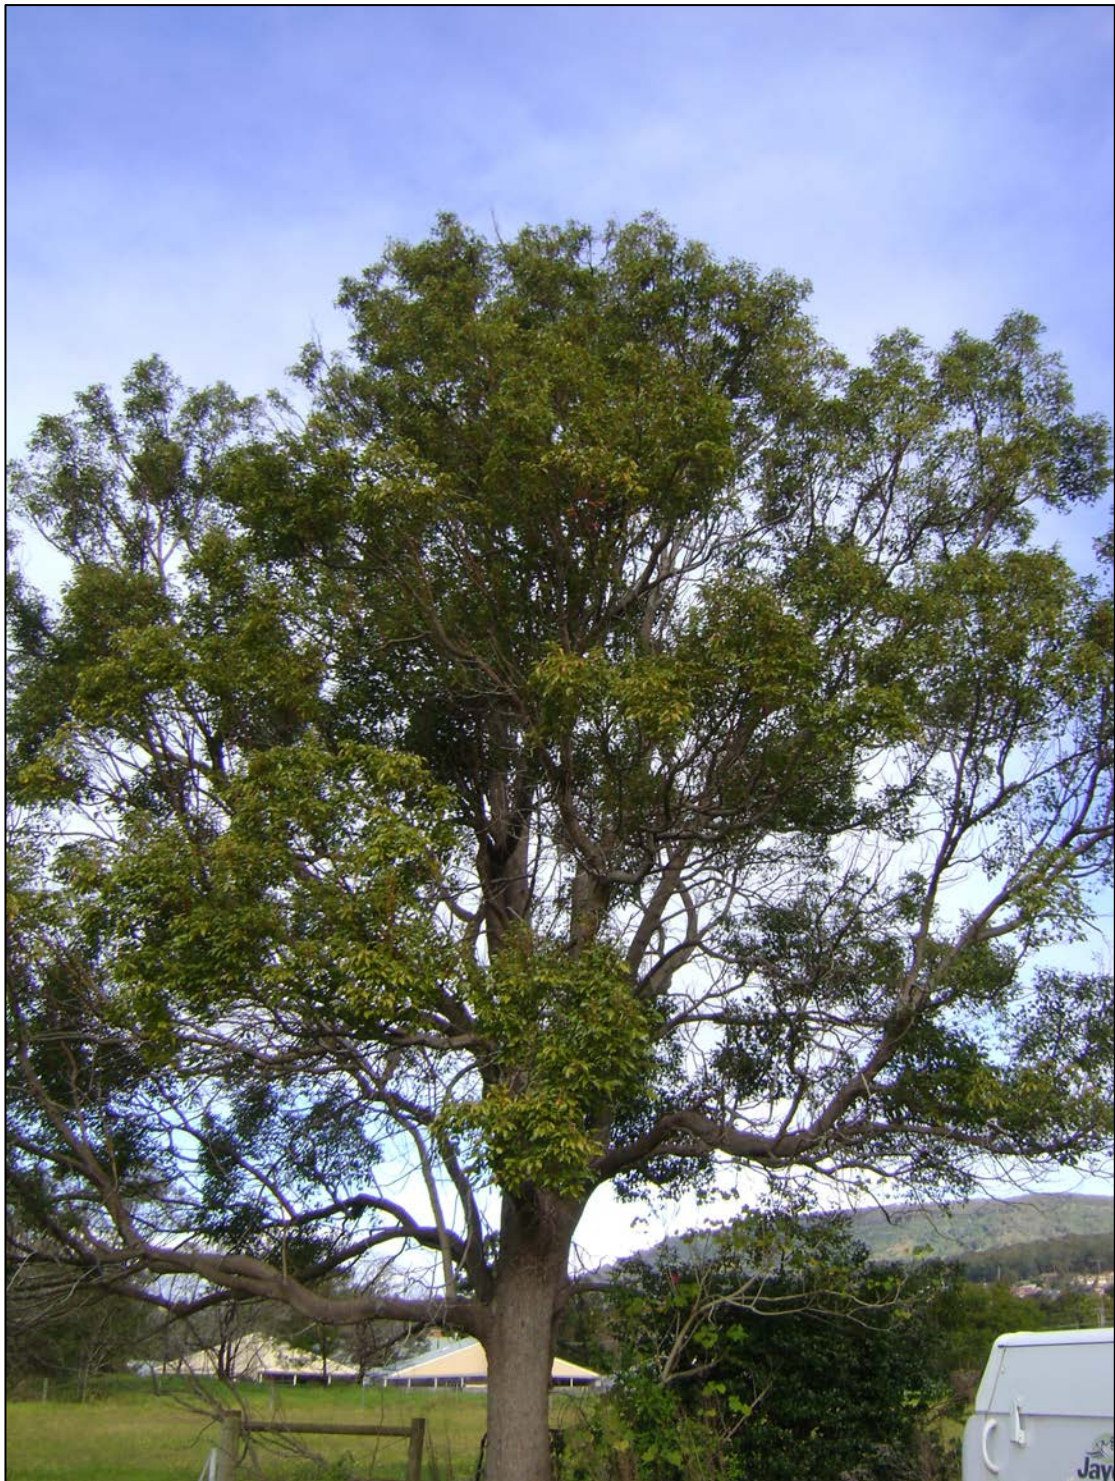
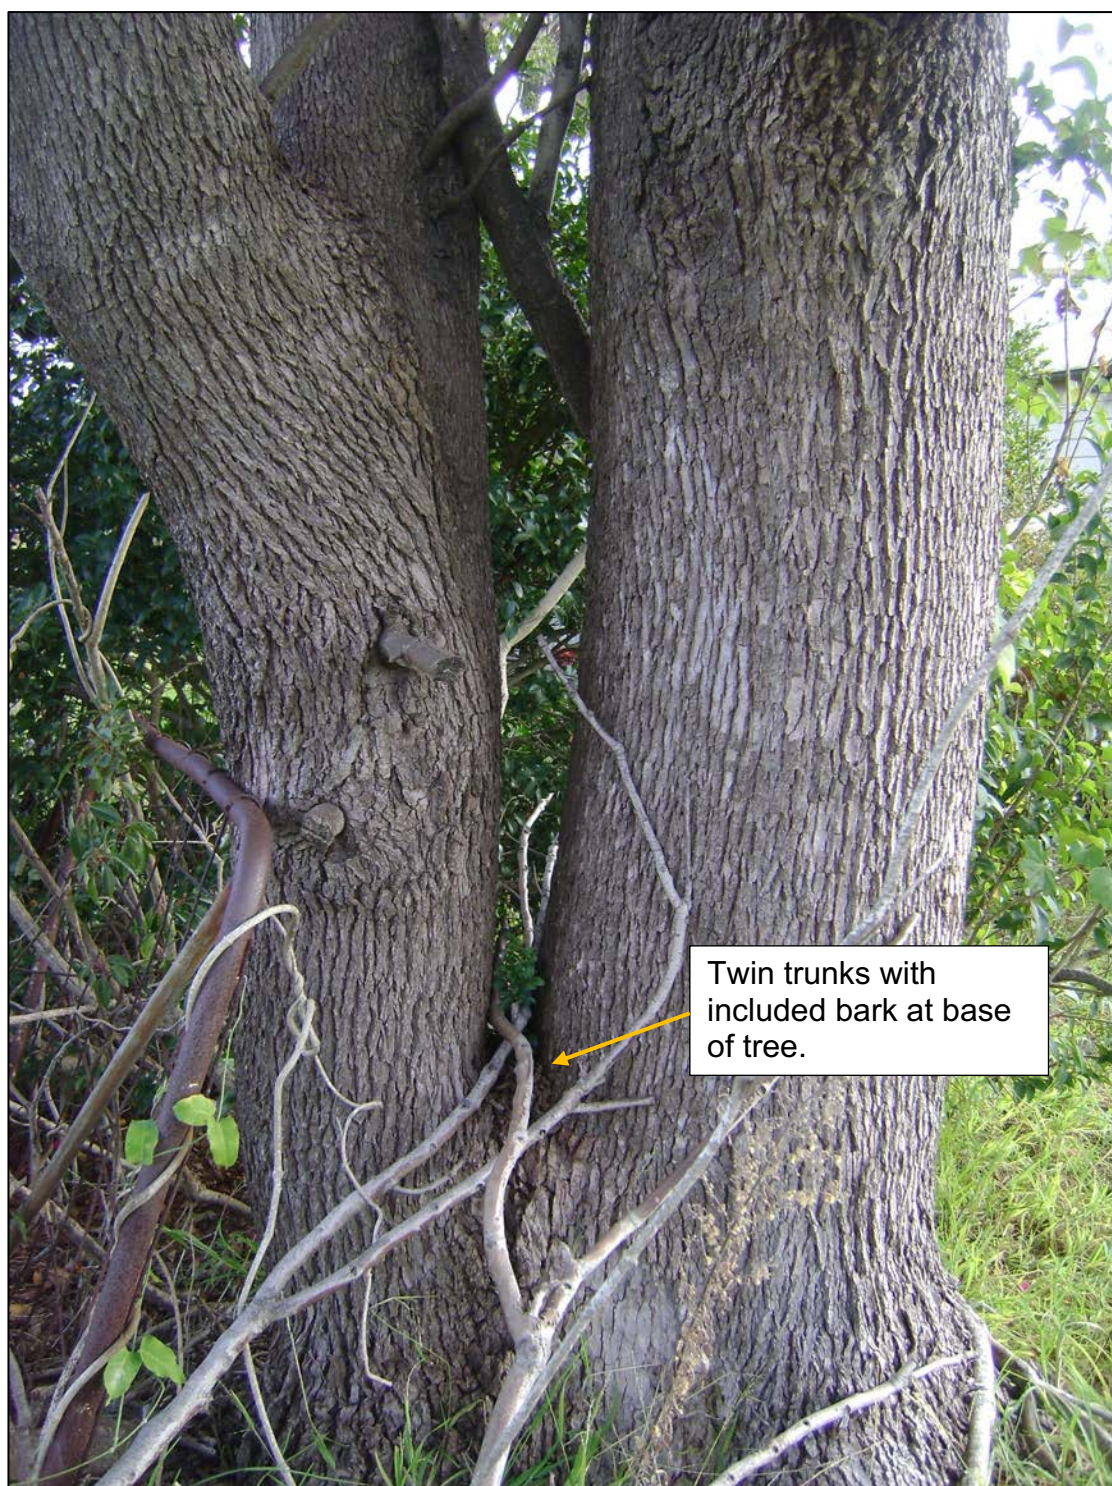
**Photo 15 – Tree 10 – *Cinnamomum camphora* (Camphor Laurel)**

This over-mature tree displays poor health, vigour, shape and structure. This tree is an exempt species that is clearly in decline. There is major dieback of branches and a history of multiple branch failures. It has a bifurcated trunk at a height of 0.5m above existing ground level. This tree is potentially dangerous. This tree is suggested for removal.

3.6	2.0
Tree #	Botanic Name			Common Name			Age Class
10	Cinnamomum camphora			Camphor Laurel			O
Height (m)	Spread (m)	DBH (cm)	Crown Class	Crown Aspect	Crown Ratio	SULE Rating	SRIV Rating
12	12	67 twin-trunk	D	SYM	S < 15%	4a	OLVP-0
Aged tree that displays poor health, vigour, shape and structure. Major dieback of branches. Multiple branch failures. Tree is in decline. Bifurcated trunk @ 0.5m. Tree is potentially dangerous. Low retention value. Suggest removal.						TPZ	SRZ

Note: This tree is listed as an exempt species.

This tree is located within Lot 17 of the proposed subdivision. If this tree is removed, then it should be replaced with a new tree at a suitable location within the proposed subdivision.

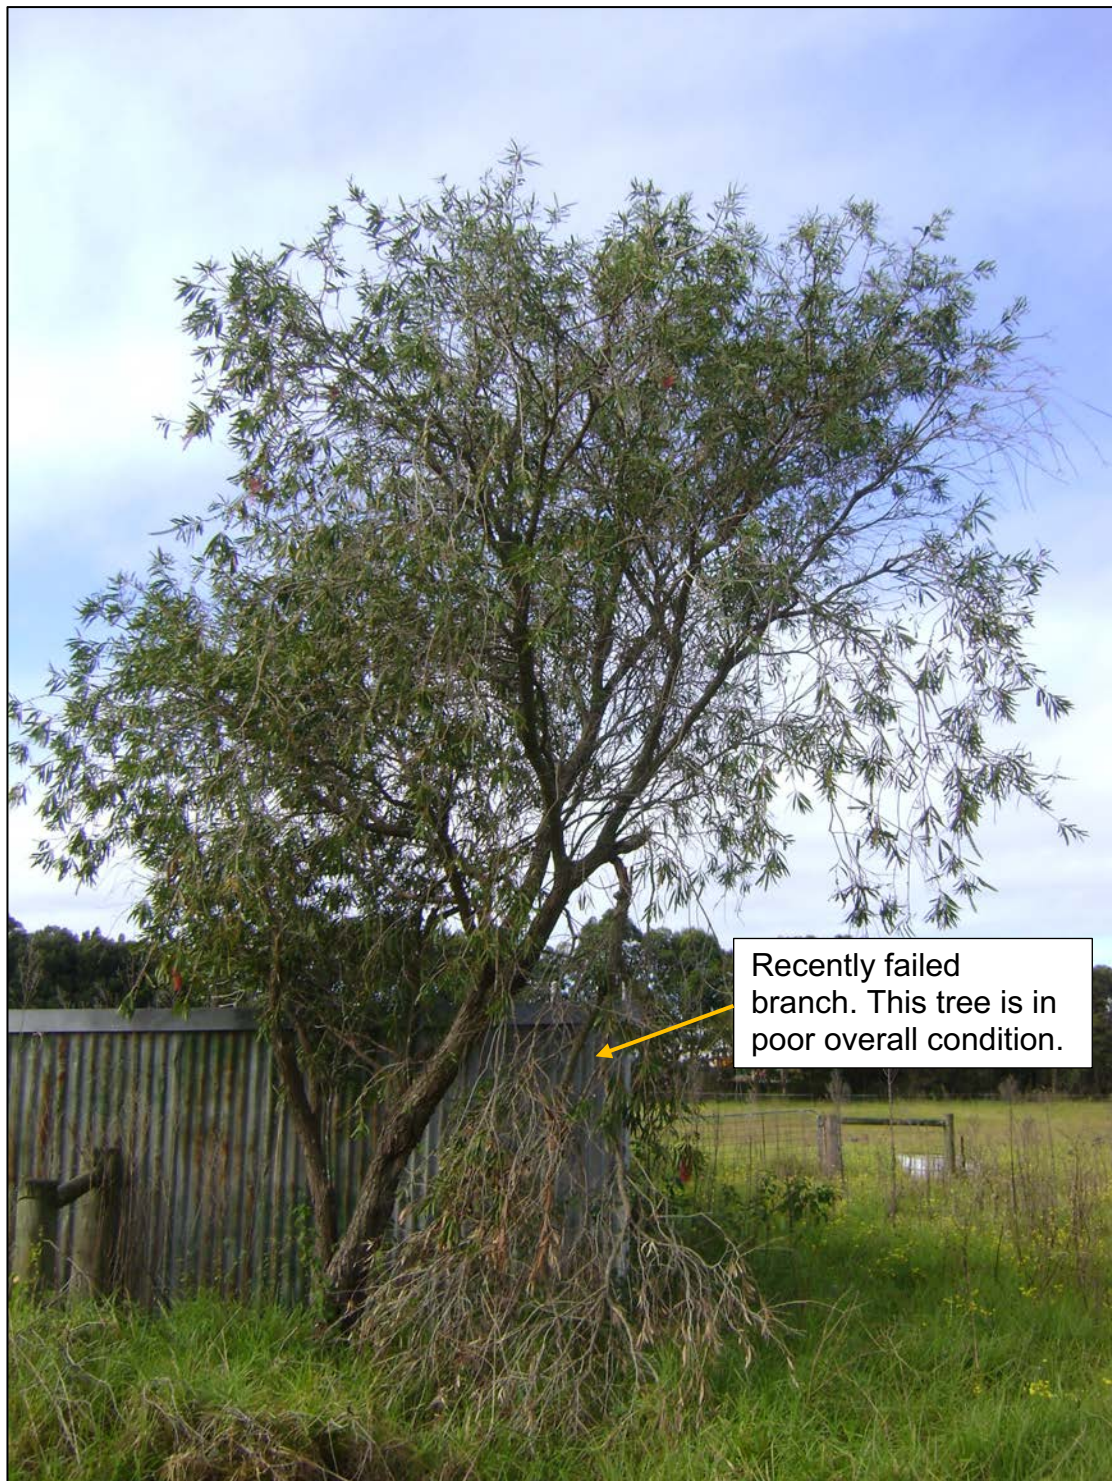
**Photo 17 – Tree 11 – *Callistemon salignus* (Crimson Bottlebrush)**

This over-mature tree displays poor health, vigour, shape and structure. This is a twin-trunked tree that is aged and in poor condition. There is included bark at the major trunk union and recent branch failure. In my opinion, this tree is beyond remediation. Therefore, it is suggested for removal.

This tree has been given a SULE rating of 4a and SRIV rating of OLVP-0. These low tree retention ratings reflect the current condition of this tree.

Tree #	Botanic Name			Common Name			Age Class
11	Callistemon citrinus			Crimson Bottlebrush			O
Height (m)	Spread (m)	DBH (cm)	Crown Class	Crown Aspect	Crown Ratio	SULE Rating	SRIV Rating
5	5	20 twin-trunk	D	SYM	S 30%	4a	OLVP-2
Aged tree that displays poor health, vigour, shape and structure. Twin-trunked tree with included bark at trunk union. Recent branch failure. Tree is beyond remediation. Low retention value. Suggest removal.						TPZ	SRZ
						2.4	1.9

This tree is located on the proposed boundary that separates Lots 25 & 26 of the proposed subdivision. If this tree is removed, then it should be replaced with a new tree at a suitable location within the proposed subdivision.
