**STRUCTURAL REPORT ON**

**THE QUEEN MARY BUILDING**  
**AT ROYAL PRINCE ALFRED HOSPITAL**

**FOR**  
**GALE PLANNING GROUP**

**Report No.** 9843-ST-01  
**Revision:** 1  
**Date** 23 November 2009

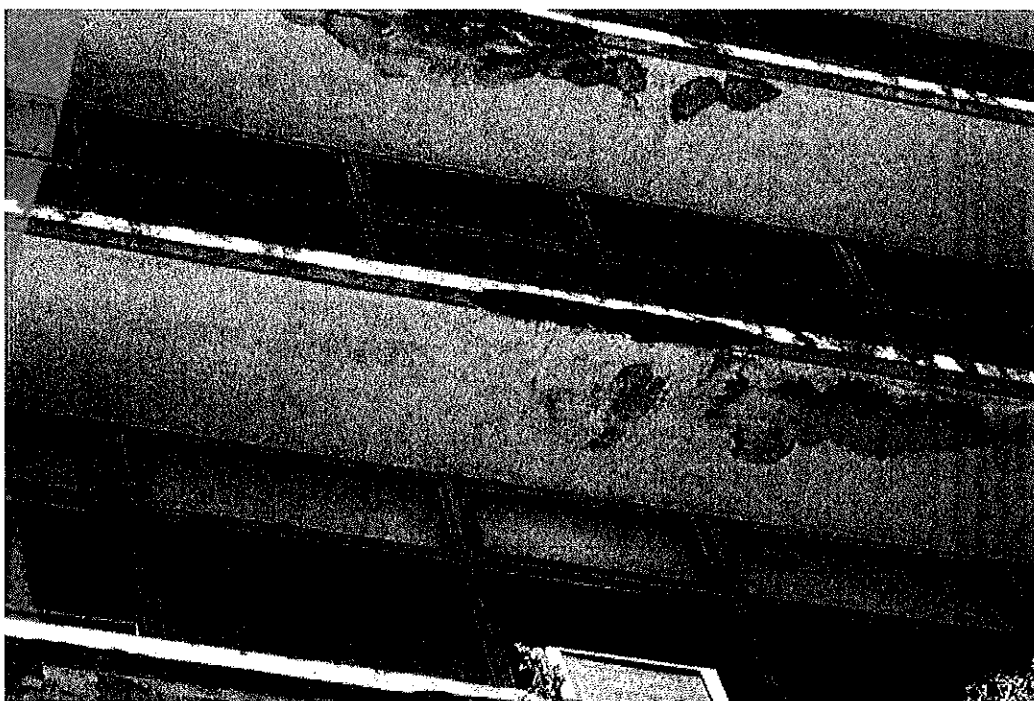
Significant corrosion of reinforcement was observed in the concrete elements exposed to the weather (e.g. balcony slabs). The corrosion of the reinforcement has lead to significant spalling of the cover concrete (refer to Photos 8, 9 and 10 in Appendix A). The balconies need to be investigated further to determine the extent and severity of the corrosion. The defective areas, if not extensive, may simply be repaired using typical concrete repair methods. If the corrosion is found to be extensive, it may be simpler and more beneficial to demolish the balconies and replace them with new structure as described in Section 4d above.

Photo 10: Concrete spalling and corrosion of reinforcement in sunhoods.

- c. Repair of existing concrete spalling and reinforcement corrosion will be necessary to prevent further deterioration and to prolong the service life of the building.

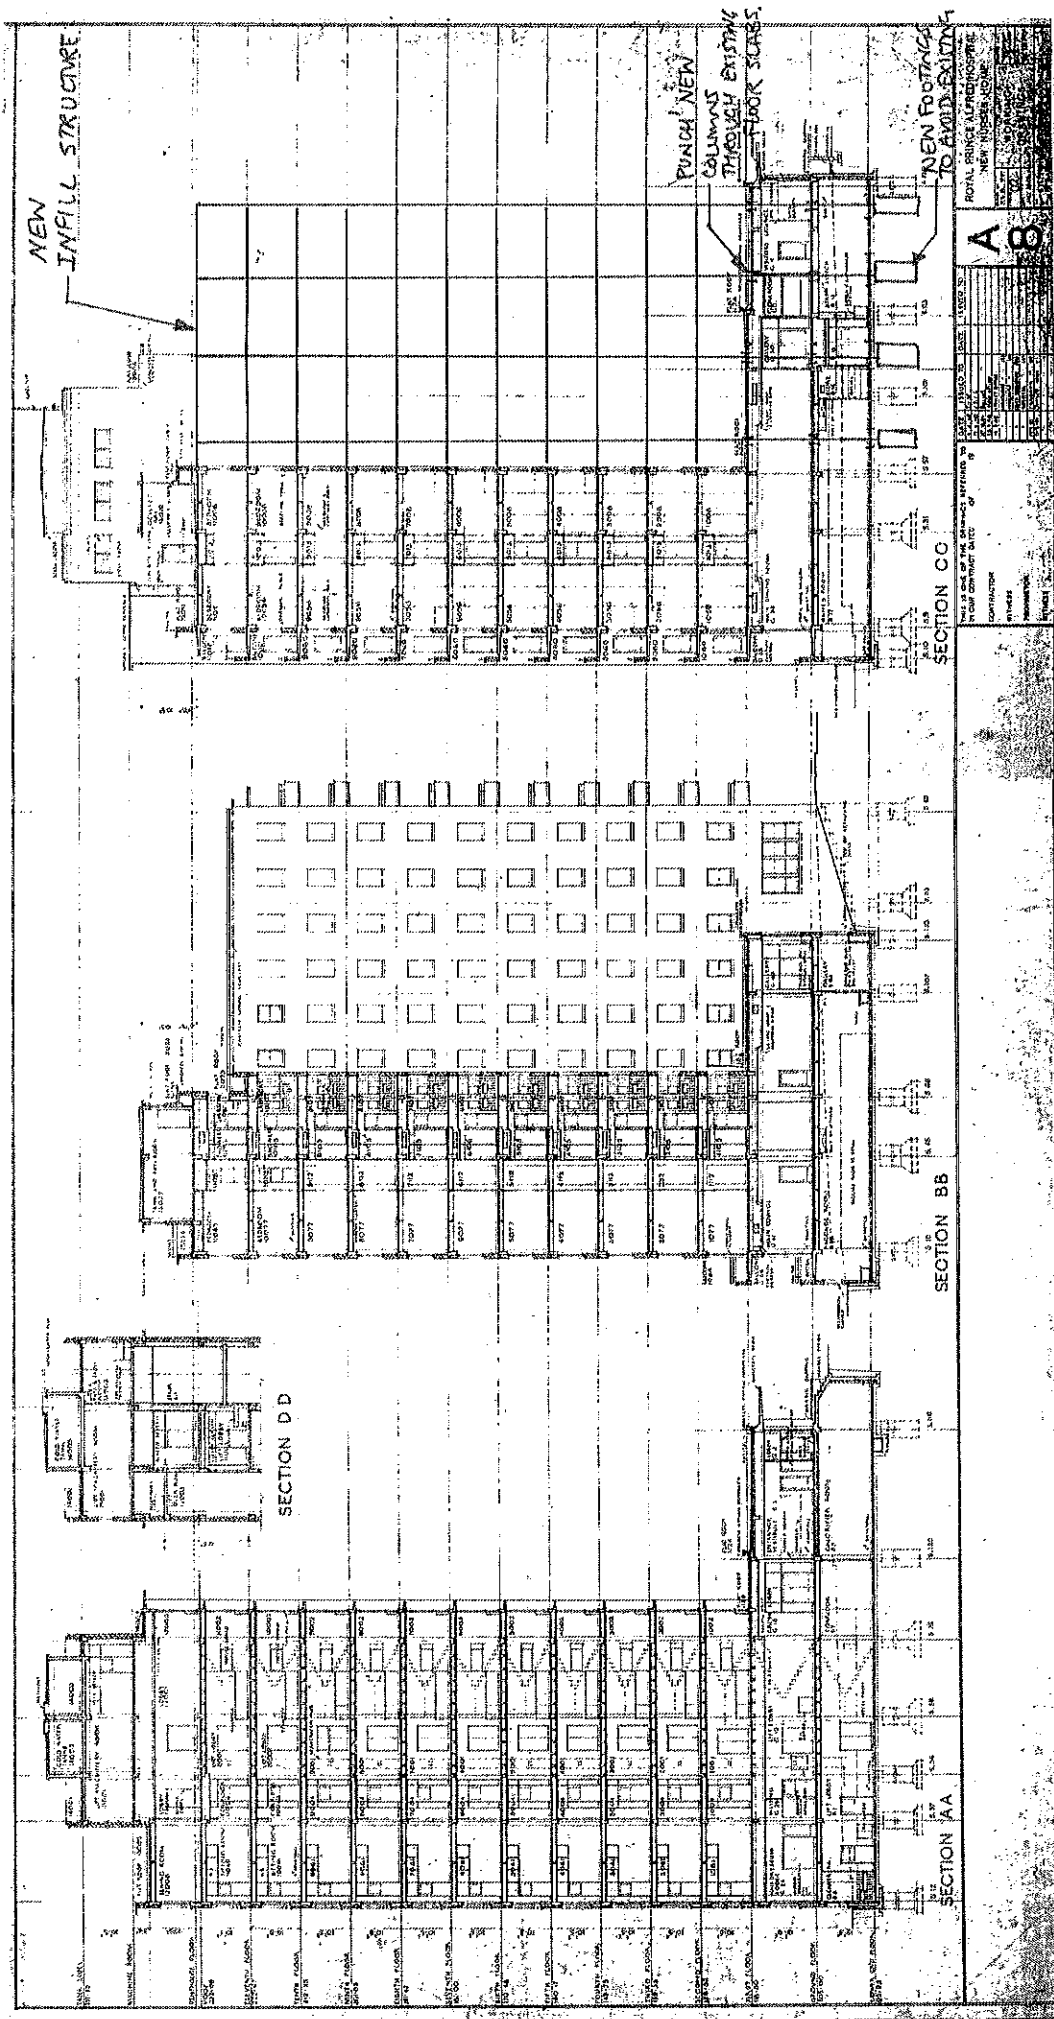
FIGURE 1.

- c. The proposed addition of structure to the south side of the building by way of infill on multiple levels to create larger floor plates is structurally feasible. There are two main options to achieve this (refer to Figures 1 and 2 in Appendix B). The first option is to install new columns that "punch" through the existing floors at lower ground floor, ground floor and first floor within the footprint of the infill floor plates. The new column positions would need to be structurally determined to avoid clashing with the existing columns, footings and floor beams. Whilst the existing floor structure can remain at lower ground floor, ground floor and first floor levels with this option, the

INFILL STRUCTURE  
OPTION ONE

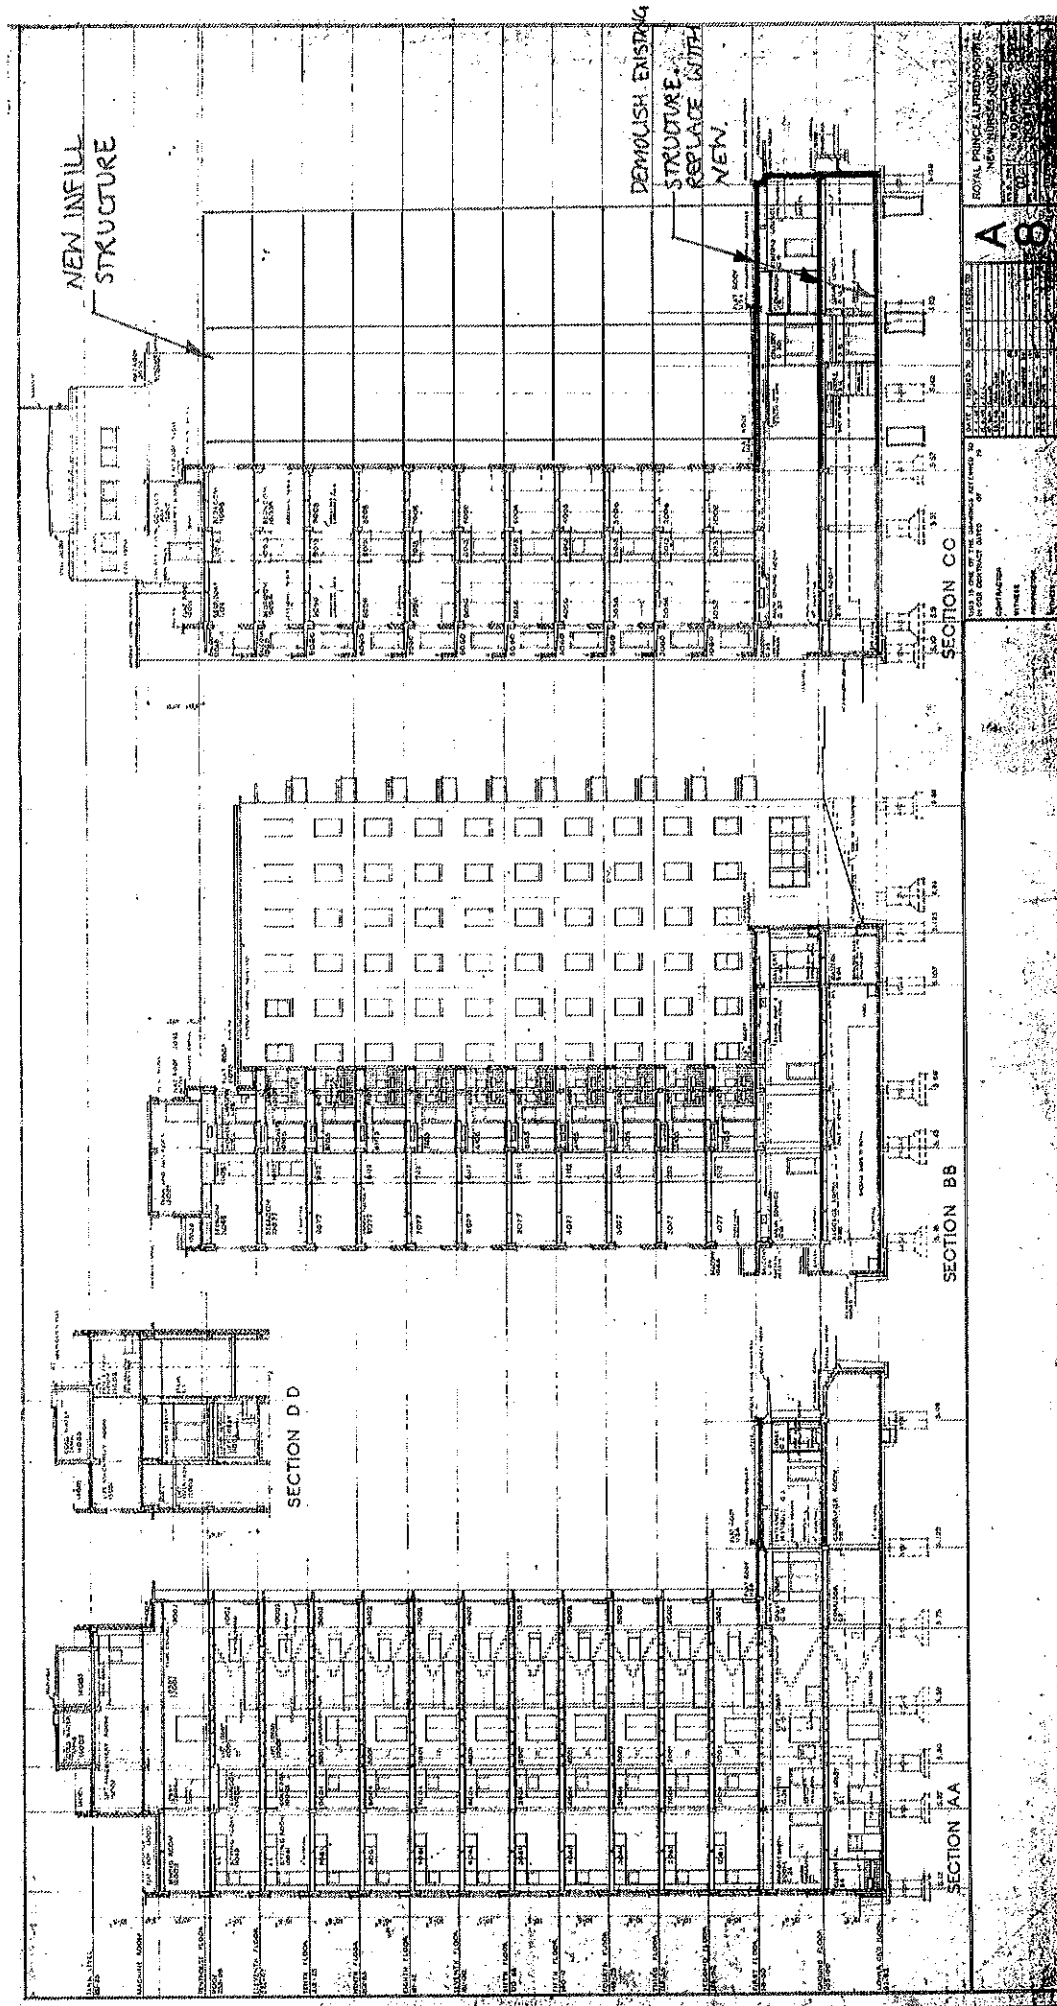
FIGURE 2.

The second option is to demolish the existing structure at lower ground floor, ground floor and first floor levels within the footprint of the infill floor plates and replace with new structure. The advantage of this option is more flexibility to locate the new columns in architecturally favourable positions.
