Elanora Country Club
PO Box 78
Narrabeen NSW 2101Project 85716.00
29 November 2016
R.001.Rev0
RKL:pc

**Preliminary Geotechnical Assessment
Elanora Country Club
Elanora Road, Elanora Heights****1. Introduction**

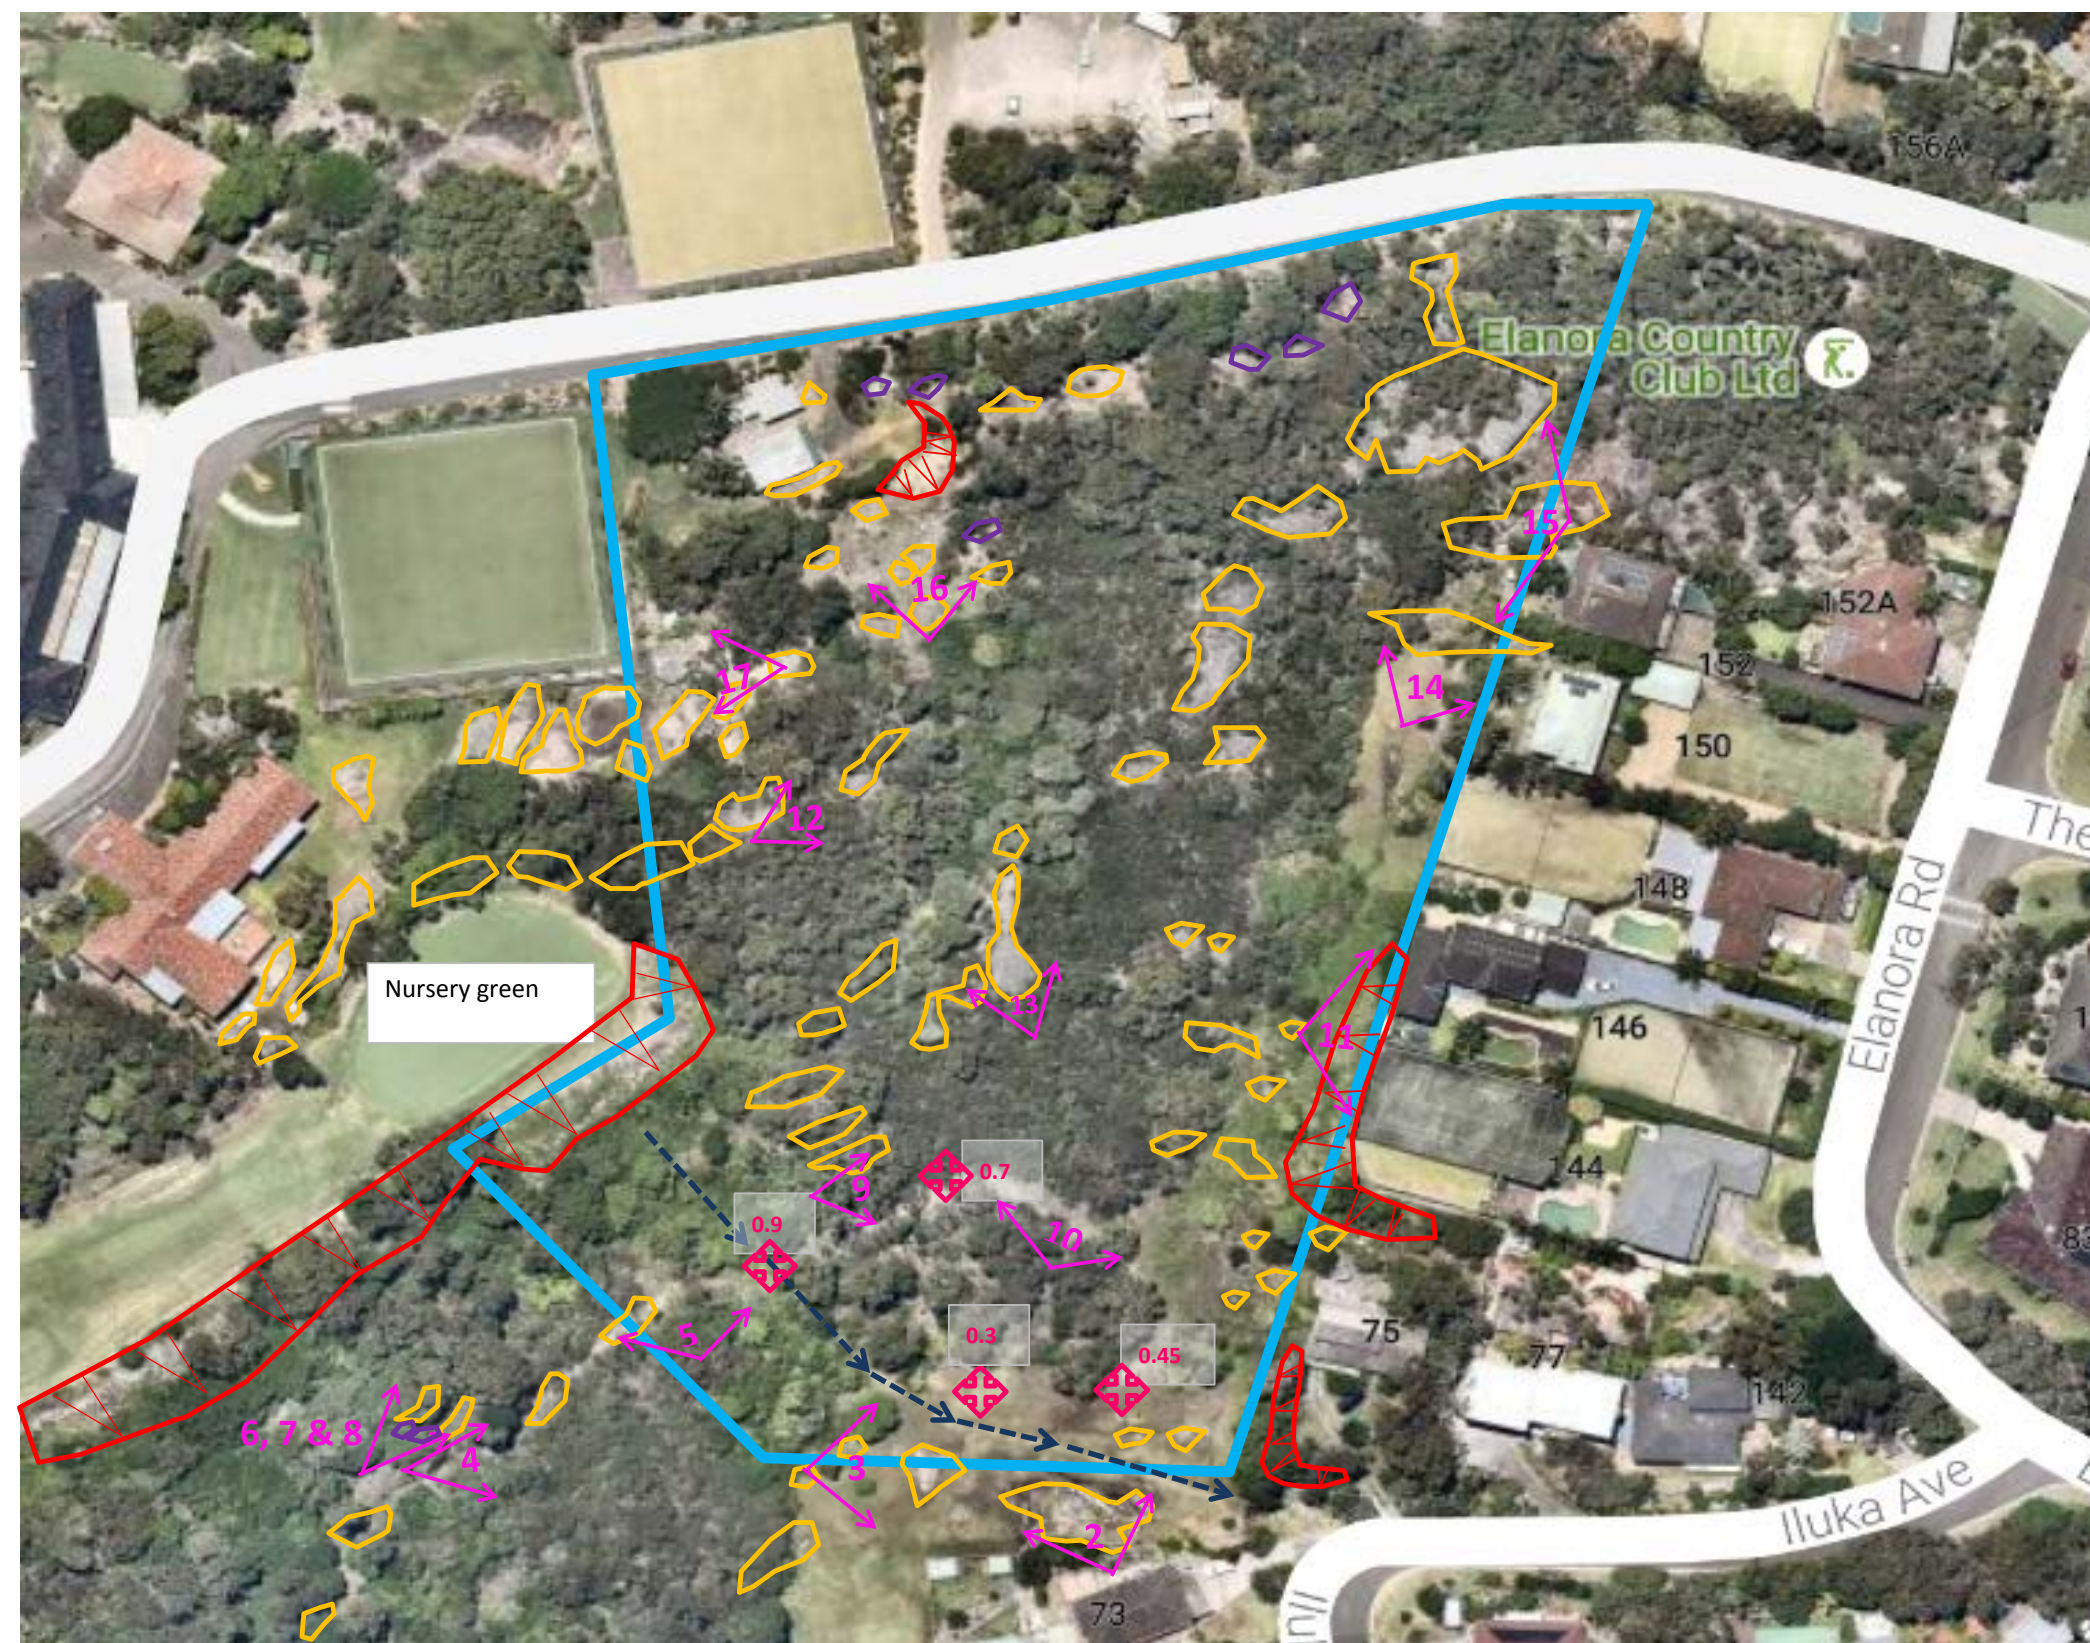
A number of test probes were also carried out across the lower, southern part of the development area (refer to Photo 1) and all encountered refusal at less than 1 m depth. The material inferred to overly bedrock was assessed as comprising typically very loose to loose sand.

The main areas of sandstone outcrop and larger detached blocks are shown on Plate 1, Photo 1.

Photo 1. Aerial view of the site showing approximate area of development.

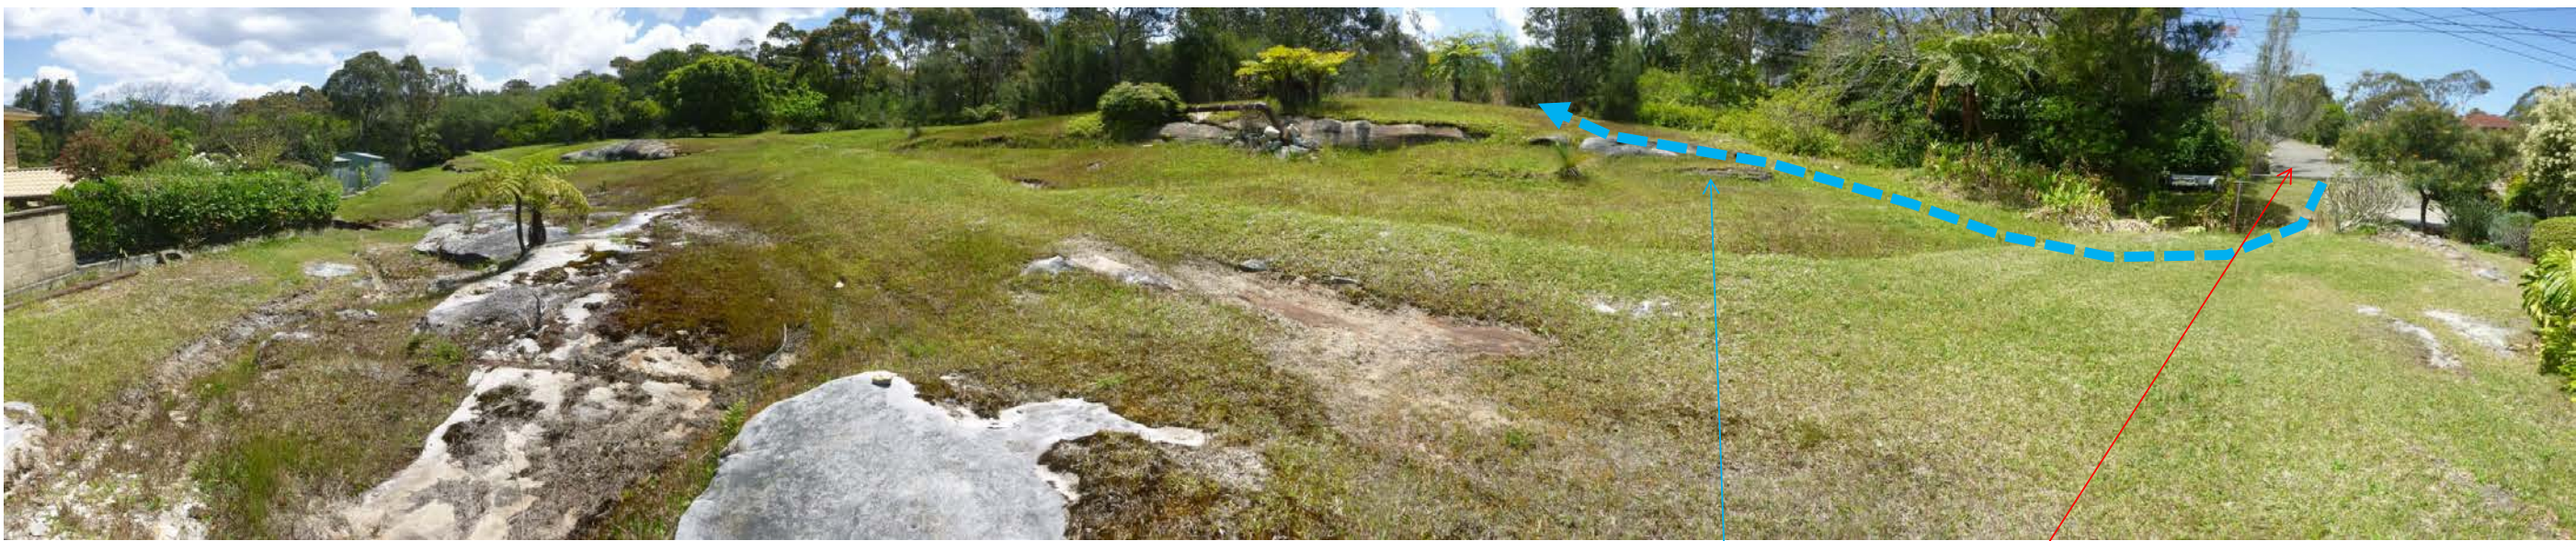
- minor groundwater seepage was observed at a number of locations along the top of rock and the southern portion of the site (refer to Photos 2 and 3) has only a shallow soil cover (typically less the 0.5 m) which test probes indicated were moist to wet.

Photo 2. Panorama of the lower, south-eastern portion of the site, viewed towards the north and showing the approximate location of proposed access road from the bend in Iluka Avenue.

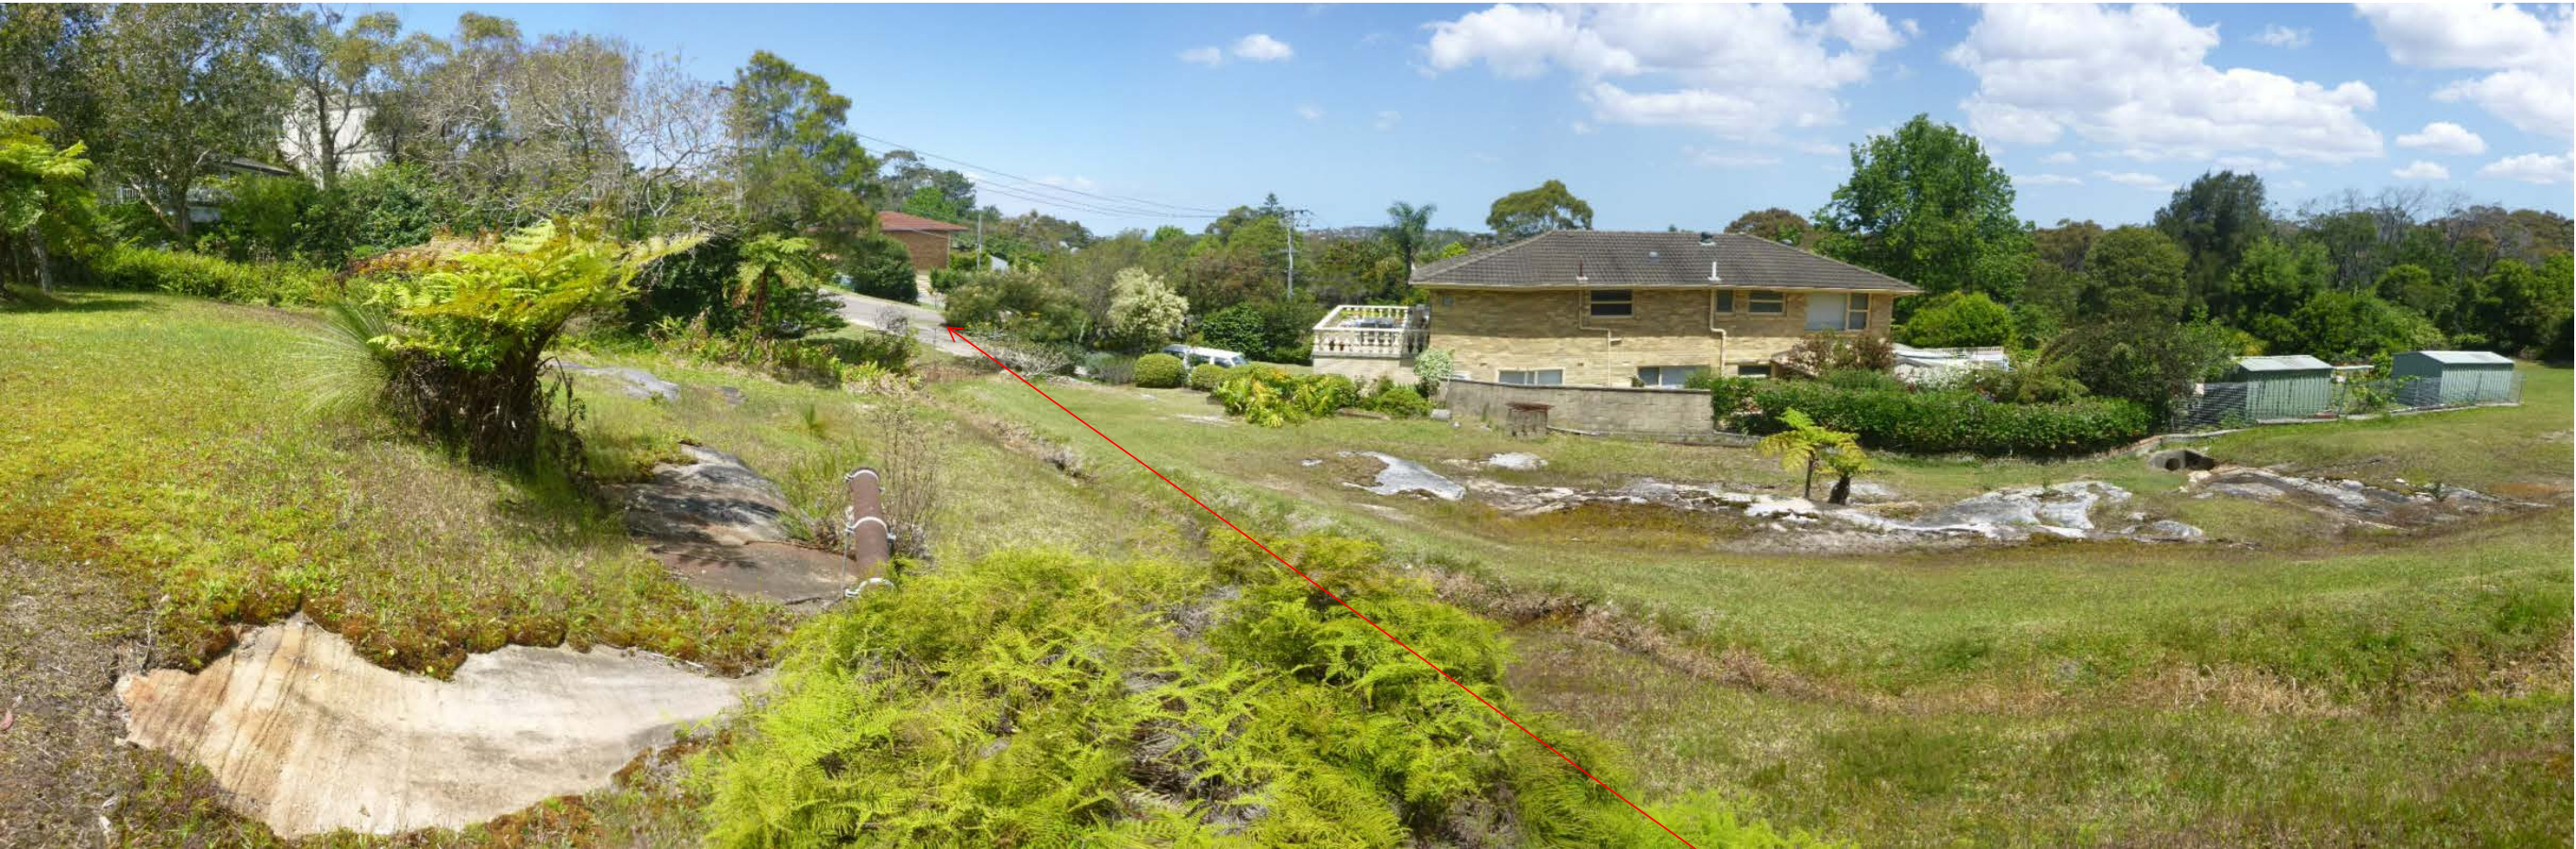
Photo 3. Panorama of the lower, south-eastern portion of the site, viewed towards the east with Iluka Avenue in the background.

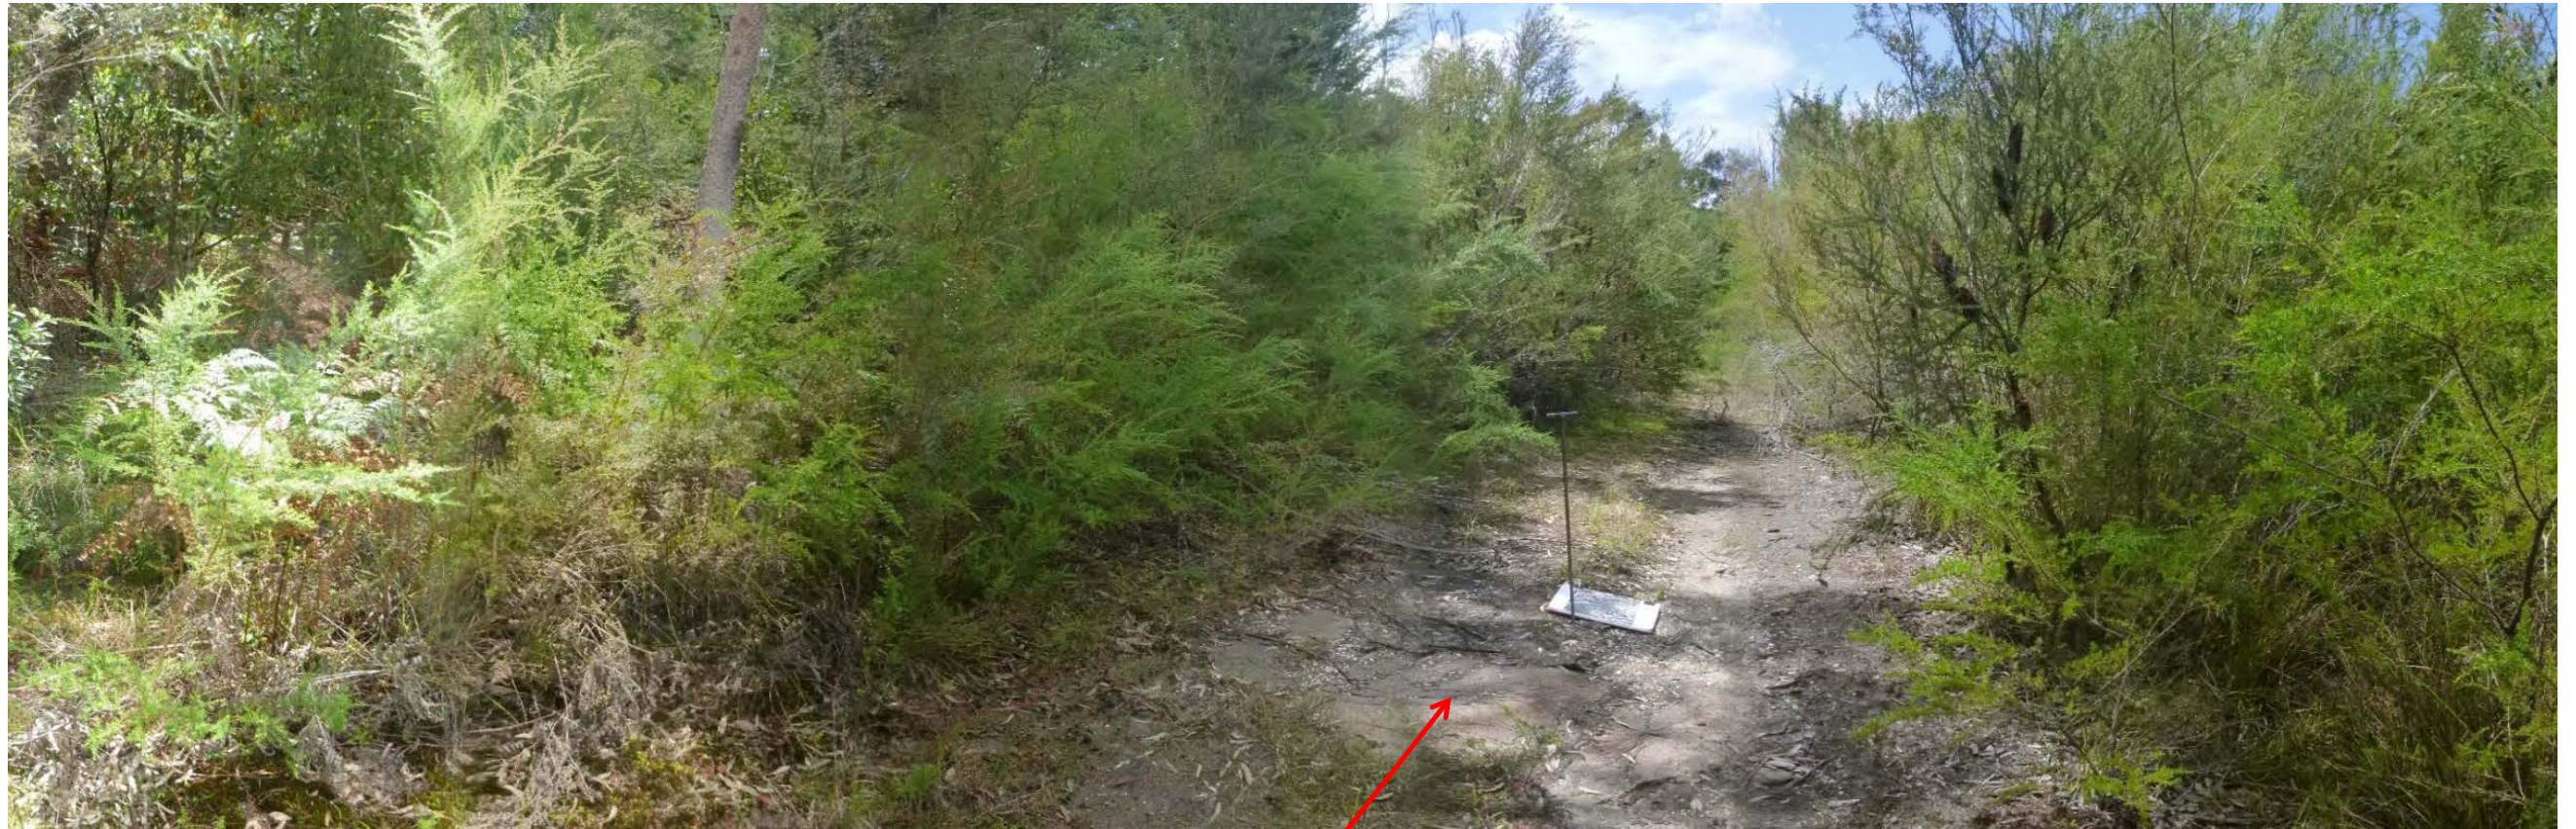
- there are a number of tracks (refer to Photos 4, 5 and 10) across the proposed development area and these typically have a relatively shallow sandy soil cover (less than 0.5 m) except for a number of minor outwash areas from the immediately upslope areas.

Photo 4. South-western part of track with sandstone outcrop in the foreground.

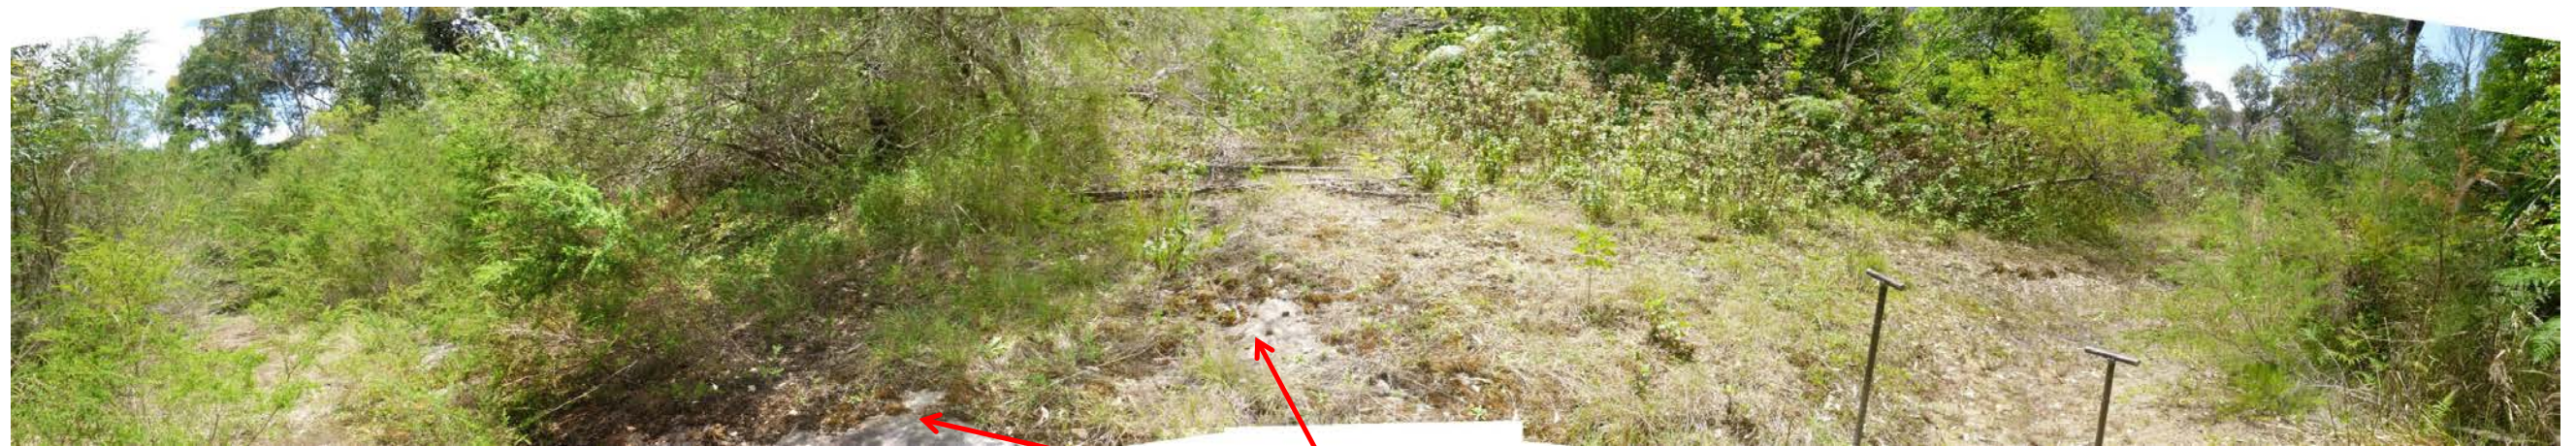
Photo 5. 220 degree panorama of the track with sandstone outcrop in the foreground.

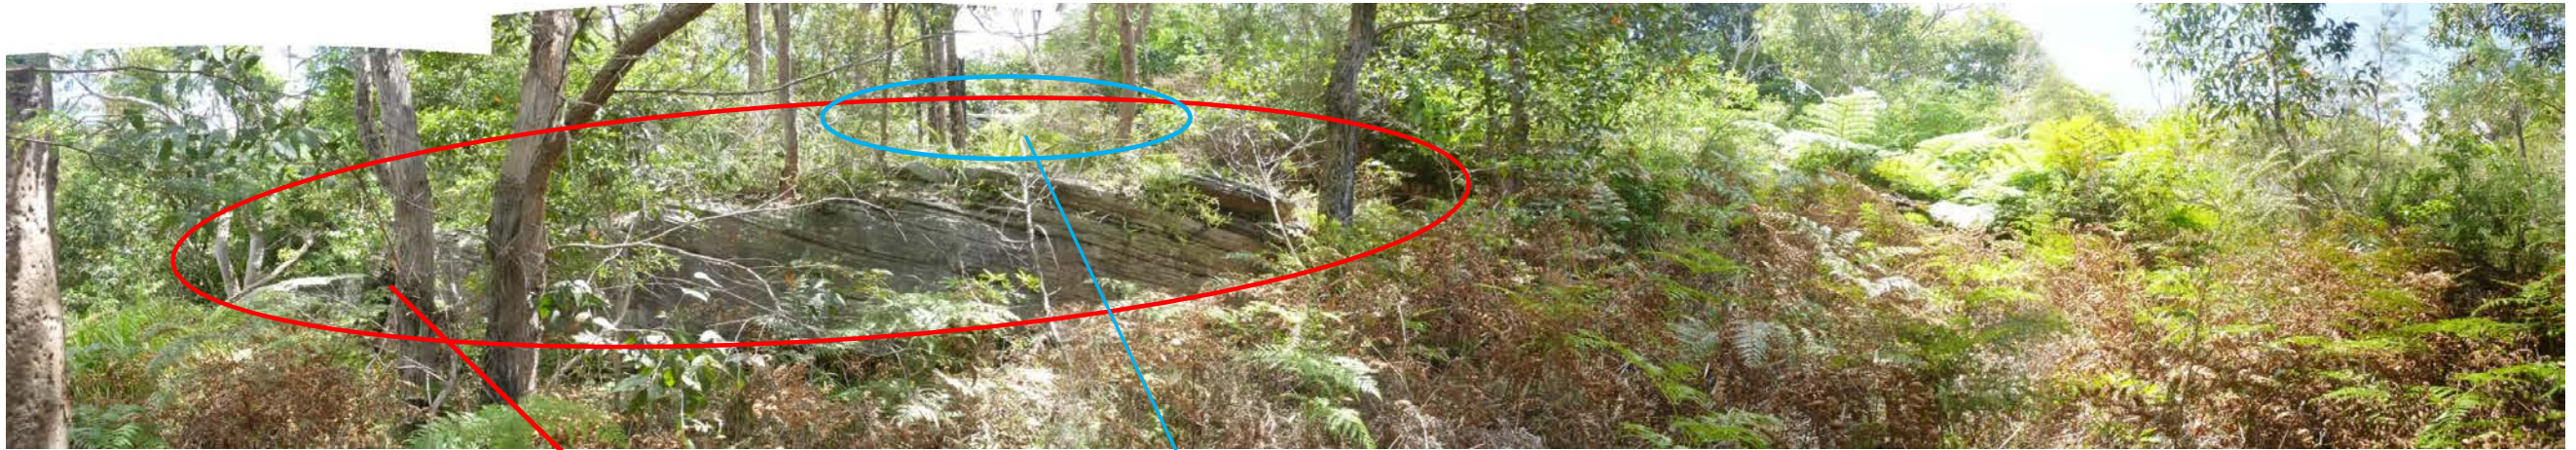
- the sandstone comprised both massive beds, with individual bed thickness ranging from less than 0.5 m to in excess of 3 m (refer to Photo 15), as well as cross bedded stratum of up to about 2.5 m bed thickness (refer to Photos 6 to 8).

Photo 6. Panorama of cross bedded sandstone outcrop. Refer to photos 7 and 8 for detail.

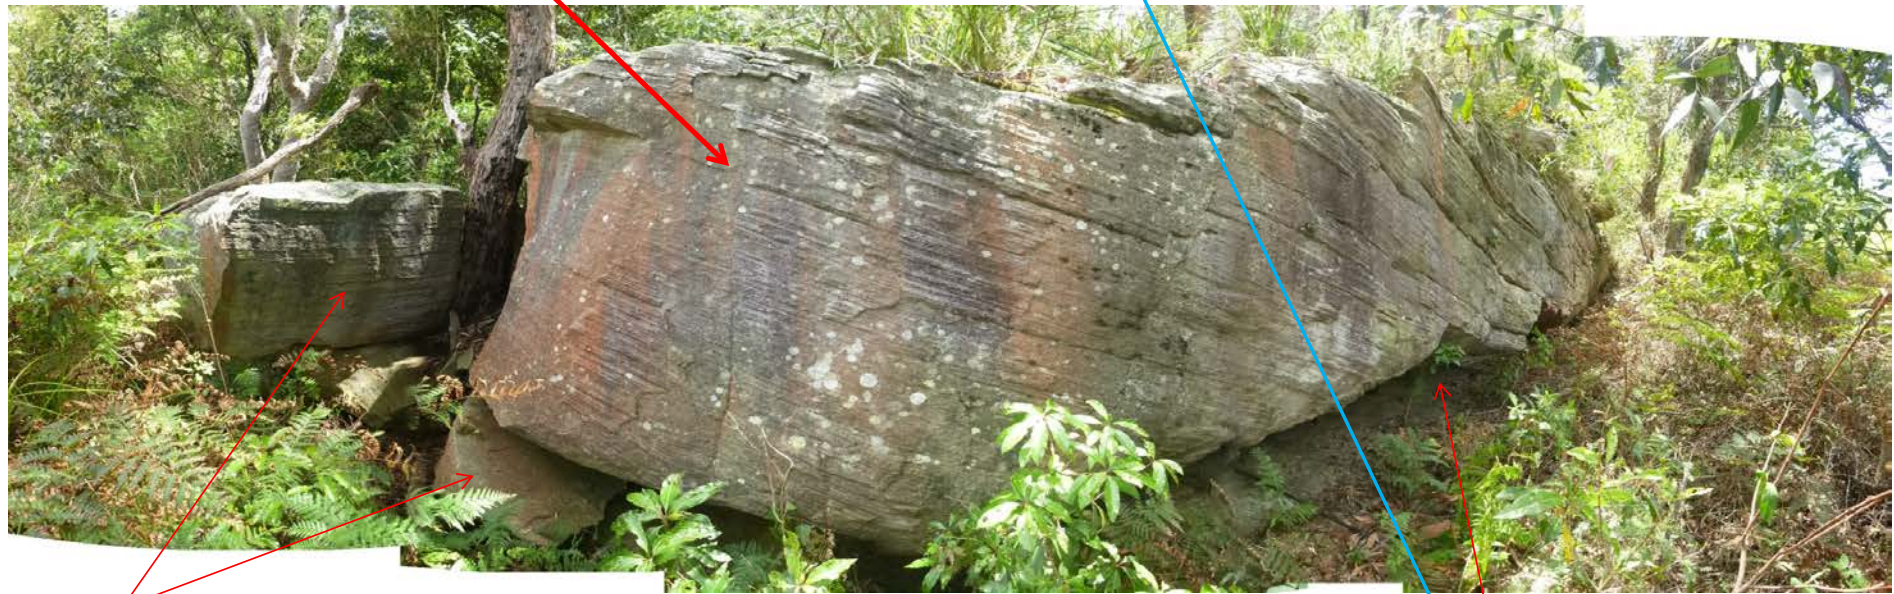
Photo 7. Lower outcrop area with highly weathered bedding plane beneath.

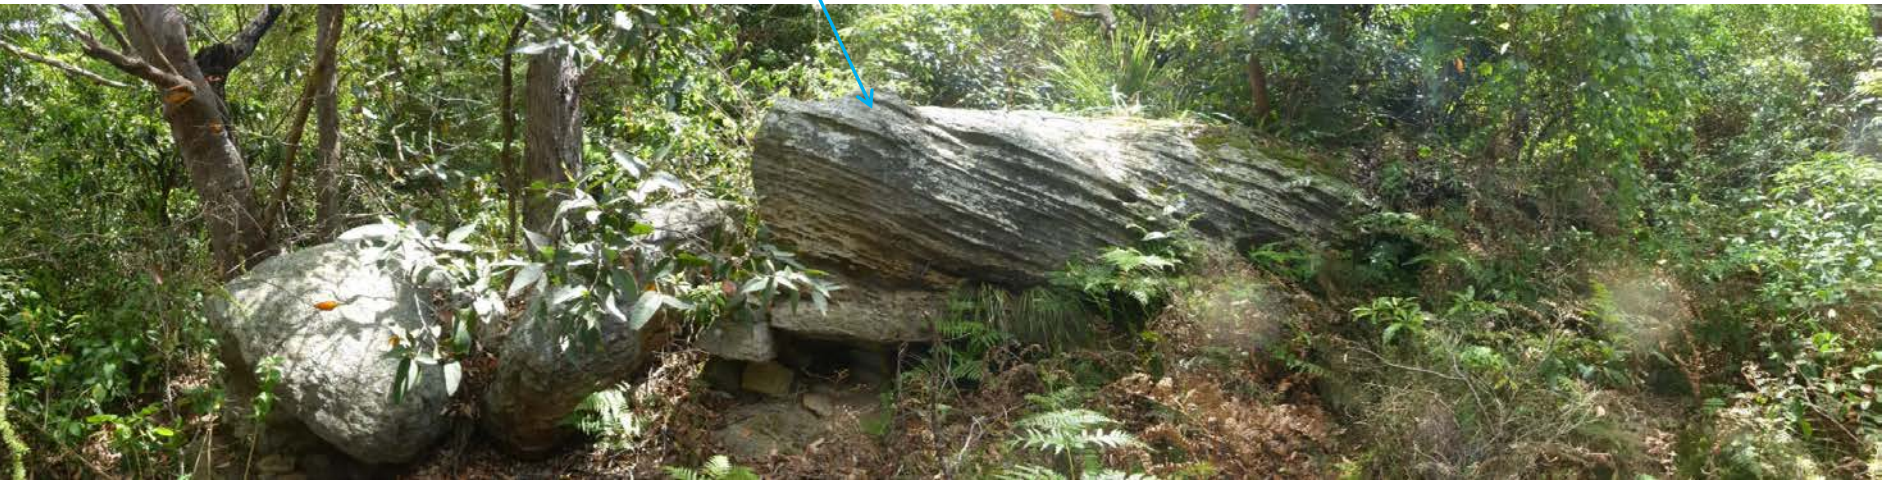
Photo 8. Upper outcrop and detached blocks.

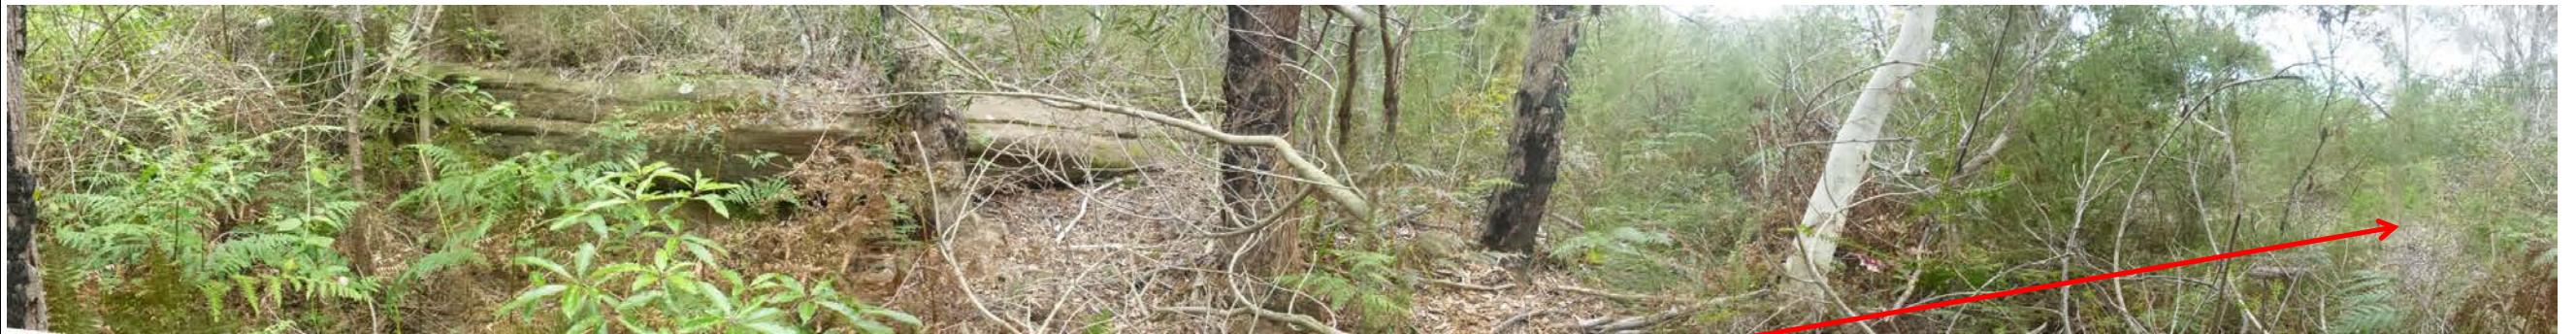
Photo 9. Outcrop on higher northern side of track. Track visible at right hand side of photo.

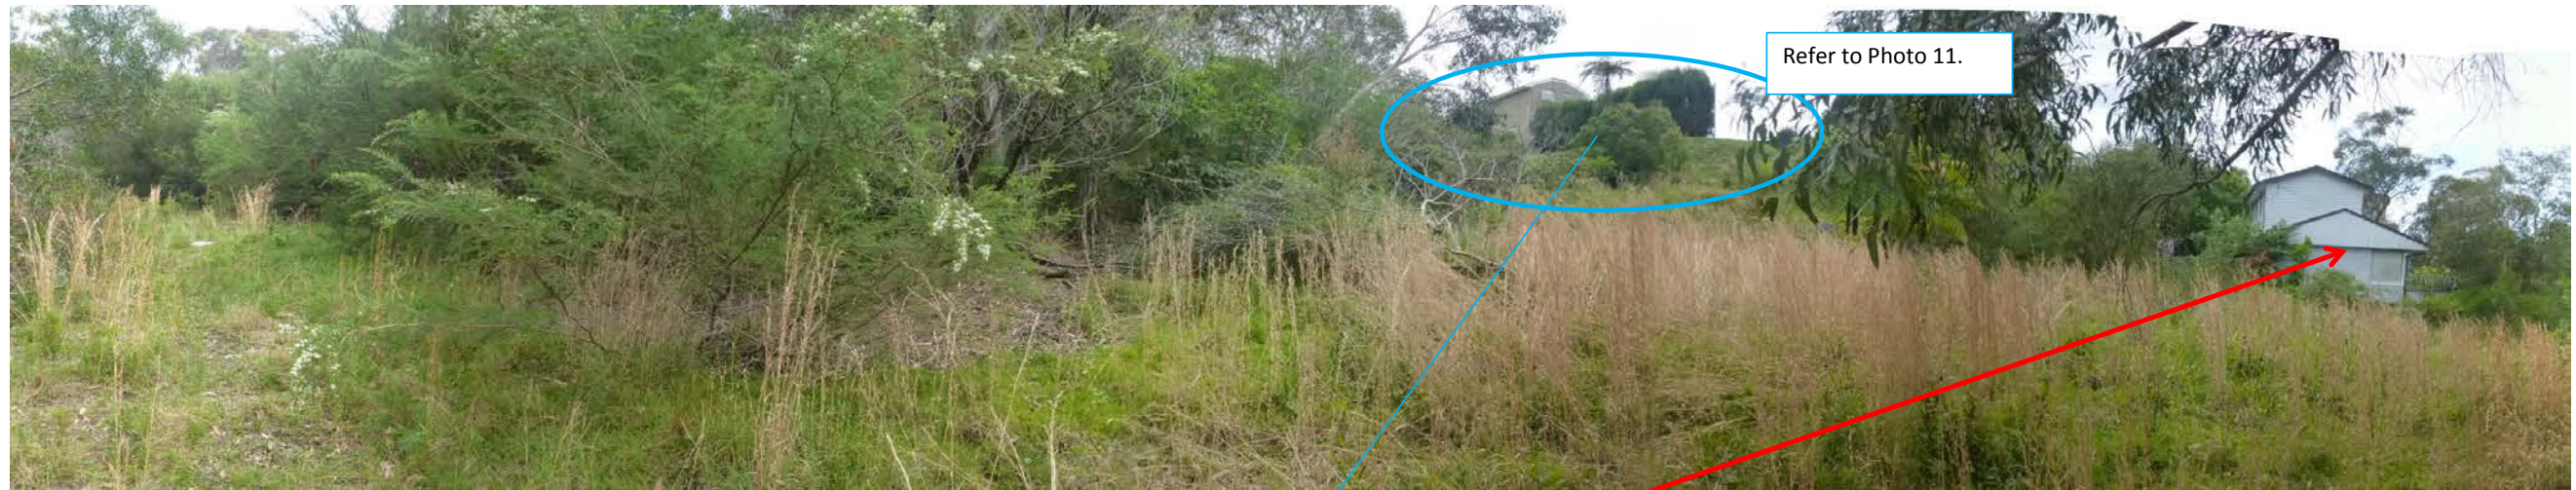
- the area along the adjoining eastern residential allotments appears to have most trees and dense vegetation removed (refer to Photos 10, 11 and 14), probably as a fire protection zone.

Photo 10. top, north-eastern end of track with adjoining residences at right hand side.

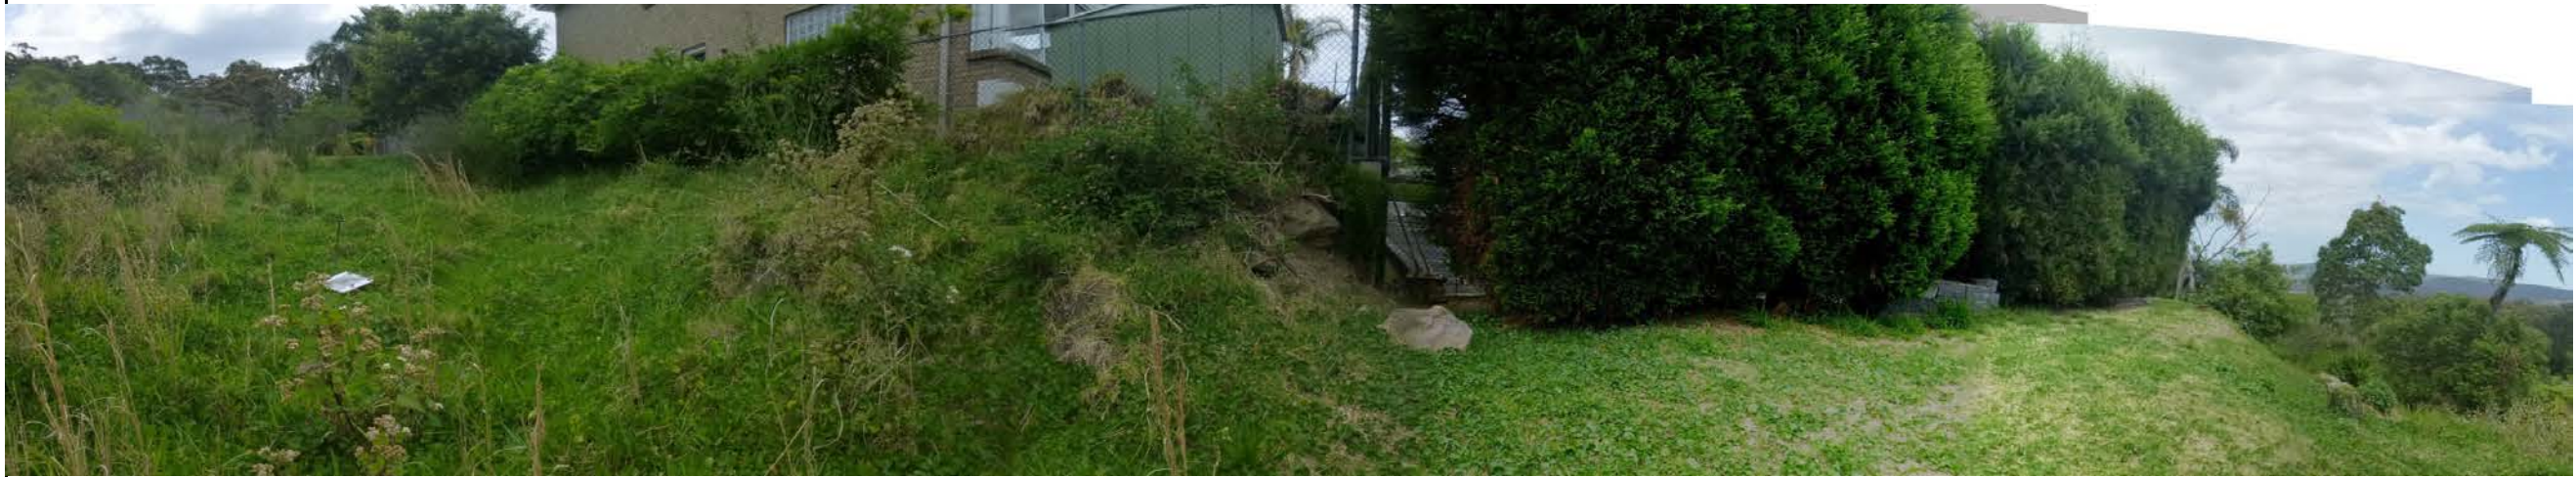
Photo 11. 200 degree panorama of the central eastern boundary showing filled batter.

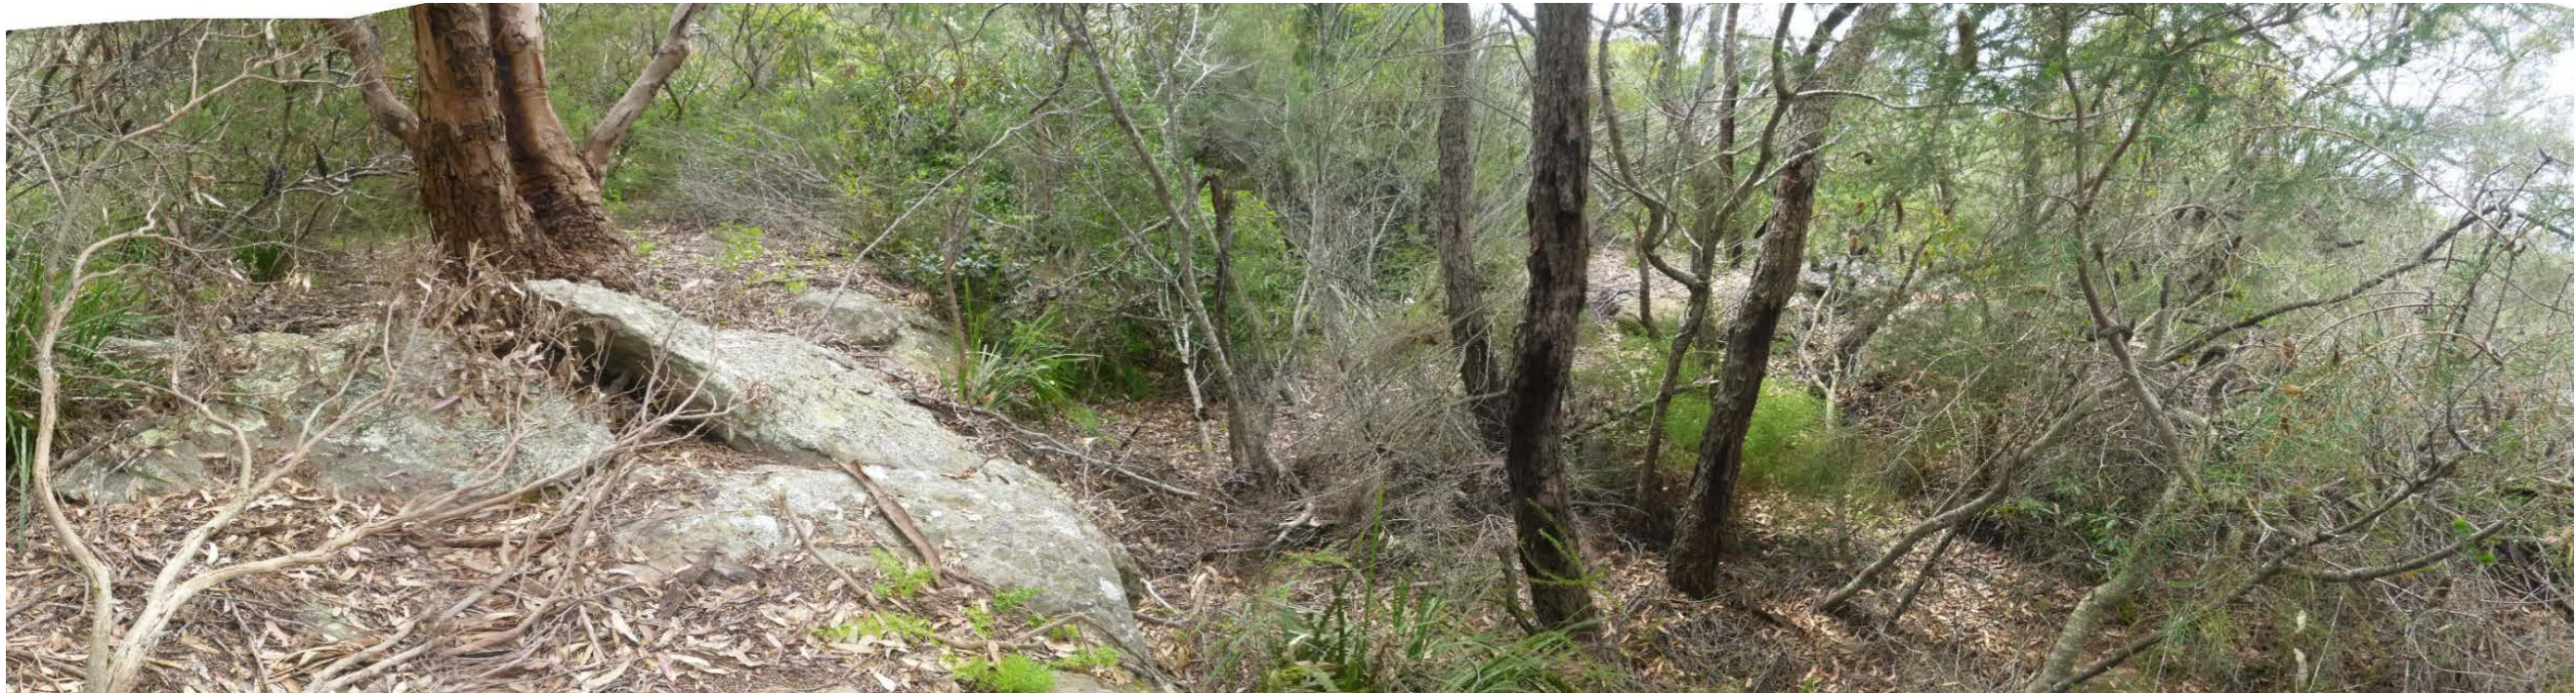
Photo 12. Sandstone outcrop trees and undergrowth .

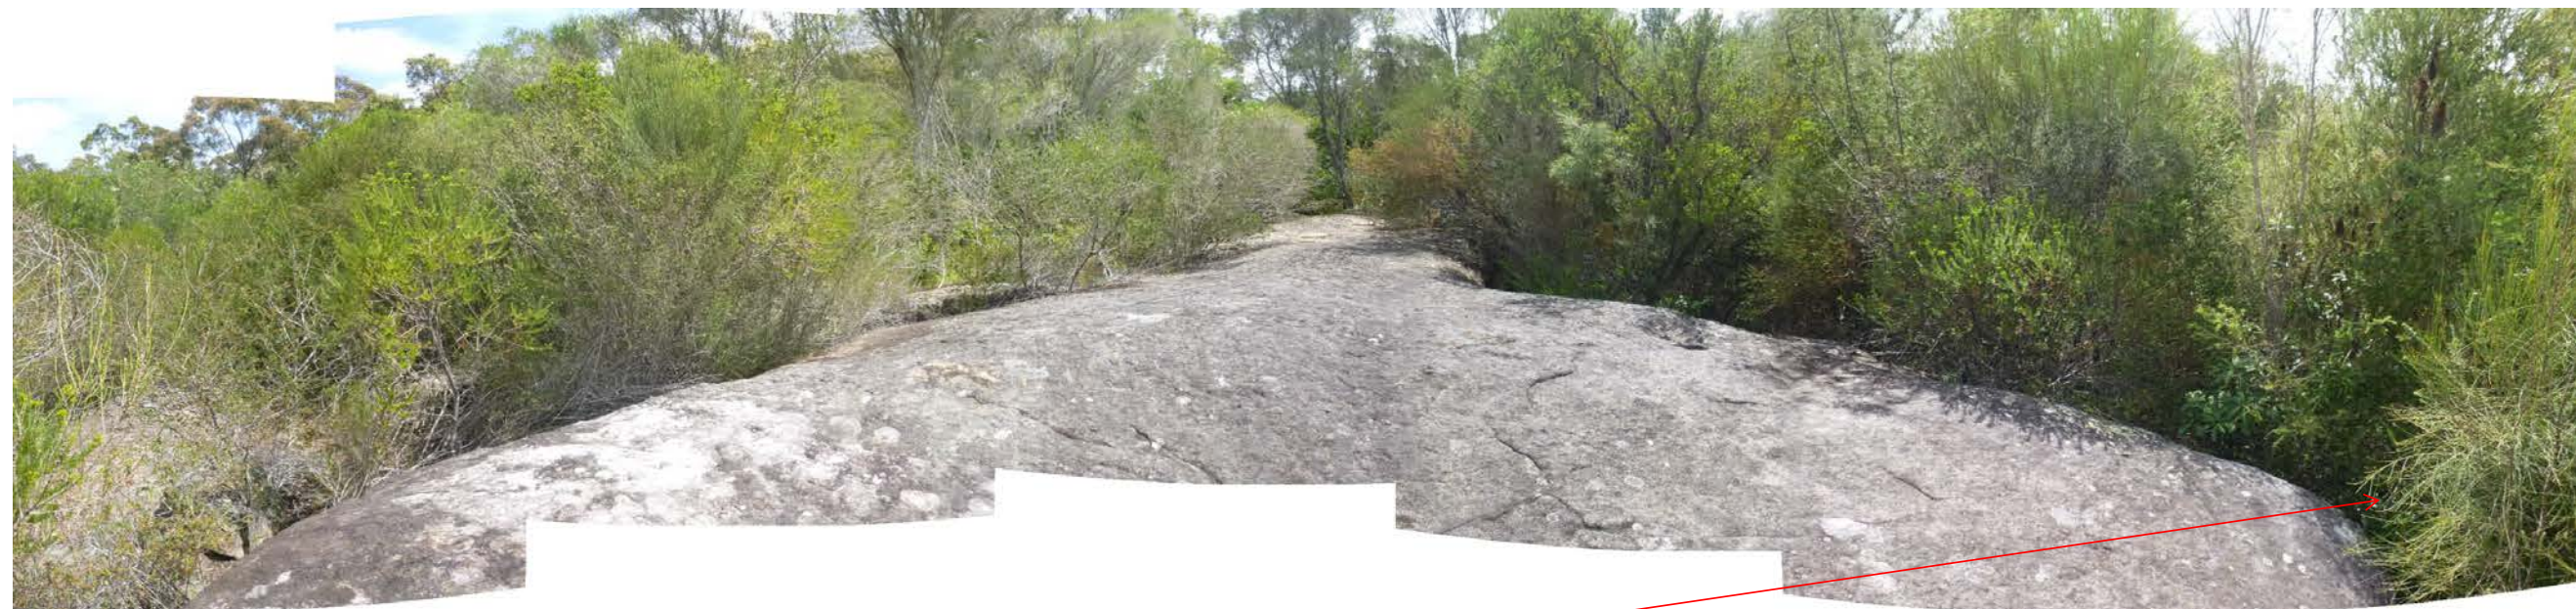
Photo 13. Panorama of larger area of sandstone outcrop, drop to right hand side of about 2m.

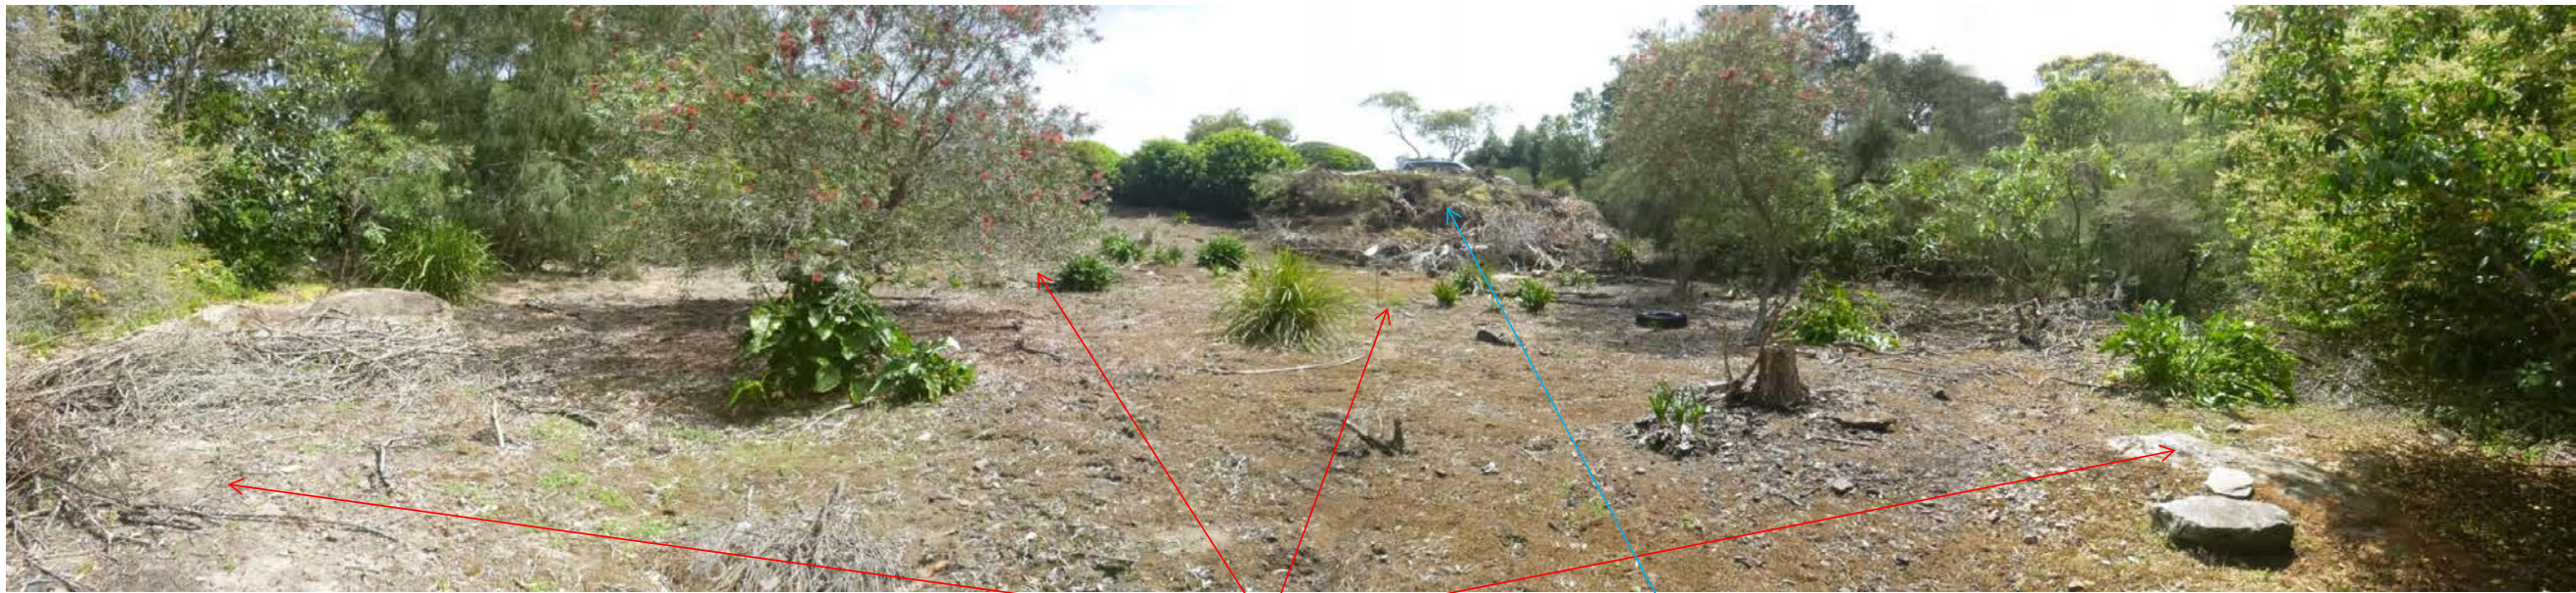
Photo 16. Panorama viewed towards the north and bowling green maintenance building area. Note sandstone outcrop and filled batter towards the centre top of photo.
