Elanora Country Club
PO Box 78
Narrabeen NSW 2101Project 85716.00
29 November 2016
R.001.Rev0
RKL:pc

**Preliminary Geotechnical Assessment
Elanora Country Club
Elanora Road, Elanora Heights****1. Introduction**

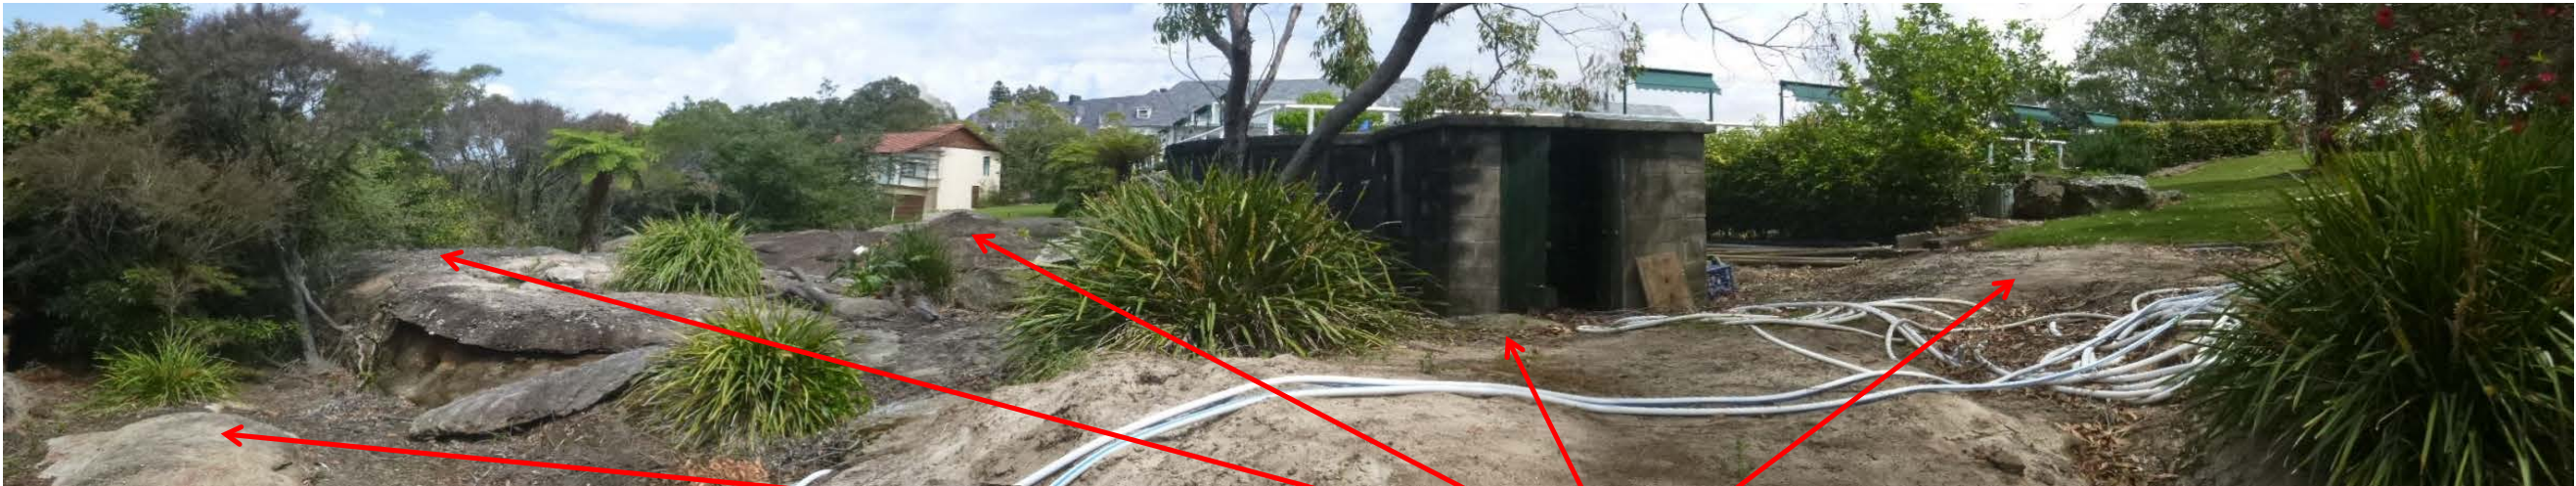
Photo 17. Panorama of the eastern side of the existing bowling green area showing sandstone outcrop.
