# WESTS MAYFIELD TREE ASSESSMENT REPORT: FIG TREES

## TREE ASSESSMENT REPORT : FIG TREES

LOCATION: 32 INDUSTRIAL DRIVE, MAYFIELD

PROJECT NO. 11964.5  
DATE: OCTOBER 2018  
REVISION B

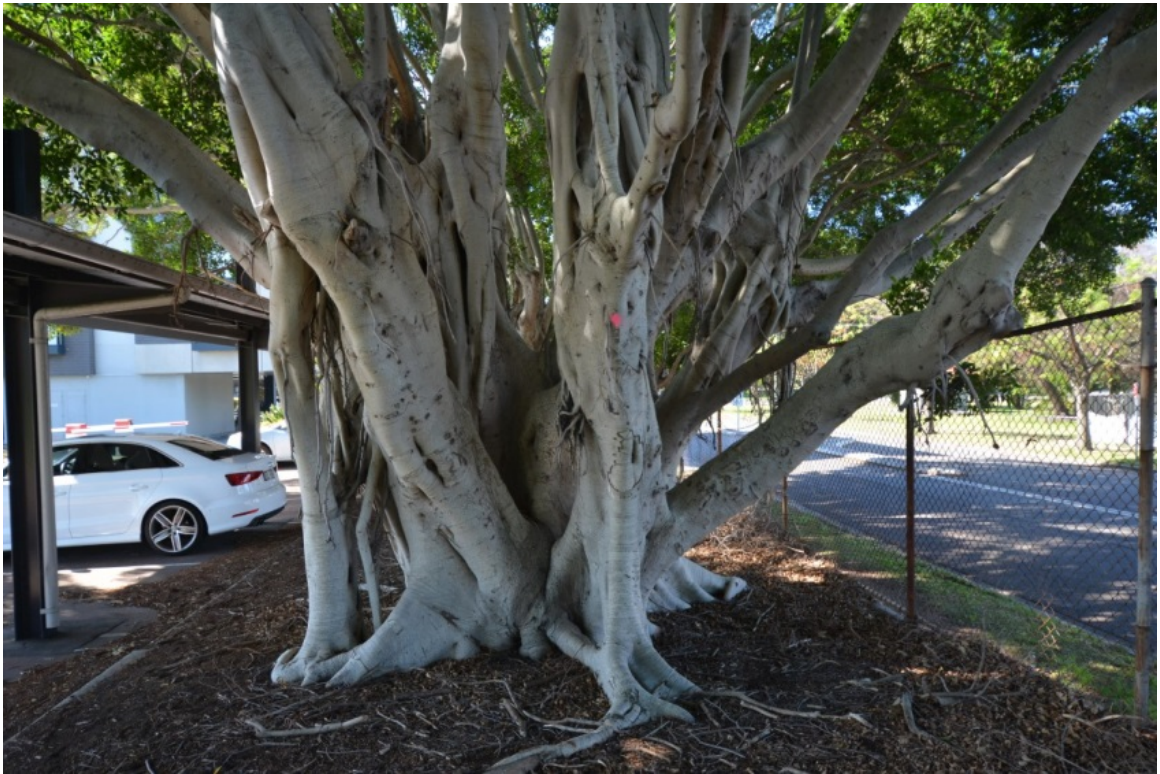
The most striking and common characteristic that these trees have is either multiple trunks or very short trunks with large, first order branches originating close to the base of the trees. Included bark is present in some branch unions but not common throughout.

**FIGURE 5:** TREE 4 WITH NUMEROUS MULTIPLE TRUNKS (TYPICAL).

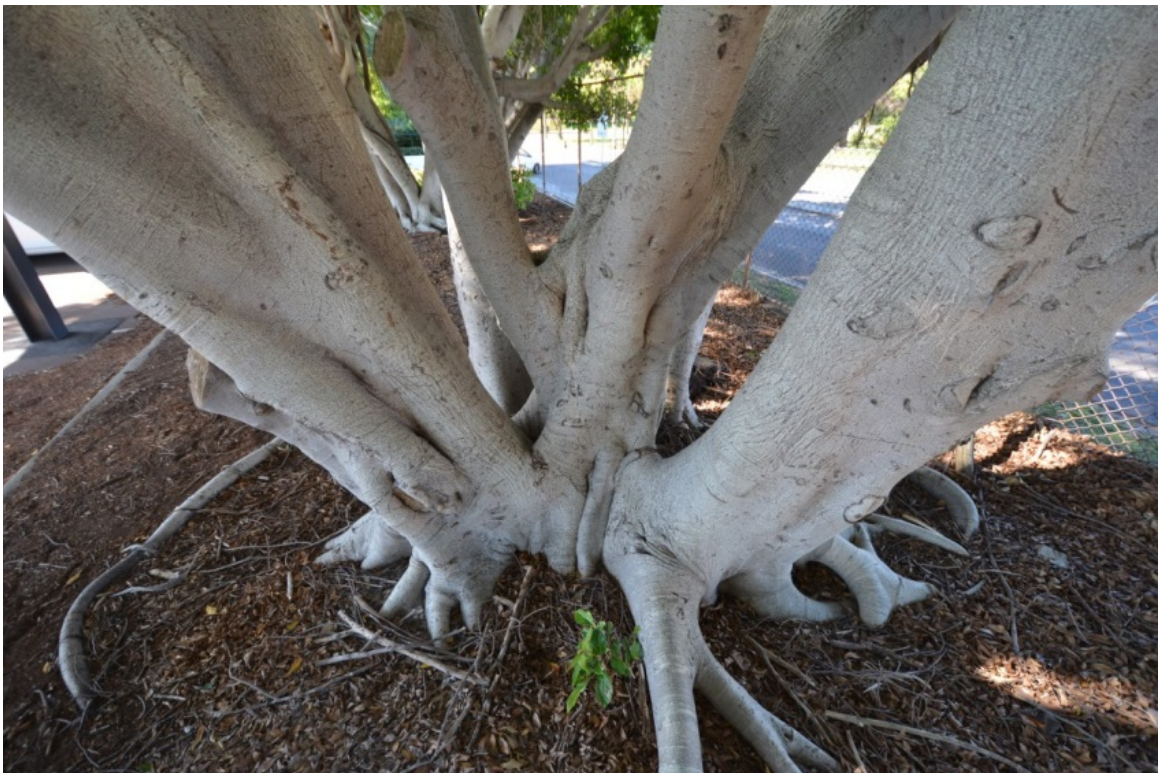
**FIGURE 6:** TREE 2 WITH DETAIL OF MULTIPLE TRUNK BASE.

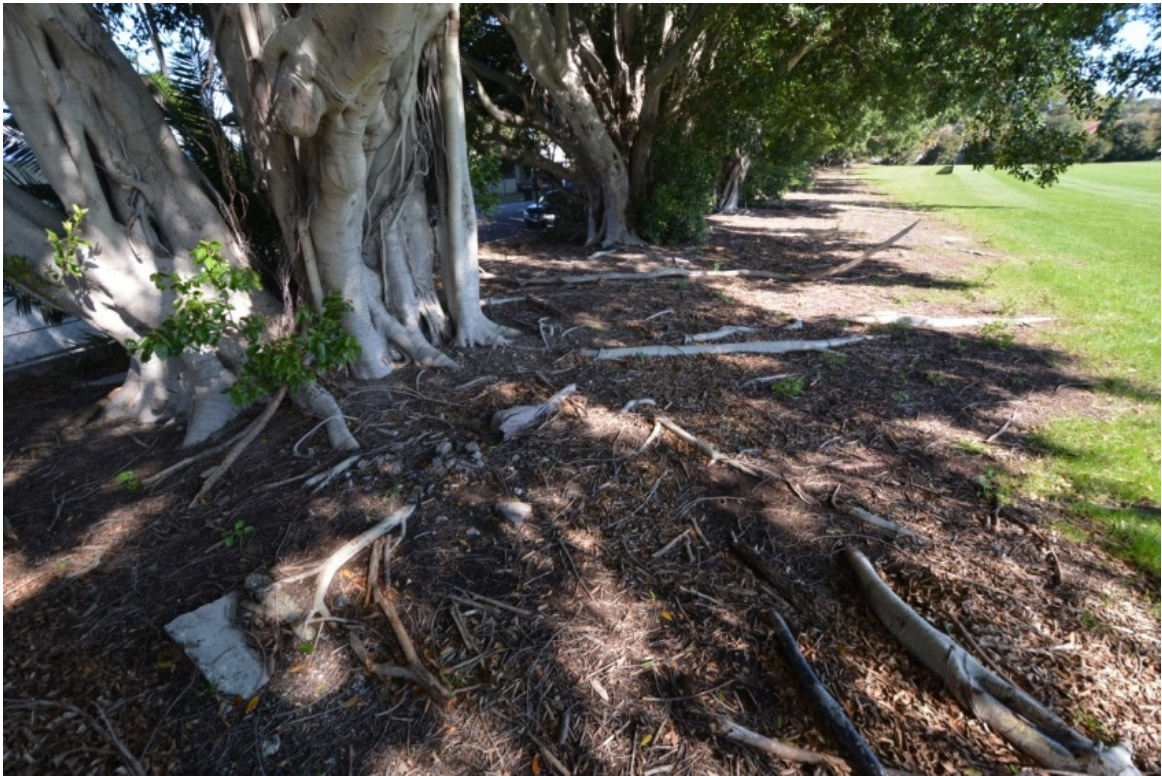
**FIGURE 7:** TREE 5 SHOWING SURFACE ROOTS WITH MULCHED GARDEN BED UNDERNEATH.

- Improve soil conditions around the bases of trees with regular mulching. An organic mulch shall be maintained at a thickness of 75mm for the purpose of retaining moisture, increasing biological activity within the soil and providing protection to the roots.

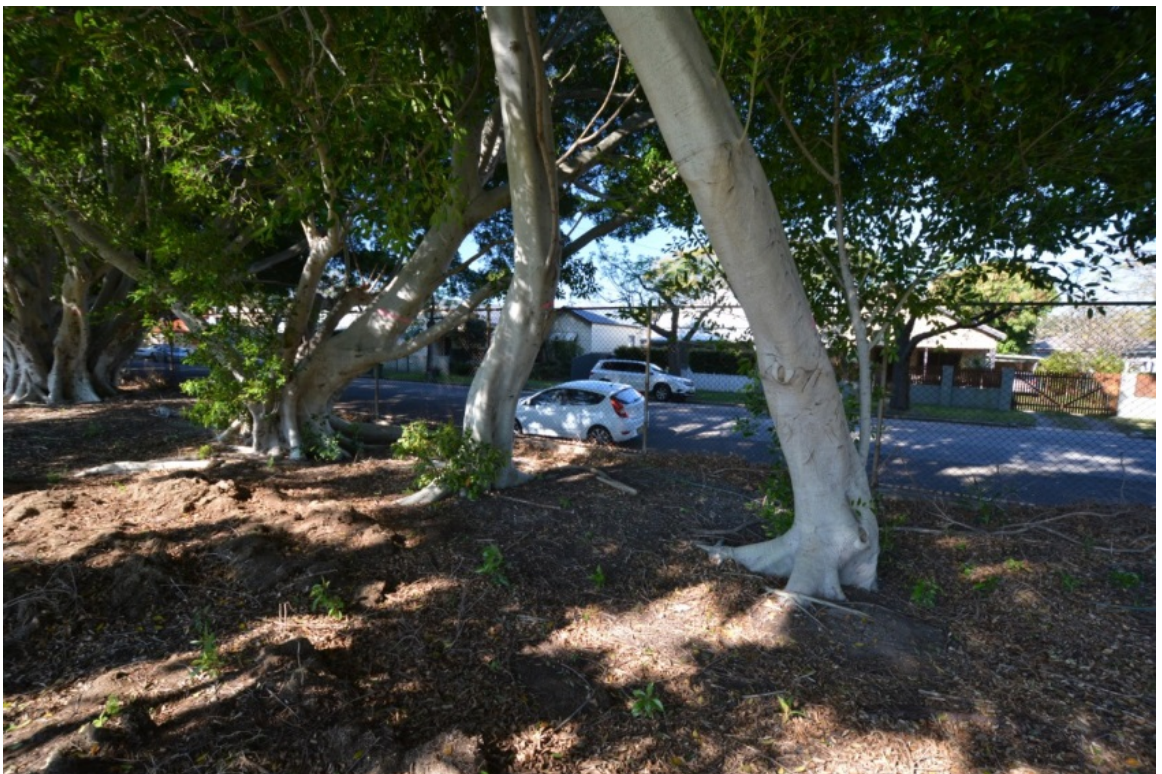
Trees 14 and 15 are younger specimens and planted at closer centres than the others (3-4 metres). It is assumed that these trees were planted to replace an earlier tree that had failed. These two trees are also vigorous and disease free although they show evidence of suppressed growth arising from the competition imposed by the nearby trees. Unlike the older trees, these two trees have taller trunks and a better structure.

**FIGURE 8:** TREES 14 AND 15 WITH SINGLE TRUNKS ALBIET WITH PRONOUNCED LEANS AS THE RESULT OF COMPETITION FROM NEARBY MATURE TREES.

Trees 14 and 15 are relatively young trees with a ULE rating of 1A and having a life expectancy of over 40 years. Their main problem is suppressed growth arising from being planted between two mature, well established trees.

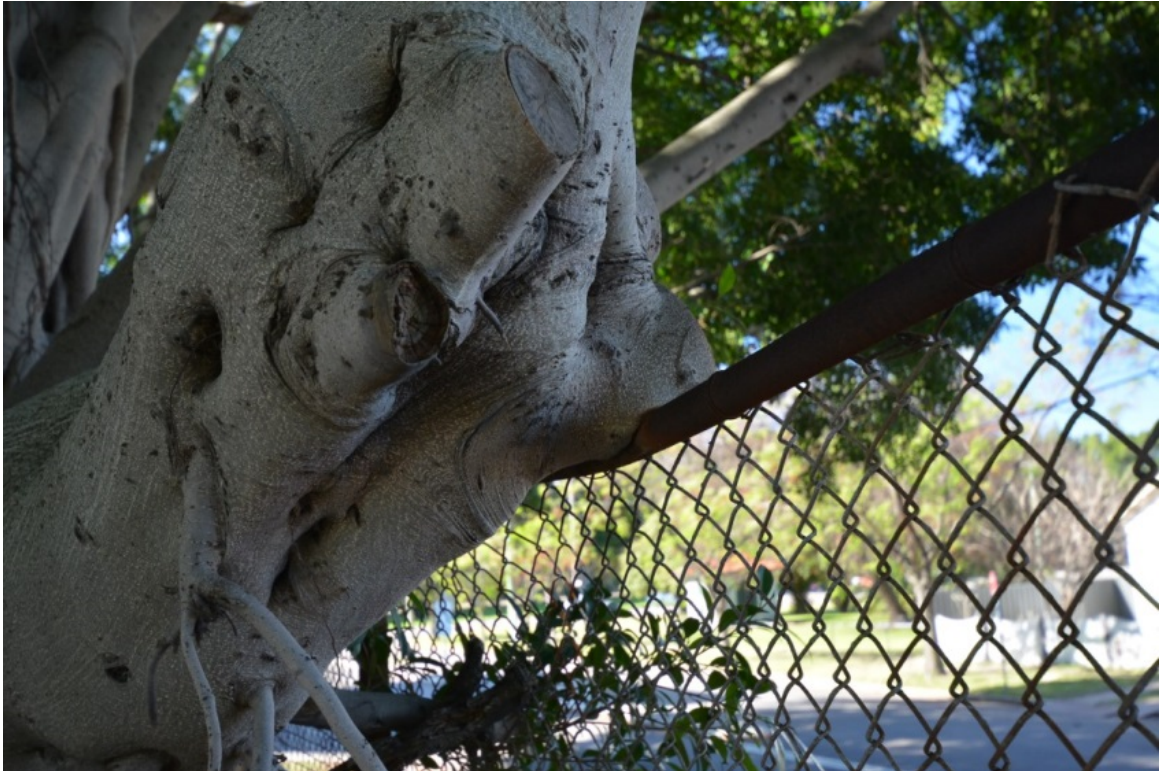
**FIGURE 9:** BRANCHES REMOVED TO TREE 3 TO RELIEVE PRESSURE ON BOUNDARY FENCE AND PREVENT FURTHER BUCKLING.

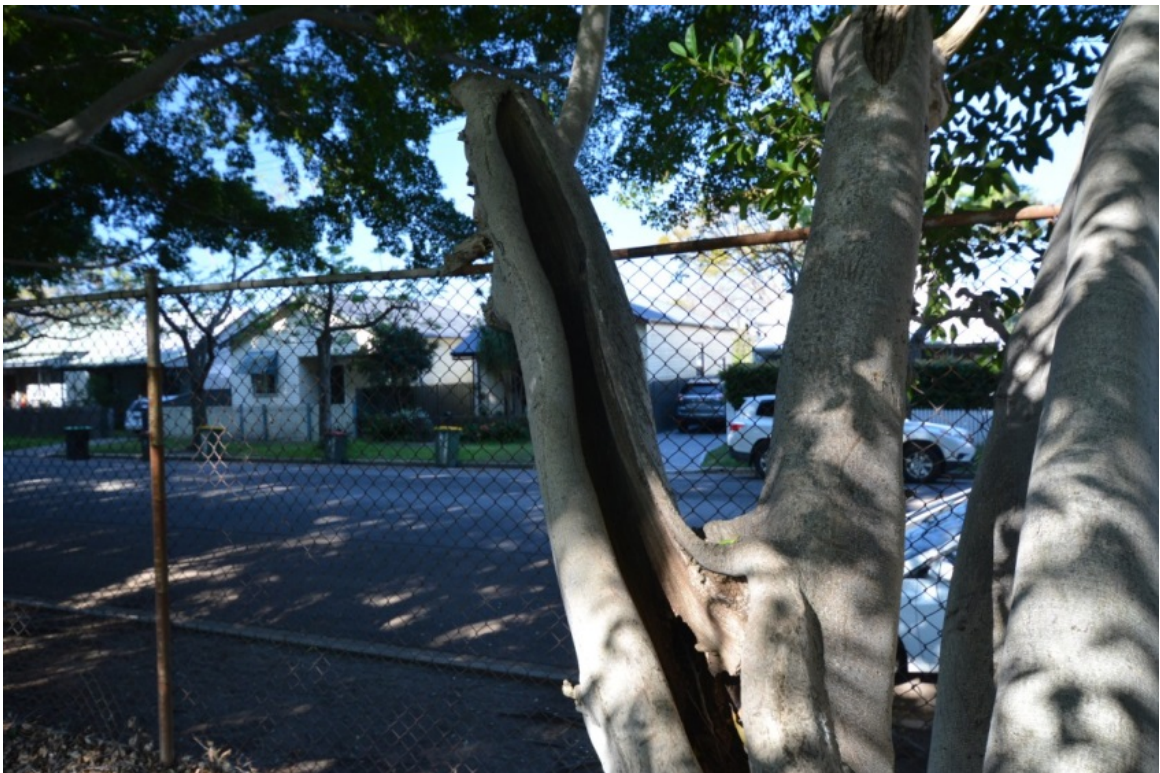
**FIGURE 10:** ONE OF THE WORSE EXAMPLES OF DECAY ORIGINATING FROM THE PREVIOUS REMOVAL OF AN OVERHANG BRANCH.

- Water the trees during periods of prolonged dry spells (i.e. no significant rain<sup>4</sup> in any 4 week period).
- Tidy up any broken branches by removing stubs in accordance with AS 4373 – *Pruning of amenity trees*.
