ARBORICULTURAL IMPACT ASSESSMENT.

On: Tree Specimens At 1 White St. Lilyfield
NSW 2040

For Mr. D. Cohen
On. 21/8/2018

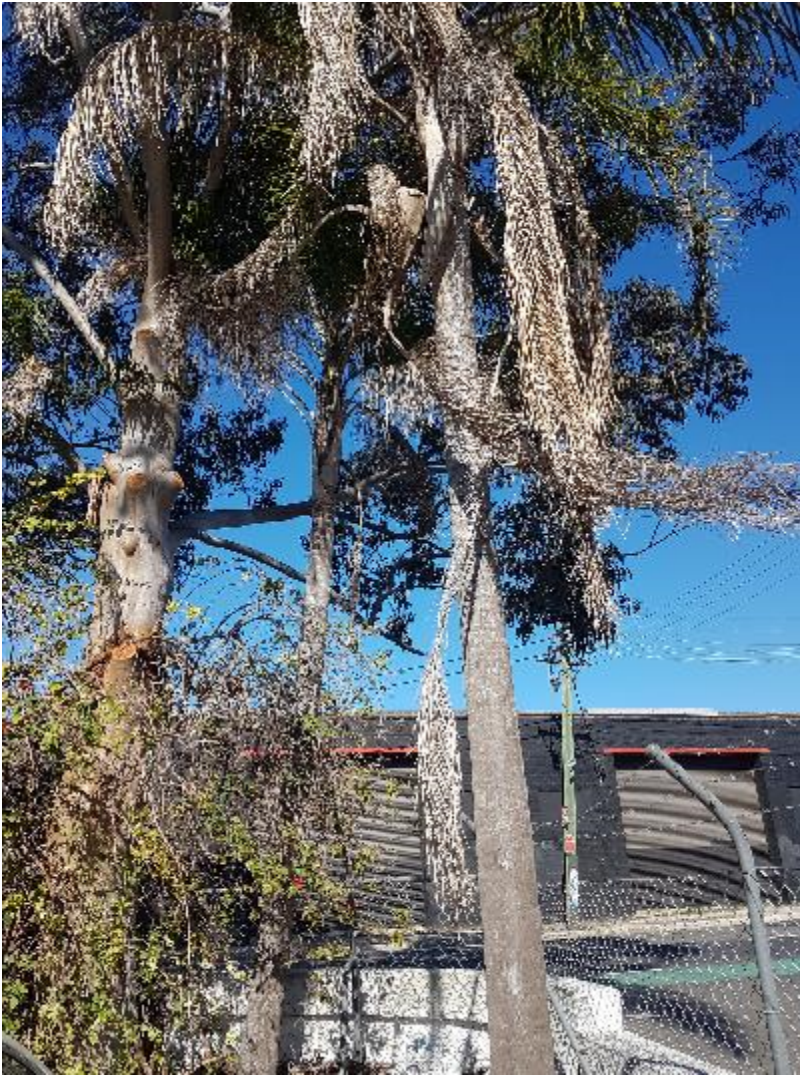
Fig 2 Photo of T1 and T2 both *Syagrus romanzoffianum*.

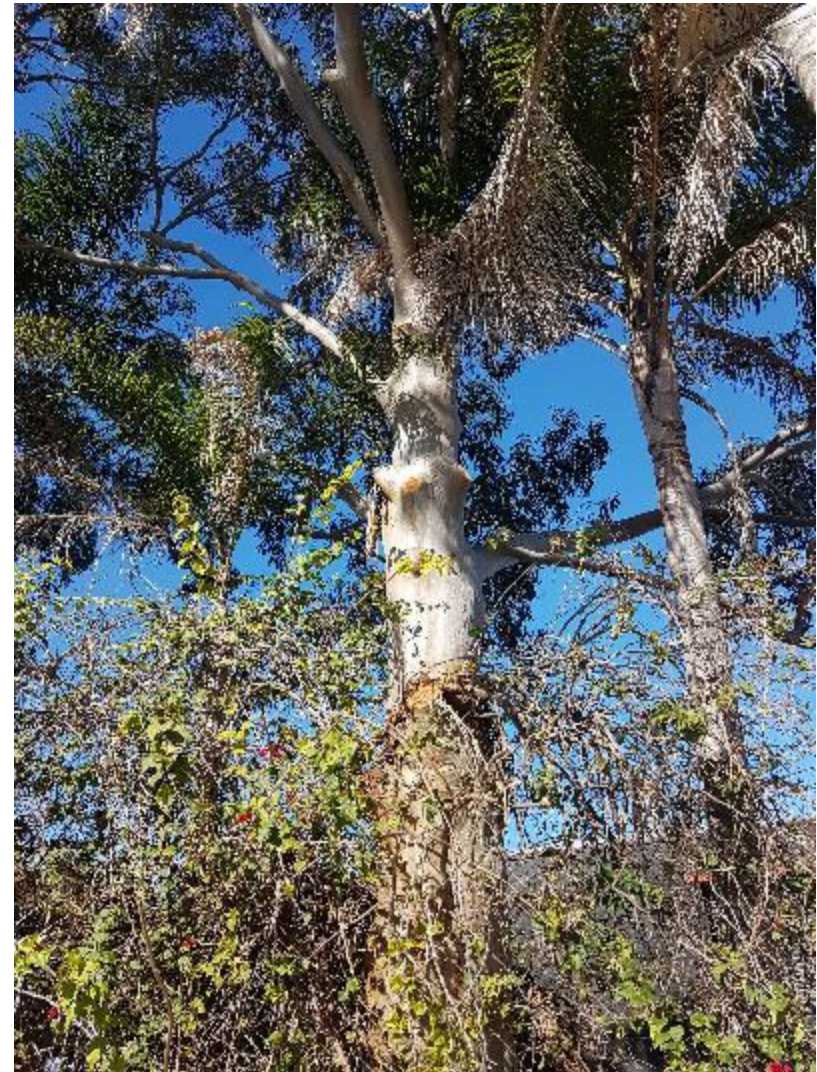
- **T3** has been planted on the site in a confined situation being the narrow garden bed to the South of the car park servicing the building. The tree has had limbs and branches removed up to 5m from the ground (See Fig 3).

T3 is located in the South East corner of the Site and has a relatively small TPZ for its species and will be subjected to a Major Encroachment by the deep excavation for the new subterranean car park (See Appendix 2b). It is considered however that the existing carpark would be inhibiting roots from this tree on its North East side where the proposed deep excavation is to be undertaken. A tree root investigation at this time is not possible as the existing car park is in use.

Fig.3 Photo of T3 a *Eucalyptus saligna*

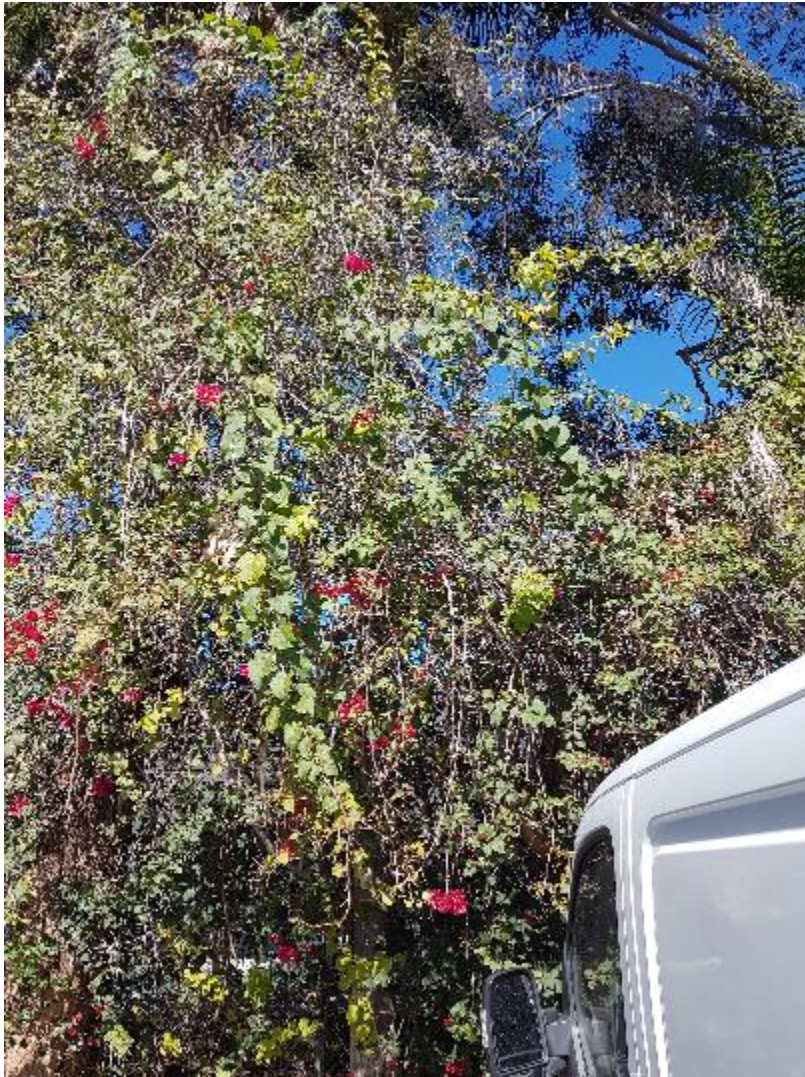
Fig 4. Photo of T4 a *Syagrus romanzoffianum* covered in vines

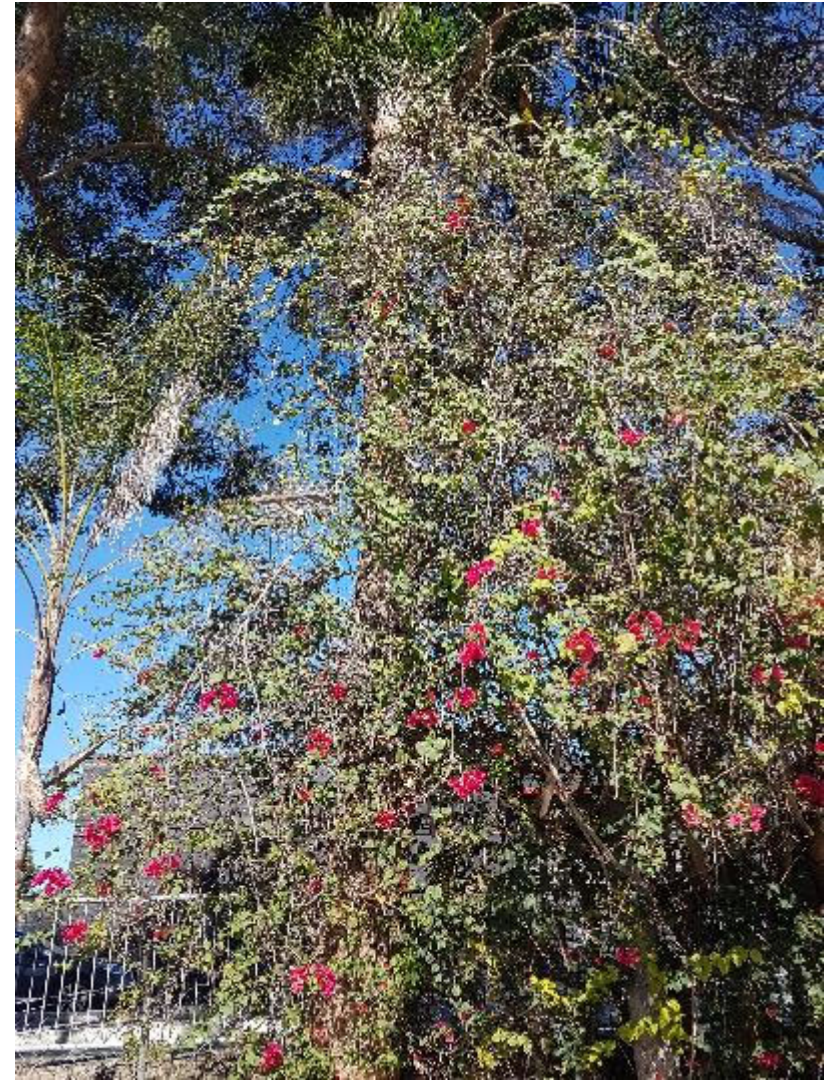
T5 <i>Eucalyptus microcorys</i> Common name 'Tallowwood'	18m	48cm 63cm at the base	N 5m E 2m S 4m W 3m	A native species native to North Eastern NSW which is growing near the Southern border of the Site. The tree was in good health and condition at the time of inspection with no significant pathogens nor defects apparent.	A1	5.76m	2.73m

Fig. 5 Photo of T5 a *Eucalyptus microcorys*

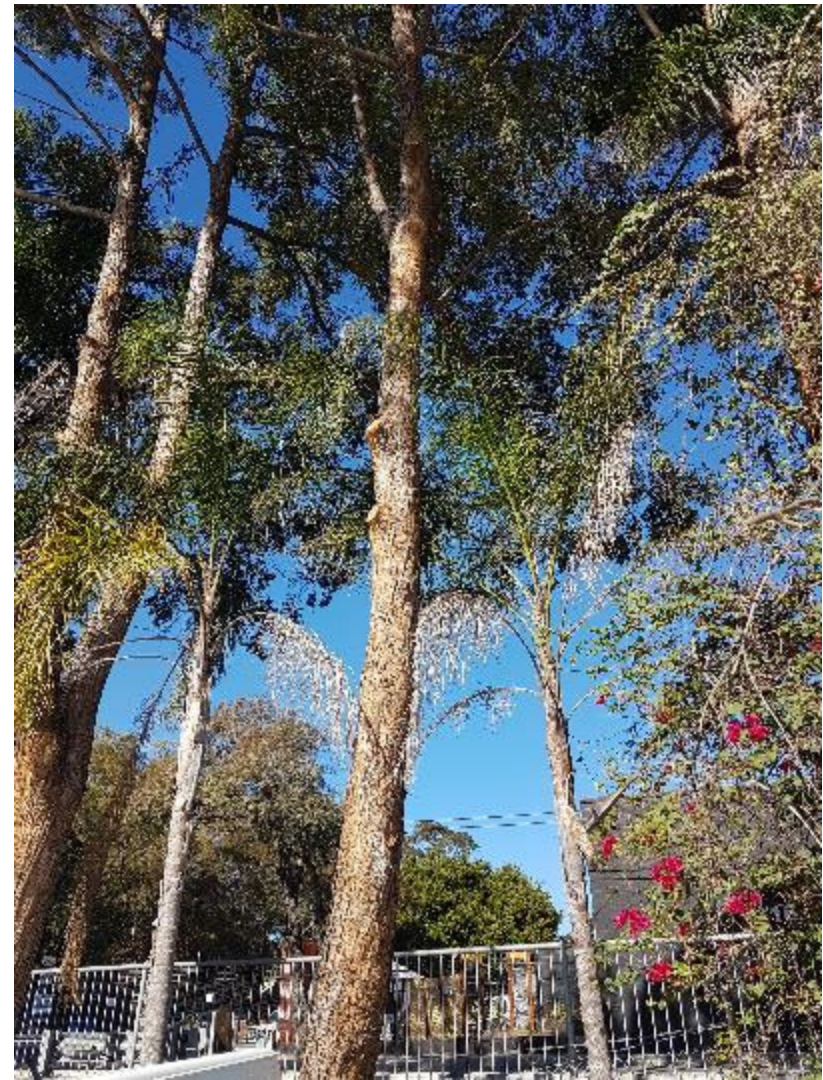
Fig. 7 Photo of T7 a *Eucalyptus microcorys*

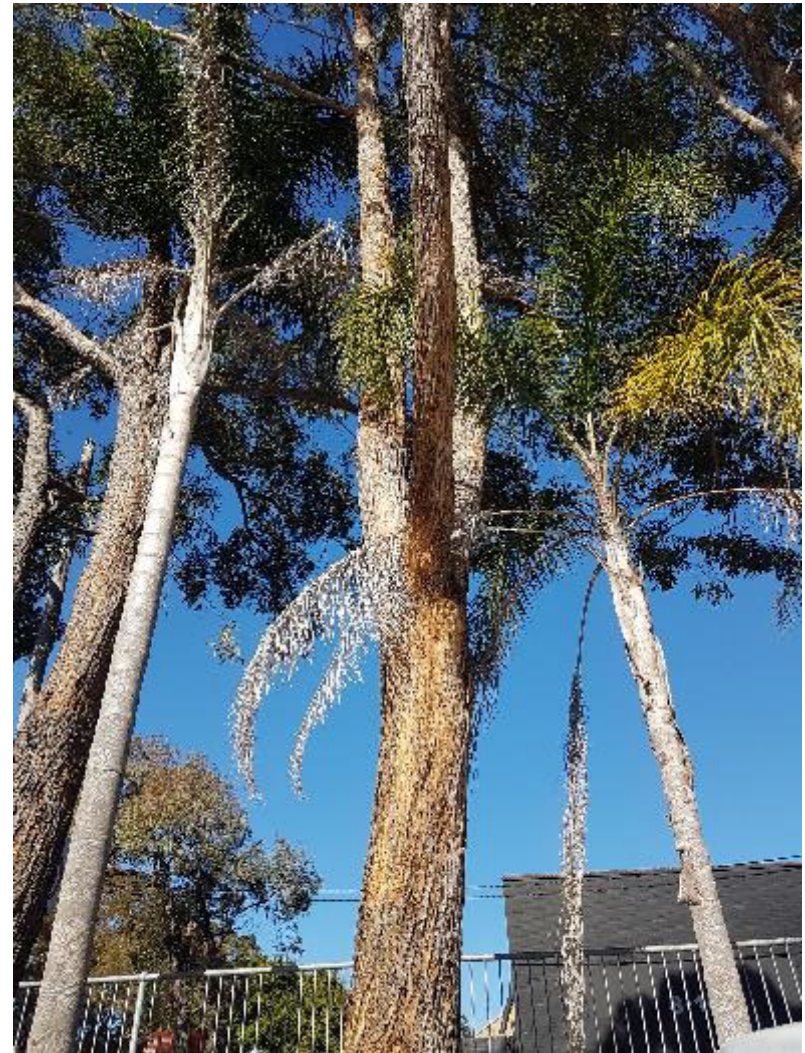
Fig. 9 Photo of T9 a *Eucalyptus microcorys*

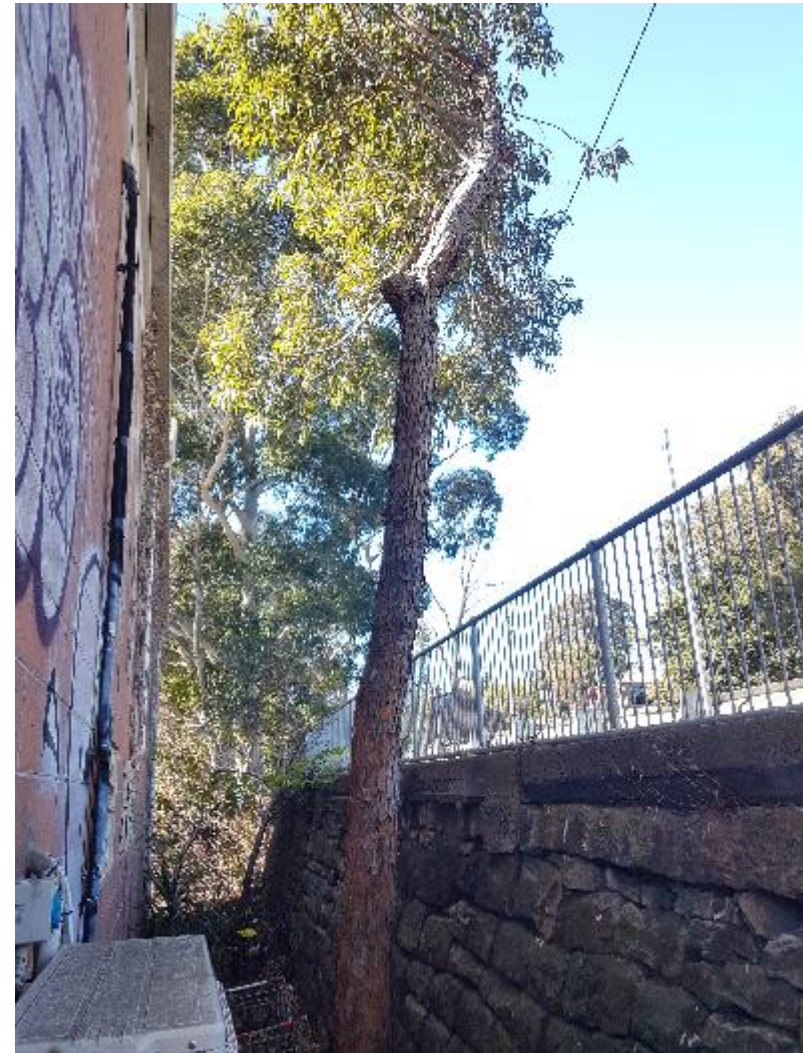
4.4 Tree **T12** is a *Eucalyptus robusta* or “Swamp Mahogany” which is growing in confined conditions adjacent to the Southern border of the Site (See Fig. 13). The tree is suppressed in its growth being in the shade for most daylight hours. Consequently it is quite stunted in its habit with a bias in its canopy to the South.

This tree will be subjected to a Major Encroachment into its TPZ to the extent that it would be unviable to retain it (See Appendix 2a & 2b).

Fig. 13. Photo of T12 a *Eucalyptus robusta*

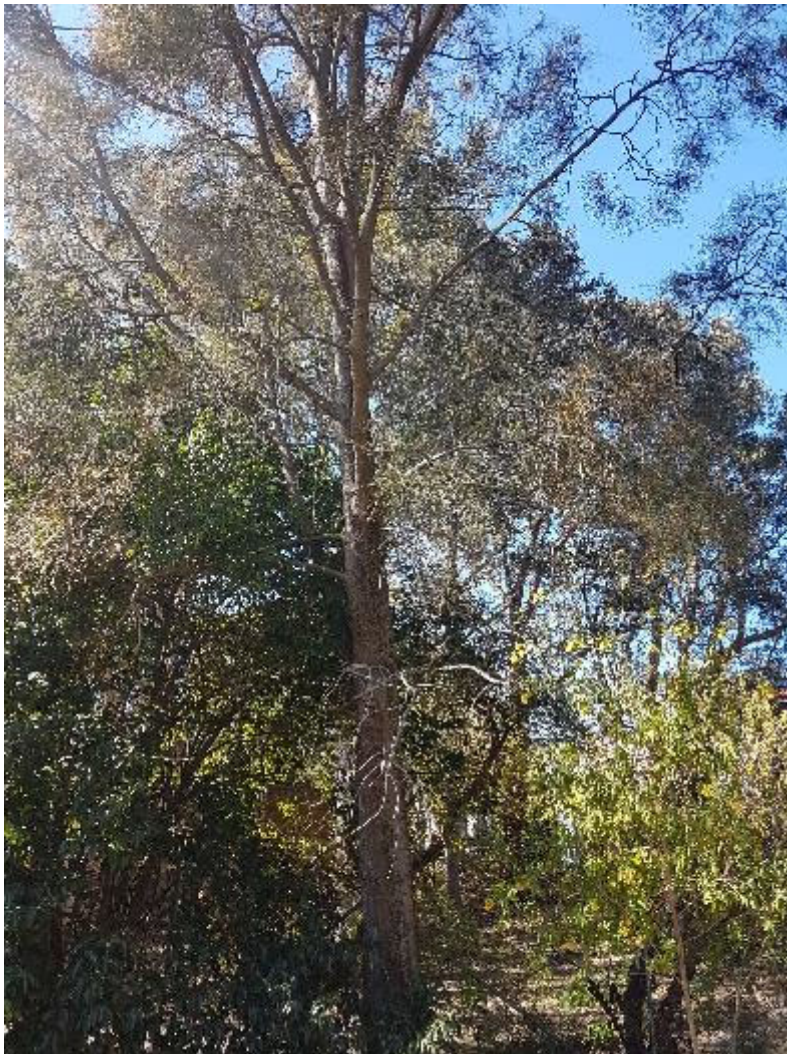
4.5 Tree **T13** is an *Allocasuarina cunninghamiana* or ‘River Sheoak’ is a native tree specimen which has been planted in the Site towards the North East of the property. The tree was in good health and condition at the time of inspection (See Fig. 14).

The tree will experience a Major Encroachment into its TPZ however the tree root investigation indicates that only two roots, one 60mm Ø and one 80mm Ø, would need to be cut to accommodate the new building footprint and so the tree could be retained.

Fig 14. Photo of tree T13 an *Allocasuarina cunninghamiana*

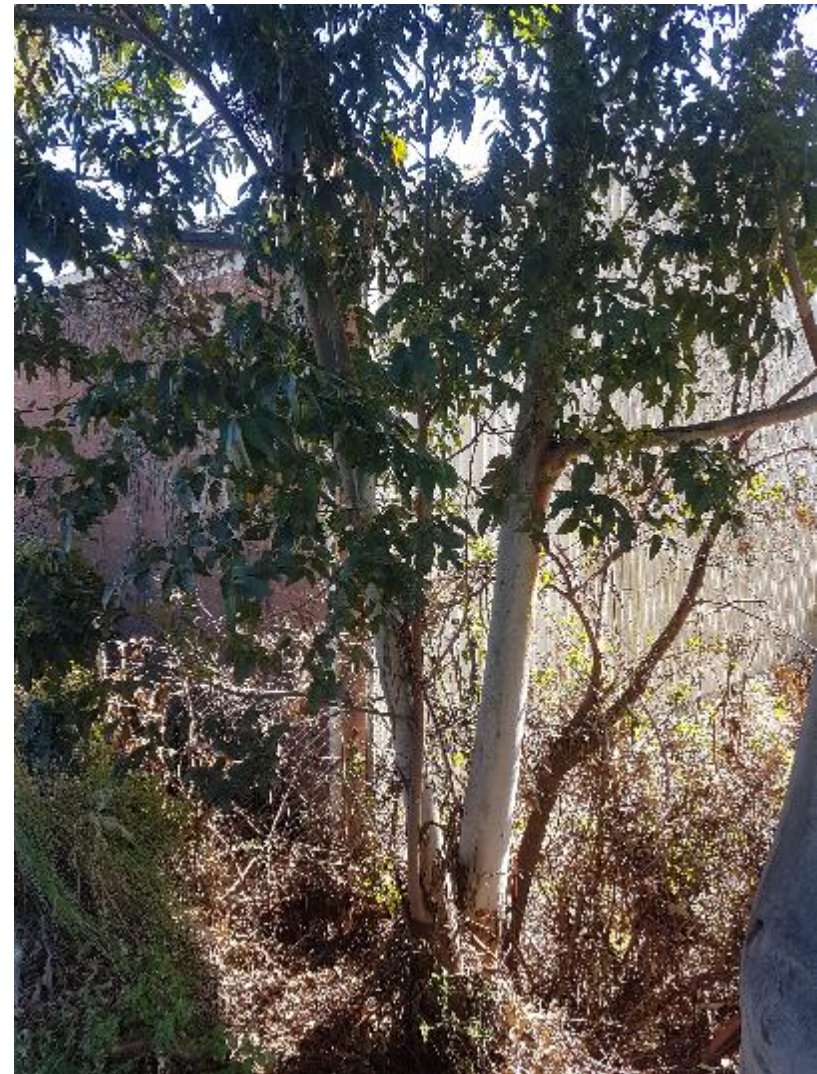
- **T16** is growing in the nature strip to the South East of the Site and was in good health and condition (See Fig. 17). The tree is a Council asset and is suppressed in its growth by surrounding vegetation. Consequently the tree is fairly small and would only receive a Minor Encroachment into its TPZ from the proposed building footprint

See Fig. 16.							
T16 <i>Eucalyptus saligna</i> Common name 'Sydney Blue Gum' Age class 20 years See Fig. 17	7m	1 x 24cm 1 x 16cm 40cm at the base	N 3m E 1m S 3m W 2m	A native species native to East coast NSW and the Sydney basin which is growing in the nature strip near the Southern border of the Site. The specimen is a IWC asset. The tree was in suppressed condition at the time of inspection with no significant pathogens nor defects apparent. The tree has co dominant stems adjoining in a saddle shape at 0.5m from the ground. The tree is located 1.9m from the border fence.	A2	3.46m	2.25m
T17 <i>Eucalyptus saligna</i> Common name 'Sydney Blue Gum' Age class 20 years See Fig. 18	20m	77cm 79cm at the base	N 10m E 5m S 6m W 4m	A native species native to East coast NSW and the Sydney basin which is growing in the nature strip near the Southern border of the Site. The specimen is a IWC asset. The tree was in good condition at the time of inspection with no significant pathogens nor defects apparent. The tree is located 2.3m from the border fence and there is a bias in the crown towards the North.	A1	9.24m	3m

Fig. 17. Photo of T16 a *Eucalyptus saligna*

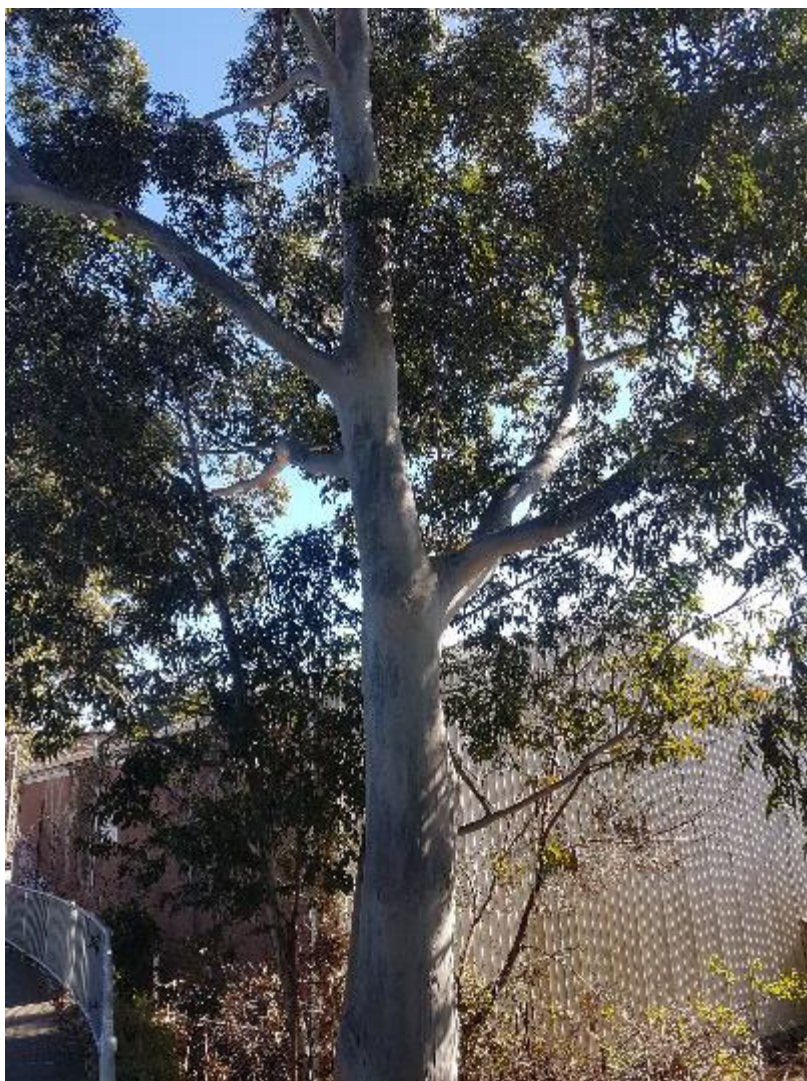
- **T17** is growing in the nature strip to the South East of the site and was in good health and condition. The tree is also a IWC asset and a planted specimen (See Fig. 18). The tree is quite large and will be subjected to a Major Encroachment into its TPZ from the proposed building footprint. Subsequently a tree root investigation has been undertaken which indicates that there are no structural roots in the building footprint within 200mm of the existing surface levels (See Figs. 31, 32 & 34).

Fig 18. Photo of tree T17 a *Eucalyptus saligna*

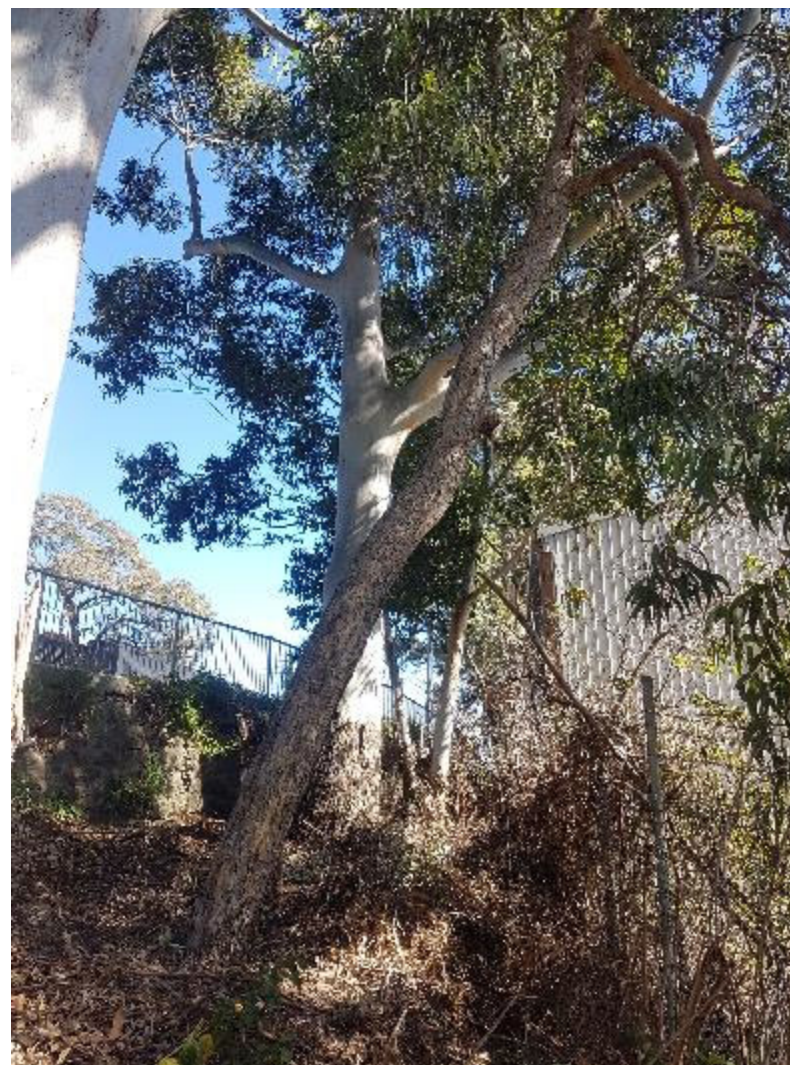
4.7 Tree **T18** is a *Corymbia eximia* or ‘Yellow Bloodwood’ which is a planted specimen that is endemic to the Sydney region usually found on Sandstone outcrops. The tree has been planted in the nature strip to the East of the Site and is an IWC asset. The tree was in suppressed condition at the time of inspection and has a strong bias in its main stem to the North (See Fig. 19).

The tree has a relatively small TPZ and would only experience a Minor encroachment into its TPZ (See Appendix 2a & 2b). Some outer branches will need to be pruned from this tree to allow for the new building walls.

T18 <i>Corymbia eximia</i> Common name 'Yellow Bloodwood' Age class 20 years See Fig. 19	9m	27cm 30cm at the base	N 5m E 1m S 2m W 3m	A native species native to East coast NSW and the Sydney region which is growing in the nature strip near the Southern border of the Site. The specimen is a IWC asset. The tree was in suppressed condition at the time of inspection with no significant pathogens nor defects apparent and a strong bias in its main stem to the North. The tree is located 1.8m from the border fence.	A1	3.24m	2m
T19 <i>Eucalyptus saligna</i> Common name 'Sydney Blue Gum' Age class 40 years See Fig. 20	20m	69cm 78cm at the base	N 10m E 7m S 8m W 4m	A native species native to East coast NSW and the Sydney basin which is growing in the nature strip near the Southern border of the Site. The specimen is a IWC asset. The tree was in good health and condition at the time of inspection with no significant pathogens nor defects apparent. The tree is located 1.8m from the	A1	8.28m	2.98m

Fig. 19. Photo of T18 a *Corymbia gummiifera*

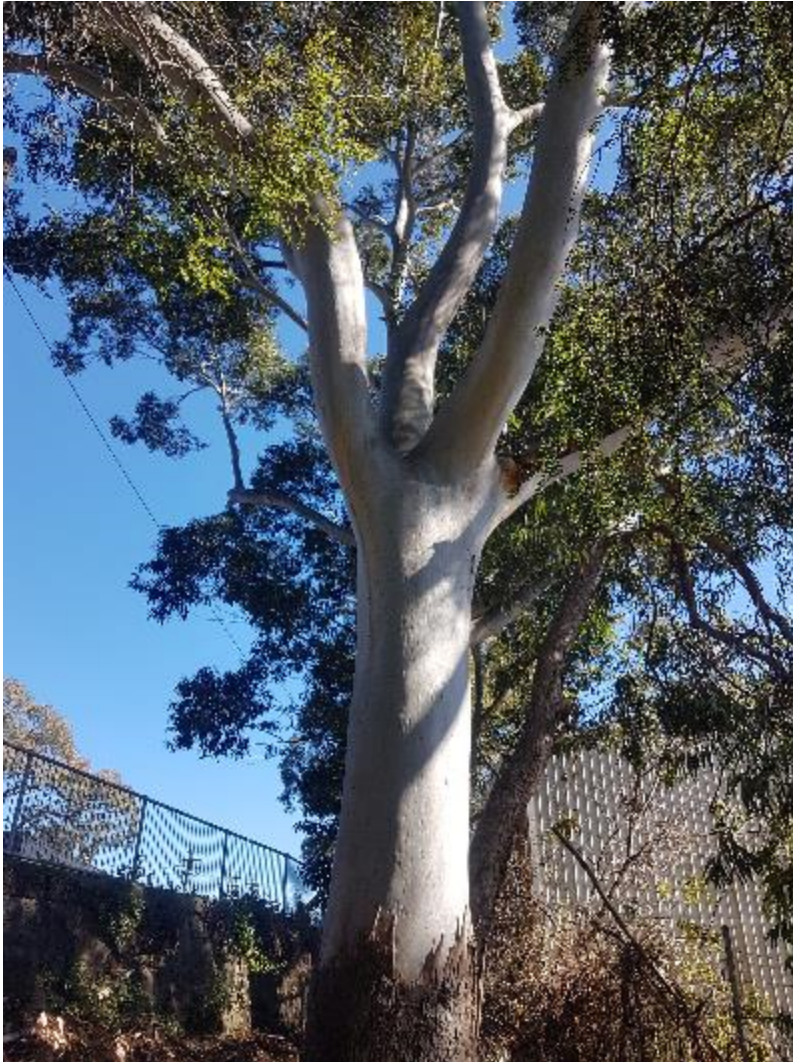
- **T19** is growing in the nature strip to the South East of the site and was in good health and condition. The tree is also a IWC asset and a planted specimen. The tree is quite large and will be subjected to a Major Encroachment into its TPZ from the proposed building footprint. Subsequently a tree root investigation has been undertaken which indicates that there are no structural roots in the building footprint within 200mm of the existing surface levels (See Figs. 31, 32 & 34).

Fig 20. Photo of tree T19 a *Eucalyptus saligna*

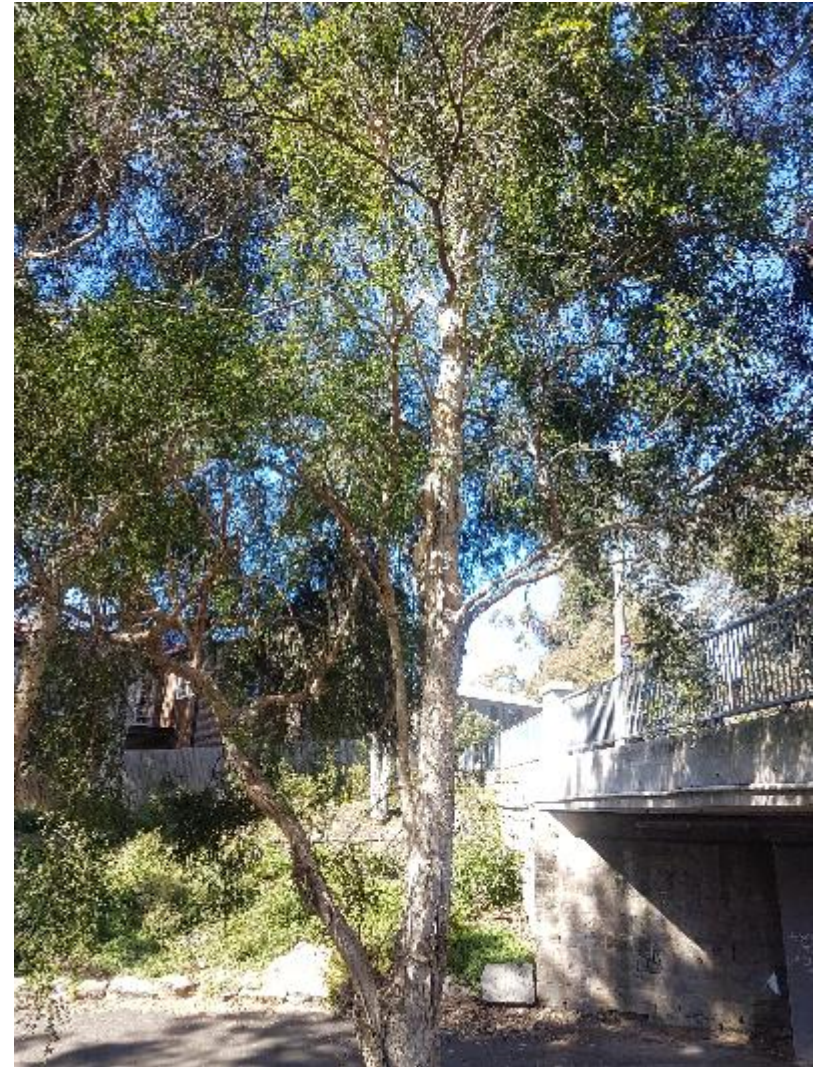
border fence. There is a bias in the crown towards the North.			
T20 <i>Melaleuca styphelioides</i> Common name 'Prickly leaved Paperbark' Age class 20 years See Fig. 21	10m	27cm 29cm at the base	N 3m E 3m S 3m W 2m	A native species native to East coast NSW and the Cumberland plain which is growing in the nature strip near the Southern border of the Site. The specimen is a IWC asset. The tree was in good health condition at the time of inspection with no significant pathogens nor defects apparent. The tree is located 5m from the border fence.	A1	3.24m	1.96m
T21 <i>Melaleuca styphelioides</i> Common name 'Prickly leaved Paperbark' Age class 20 years See Fig. 22	10m	1 x 11cm 1 x 32cm 36cm at the base	N 5m E 4m S 4m W 4m	A native species native to East coast NSW and the Cumberland plain which is growing in the nature strip near the Southern border of the Site. The specimen is a IWC asset. The tree was in good health condition at the time of inspection with no significant pathogens nor defects apparent. The tree is located 2.2m from the border fence.	A1	4.13m	2.15m

Fig. 21. Photo of T20 a *Melaleuca styphelioides*

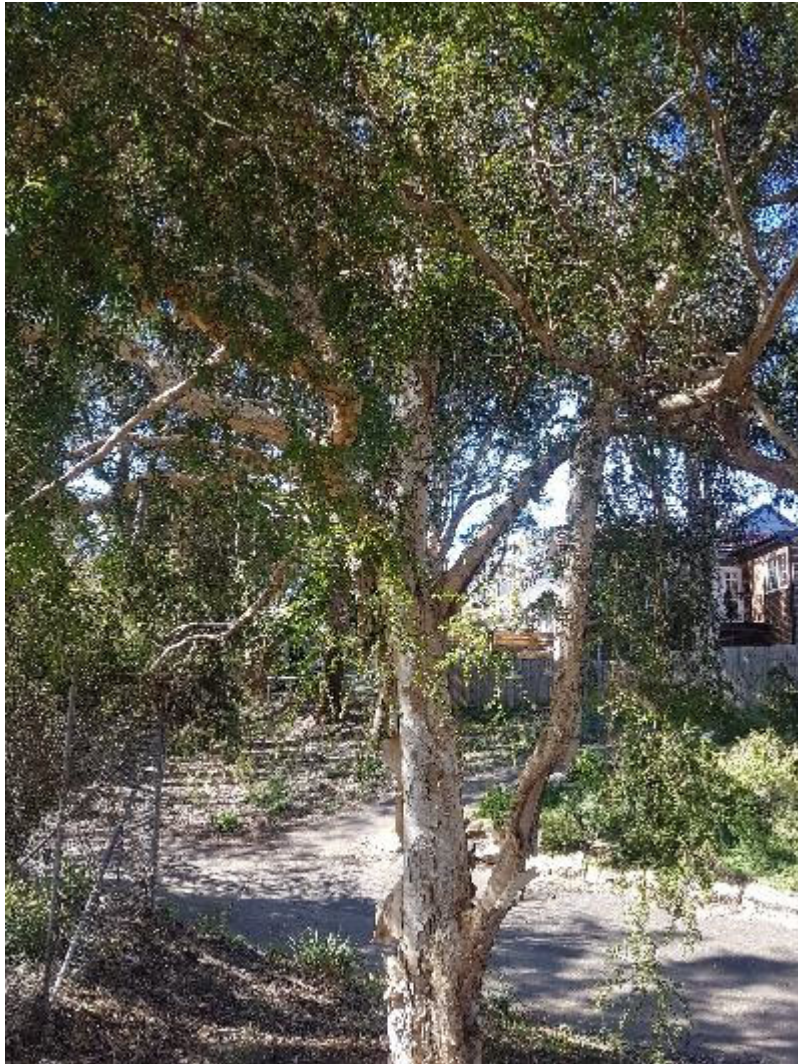
Fig 22. Photo of tree T21 a *Melaleuca styphelioides*

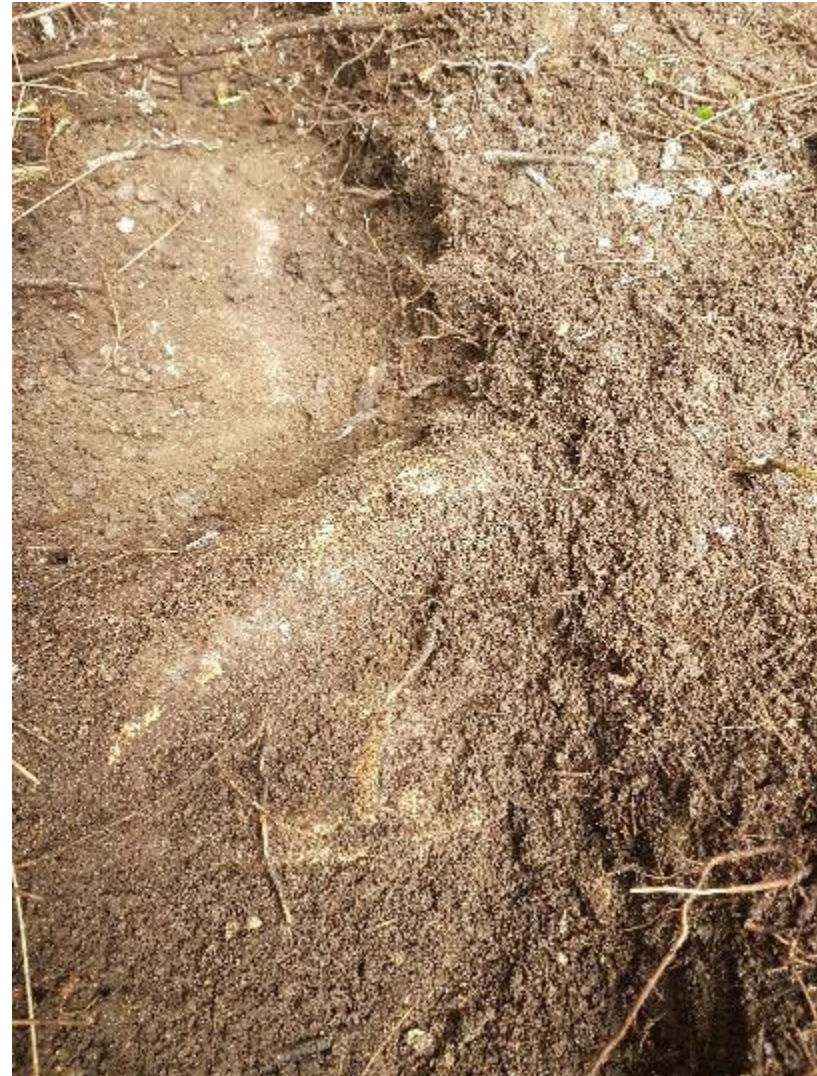
Fig. 27. Photo of 1 x 60mm tree root from T14

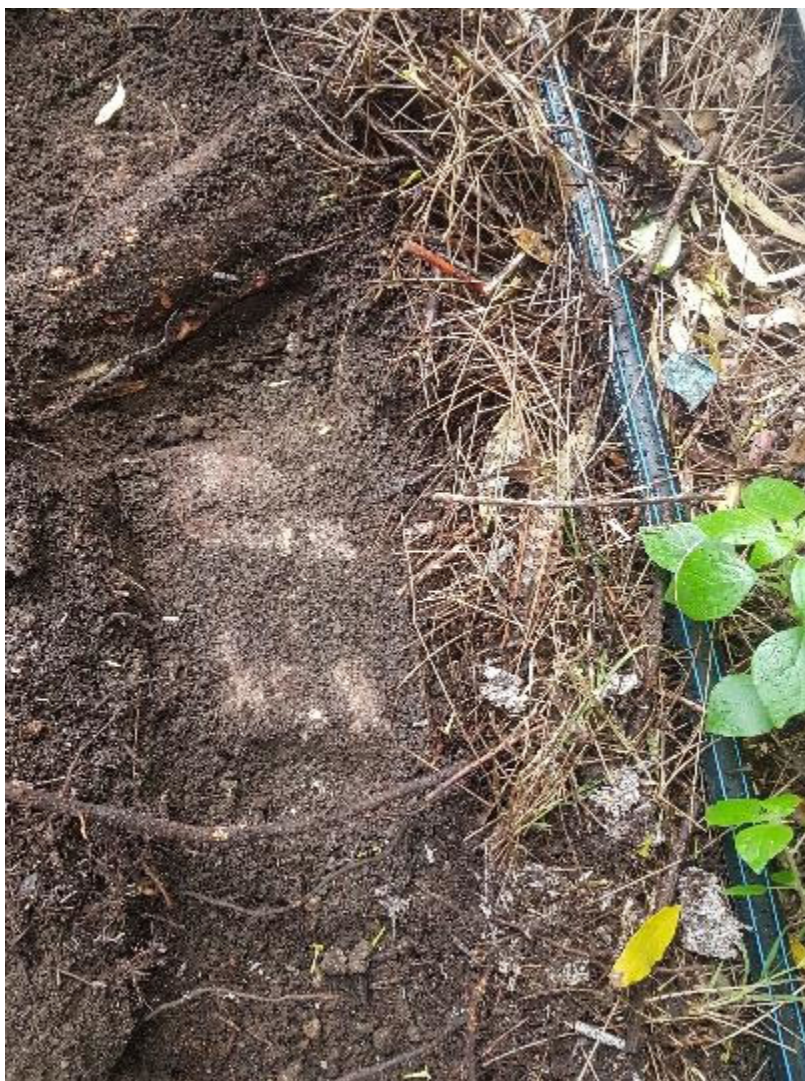
Fig 28. Photo of 1 x 80mm tree root near tree T14

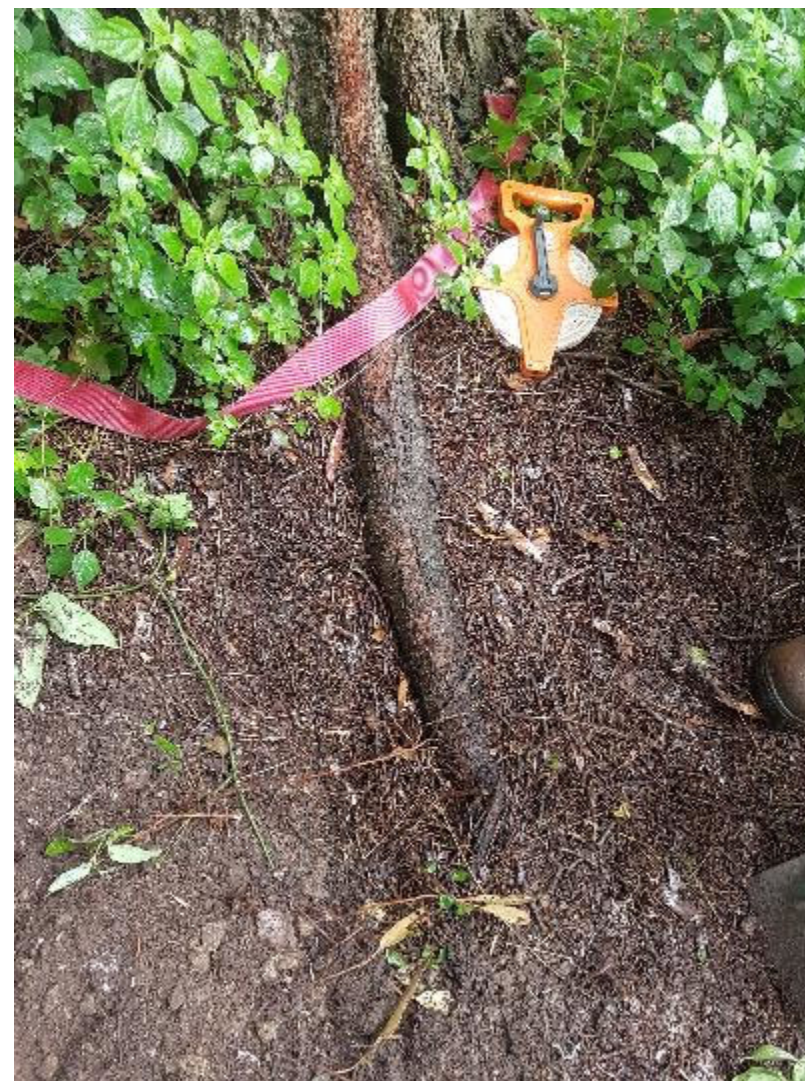
Fig. 29. Photo of root buttress from connected to 80mm Ø root from T14

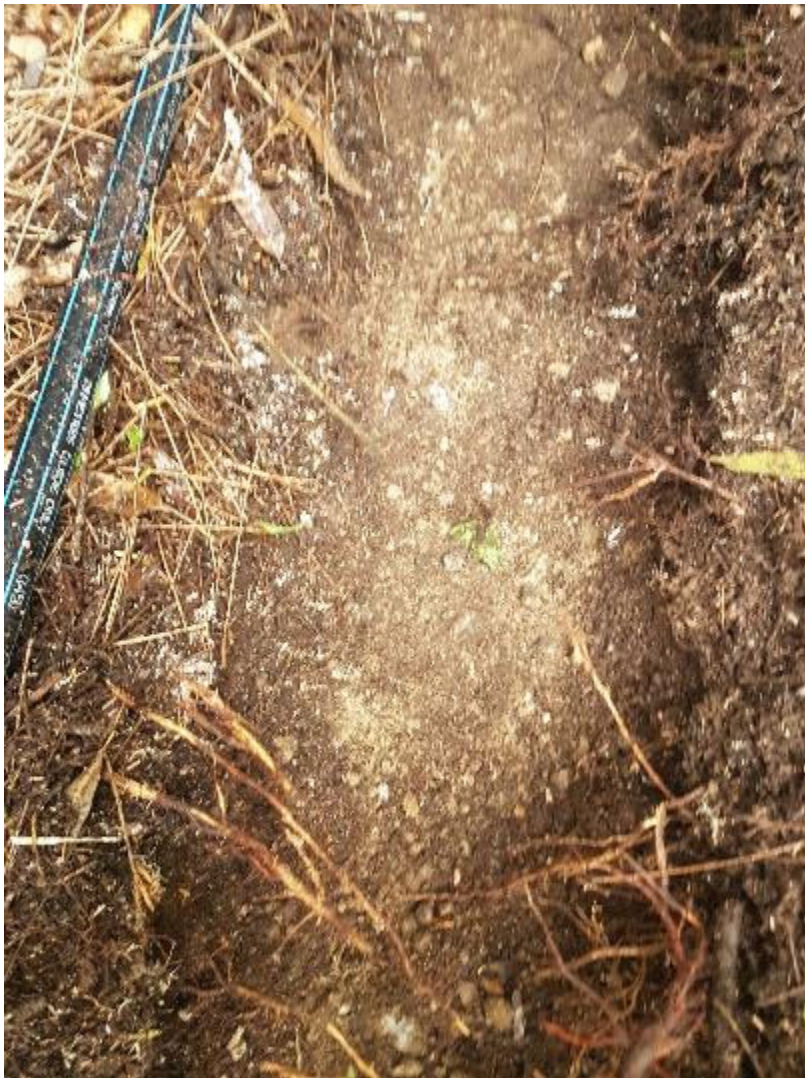
The specimen is growing on hard packed subgrade and has a shallow root system (See Fig. 30).

Fig 30. Photo of hard compacted layer of gravel and sand in trench 1

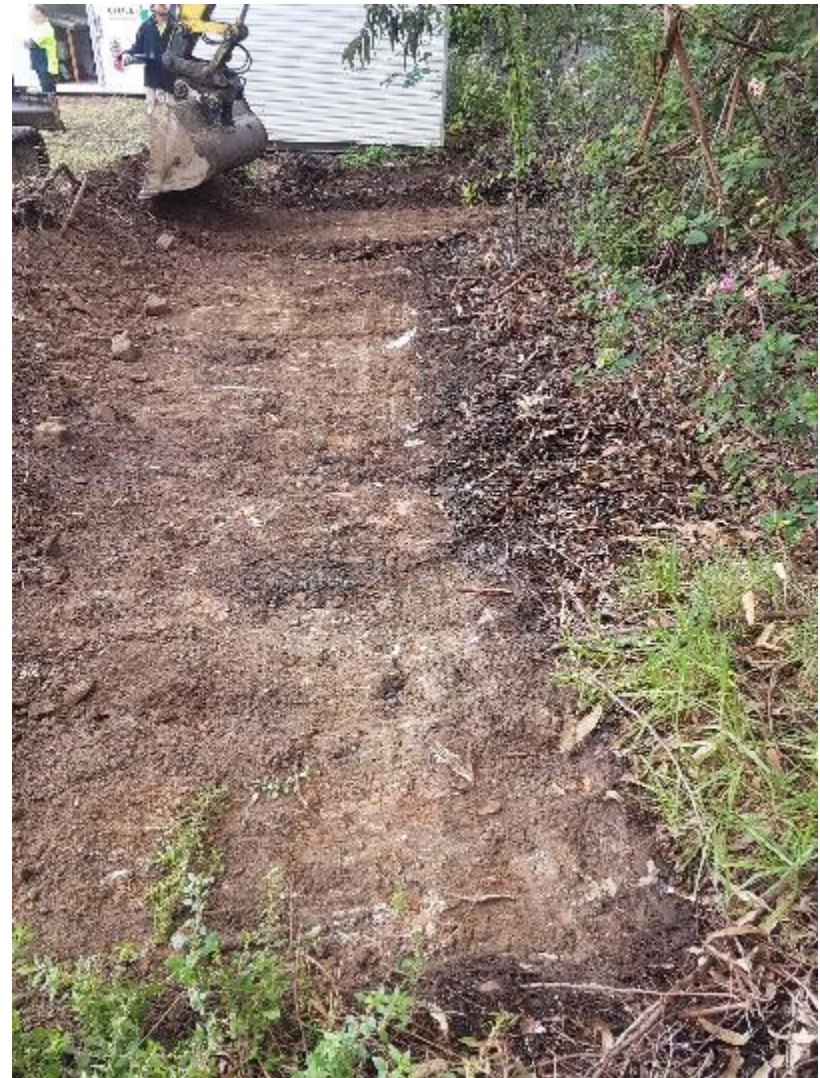
Fig. 31. Trench 1 dug using blade bucket along Sth building line

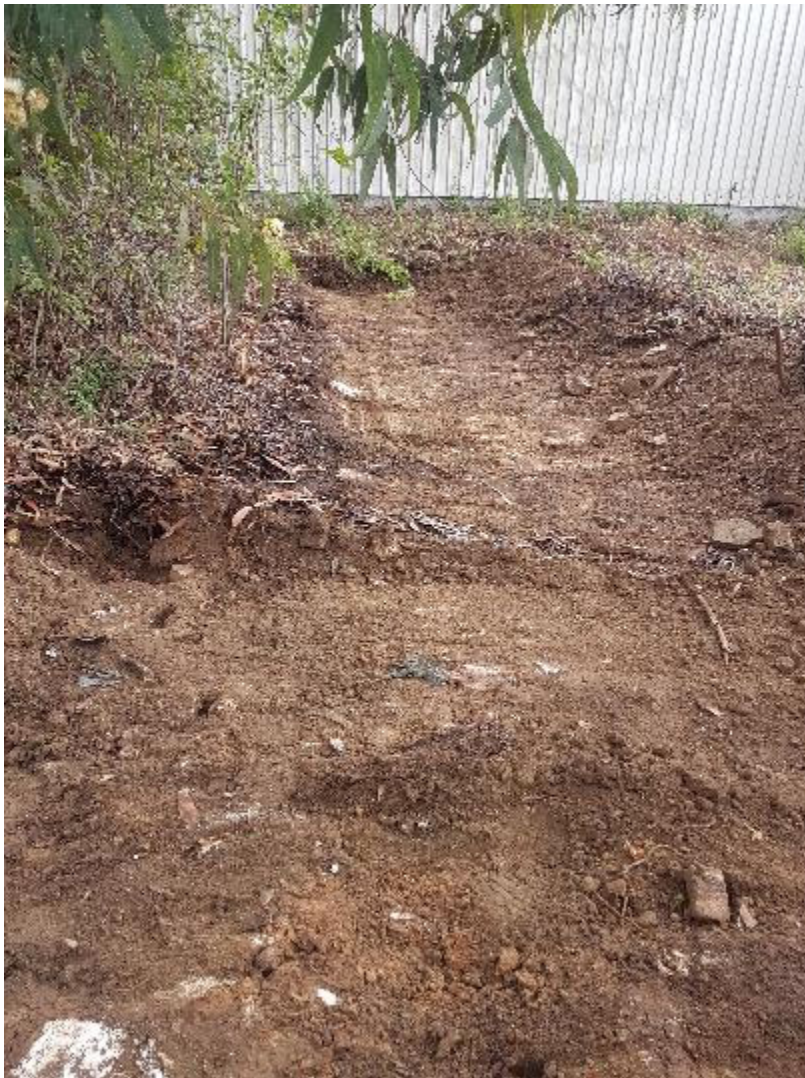
Fig 32. Photo of hard compacted layer of gravel and sand in trench 1

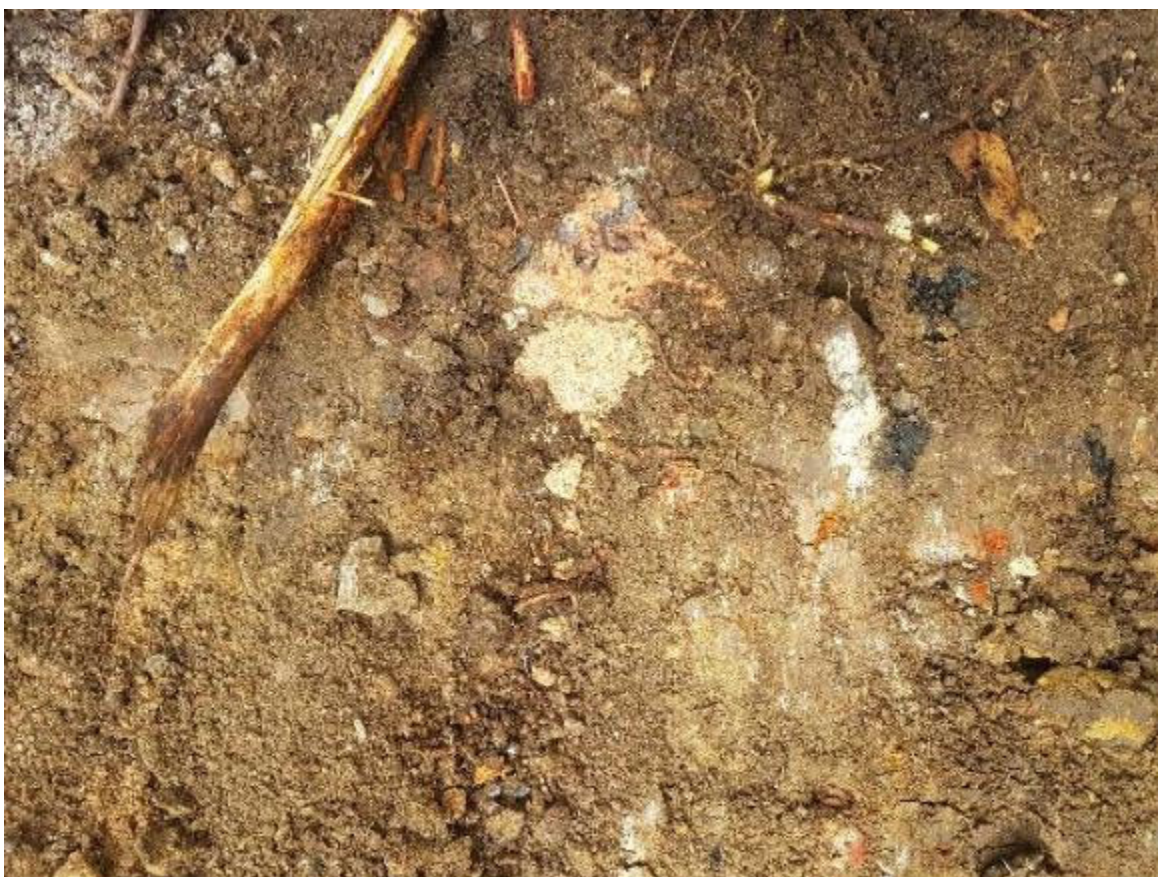
Fig 34 photo of soil profile showing fill material with small tree roots < 20mm Ø

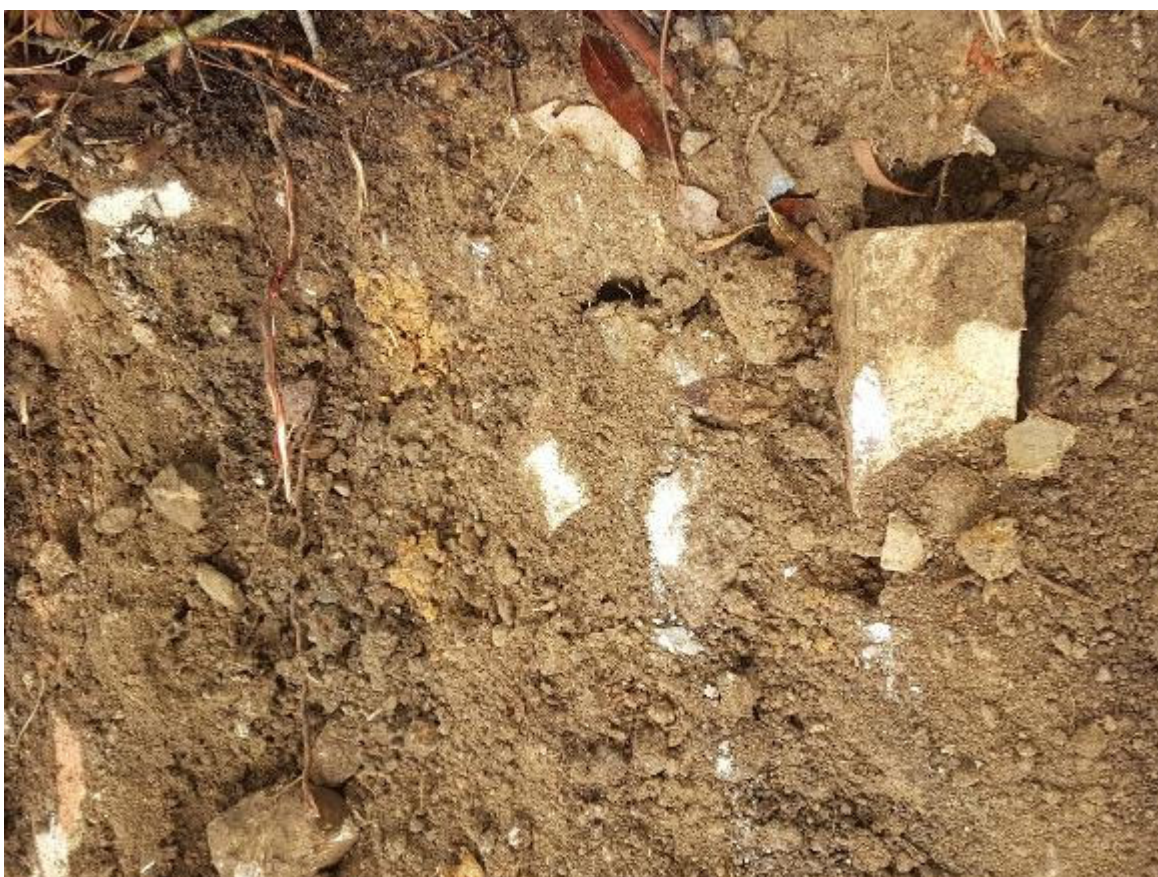
Fig 35 Photo of soil profile showing fill material with small tree roots < 20mm Ø
